# SAFETYVISION AI

INDUSTRIAL VISUAL SAFETY INSPECTION AUDIT REPORT

| Inspection ID: INS-20261007-7EDC37 | Date/Time: 2026-10-07 07:54:39 |
| Equipment Type: Industrial Angle Grinder | Model Version: 0.1.0 |

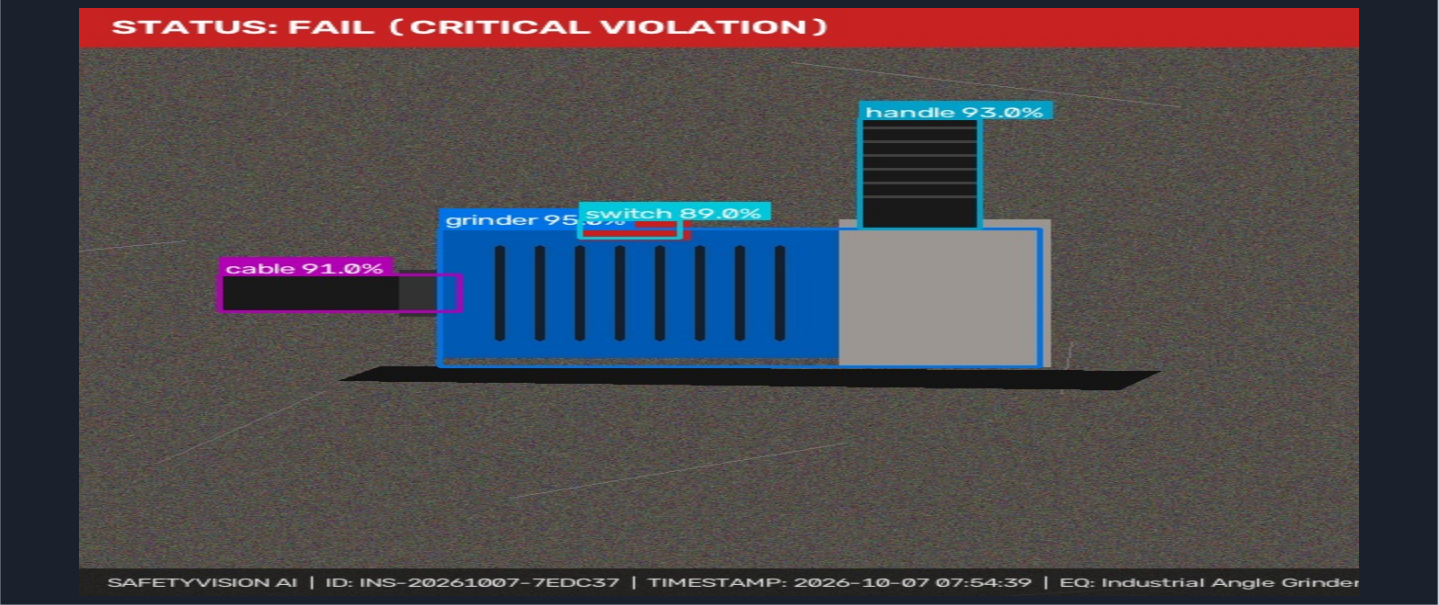
OVERALL RESULT: FAIL — CRITICAL VIOLATION

| Component | Mandatory | Detection Status | Confidence | Severity | Audit Finding |
|---|---|---|---|---|---|
| Protective Wheel Guard | YES | FAIL | N/A | CRITICAL | Abrasive wheel guard is missing. Operating wi... |

**Root Evaluation:** FAIL — Missing mandatory components: guard.

**Recommended Action:** Do NOT operate tool. Lockout/tagout equipment immediately and schedule a certified competent-person mechanical and electrical safety inspection.
