**CONDITION BASED ASSESSMENT  
QUICK SCANNING REPORT  
SBUM DIAGNOSTIC PAHANG  
TNB BAHAGIAN PEMBAHAGIAN PAHANG**

| SUBSTATION NAME (ERMS) | : | JALAN ROBINSON |
| SUBSTATION TYPE | : | PAT+RMU |
| DATE | : | 01 JUN 2026 |

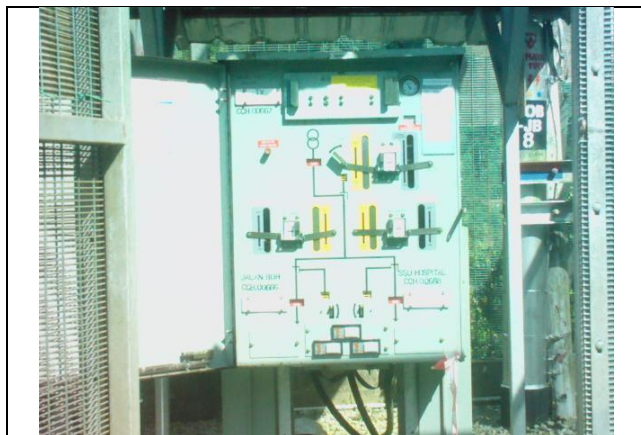
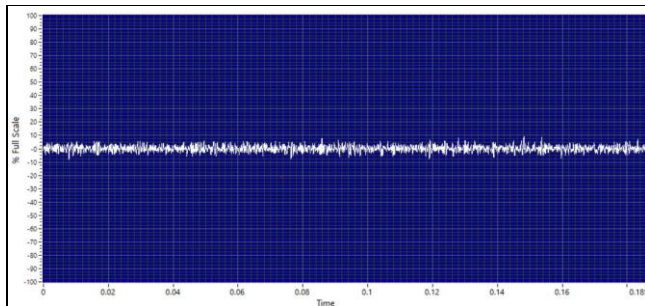
| | Area | OVERVIEW | | | Panel No. |

| PARAMETER | VALUE |
|---|---|
| Average Temp. (Ar1) | 38.1 °C |

**Analysis:** No Anomaly.

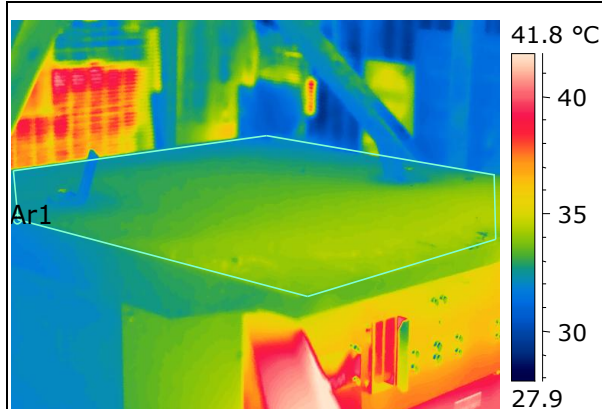
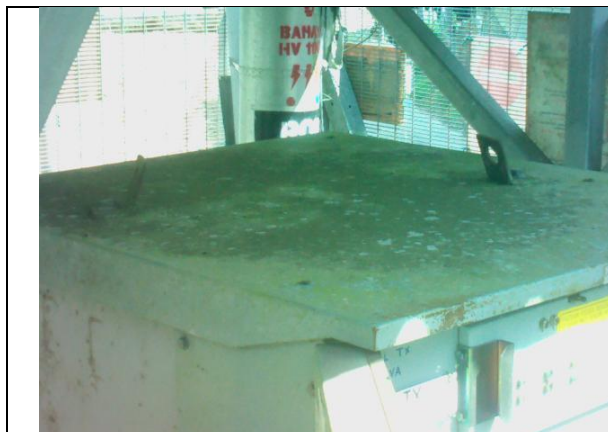
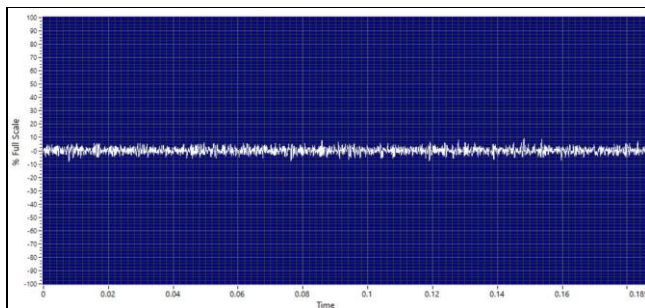
| | Area | OVERVIEW TOP | | Panel No. | - |

| PARAMETER | VALUE |
|---|---|
| Average Temp. (Ar1) | 33.4 °C |

**Analysis:** No Anomaly.

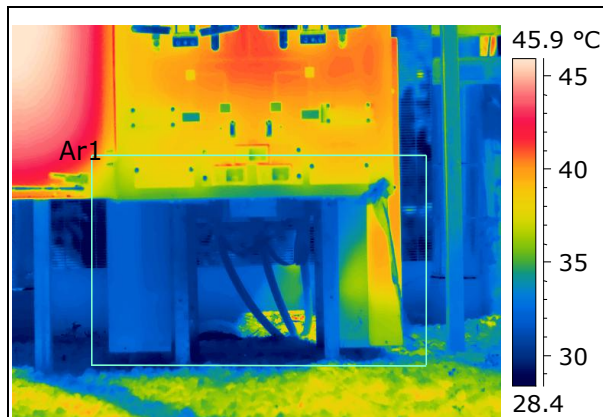
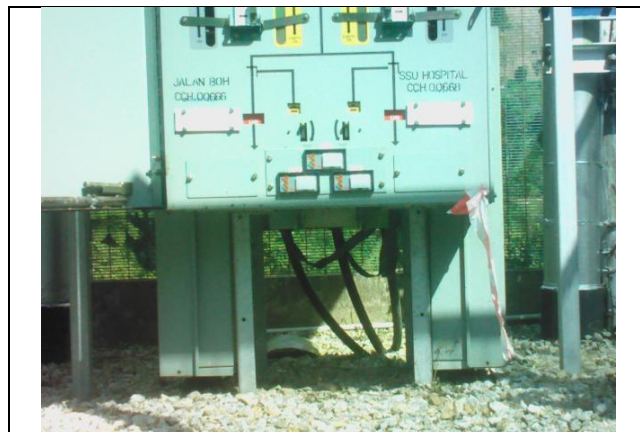
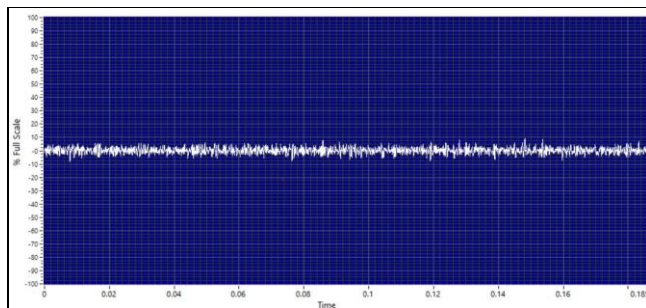
| | Area | OVERVIEW BOTTOM | | Panel No. | - |

| PARAMETER | VALUE |
|---|---|
| Average Temp. (Ar1) | 33.0 °C |

**Analysis:** No Anomaly.

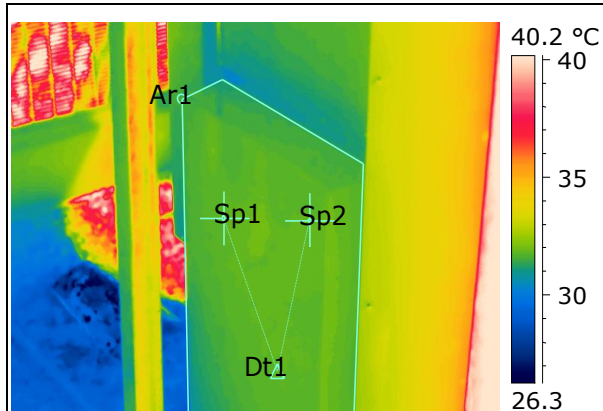
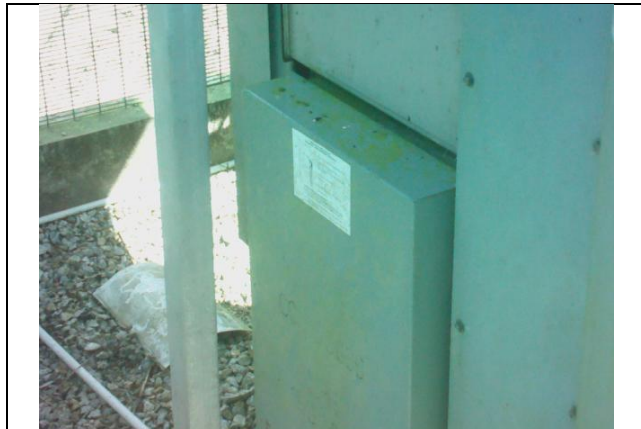
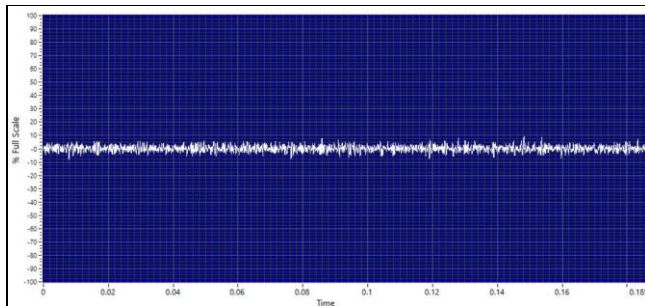
| | Area | CABLE COMPARTMENT | Panel No. | CCH00666 | |

| PARAMETER | VALUE |
|---|---|
| Delta T ( $\Delta T$ ) | 0.0 °C |

**Analysis:** No Anomaly.

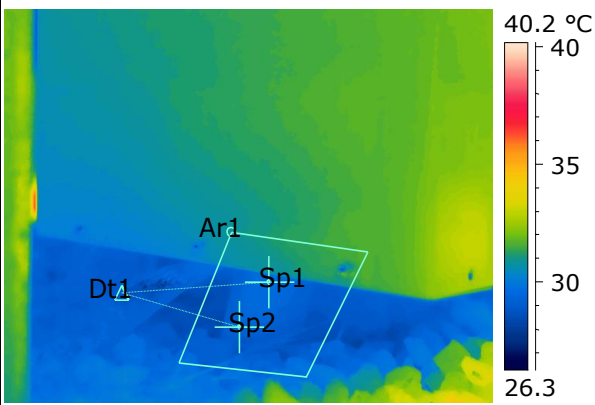
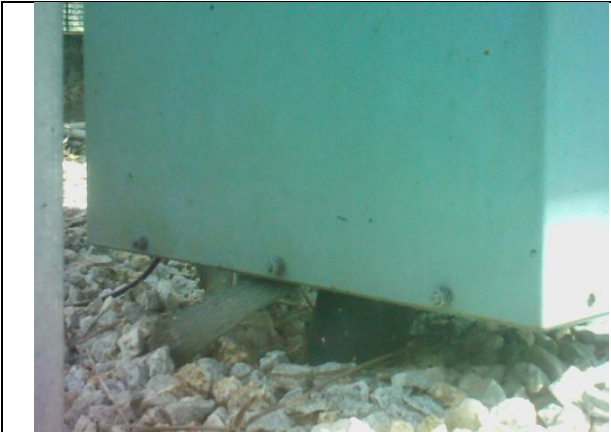
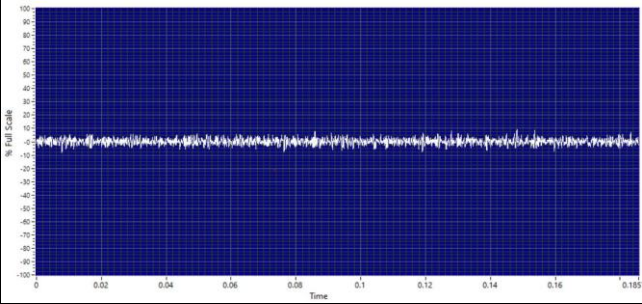
| | Area | CABLE ENTRY | | Panel No. | CCH00666 |

| IR IMAGE | | VISUAL IMAGE | |
|---|---|---|---|
| Delta T ( Δ T) | 0.4 °C | Cable Type | XLPE |

**Analysis:** No Anomaly.

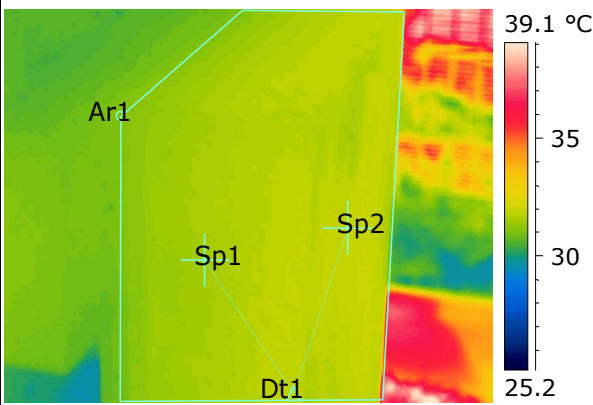
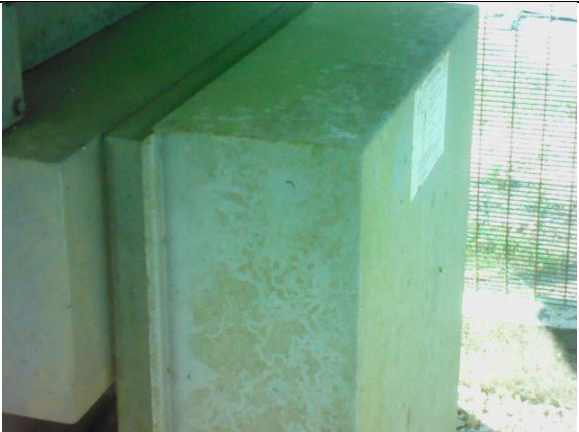
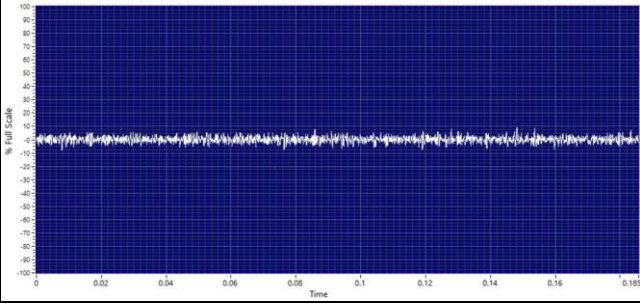
| | Area | CABLE COMPARTMENT | | Panel No. | CCH00667 |

| IR IMAGE | | VISUAL IMAGE | |
|---|---|---|---|
| Delta T ( Δ T) | 0.4 °C | Cable Type | XLPE |

| ULTRASOUND IMAGE | |
|---|---|
| <b>Analysis:</b> No Anomaly. | |

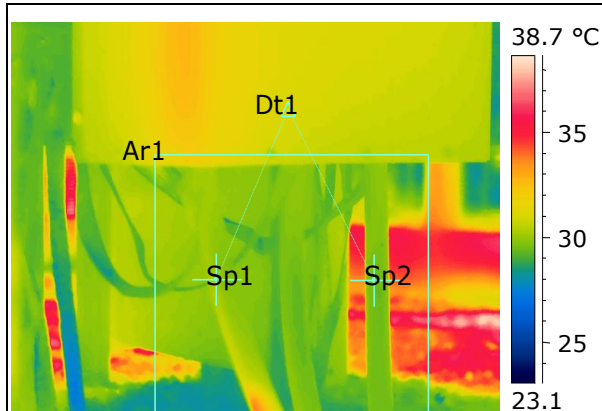
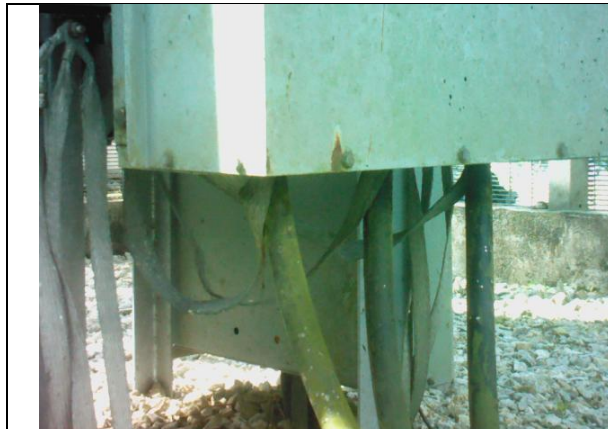
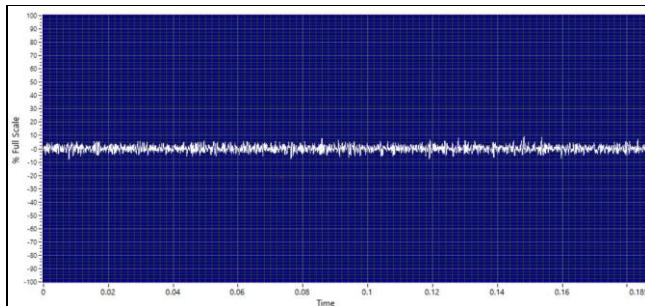
| | Area | CABLE ENTRY | | Panel No. | CCH00667 |

| PARAMETER | VALUE |
|---|---|
| Delta T ( $\Delta T$ ) | 0.5 °C |

**Analysis:** No Anomaly.

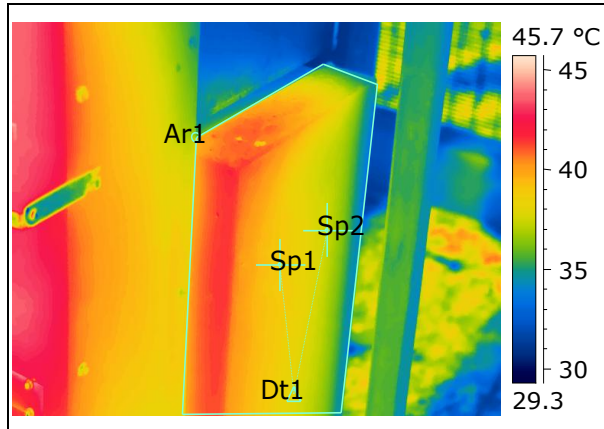
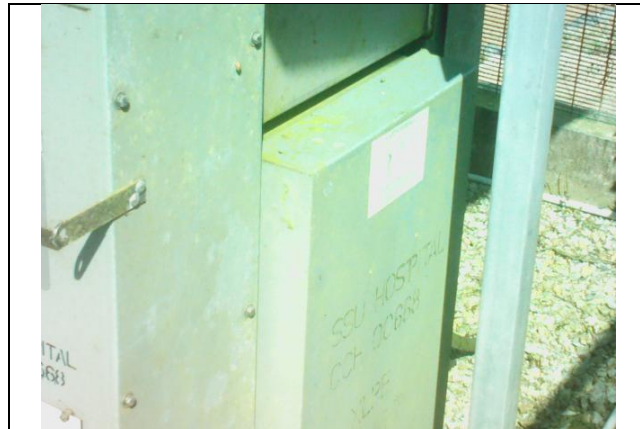
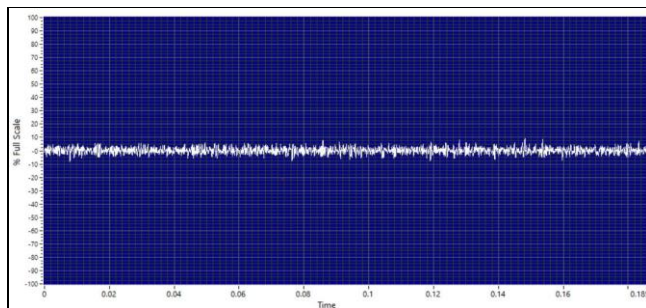
| | Area | CABLE COMPARTMENT | Panel No. | CCH00668 | |

| PARAMETER | VALUE |
|---|---|
| Delta T ( $\Delta T$ ) | 0.4 °C |

**Analysis:** No Anomaly.

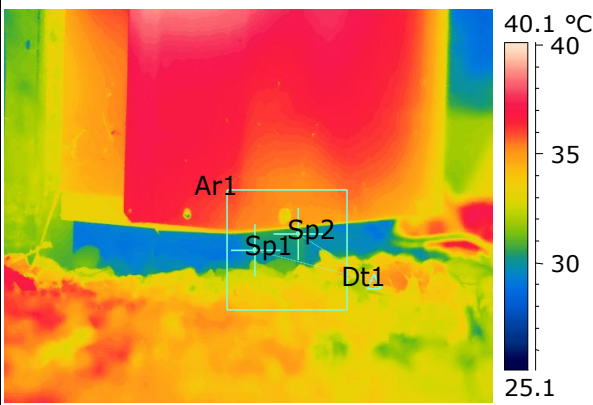
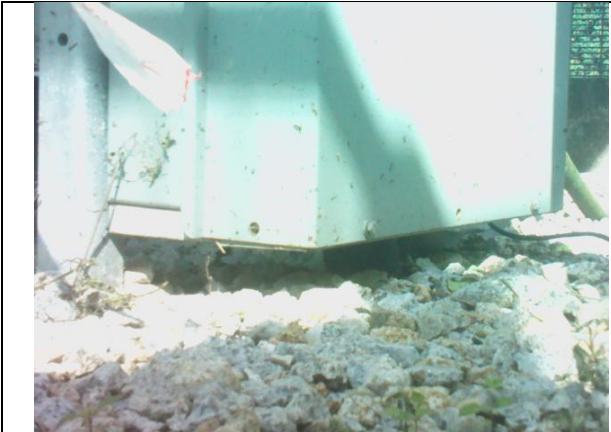
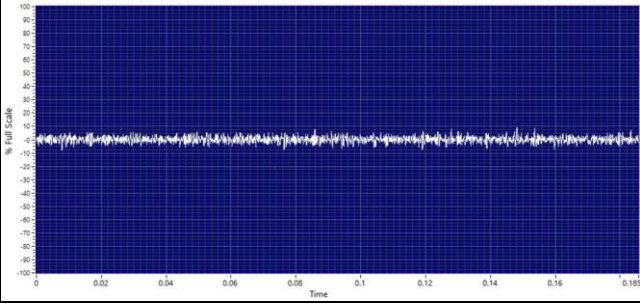
| | Area | CABLE ENTRY | | Panel No. | CCH00668 |

| IR IMAGE | | VISUAL IMAGE | |
|---|---|---|---|
| Delta T ( Δ T) | 0.6 °C | Cable Type | XLPE |

**Analysis:** No Anomaly.

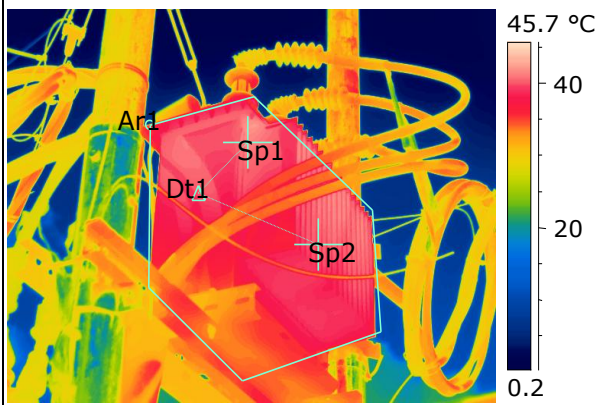
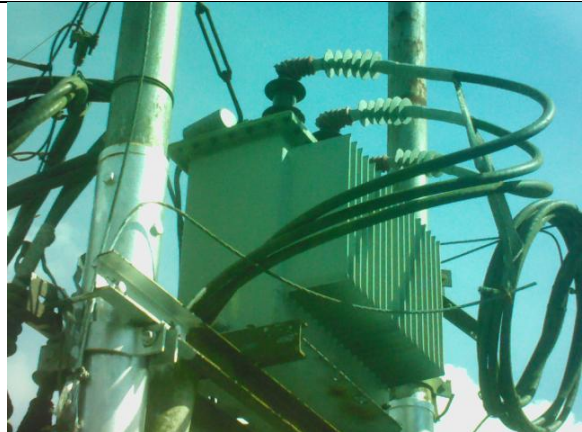
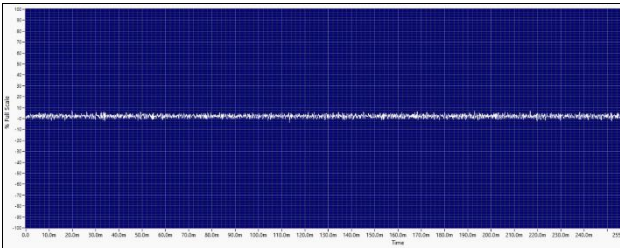
| | Area | OVERVIEW | | Tx No. | 1 |

| IR IMAGE | | VISUAL IMAGE | | | | | | | | | | | | | | | | | | | | | | | | | | | | | |
|---|---|---|---|---|---|---|---|---|---|---|---|---|---|---|---|---|---|---|--|---|---|---|---|---|---|---|---|---|---|---|---|
| Delta T ( Δ T) | 0.8 °C | | | | | | | | | | | | | | | | | | | | | | | | | | | | | | |
| Analysis: No Anomaly. | | | | | | | | | | | | | | | | | | | | | | | | | | | | | | | |

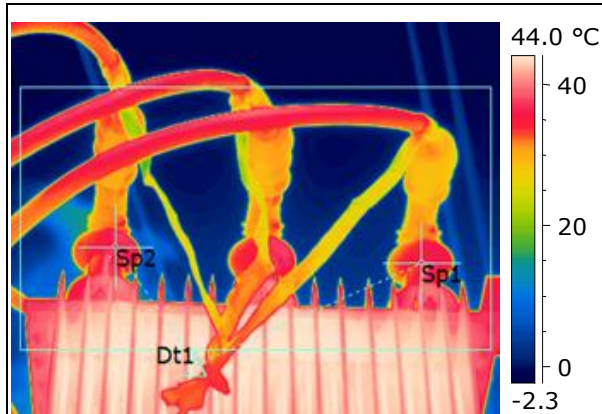
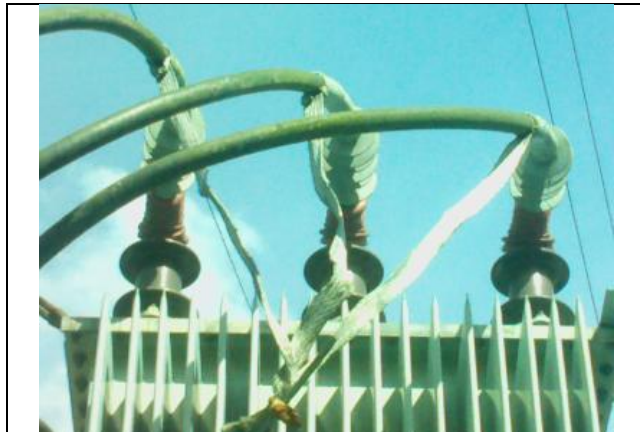
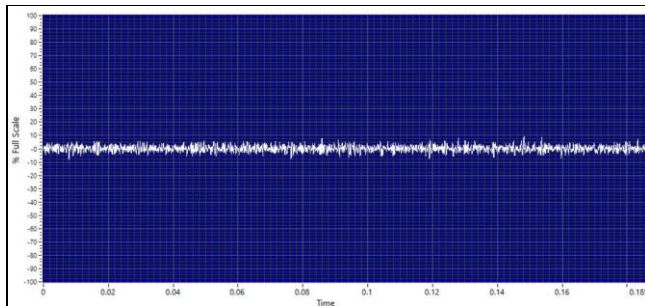
| | Area | BUSHING | | Tx No. | 1 |

| PARAMETER | VALUE |
|---|---|
| Delta T ( $\Delta T$ ) | 0.2 °C |

**Analysis:** No Anomaly.

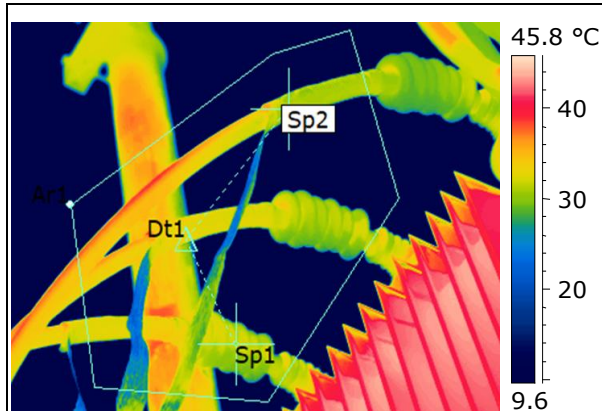
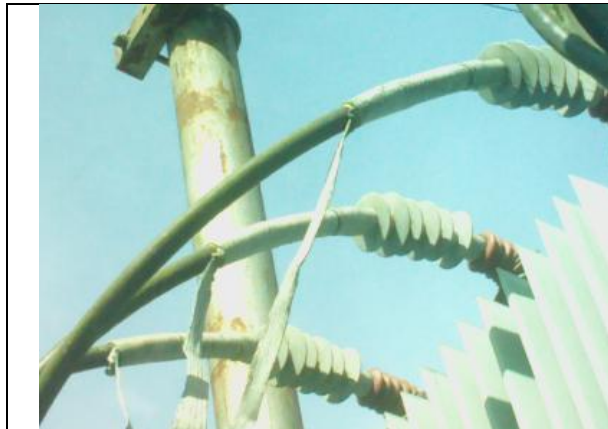
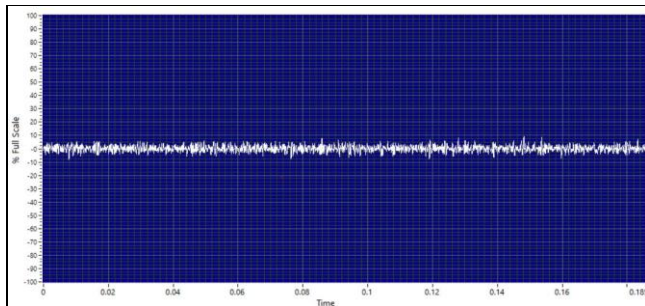
| | Area | CABLE | Tx No. | 1 | |

| PARAMETER | VALUE |
|---|---|
| Delta T ( $\Delta T$ ) | 0.2 °C |

**Analysis:** No Anomaly.

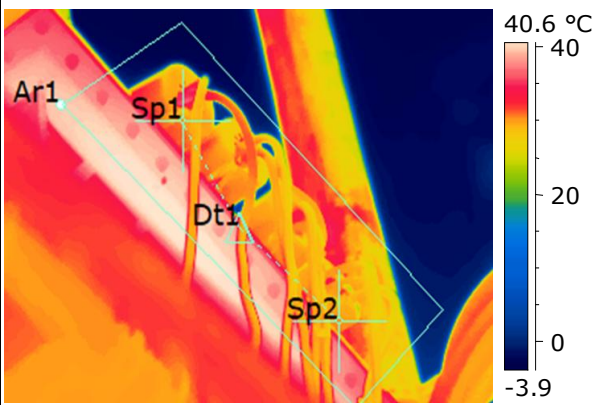
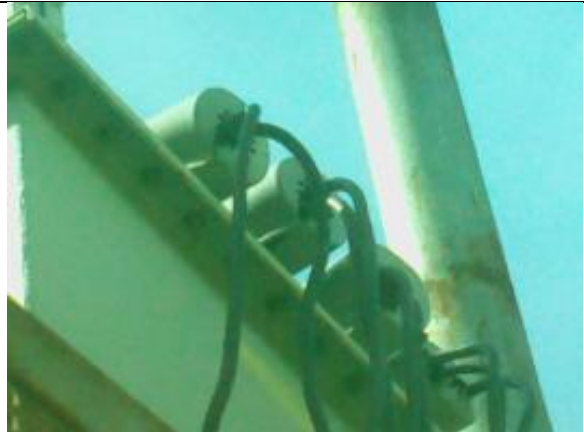
| | Area | BUSHING | | Tx No. | 1 |

| IR IMAGE | | VISUAL IMAGE | |
|---|---|---|---|
| Delta T ( $\Delta T$ ) | 0.3 °C | Cable Type | XLPE |

**Analysis:** No Anomaly.

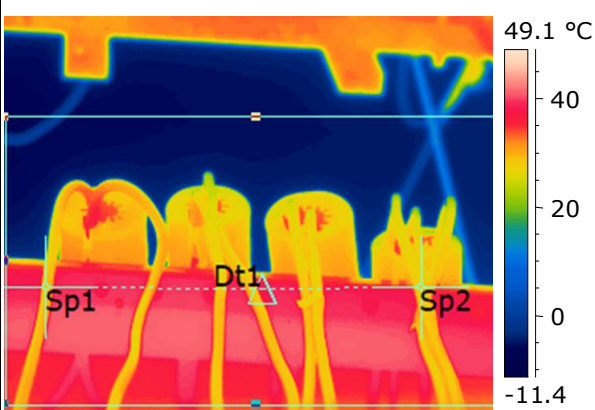
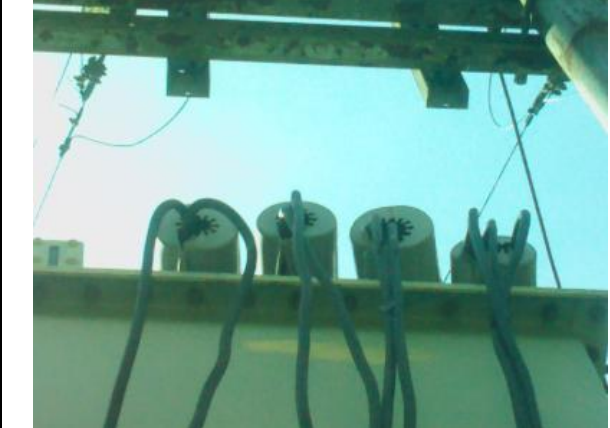
| | Area | CABLE | | Tx No. | 1 |

| IR IMAGE | | VISUAL IMAGE | |
|---|---|---|---|
| Delta T ( Δ T) | 0.0 °C | Cable Type | XLPE |

**Analysis:** No Anomaly.

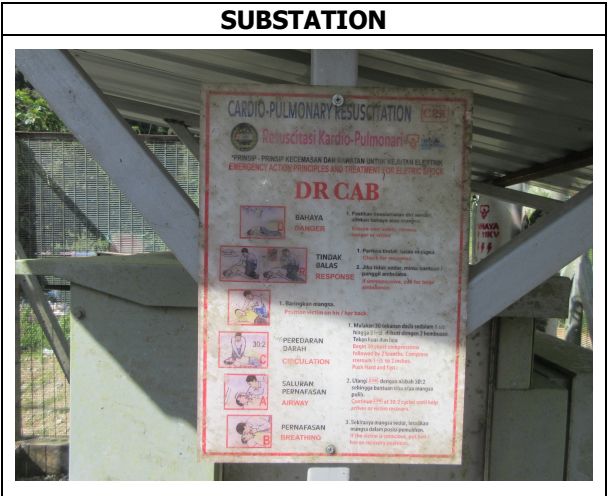
CPR POSTER OLD VERSION – SWG BAY
