| | Substation | JALAN ROBINSON | | | Date: 01/06/2026 |
| | Equipment | RMU SF6 | Manufacturer | TAMCO | Time: 4:02 PM |
| | Model | GR1 | Rating | 12kV | Humidity: 77% |

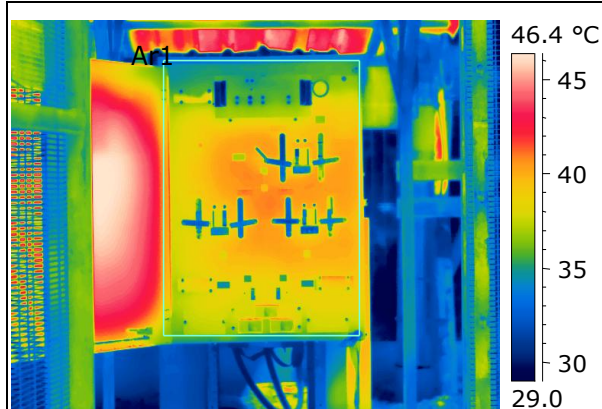
| | Area | OVERVIEW | | | Panel No. |

| PARAMETER | VALUE |
|---|---|
| Average Temp. (Ar1) | 38.1 °C |
| Ambient Temp. | 23.2 °C |

**Analysis:** No Anomaly.

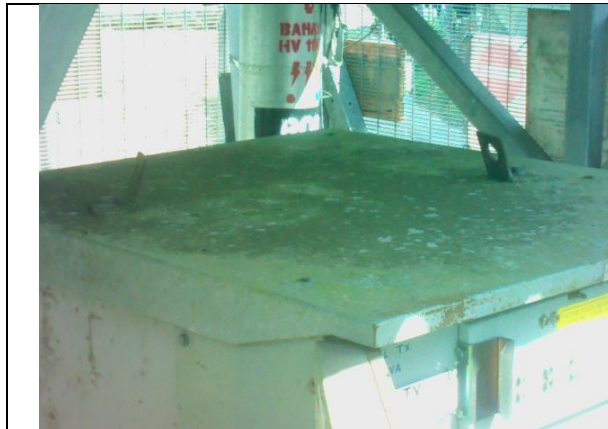
| | Area | OVERVIEW TOP | | Panel No. | - |

| PARAMETER | VALUE |
|---|---|
| Average Temp. (Ar1) | 33.4 °C |
| Ambient Temp. | 23.2 °C |

**Analysis:** No Anomaly.

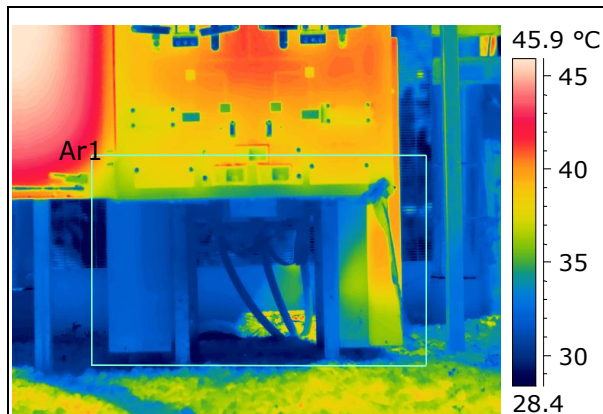
| | Area | OVERVIEW BOTTOM | | Panel No. | - |

| PARAMETER | VALUE |
|---|---|
| Average Temp. (Ar1) | 33.0 °C |
| Ambient Temp. | 23.2 °C |

**Analysis:** No Anomaly.

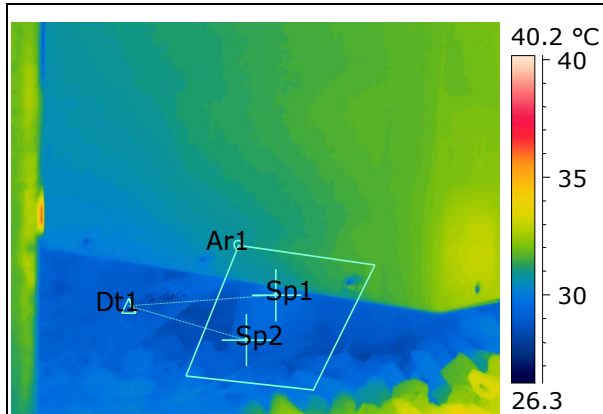
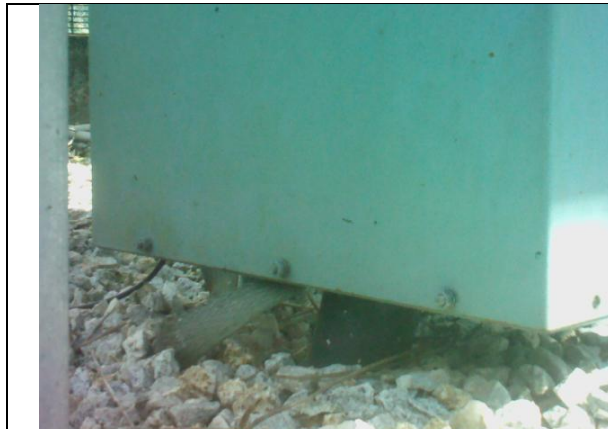
| | Area | CABLE ENTRY | | Panel No. | CCH00666 |

| PARAMETER | VALUE |
|---|---|
| Spot Temp.1 (Sp1) | 29.7 °C |
| Spot Temp. 2 (Sp2) | 29.3 °C |
| Delta T ( $\Delta T$ ) | 0.4 °C |

| Decibel (dB) | 0dB |
| Sound characteristic | Normal |

**Analysis:** No Anomaly.

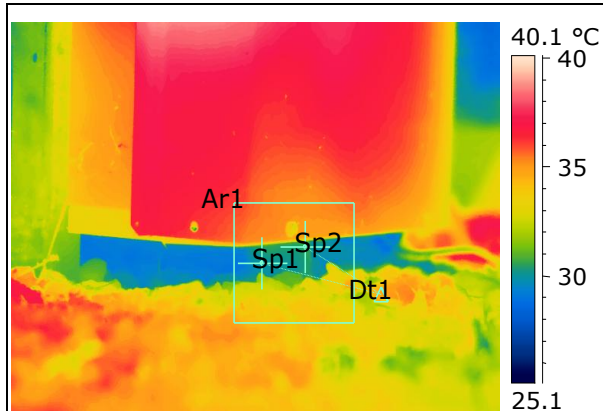
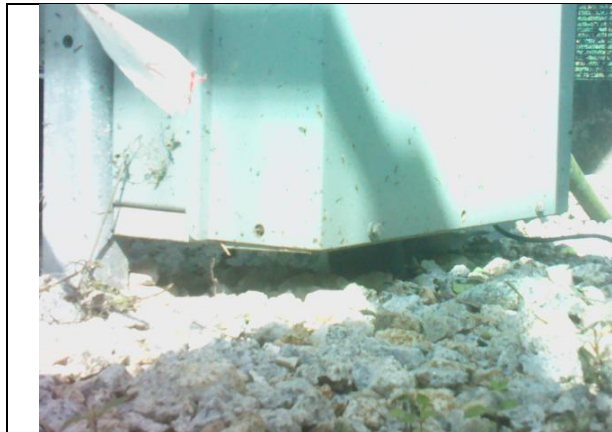
| | Area | CABLE ENTRY | | Panel No. | CCH00668 |

| PARAMETER | VALUE |
|---|---|
| Spot Temp.1 (Sp1) | 30.0 °C |
| Spot Temp. 2 (Sp2) | 30.6 °C |
| Delta T ( $\Delta T$ ) | 0.6 °C |

| Decibel (dB) | 0dB |
| Sound characteristic | Normal |

**Analysis:** No Anomaly.

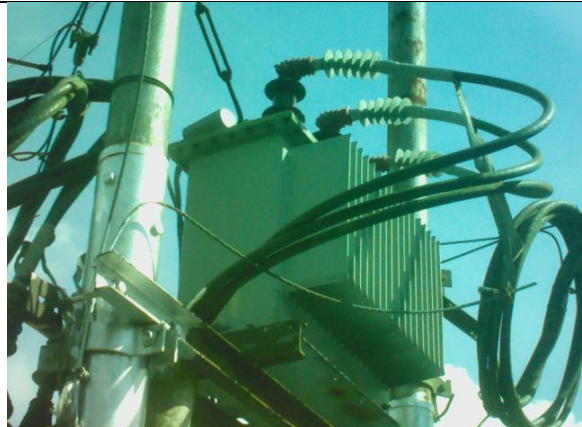
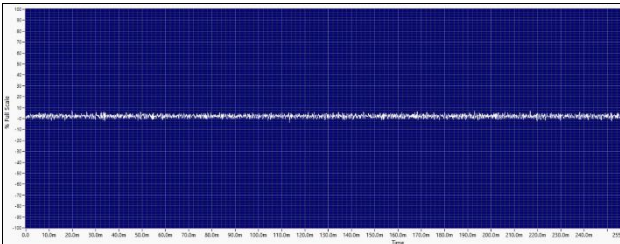
| | Area | OVERVIEW | | Tx No. | 1 |

| IR IMAGE | | VISUAL IMAGE | | | | | | | | | | | | | | | | | | | | | | | | | | | | | |
|---|---|---|---|---|---|---|---|---|---|---|---|---|---|---|---|---|---|---|--|---|---|---|---|---|---|---|---|---|---|---|---|
| Spot Temp.1 (Sp1) | 40.8 °C | | | | | | | | | | | | | | | | | | | | | | | | | | | | | | |
| Spot Temp. 2 (Sp2) | 39.9 °C | | | | | | | | | | | | | | | | | | | | | | | | | | | | | | |
| Delta T ( Δ T) | 0.8 °C | | | | | | | | | | | | | | | | | | | | | | | | | | | | | | |
| Analysis: No Anomaly. | | | | | | | | | | | | | | | | | | | | | | | | | | | | | | | |
