## CONDITION BASED ASSESSMENT

### FULL SCANNING REPORT

| SUBSTATION NAME (ERMS) | : | S/S LOJI AIR HABU |
| DATE | : | 01 JUN 2026 |

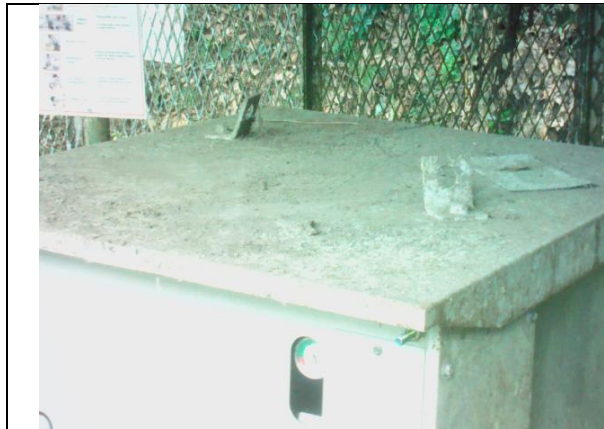
| | Area | OVERVIEW TOP | | Panel No. | - |

**Analysis:** No Anomaly.

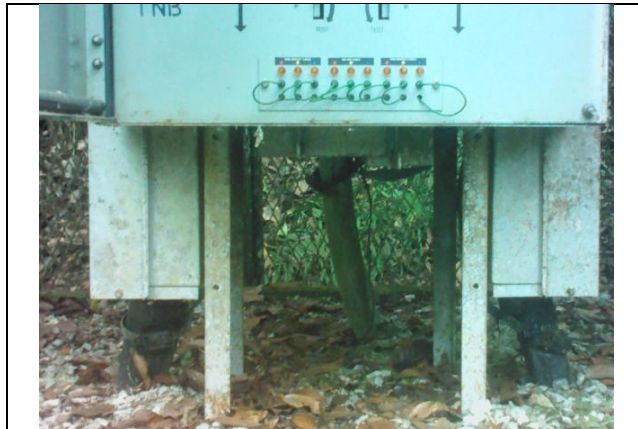
| | Area | OVERVIEW BOTTOM | | Panel No. | - |

**Analysis:** No Anomaly.

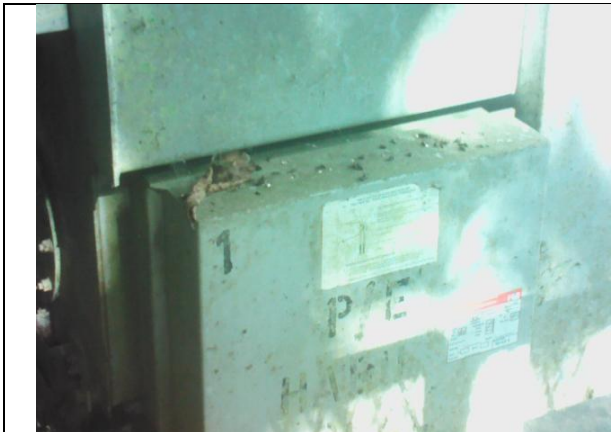
| | Area | CABLE COMPARTMENT | | Panel No. | CCH00347 |

**Analysis:** No Anomaly.

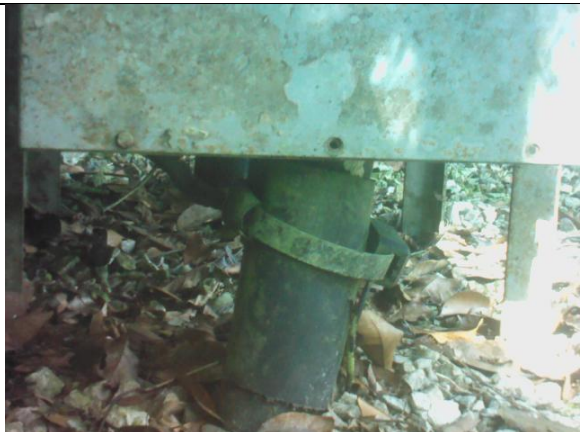
| | Area | CABLE ENTRY | | Panel No. | CCH00347 |

**Analysis:** No Anomaly.

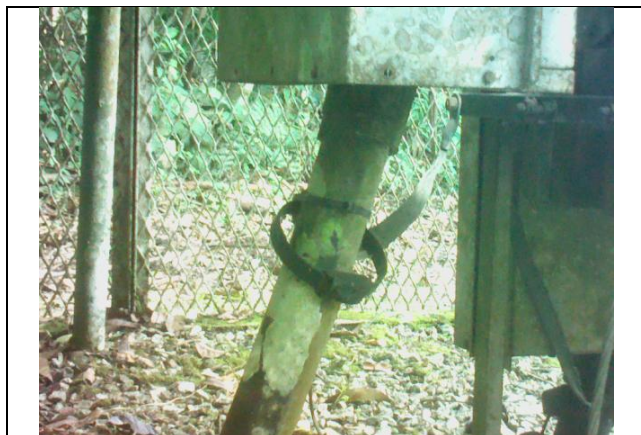
| | Area | CABLE ENTRY | | Panel No. | CCH00346 |

**Analysis:** No Anomaly.

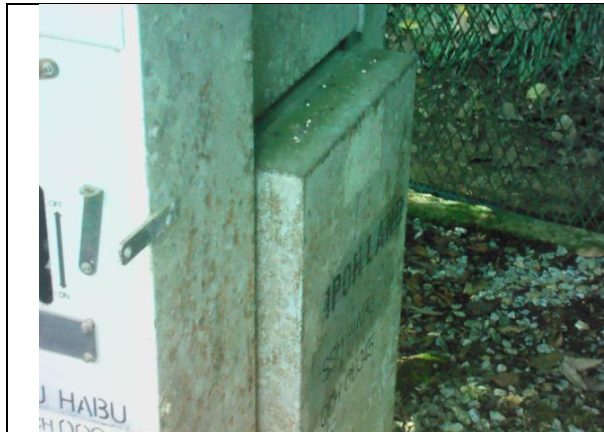
| | Area | CABLE COMPARTMENT | | Panel No. | CCH00345 |

**Analysis:** No Anomaly.

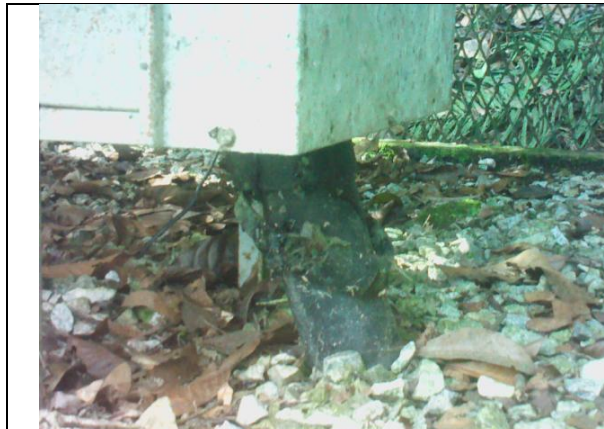
| | Area | CABLE ENTRY | | Panel No. | CCH00345 |

**Analysis:** No Anomaly.

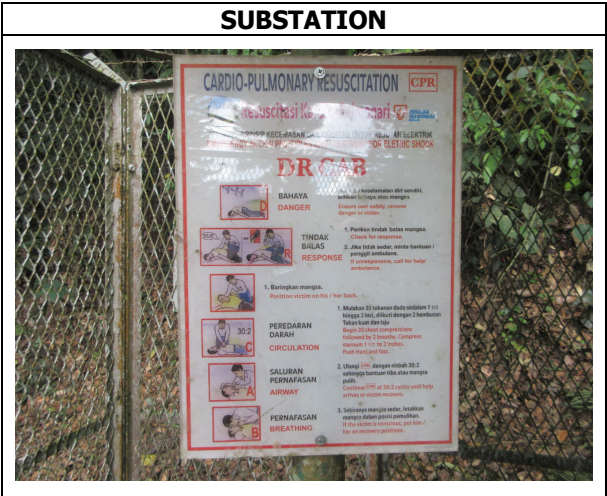
| NO. | EQUIPMENT | DEFECT DESCRIPTION | ADDITIONAL REMARKS |
|---|---|---|---|
| 1 | SUBSTATION | CPR POSTER OLD VERSION | SWG BAY |

CPR POSTER OLD VERSION – SWG BAY
