| | Substation | S/S LOJI AIR HABU | | | Date: 01/06/2026 |
| | Equipment | RMU SF6 | Manufacturer | TAMCO | Time: 4:21 PM |
| | Model | FALCON BETA | Rating | 12kV | Humidity: 80% |

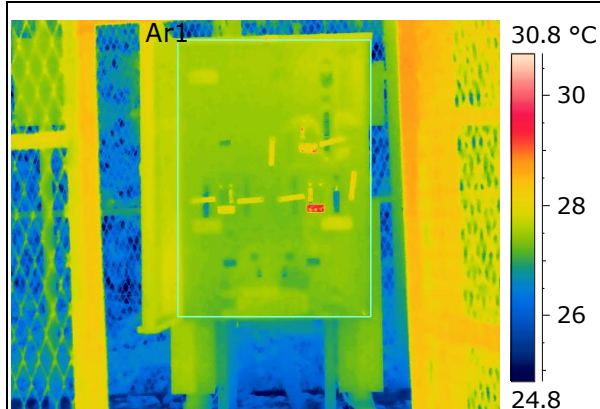
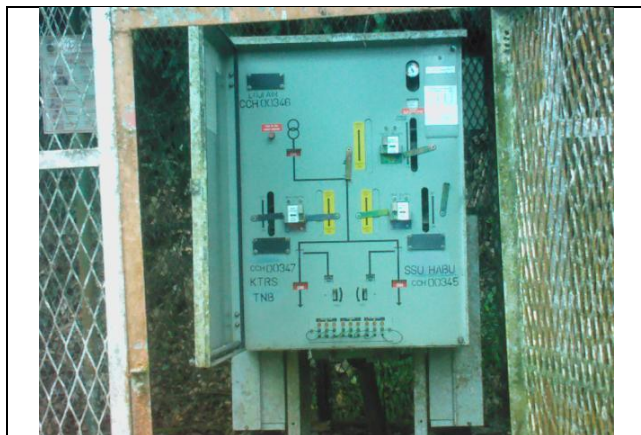
| | Area | OVERVIEW | | Panel No. | - |

| PARAMETER | VALUE |
|---|---|
| Average Temp. (Ar1) | 27.4 °C |
| Ambient Temp. | 21.2 °C |

**Analysis:** No Anomaly.

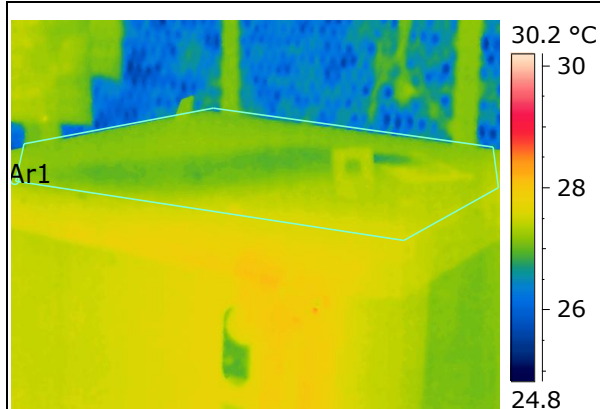
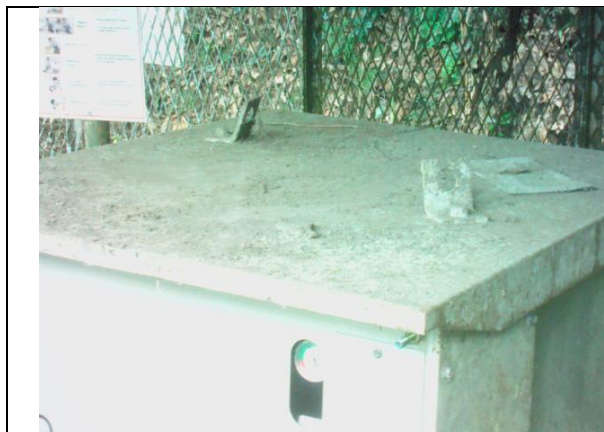
| | Area | OVERVIEW TOP | | Panel No. | - |

| PARAMETER | VALUE |
|---|---|
| Average Temp. (Ar1) | 27.2 °C |
| Ambient Temp. | 21.2 °C |

**Analysis:** No Anomaly.

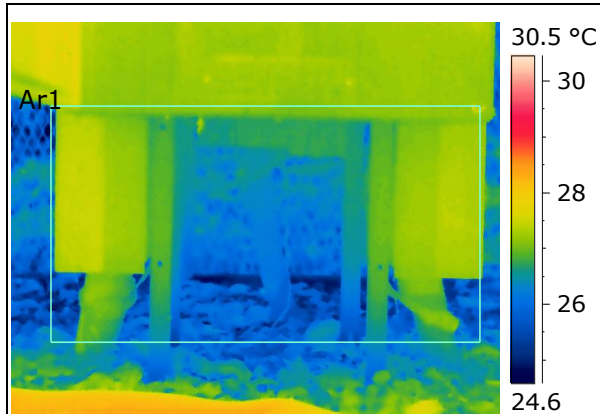
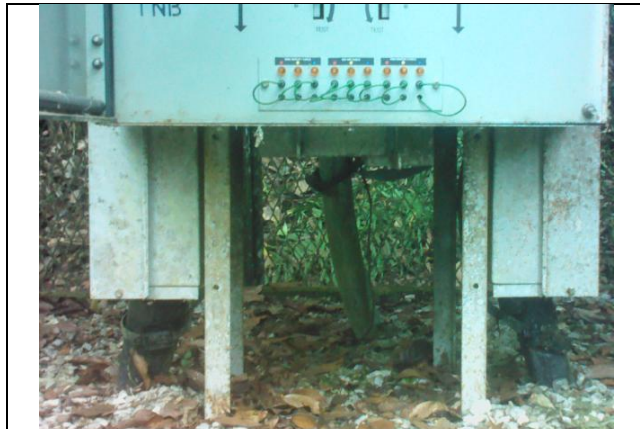
| | Area | OVERVIEW BOTTOM | | Panel No. | - |

| PARAMETER | VALUE |
|---|---|
| Average Temp. (Ar1) | 26.6 °C |
| Ambient Temp. | 21.2 °C |

**Analysis:** No Anomaly.

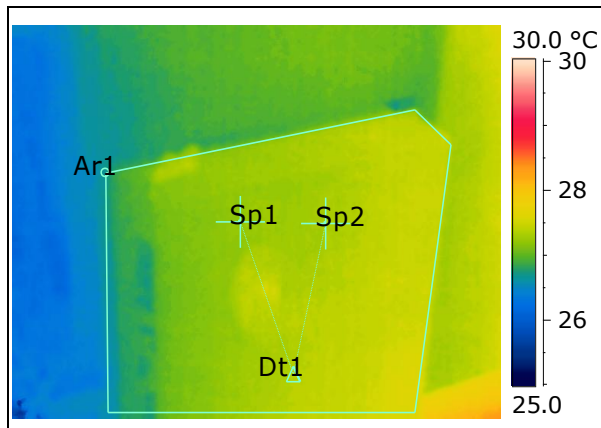
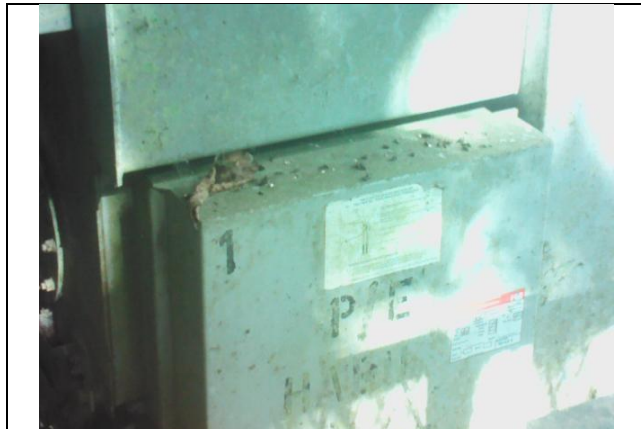
| | Area | CABLE COMPARTMENT | | Panel No. | CCH00347 |

| PARAMETER | VALUE |
|---|---|
| Spot Temp.1 (Sp1) | 27.2 °C |
| Spot Temp. 2 (Sp2) | 27.3 °C |
| Delta T ( $\Delta T$ ) | 0.1 °C |

| Decibel (dB) | 0dB |
| Sound characteristic | Normal |

**Analysis:** No Anomaly.

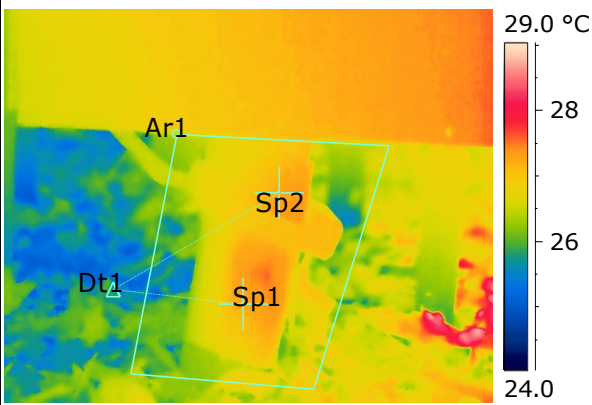
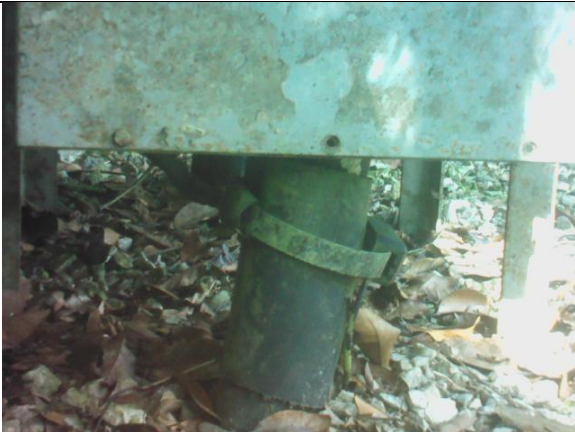
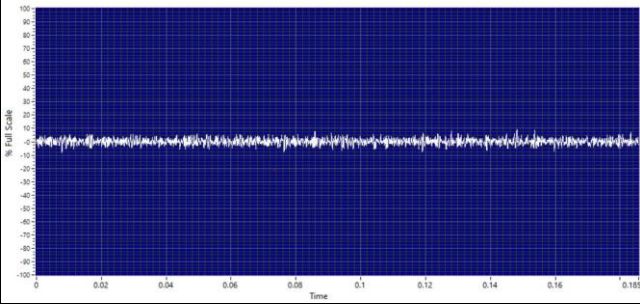
| | Area | CABLE ENTRY | | Panel No. | CCH00347 |

| IR IMAGE | | VISUAL IMAGE | |
|---|---|---|---|
| Spot Temp.1 (Sp1) | 27.2 °C | Serial No. | B971569 |
| Spot Temp. 2 (Sp2) | 27.2 °C | Heater (A) | - |
| Delta T ( Δ T) | 0.0 °C | Cable Type | XLPE |

| ULTRASOUND IMAGE | |
|---|---|
| Decibel (dB) | 0dB |
| Sound characteristic | Normal |

**Analysis:** No Anomaly.

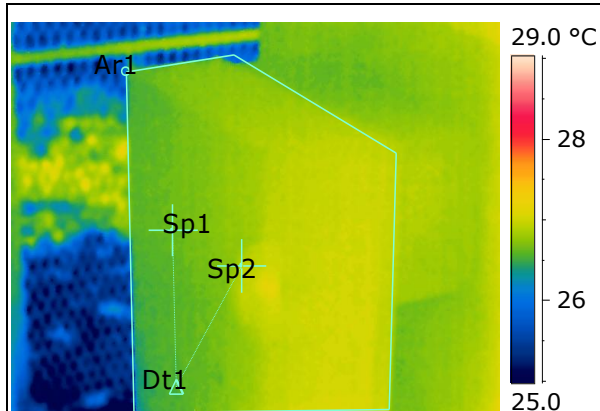
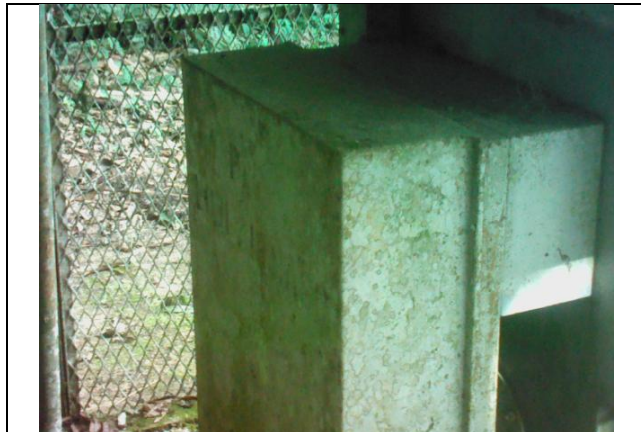
| | Area | CABLE COMPARTMENT | Panel No. | CCH00346 | |

| PARAMETER | VALUE |
|---|---|
| Spot Temp.1 (Sp1) | 26.6 °C |
| Spot Temp. 2 (Sp2) | 26.9 °C |
| Delta T ( $\Delta T$ ) | 0.3 °C |

| Decibel (dB) | 0dB |
| Sound characteristic | Normal |

**Analysis:** No Anomaly.

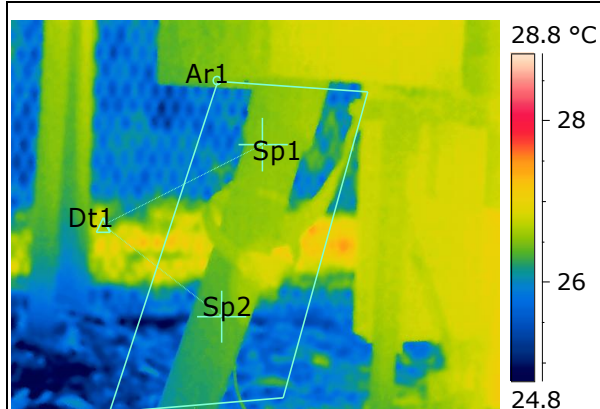
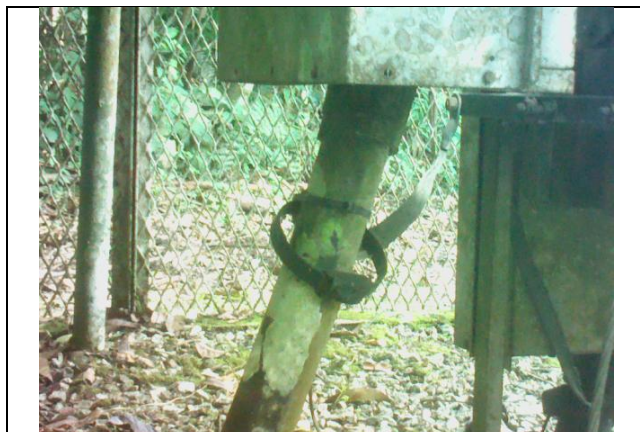
| | Area | CABLE ENTRY | | Panel No. | CCH00346 |

| PARAMETER | VALUE |
|---|---|
| Spot Temp.1 (Sp1) | 26.5 °C |
| Spot Temp. 2 (Sp2) | 26.4 °C |
| Delta T ( $\Delta T$ ) | 0.1 °C |

| Decibel (dB) | 0dB |
| Sound characteristic | Normal |

**Analysis:** No Anomaly.

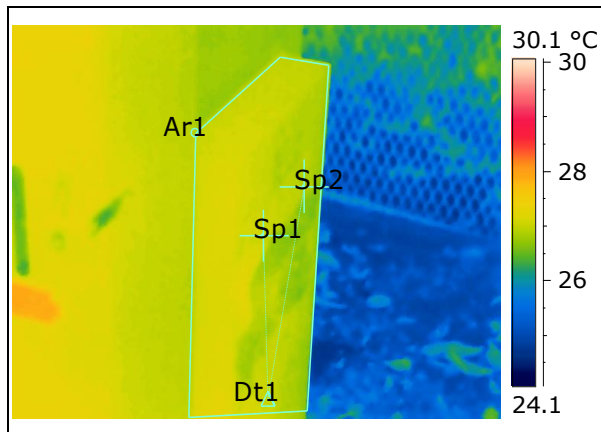
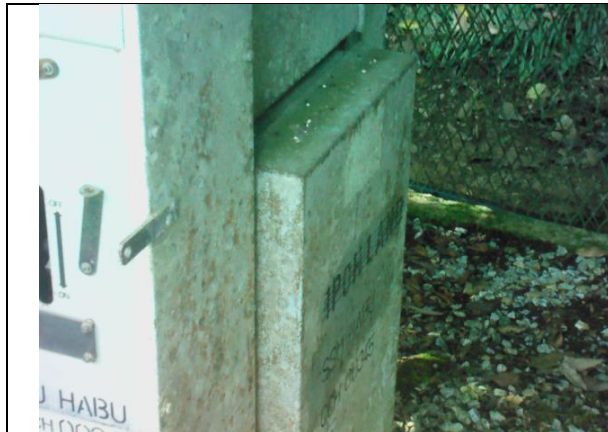
| | Area | CABLE COMPARTMENT | | Panel No. | CCH00345 |

| PARAMETER | VALUE |
|---|---|
| Spot Temp.1 (Sp1) | 27.0 °C |
| Spot Temp. 2 (Sp2) | 26.9 °C |
| Delta T ( Δ T) | 0.2 °C |

| Decibel (dB) | 0dB |
| Sound characteristic | Normal |

**Analysis:** No Anomaly.

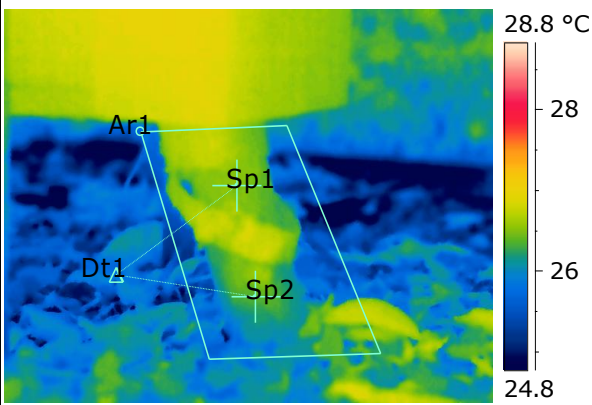
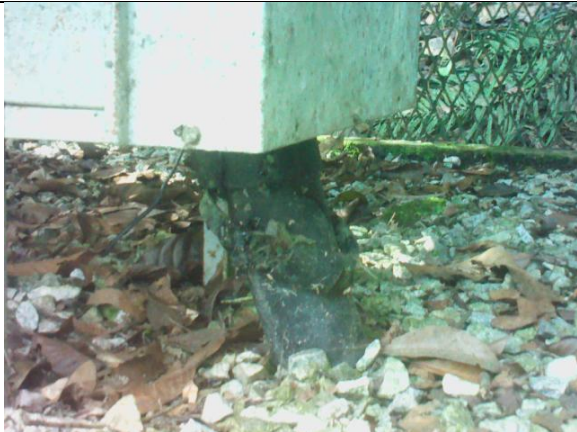
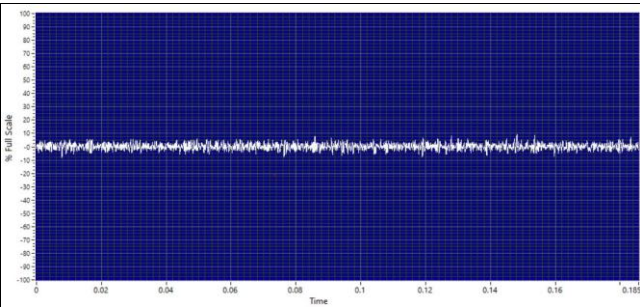
| | Area | CABLE ENTRY | | Panel No. | CCH00345 |

| IR IMAGE | | VISUAL IMAGE | |
|---|---|---|---|
| Spot Temp.1 (Sp1) | 26.5 °C | Serial No. | B971569 |
| Spot Temp. 2 (Sp2) | 26.4 °C | Heater (A) | - |
| Delta T ( Δ T) | 0.1 °C | Cable Type | XLPE |

| ULTRASOUND IMAGE | |
|---|---|
| Decibel (dB) | 0dB |
| Sound characteristic | Normal |
| <b>Analysis:</b> No Anomaly. | |
