## CONDITION BASED ASSESSMENT

### FULL SCANNING REPORT

| SUBSTATION NAME (ERMS) | : | KK3 PAYA BESAR |
| DATE | : | 03 MAR 2026 |

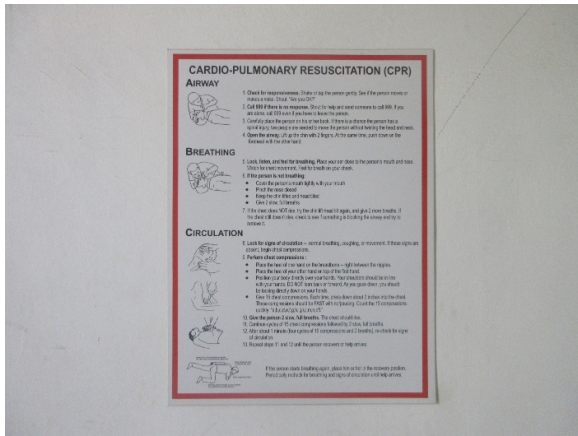
## **SUBSTATION**

| NO. | EQUIPMENT | DEFECT DESCRIPTION | ADDITIONAL REMARKS |
|---|---|---|---|
| 1 | SUBSTATION | CPR POSTER OLD VERSION | SWG ROOM |

CPR POSTER OLD VERSION – SWG ROOM

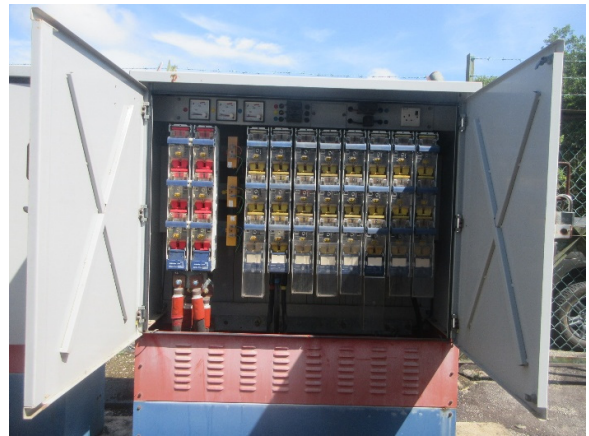
## **FP/LVDB**

| NO. | EQUIPMENT | DEFECT DESCRIPTION | ADDITIONAL REMARKS |
|---|---|---|---|
| 2 | FP/LVDB | NO FEEDER NO./FEEDER NAME | FP TX1 - NOT FOLLOW NEW STANDARD |

NO FEEDER NO./FEEDER NAME – FP TX1 - NOT FOLLOW NEW STANDARD

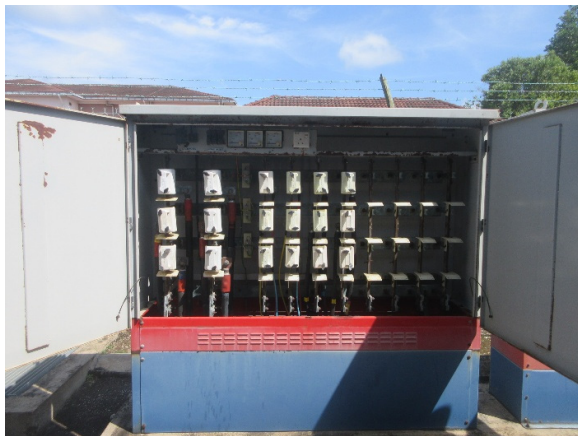
## **FP/LVDB**

| NO. | EQUIPMENT | DEFECT DESCRIPTION | ADDITIONAL REMARKS |
|---|---|---|---|
| 3 | FP/LVDB | NO FEEDER NO./FEEDER NAME | FP TX2 - NOT FOLLOW NEW STANDARD |

NO FEEDER NO./FEEDER NAME – FP TX2 - NOT FOLLOW NEW STANDARD
