**CONDITION BASED ASSESSMENT  
FULL SCANNING REPORT  
SBUM DIAGNOSTIC PAHANG  
TNB BAHAGIAN PEMBAHAGIAN PAHANG**

| SUBSTATION NAME (ERMS) | : | JPS |
| DATE | : | 06 MAR 2026 |

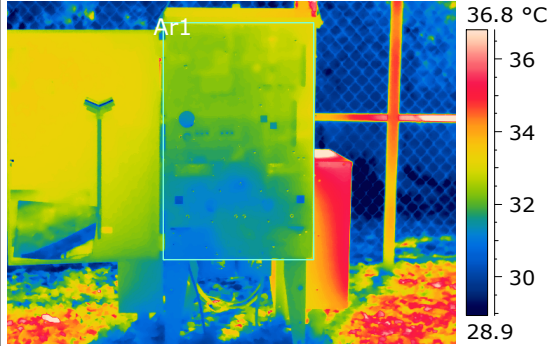
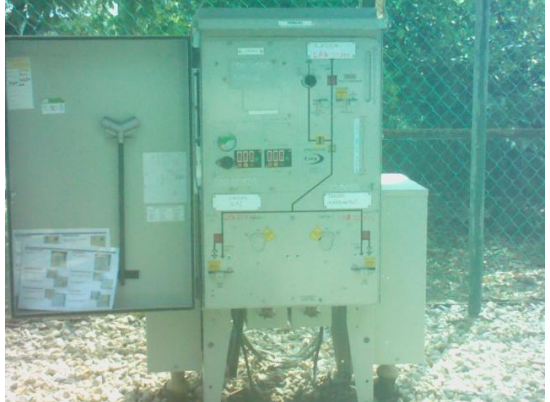
**Analysis:** Please refer the following page for details defect.

**Recommendation:** N/A

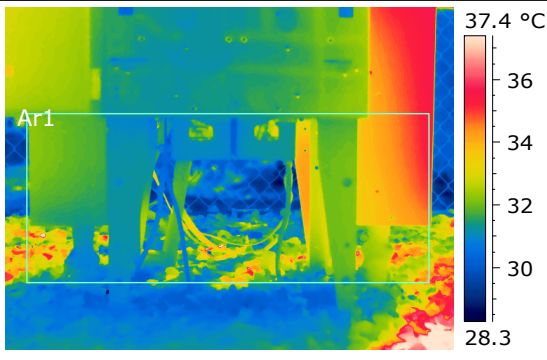
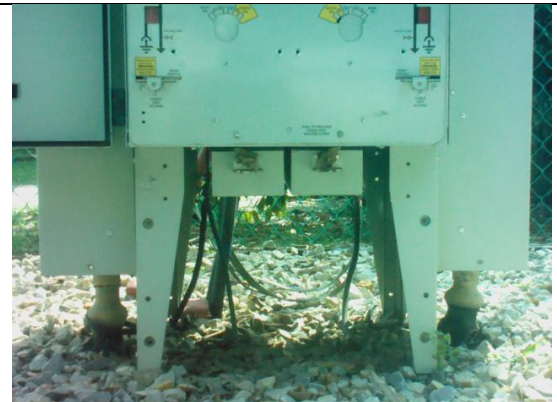
**Analysis:** Please refer the following page for details defect.

**Recommendation:** N/A

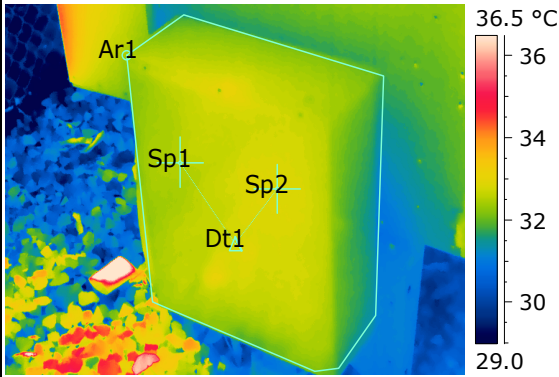
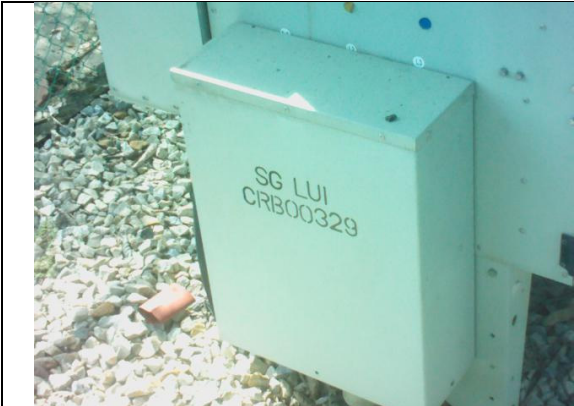
| | Area | CABLE COMPARTMENT | | Humidity: 71% |

**Analysis:** No Anomaly.

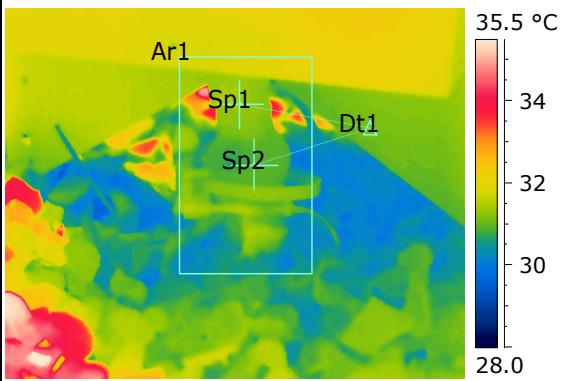
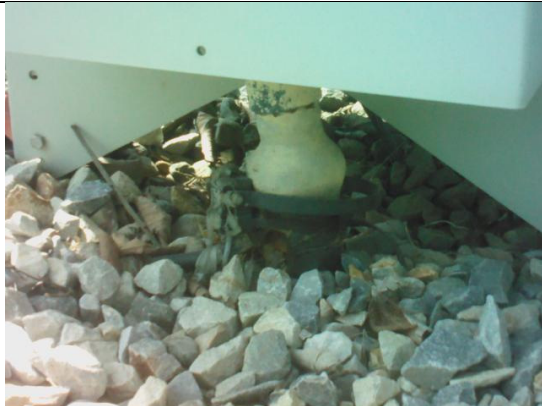
| | Area | CABLE ENTRY | | Panel No. | CRB00329 |

**Analysis:** No Anomaly.

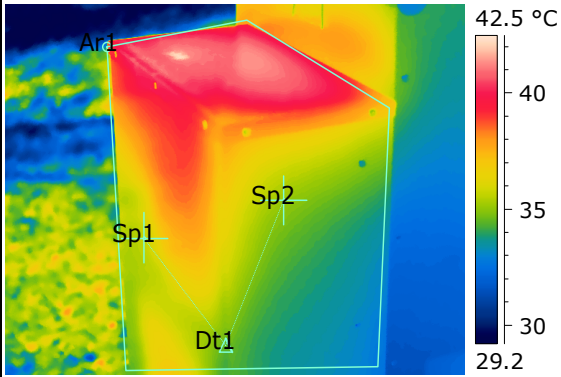
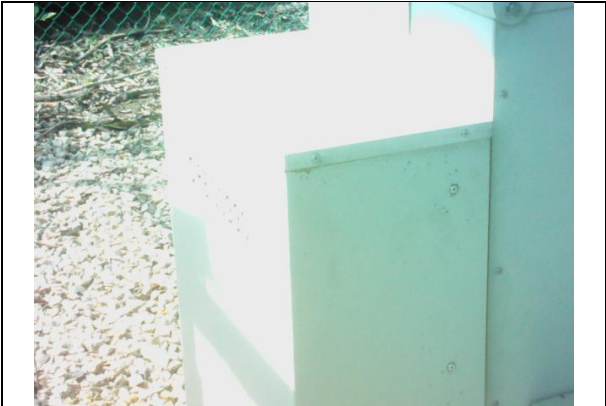
| | Area | CABLE COMPARTMENT | | Panel No. | CRB00330 |

**Analysis:** No Anomaly.

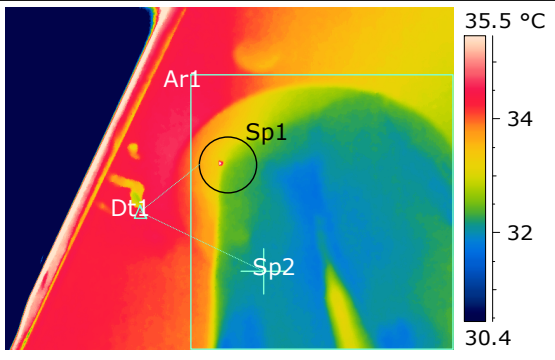
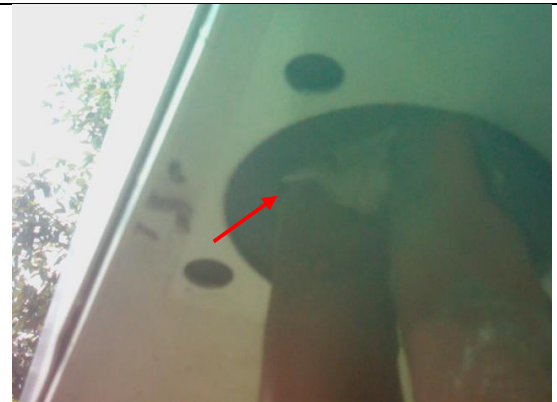
| | Area | CABLE ENTRY | | Panel No. | CRB00330 |

| IR IMAGE | | VISUAL IMAGE | |
|---|---|---|---|
| Delta T ( Δ T) | 4.0 °C | Cable Type | XLPE |

**Analysis:** Thermal image above indicates hotspot detected at **CABLE XLPE – CABLE TERMINATION**.

**Recommendation:** To inspect and make a new termination or replace defective parts if necessary.

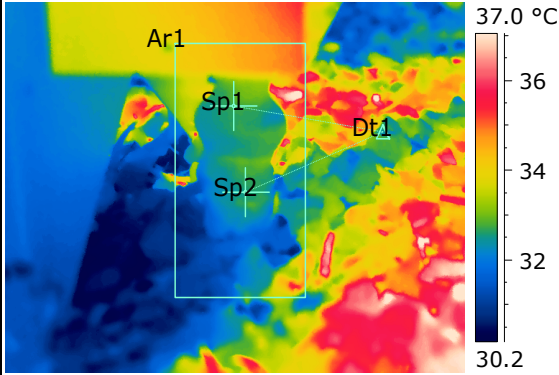
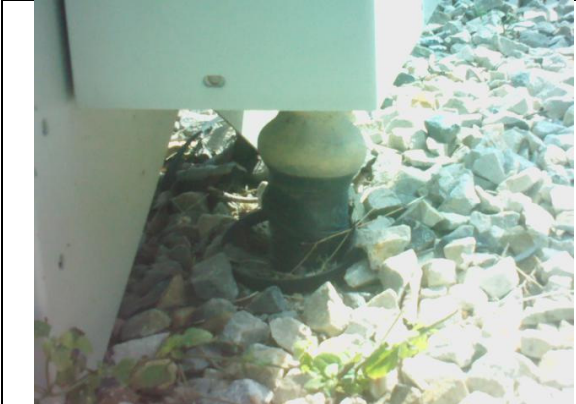
| | Area | CABLE ENTRY | | Panel No. | CRB00330 |

**Analysis:** No Anomaly.

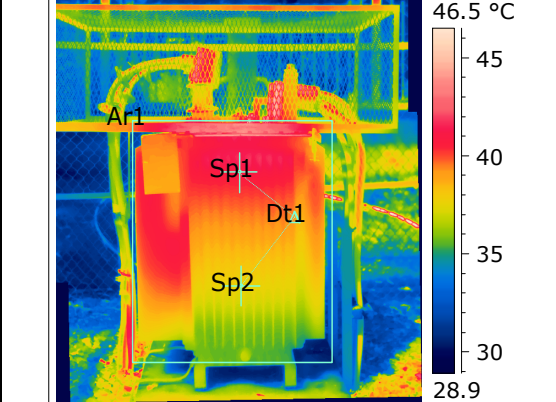
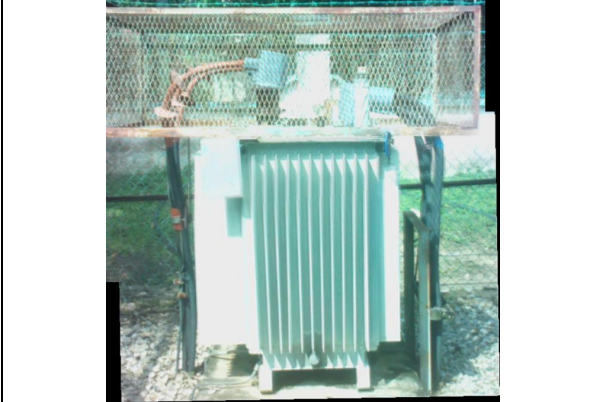
| | Area | OVERVIEW | | Tx No. | TX1 |

**Analysis:** No Anomaly.

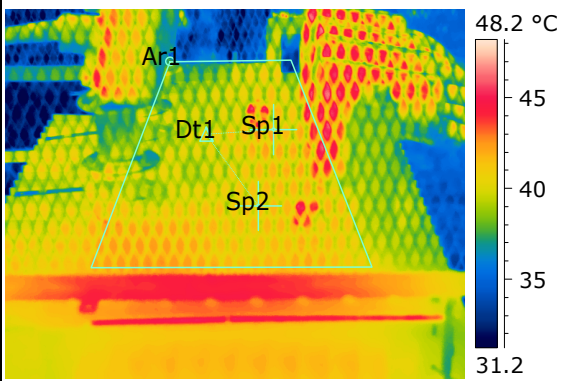
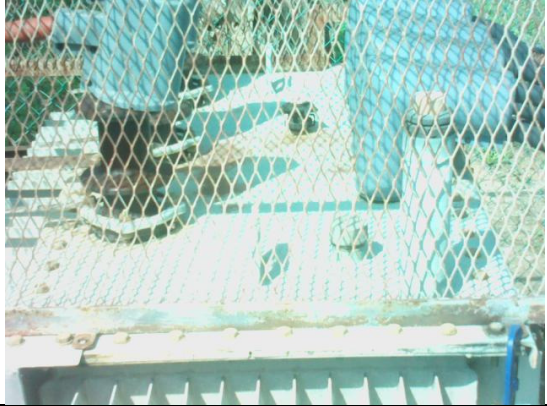
| | Area | OVERVIEW TOP | | Tx No. | TX1 |

| IR IMAGE | | VISUAL IMAGE | |
|---|---|---|---|
| <b>Analysis:</b> No Anomaly. | | | |

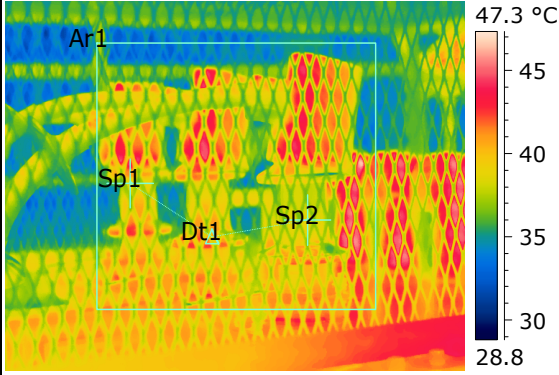
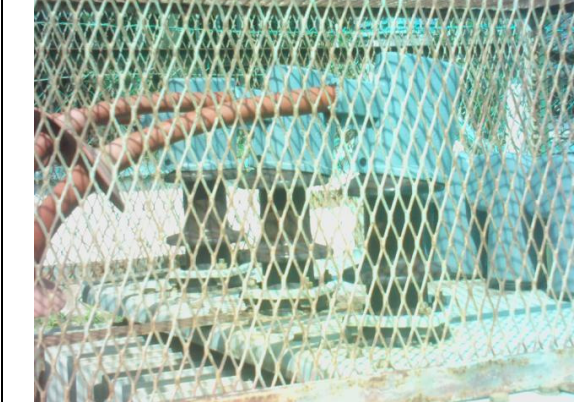
| | Area | BUSHING | | Tx No. | TX1 |

| IR IMAGE | | VISUAL IMAGE | |
|---|---|---|---|
| <b>Analysis:</b> No Anomaly. | | | |

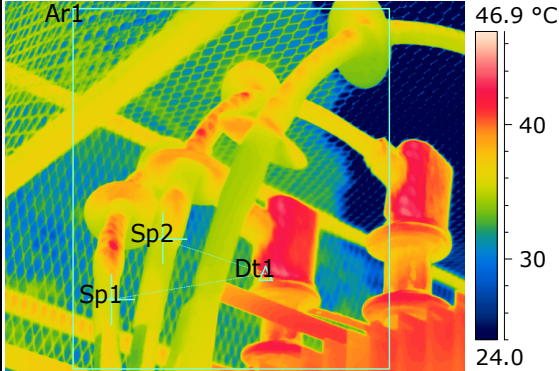
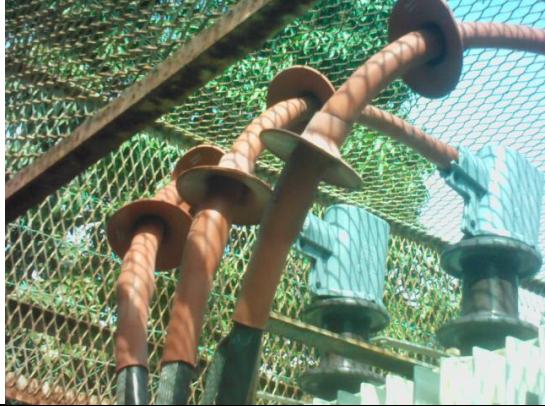
| | Area | CABLE | | Tx No. | TX1 |

**Analysis:** No Anomaly.

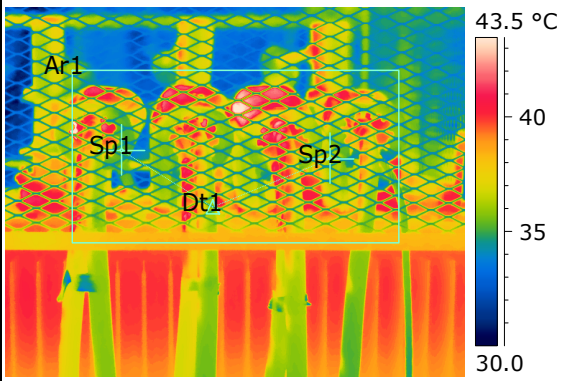
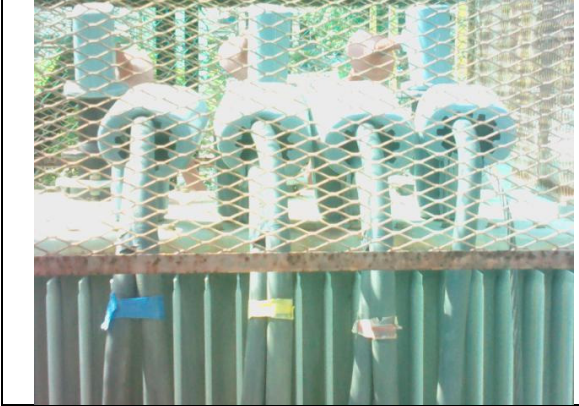
| | Area | BUSHING | | Tx No. | TX1 |

**Analysis:** No Anomaly.

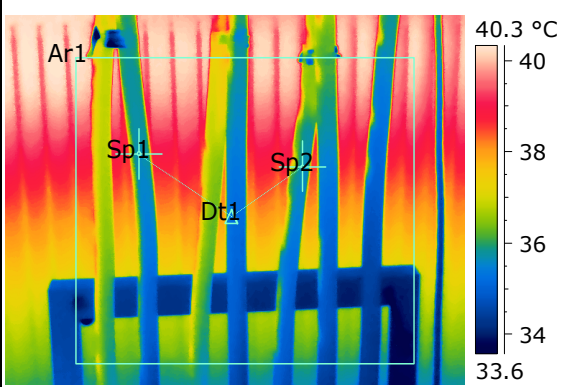
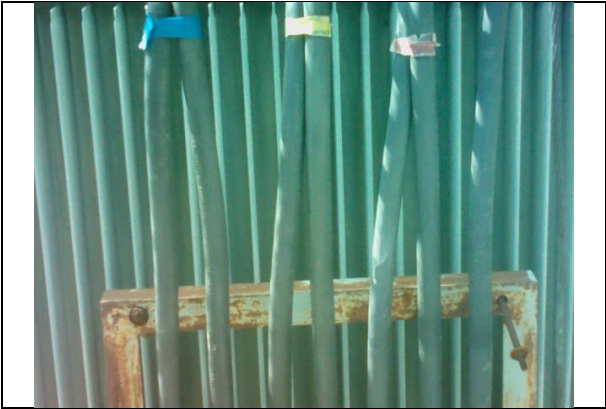
| | Area | CABLE | | Tx No. | TX1 |

**Analysis:** No Anomaly.

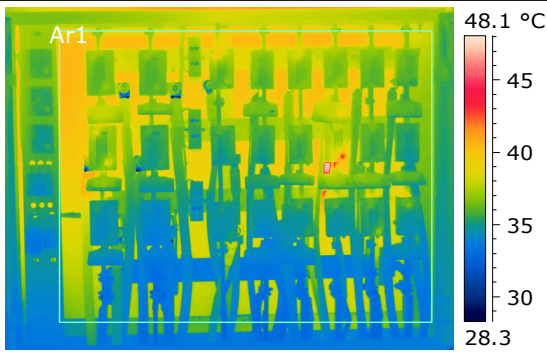
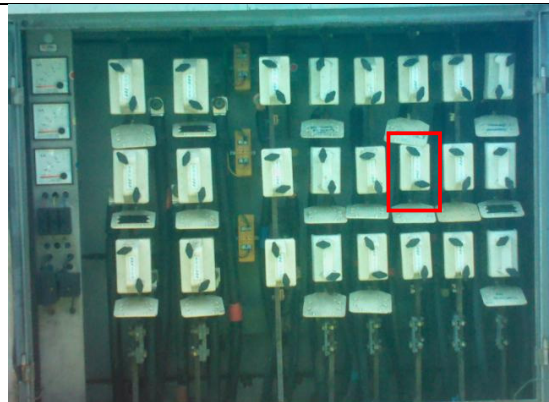
**Analysis:** Please refer the following page for details defect.

**Recommendation:** N/A

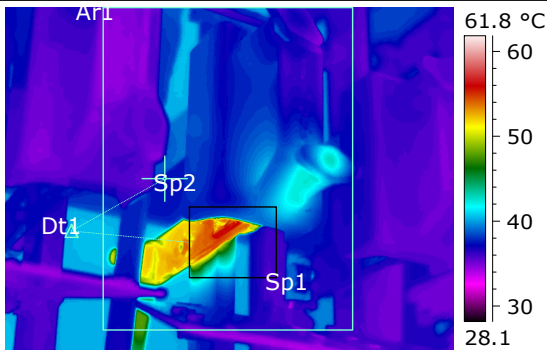
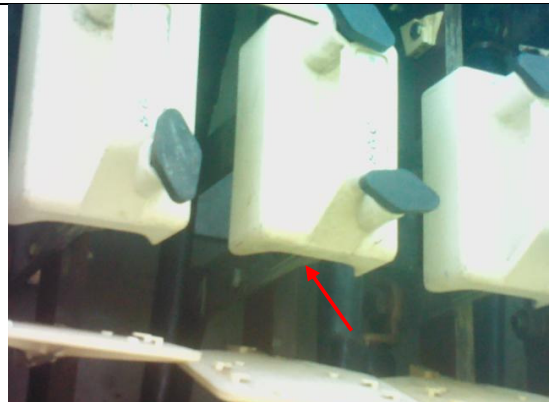
| | Area | FUSE CONNECTION – YELLOW PHASE | | Feeder No. | OUTGOING F4 |

| IR IMAGE | | VISUAL IMAGE | |
|---|---|---|---|
| Spot Temp.1 (Sp1) | 56.2 °C | Serial No. | 15519 |
| Delta T ( $\Delta T$ ) | 18.7 °C | Cable Type | PILC |

**Analysis:** Thermal image above indicates hot spot detected at **OUTGOING FUSE CONNECTION**. The anomaly is due to loosen or bad contact at the connection point.

**Recommendation:** To inspect, clean the contact surface and re-tighten the connection point. Replace defective parts if necessary.

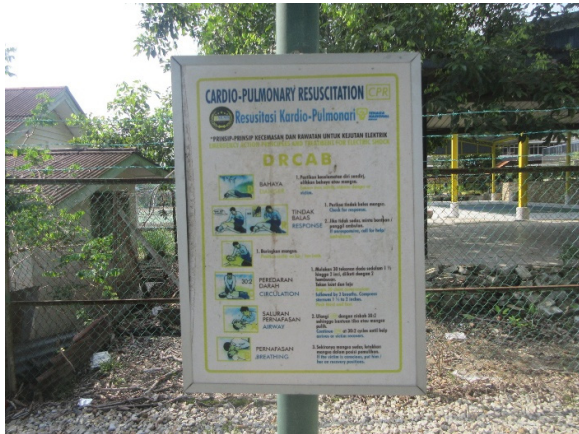
## **SUBSTATION**

CPR POSTER OLD VERSION – SWG BAY

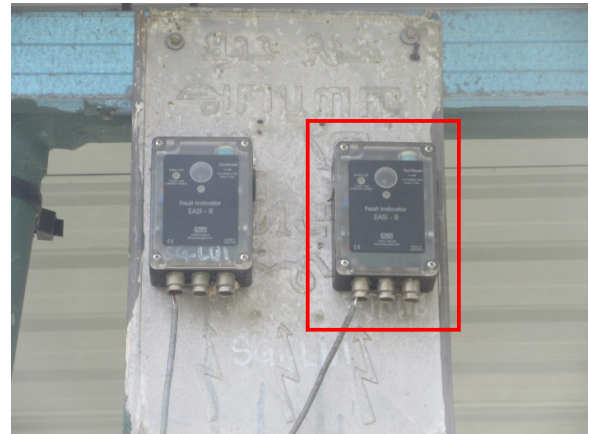
## **EFI**

NO FEEDER LABEL – CRB00331 - TAMAN SHAHBANDAR

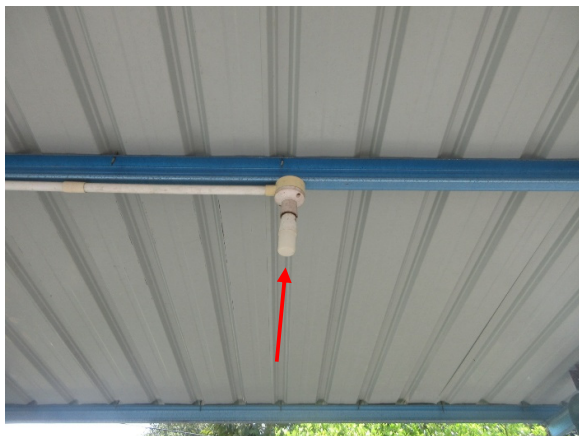
## **LIGHTING**

NOT OPERATED – SWG BAY

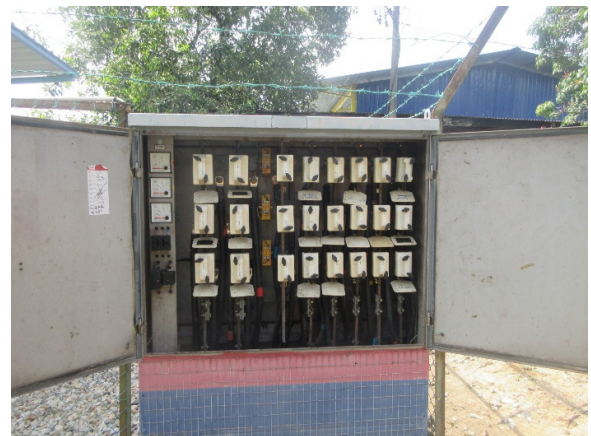
## **FP/LVDB**

NO FEEDER NO./FEEDER NAME – FP TX1 - NOT FOLLOW NEW STANDARD

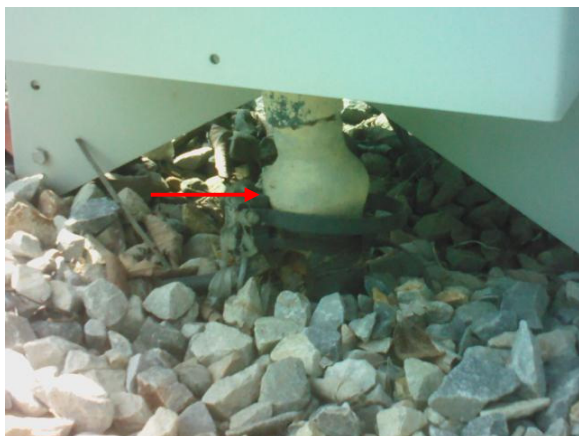
## **CABLE PILC**

CABLE PILC SWG – CRB00329 - SUNGAI LUI

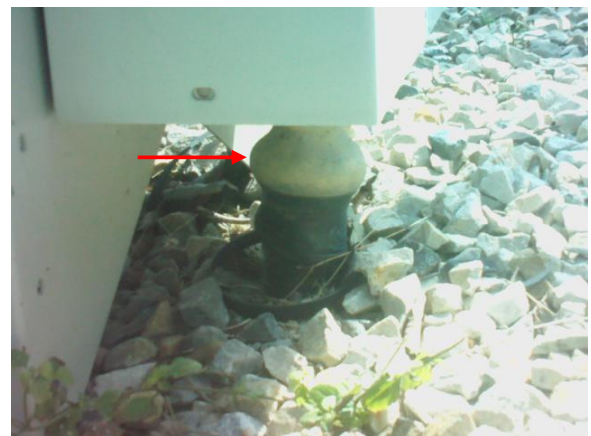
## **CABLE PILC**

CABLE PILC SWG – CRB00331 - TAMAN SHAHBANDAR

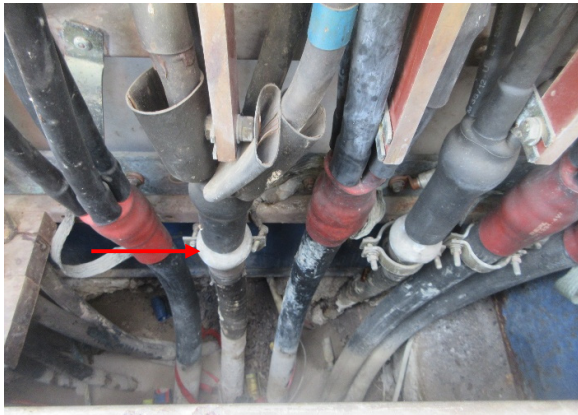
**CABLE PILC**

FP TX1 / OUTGOING F2

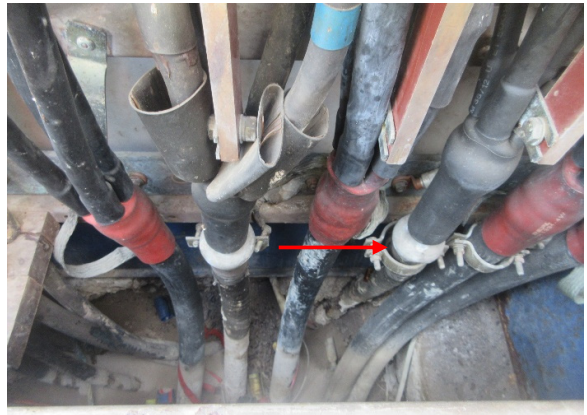
**CABLE PILC**

FP TX1 / OUTGOING F4
