**CONDITION BASED ASSESSMENT  
FULL SCANNING REPORT  
SBUM DIAGNOSTIC PAHANG  
TNB BAHAGIAN PEMBAHAGIAN PAHANG**

| SUBSTATION NAME (ERMS) | : | BATU 3 |
| DATE | : | 06 MAR 2026 |

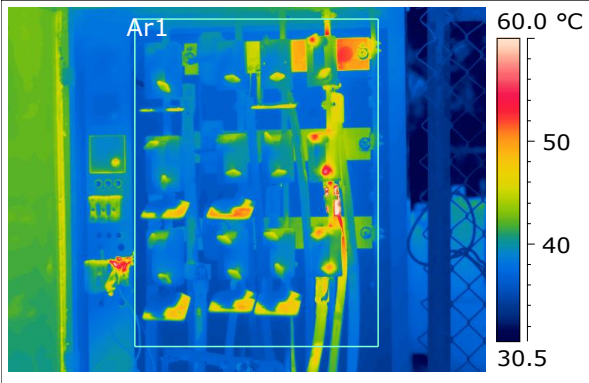
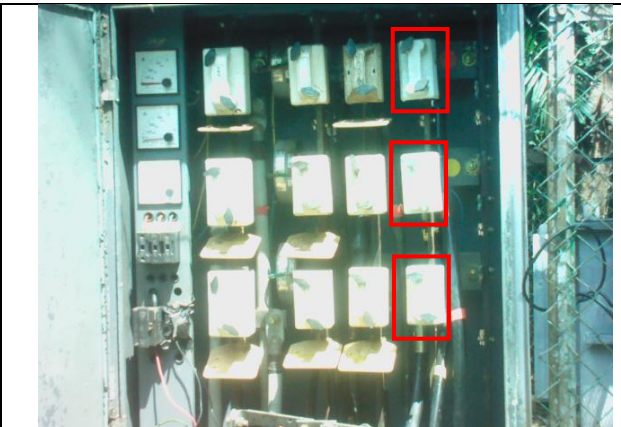
| Feeder Name | - | | | | |

**Analysis:** Please refer the following page for details defect.

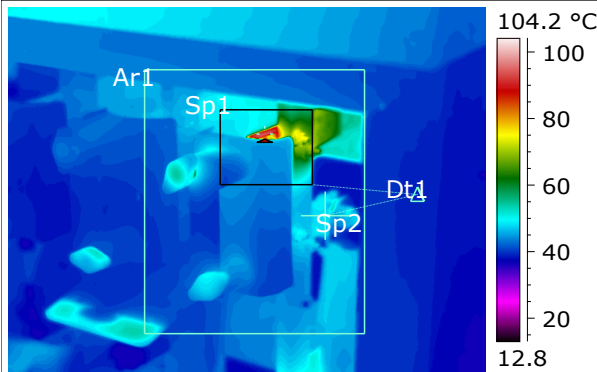
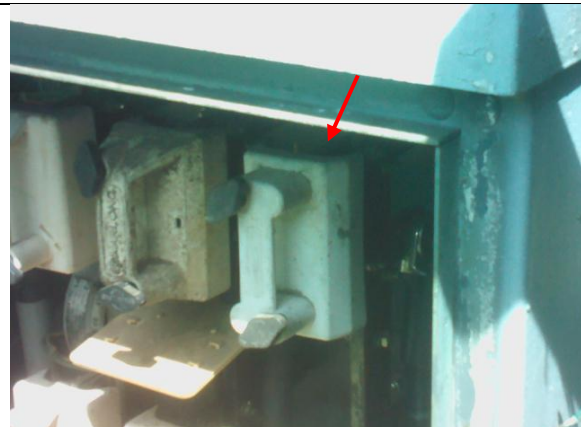
| | Area | FUSE CONNECTION – RED PHASE | | Feeder No. | OUTGOING F3 |

| IR IMAGE | | VISUAL IMAGE | |
|---|---|---|---|
| Spot Temp.1 (Sp1) | 93.6 °C | Serial No. | - |
| Delta T ( $\Delta T$ ) | 45.5 °C | Cable Type | XLPE |

**Analysis:** Thermal image above indicates hot spot detected at **INCOMING FUSE CONNECTION**. The anomaly is due to loosen or bad contact at the connection point.

**Recommendation:** To inspect, clean the contact surface and re-tighten the connection point. Replace defective parts if necessary.

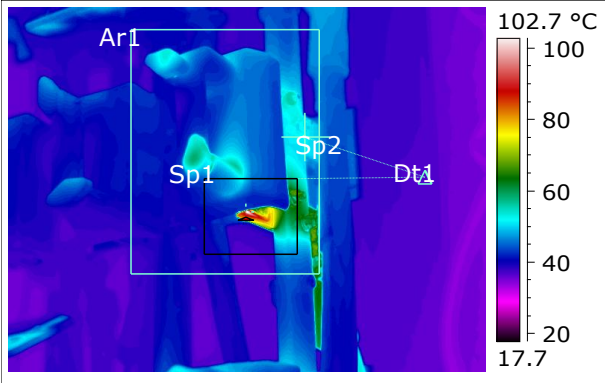
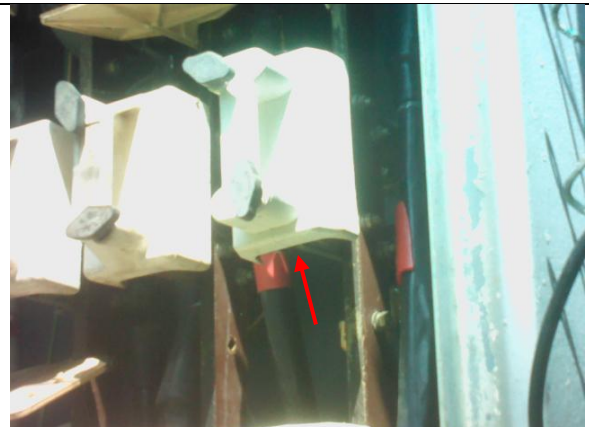
| | Area | FUSE CONNECTION – YELLOW PHASE | | Feeder No. | OUTGOING F3 |

| IR IMAGE | | VISUAL IMAGE | |
|---|---|---|---|
| Spot Temp.1 (Sp1) | 110.6 °C | Serial No. | - |
| Delta T ( Δ T) | 59.0 °C | Cable Type | XLPE |

**Analysis:** Thermal image above indicates hot spot detected at **OUTGOING FUSE CONNECTION**. The anomaly is due to loosen or bad contact at the connection point.

**Recommendation:** To inspect, clean the contact surface and re-tighten the connection point. Replace defective parts if necessary.

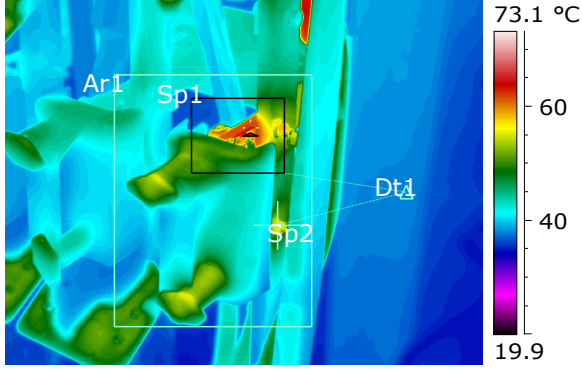
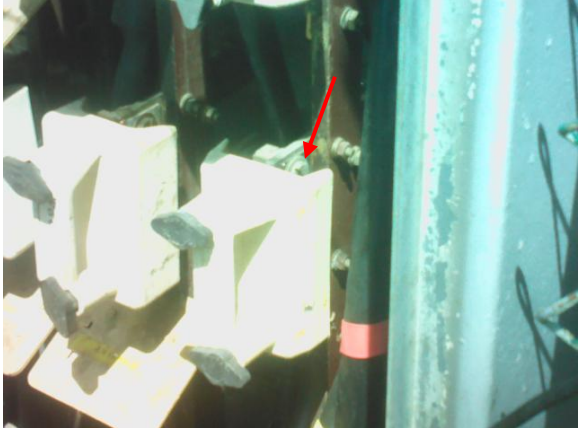
| | Area | FUSE CONNECTION – BLUE PHASE | | Feeder No. | OUTGOING F3 |

| IR IMAGE | | VISUAL IMAGE | |
|---|---|---|---|
| Spot Temp.1 (Sp1) | 64.8 °C | Serial No. | - |
| Delta T ( $\Delta T$ ) | 9.5 °C | Cable Type | XLPE |

**Analysis:** Thermal image above indicates hot spot detected at **INCOMING FUSE CONNECTION**. The anomaly is due to loosen or bad contact at the connection point.

**Recommendation:** To inspect, clean the contact surface and re-tighten the connection point. Replace defective parts if necessary.

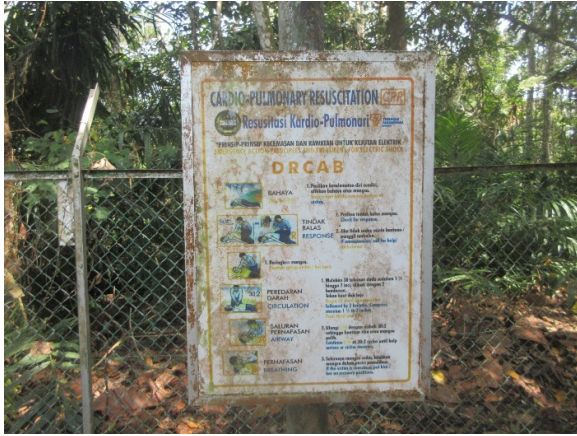
CPR POSTER OLD VERSION – SWG BAY

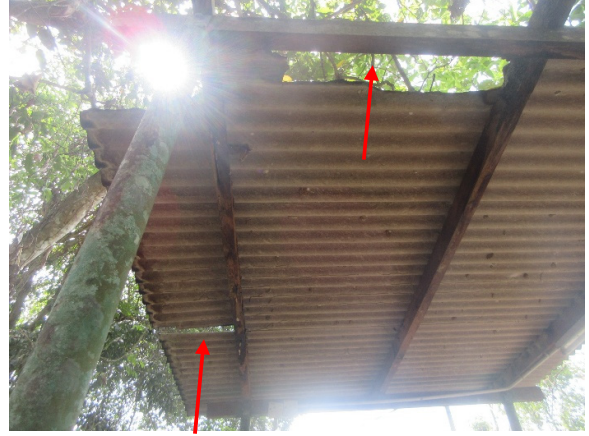
ROOF BROKEN – SWG BAY

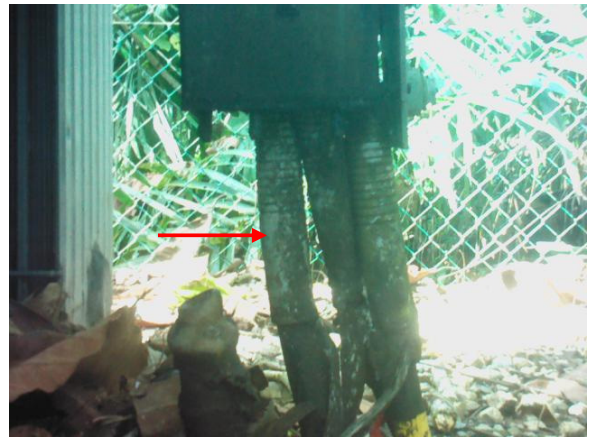
NO CABLE SUPPORT – TX1 - HV SIDE

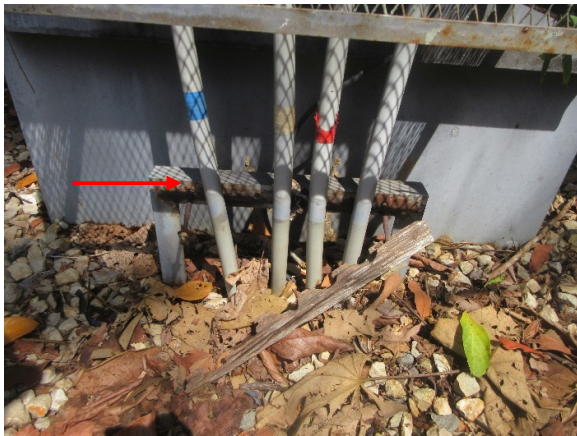
CABLE SUPPORT IN POOR CONDITION – TX1 - LV SIDE

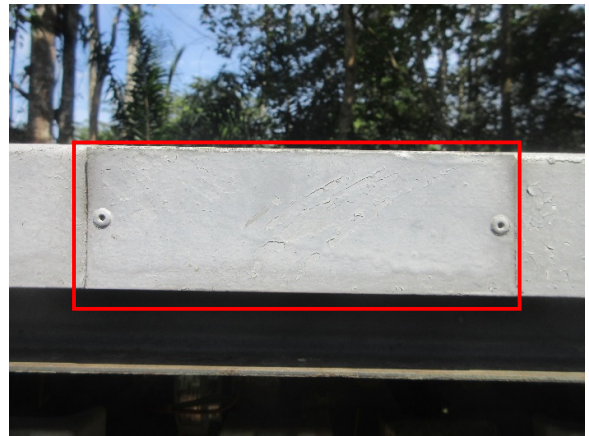
INFO PLATE POOR CONDITION – FP TX1

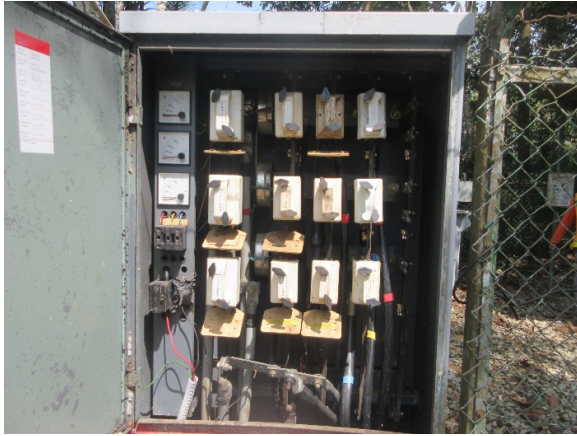
NO FEEDER NO./FEEDER NAME – FP TX1 - NOT  
FOLLOW NEW STANDARD

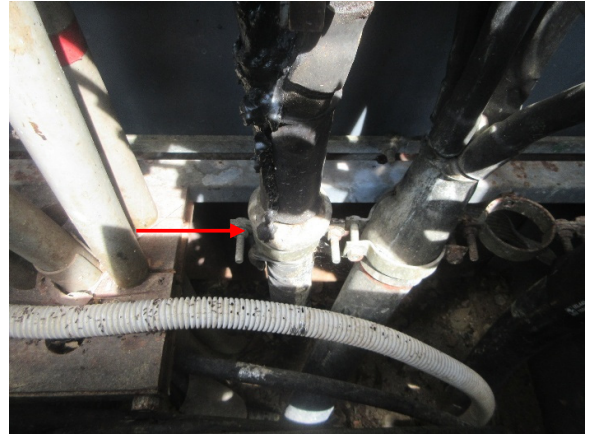
| NO. | EQUIPMENT | DEFECT DESCRIPTION | ADDITIONAL REMARKS |
|---|---|---|---|
| 8 | CABLE PILC | CABLE PILC LVDB/FP | FP TX1 / OUTGOING F1 |
