**CONDITION BASED ASSESSMENT  
FULL SCANNING REPORT  
SBUM DIAGNOSTIC PAHANG  
TNB BAHAGIAN PEMBAHAGIAN PAHANG**

| SUBSTATION NAME (ERMS) | : | GOLDEN HILL NO.1 |
| DATE | : | 13 MAR 2026 |

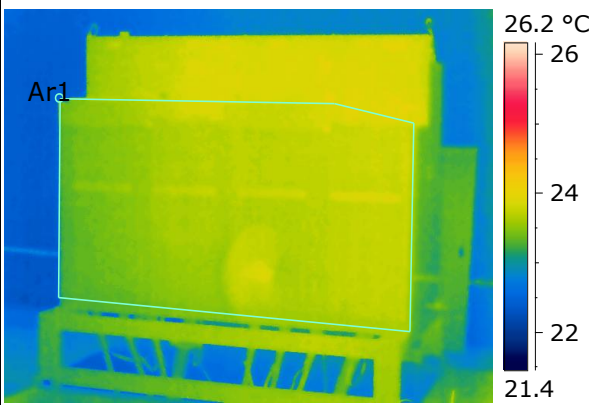
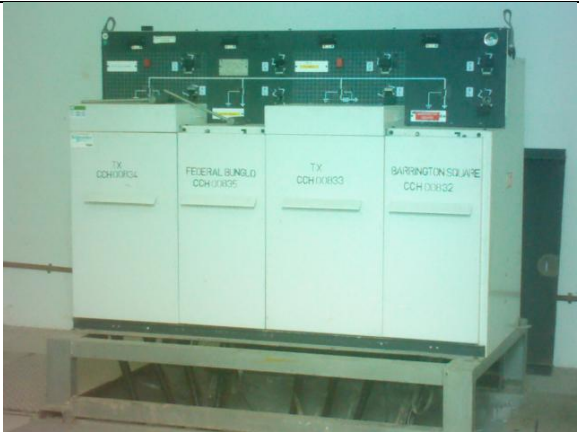
| | Area | OVERVIEW | | Panel No. | - |

**Analysis:** No Anomaly.

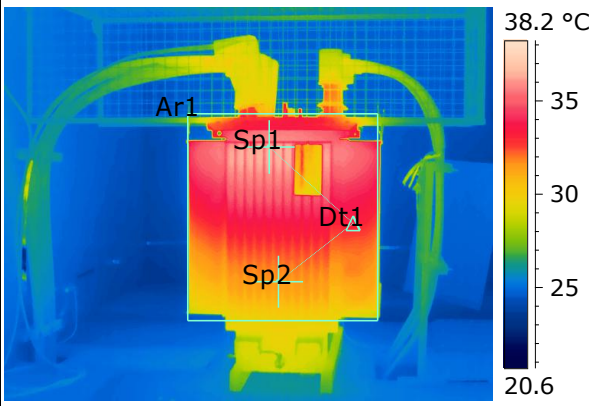
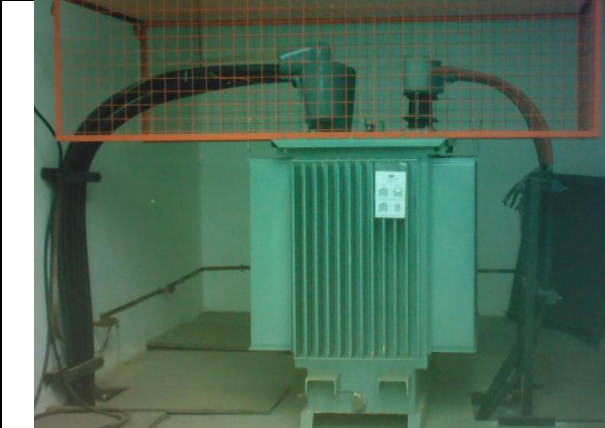
| | Area | OVERVIEW | | Tx No. | TX1 |

**Analysis:** No Anomaly.

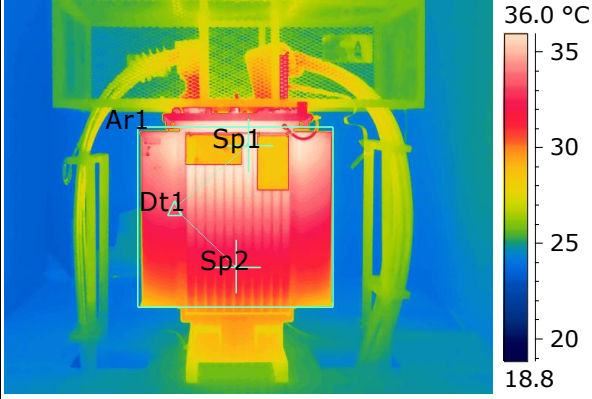
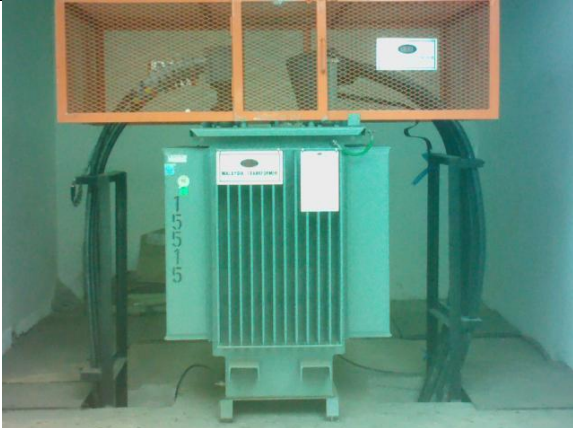
| | Area | OVERVIEW | | Tx No. | TX2 |

**Analysis:** No Anomaly.

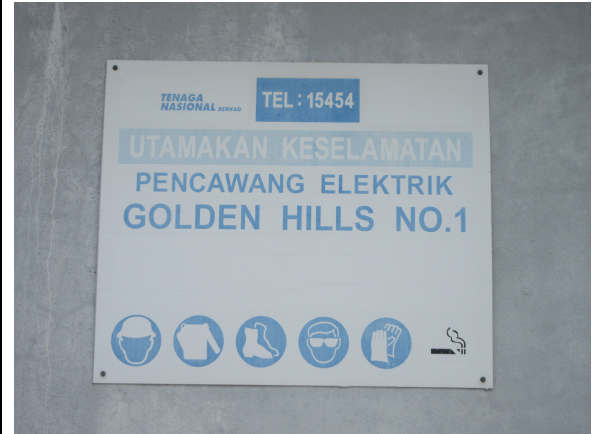
**SIGNBOARD**

| NO. | EQUIPMENT | DEFECT DESCRIPTION | ADDITIONAL REMARKS |
|---|---|---|---|
| 1 | SIGNBOARD | NO FUNCTIONAL LOCATION | - |

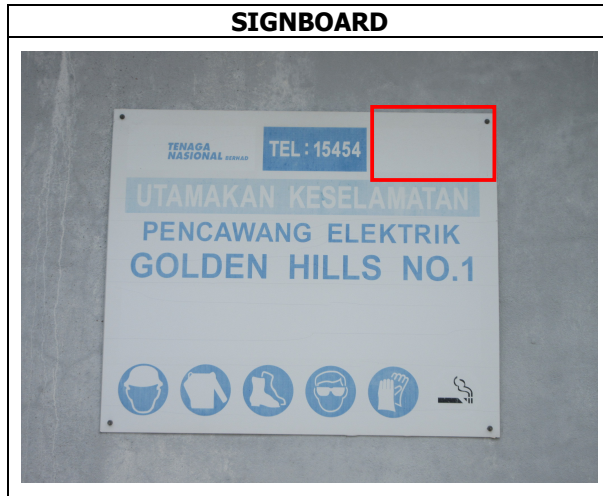
NO FUNCTIONAL LOCATION
