INVESTIGATION REPORT

AMMONIA RELEASE — FERNIE MEMORIAL ARENA
DATE OF INCIDENT: OCTOBER 17, 2017

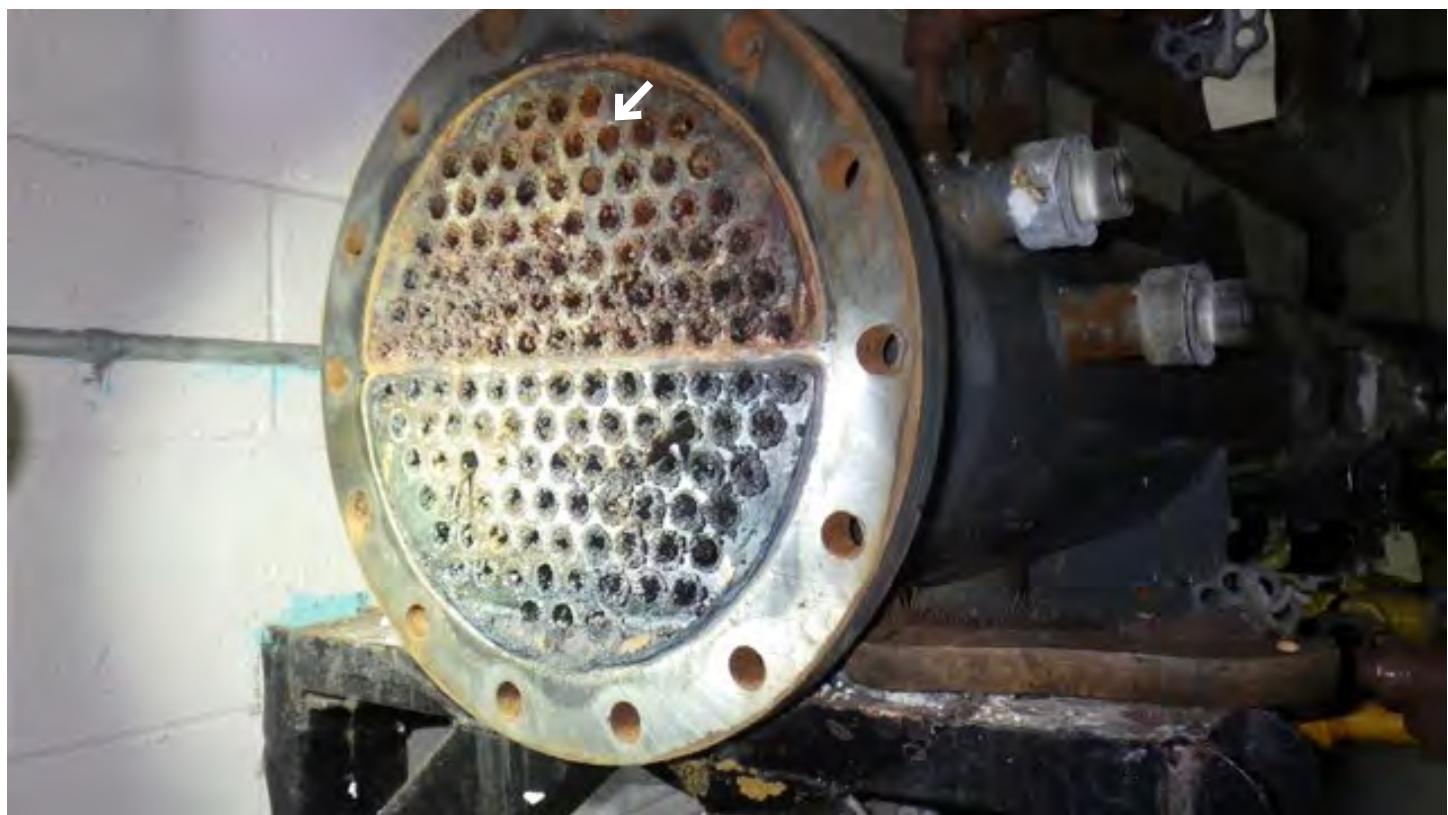
When the chiller heads were removed in the mechanical room in January 2018, they revealed the following:

- Tubes and tube sheets appeared corroded and contaminated.
- Lower tube contamination was dark and oily in appearance.
- Contamination was soluble in water.
- Ultrasonic measurement detected one leaking tube (row 2, tube 3).
- The identified leaking tube was noticeably less contaminated than other tubes.

Photo 1: Curling chiller opened showing contamination. The leaking upper tube is identified by the white arrow – second row, third tube from the right side of the photo.

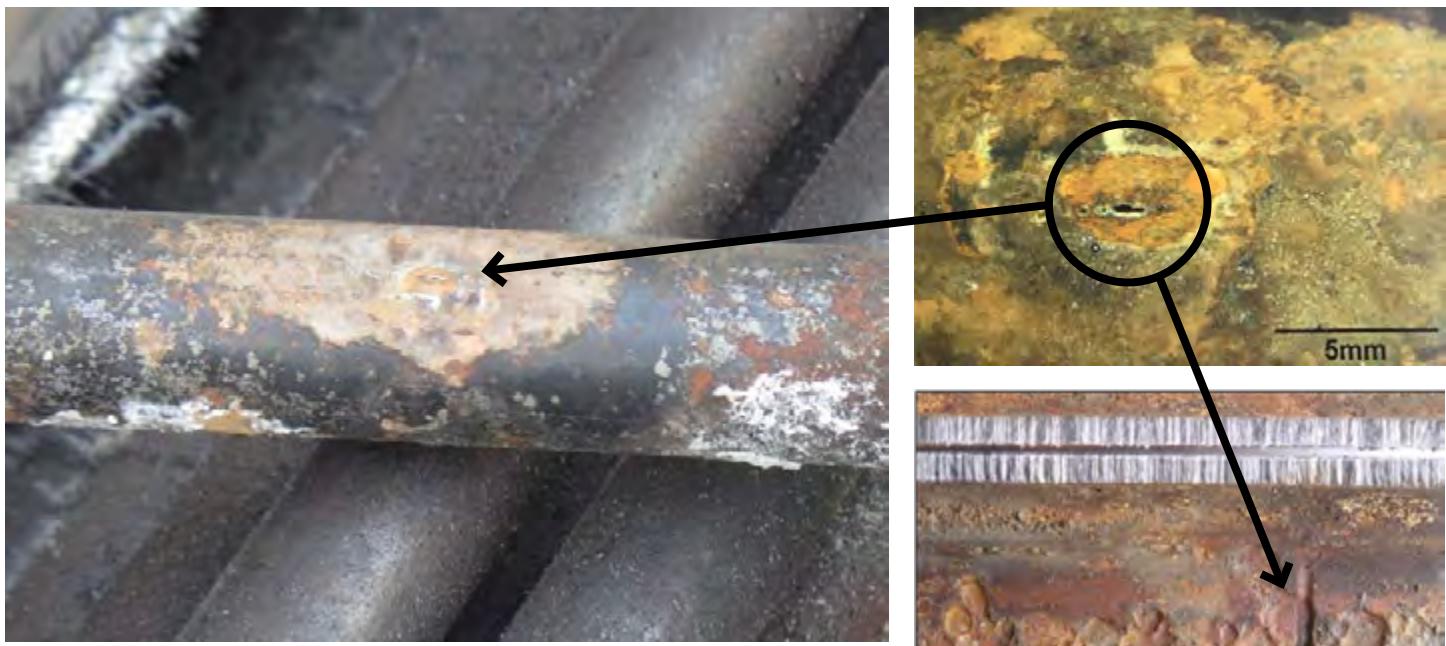
Ammonia was detected to have leaked into the curling brine system during the 2016/2017 operating season at the Fernie Memorial Arena. Examination of the curling brine chiller after the incident identified the source of the leak as a carbon-steel tube failure within the curling system brine chiller. The failed tube showed evidence of corrosion pitting along the inner tube walls with accelerated pitting on an electric resistance weld line due to weld line fusion defects. A corrosion penetration occurred at a weld location resulting in a hole measuring approximately 2.2 mm x 0.2 mm with potential adjacent smaller holes along the same weld line.

Photo 2 (above): outside of failed tube showing hole and corrosion due to brine spray.

Photo 3 (right-upper): close-up of hole from outside surface of tube.

Photo 4 (right-lower): close-up of hole from inside surface of tube showing pitting corrosion and line of smaller pits along weld line (Appendix E).

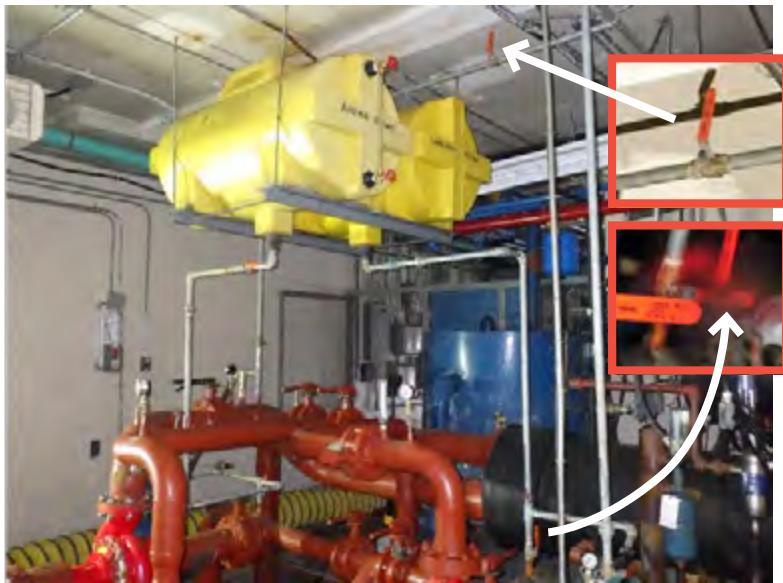
This configuration isolated an estimated 90 lb. of ammonia within the chiller (Appendix A) and inhibited brine system venting and pressure relief through the expansion tank.

Photo 5: Brine expansion tanks – closed valve positions as found after incident shown in photo insets. Main photo taken after hazardous material removal.

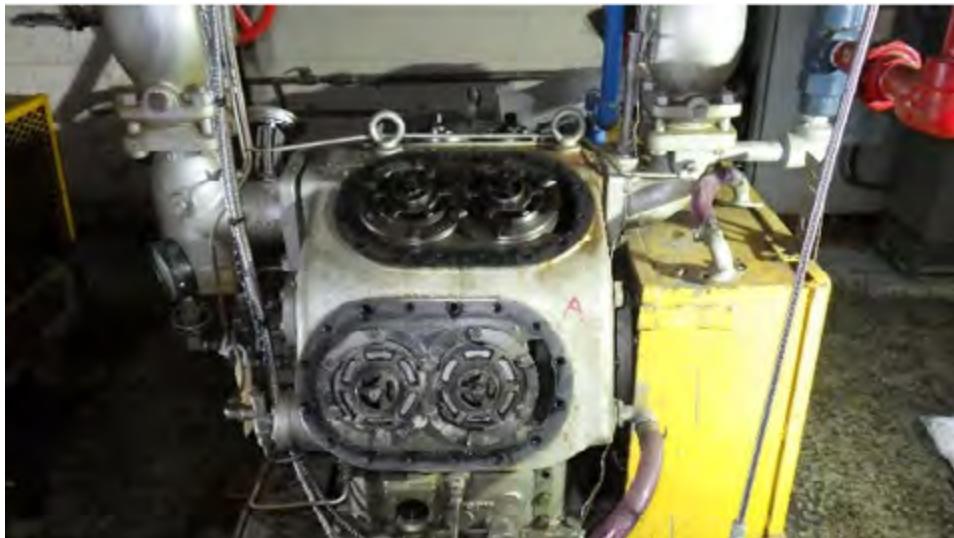
Oil with a cloudy or milky appearance is identified as an indication of a water/brine contamination. The compressor and cylinder heads were removed post incident and inspected which revealed the presence of salt deposits most likely from brine contamination of the ammonia.

Photo 6: Compressor #2 (#1 similar) showing salt crystal build-up on lower compressor cylinder heads, upper heads were clean.

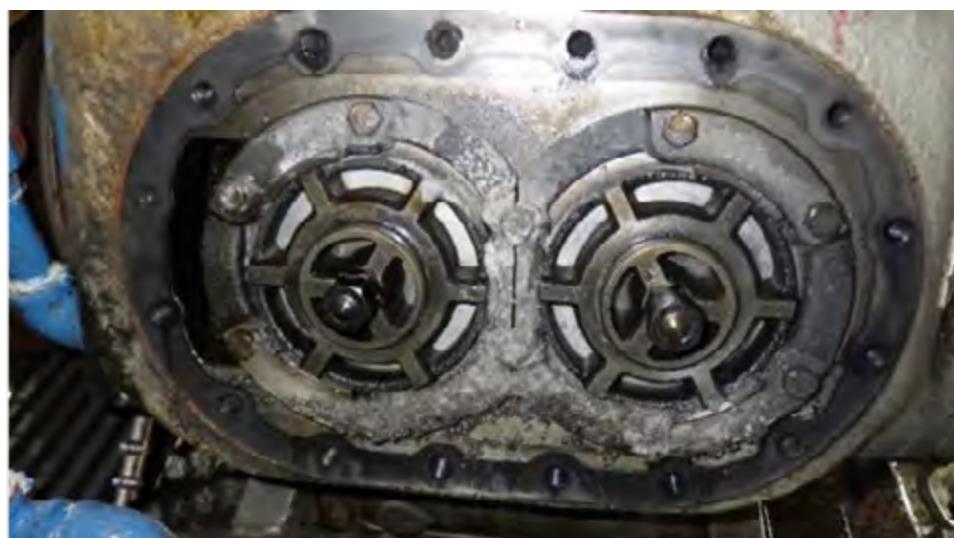
Photo 7: Build-up of salt crystals from brine around lower compressor cylinder heads of compressors #1 and #2.

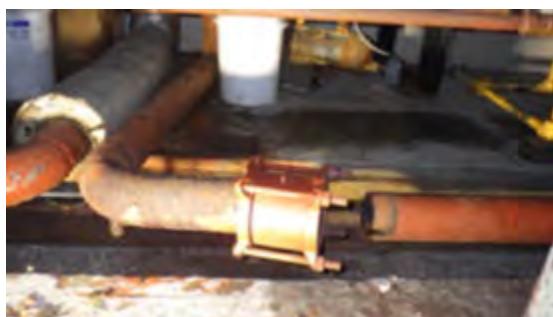
It is therefore estimated that the pressure within the brine system reached between 30 psi and 150 psi. The friction from the weight of the pipe and the torsional friction of the vertical coupling would have added to the force needed to separate the coupling beyond that associated with the 30 psi coupling separation pressure.

Photo 8: Separated brine system coupling.

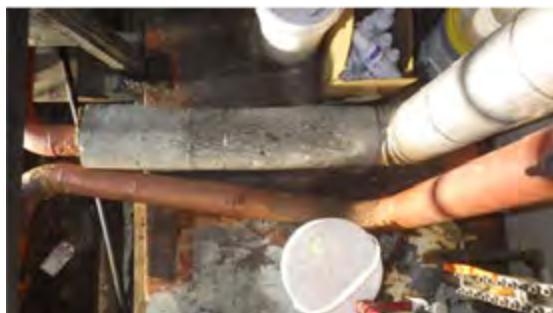
Photo 9: View looking down on pipe segment between vertical coupling and horizontal coupling. Angle of rotation estimated at approximately 7 degrees.

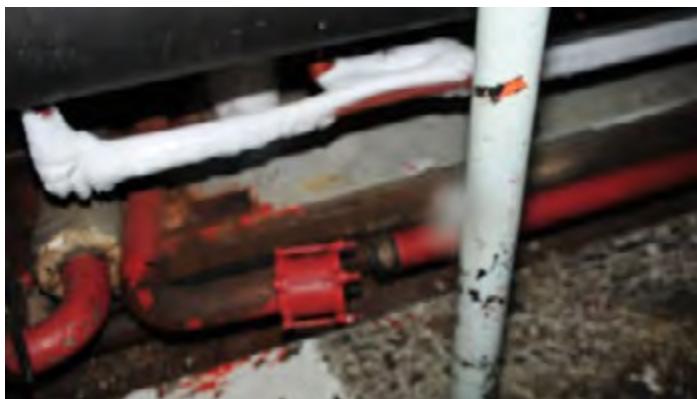
Evidence of brine chiller and pipe contents projecting from the separated brine system coupling was observed immediately following the incident as shown in Photo 10 and Photo 11 below.

Photo 10: Separated coupling and projected brine system contents. Photo taken on October 18, 2017.

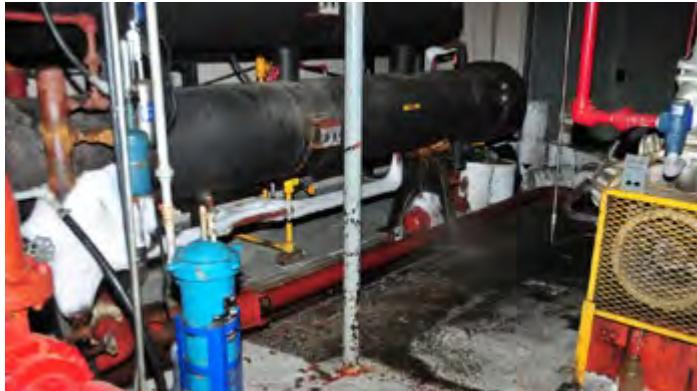
Photo 11: Projected contents of the brine piping from the separated coupling.

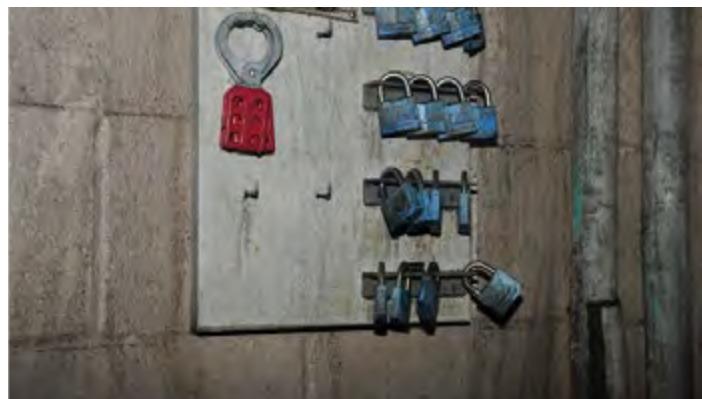
Exposed copper pipe and locks within the mechanical room were observed to be corroded (blue) indicating exposure to ammonia.

Photo 12: Lock-out board showing corroded (blue) copper consistent with ammonia exposure.

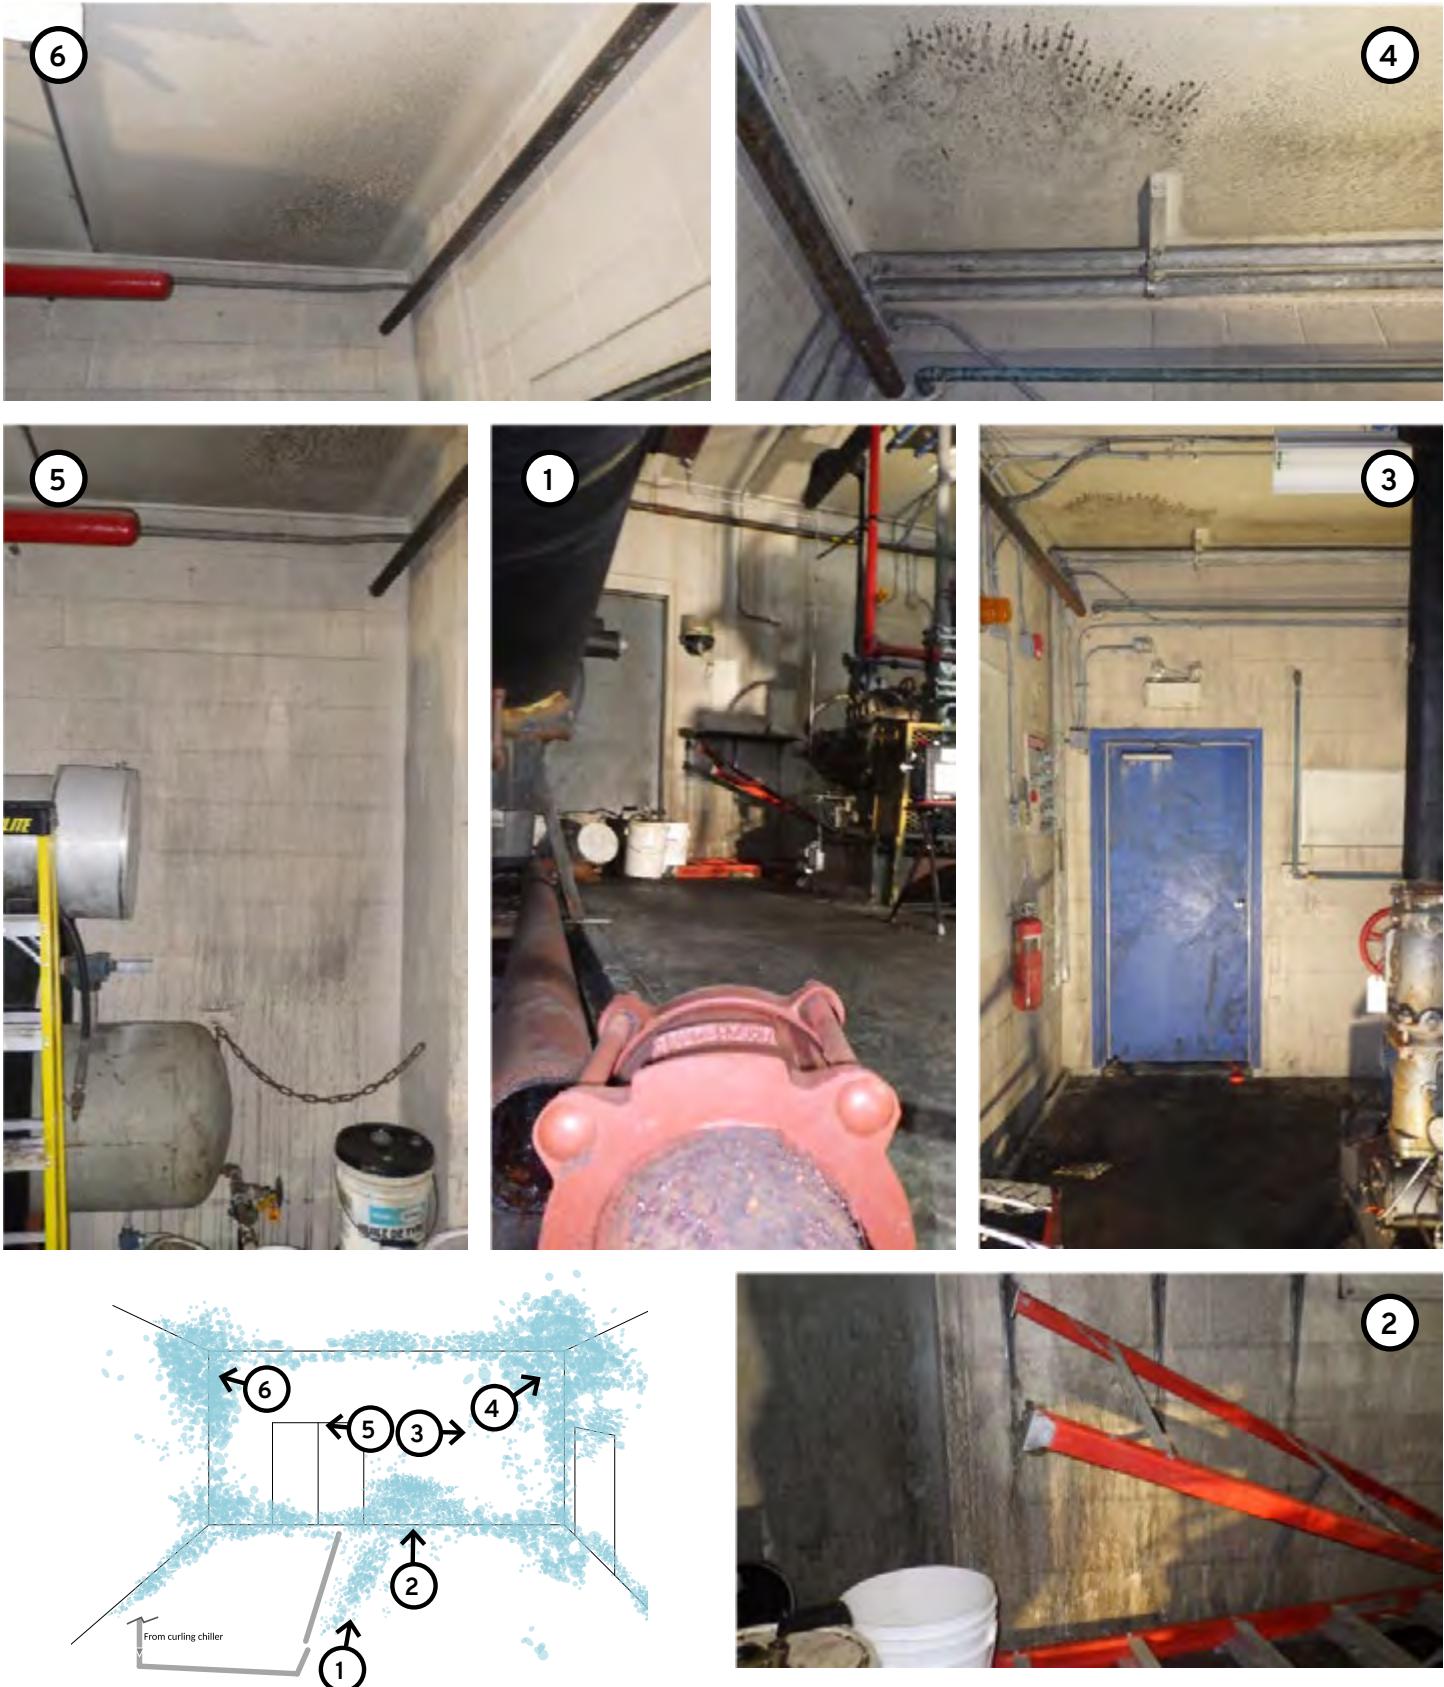
Samples from the residue on the walls were taken and analyzed. The results are contained in Appendix I and identified the likely presence of calcium chloride, consistent with brine having originated from the chiller/brine system piping.

Figure 6: Photos of residue locations on the mechanical room wall. Pattern location is consistent with originating from the separated brine coupling. Samples of the residue tested identified a likely presence of calcium chloride consistent with brine.

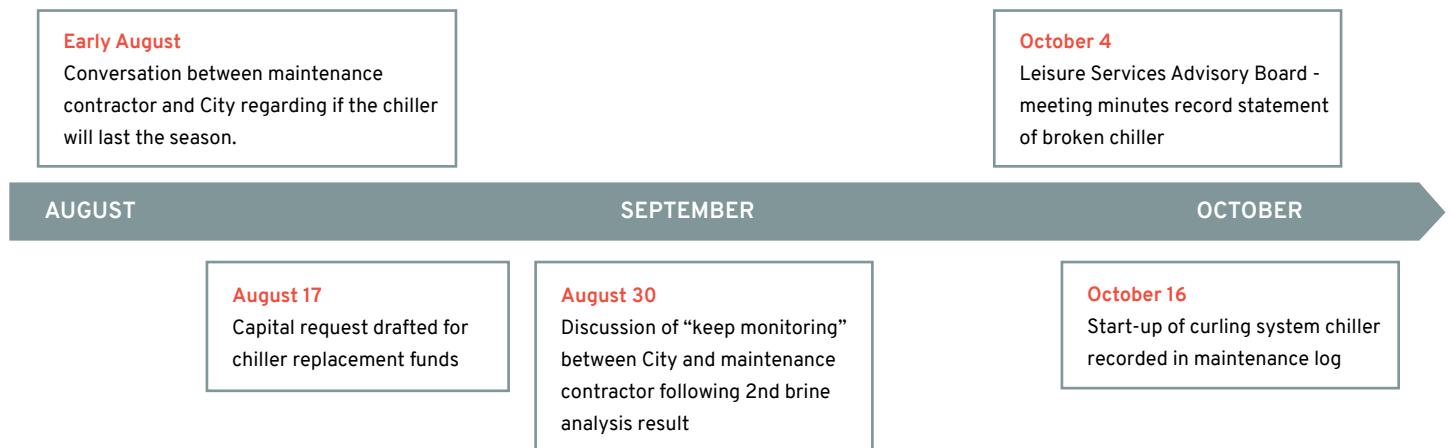
Technical Safety BC's investigation concludes that the City of Fernie knew the chiller had failed, yet chose to operate it until a replacement could be arranged. Evidence obtained by Technical Safety BC identifies that this decision was likely influenced by the failure to recognize the leaking chiller as hazardous, an intention to monitor the chiller in operation, and ineffective communication about the condition of the chiller.

Figure 12: Timeline of decision to operate the failed chiller

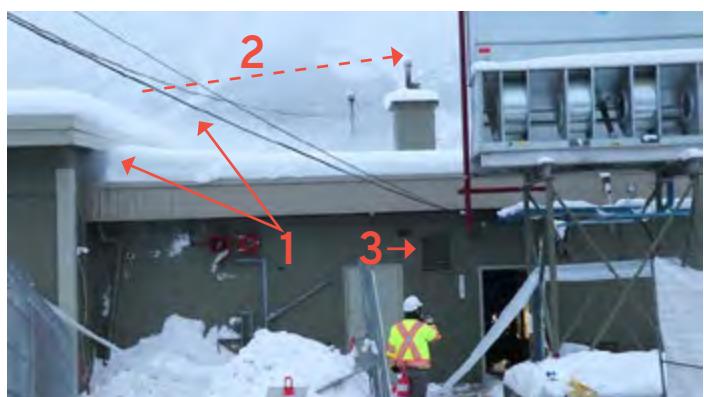
Photo 14 (above): Smoke test showing roof above mechanical room. Smoke became trapped (1) in depression between curling and arena roofs and was observed moving toward the roof edge rather than up into outside airstream (2). The air inlet for the furnace room for the building is identified (3).

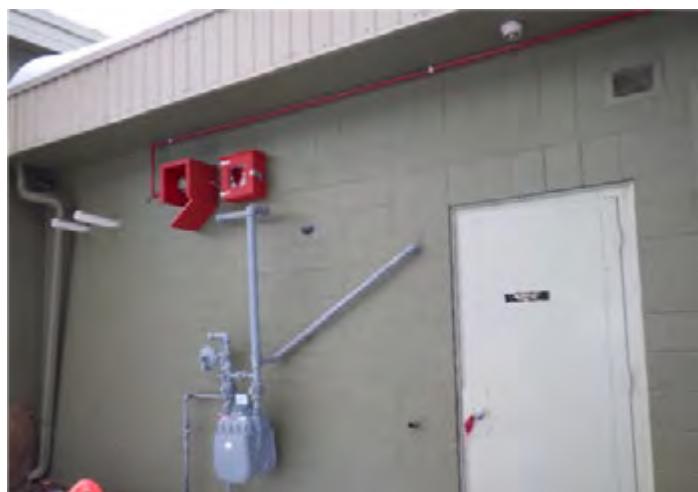
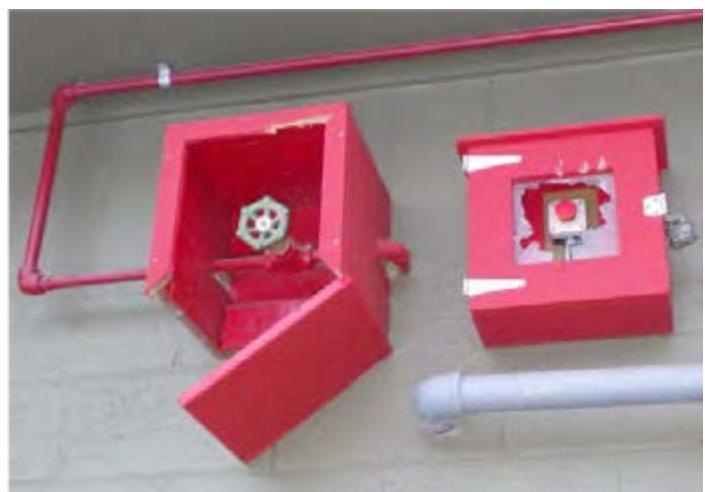
During the initial response to the incident, fire department first responders were instructed by a previous arena refrigeration operator to open the emergency discharge valve and activate the emergency stop button. The valve was opened at approximately 1:50 p.m. on October 17 and was evaluated to have initially released approximately 55 lb. of ammonia into the atmosphere.

Photos 16 (left) and 17 (right): Opened Emergency Discharge Valve and Actuated Emergency Stop Button.

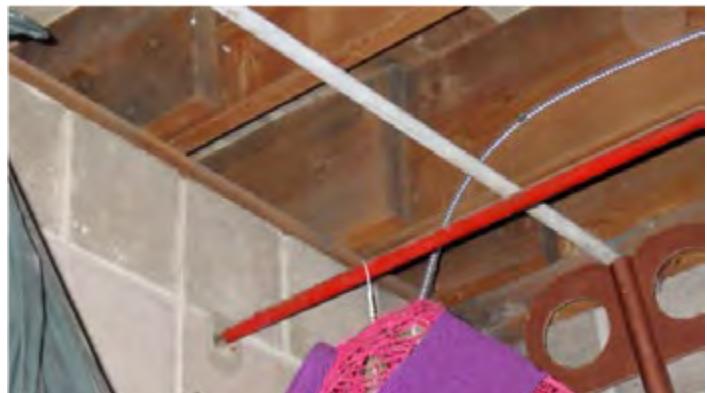
Photo 18 (above): Emergency discharge piping routed through concrete wall of closet used to hang storage item.
