# Johnson Street Bridge Condition Assessment Report

**Delcan**

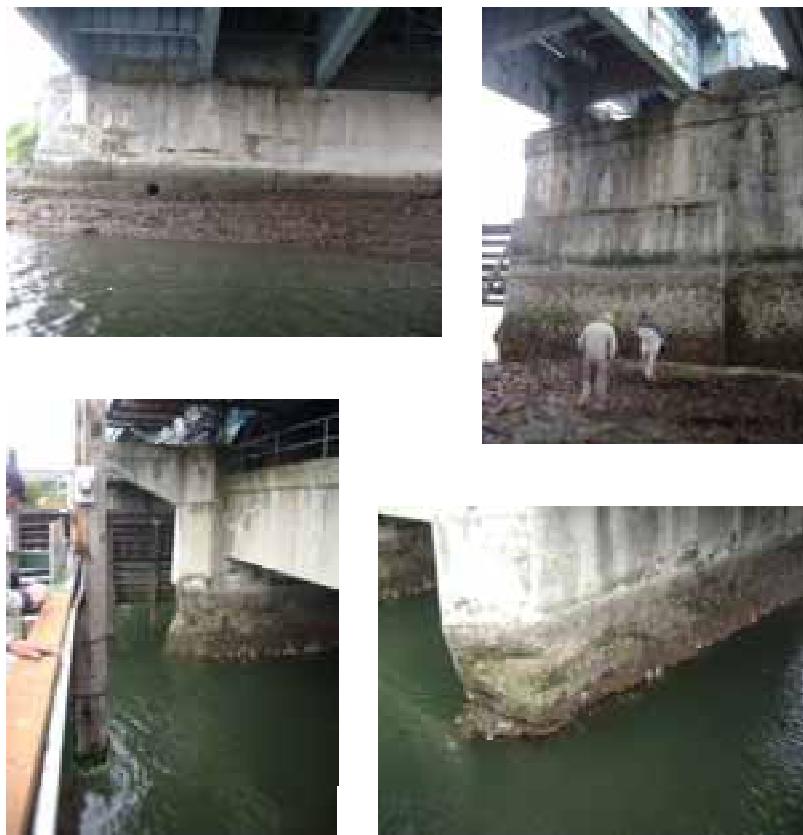
**Figure 3.3.1 – Substructures at low tide (a) Pier 1 looking west (b) Pier 1 looking east (c) Pier 2 looking west (d) Pier 2 showing erosion of concrete on the south side**

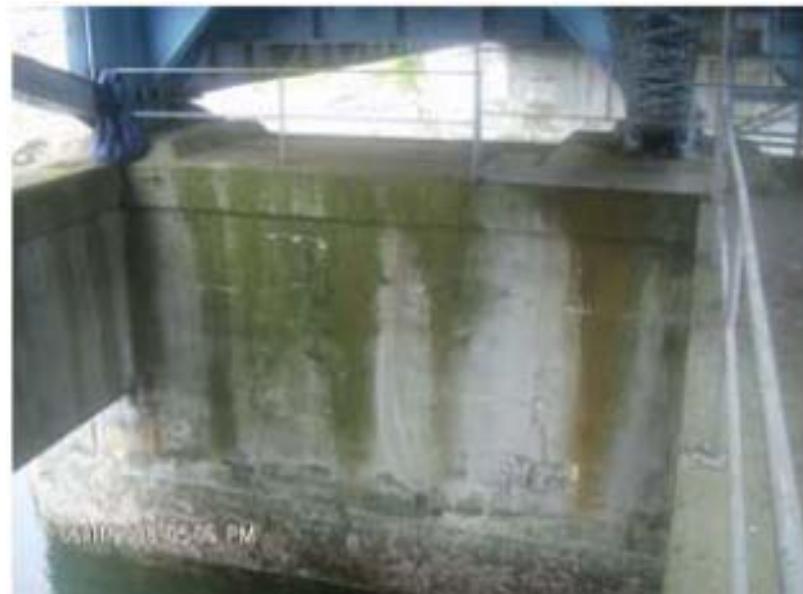
**Figure 3.3.2 –Pier 3, West face showing minor cracking and efflorescence**

It was noticed that the north east bearing on Pier 3 has reduced anchor bolt stiffeners, so it should be noted that thorough cleaning and a weld repair to replace the existing stiffeners should be carried out.

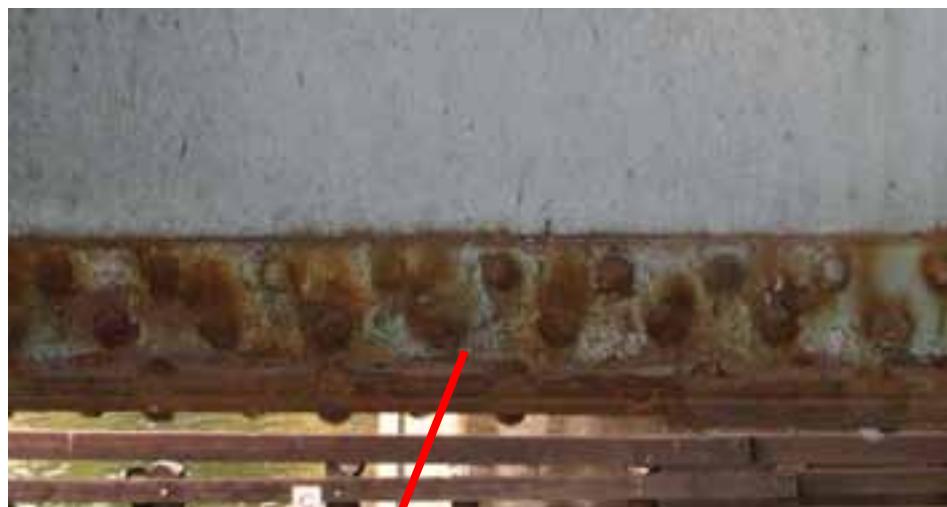
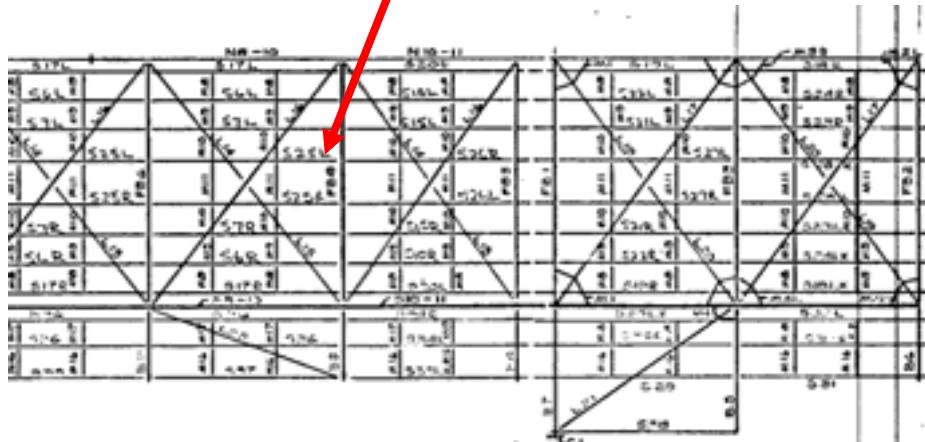
Extensive member corrosion was observed in many areas along the bridge – especially in the floor beams and stringers. The joints along the bridge are in good condition and minimal water and debris is coming through. Corrosion and paint deterioration is visible throughout the bridge on most members. However, most of the bridge components were found to be in fair to good condition. Member corrosion was observed in many areas along the bottom flanges of the stringers and floor beams of the road bridge shown below in **Figure 3.3.3, 3.3.4** and **Appendix A**.

**Figure 3.3.3 – Typical corrosion on bottom flange of bascule span (Member S25L)**

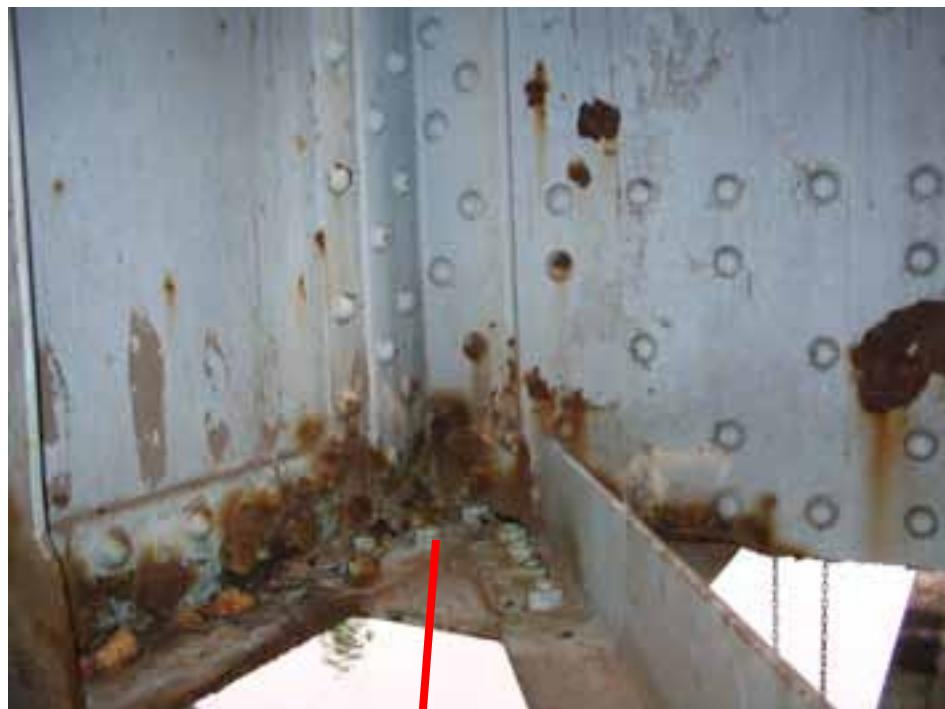
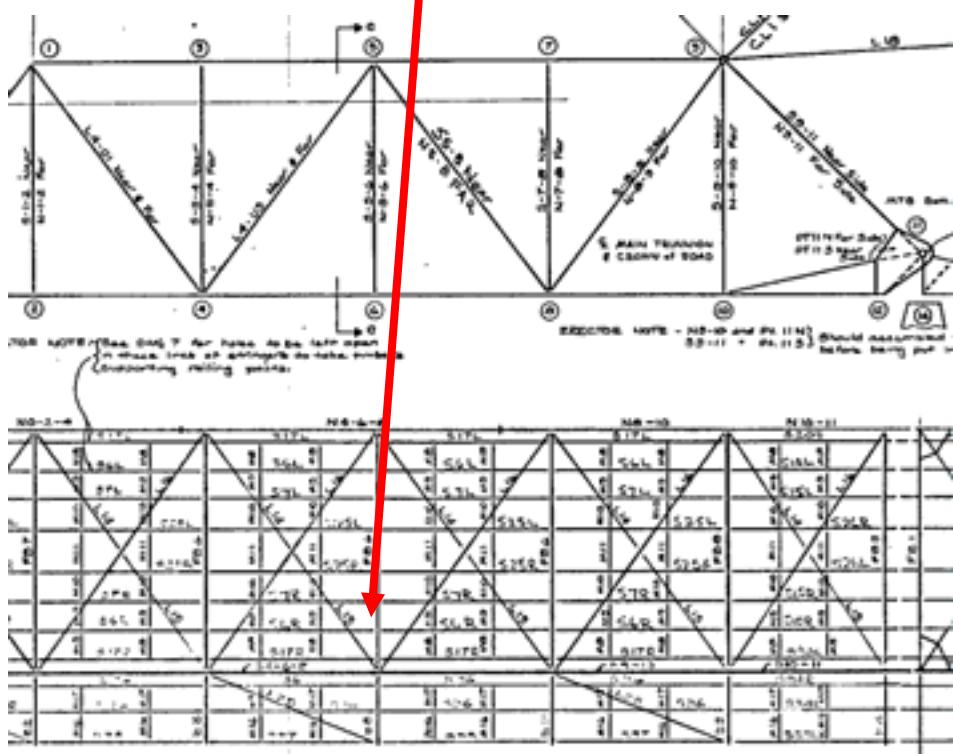
Figure 3.3.4 – Typical corrosion on bottom flange and gusset plate (Bracing Member L15 to Floor Beam FB6)

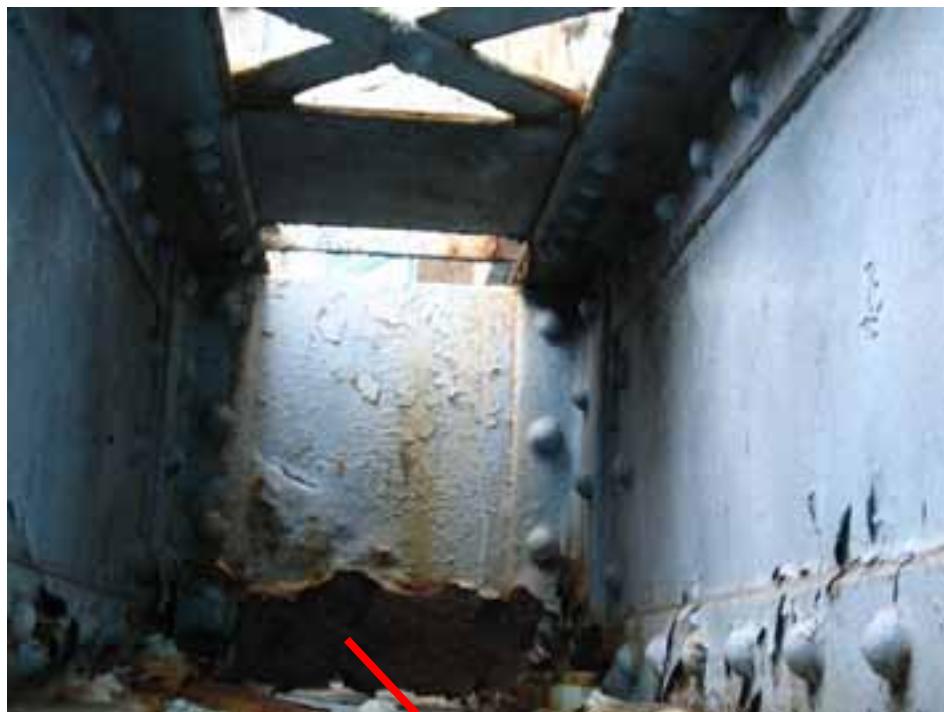
The structural integrity of the bridge appears to be intact and performing as originally intended with no signs of major distress. However, it was noticed that the paint coating in many areas along the bridge has failed or is beginning to fail. Other than the obvious corroded areas, the paint coating is peeling in areas on the top and bottom and interior surfaces of the diagonals, verticals and girders. Paint coating deterioration is estimated to cover approximately 30-35% of the bridge. Typical interior section paint deterioration is shown in **Figure 3.3.5** below.

**Figure 3.3.5 – Typical condition inside built-up truss member**

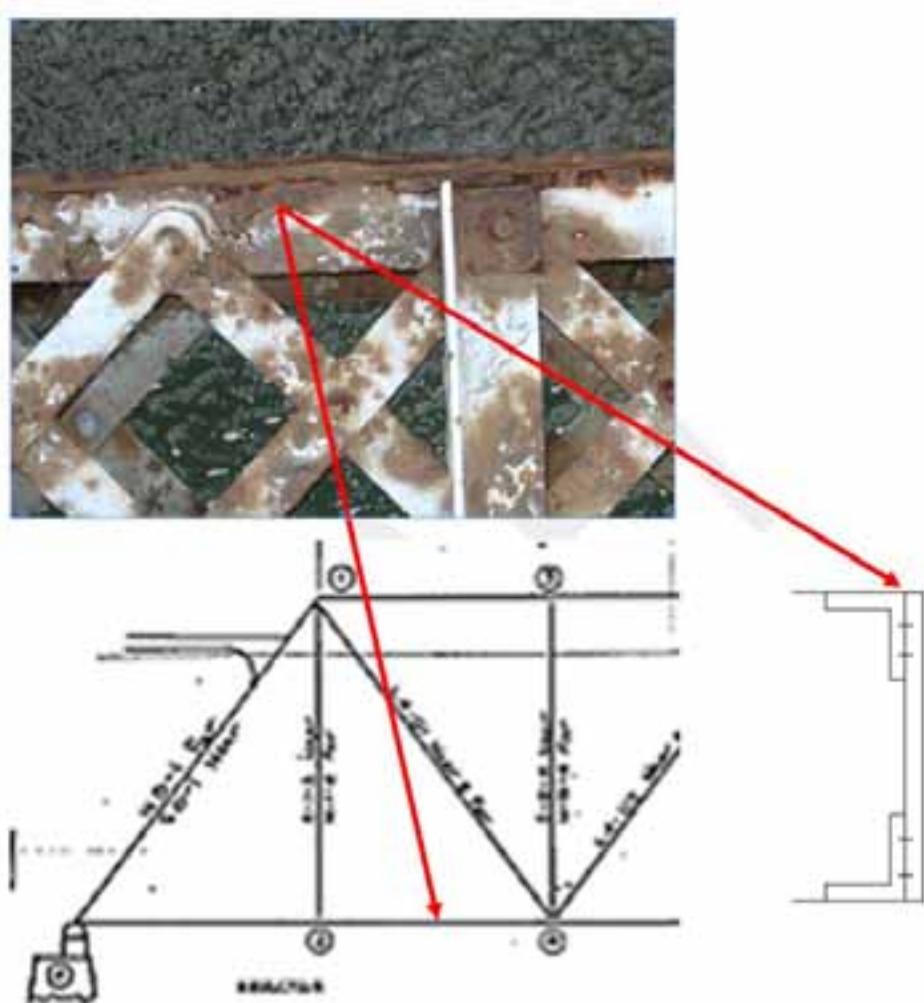
The vertical and diagonal truss members are in generally good condition. There are some localized areas where the steel coating has deteriorated and pack rust is forming between the members built-up plates. This can be seen in **Figure 3.6.4**. The pack rust, over time, can induce undesirable tensile stresses on the rivets and if the resultant stress becomes too high, rivets can break or tear through the parent material. Pack rust can typically not be eliminated although its rate of growth can be reduced.

**Figure 3.3.6 – Typical condition on top surface of laced member.**

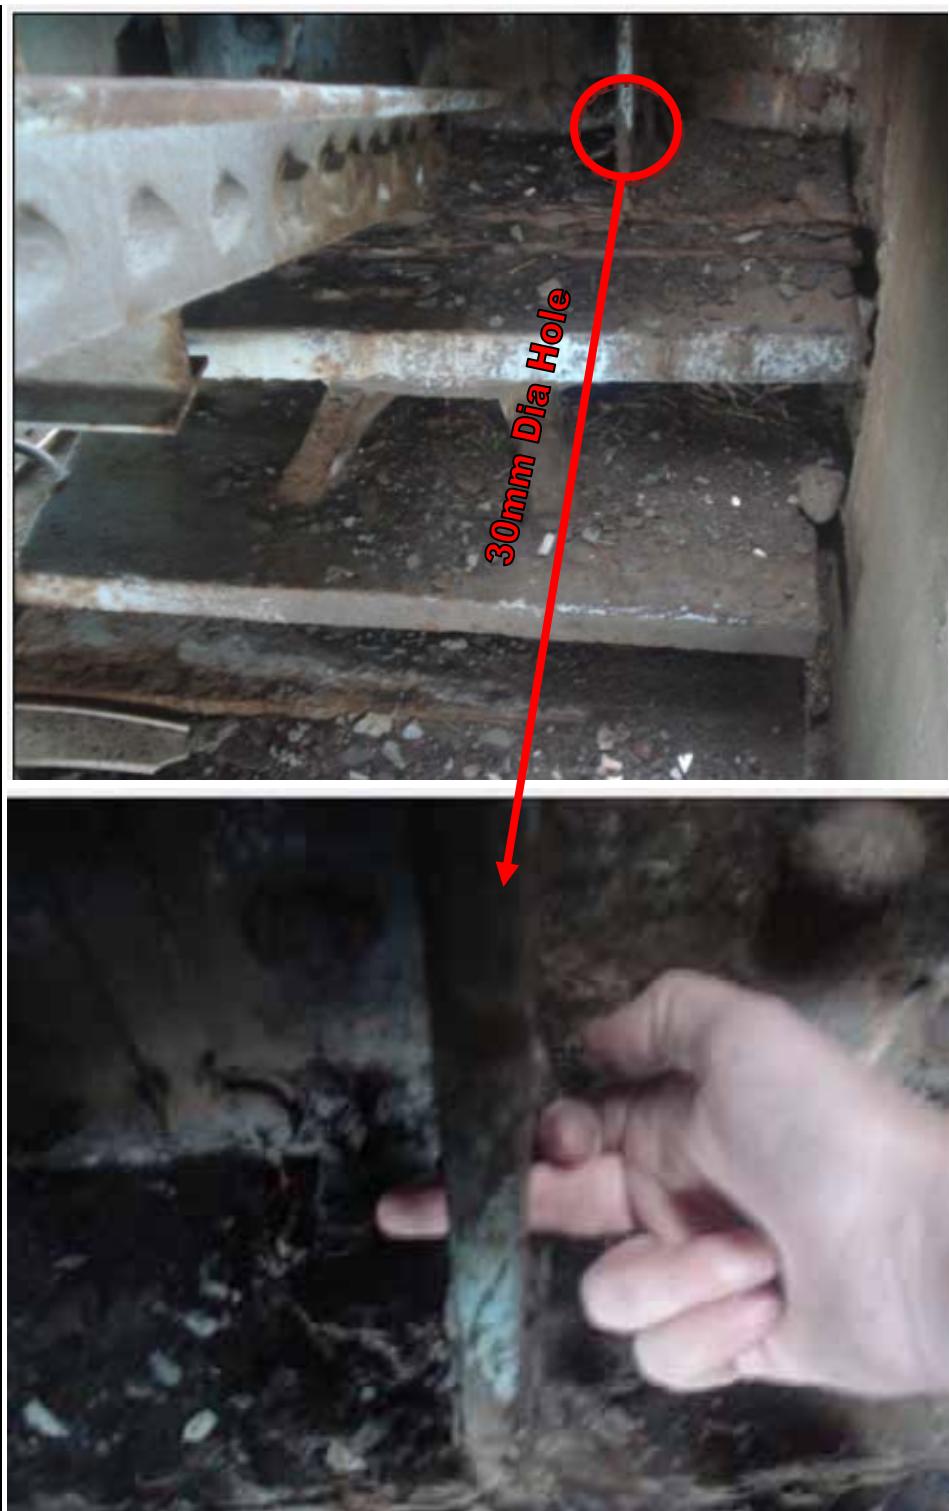
Members with 100% section loss were observed in areas where debris and moisture were trapped such as at gusset plates and bracing connections, see **Figures 3.3.7 and 3.3.8**. These affected areas are the result of severe corrosion due to paint loss and/or water accumulation on the member surfaces. It should be noted that this level of deterioration was found in localized areas and is not widespread on the bridge.

**Figure 3.3.7 – 100% section loss on bearing stiffener, Northeast bearing, Span 1**

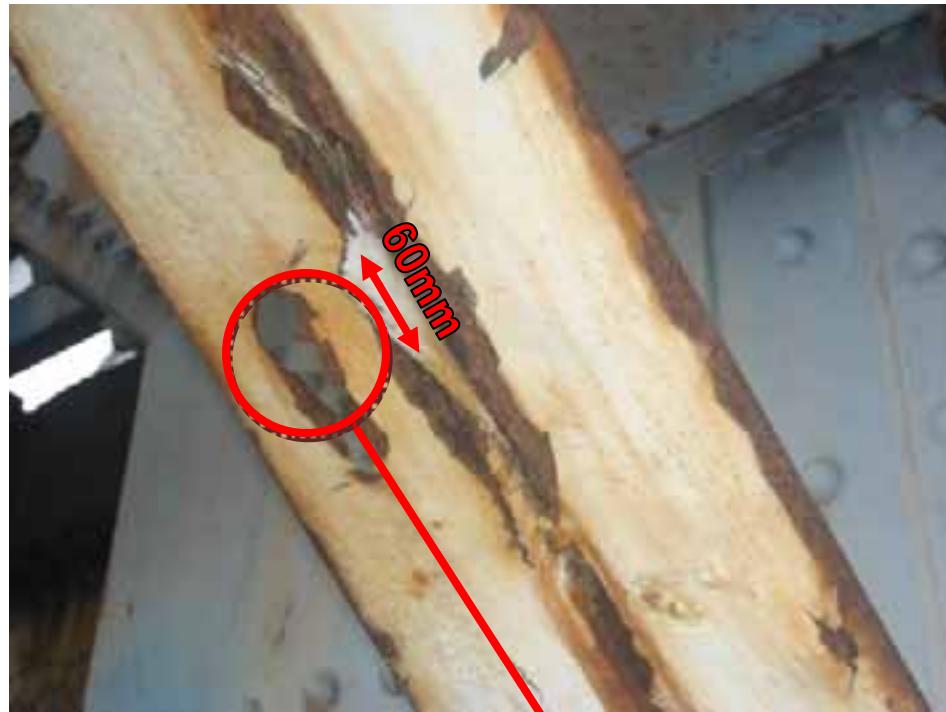
**Figure 3.3.8 – 100% section loss, underside of lateral cross bracing, Span 1**

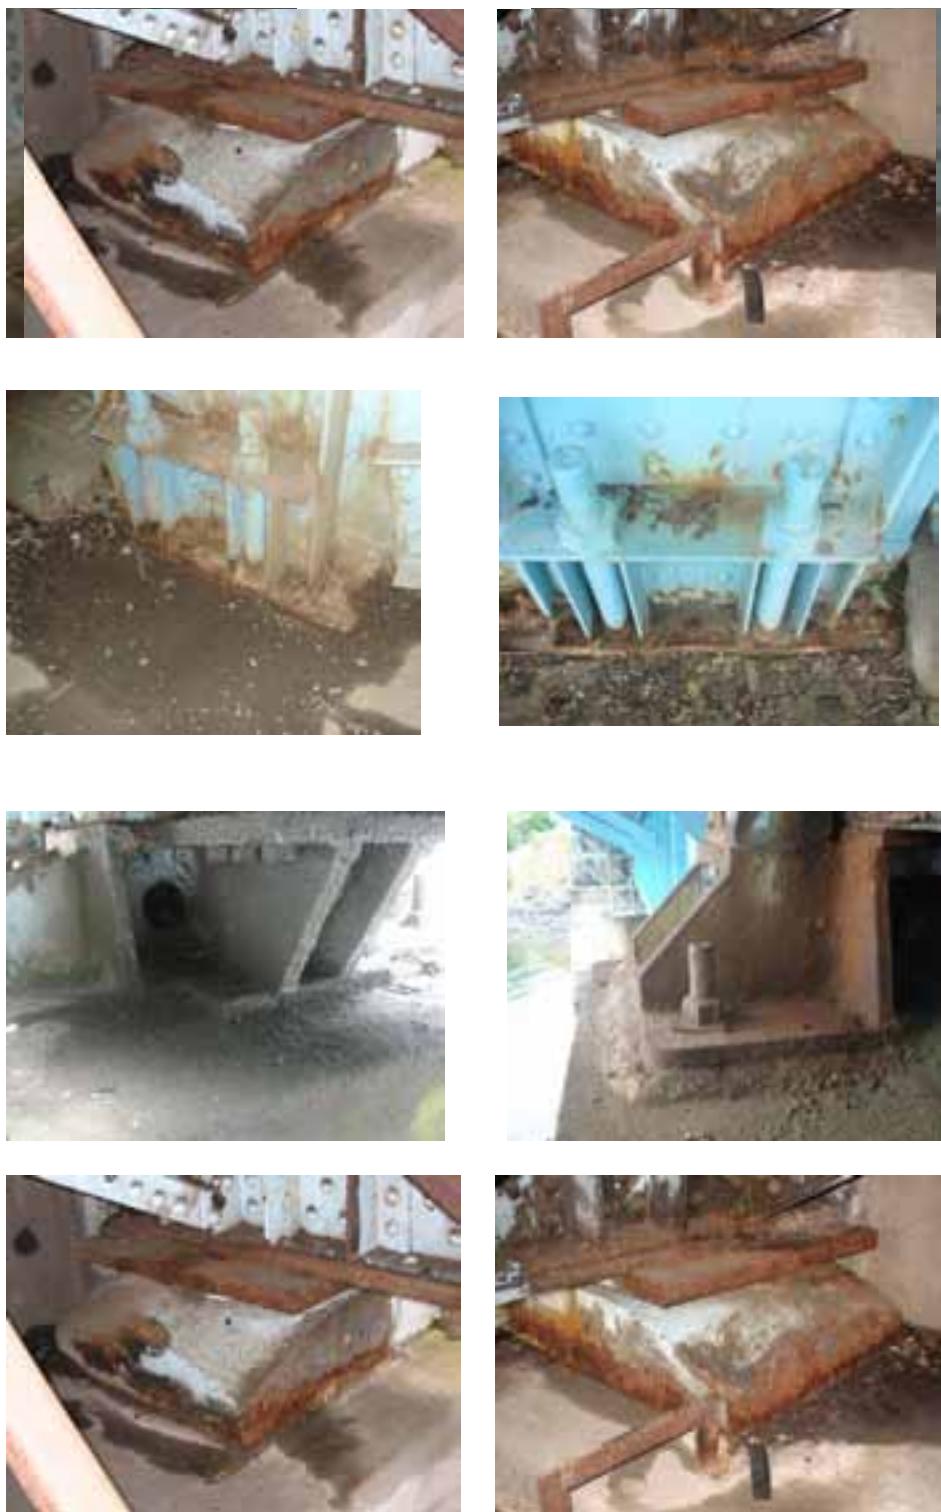
Although there is only minor dirt and debris accumulation on the bridge bearing seats, significant corrosion of the bearing plates was observed as shown in **Figure 3.3.9.**

**Figure 3.3.9 – Bearing Plate Deterioration**

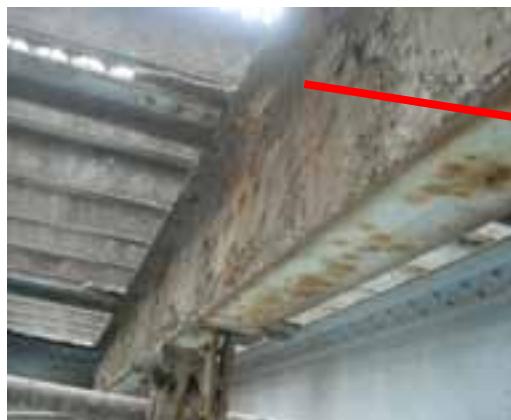
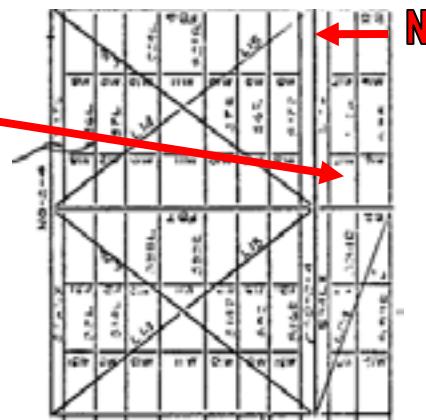
Corrosion and section loss in the deck beams for the road and pedestrian walkways were observed, see **Figure 3.3.10** and **Figure 3.3.11**. It appears that run-off from the deck passes through the open steel grid and gets trapped along the top flanges and the bottom flanges of the supporting beams. Consequently, extensive corrosion has developed on the flanges, webs and rivets on a majority of the beams underneath the lift span, see **Figure 3.3.12**. The webs on the beams in this span have also experienced up to 60% or more paint loss.

Figure 3.3.10 – North side of a typical floor beam

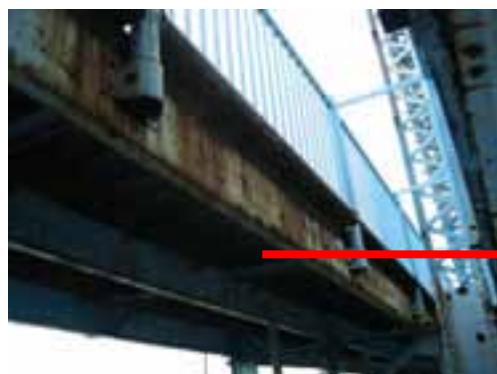
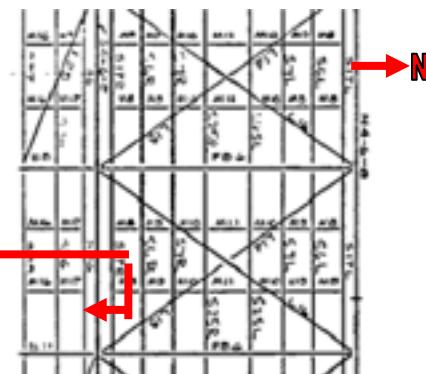
Figure 3.3.11 – Girder under pedestrian walkway, North face

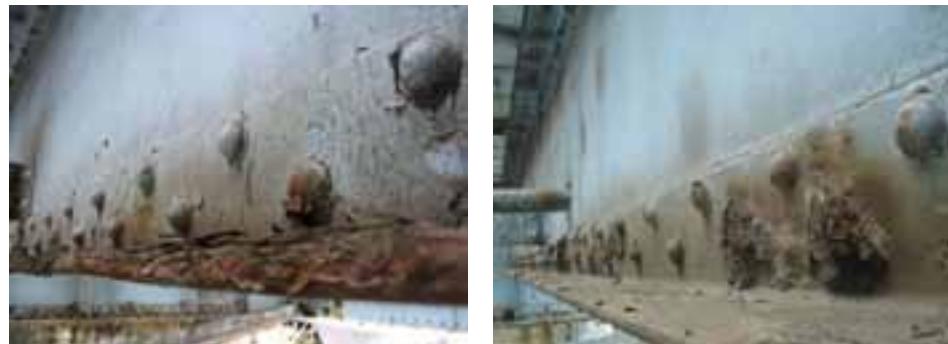
**Figure 3.3.12 – Typical corroded bottom flange and rivets on floorbeam**

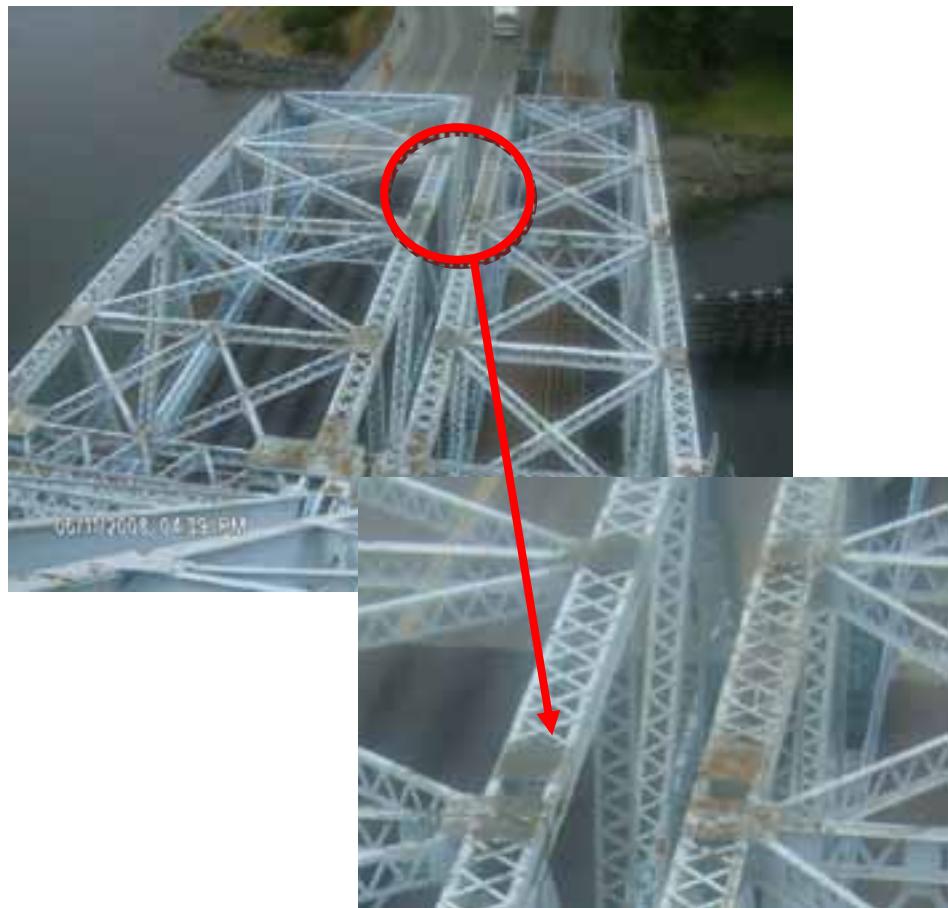
**Figure 3.3.13** shows the aerial view of the lift span. There is minimal corrosion on upper lateral bracing. However, the horizontal gusset plates have extensive corrosion and should be cleaned or restored, as the paint has failed there.

**Figure 3.3.13 – Aerial view of lift span, (looking west)**

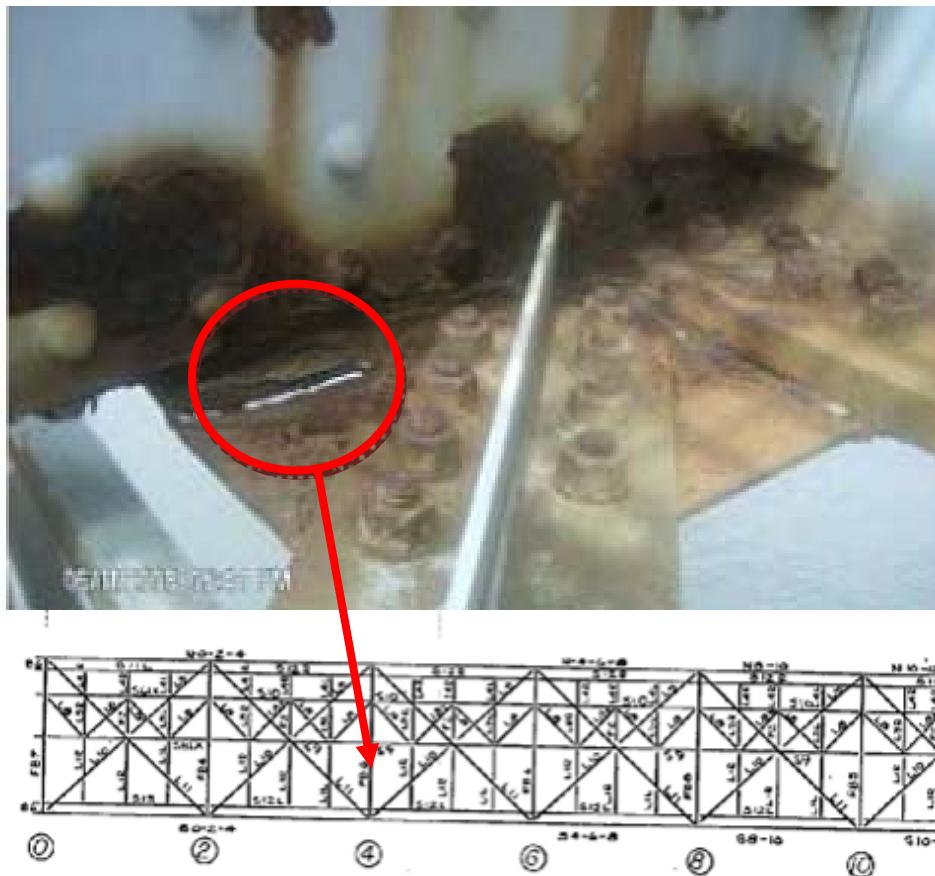
**Figure 3.3.14 – Perforation in horizontal gusset plate between bottom chord and lateral bracing**

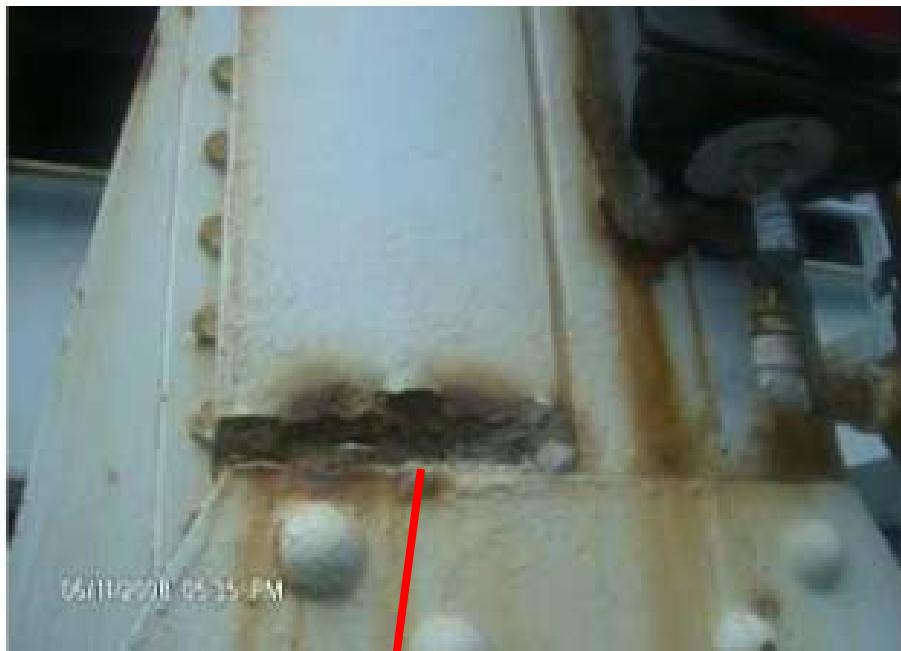
**Figure 3.3.15 – South vertical at east end of Panel 3, 50% section loss**

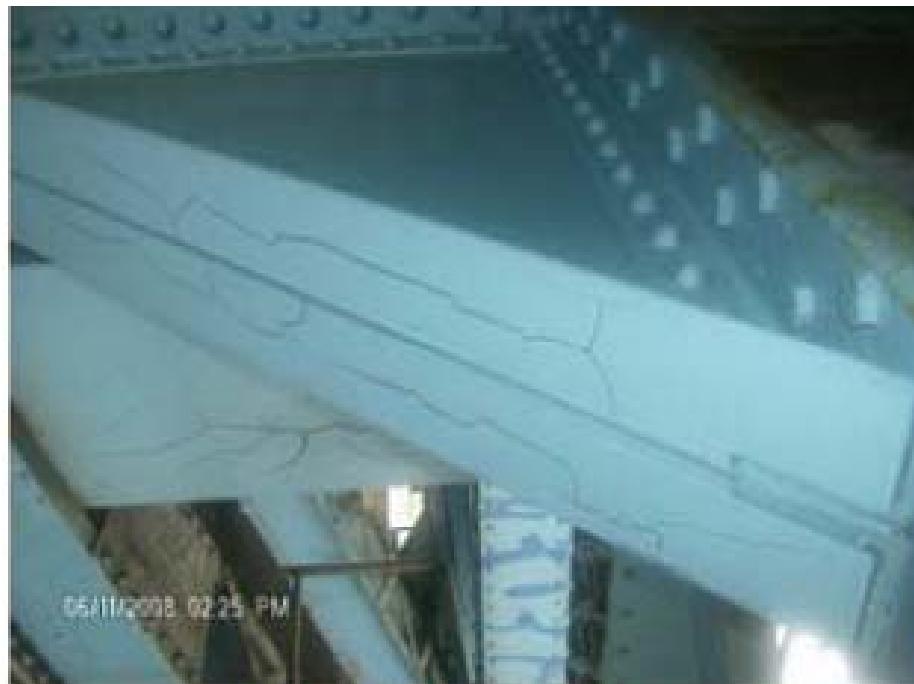
The paint coating is generally in poor condition and has failed, see **Figure 3.3.16**.

**Figure 3.3.16 – Typical cracks in paint system, Span 3**

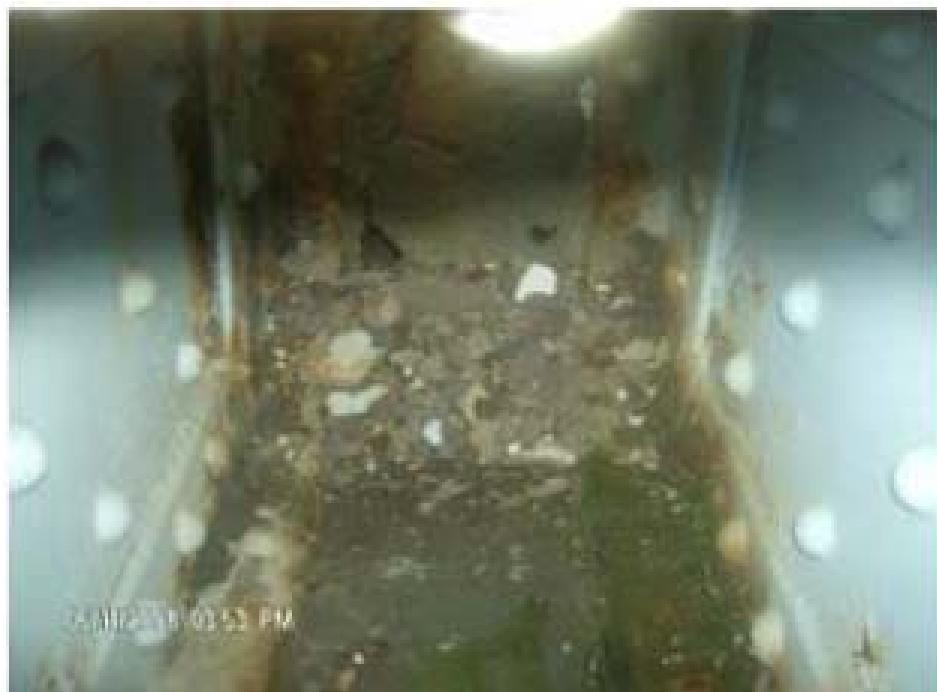
**Figure 3.3.17 – Typical debris build-up inside of truss bottom chord at verticals**

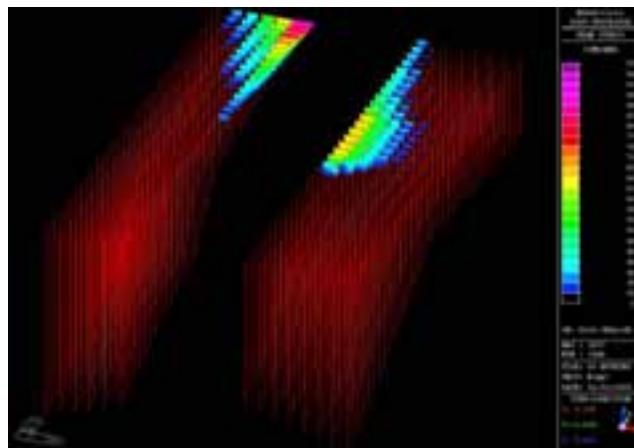
**Figure 4.3 – Stresses in the Timber Pile that Exceeds the Ultimate Capacity**

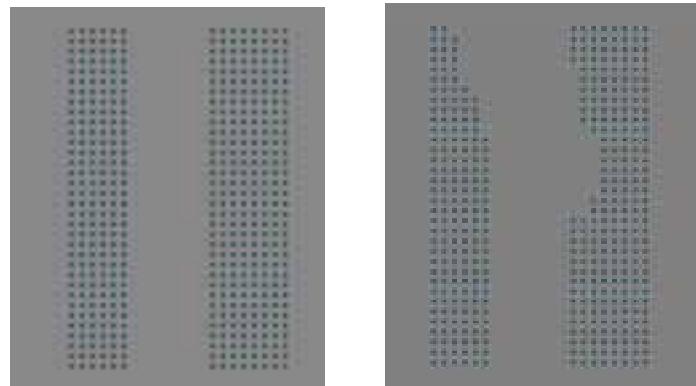
**Figure 4.4 – Critical Case, the Timber Piles that Might be Lost During 35% Pōe Earthquake**

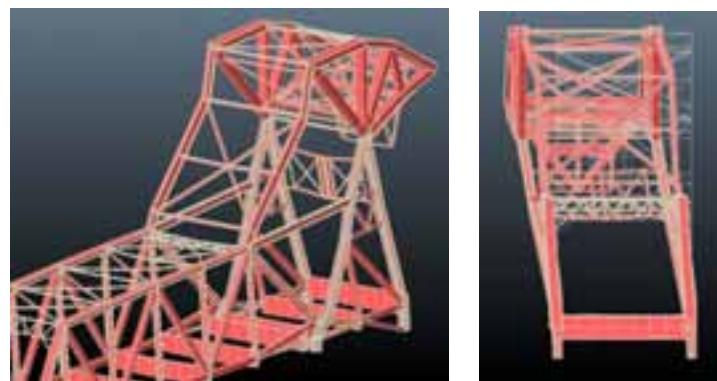
The deflected shape of the bridge in its current configuration under seismic loads is shown in **Figure 4.6**. Because of the weak bracing used in the structure, much of the bridge's strength is not engaged and consequently the bascule span and the counterweight tower act as discrete units rather than as a continuum.

**Figure 4.6 - Deflected Shape of Existing Bridge Under Seismic Loading**

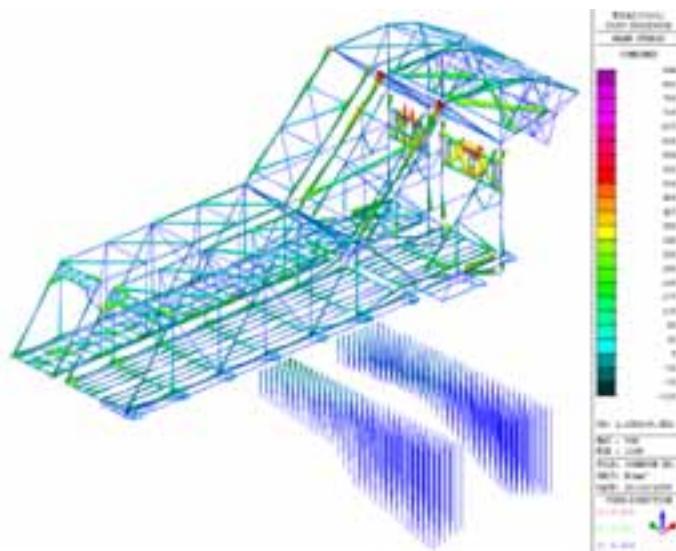
Under the minimum seismic event for design (10% exceedance in 50 years), bracing and connecting elements in the counterweight tower of the existing bridge will be severely overstressed while the bascule span will not be significantly affected. This condition could lead to collapse of the counterweight tower.

It can be seen from the **Figure 4.7** that the main bascule trusses are not heavily stressed in a seismic event whereas the cross bracing in the counterweight tower is stressed well beyond failure.

**Figure 4.7 - Stresses in the Existing Bridge Under Seismic Loading**

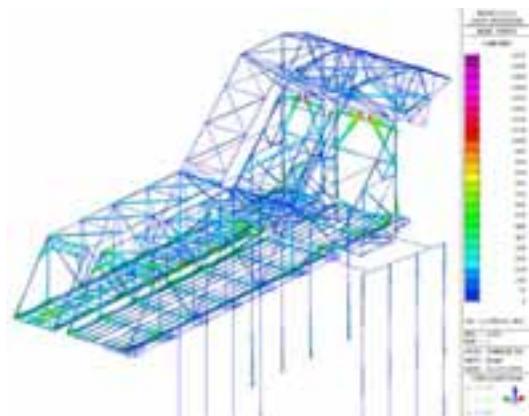
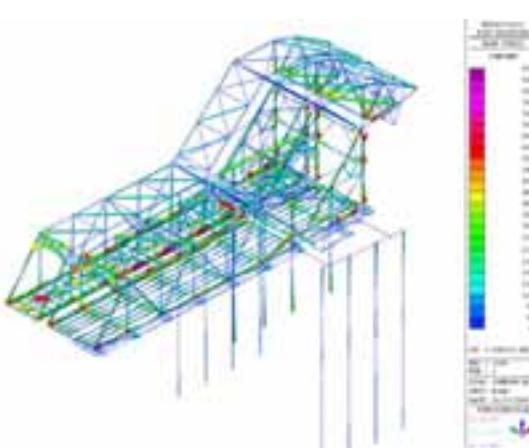
**Figure 5.6** - Alternative 5 stresses (a) commencement of earthquake; (b) after formation of plastic hinges.

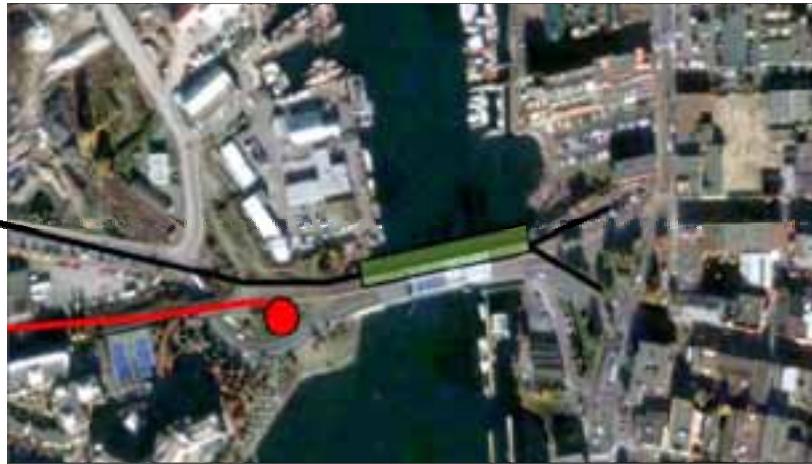
**Figure 7.1 – Alternate alignment for Johnson Street Bridge Replacement**  
*[red line indicates railway line, red circle indicates relocated train station, black line indicates Johnson Street, North is up].*

To reduce replacement costs, the road/rail alignment of the bridge could be modified by relocating the existing train station to the west side of the crossing. This would eliminate the need to provide a crossing for the railway, allow for a better alignment on Johnson Street and free up land currently used by Johnson Street for other purposes or sale, see **Figure 7.1**. This alignment would reduce the bridge width from 20m to 15m and with proper staging allow construction of the new bridge with reduced disruption to Johnson Street traffic.

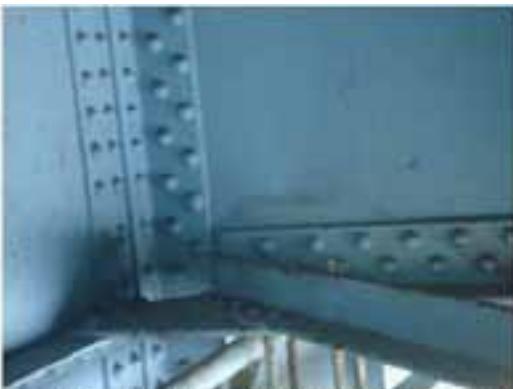
Span 1 - Lateral Bracing Connection  
Top Lateral Bracing  
Lift Truss  
Starting East Working West

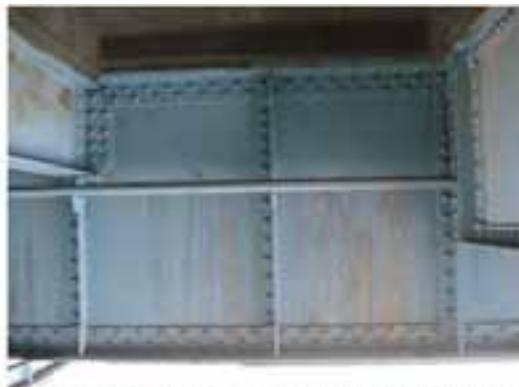
Span 1 - South Side, North Face Built Up Panel  
Top Lateral  
Bracing  
Lift Truss

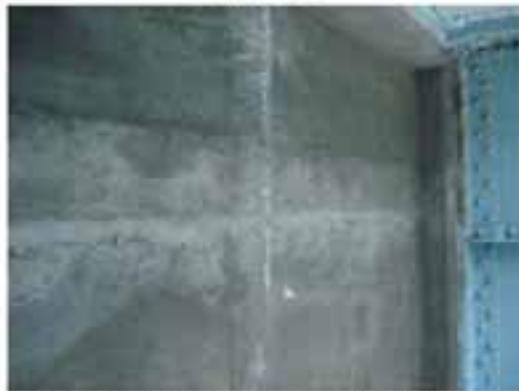
Span 1 - Efflorescence on Soffit  
Top Lateral Bracing  
Lift Truss  
Starting East Working West

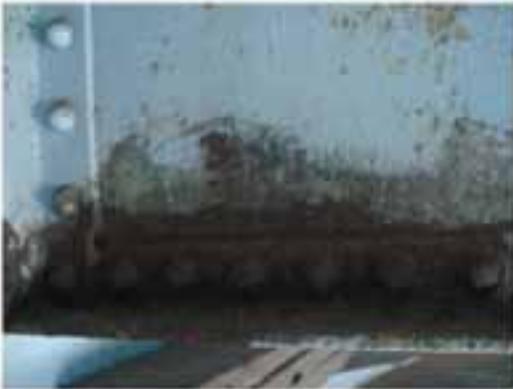
Span 1 - Corrosion on Bottom Flange and Rivets  
Top Lateral  
Bracing  
Lift Truss

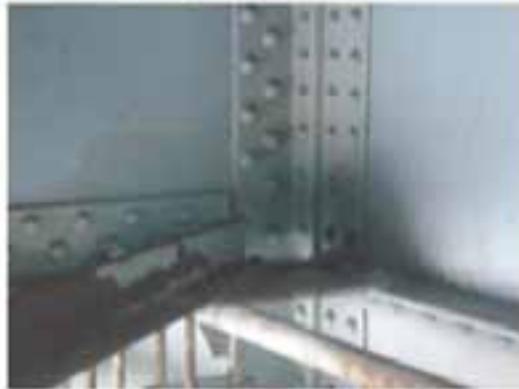
Span 1 - Lateral Bracing Connection  
Top Lateral Bracing  
Lift Truss  
Starting East Working West

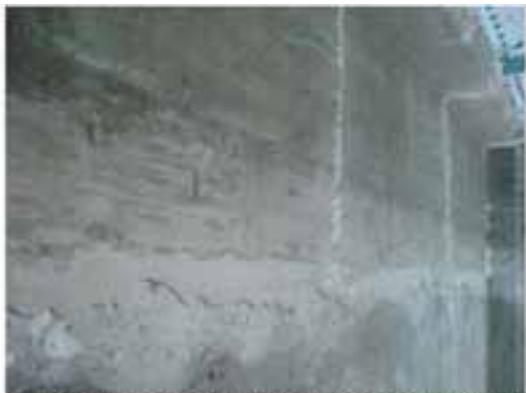
Span 1 - Efflorescence on Concrete Soffit Top Lateral Bracing  
Lift Truss  
Starting East Working West

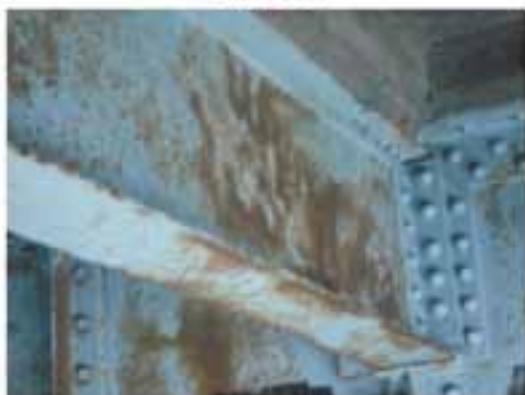
Span 1 - Paint Loss and Corrosion on Floor Beam Top Lateral  
Bracing  
Lift Truss

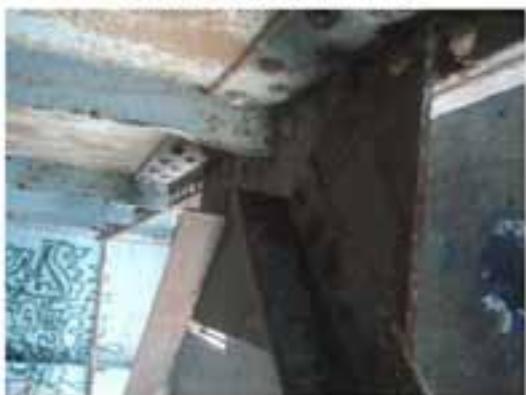
Span 1 - Corrosion on Lateral Bracing Connection Plate Top  
Lateral Bracing  
Lift Truss

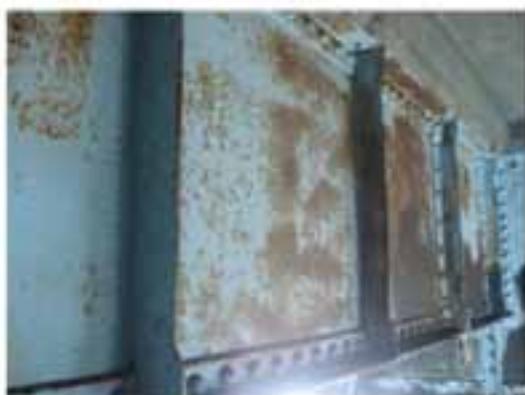
Span 1 - Corrosion on Built-Up Web Panels Top Lateral Bracing  
Lift Truss  
Starting East Working West

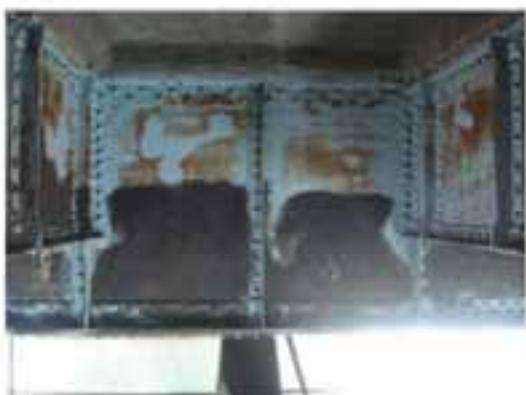
Span 1 - Corrosion on Web of Built-Up Members Top Lateral  
Bracing  
Lift Truss

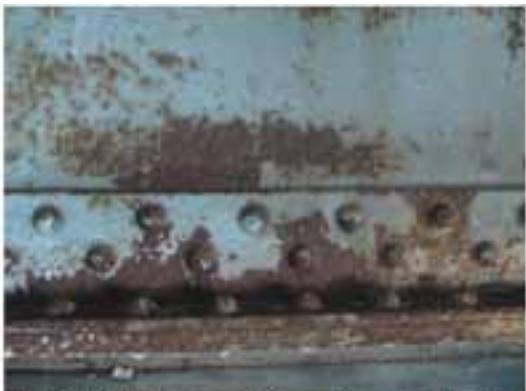
Span 1 - Typical Paint Loss and Corrosion along Bottom Flange  
of Beams Top Lateral Bracing  
Lift Truss

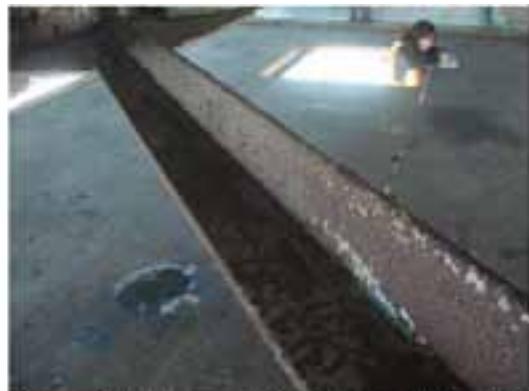
Span 1 - Severe Paint Loss and Corrosion on Lateral Bracing Top  
Lateral Bracing  
Lift Truss

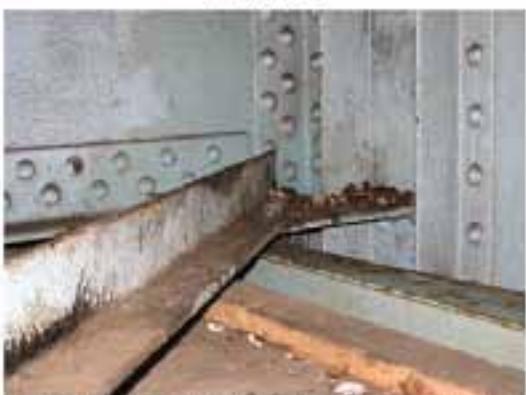
Span 1 - Debris Build Up at Lateral Bracing Connection, Paint  
Loss and Corrosion Top Lateral Bracing  
Lift Truss

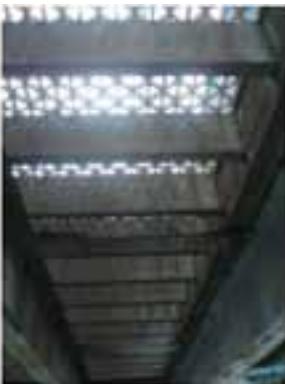
Span 2 - Open Grid Decking Top Lateral Bracing  
Lift Truss  
Starting East Working West

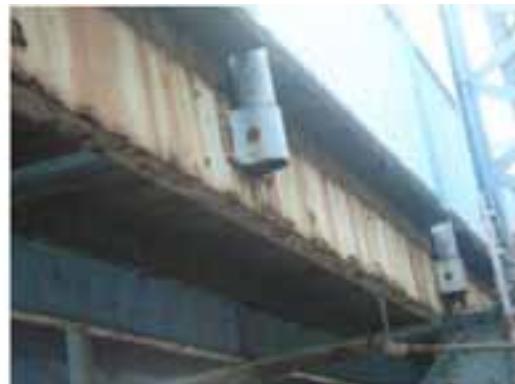
Span 2 - Edge of Side Walk Top Lateral Bracing  
Lift Truss  
Starting East Working West

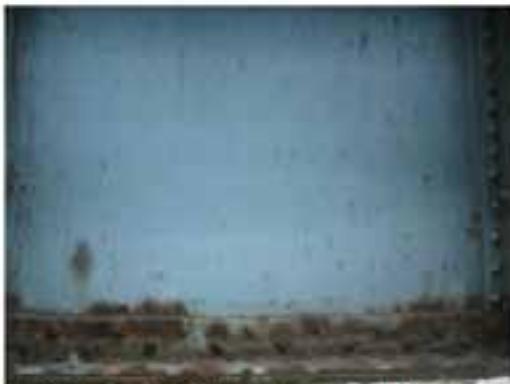
Span 2 - Corrosion on Bottom Flange and Rivets Top Lateral  
Bracing  
Lift Truss

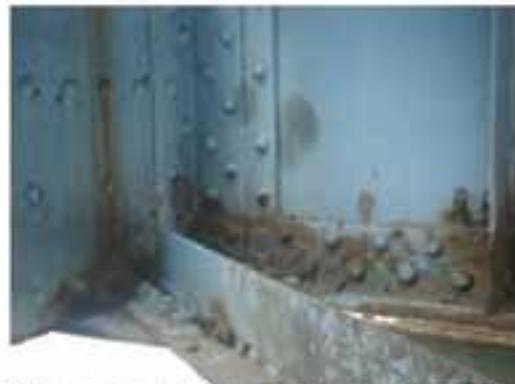
Span 2 - Corrosion on Rivets and Bottom Flange Top Lateral  
Bracing  
Lift Truss

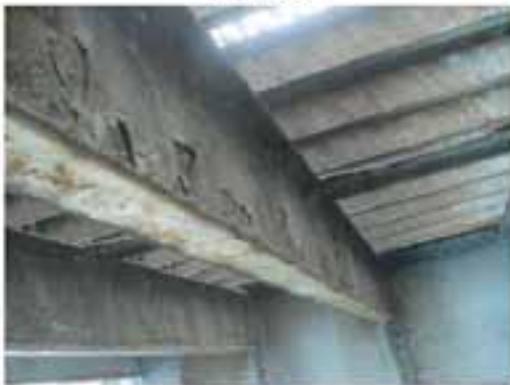
Span 2 - Paint Loss on Web Top Lateral Bracing  
Lift Truss  
Starting East Working West

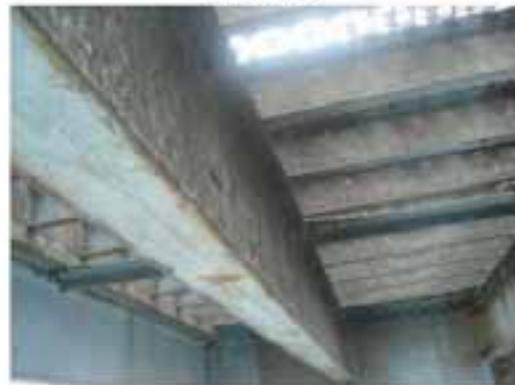
Span 2 - Paint Loss on Web Top Lateral Bracing  
Lift Truss  
Starting East Working West

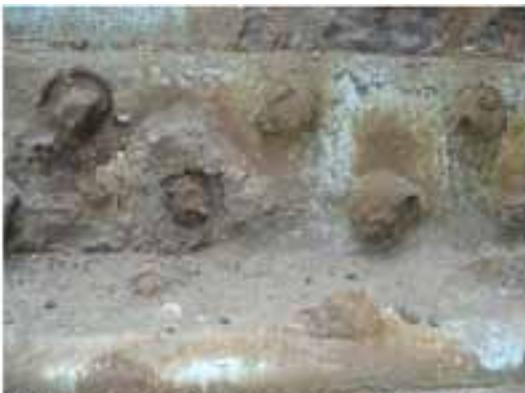
Span 2 - Corrosion on Rivets and Bottom Flange Top Lateral  
Bracing  
Lift Truss

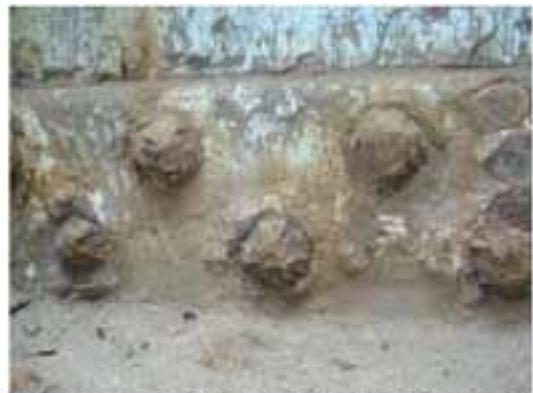
Span 2 - Corrosion on Rivets and Bottom Flange Top Lateral  
Bracing  
Lift Truss

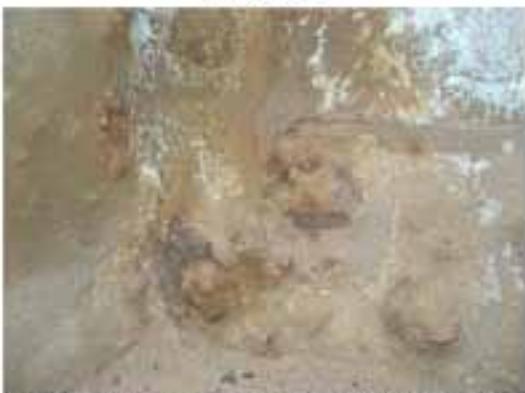
Span 2 - Corrosion on Rivets and Bottom Flange Top Lateral  
Bracing  
Lift Truss

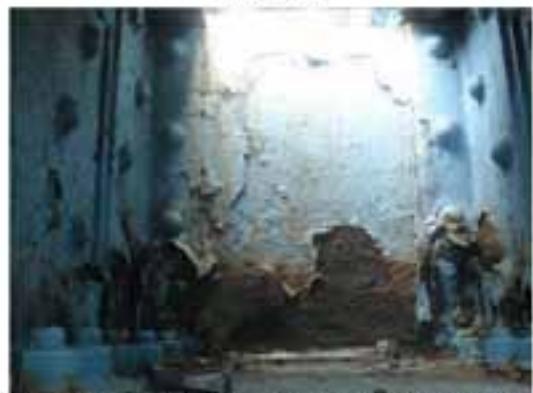
Span 2 - Paint Loss and Corrosion inside Built Up Members Top  
Lateral Bracing  
Lift Truss

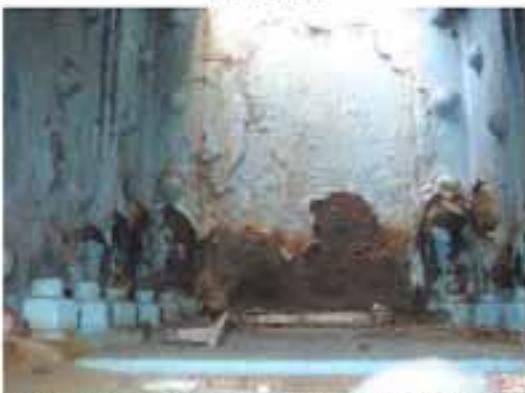
Span 2 - Paint Loss and Corrosion inside Built Up Members Top  
Lateral Bracing  
Lift Truss

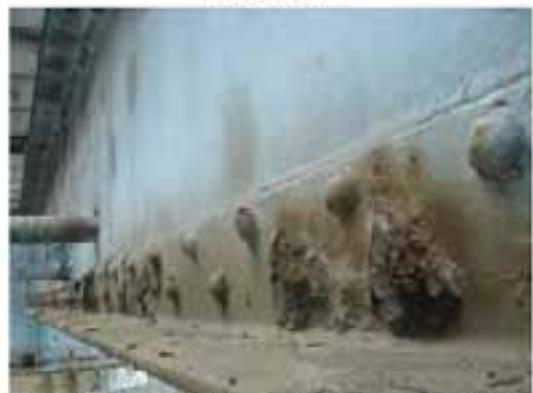
Span 2 - Corrosion on Rivets and Bottom Flange Top Lateral  
Bracing  
Lift Truss

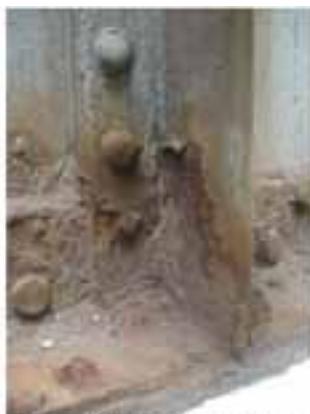
Span 2 - Corrosion on Rivets and Bottom Flange Top Lateral  
Bracing  
Lift Truss

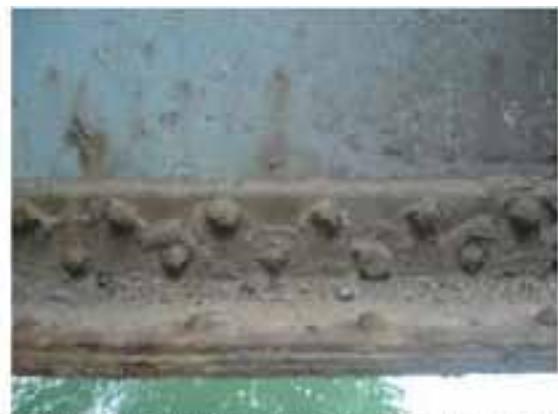
Span 2 - Corrosion on Rivets and Bottom Flange Top Lateral  
Bracing  
Lift Truss
