# Johnson Street Bridge Condition Assessment Report

**Delcan**

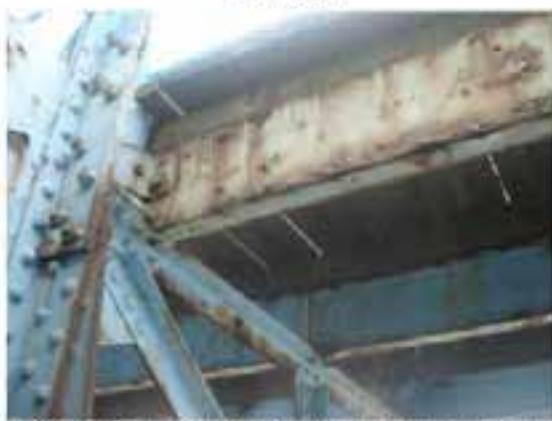
Span 2 - Corrosion Along Sidewalk Top Lateral Bracing  
Lift Truss  
Starting East Working West

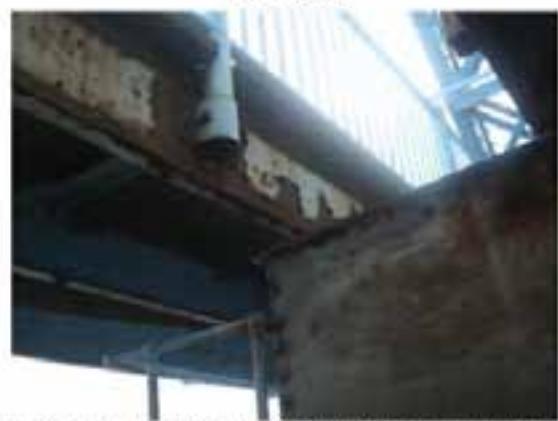
Span 2 - Corrosion Along Sidewalk Top Lateral Bracing  
Lift Truss  
Starting East Working West

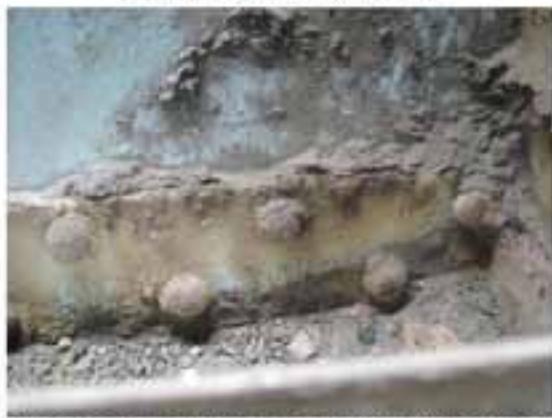
Span 2 - Corrosion on Rivets and Bottom Flange Top Lateral  
Bracing  
Lift Truss

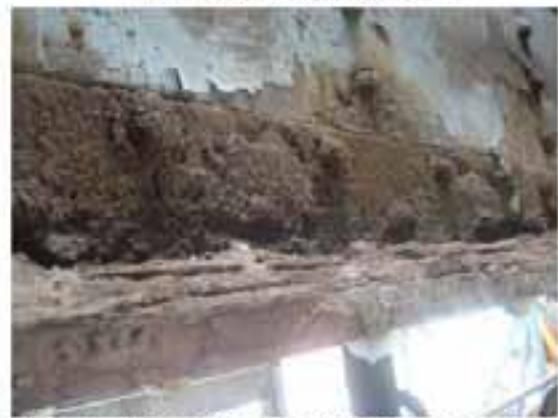
Span 2 - Corrosion on Rivets and Bottom Flange Top Lateral  
Bracing  
Lift Truss

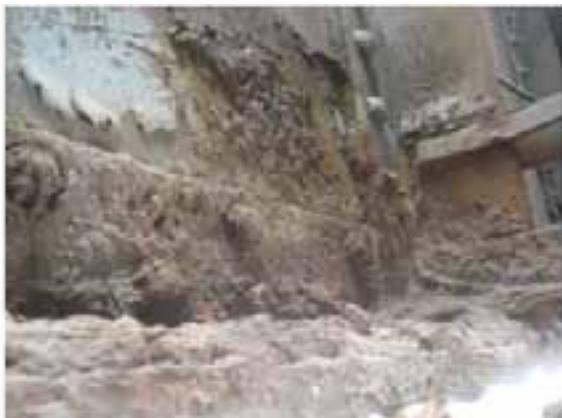
Span 2 - Corrosion on Rivets and Bottom Flange Top Lateral  
Bracing  
Lift Truss

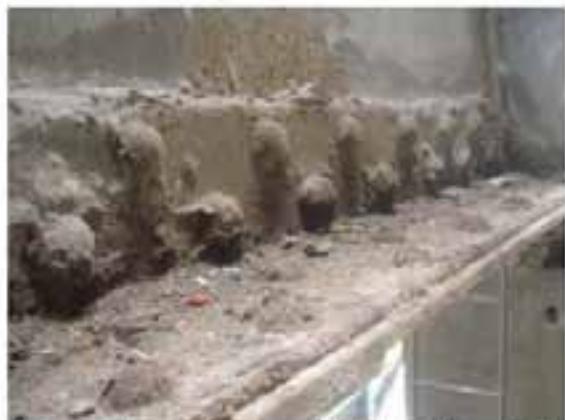
Span 2 - Corrosion on Rivets and Bottom Flange Top Lateral  
Bracing  
Lift Truss

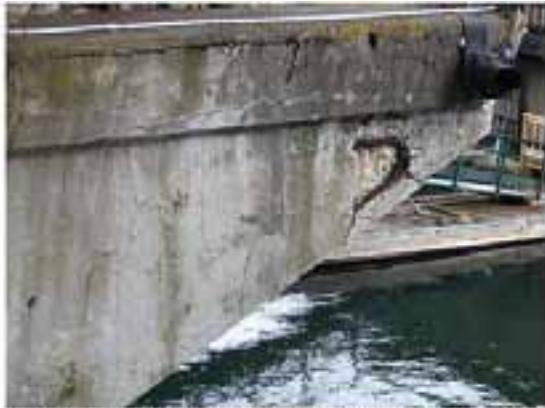
Span 2 - Exposed Rebar on Pier Top Lateral Bracing  
Lift Truss  
Starting East Working West

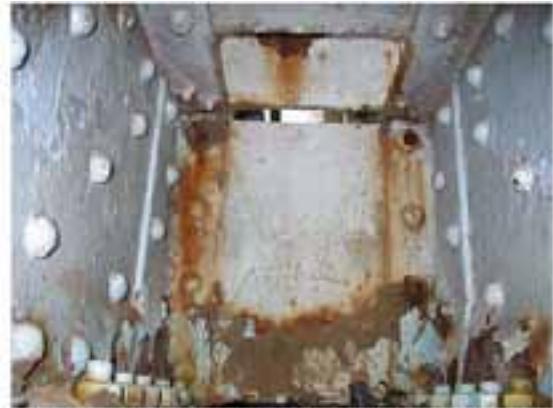
Span 2 - Corrosion Inside Built Up Member Top Lateral Bracing  
Lift Truss  
Starting East Working West

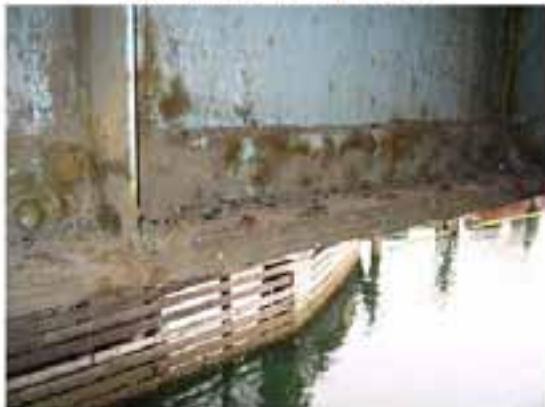
Span 2 - Corrosion on Rivets and Bottom Flange Top Lateral  
Bracing  
Lift Truss

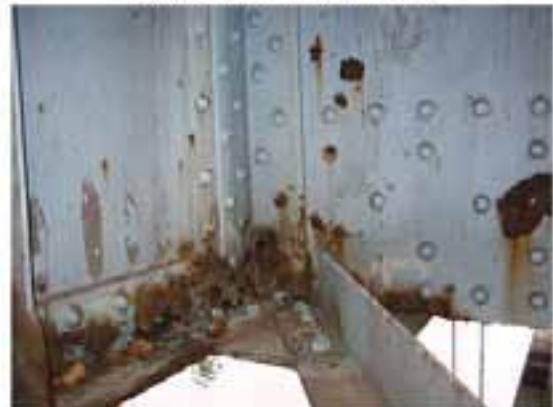
Span 2 - Corrosion on Rivets and Bottom Flange Top Lateral  
Bracing  
Lift Truss

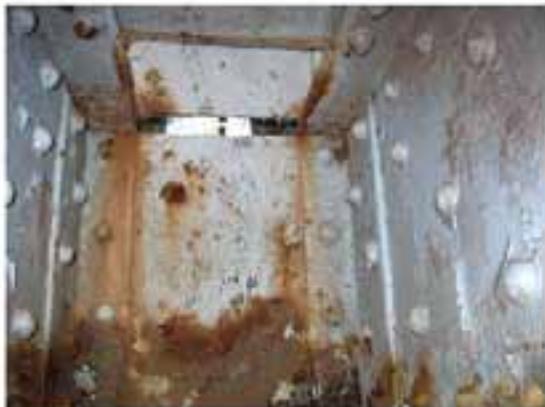
Span 2 - Corrosion Inside Built Up Member Top Lateral Bracing  
Lift Truss  
Starting East Working West

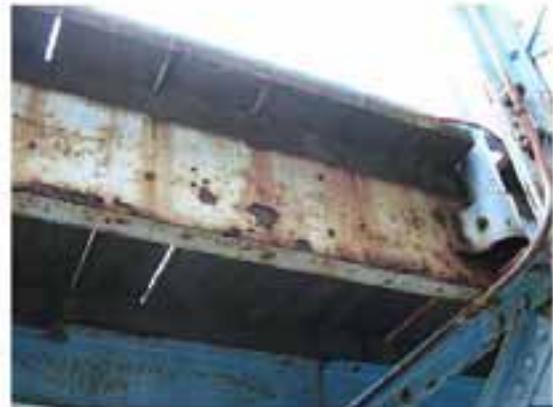
Span 2 - Corrosion Along Edge of Walkway Top Lateral Bracing  
Lift Truss  
Starting East Working West

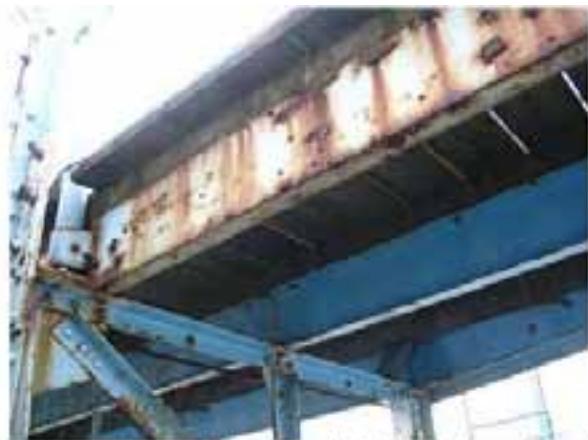
Span 2 - Corrosion on Rivets and Bottom Flange Top Lateral  
Bracing  
Lift Truss

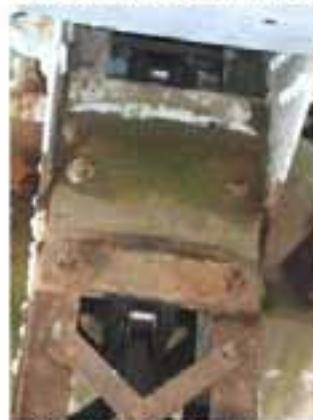
South Side - Sout Face  
Member to Member Connections  
Starting East Working West

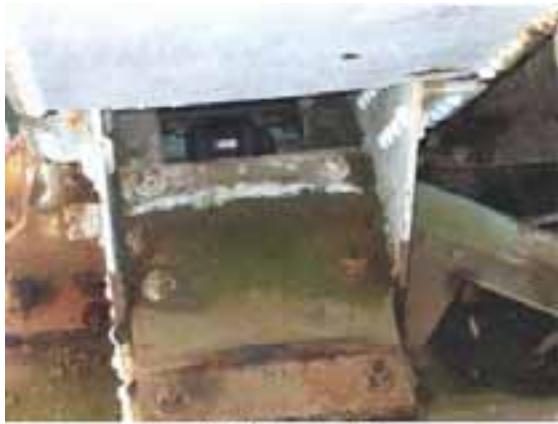
**South Side - Sout Face**  
**Member to Member Connections**  
**Starting East Working West**

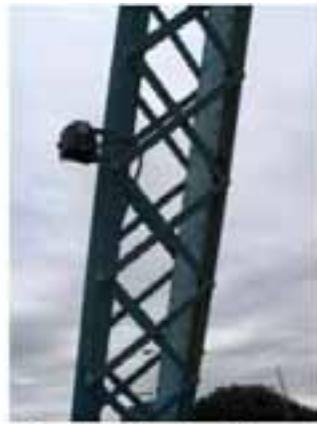
**South Side - Sout Face**  
**Member to Member Connections**  
**Starting East Working West**

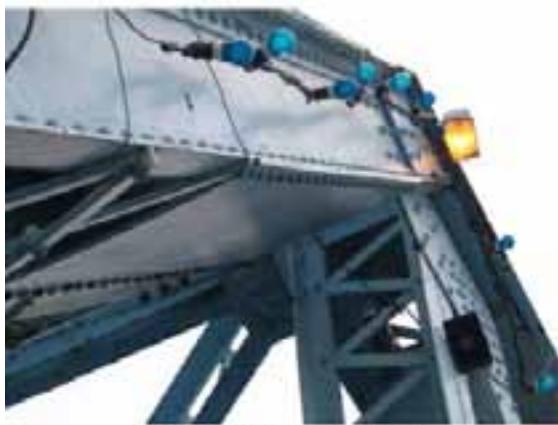
**South Side - Sout Face**  
**Member to Member Connections**  
**Starting East Working West**

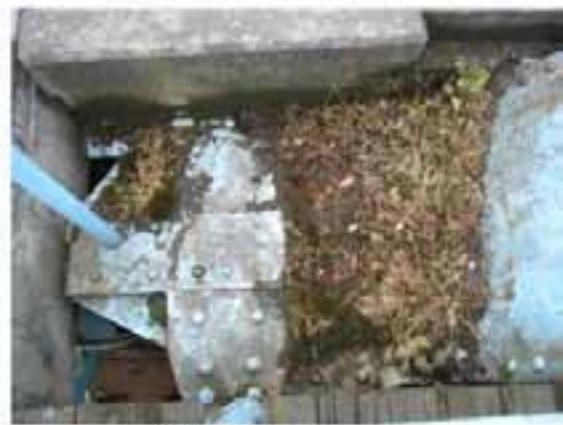
**South Side - Sout Face**  
**Member to Member Connections**  
**Starting East Working West**

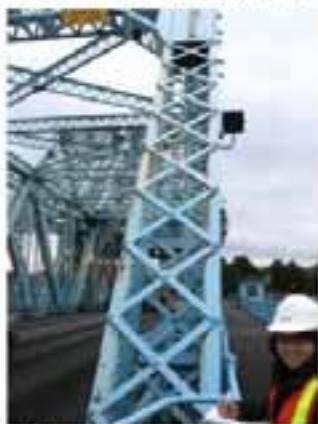
**South Side - Sout Face**  
**Member to Member Connections**  
**Starting East Working West**

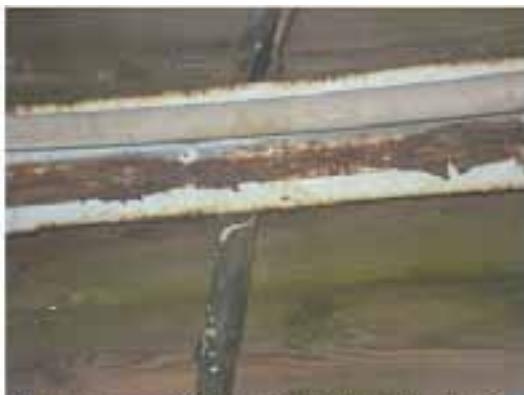
Span 3 - Corrosion on Walkway Cantilever Member Top Lateral  
Bracing  
Lift Truss

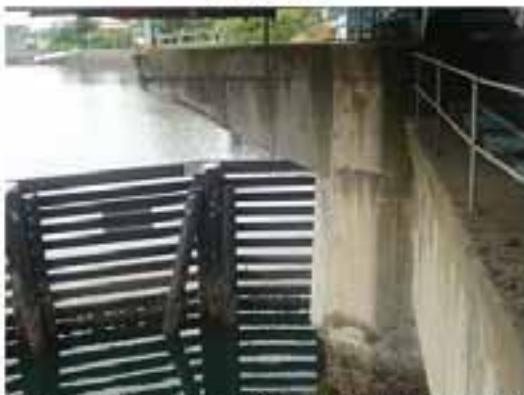
Span 3 - Exposed Rebar and Spalling Concrete on Pier 2 Top  
Lateral Bracing  
Lift Truss

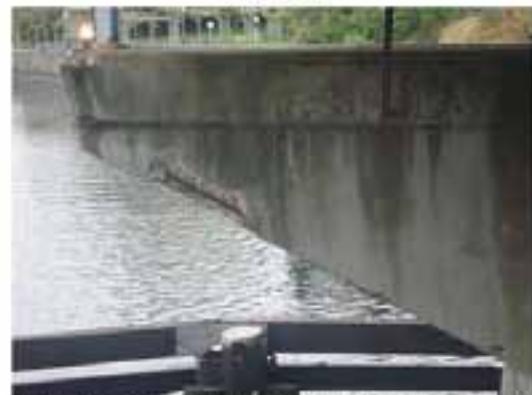
Span 3 - Exposed Rebar and Spalling Concrete on Pier 2 Top  
Lateral Bracing  
Lift Truss

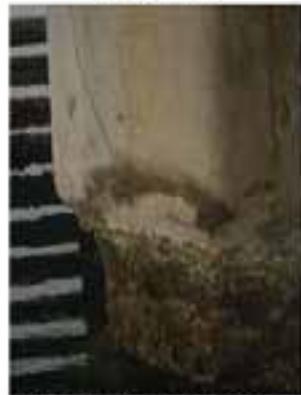
Span 3 - Spalling Concrete on Pier 2 Top Lateral Bracing  
Lift Truss  
Starting East Working West

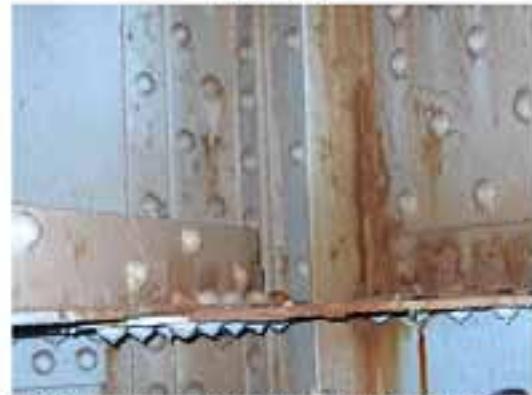
Span 3 - Corrosion on Rivets and Bottom Flange Top Lateral  
Bracing  
Lift Truss

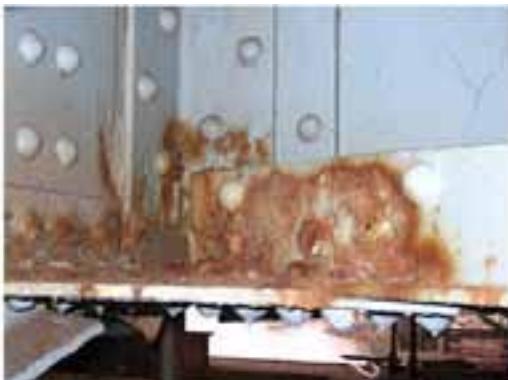
Span 3 - Corrosion on Rivets and Bottom Flange Top Lateral  
Bracing  
Lift Truss

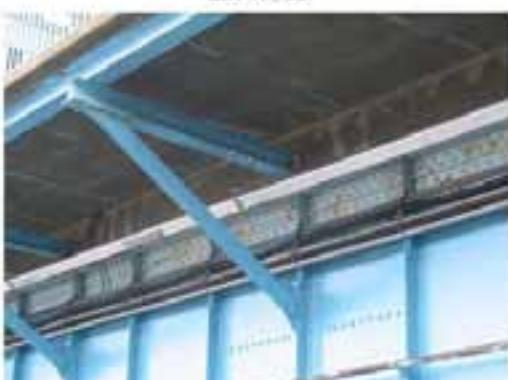
Span 3 - Efflorescence Under Pedestrian Walkway Top Lateral  
Bracing  
Lift Truss

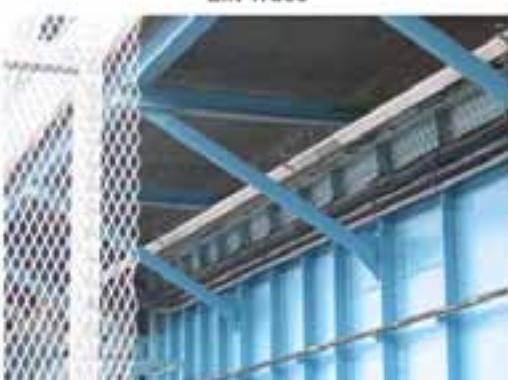
Span 3 - Efflorescence Under Pedestrian Walkway Top Lateral  
Bracing  
Lift Truss

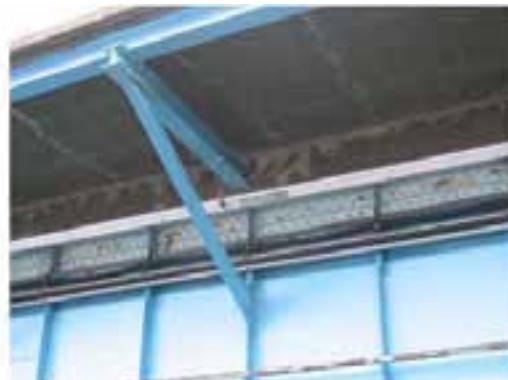
Span 3 - Efflorescence Under Pedestrian Walkway Top Lateral  
Bracing  
Lift Truss

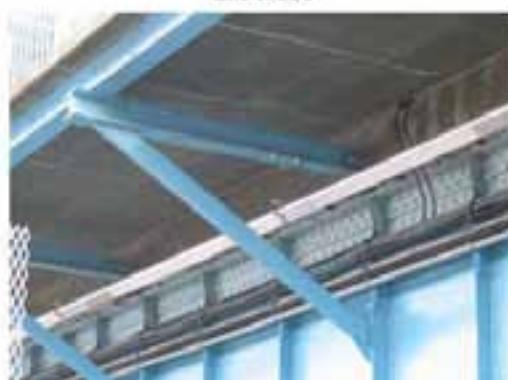
Span 3 - Efflorescence Under Pedestrian Walkway Top Lateral  
Bracing  
Lift Truss

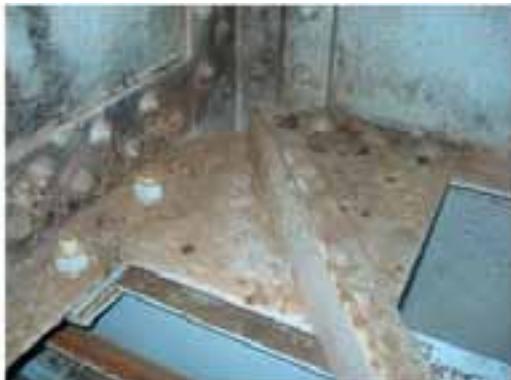
Span 4 - Dirt Build Up on Connection Plate Top Lateral Bracing  
Lift Truss  
Starting East Working West

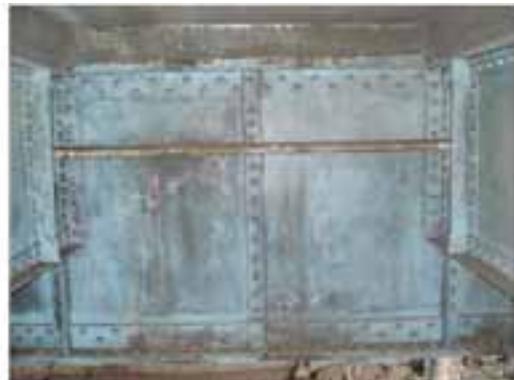
Span 4 - Dirt Build Up on Bottom Flange Top Lateral Bracing  
Lift Truss  
Starting East Working West

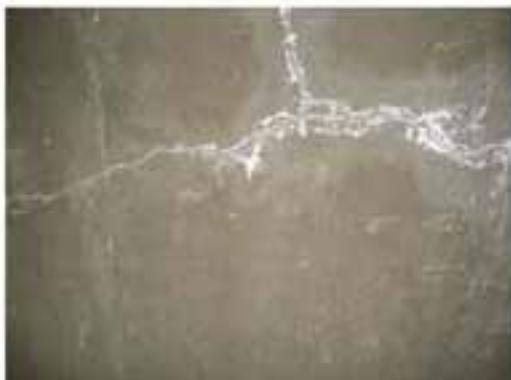
Span 4 - Efflorescence on Concrete Soffit Top Lateral Bracing  
Lift Truss  
Starting East Working West

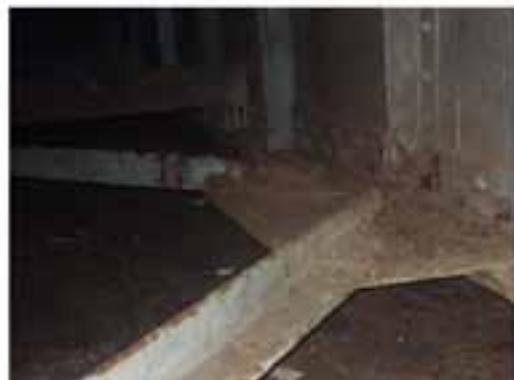
Span 4 - Dirt and Corrosion on Lateral Bracing Connection  
Plate Top Lateral Bracing  
Lift Truss

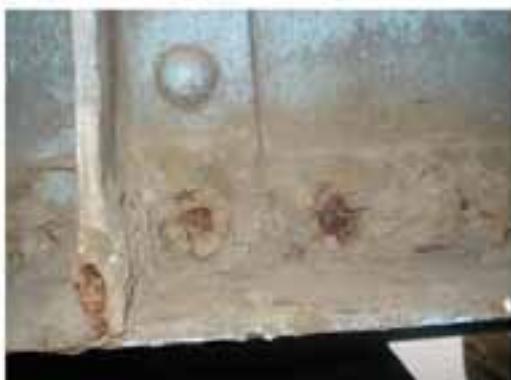
Span 4 - Rivets Worn Away, Corrosion and Paint Loss Top Lateral  
Bracing  
Lift Truss

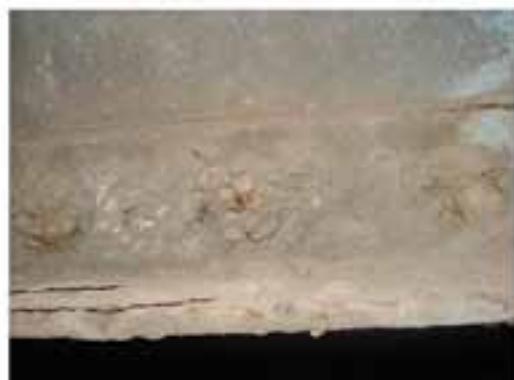
Span 4 - Rivets Worn Away, Corrosion and Paint Loss Top Lateral  
Bracing  
Lift Truss

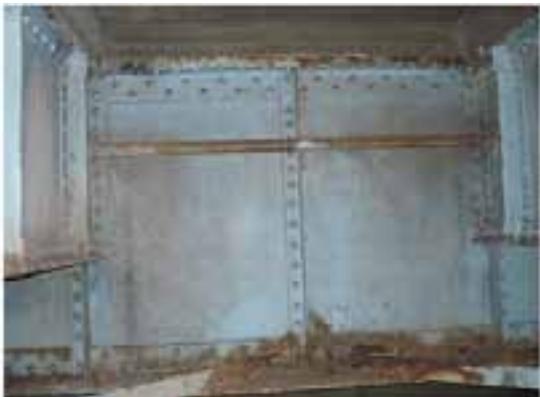
Span 4 - Corrosion at Lateral Bracing Top Lateral Bracing  
Lift Truss  
Starting East Working West

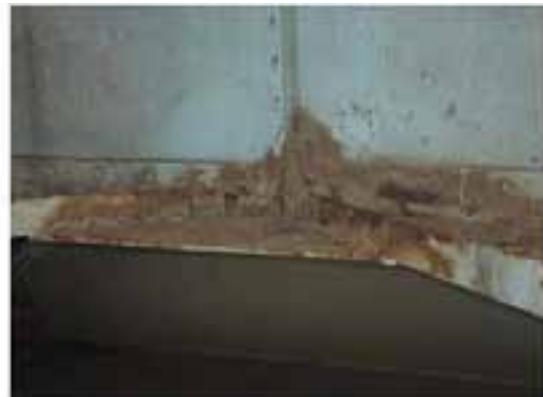
Span 4 - Corrosion at Lateral Bracing Top Lateral Bracing  
Lift Truss  
Starting East Working West

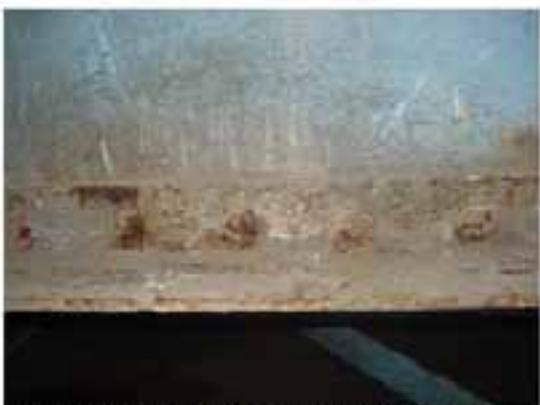
Span 4 - Rivets Worn Away, Corrosion and Paint Loss Top Lateral  
Bracing  
Lift Truss

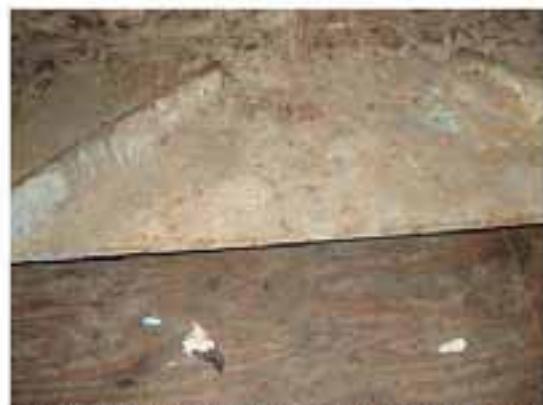
Span 4 - Paint Loss at Lateral Bracing Plate Top Lateral Bracing  
Lift Truss  
Starting East Working West

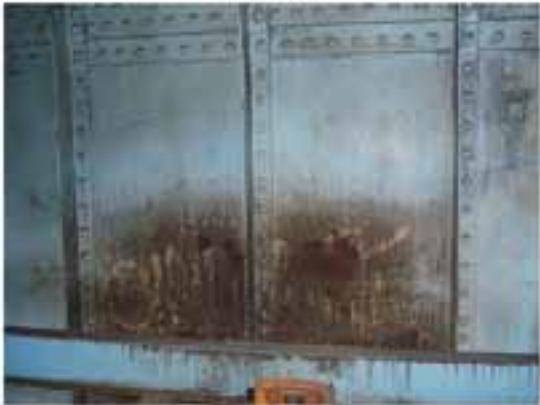
Span 4 - Paint Loss and Corrosion on Web of Built Up  
Member Top Lateral Bracing  
Lift Truss

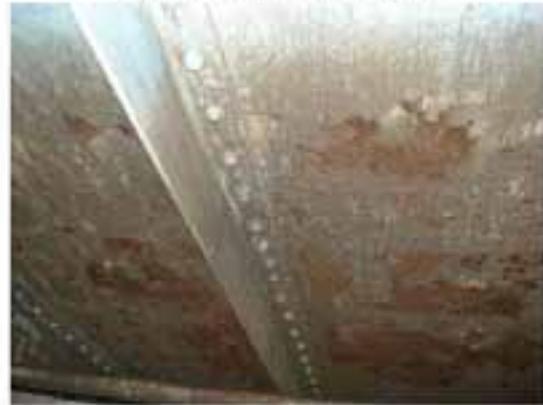
Span 4 - Paint Loss and Corrosion on Web Top Lateral Bracing  
Lift Truss  
Starting East Working West

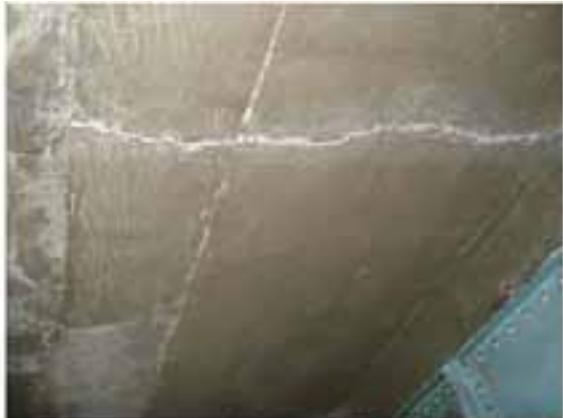
Span 4 - Efflorescence on Concrete Soffit Top Lateral Bracing  
Lift Truss  
Starting East Working West

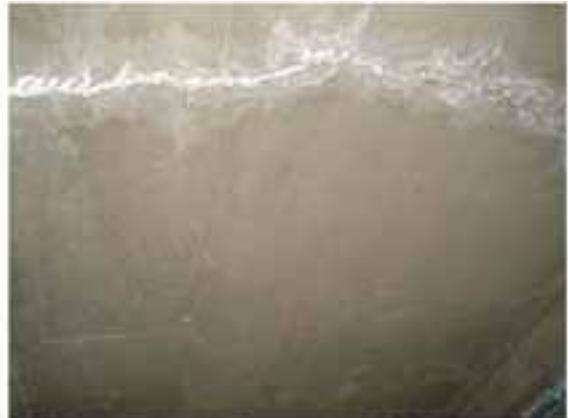
Span 4 - Efflorescence on Concrete Soffit Top Lateral Bracing  
Lift Truss  
Starting East Working West

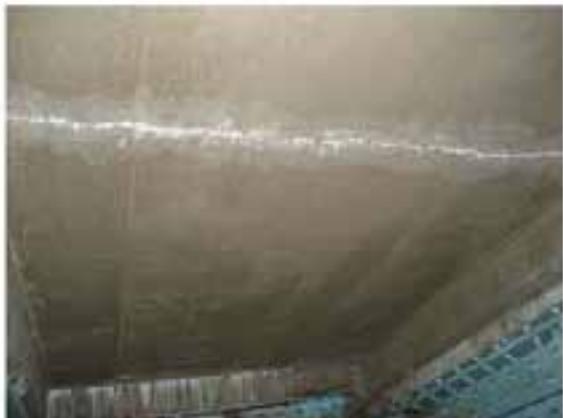
Span 4 - Efflorescence on Concrete Soffit Top Lateral Bracing  
Lift Truss  
Starting East Working West

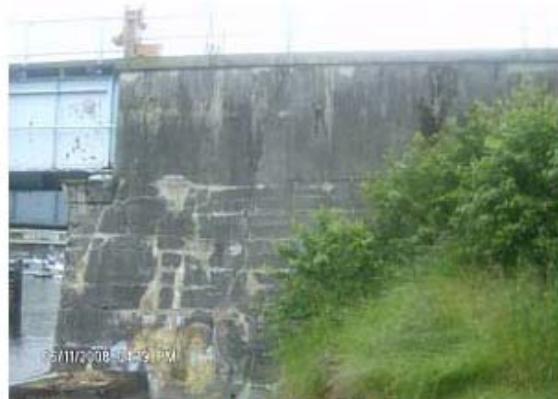
**HPIM3957.JPG**  
**P004 - West Abutment 1 - North Wing Wall - 2 mm Vertical Crack Full Height - Minor Cracking and Efflorescence - No Spalling**

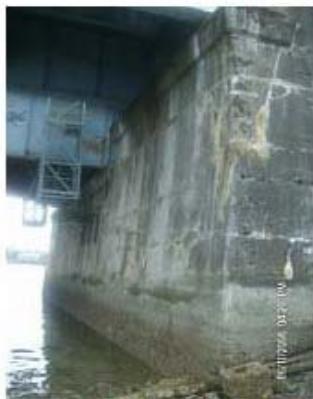
**HPIM3958.jpg**  
**P005 - West Abutment 1 - Minor Cracking and Efflorescence - No Spalling**

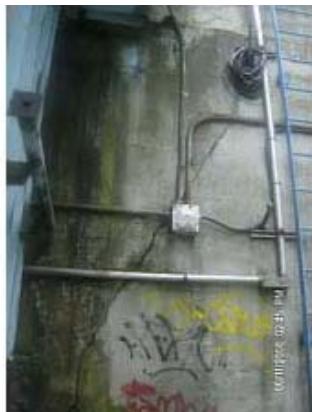
HPIM3910.JPG

P007 - West Abutment 1 - Wide Diagonal Crack (4 mm) in Backwall Between Railway and Roadway Bridges Almost to Waterline

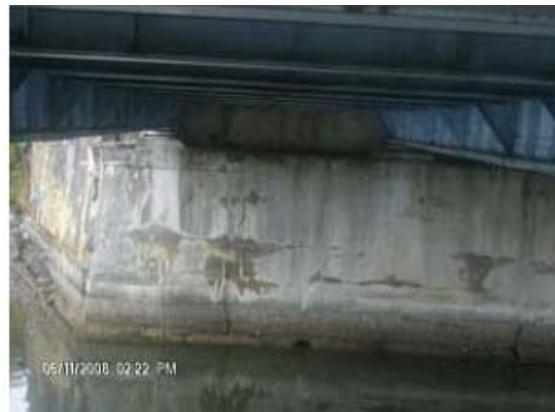
HPIM3884.JPG

P008 - East Abutment 2 - Minor Cracking, Efflorescence and Moisture Staining - Bearing Seat OK

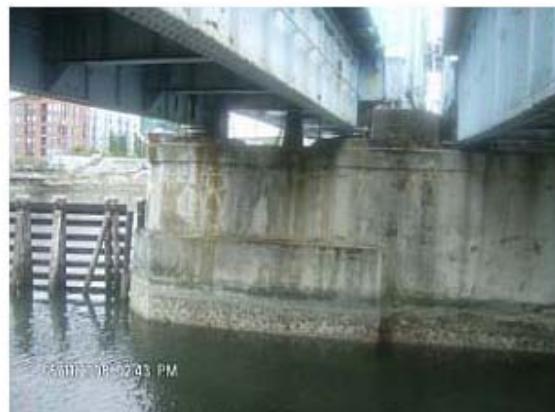
HPIM3908.JPG

P012 - Concrete Pier 1 - North Face - Minor Cracking and Efflorescence But No Spalling

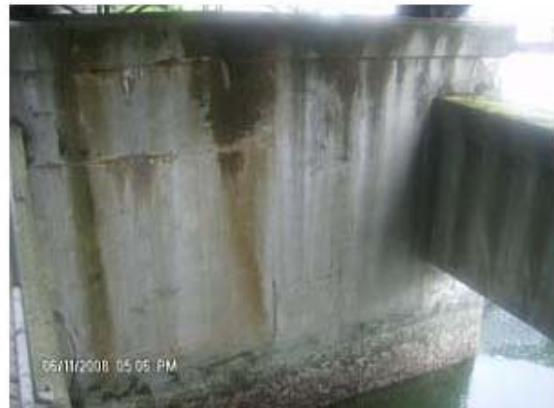
05/11/2008 05:05 PM  
HPIM3990.JPG  
**P016 - Concrete Pier 2 - East Face - 2 mm Horizontal Crack Along Construction Joint - Moisture Staining and Efflorescence**

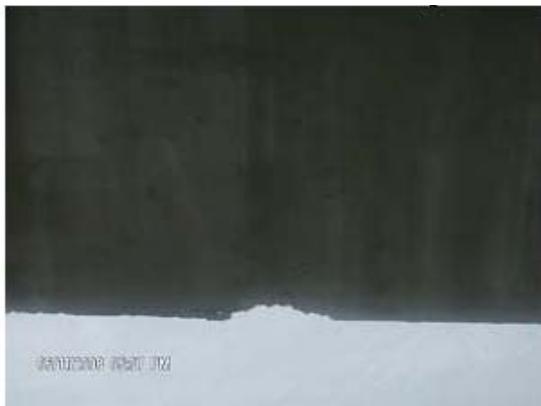
HPIM3991.JPG

P019 - North Strong Beam Between  
Piers 2 and 3 - 10 cm x 40 cm Spall  
Bottom of Beam

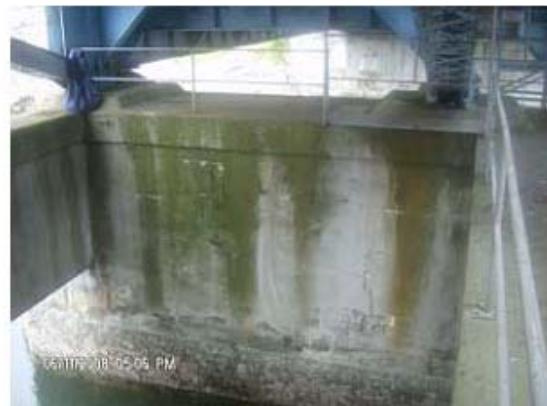
HPIM3989.JPG

P020 - Concrete Pier 3 - West Face -  
Minor Cracking and Efflorescence But  
No Spalling and Bearing Seats are Good

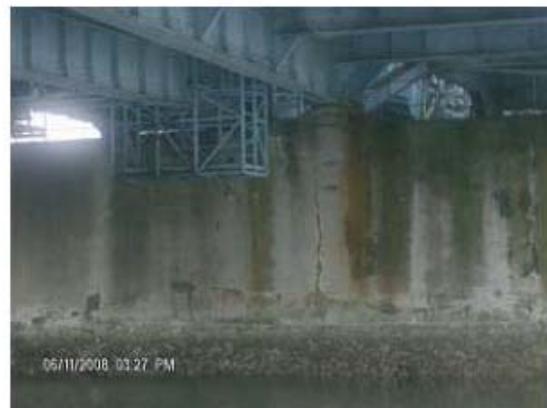
HPIM3934.jpg

P022 - North Face of Pier 3 - 1 mm  
Vertical Crack Below Railway Bridge  
South Bearing

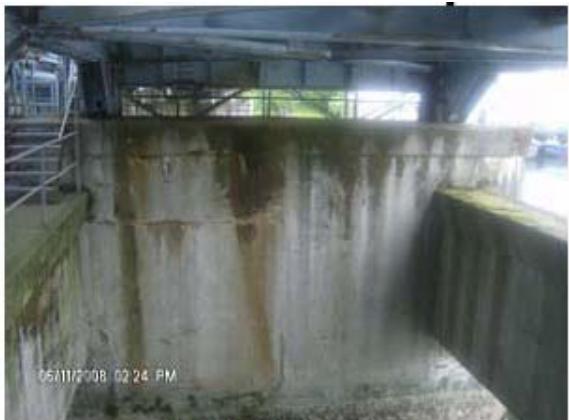
HPIM3897.JPG

P024 - Concrete Pier 3 - North End

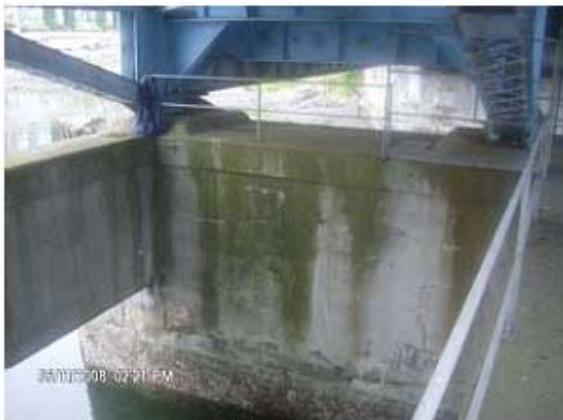
HPIM3886.JPG  
P025 - Pier 3 - East Face

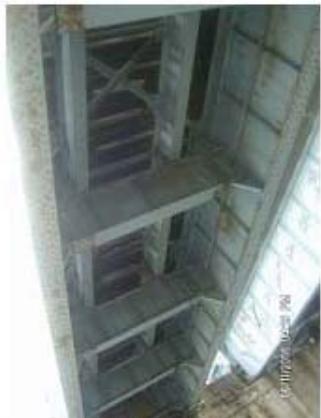
HPIM3882.JPG  
P026 - Pier 3 - West Face

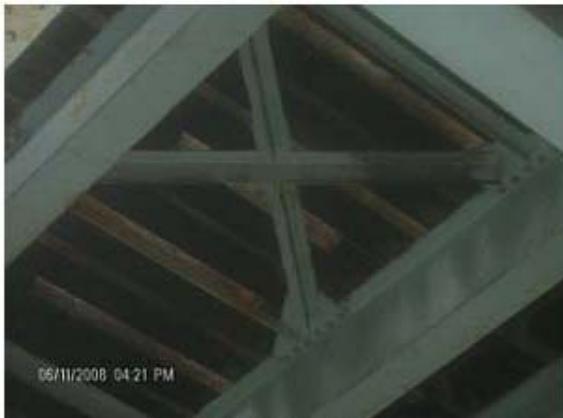
HPIM3959.jpg  
P027 - West Approach Span 1 - Floor System - Stringers and Floorbeams Replaced Since Initial Construction

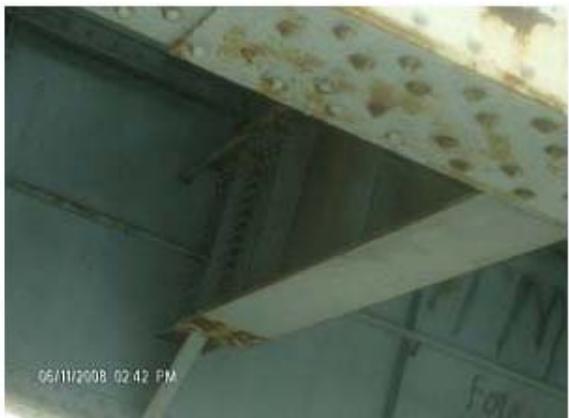
HPIM3960.JPG  
P028 - West Approach Span 1 - Floor System - Bolted Connections - Bracing Replaced Since Initial Construction

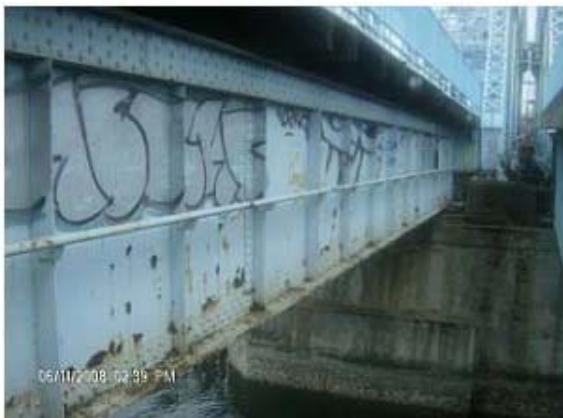
HPIM3907.JPG  
P029 - West Approach Span 1 - Floor Beam 1 - Bolted Connections

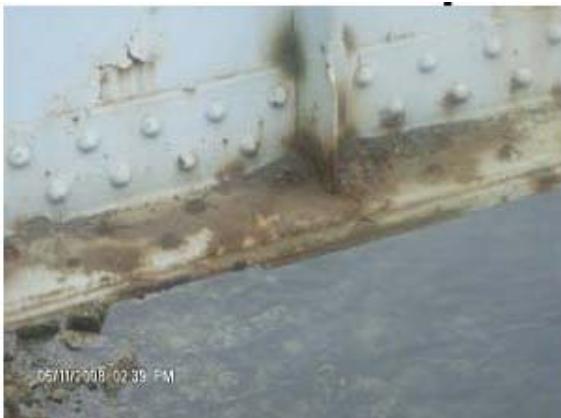
HPIM3902.JPG  
P030 - West Approach Span 1 - South Main Girder

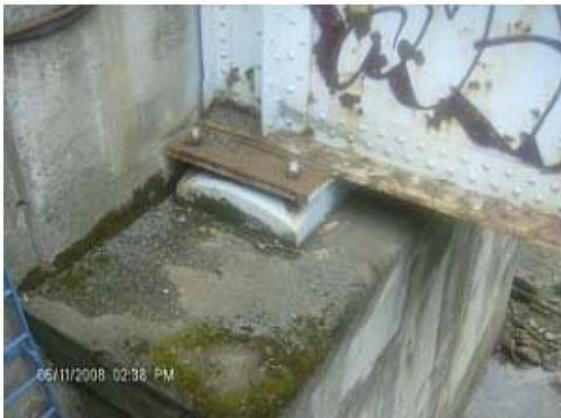
HPIM3904.JPG  
**P032 - West Approach Span 1 - Top Flange and Shelf Angle on South Main Girder**

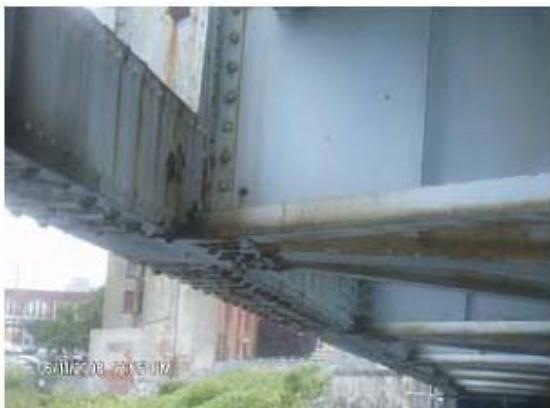
**HPIM3900.JPG**  
**P041 - Lift Span 2 - North Bottom Chord**

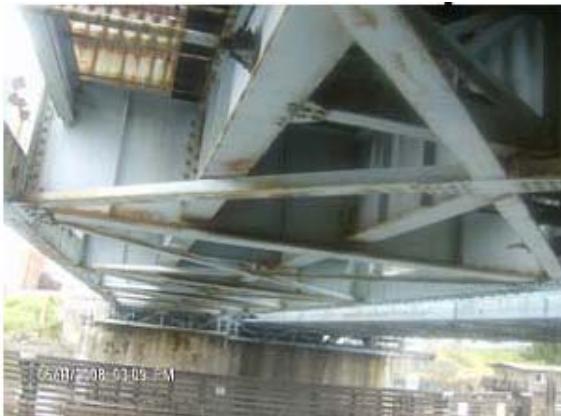
**HPIM3918.JPG**  
**P042 - Lift Span 2 - North Bottom Chord**

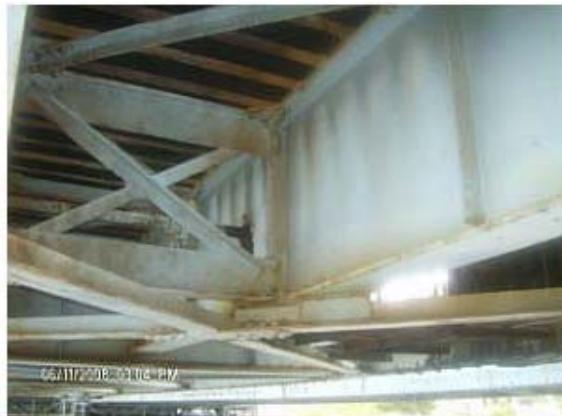
HPIM3923.JPG

P043 - Lift Span 2 - Floor System is in Good Condition with Updated Stringers, Floor Beams and Bracing Since Initial Construction

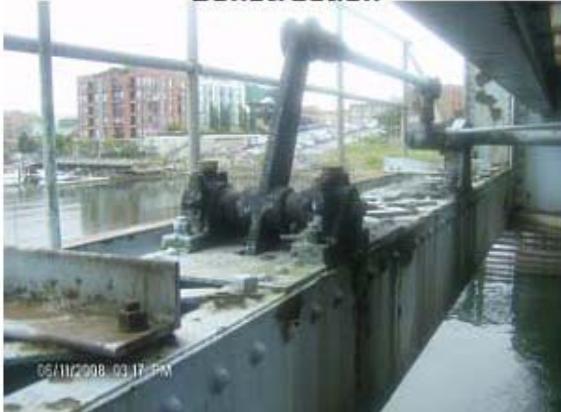
HPIM3922.JPG

P044 - Lift Span 2 - South Main Stringer in Panel 1 - Bolted Connections

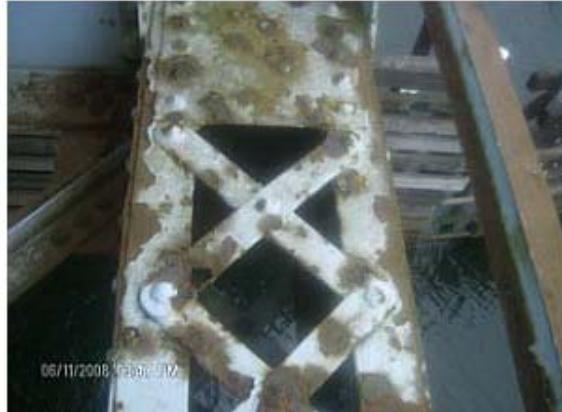
HPIM3927.JPG

P045 - Lift Span 2 - North Bottom Chord in Panel 1

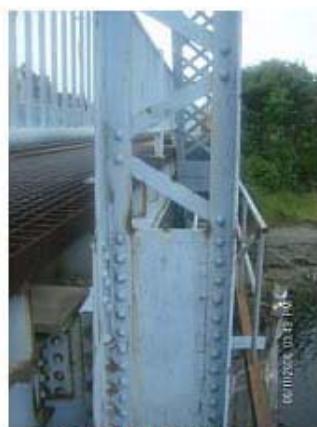
HPIM3945.JPG

P046 - Lift Span 2 - North Bottom Chord in Panel 1 - 1 Holed Lacing Member

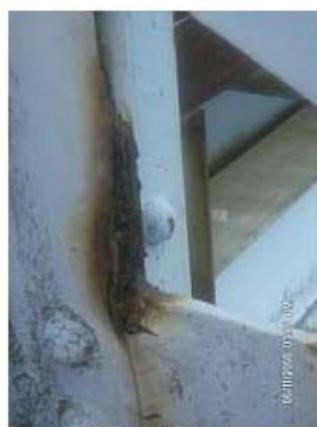
HPIM3946.jpg

P047 - Lift Span 2 - North Vertical Hanger - End of Panel 1 - 10 mm Pack Rust Between Angles

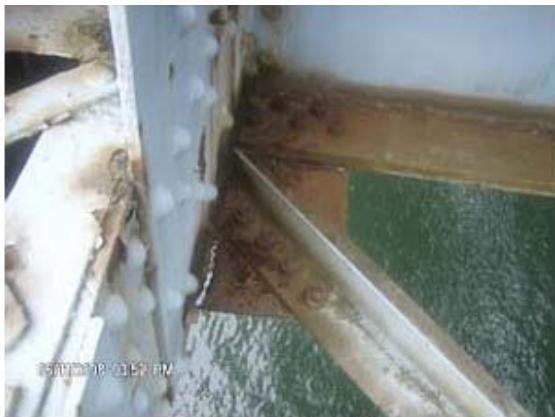
HPIM3947.jpg

P048 - Lift Span 2 - North Vertical Hanger - End of Panel 1 - 10 mm Pack Rust Between Angles

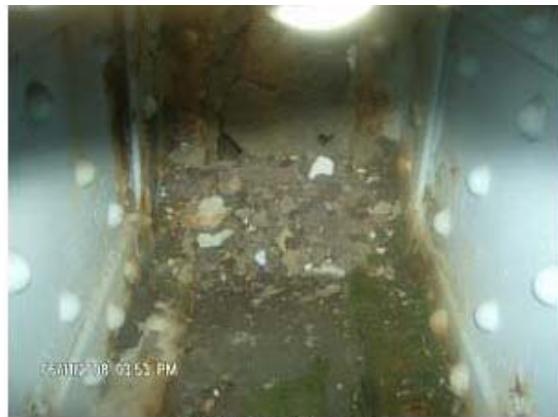
HPIM3948.JPG

P049 - Lift Span 2 - North Horizontal Gusset Plate Holed Along Bottom Chord at End of Panel 2

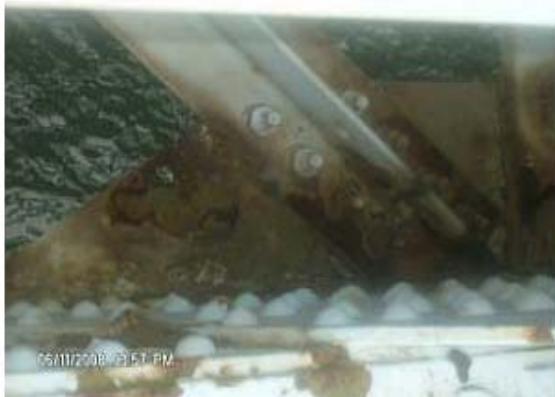
HPIM3949.JPG

P050 - Lift Span 2 - Debris Buildup Inside of Bottom Chord at Verticals - Typical

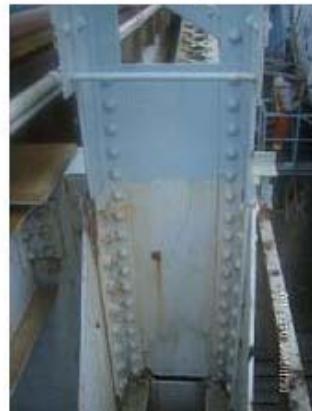
HPIM3950.JPG

P051 - Lift Span 2 - North Horizontal Gusset Plate Holed at Beginning of Panel 6

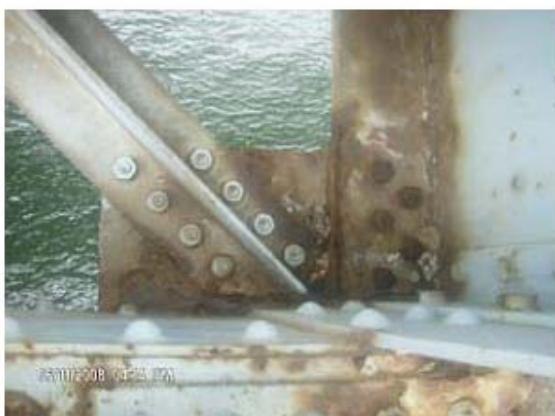
HPIM3954.jpg

P052 - Lift Span 2 - South Vertical Hanger - End of Panel 5 - 10 mm Pack Rust Between Angle and Vertical Gusset Plate

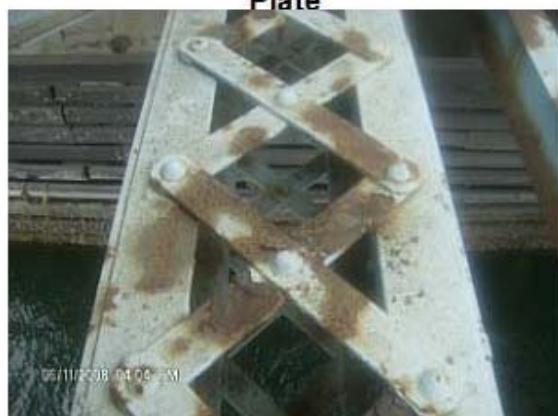
HPIM3955.JPG

P053 - Lift Span 2 - South Horizontal Gusset Plate at End of Panel 1 - Pitted up to 3 mm But Not Holed

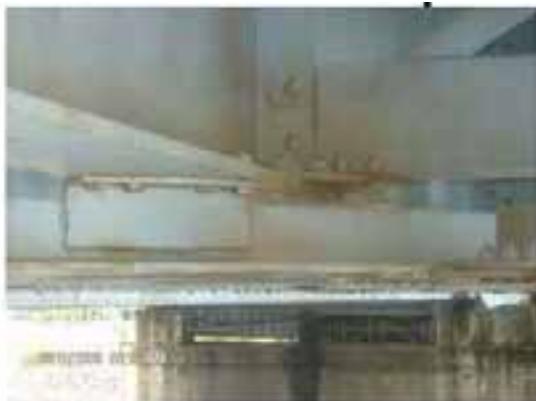
HPIM3953.JPG

P054 - Lift Span 2 - South Bottom Chord of Panel 5 - Approx 5% of Lacing Members are 10% Reduced

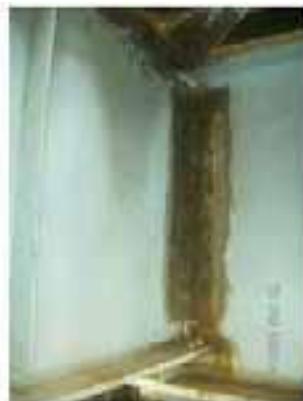
HPIM3995.JPG

P055 - Lift Span 2 - Panel 6 - Lower Sway Braces are Welded and Bolted

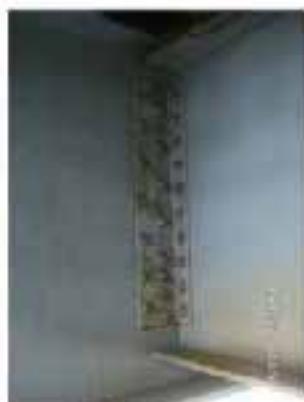
HPIM3996.jpg

P056 - Lift Span 2 - Typical Main Stringer Floorbeam Connections are Bolted - Floor System Has Been Replaced Since Initial Construction in 1923

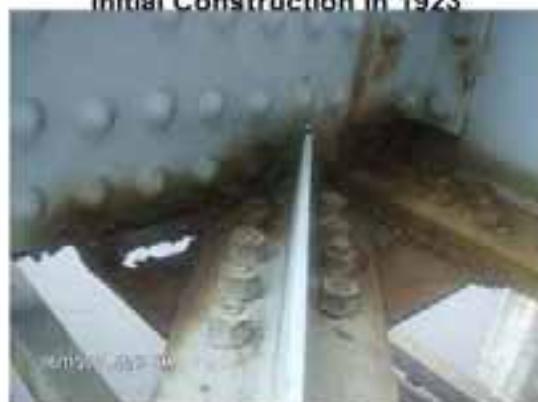
HPIM3997.jpg

P057 - Lift Span 2 - Typical Main Stringer Floorbeam Connections are Bolted - Floor System Has Been Replaced Since Initial Construction in 1923

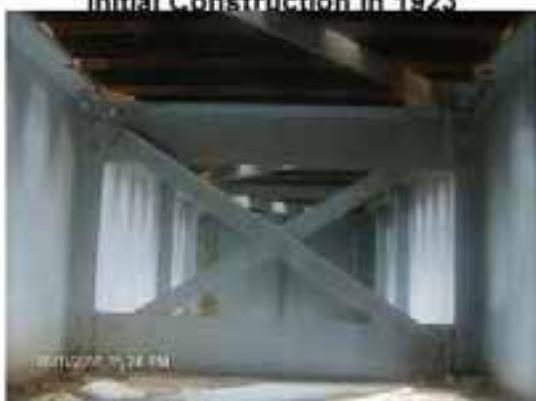
HPIM3998.JPG

P058 - Lift Span 2 - Holed Gusset Plate - Southwest Corner of Panel 5

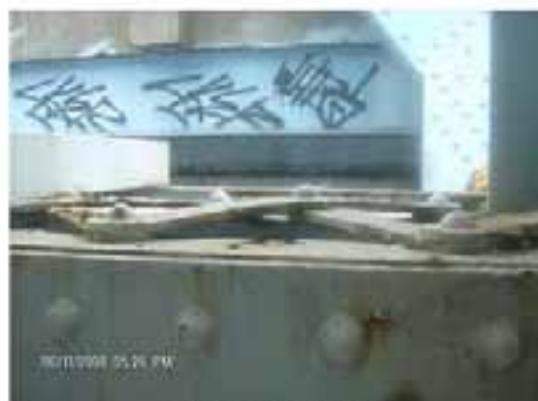
HPIM3999.JPG

P059 - Lift Span 2 - Vertical Cross Bracing Between Main Stringers - Middle of Panel 5 - Bolted and Welded - Typical

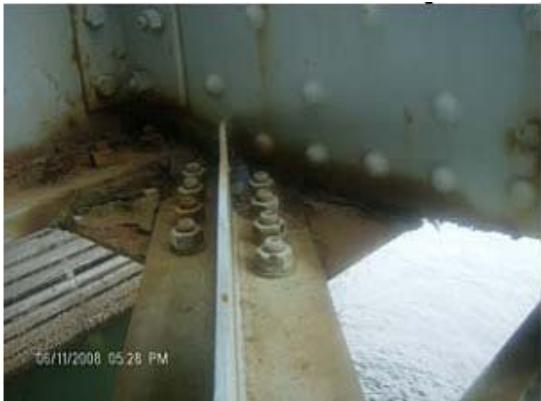
HPIM4000.JPG

P060 - Lift Span 2 - South Bottom Chord - Minor Bowing of Lacing Members

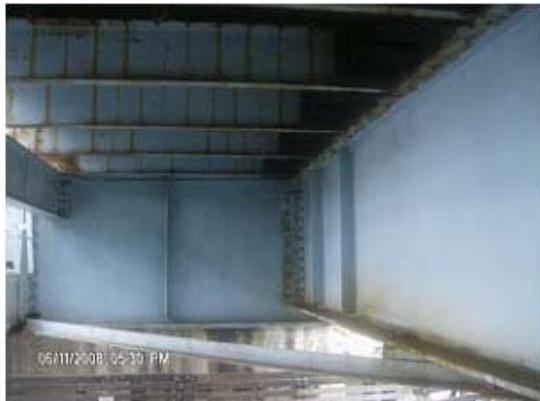
HPIM4001.JPG

P061 - Lift Span 2 - Horizontal Gusset Plate 4 mm Reduction Groove Along Bottom Chord - Southeast Corner of Panel 4

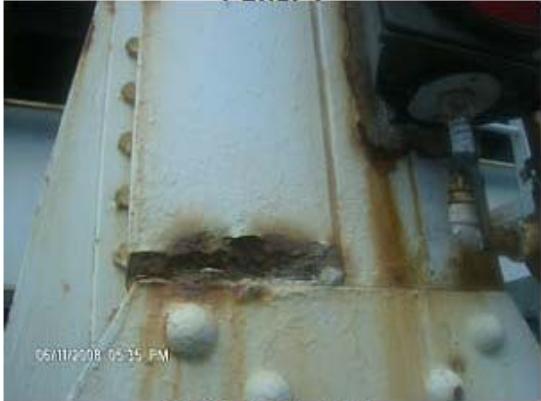
HPIM4002.JPG

P062 - Lift Span 2 - Welded Stiffeners in Stringers and Floorbeams - Typical

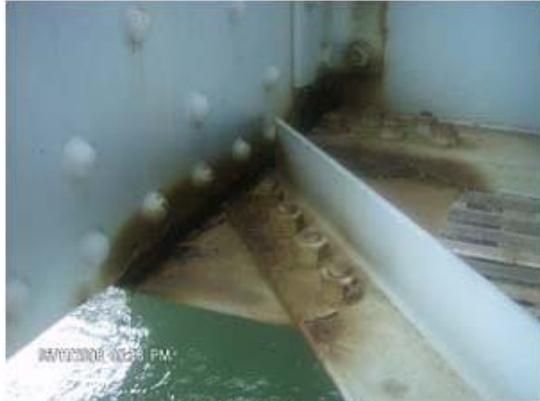
HPIM4006.JPG

P063 - Lift Span 2 - South Vertical at East End of Panel 3 - One Leg of Angle Has Reduction Groove with 50% Section Loss and Holed

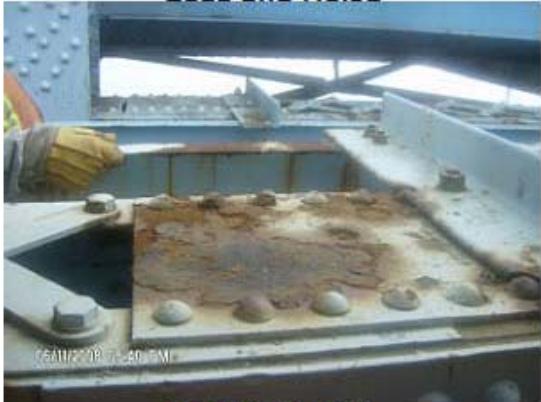
HPIM4007.JPG

P064 - Lift Span 2 - Horizontal Gusset Plates - Reduction Grooves Along Bottom Chords are Typical

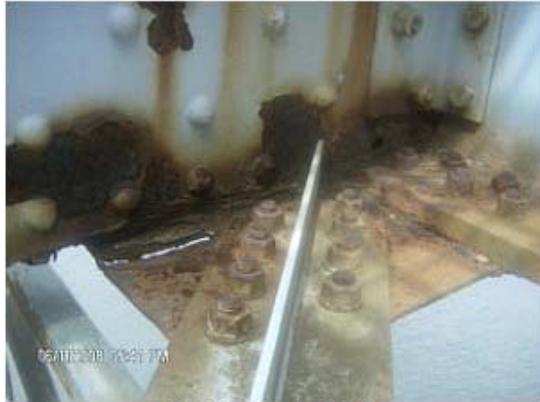
HPIM4008.JPG

P065 - Lift Span 2 - South Bottom Chord in Bay 2 - Horizontal Top Plate is Holed

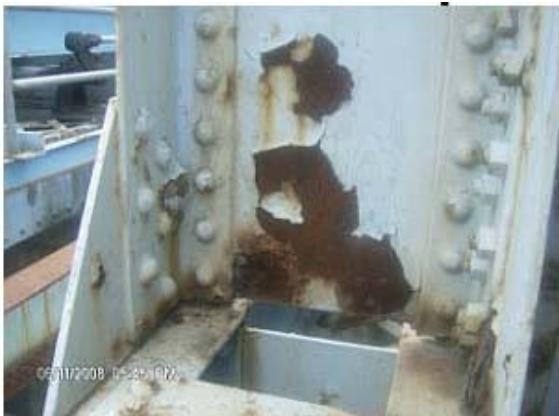
HPIM4009.JPG

P066 - Lift Span 2 - Horizontal Gusset Plate Holed Along Bottom Chord - Northeast Corner of Panel 2

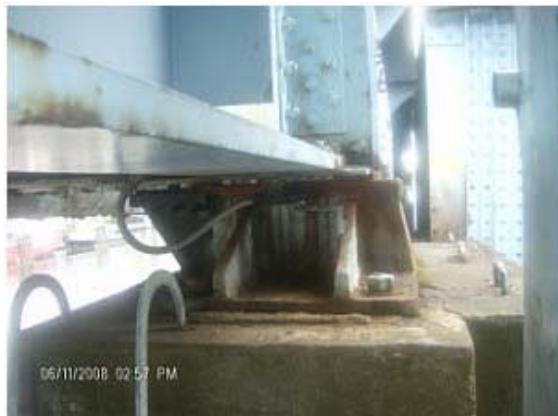
HPIM4010.JPG

P067 - Lift Span 2 - South Hanger at End of Panel 1 - Lower Vertical Plate is Pitted 10 mm

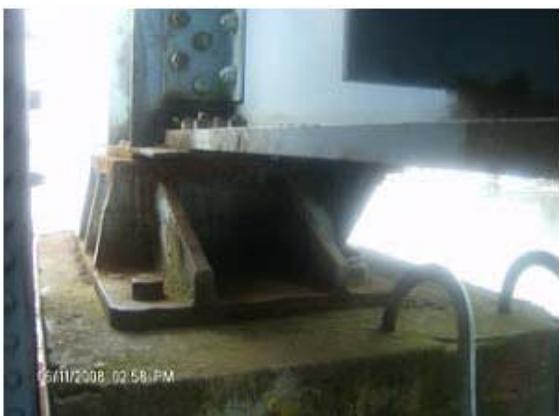
HPIM3919.JPG

P068 - South Rest Bearing on Pier 1 for Lift Span 2

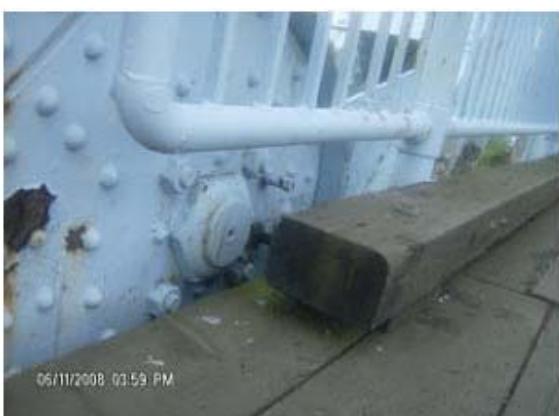
HPIM3944.JPG

P070 - Lift Span 2 - West Portal - No Collision Damage

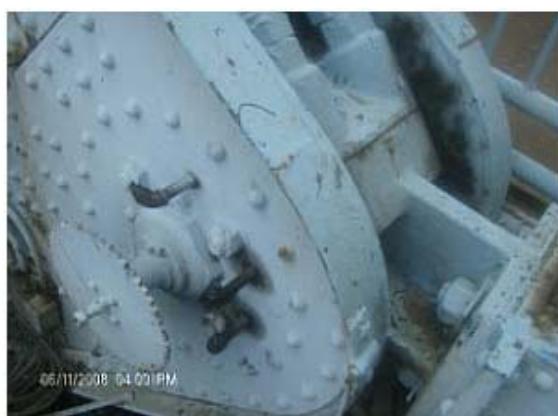
HPIM3951.JPG

P071 - Lift Span 2 - North Lower Pin at Pier 2

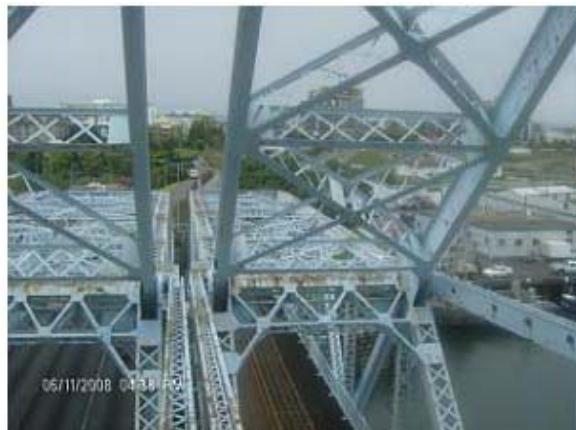
**HPIM3963.JPG**  
**P073 - Lift Span 2 - East Portal**

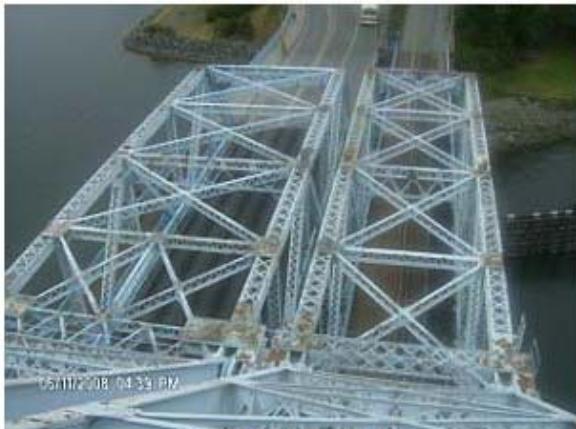
**HPIM3970.JPG**  
**P074 - Lift Span 2 - Overhead Bracing**

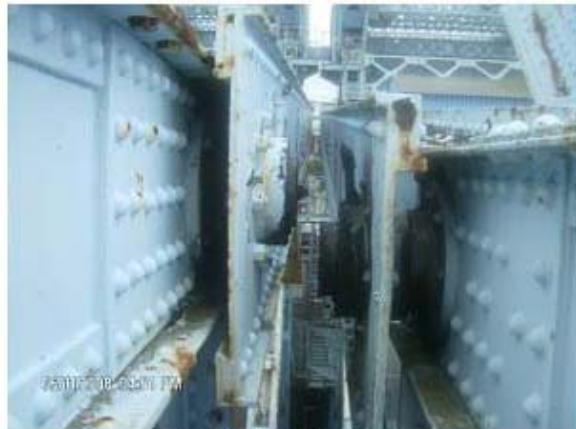
**HPIM3972.JPG**  
**P075 - Lift Spans - Top Chords and Overhead Bracing**

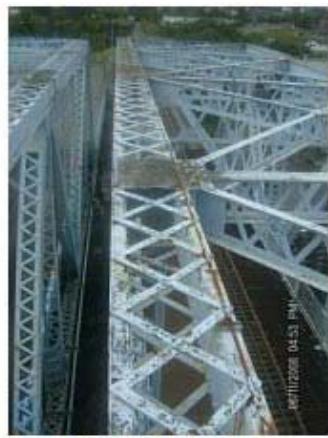
**HPIM3981.JPG**  
**P076 - Between Bridges - Lift Span 2 - Pins - Top of East Portals**

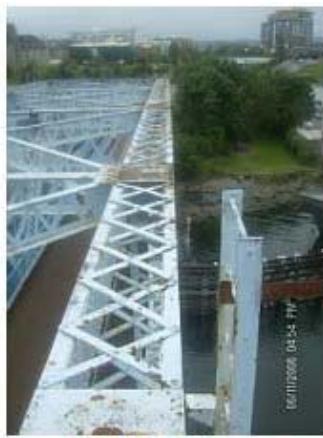
**HPIM3982.jpg**  
**P077 - Lift Span 2 - South Top Chord**

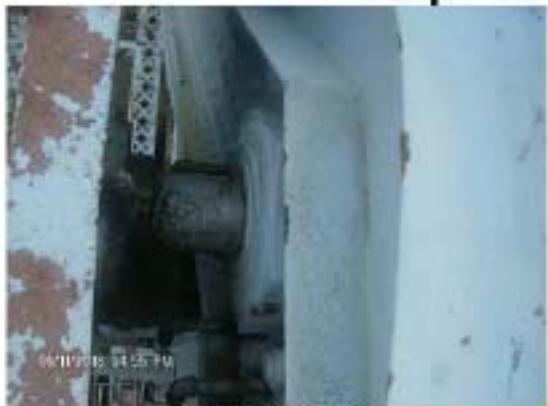
**HPIM3984.jpg**  
**P078 - Lift Span 2 - Top North Chord**
