# Johnson Street Bridge Condition Assessment Report

**Delcan**

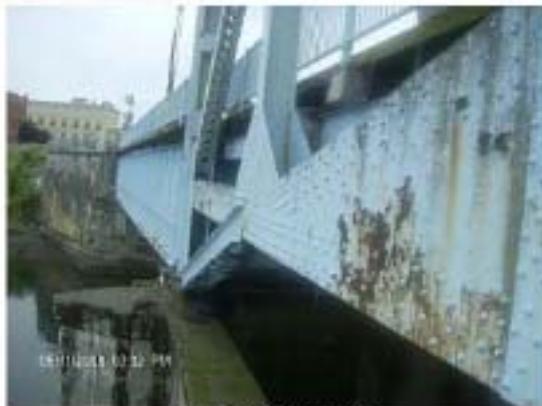
HPIM3985.JPG  
**P079 - Lift Span 2 - North Pin at Node 9 -  
Top of East Portal**

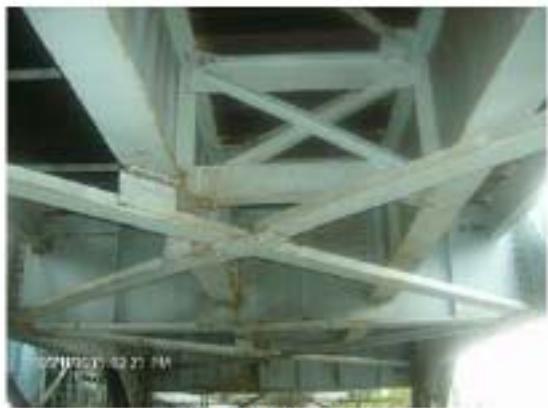
HPIM3899.JPG  
**P080 - Spans 3 and 4 - North Side**

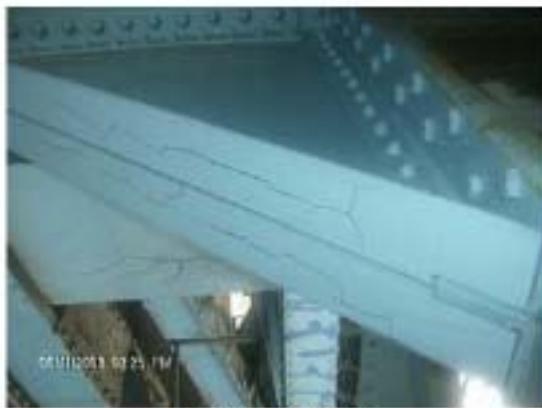
HPIM3885.JPG  
**P081 - Span 3 - 2 Large Stringers Below  
Track, 2 Small Stringers at Cantilevers**

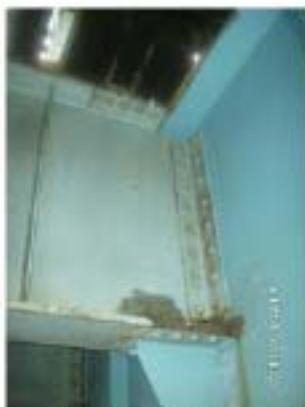
HPIM3889.JPG  
**P082 - Span 3 - Shrinkage Cracks in  
Paint System**

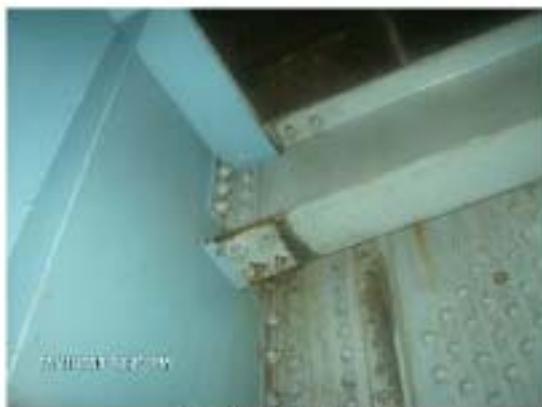
HPIM3887.jpg  
**P083 - Span 3 - South Main Stringer  
Connection to Floor Beam 0 - Bolted  
Connections Typical**

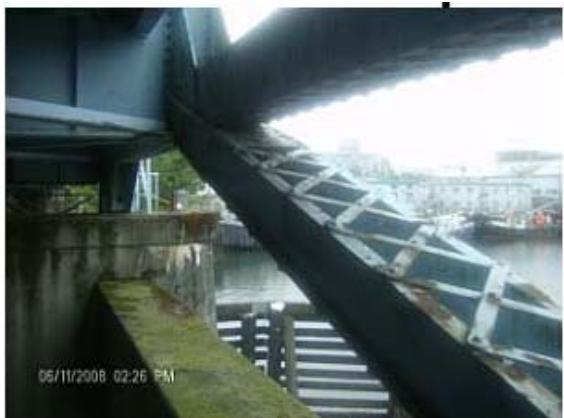
HPIM3891.JPG  
**P084 - Span 3 - South Small Stringer  
Connection to Floorbeam 2 - Bolted  
Connections Typical**

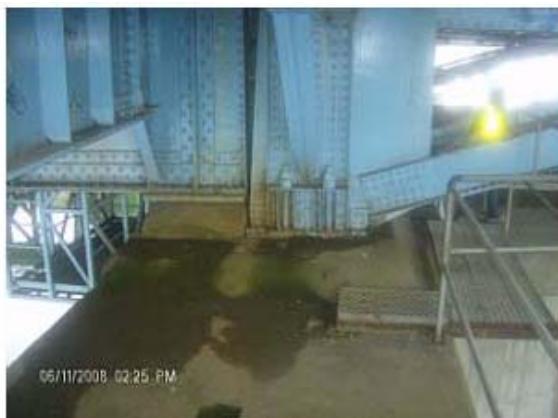
**HPIM3890.JPG**  
**P085 - Span 3 - North Bottom Chord**

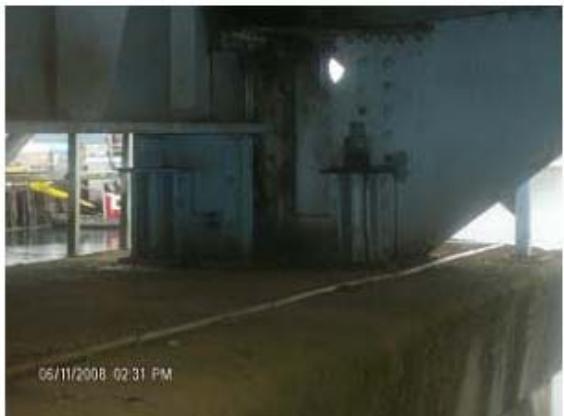
**HPIM3888.JPG**  
**P086 - Pier 3 - South Bearings - North Side**

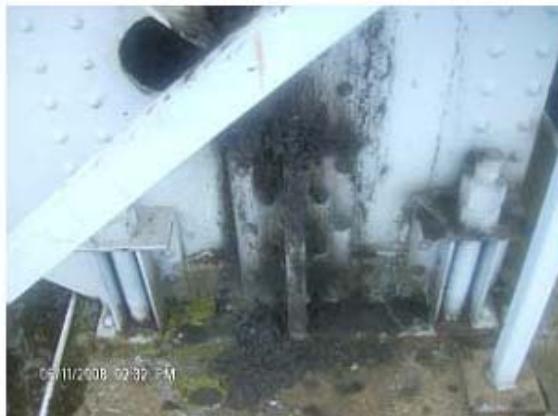
**HPIM3896.JPG**  
**P087 - Pier 3 - South Face of North Bearings**

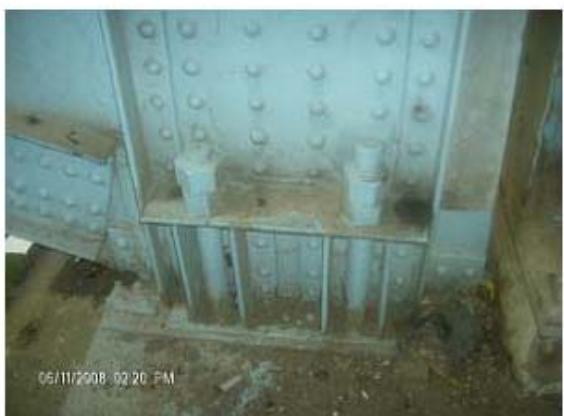
**HPIM3898.JPG**  
**P088 - Pier 2 - North Side of North Bearings**

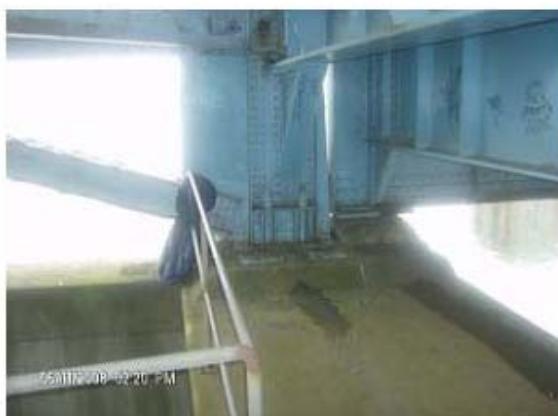
**HPIM3880.JPG**  
**P089 - Pier 3 - South Bearing for Span 3**

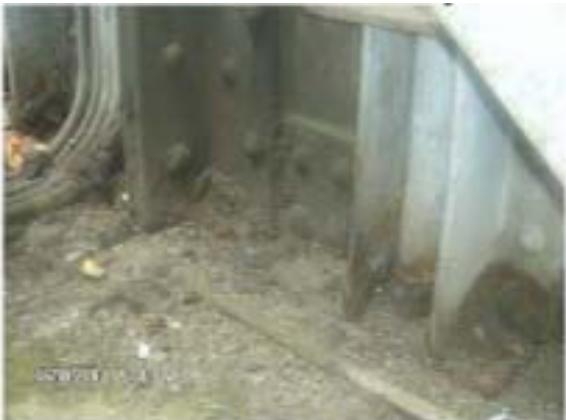
**HPIM3879.JPG**  
**P090 - Pier 3 - North Bearings for Spans 3 and 4**

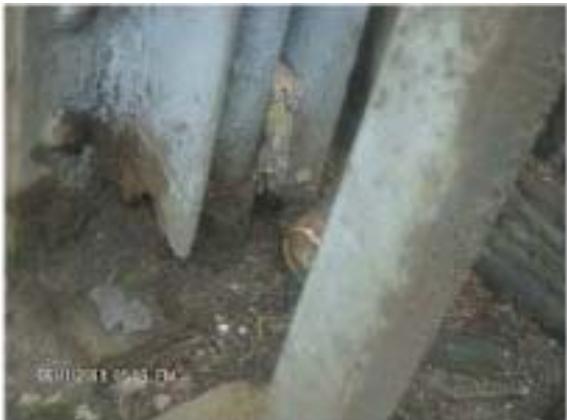
HPIM3992.JPG  
**P091 - Pier 2 - Span 3 - Section Loss in Anchor Bolt Stiffeners**

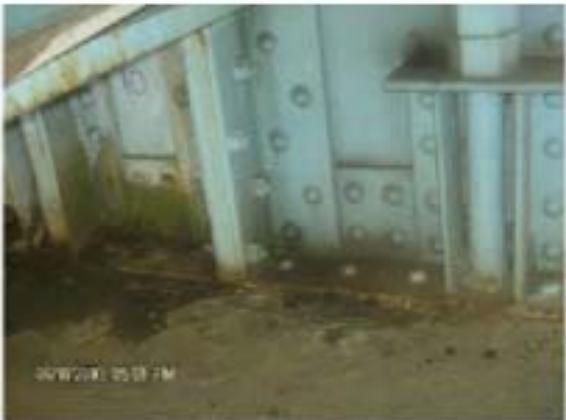
HPIM3993.JPG  
**P092 - Pier 2 - Span 3 - South Side of South Bearing Holed Anchor Bolt Stiffeners at Mortar Plate**

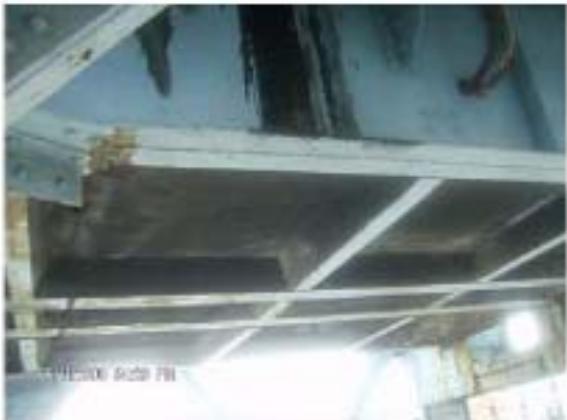
HPIM3994.JPG  
**P093 - Pier 2 - Span 3 - North Side of South Bearing - Anchor Bolt Stiffeners at Mortar Plate are Not As Bad**

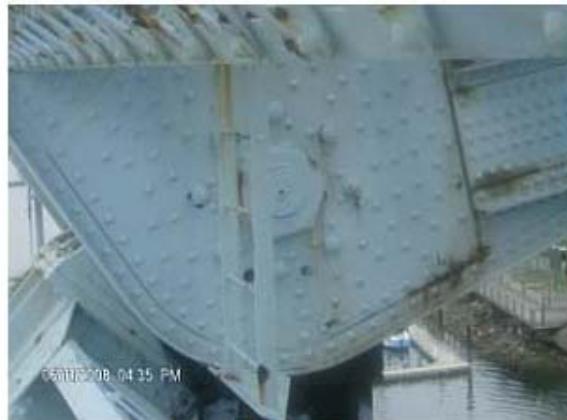
HPIM3967.JPG  
**P097 - South Trunnion Pin at Node 19**

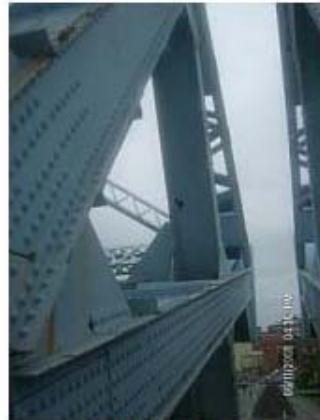
HPIM3968.JPG  
**P098 - North Trunnion Pin at Node 19**

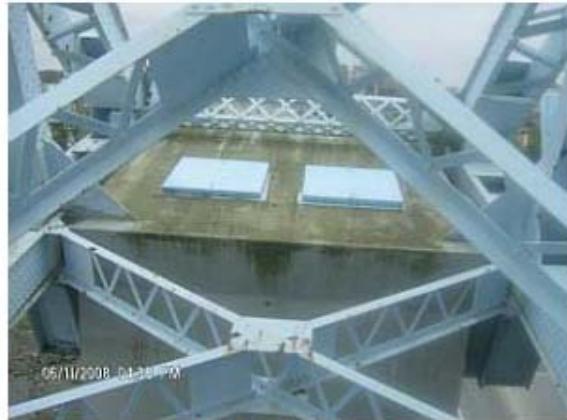
HPIM3969.jpg  
**P099 - South Counterweight Support Truss**

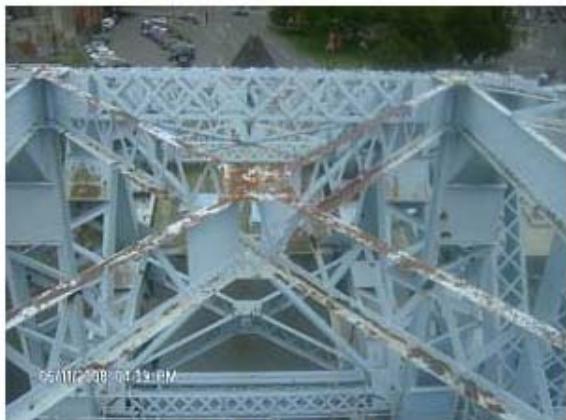
HPIM3971.JPG  
**P100 - Top of Concrete Counterweight**

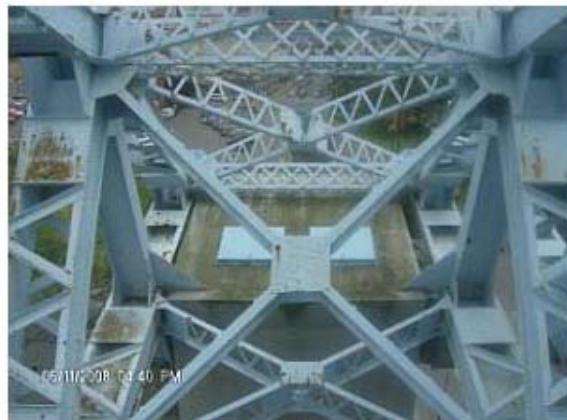
HPIM3973.JPG  
**P101 - Counterweight Support Truss Over Span 3**

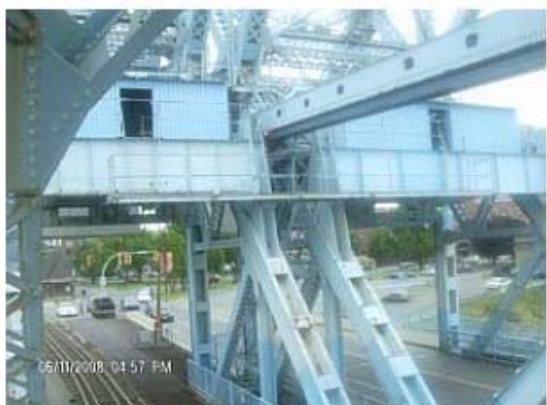
HPIM3980.JPG  
**P106 - Roadway Bridge - North Pin - Top of East Portal**

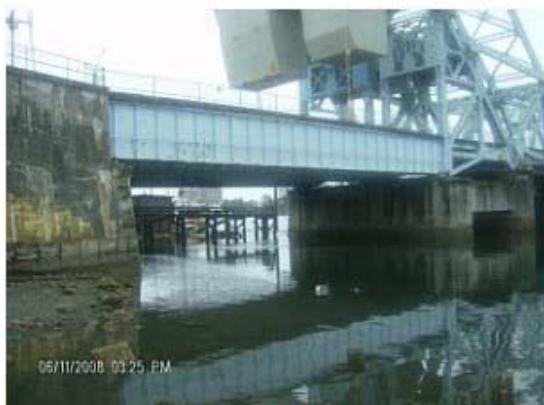
HPIM3986.JPG  
**P107 - Both Mechanical Sheds Above Span 3**

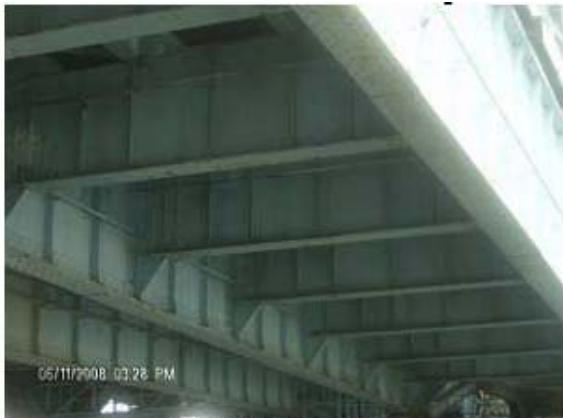
HPIM3930.JPG  
**P108 - North Side of East Approach Span 4**

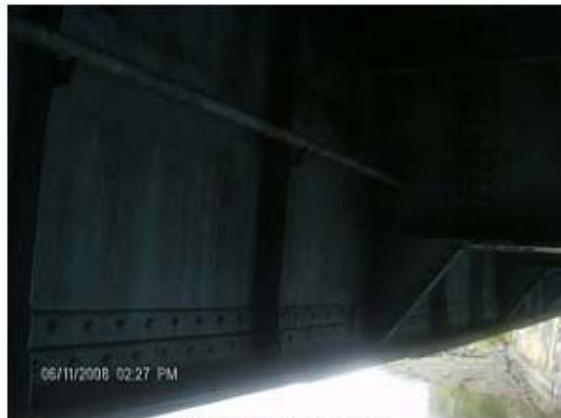
**HPIM3935.JPG**  
**P109 - East Approach Span 4 - Floor  
Beams**

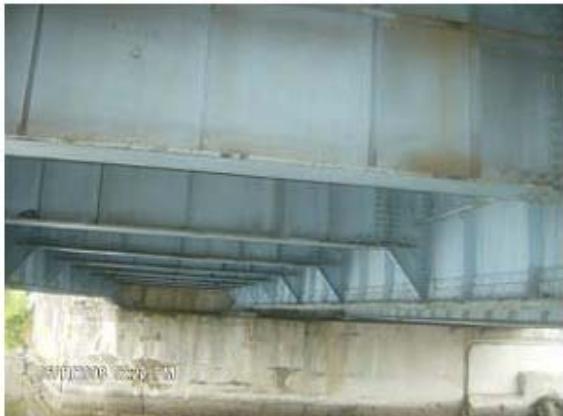
**HPIM3892.JPG**  
**P110 - Span 4 - North Main Girder**

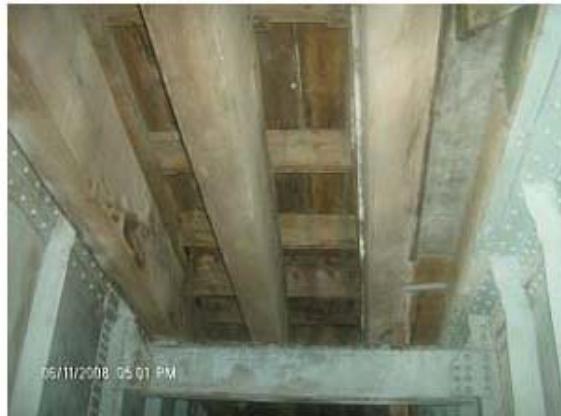
**HPIM3883.JPG**  
**P111 - Span 4 - Looking East**

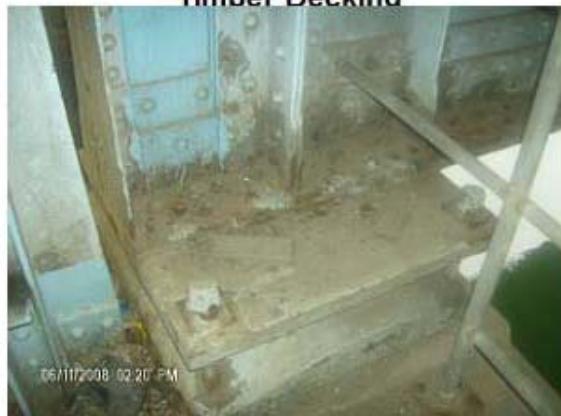
**HPIM3936.JPG**  
**P113 - East Abutment 2 - North Bearing  
and Bearing Seat - 3 mm Pack Rust  
Between 2 Adjacent Bearing Stiffeners**

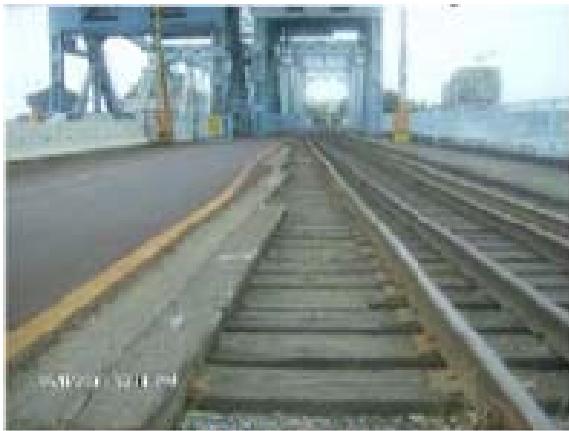
**HPIM3881.JPG**  
**P114 - Span 4 - South (Fixed) Bearing on  
Pier 3**

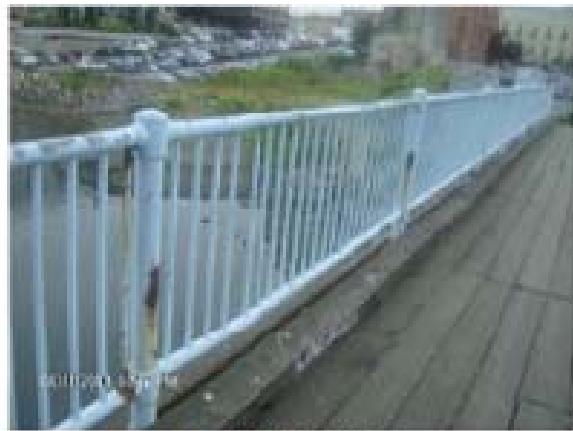
P116 - Track Alignment is Curved in the East Approach Span

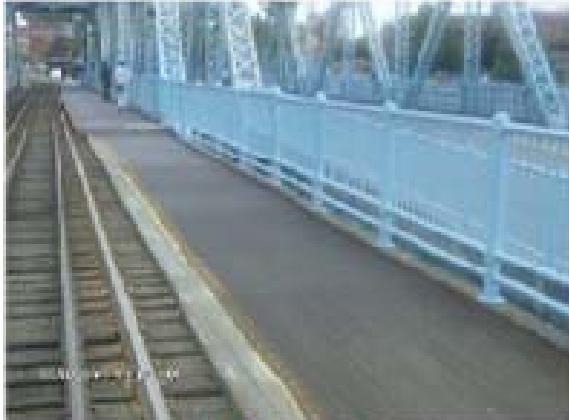
P116 - North Steel Railing

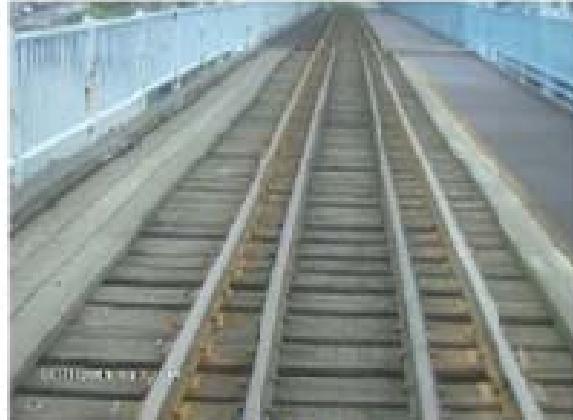
P117 - Span 1 - Timber Walkway on South Side

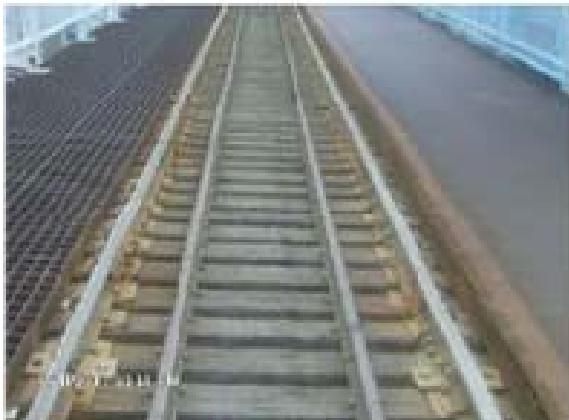
P118 - 65 Span 1 Ties (10" x 12") - No Rejects

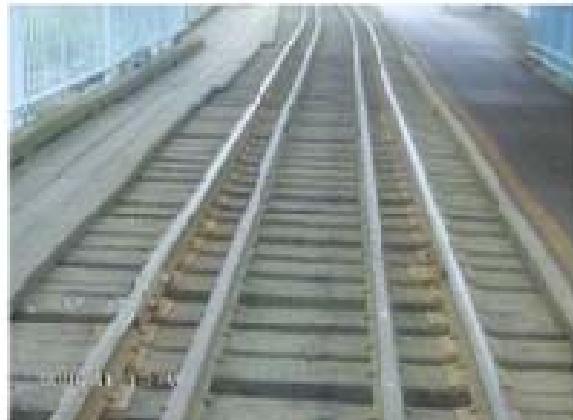
P119 - 147 Span 2 Ties (8" x 12") - No Rejects

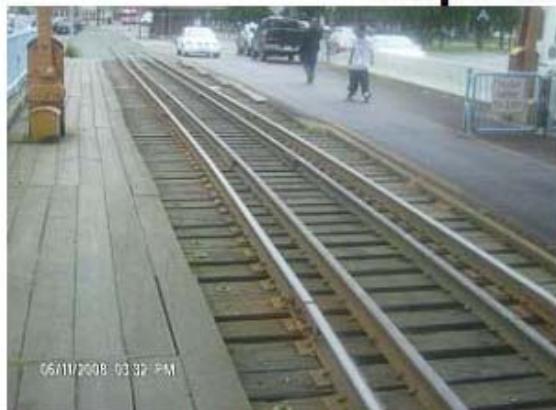
P120 - 61 Span 3 Ties (8" x 12") - No Rejects

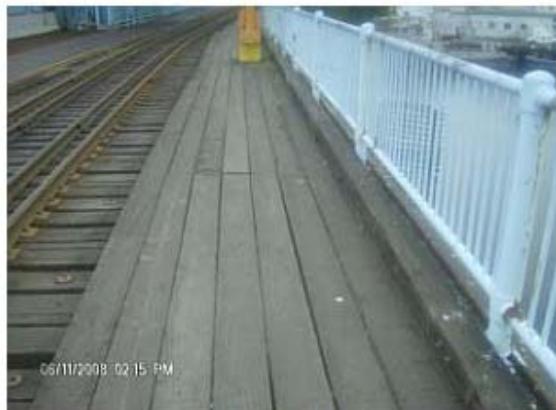
**HPIM3926.JPG**  
**P122 - Lift Span 2 - North Steel Grating Walkway Supported on Transverse Channels**

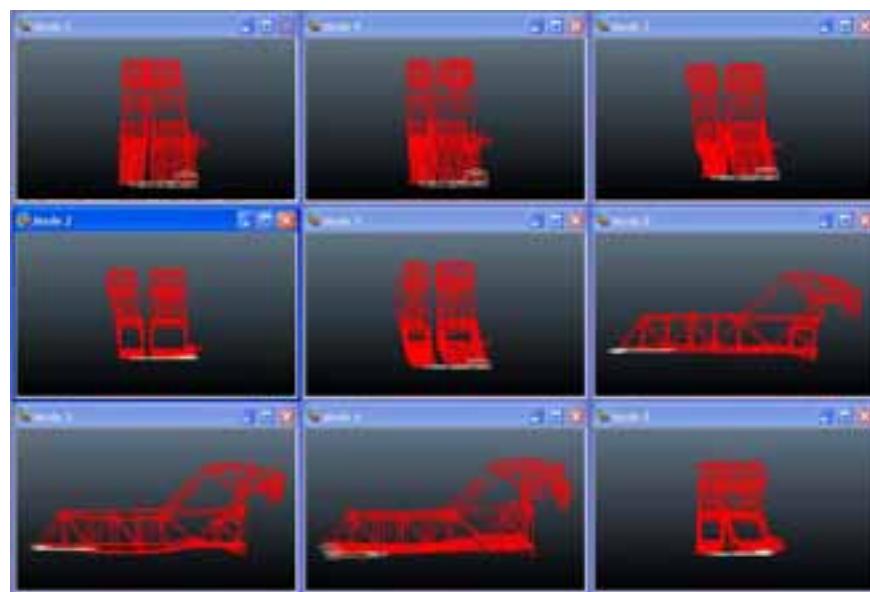
Fig (A-D 2.1 ) the first 9 mode shapes of the existing bridge

Thorough observation of the modal analysis results that has been carried out to determine the weak planes and the actual structural behavior during Earthquake events and the shape of displacement considerations, fig (A-D 2.1). It has been shown that longitudinal direction of ground motion (i.e. X axis) has less effects than the transverse direction (i.e. Y axis), in spite of the fact that the bridge is stiffer in the longitudinal direction and has less fundamental period means more spectral acceleration resulting in more seismic forces, but the structure is designed to carry such forces While in lateral (transverse i.e. Y axis) the fundamental period is higher but the structure very weak in this direction.

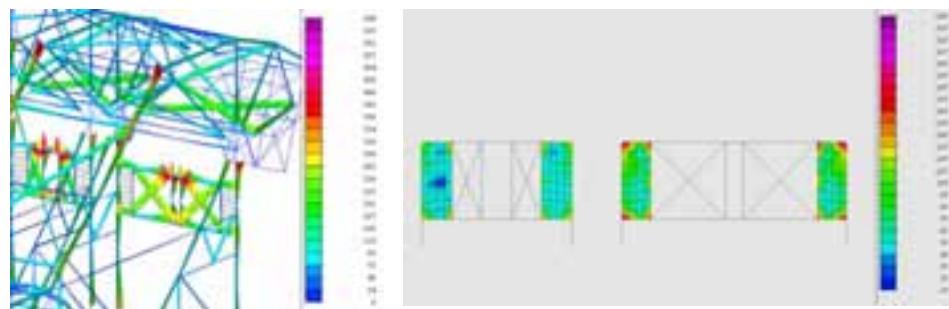
Fig (A-D 2.2 ) the stresses of the bracings of the existing bridge

It could be shown on Fig (A-D 2.2) that some members in the superstructure still suffer excessive stresses and plastic deformation. These members are mainly the lateral bracing and the triangle chord.

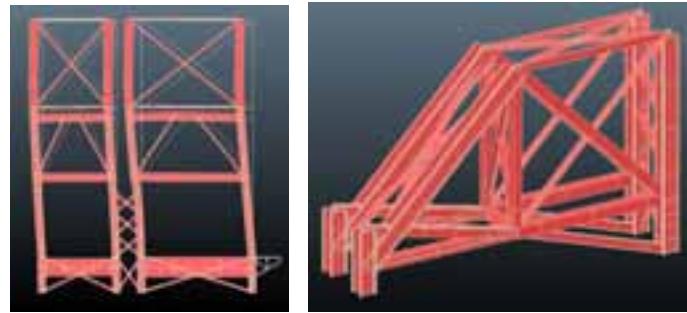
Fig (A-D 2.3 ) the added members in Alternative 3

All link elements yielded and all main elements remained elastic under the design earthquake, inelastic behavior (damage) is therefore accepted if it does not cause collapse. This eccentric frame is ductile in nature and the damage occurs in designated components.

Fig (A-D 2.3) represents the new added members in this alternative.

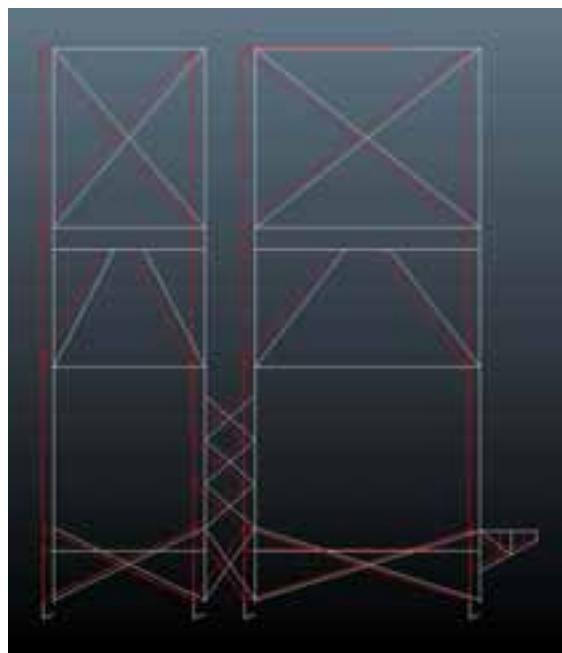
**Fig (A-D 2.4)** the elastic deflected shape of the main verticals of the isolated bridge, during the first mode of vibration (first shock)

The isolation in Piers P2 and P3 attracts the horizontal bracing system in the whole bridge to work together to increase seismic performance.

Isolation gave less concentration of forces in the short verticals over the supports.

The demand/capacity values given by the analysis indicate that the combination of seismic isolation bearings placed under the counterweight tower and the energy dissipating bracing described under Alternative 3 improve the response of the bridge.

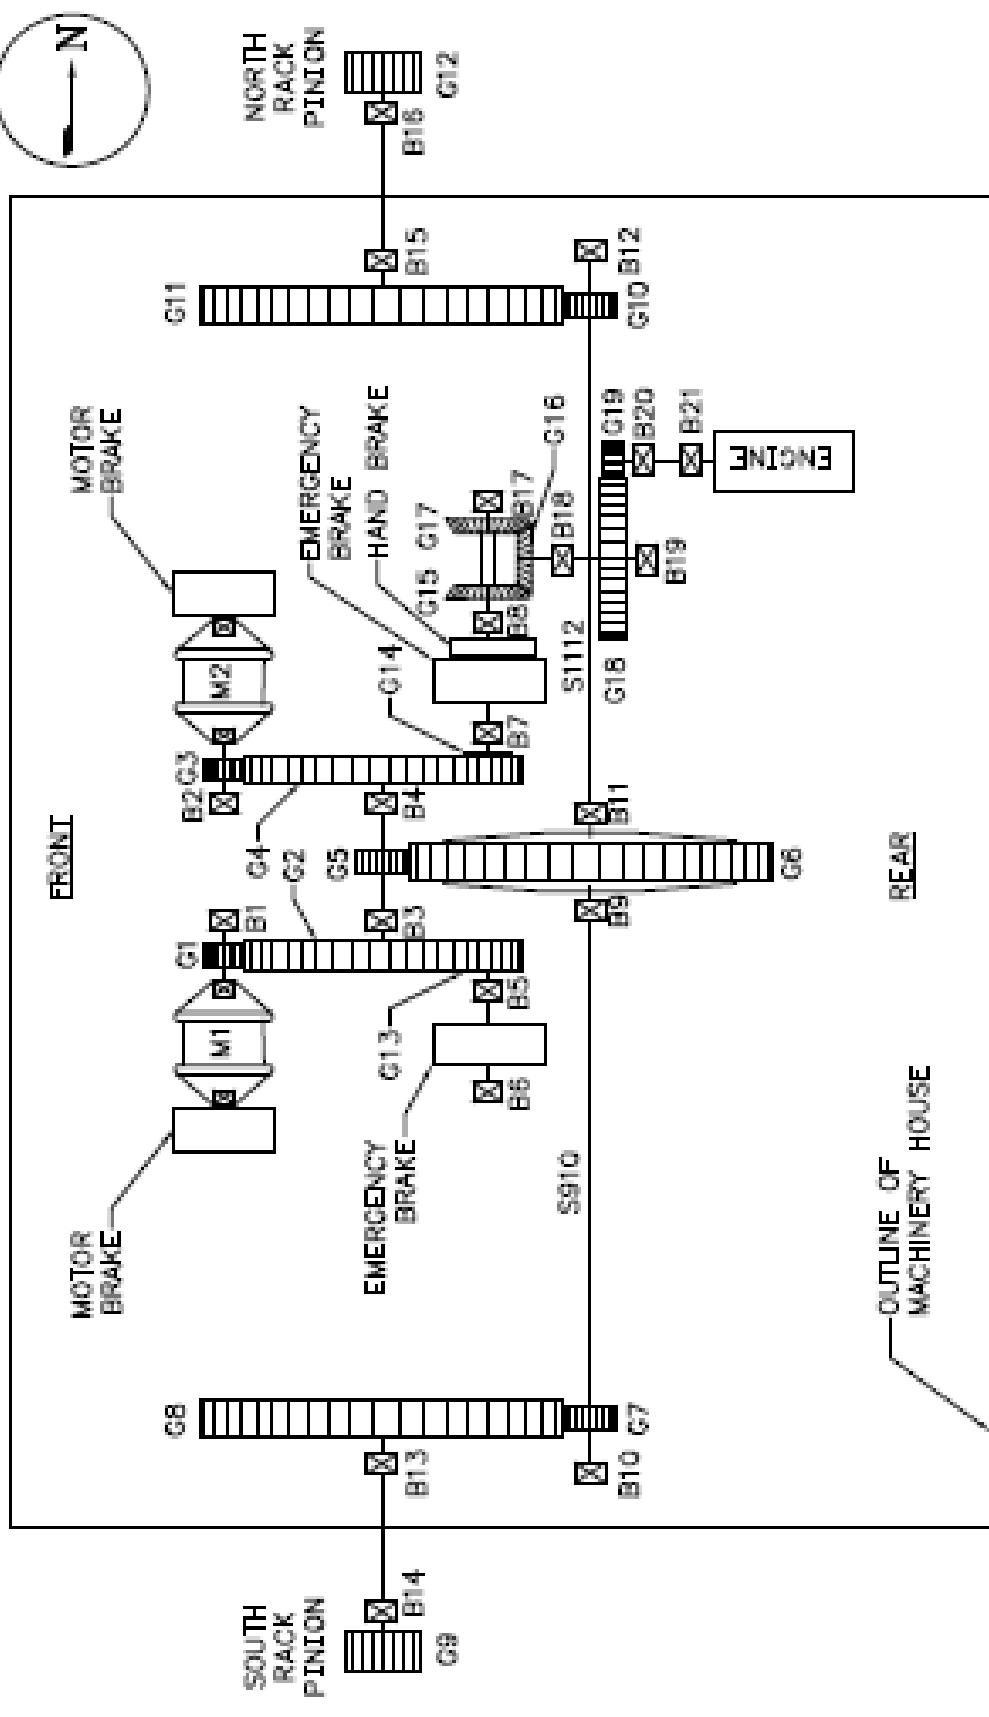
Figure 1. Span Drive Machinery Highway Bridge

A schematic of the normal and auxiliary span drives with component designations for each bridge is presented in Figures 1 and 2, Appendix E. The component designations are consistent with those found on the schematics in the machinery houses.

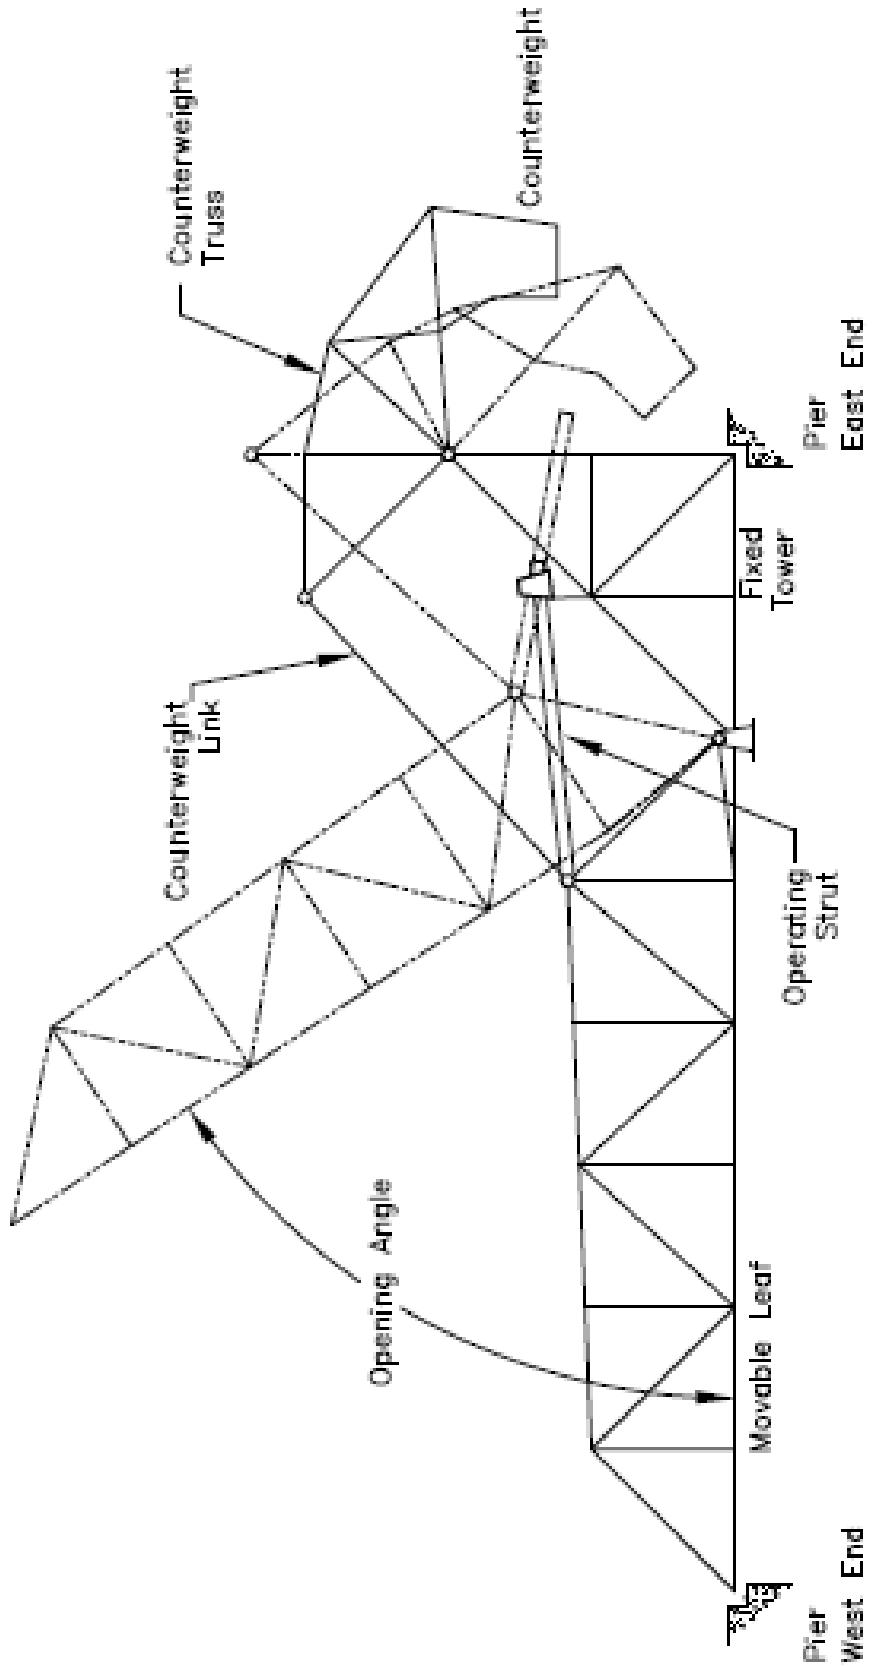
The dead weight of the movable leaf is supported by two main trunnions located at the heel of the span; live load is supported by two live load supports at the toe end of the span. The counterweight is located directly above the roadway. It is supported by two counterweight trunnion bearings mounted on a tower above the east approach. The steel counterweight frame is connected to the bascule leaf by a counterweight link utilizing four link pins. There are two link pins (1st link pins) and bearings at the connecting points between the counterweight frame and the counterweight link and two additional link pins (2nd link pins) and bearings that connect the counterweight link to the upper chord of the bascule span. The trunnions and pins are arranged such that they form a parallelogram in a vertical plane. As the span opens the first and second link pin bearing assemblies move while the main and counterweight trunnion bearing assemblies remain stationary with the exception of the rotational movement within the assembly. The movement of the link pins causes the shape of the parallelogram to change however the four sides of the parallelogram remain parallel regardless of the span position. **Figure 3, Appendix E** identifies the primary span support components. **Figure 4, Appendix E** illustrates the change in geometry of the span support system during movable leaf operation.

<p>Project Johnson Street Bridge Mechanical Inspection Inspection – June 2008</p> <p>Prepared by Stafford Bandelow Engineering, Inc.</p>
<p>Figure 4. Schematic of Johnson Street Bridge Shown in Closed Position – Solid Lines Shown in Open Position – Phantom Lines</p>

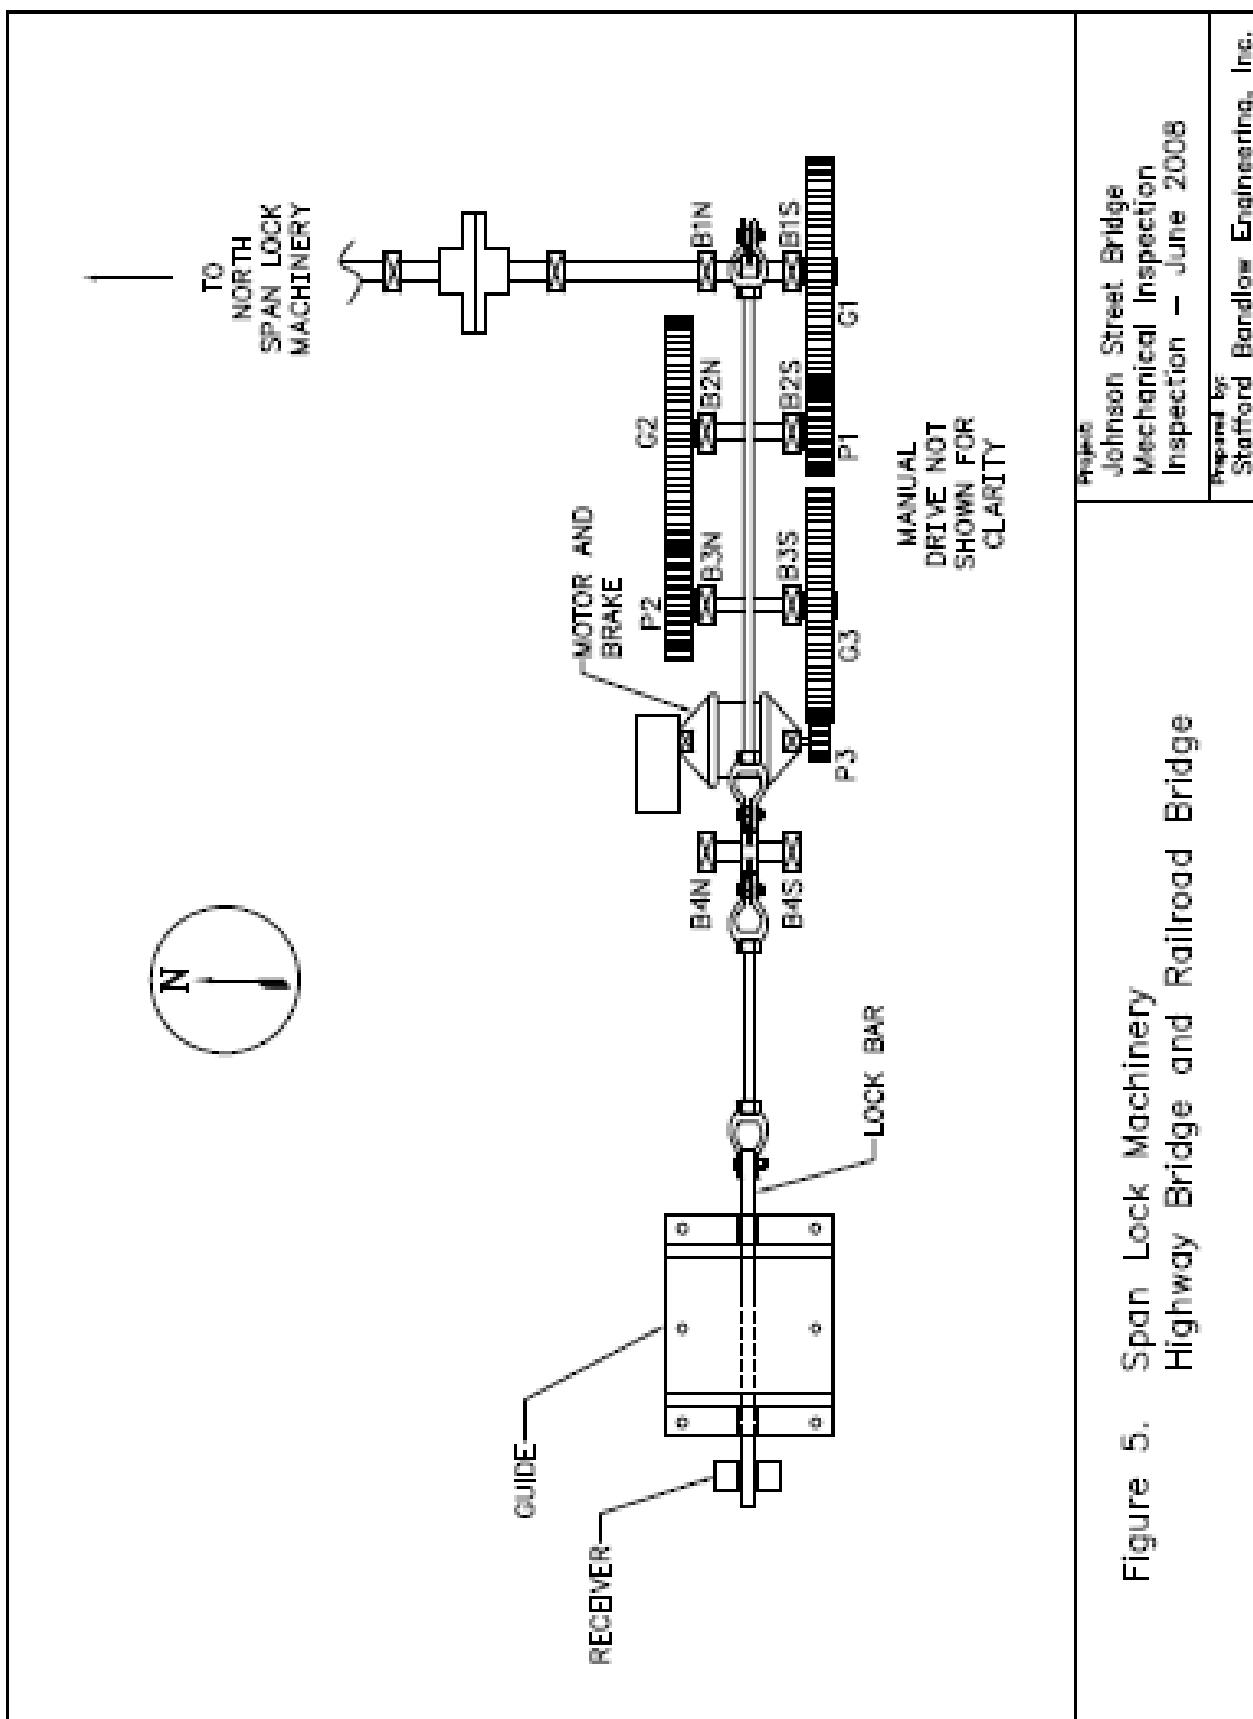
Figure 5. Span Lock Machinery  
Highway Bridge and Railroad Bridge

Each bridge has two span locks. The locking mechanism consists of a lock bar supported in roller assembly that is mounted in the bottom cord of each truss at the toe end of the bridge. Each lock bar engages a receiver that is mounted on the channel side of the live load support casting. The lock bars are driven by an electric motor through a series of gears, bearings, shafts, levers, and links. The low speed machinery shaft extends across the bridge to drive the lock bar on the opposite side of the bridge. **Figure 5, Appendix E** shows a schematic of the span drive machinery.

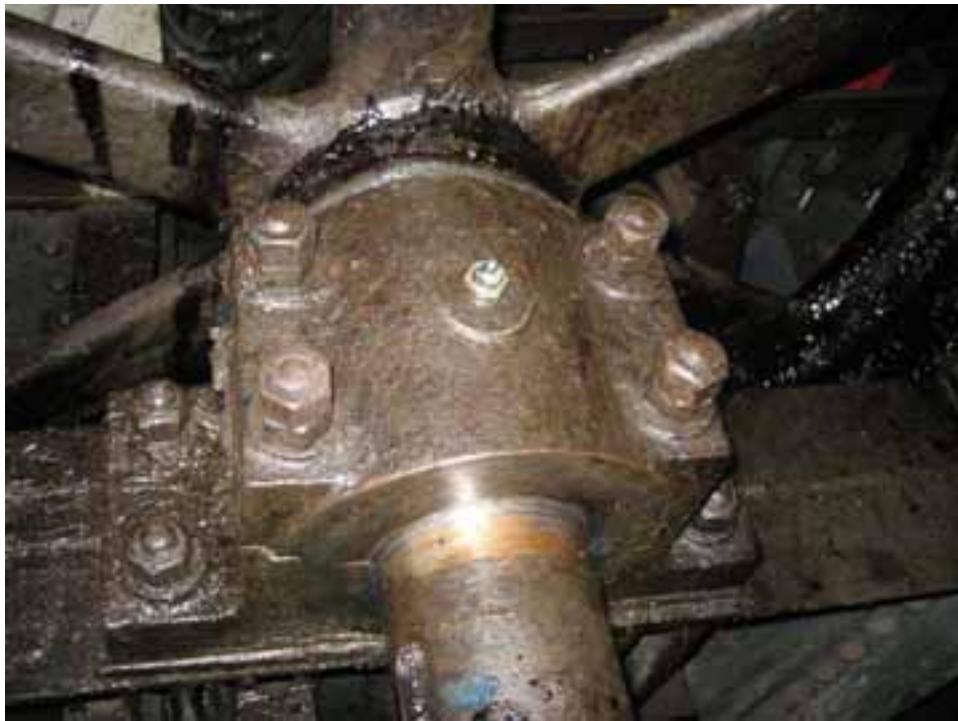
**Photo M-1.1. Highway Bridge, Bearing B3. Note the deformation of the bearing cap and the degradation of the shaft.**

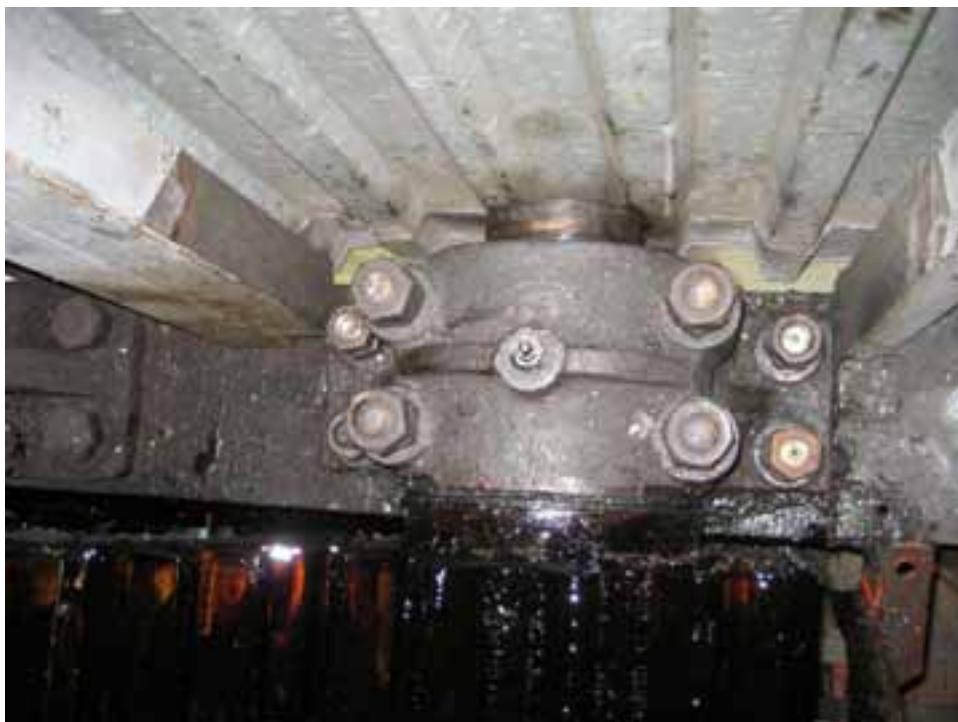
**Photo M-2. Highway Bridge, Bearing B12. This bearing oscillates during operation of the machinery. Note that the base bolts have been replaced.**

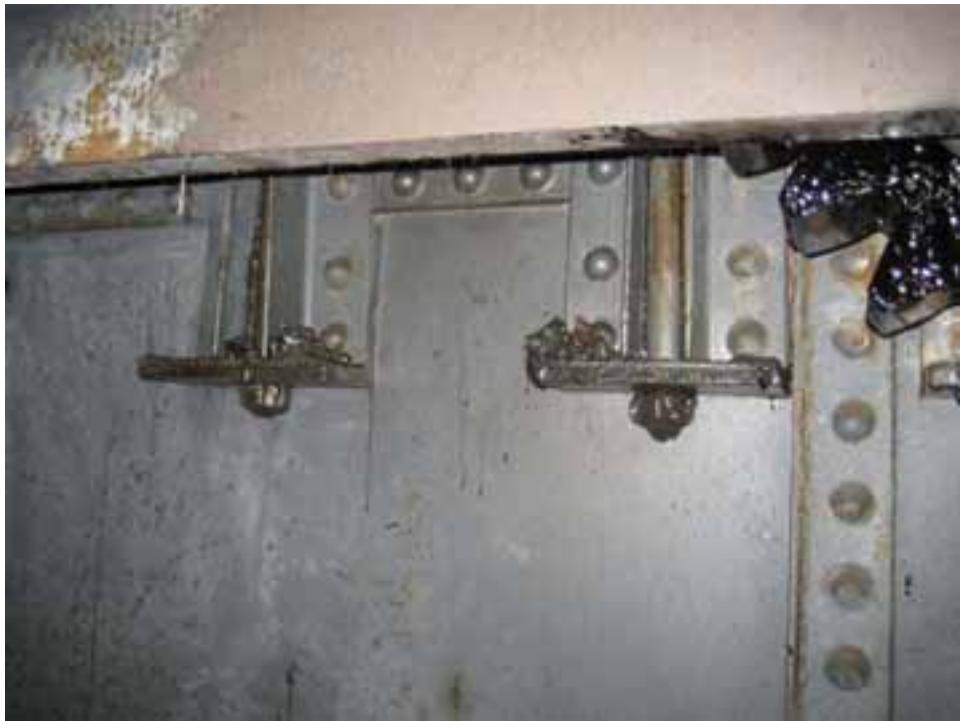
**Photo M-3. Highway Bridge, Bearing B13.** Note the gap between the nuts and the support indicating that the bolts are loose.

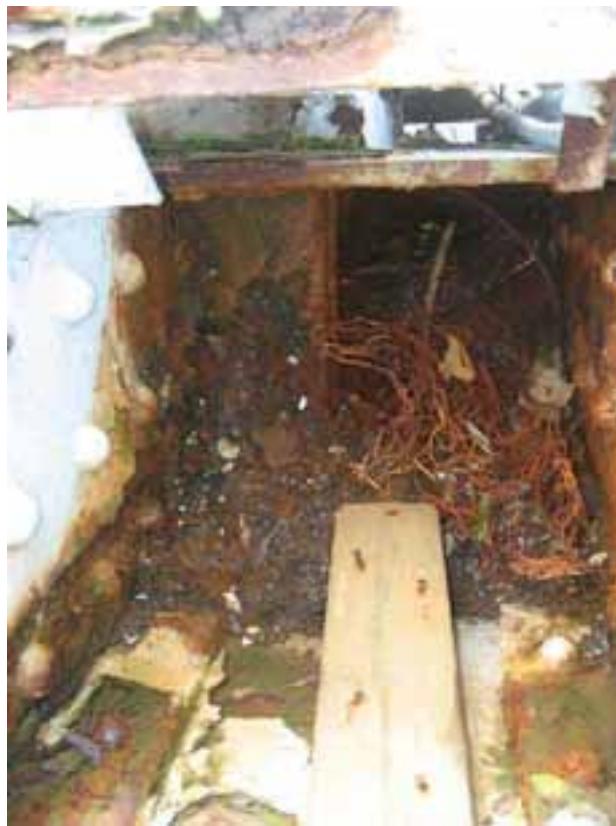
**Photo M-4. Highway Bridge, Bearing B14.** The body of the upper inboard bearing mounting bolt is behind the heavily corroded stiffener. Note the accumulated debris.

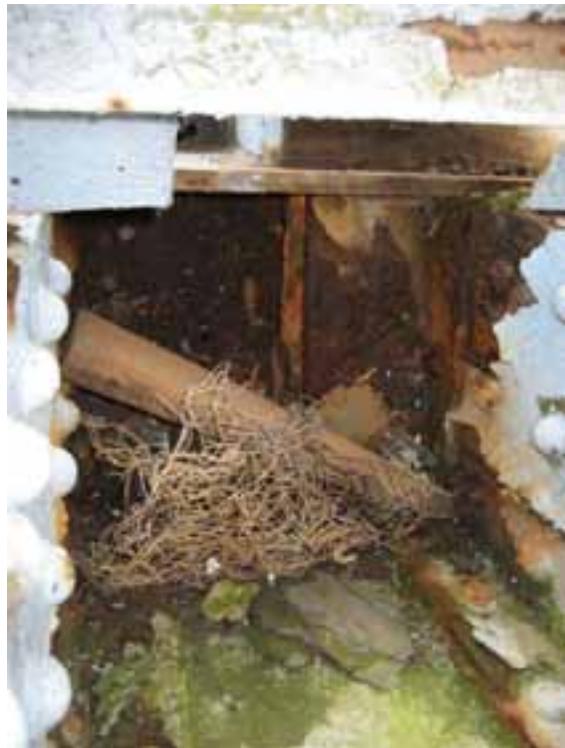
**Photo M-5. Highway Bridge, Bearing B16.** The upper inboard bearing mounting bolt is located behind the stiffener. Note the accumulated debris and corrosion.

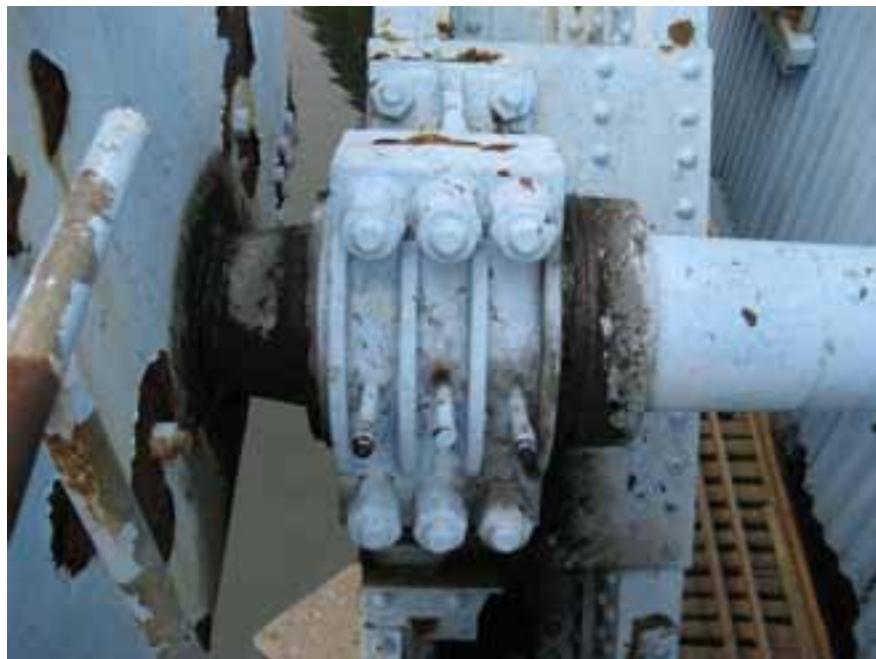
**Photo M-6. Railroad Bridge, Bearing B14.** Note the center lube fitting has been replaced with a pipe cap.

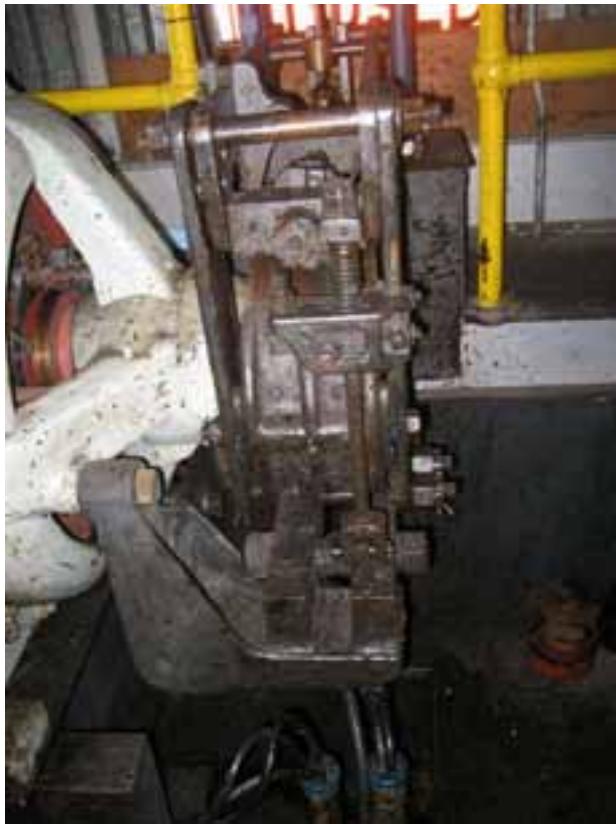
**Photo M-7. Highway Bridge, North Motor Brake.** The brake assembly is covered with lubricant and lubricant has contaminated the brake wheel.

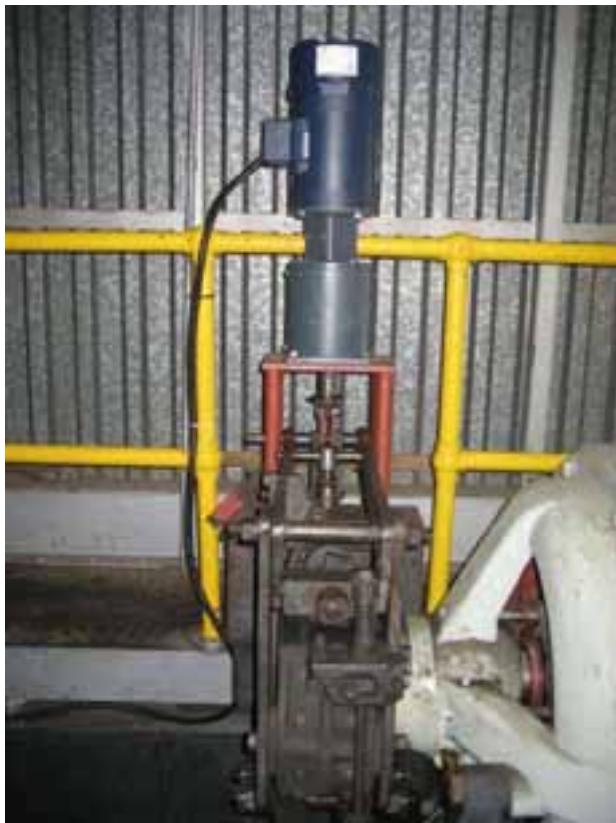
**Photo M-8. Highway Bridge, South Motor Brake.** The brake has been retrofit with a custom actuator. A cotter pin is missing from one of the pins near the actuator.

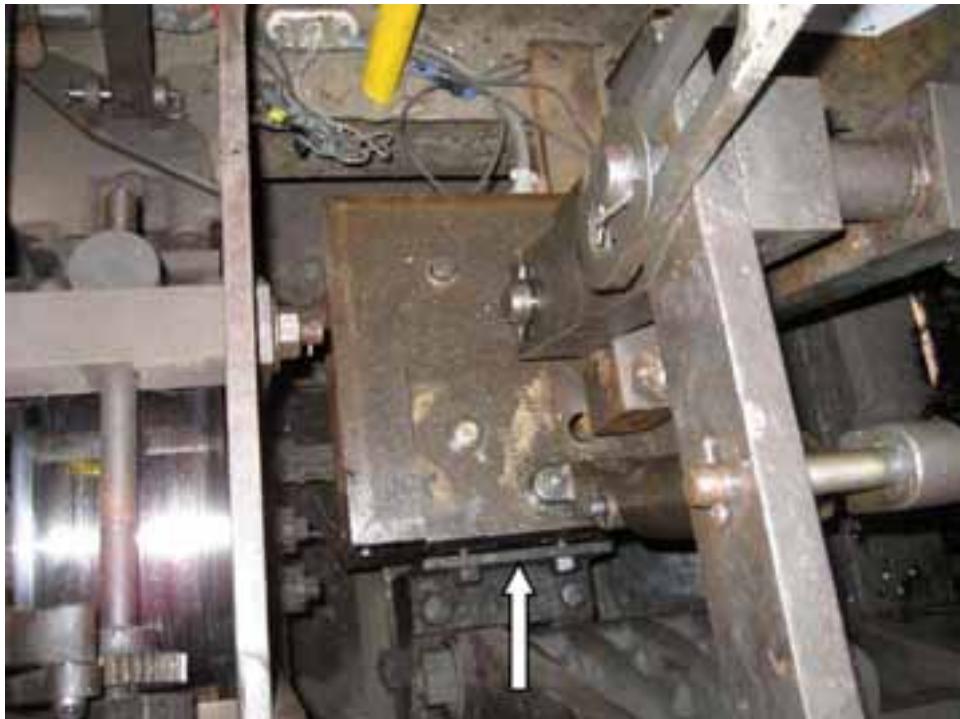
**Photo M-9. Railroad Bridge, North Emergency Brake. Note the loose bolts (arrow) at the solenoid.**

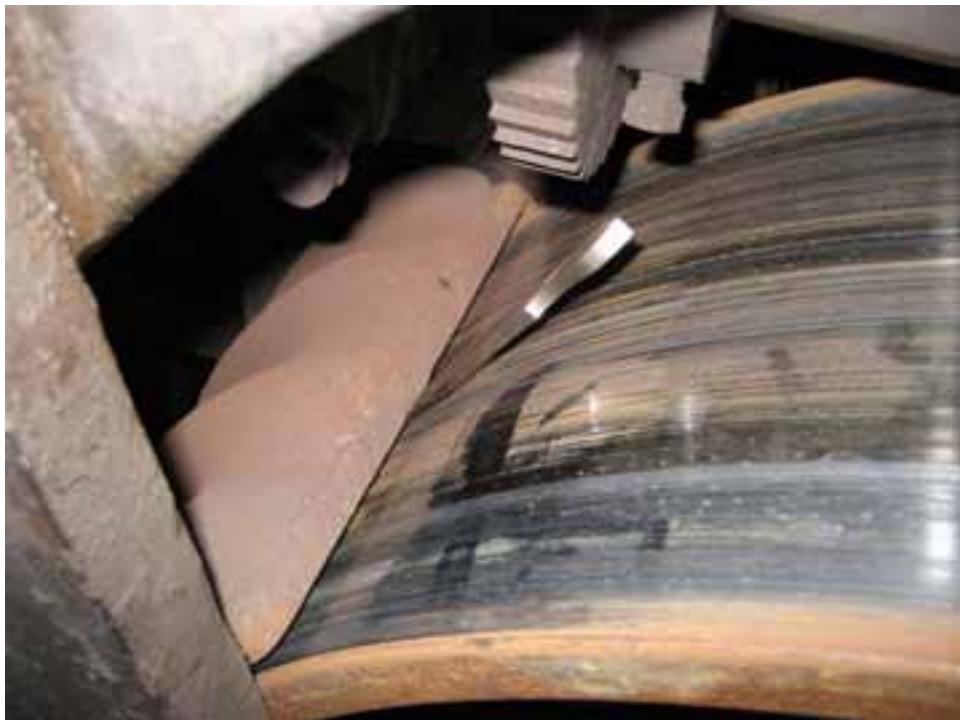
**Photo M-10. Railroad Bridge, South Emergency Brake. The taper gage is used to demonstrate clearance between the brake shoe and the brake wheel.**
