# Johnson Street Bridge Condition Assessment Report

**Delcan**

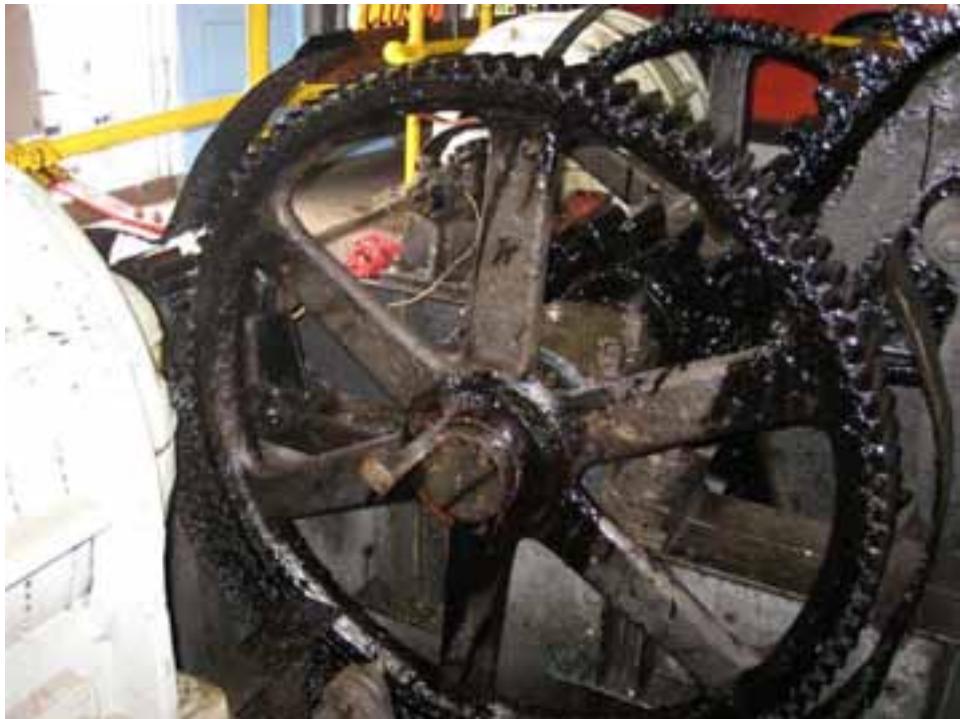
**Photo M-11. Highway Bridge, Gear G2.** The key for this gear is loose. The key was pulled out by hand to take this photo and then returned to its original position.

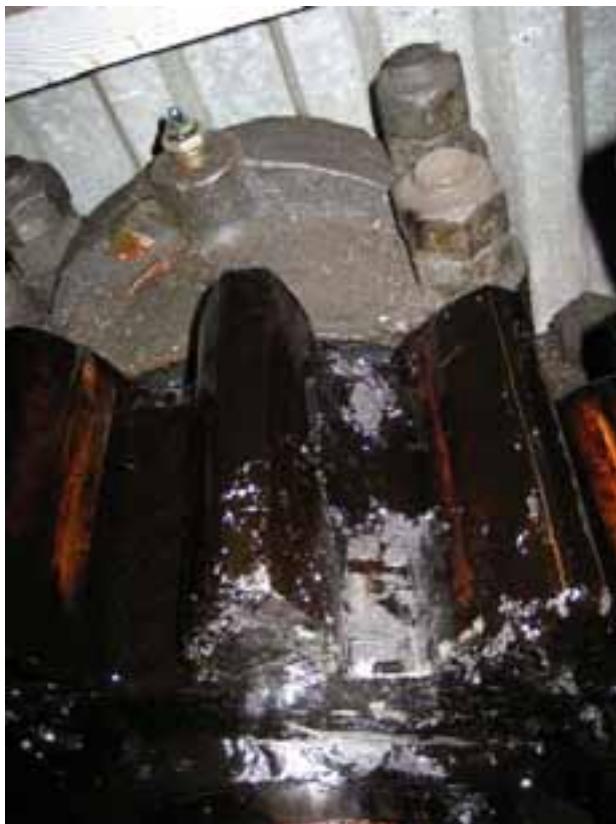
**Photo M-12. Highway Bridge, Gearset G7/G8.** Note the heavy accumulation of hardened lubrication deposits in the root of the teeth. Some of the lubricant was scraped away prior to taking the photo.

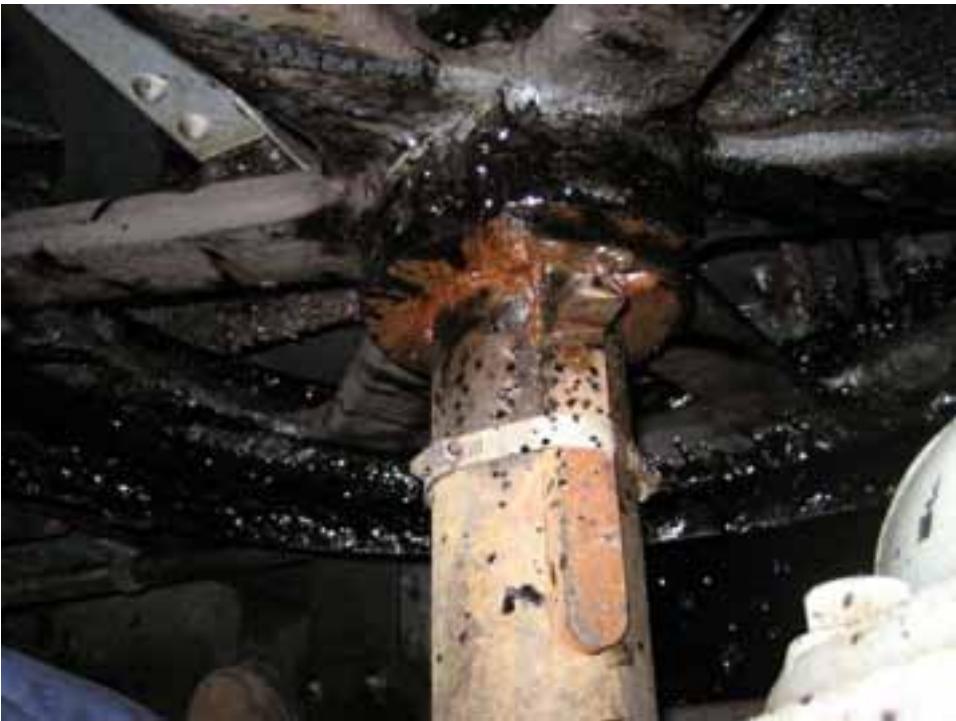
**Photo M-13. Railroad Bridge, Gear G4.** Note the addition of a second key secured by a hose clamp to restrain the primary key. Also note the fretting corrosion at the interface of the shaft and gear hub.

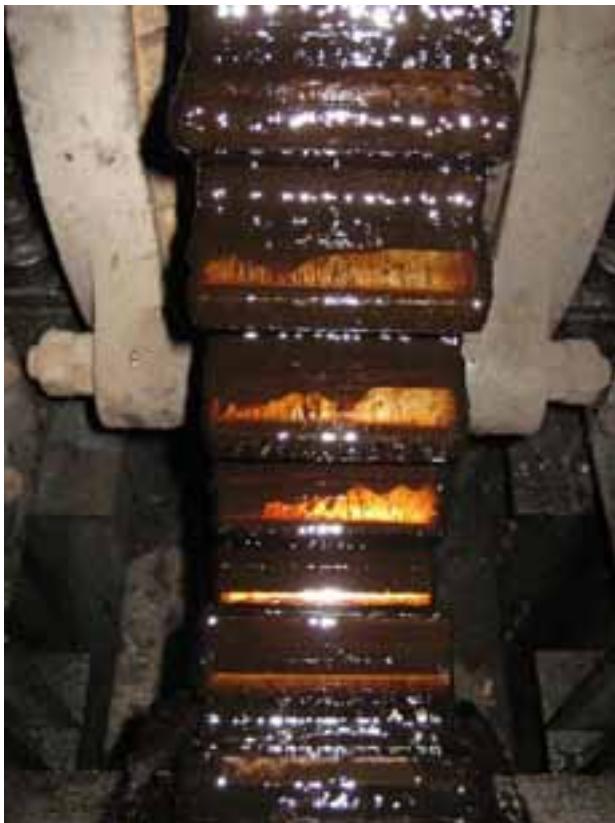
**Photo M-14. Railroad Bridge, Gearset G5/G6.** The abrasive wear and scoring seen on this gearset was the most severe surface degradation found at any of the gears.

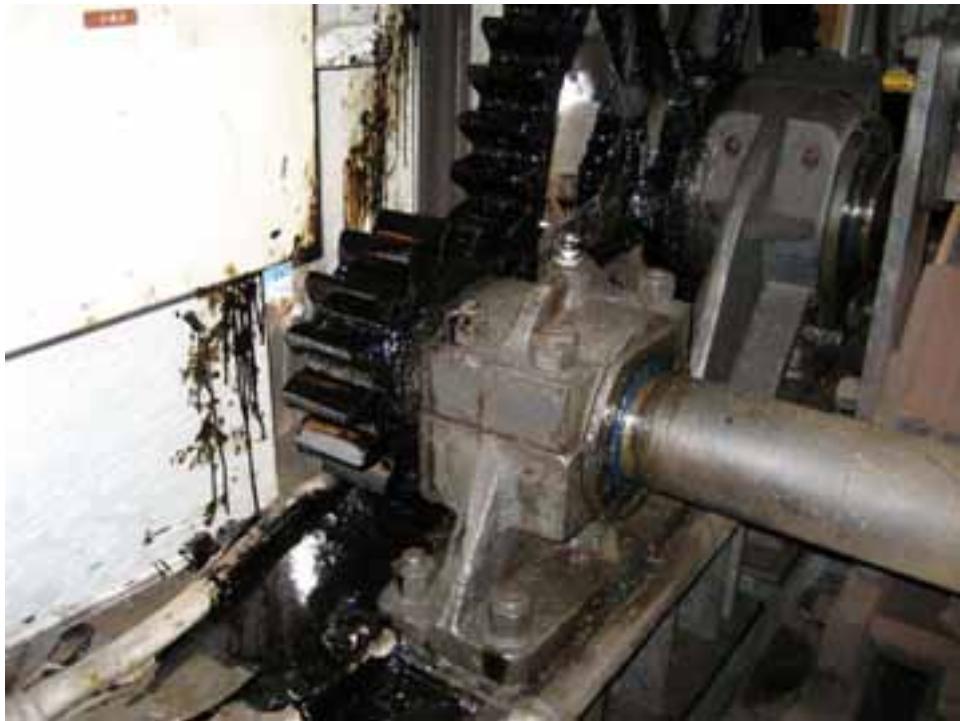
**Photo M-15. Railroad Bridge, Gearset G7/G8. Note the accumulated lubricant below Gear G7.**

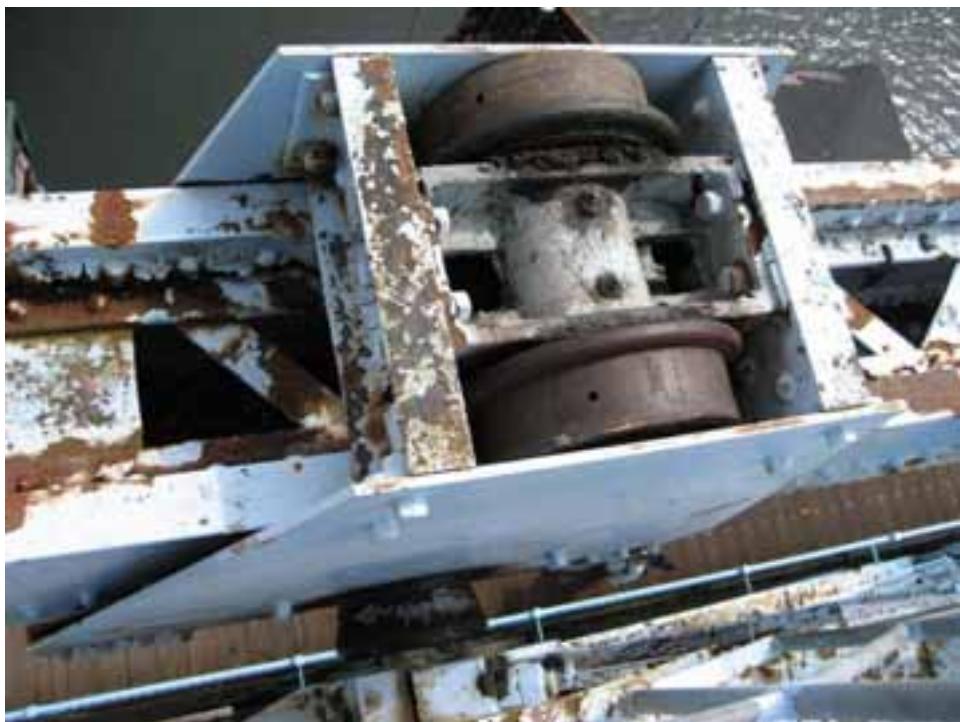
**Photo M-16. Highway Bridge, South Operating Strut Guide. Note the paint deterioration and light to moderate corrosion.**

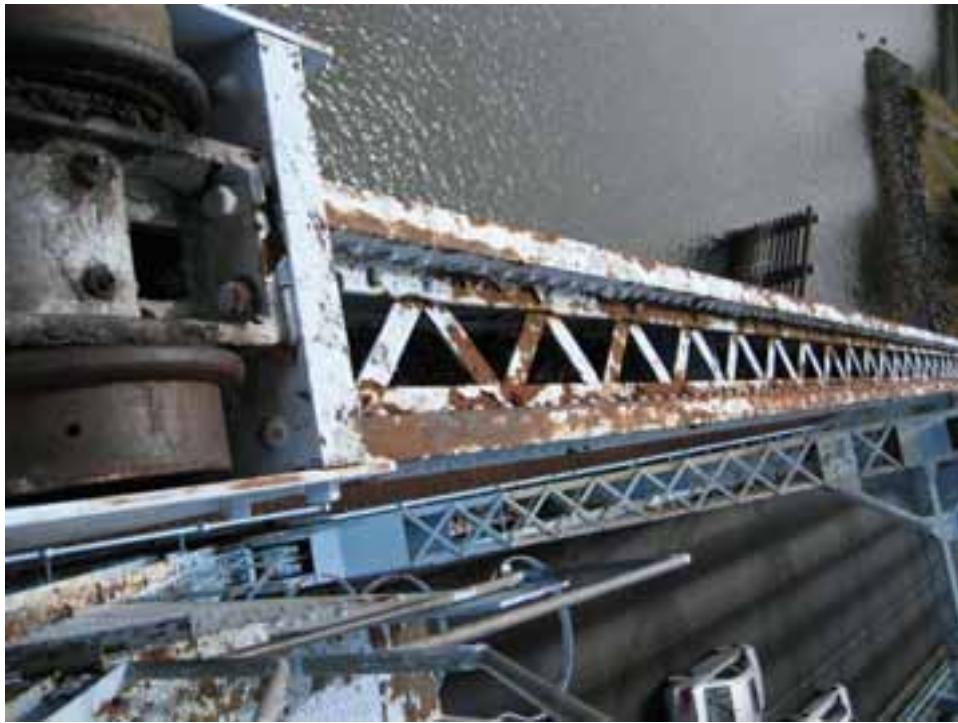
**Photo M-17. Highway Bridge, South Operating Strut. Note the paint deterioration and light to moderate corrosion.**

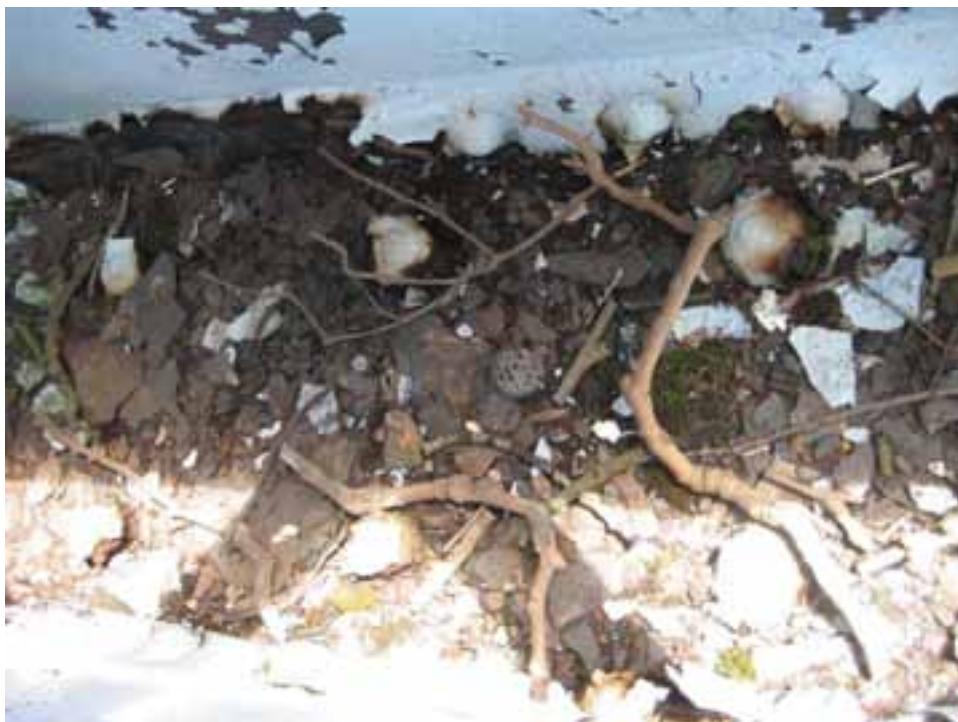
**Photo M-18. Highway Bridge, South Operating Strut. This is the area between the structural channels that form the operating strut. Note the accumulated debris.**

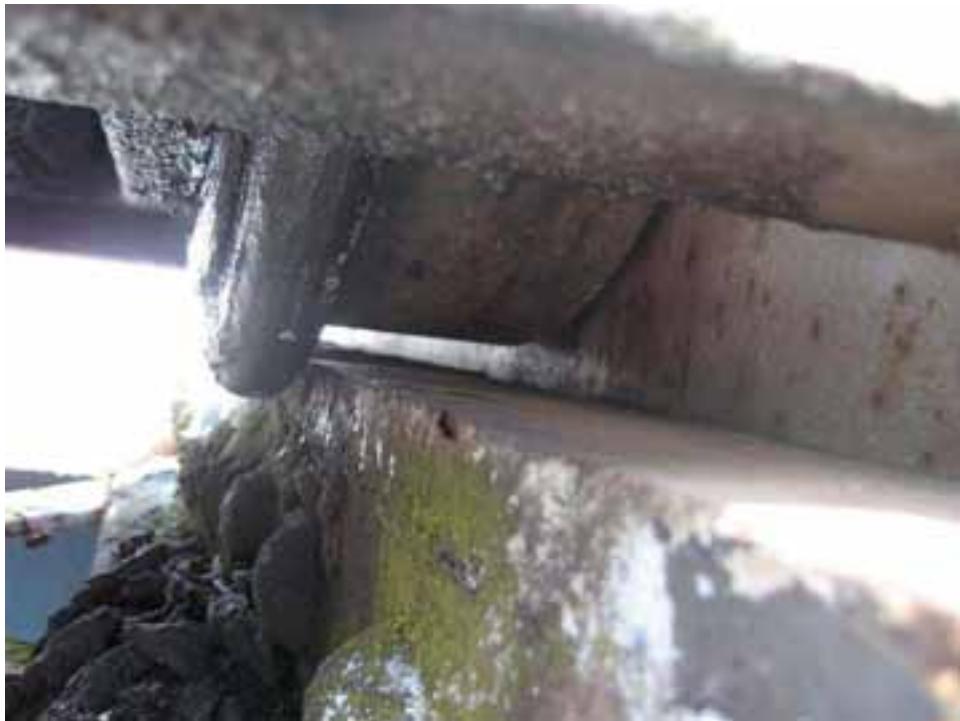
**Photo M-19. Highway Bridge, South Operating Strut Upper Outboard Guide Roller. The original drawings indicate a gap of 1/8" at this location. At the time of the inspection the gap measured between 0.350" and 0.475"**

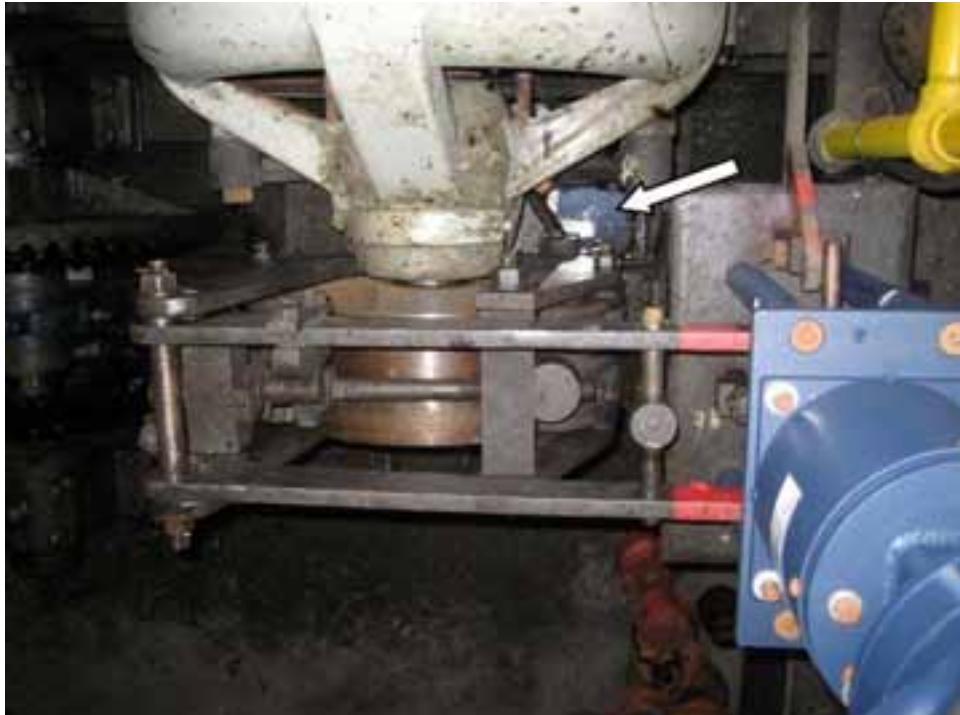
**Photo M-20. Highway Bridge, Motor M2. Note the puddle of oil (arrow) between the brake and the motor.**

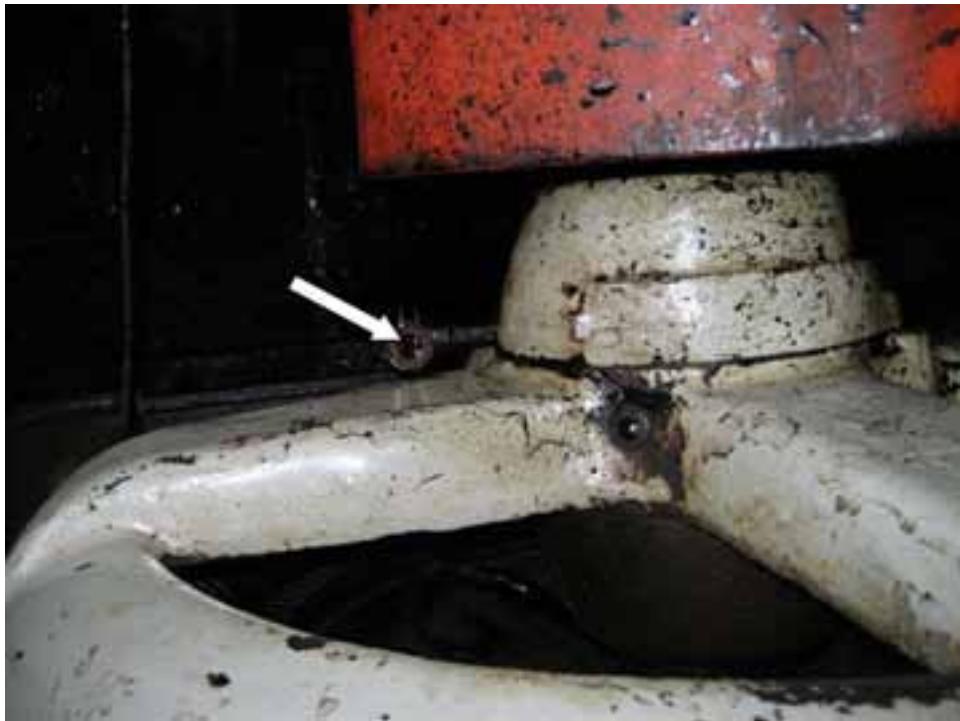
**Photo M-21. Railroad Bridge, Motor M1. The cover for the oil check fitting (arrow) is missing.**

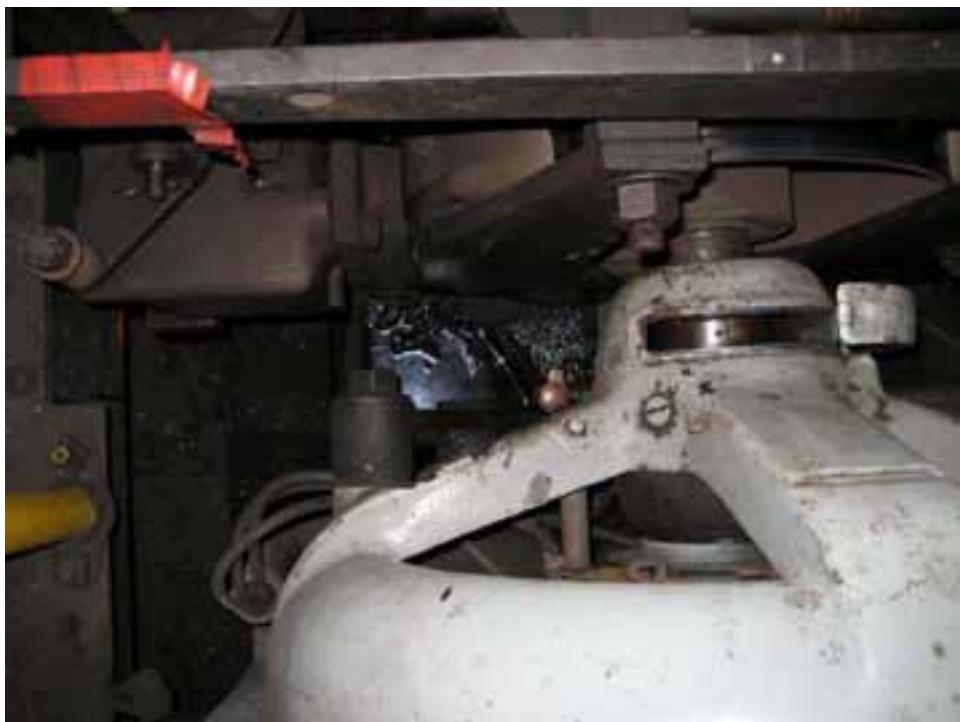
**Photo M-22. Railroad Bridge, Motor M2. The opened cover provides access to the motor bearing. The bearing appears severely damaged but could not be photographed due to limited access. Also note the puddle of oil to the left of the motor bearing.**

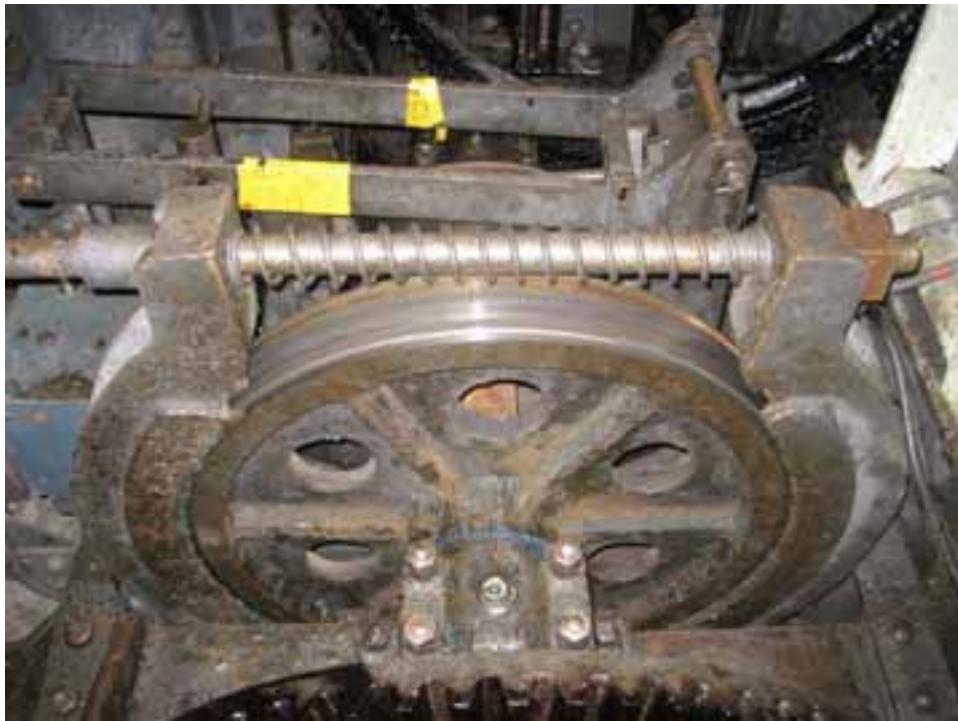
**Photo M-23. Highway Bridge, Hand Brake. The brake assembly is coated with lubricant and there is oil on the brake wheel.**

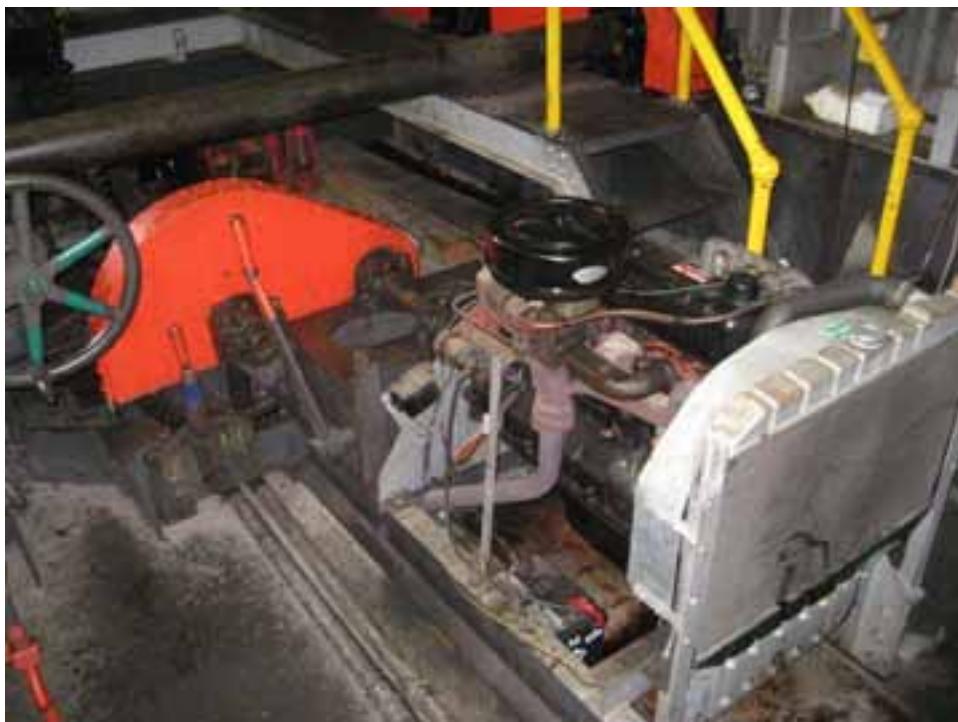
**Photo M-24. Highway Bridge, Auxiliary Bridge Engine. The engine has a significant oil leak.**

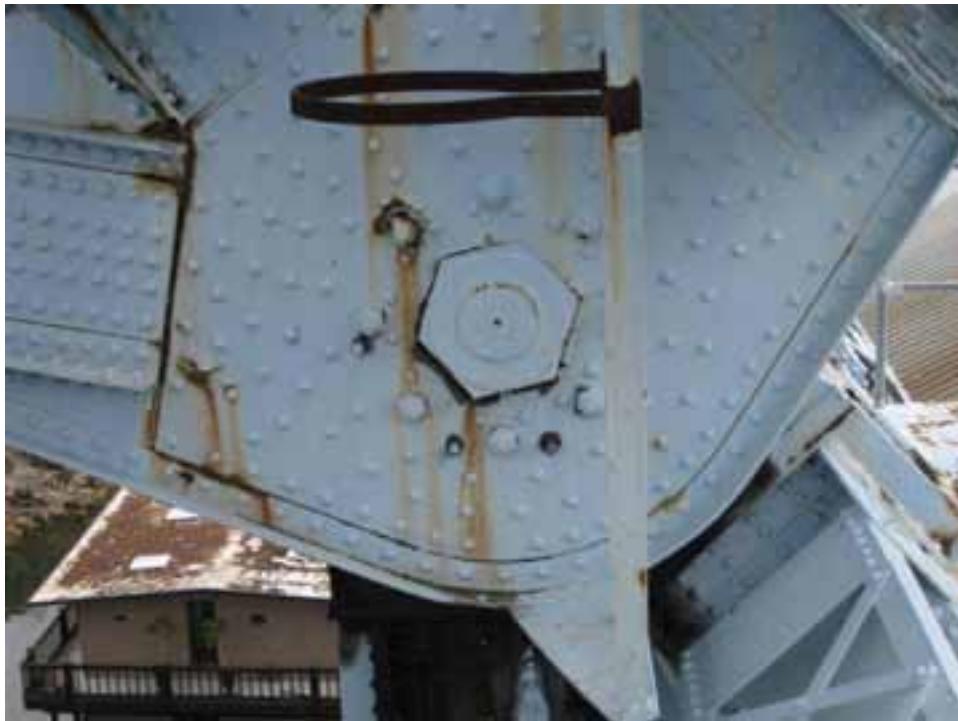
**Photo M-25.** Railroad Bridge, South Counterweight Trunnion. All of the lube piping is capped at this side (south) of the bearing and there is no indication that the caps have been removed recently. Proper maintenance requires removal of the caps to purge old lubricant.

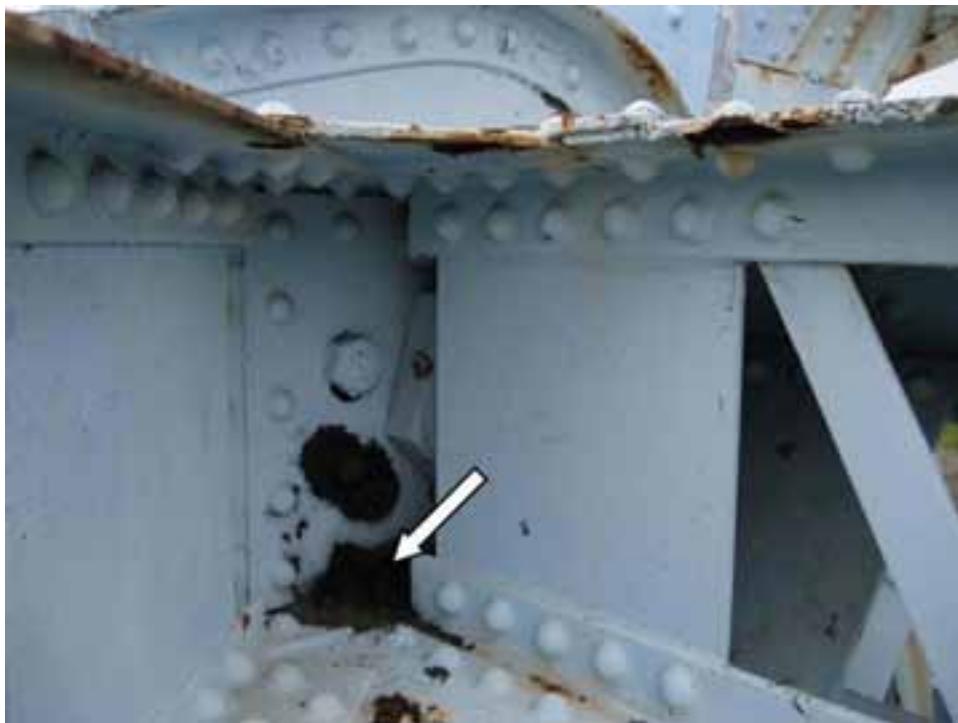
**Photo M-26.** Railroad Bridge, North 2nd Link Pin. The accumulated lubricant (arrow) at the south side of the pin may indicate a loose or failed lube pipe connection.

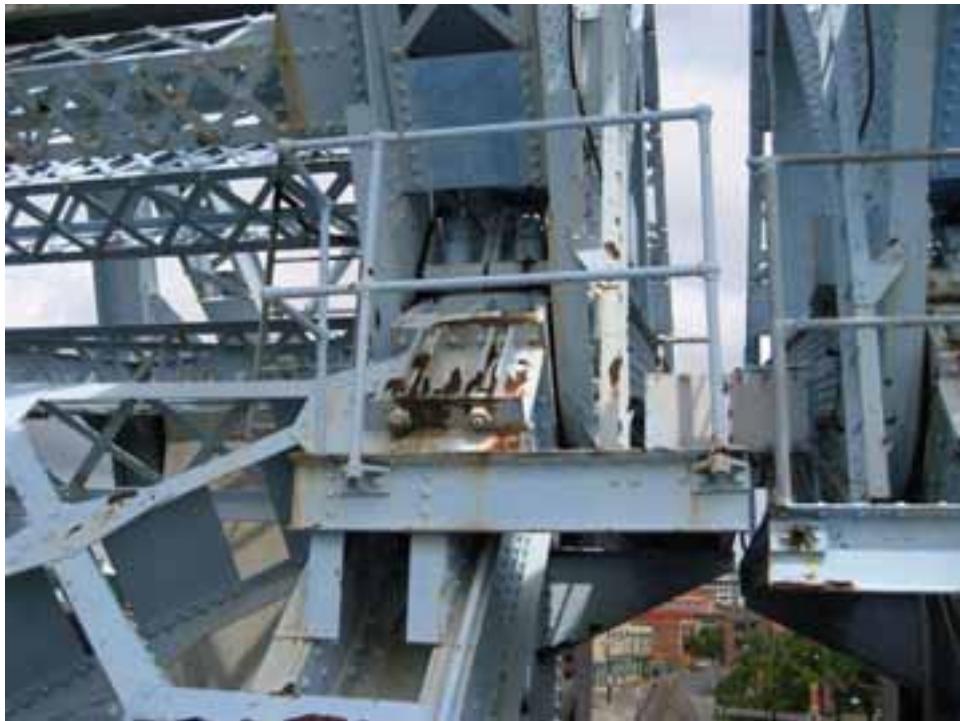
**Photo M-27. Railroad Bridge, South Counterweight Trunnion.** The condition of this trunnion is typical of all the counterweight trunnions. Note the paint deterioration and corrosion.

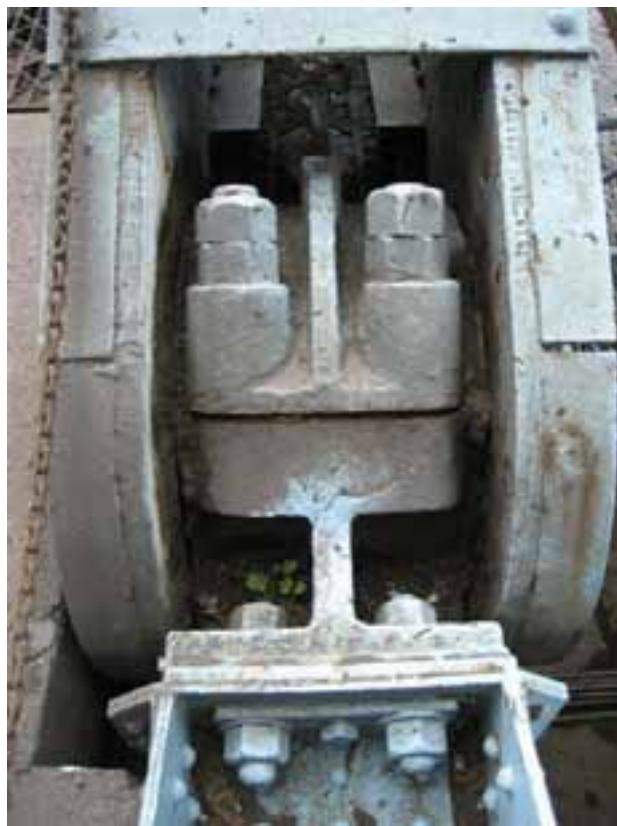
**Photo M-28. Highway Bridge, North Main Trunnion Bearing.** The condition of this trunnion is typical of all the main trunnions. Note the accumulated debris.

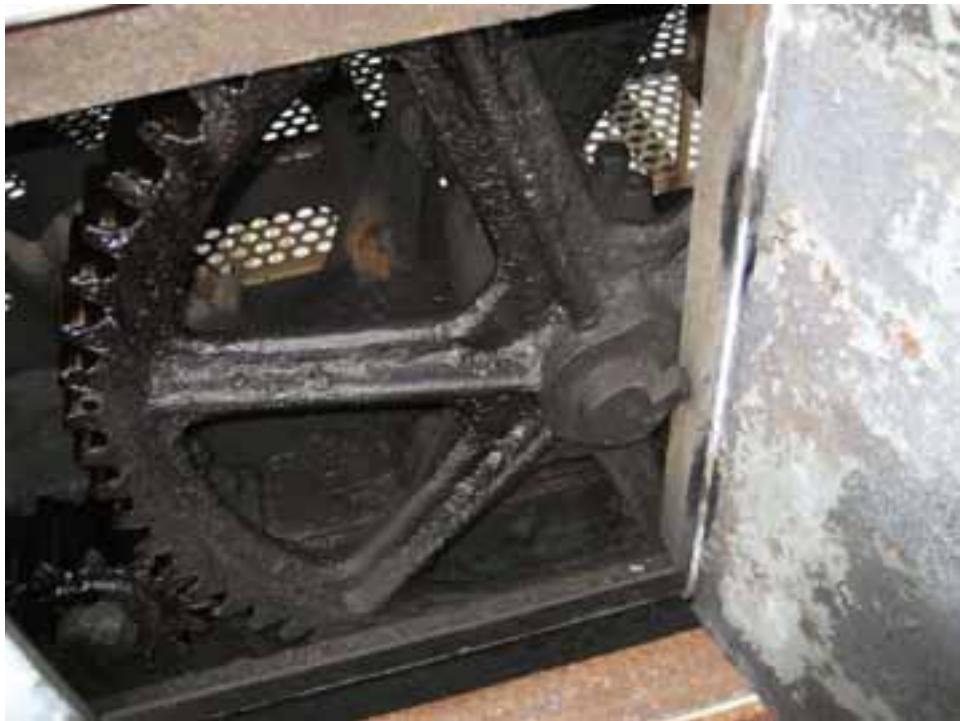
**Photo M-29. Highway Bridge and Railroad Bridge. The key for Gear G1 contacts the machinery enclosure. This photo is of the railroad bridge however the condition exists at both bridges.**

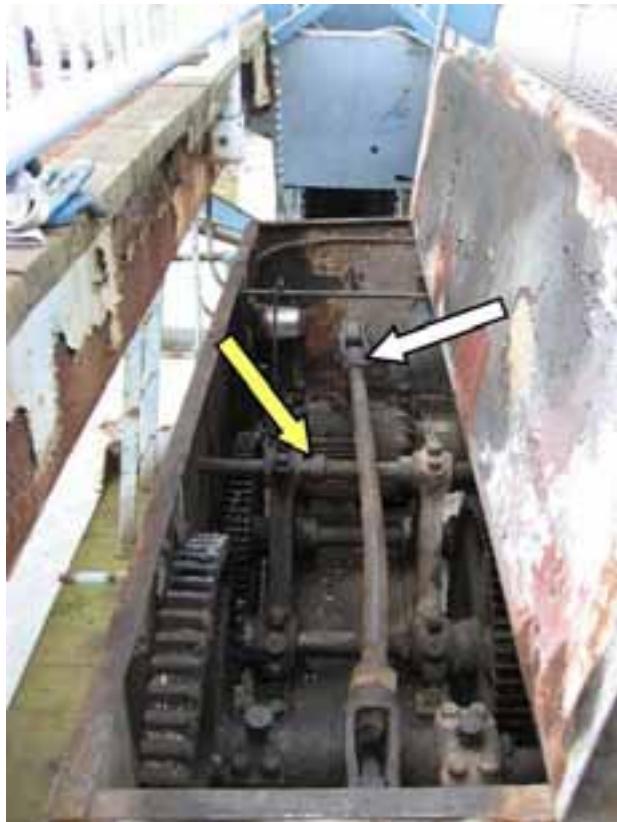
**Photo M-30. Highway Bridge, Span Lock Machinery. The nut for the connecting rod (white arrow) is loose, the connecting rod is bent, the thrust collar (yellow arrow) for the hand crank shaft is not properly position and the enclosure is in poor condition.**

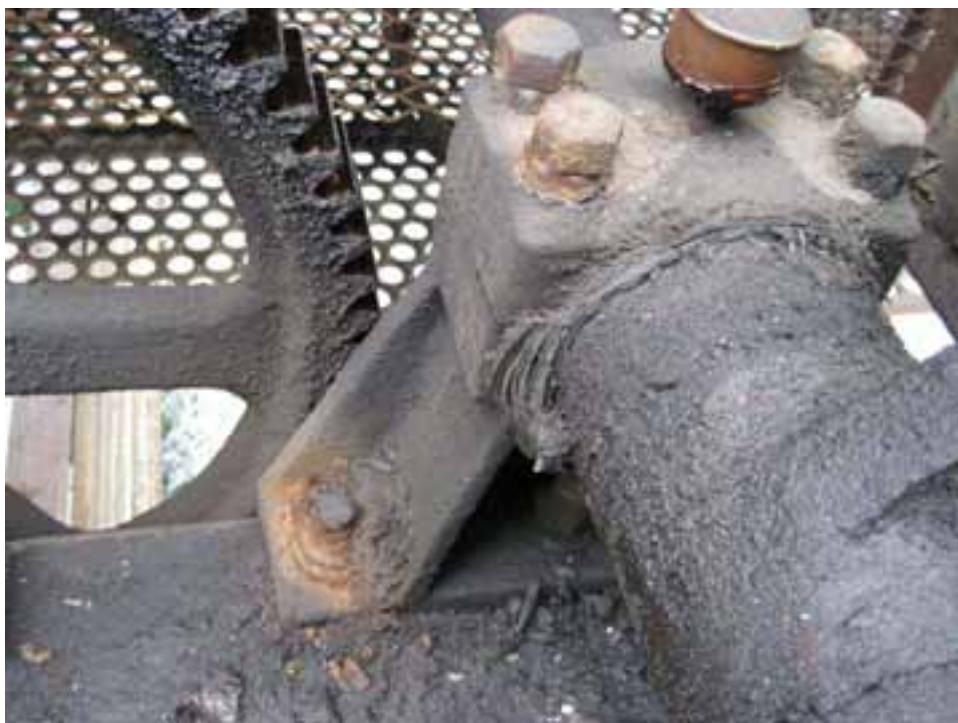
**Photo M-31. Railroad Bridge, Span Lock Machinery Bearing B1. The nut for the bearing bolt has complete section loss due to corrosion.**

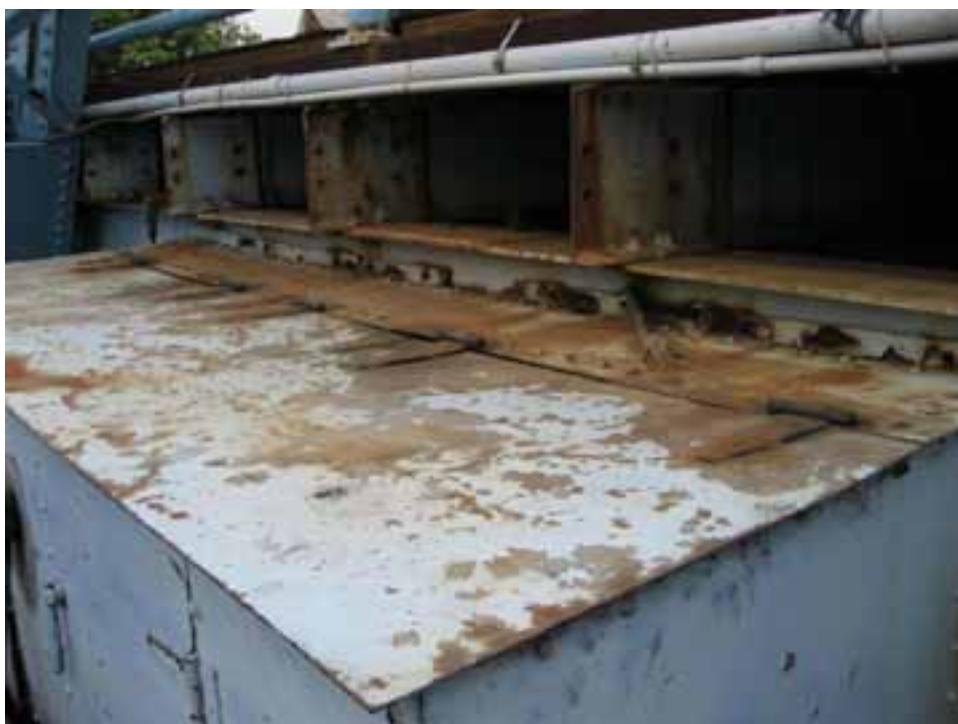
**Photo M-32. Railroad Bridge, Span Lock Machinery Enclosure. The enclosure is in poor condition.**

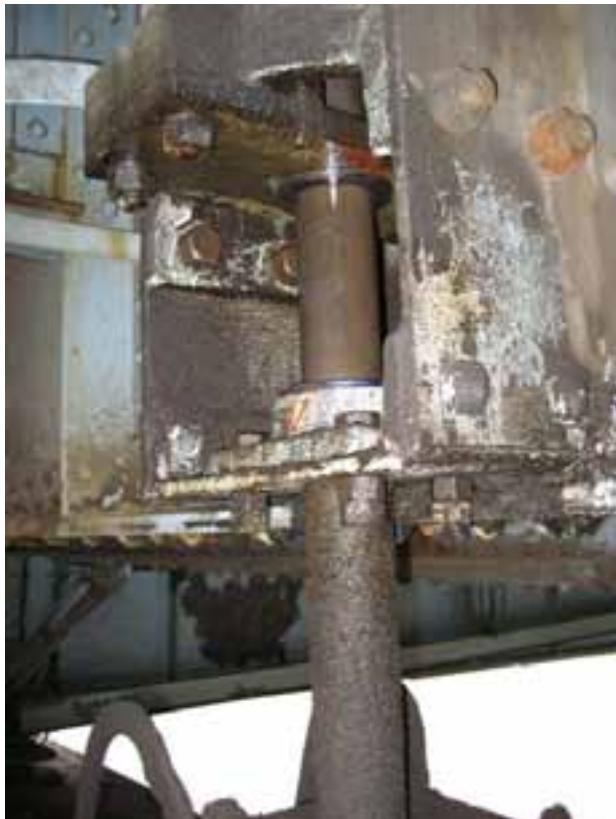
**Photo M-33. Highway Bridge, Air Buffer. The four mounting bolts for the bottom bearing are loose.**

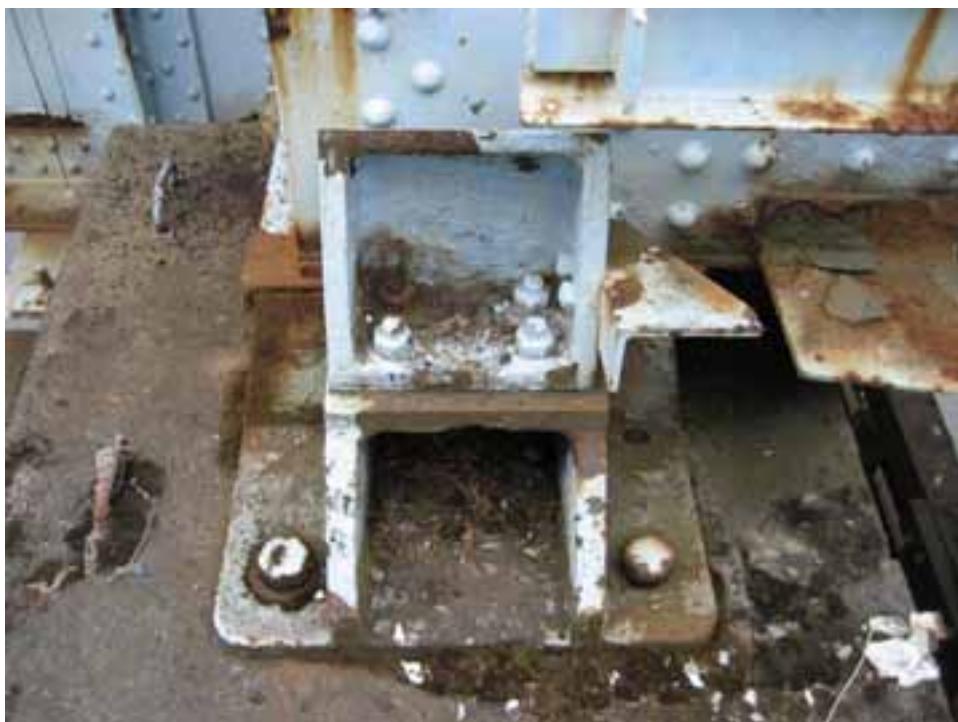
**Photo M-34. Railroad Bridge, South Live Load Support. Three of the four anchor bolts for this support are loose. Note the paint deterioration and corrosion.**

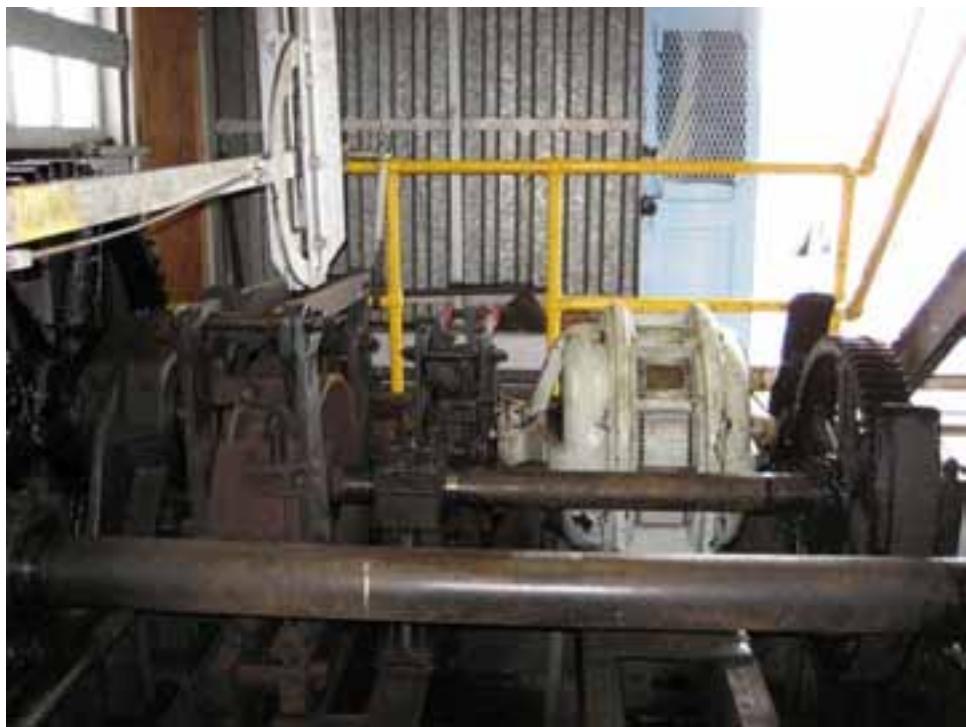
**Photo E1.1.1. Highway Machinery Room. Note difficult accessibility of drive motors.**

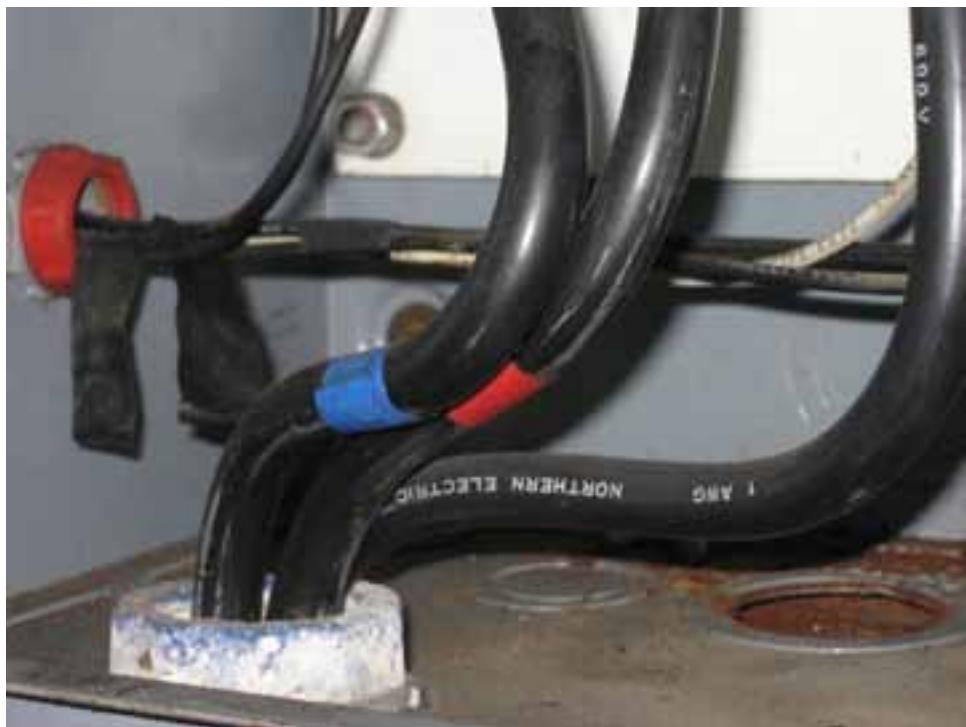
**Photo E1.1.2. Highway South Drive Contactor Panel. Note improper color coding of conductors.**

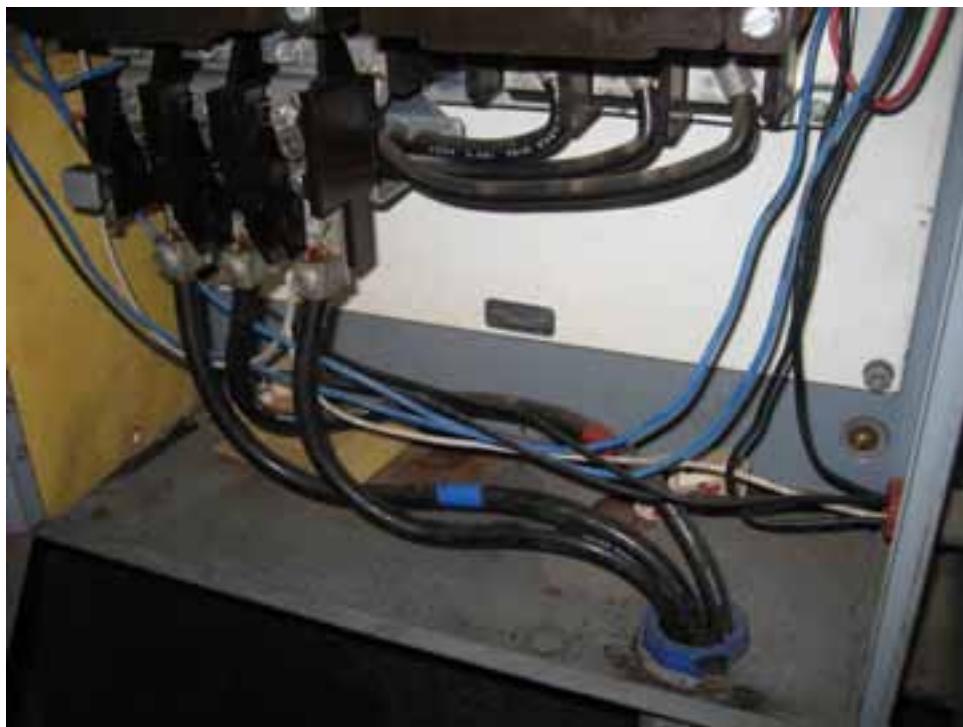
**Photo E3.** Highway North Drive Motor Contactor. Note improper color coding of conductors.

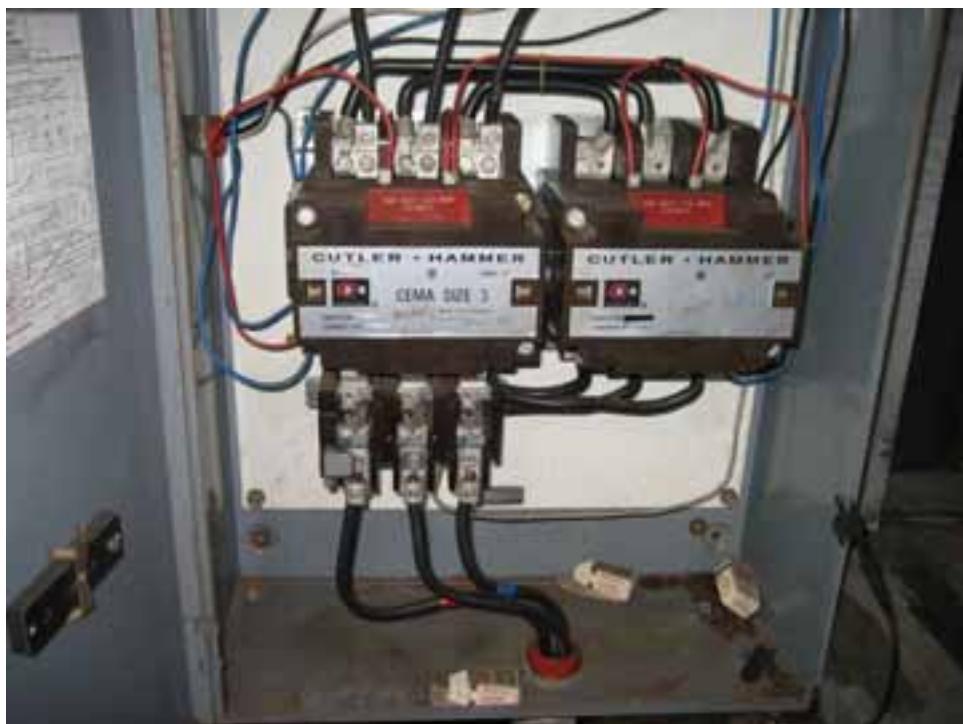
**Photo E4.** Railway South Drive Motor Contactor. Note improper color coding of conductors.

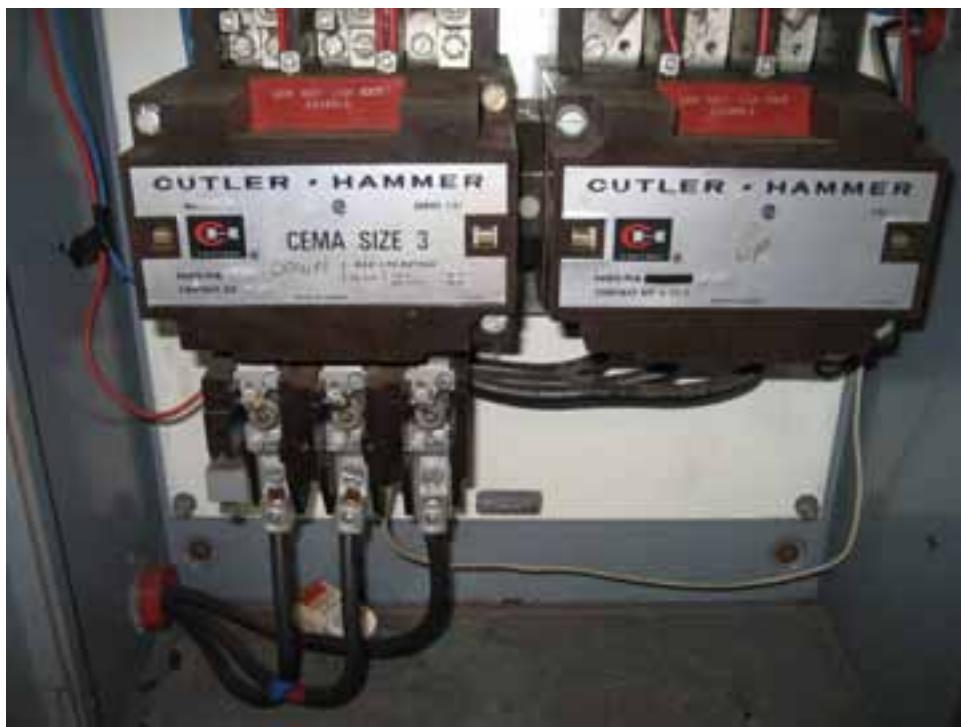
**Photo E5. Railway North Drive Motor Contactor. Note improper color coding of conductors.**

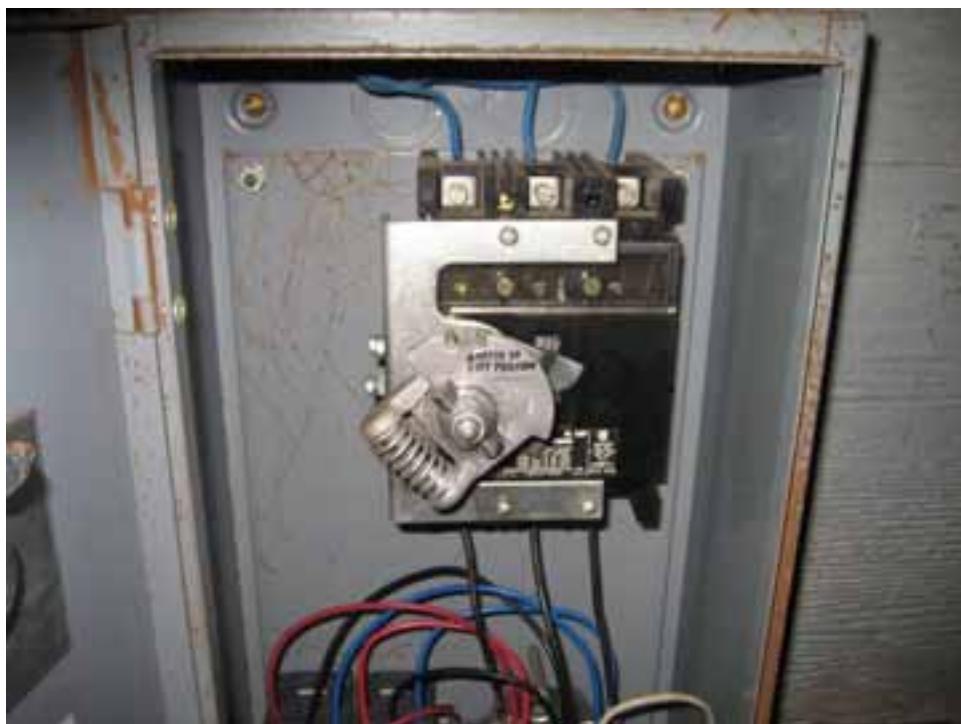
**Photo E6. Typical Motor Brake Enclosures. Note improper color coding of conductors.**

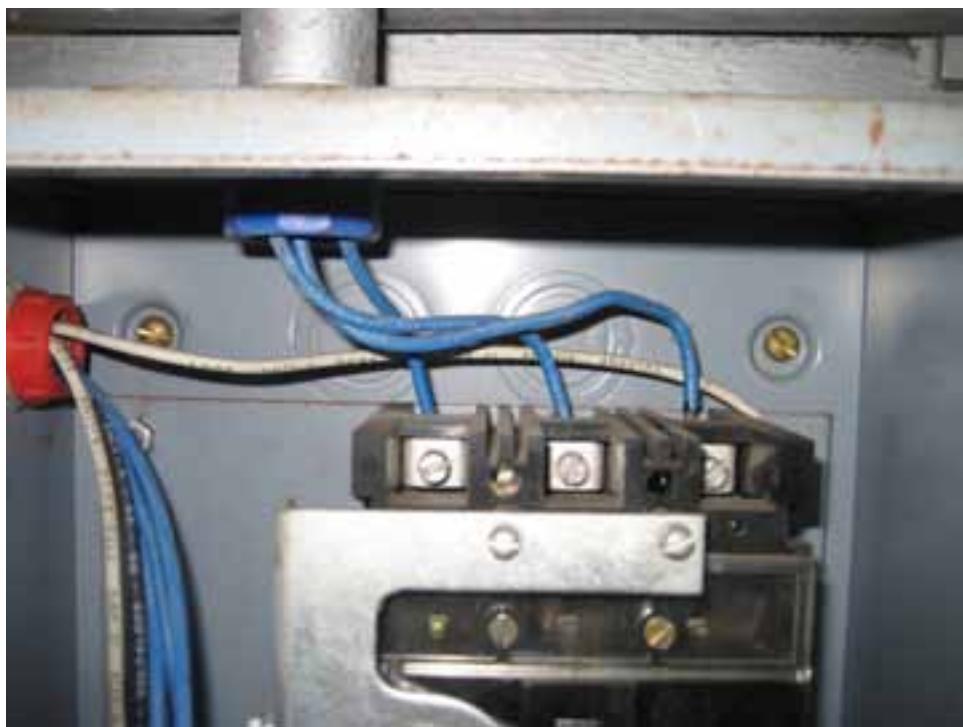
**Photo E7. Typical Emergency Brake Enclosures. Note improper color coding of conductors.**

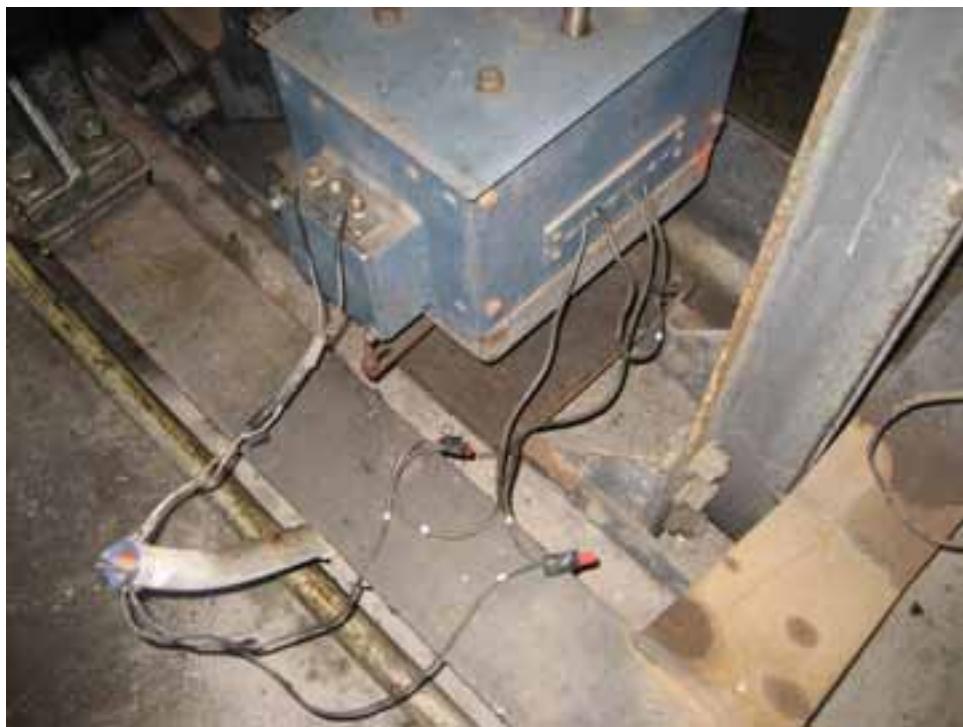
**Photo E8. Typical Emergency Brakes. Note conductors not properly protected from accidental contact.**

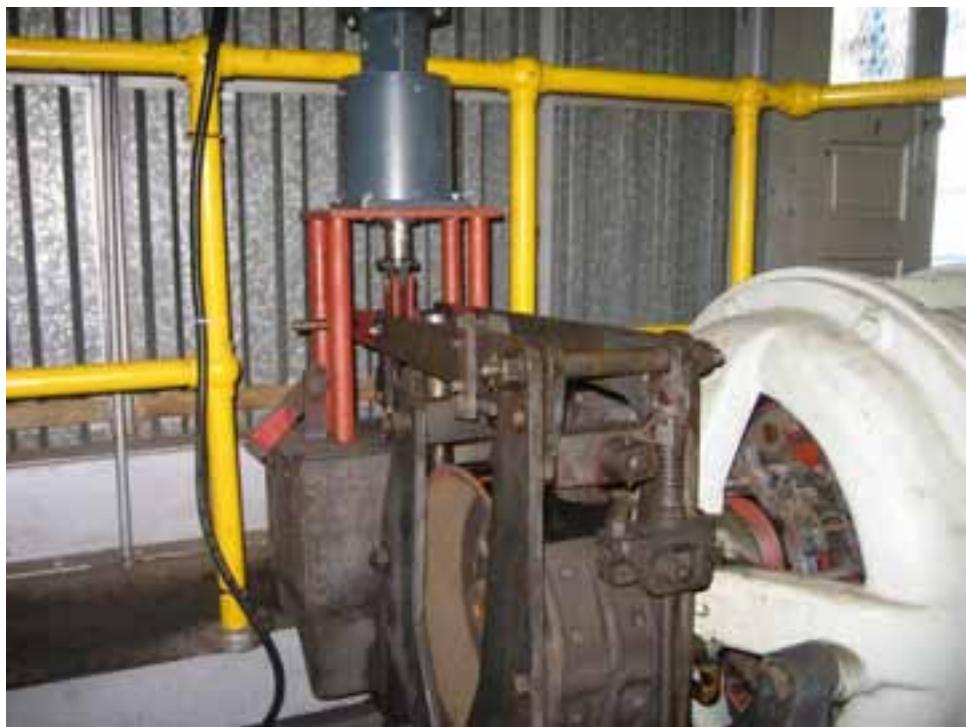
**Photo E9. Typical Highway Brakes. Note brakes are not equipped with position limit switches.**
