# Johnson Street Bridge Condition Assessment Report

**Delcan**

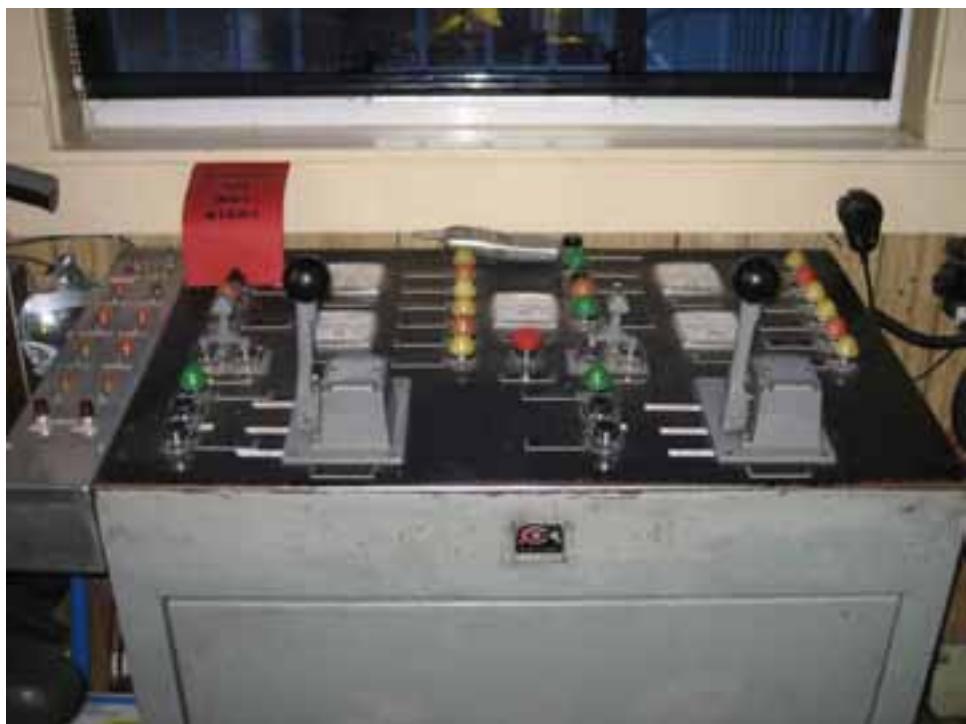
**Photo E10. Control Desk. Note age of equipment and indicators.**

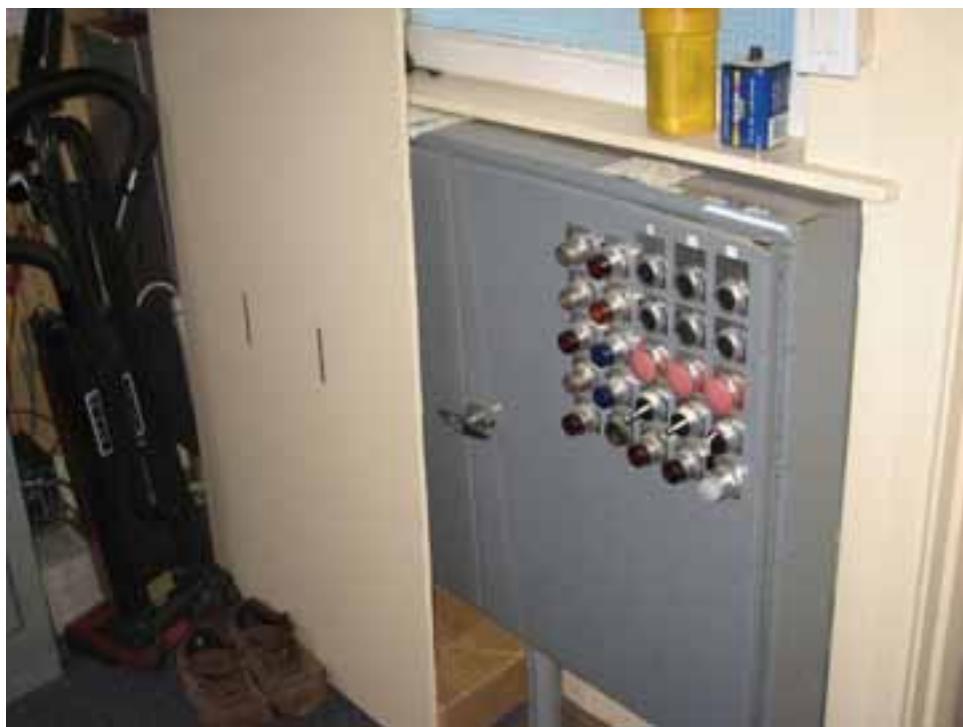
**Photo E11. Wall Mounted Control Panel. Note indicators, buttons, and switches.**

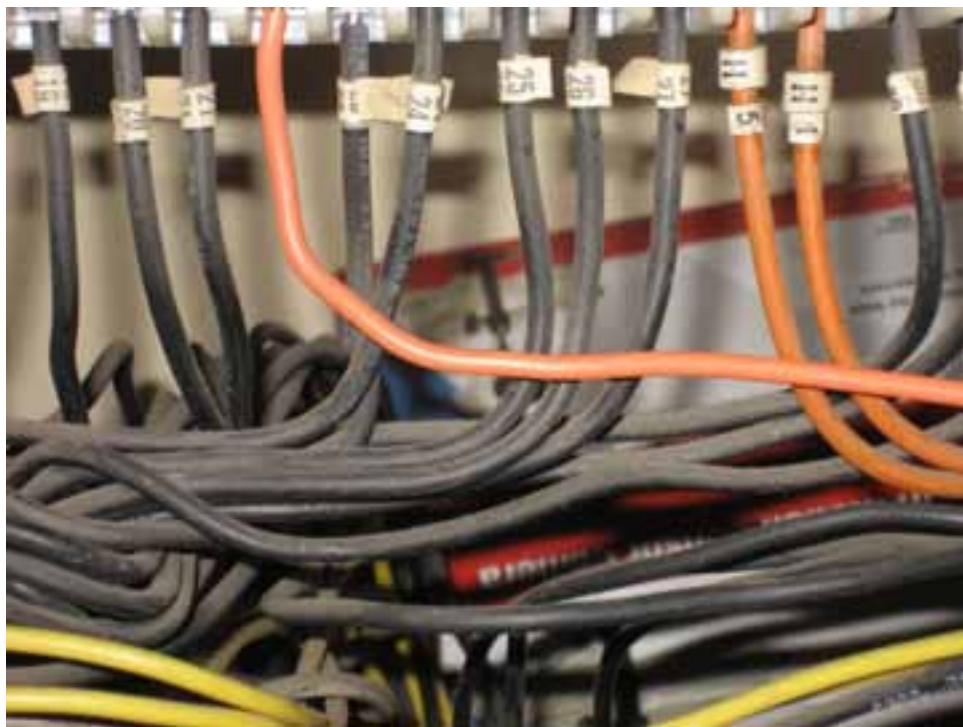
**Photo E12. Control Desk. Note flammable materials stored in control desk housing.**

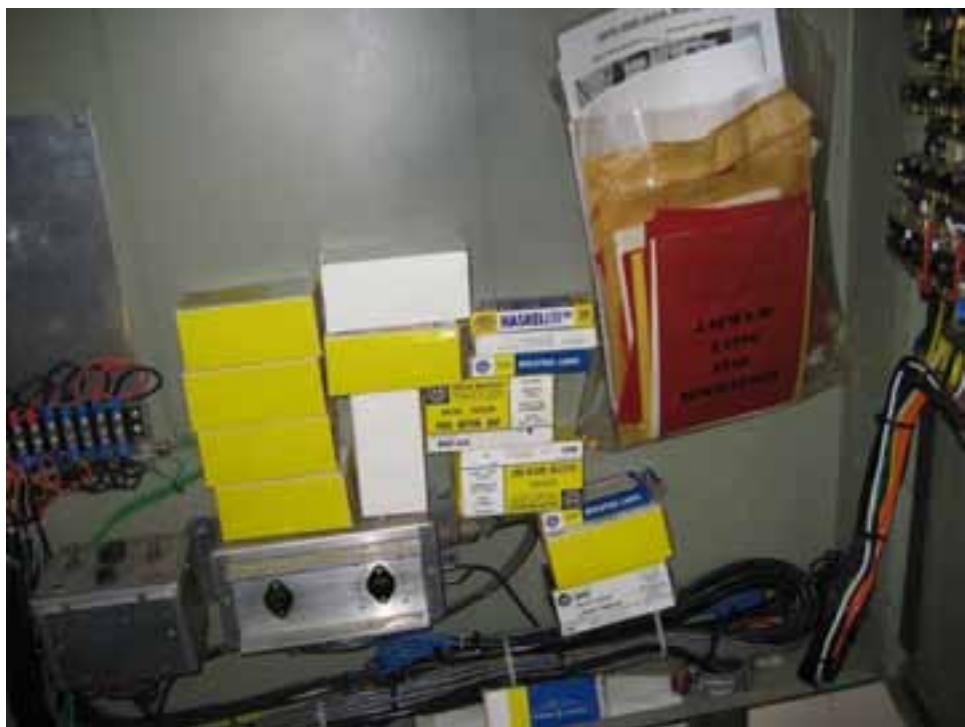
**Photo E13. Wall Mounted Control Panel. Note flammable materials being stored in and on equipment inside enclosure.**

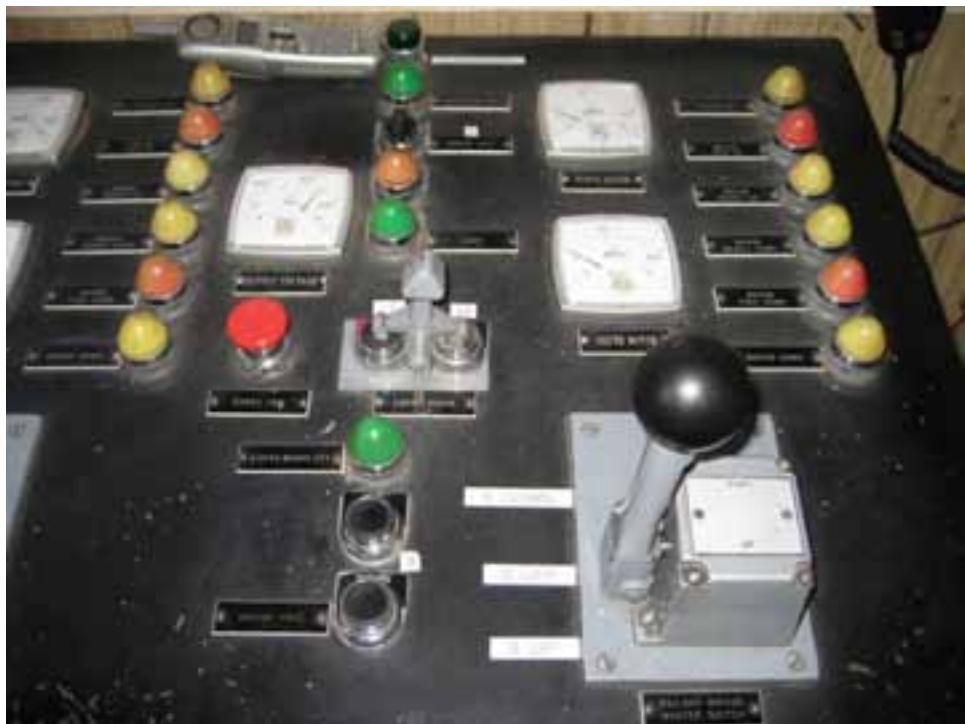
**Photo E14. Control Desk. Note drum control switch used for span operation of bridge.**

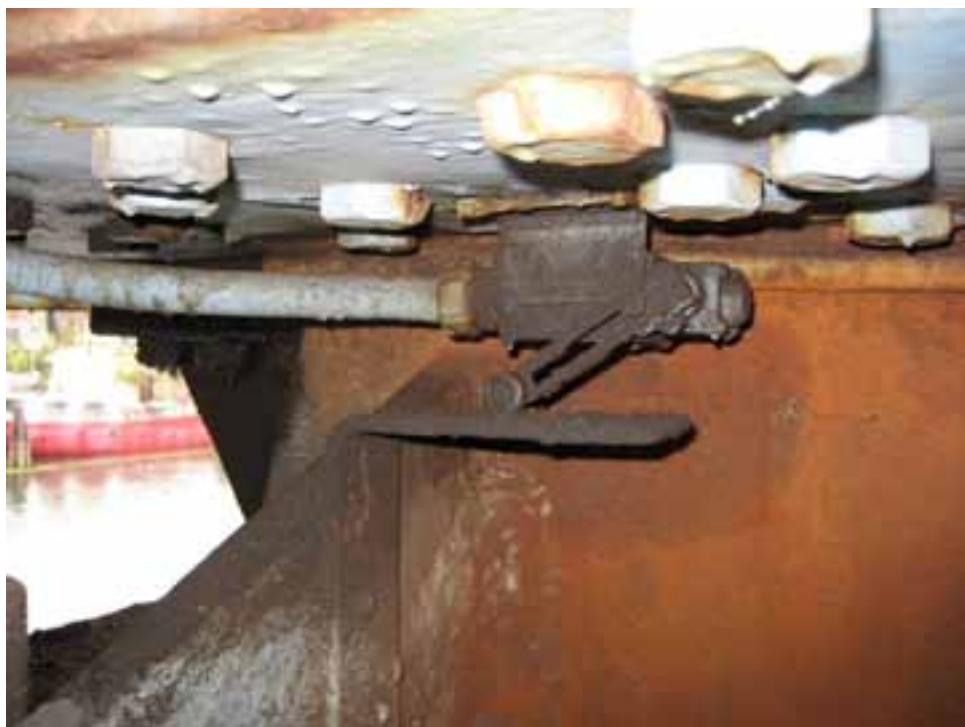
**Photo E15.** Typical Span Position Limit Switch. Note the fair to poor condition of the limit switch.

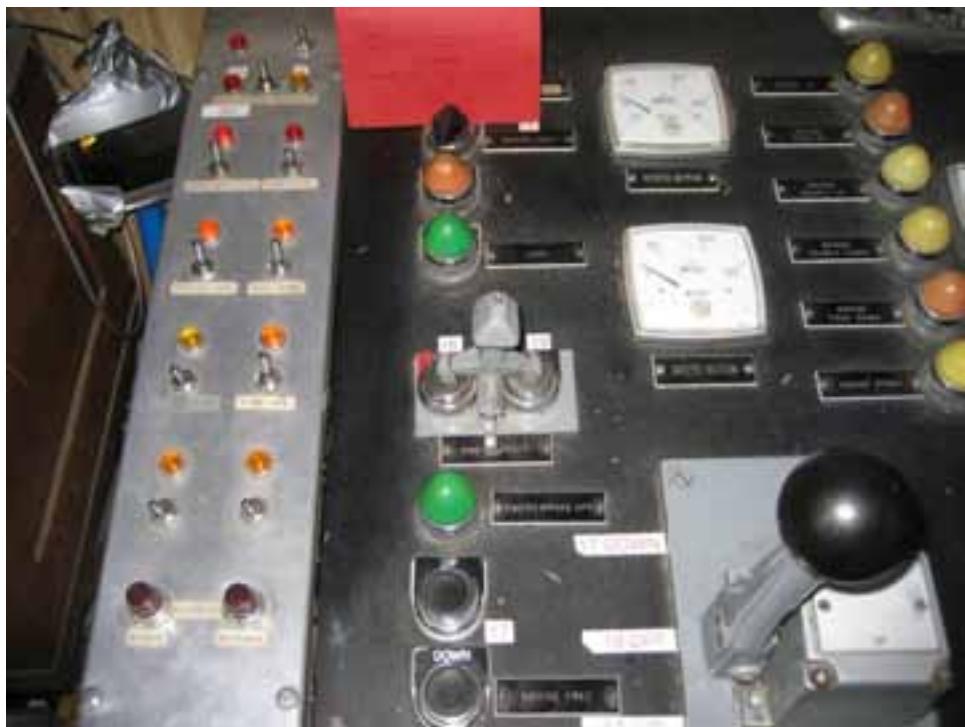
**Photo E16.** Control Desk. Note age and condition of span lock indicators.

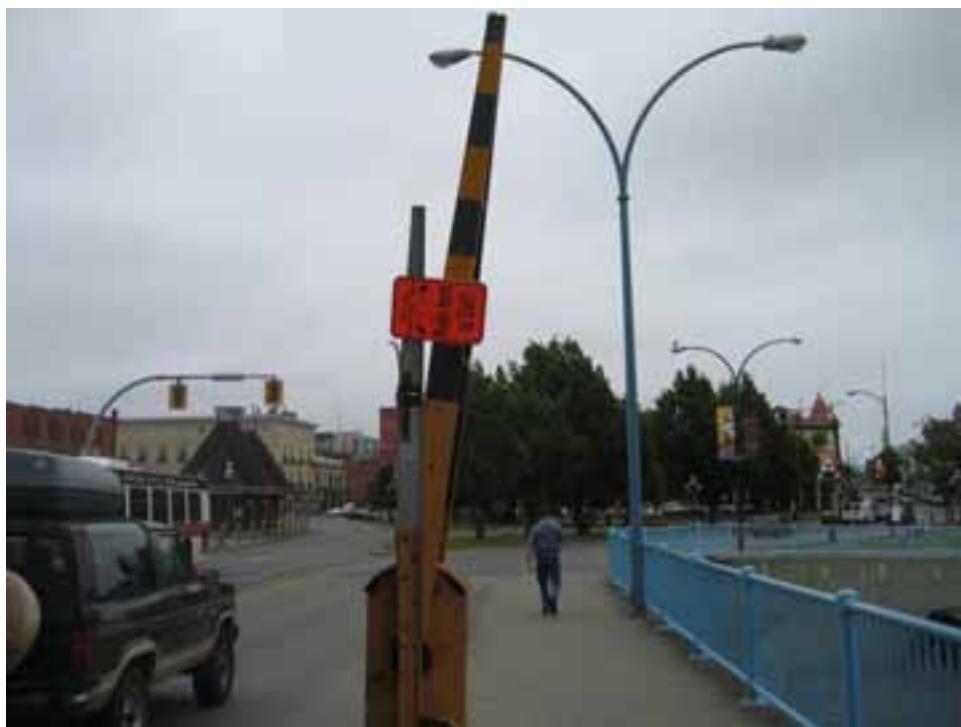
**Photo E17. Southeast Traffic Gate. Note traffic gate arm does not set at 90 degrees vertical.**

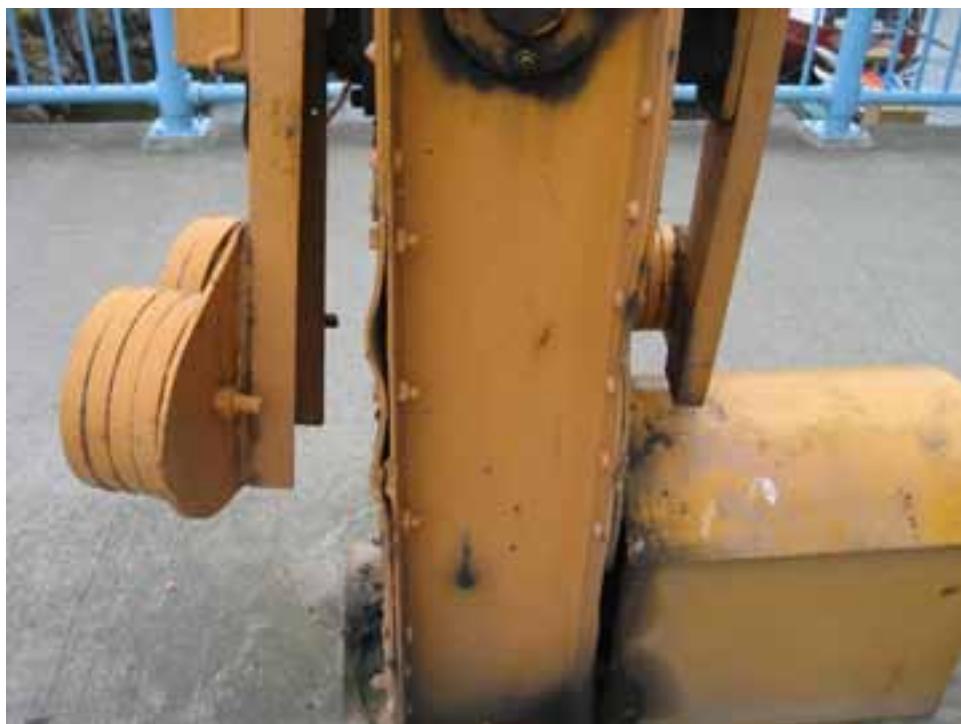
**Photo E18. Southeast Traffic/Pedestrian Gate. Note damage of both gate housing and arm.**

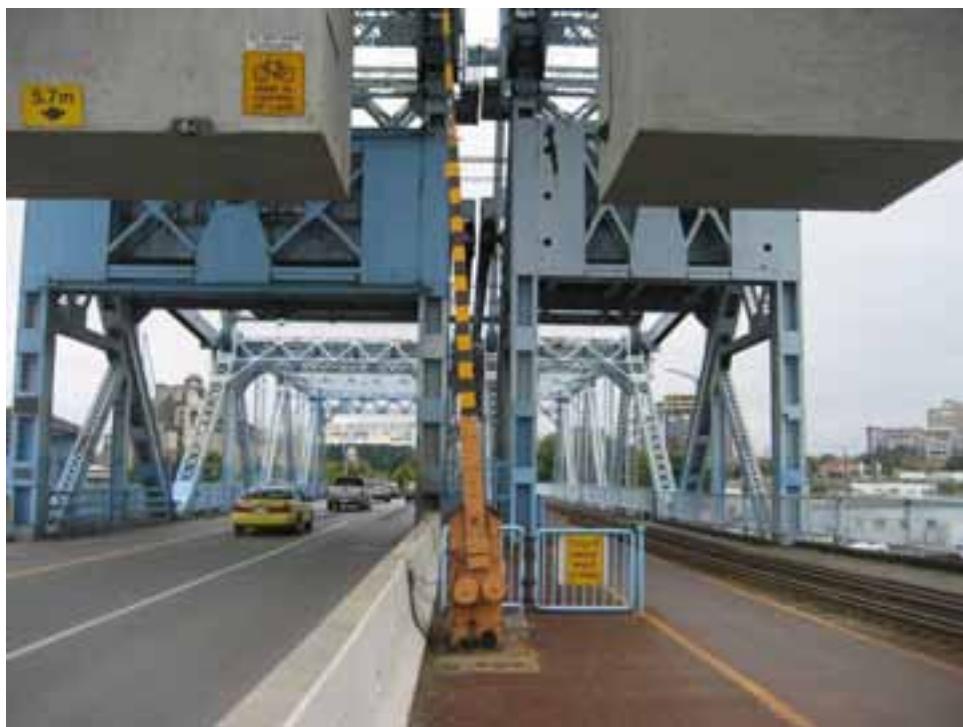
**Photo E19. Northeast Traffic Gate.** Note traffic gate arm does not set 90 degrees vertical.

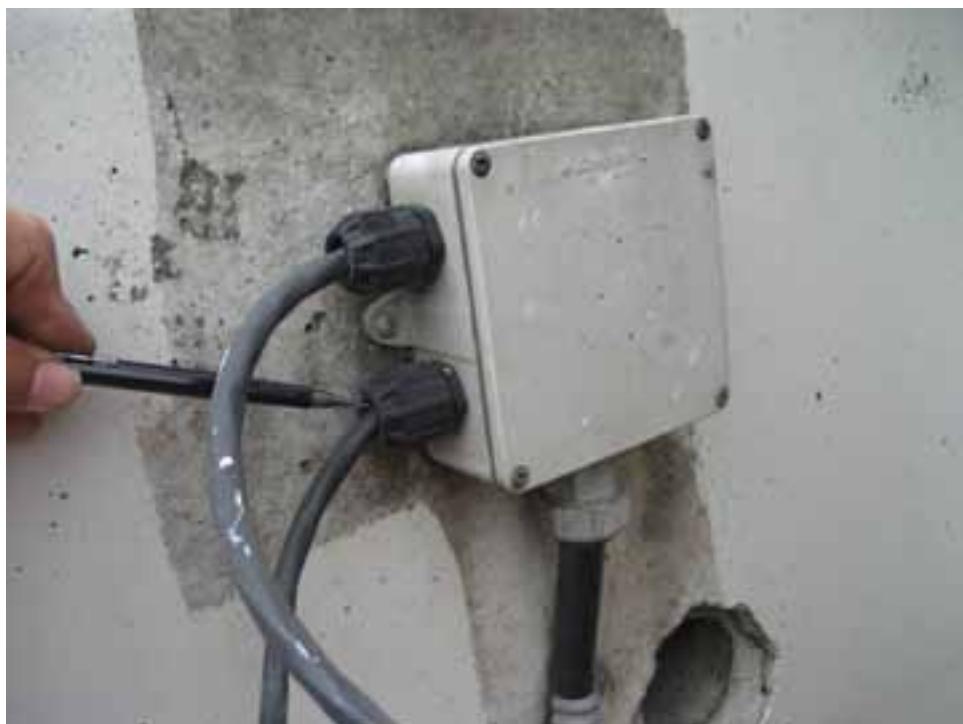
**Photo E20. Conduit Box.** Note the water-tight connection is damaged.

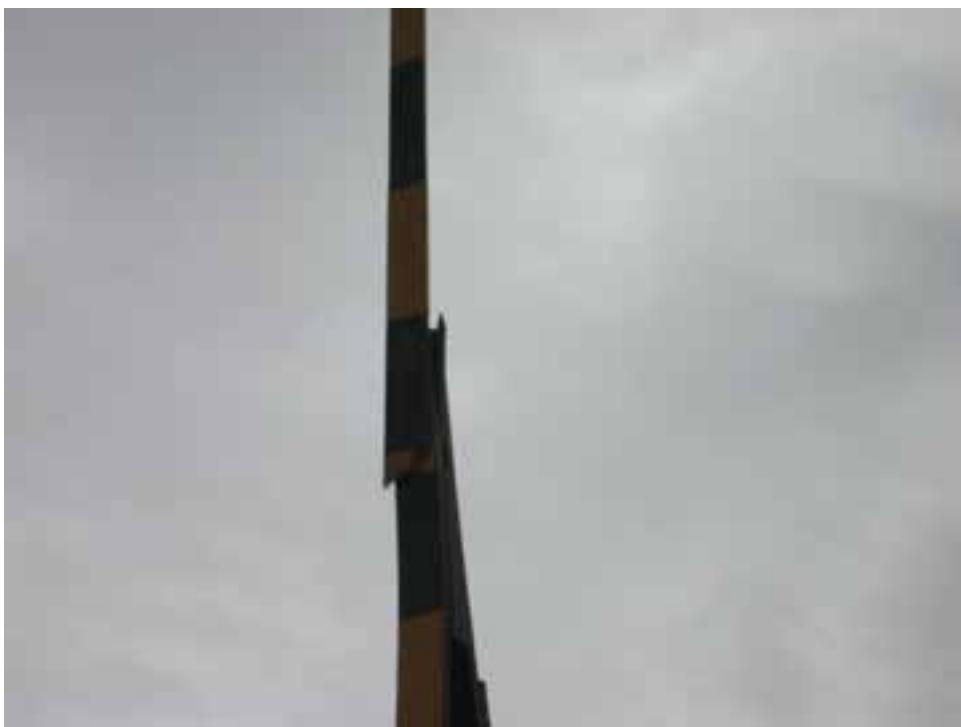
**Photo E21. Northwest Traffic Gate. Note damaged traffic gate arm.**

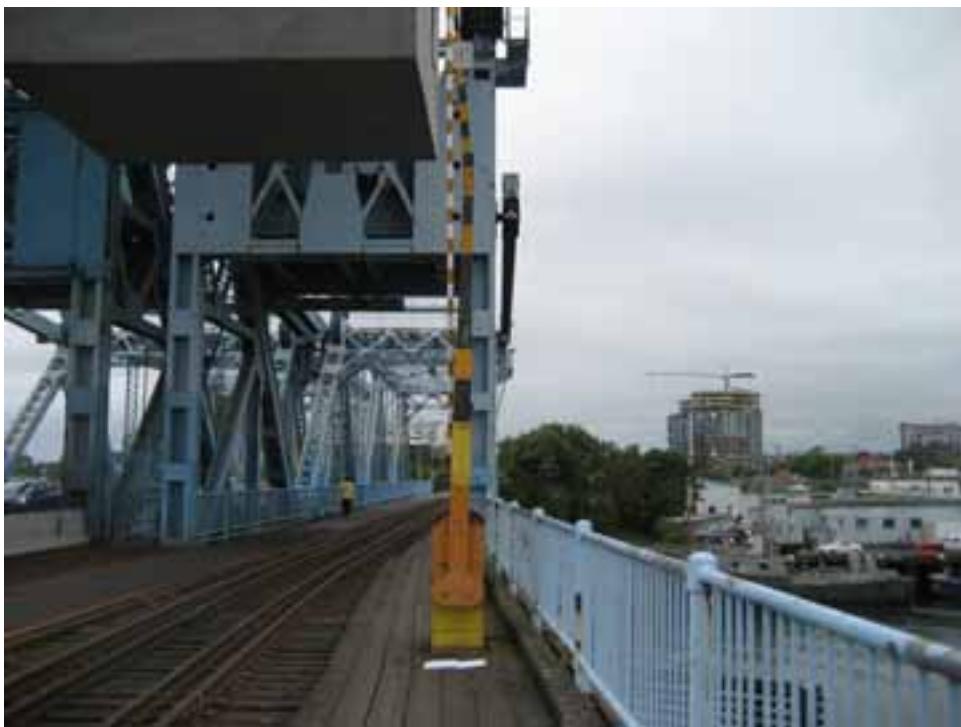
**Photo E22. Northeast Railway Pedestrian Gate. Note the northeast railway pedestrian gate is over 90 degrees.**

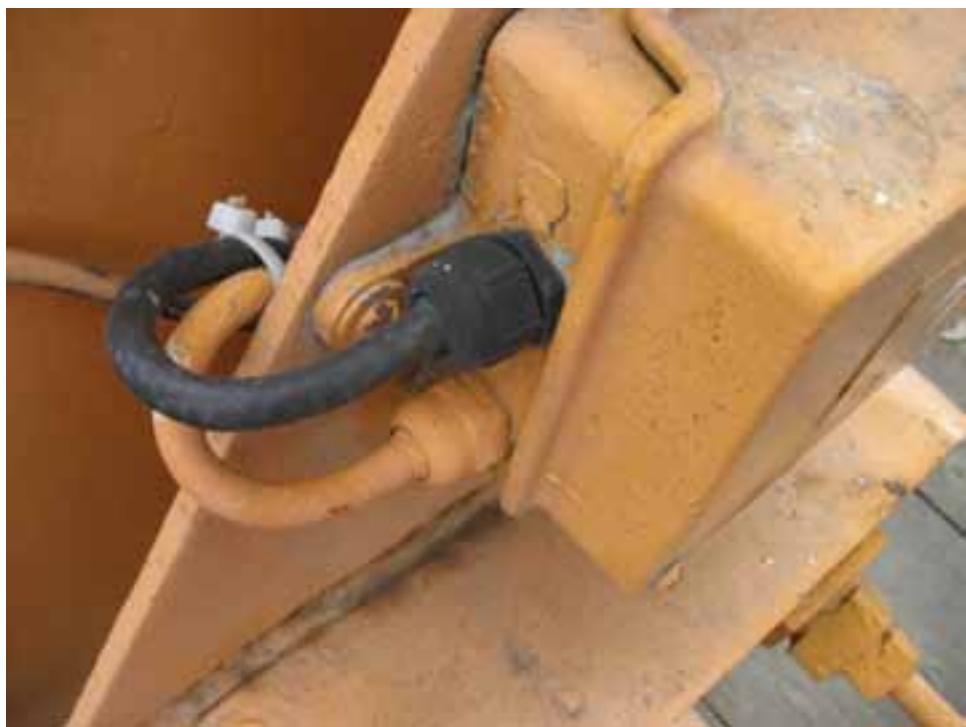
**Photo E23. Northwest Railway Gate. Note the water-tight fitting for the SO cord is cracked.**

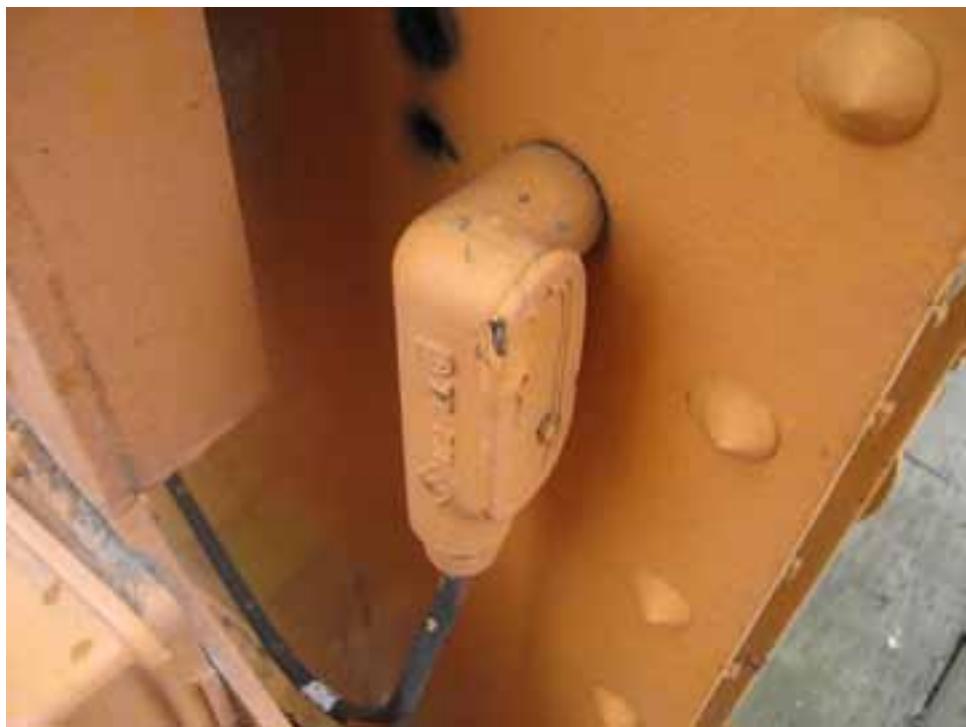
**Photo E24. Northeast Railway Gate. Note the water-tight seal for the conduit "LB" is damaged.**

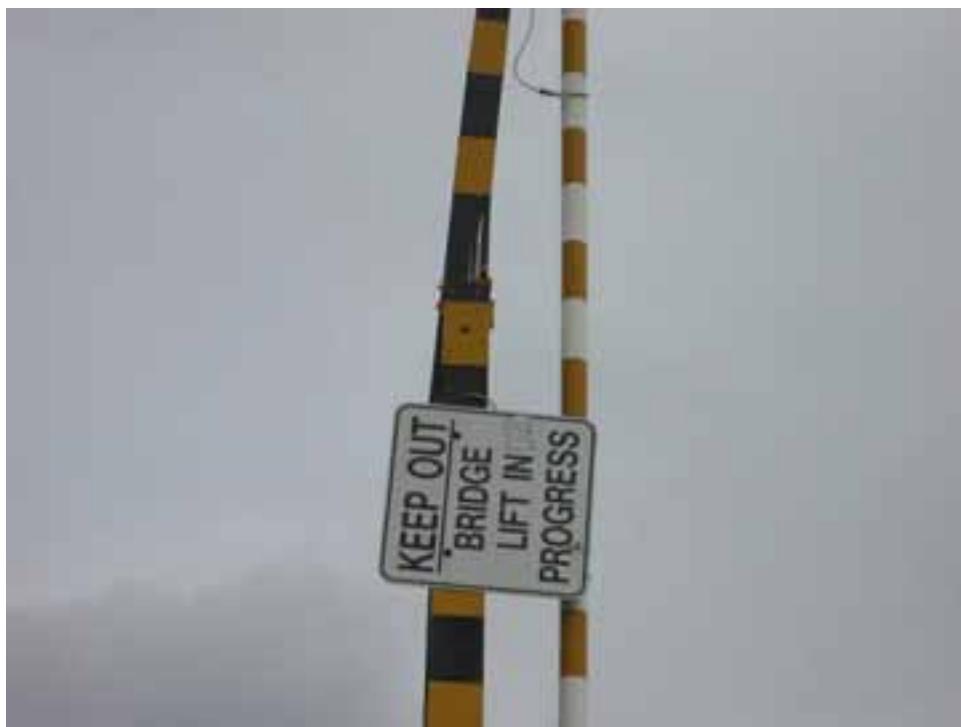
**Photo E25.** Northwest Railway Gate. Note the gate arm shows evidence of being damaged.

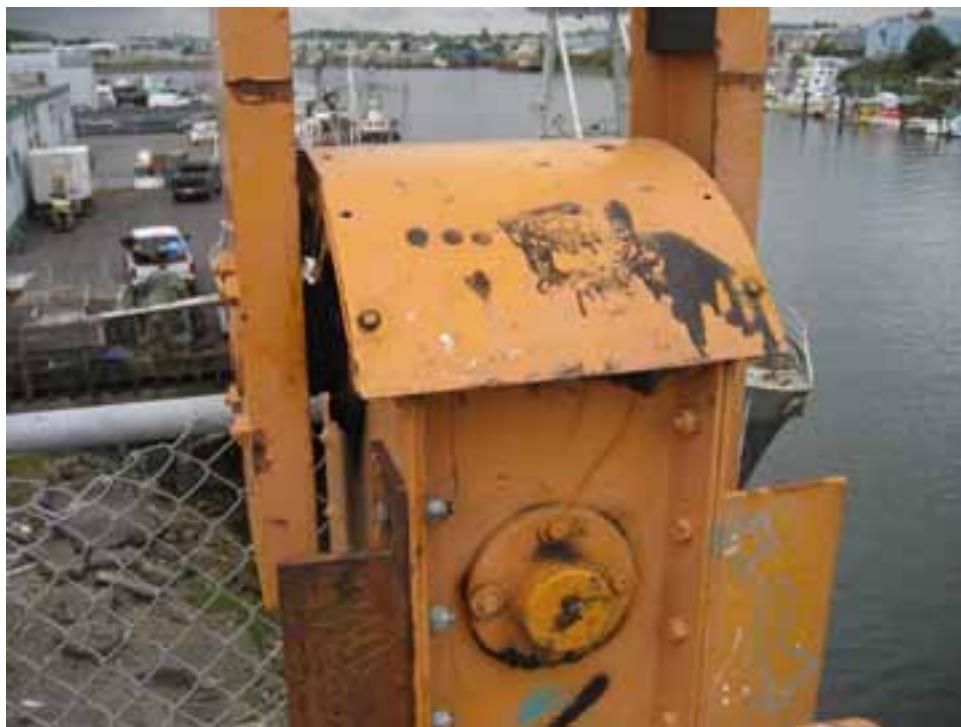
**Photo E26.** Northwest Railway Gate. Note minor surface corrosion on gate housing.

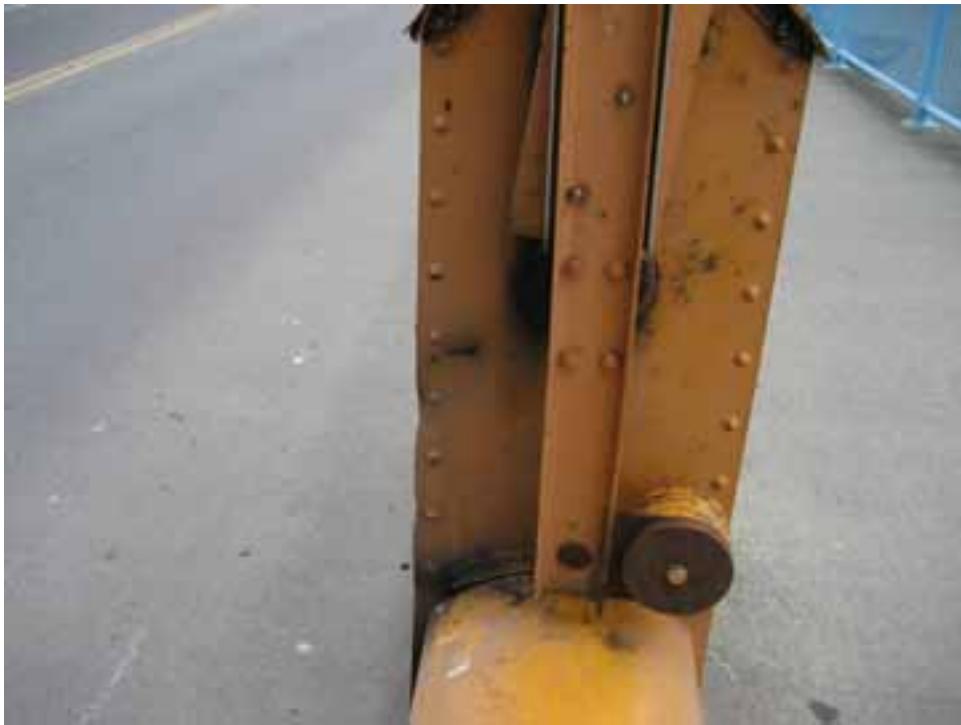
**Photo E27. Southeast Traffic Gate. Note housing for the gate motor is not secured. Non-qualified personnel can access the electrical and mechanical equipment.**

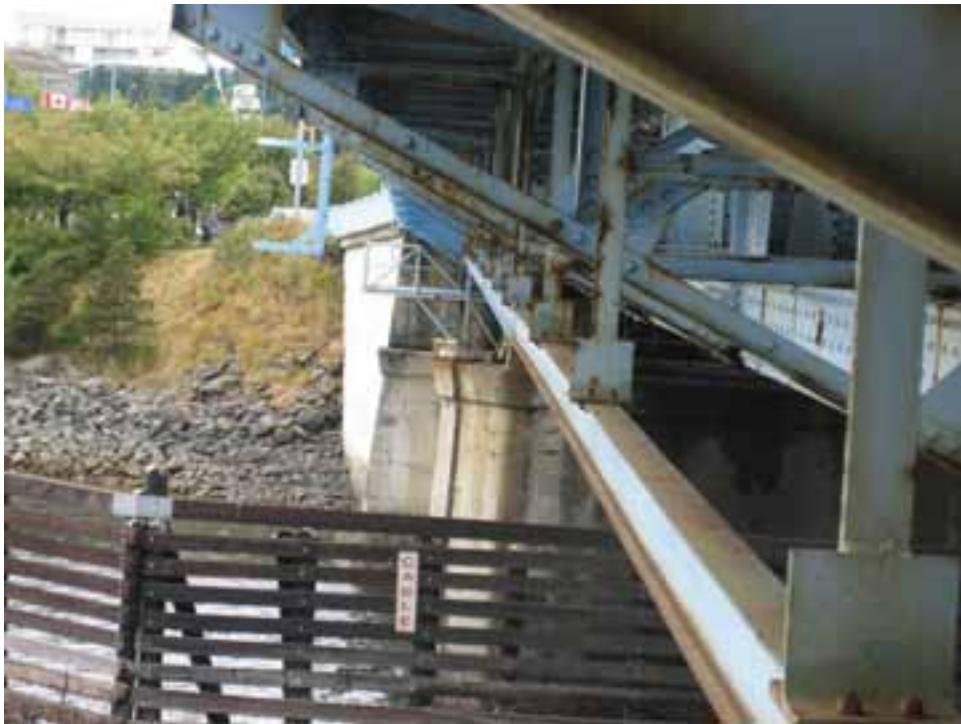
**Photo E28. Far Side Submarine Cable Junction Box. Note the location of the junction box that the two submarine cables enter.**

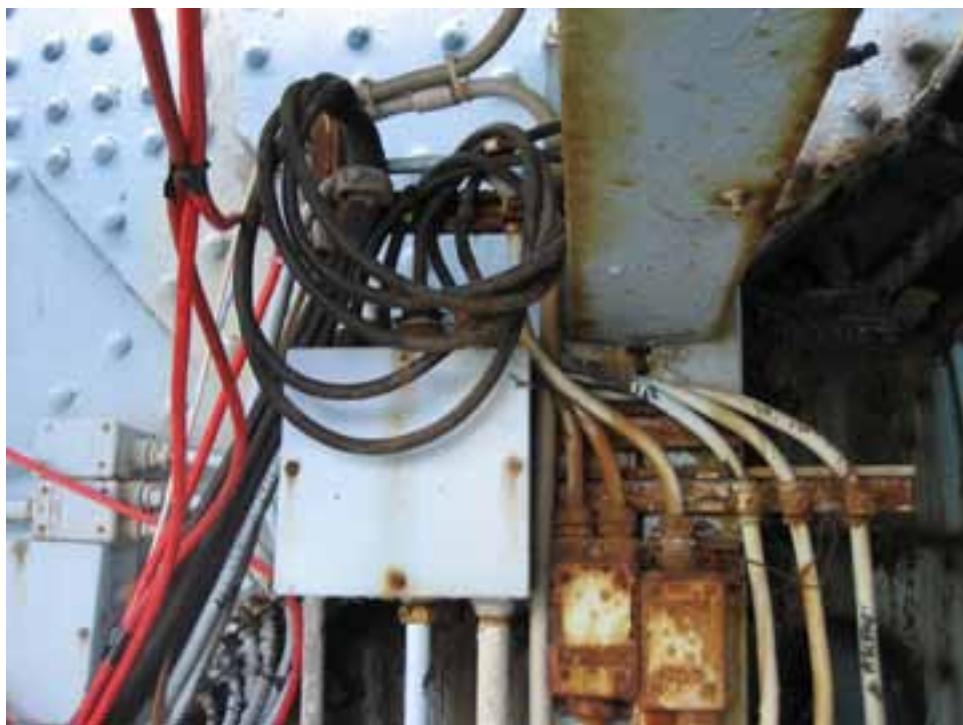
**Photo E29. Typical Bascule Span SO Cables. Note the poor condition of both the SO cables and their associated junction boxes.**

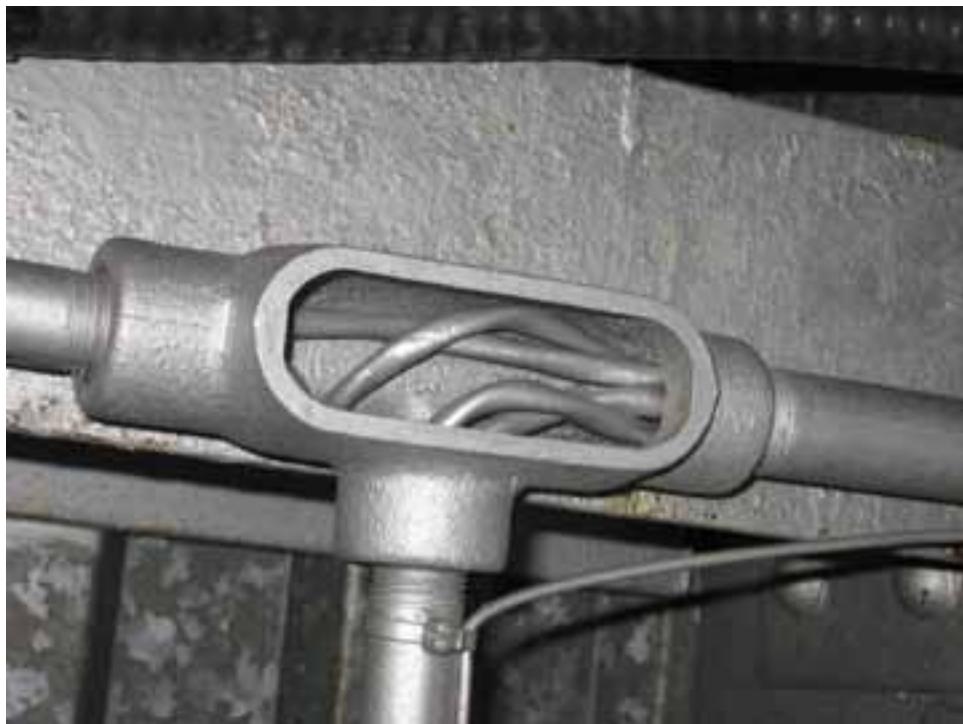
**Photo E30. Highway Machinery Room. Note missing cover for the conduit tee body.**

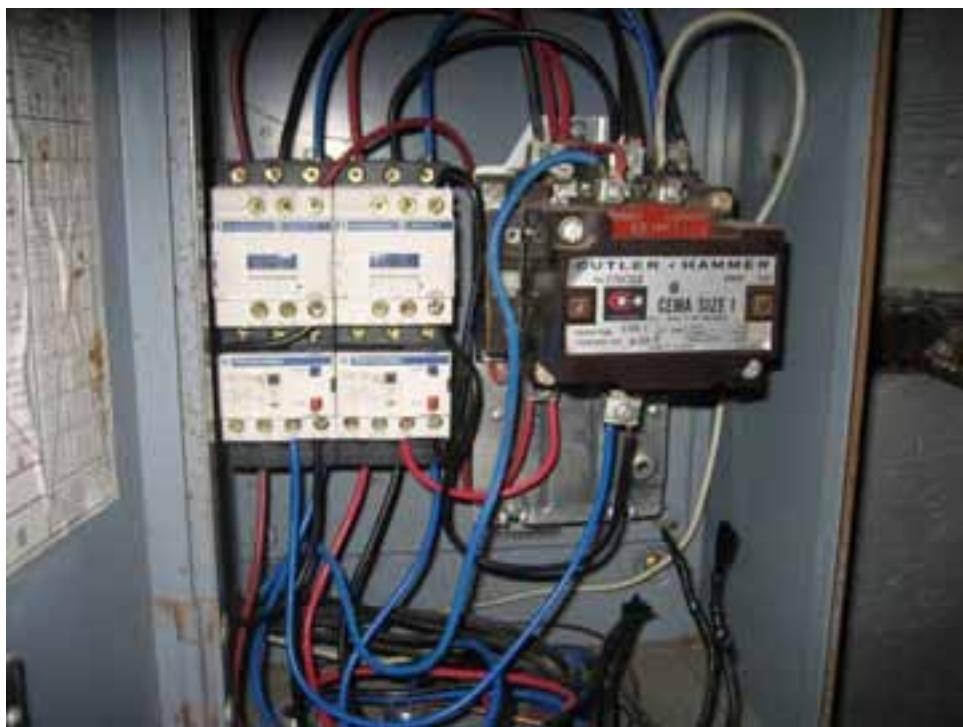
**Photo E31. Highway Machinery Room. Note the use of solid conductors in the distribution equipment for power circuits.**

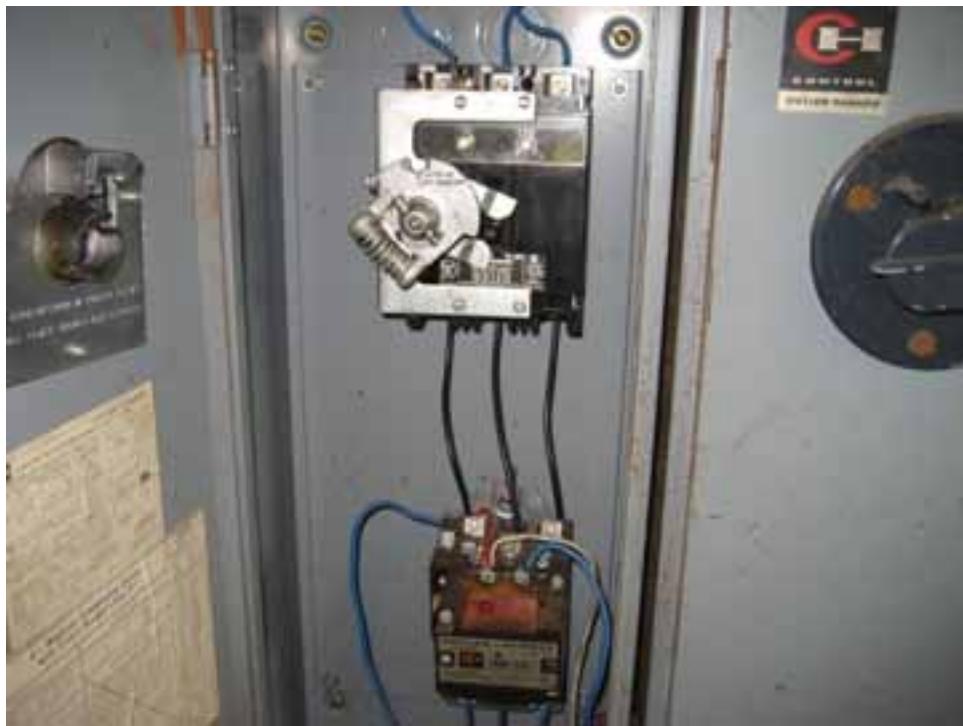
**Photo E32. Railway Machinery Room. Note the use of solid conductors in the distribution equipment for power circuits**

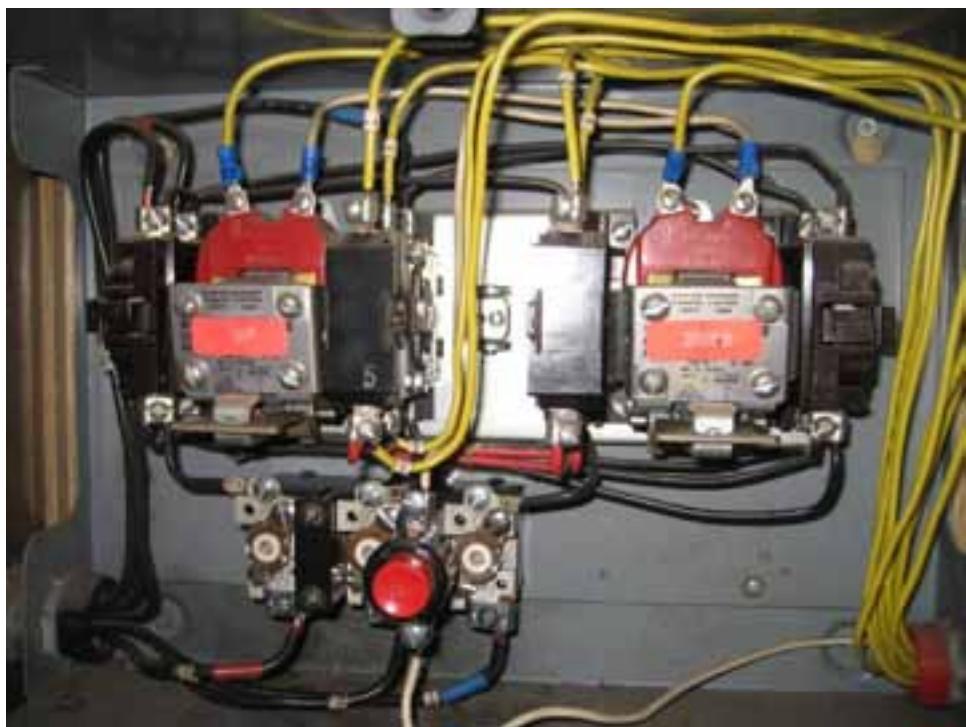
**Photo E33. Control House. Note the use of solid conductors in the distribution equipment for power circuits.**

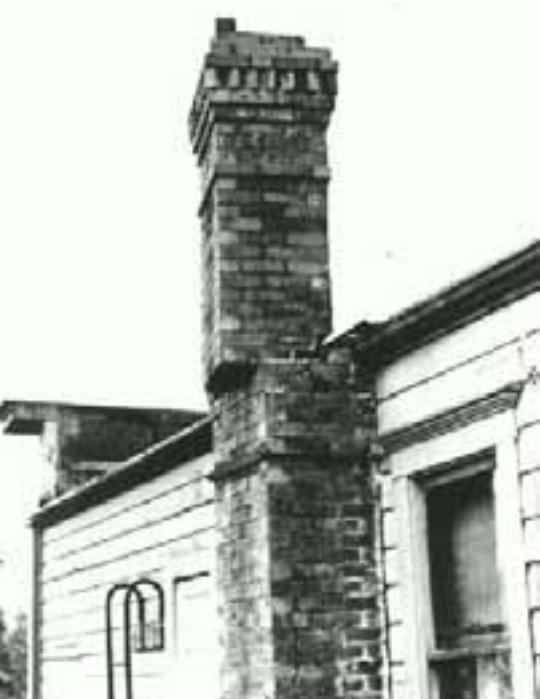
**Port Alberni B.C – Chimney Rotation**

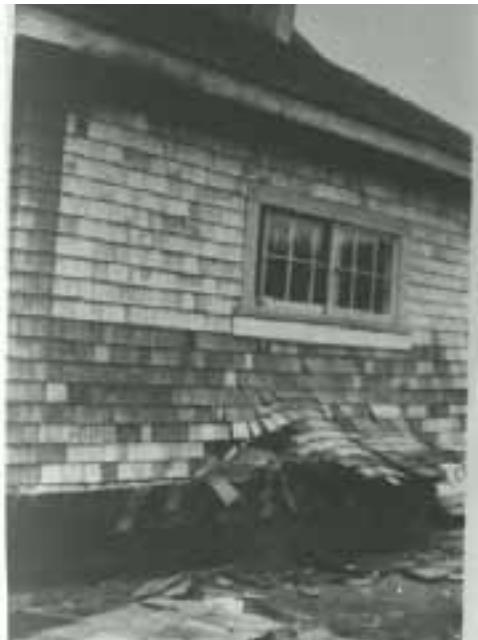
**Comox B.C – House Foundation Failure**

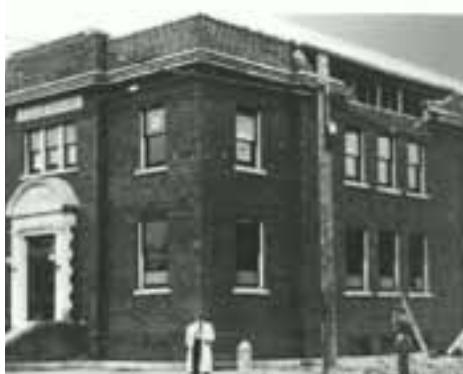
**Courtenay B.C – Masonry Failure**

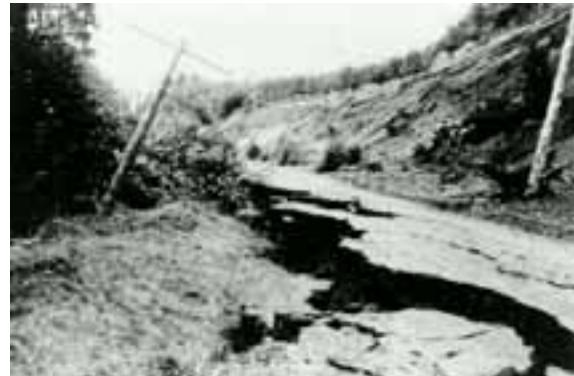
**North of Campbell River B.C  
Soil Failure on the Kelsey Bay Highway**
