# **SDAR Field Rehabilitation Project**

**SDARA & Persatuan Alumni SDAR LIONS ("PASL")**

**Report Date: 5 July 2025**

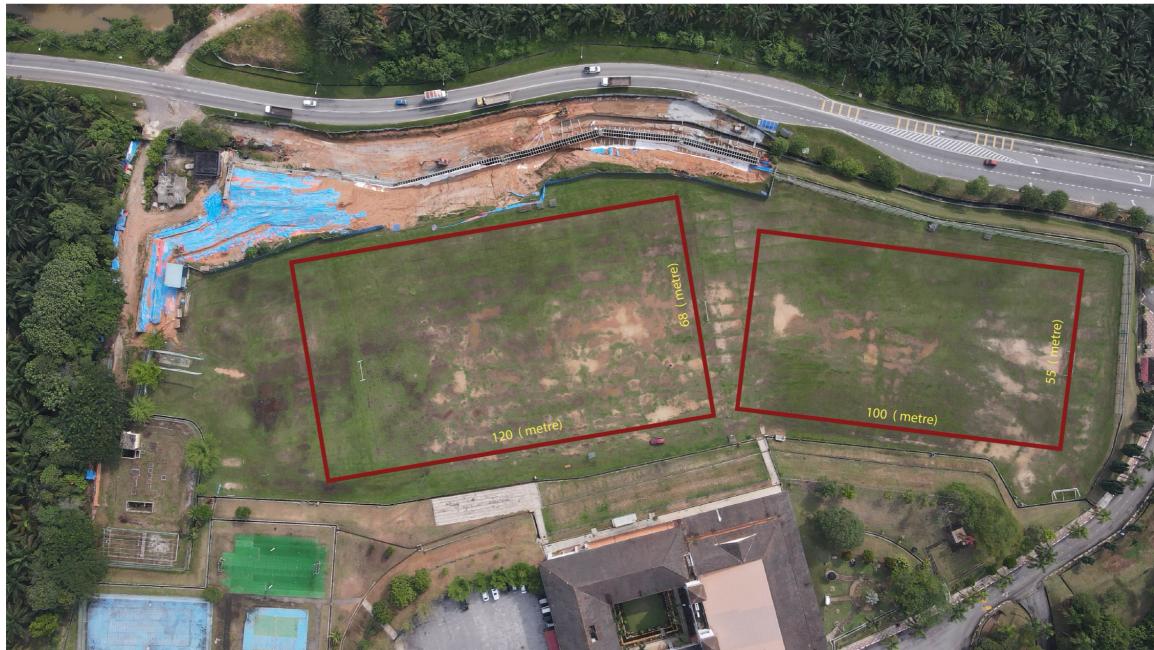
Purpose: To identify the lowest and highest point of the field contour for crowning.

Crowning was the main approach of this project in order to improve surface drainage. By raising the center of the field, water is naturally directed towards the edges, where it can be channeled away.

At this stage it was identified that the official site for this project is **13,660** square metres/ **147,036** square feet. The details of the area are as follows:

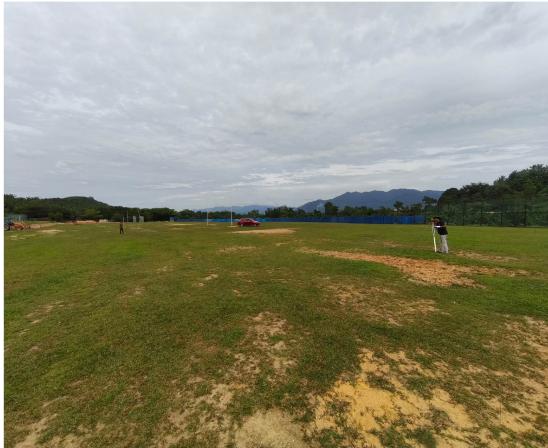
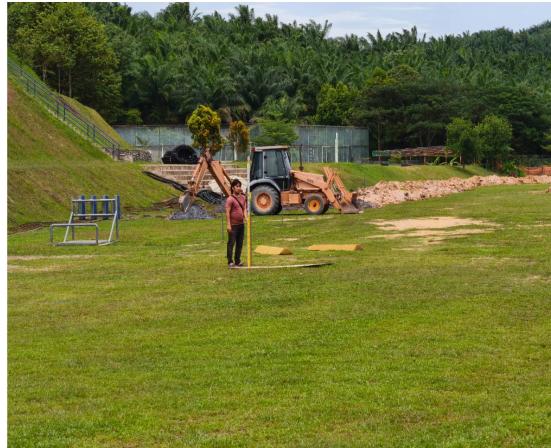
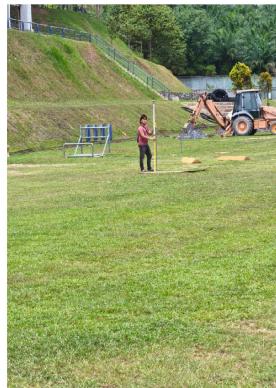
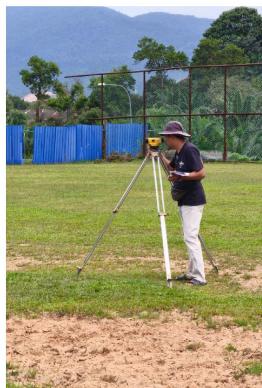
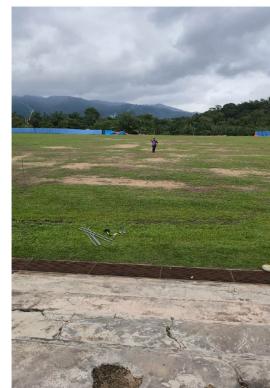
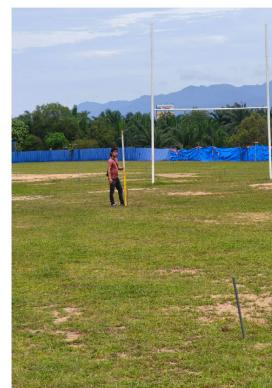
During the process, it was discovered that several points in the middle area were lower than the areas surrounding it, explaining the water residue in the middle of the field which resulted in surface damage in the long run. This was the main cause of the damaged turf and formation of puddles and muddy patches especially during the rainy season.

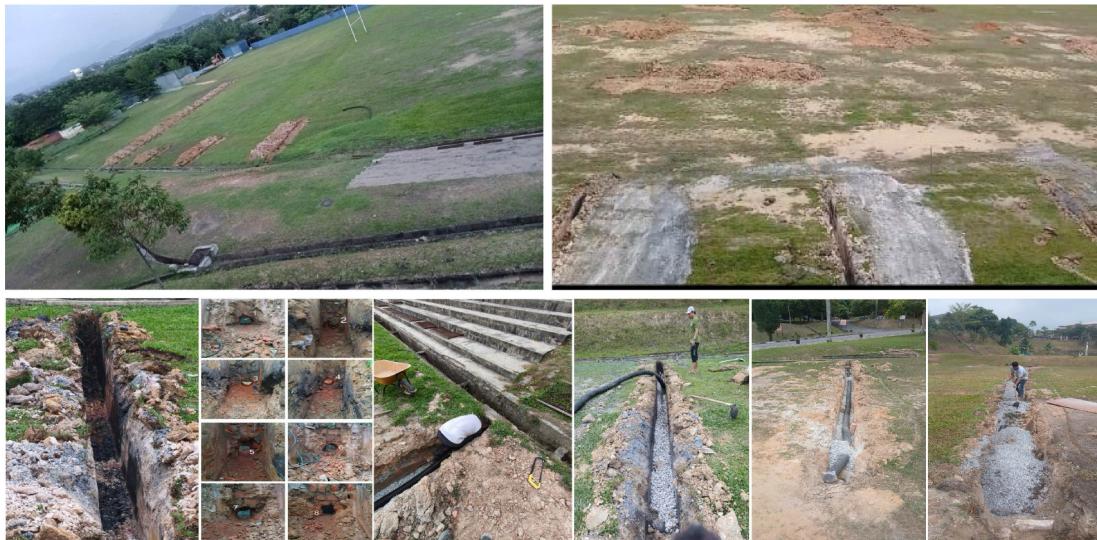
Layers of different materials were used for smooth water removal by gravity, crusher run gravel was used as the bedding as well as first layer, followed by washed sand as backfill material. This sand acts as a filter, allowing water to pass through while preventing soil particles from clogging the drainage system.

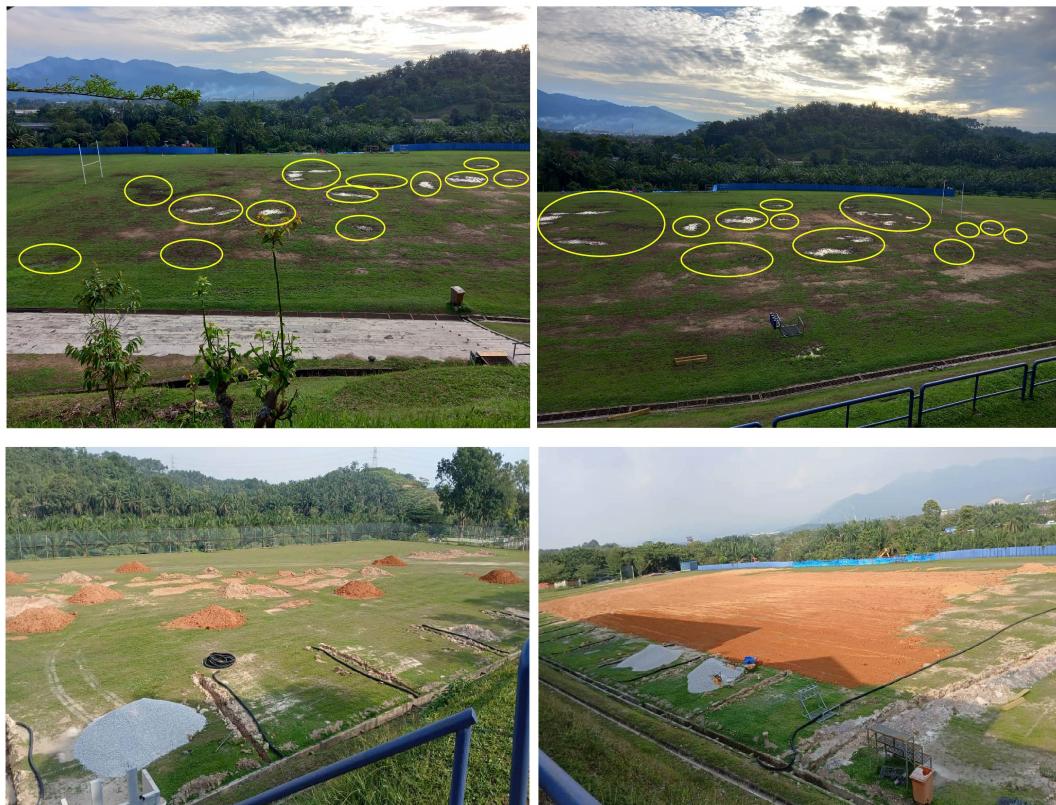
Initially, all the bad soil in the areas that had been identified during initial stage of the project was removed. During this stage, a large amount of topsoil was used as backfill material to fill up the area. Then, another layer of topsoil was used to raise the surface to the required height at the designated points.

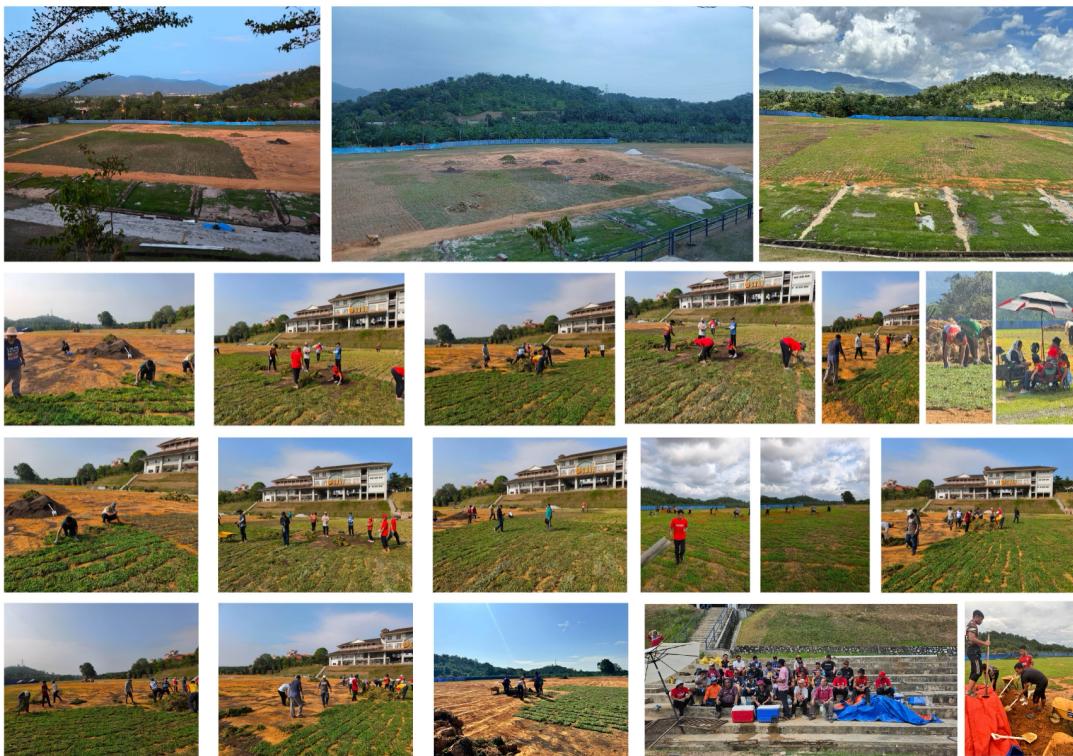
The type of grass selected is cow grass which is commonly used due to its durability, low maintenance requirements and aesthetic appeal. A total of almost 45,000 square feet of cow grass in sod was planted, covering almost 60 % of the field surface. During this stage, a series of gotong-royong programme was carried out involving volunteers among alumni, school staff, parents and students.

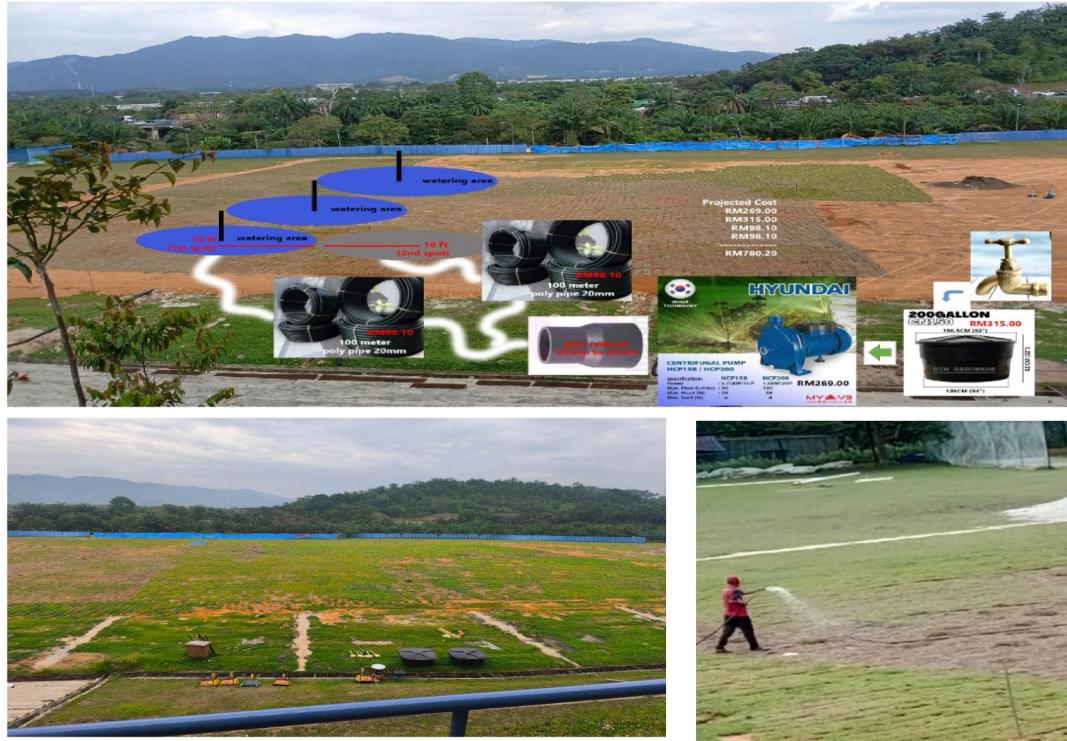
After the planting stage, the most challenging task was to ensure that the grass planted had sufficient and steady supply of water due to the dry season. A few lines of poly pipes with sprinkler system, along with a water pump and tanks were installed to provide enough pressure head for that purpose. In addition, manual watering had to be carried out for critical spots.

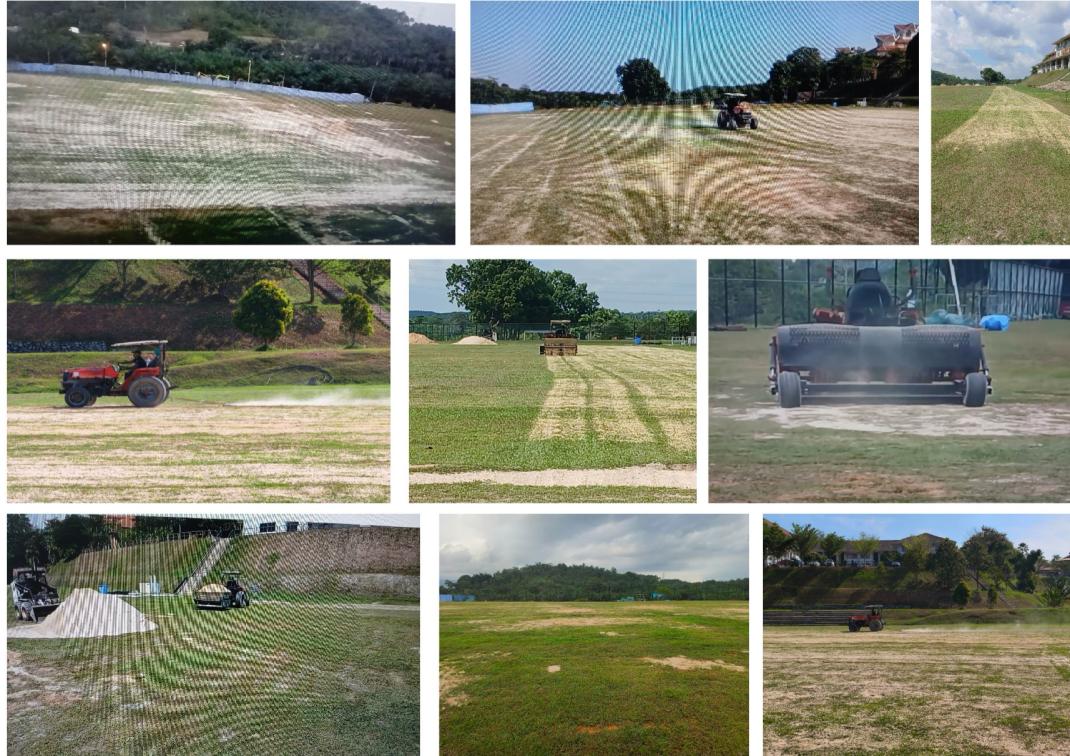
There were 2 stages of top dressing involved. All uneven areas were identified and fine sand was manually applied to the affected areas right after the first grass cutting. The first stage of this process was a very labour-intensive one. The next stage was done by machines for the application of a very thin layer of fine sand. It was carried out right after soil aeration was done and once completed, it was spread evenly by using dragmat.
