## SUBMITTAL REVIEW

Description: Aluminum Framed Entrances and Storefronts -SD

Project Name: UT SEAY Building Addition

Project No.: 102-782

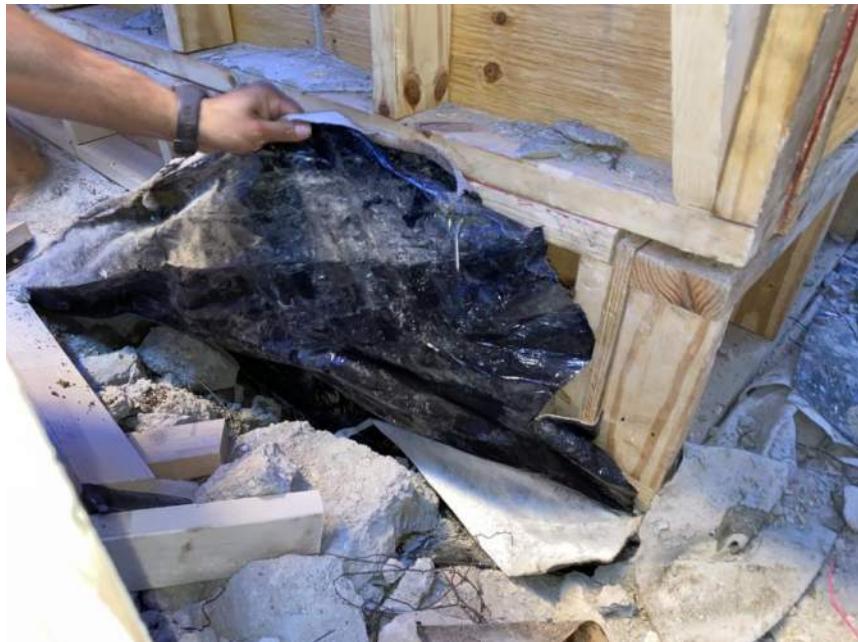
**Photo 1**  
**Example of Excess Precon Membrane Observed for Tie-In**

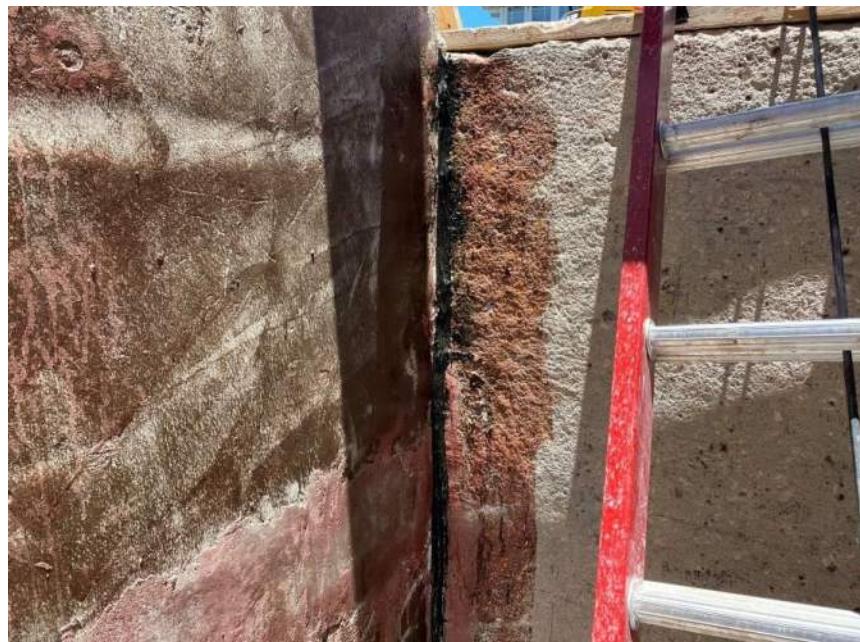
- At the tunnel chamber, Chamberlin is installing sheet waterproofing membrane (Mel-Roll) in what appears to be a workmanlike manner. The concrete substrate was observed to be primed and allowed to cure prior to installation of sheet waterproofing. Sealant cant beads were observed to be installed at inside corners to promote transition between surfaces. Inside corner reinforcing membrane strips were observed to be installed prior to installation of field membrane. Membrane was observed to be tied-in to blindside membrane (Precon). A hand roller was used to promote adhesion at the concrete substrate per manufacturer's specifications. Pointing mastic was observed to be installed at the tie-in to blindside membrane, leading up to 12" above the concrete footing per manufacturer's recommendations. No deficiencies were noted at the time of observation, and installation appears to be sufficient. *See Photos 1-7*

**Photo 2**  
**Example of Corner Cant Bead Installation**

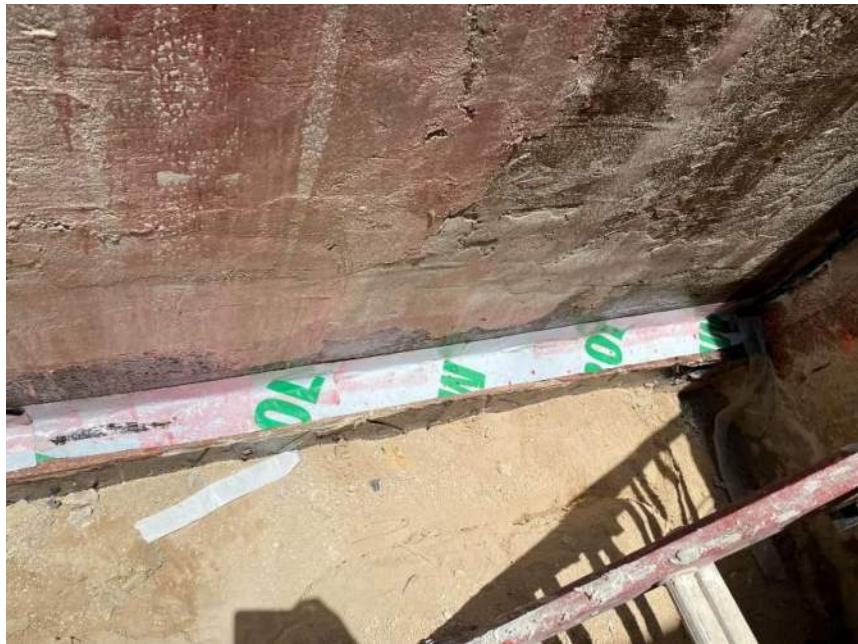
**Photo 3**  
**Example of Inside Corner Reinforcing Membrane Strips**

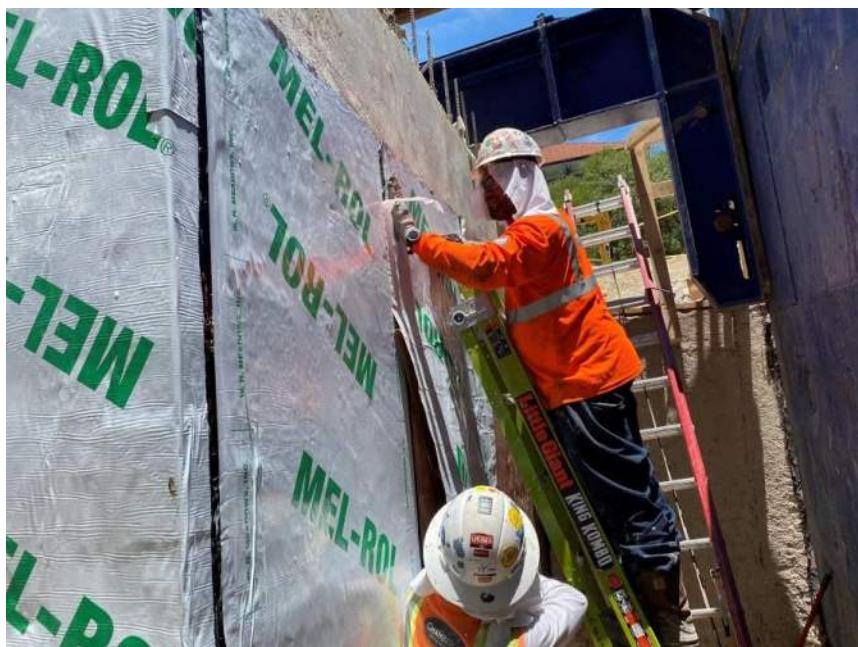
**Photo 4**  
**Example of Sheet Waterproofing Membrane Installation Underway**

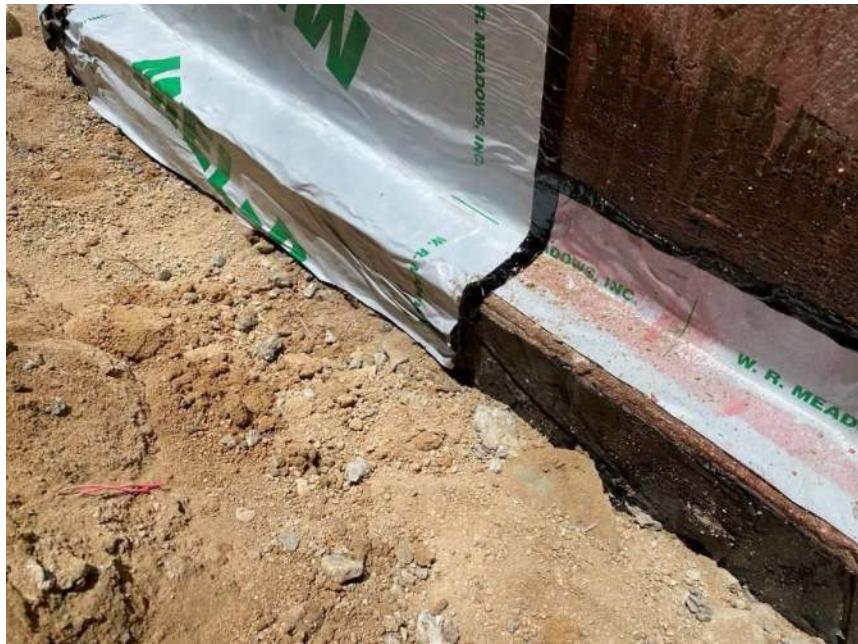
**Photo 5**  
**Example of Sheet Waterproofing Tie-In to Blindsides Membrane**

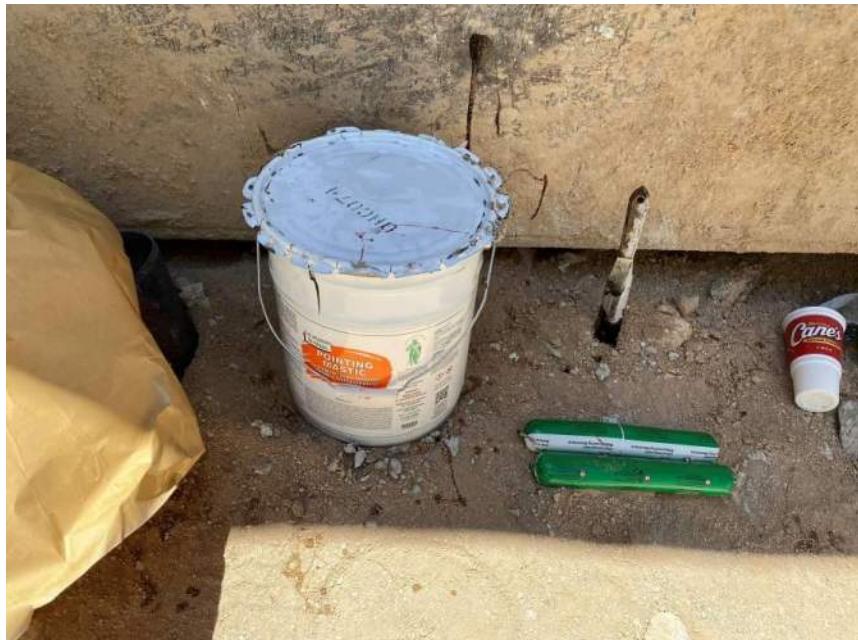
**Photo 6**  
**Overview of Mastic and Sealant Utilized**

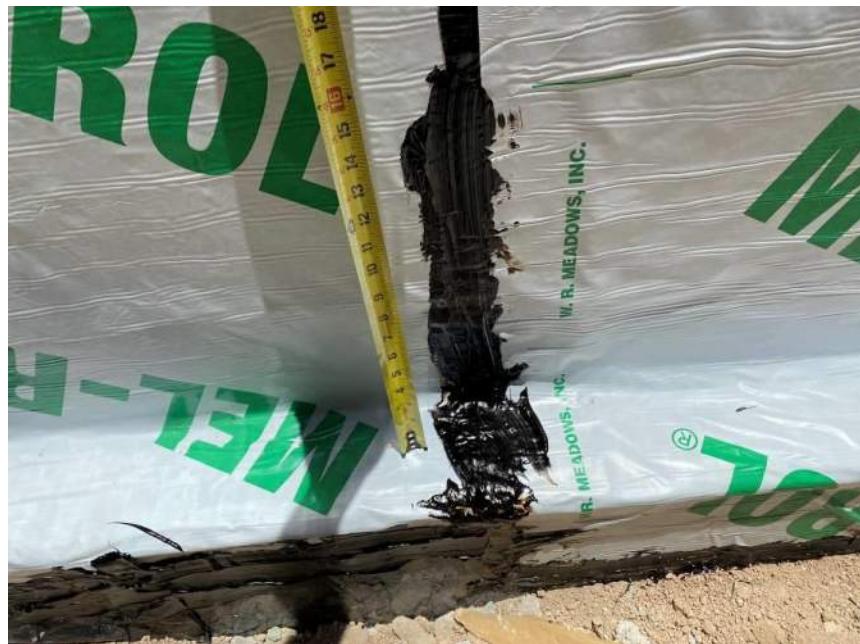
**Photo 7**  
**Example of Membrane Termination**

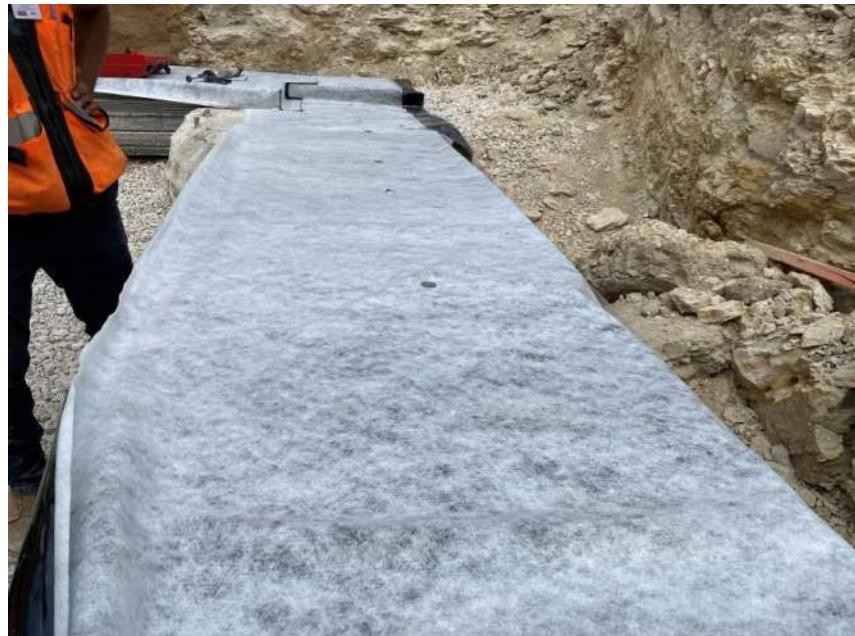
1. ZSC on site 7/21 to observe blindside waterproofing installation underway at vertical wall locations. Precon has been installed along beams and appears to have sufficient laps. No detail sealant has been installed at the time of observation, as this was to be an interim observation. ZSC recommends a formal inspection be performed prior to concrete placement. **See Photos 1-2**

**Photo 1**  
**Overview of Membrane Installation**

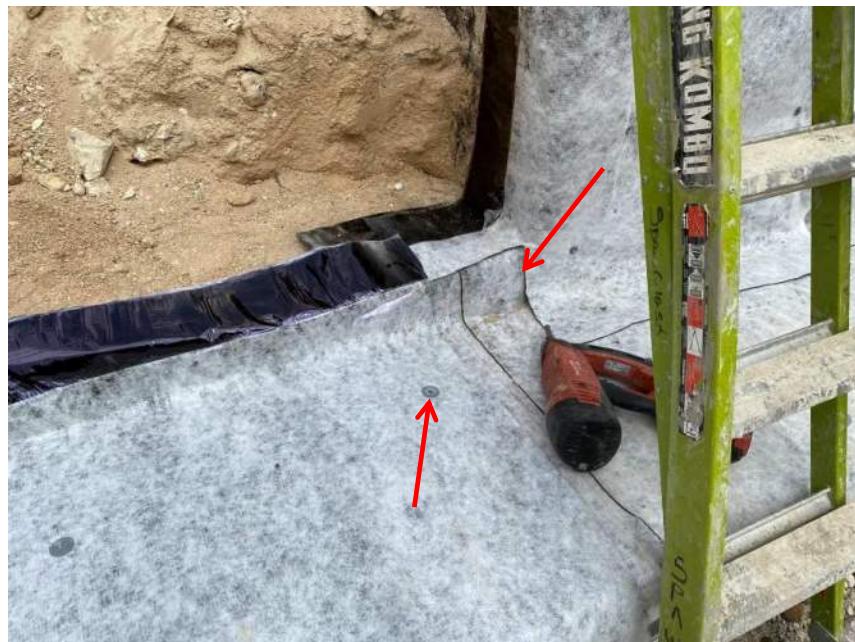
**Photo 2**  
**Membrane Laps and Fasteners Lacking Termination Sealant**

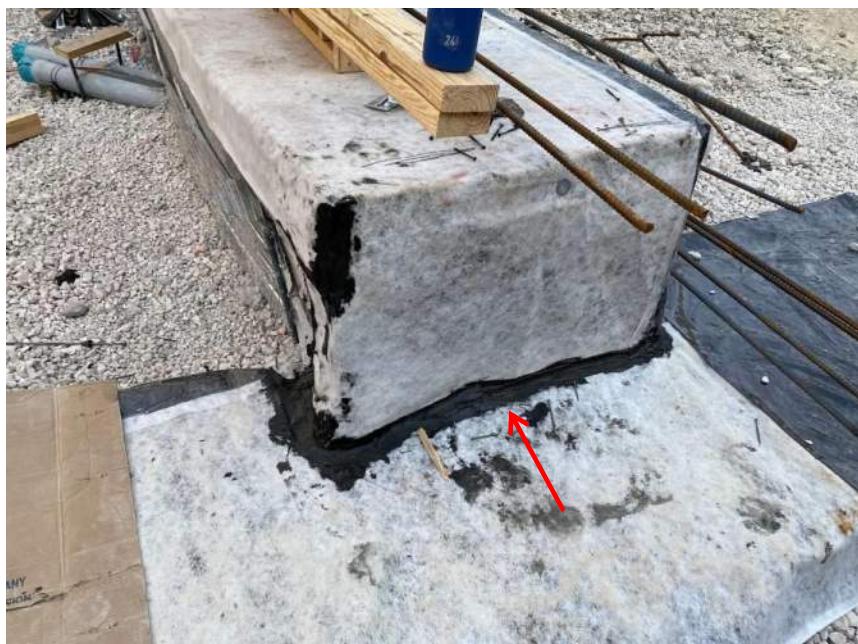
3. ZSC on site 7/24 to observe completed membrane detailing. Upon observation, it was noted that rebar has been installed at piers creating a breach in the

membrane. It was also noted that membrane laps at the detail to the existing structure have not been terminated per manufacturer's specifications. Please ensure rebar is detailed as a typical penetration, and all laps are terminated per manufacturer's specifications. **See Photos 4-7**

**Photo 6**  
**Example of Rebar Penetrations at Piers**

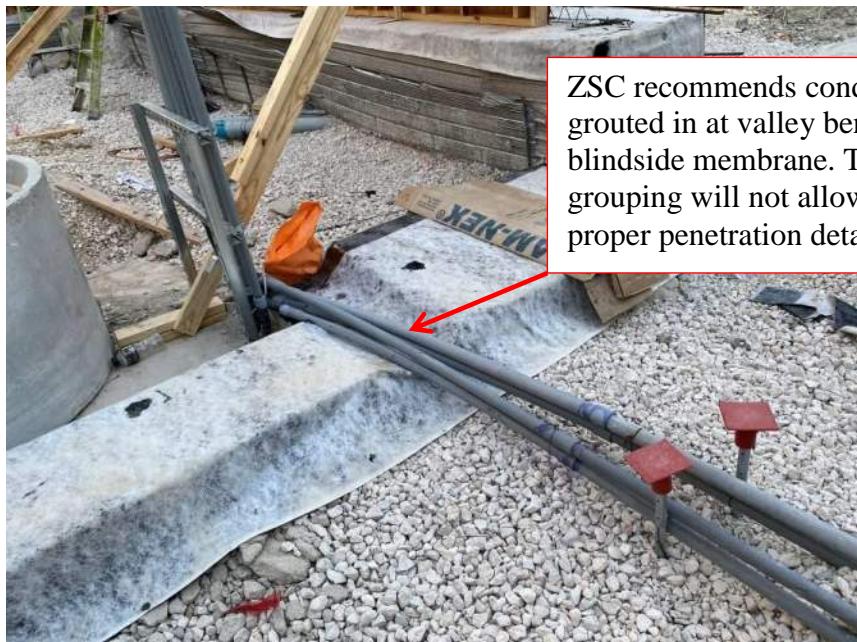
**Photo 8**  
**Overview of Conduit Ran Above Blindside Membrane**

ZSC recommends conduit be grouted in at valley beneath blindside membrane. Tight grouping will not allow for proper penetration detailing.

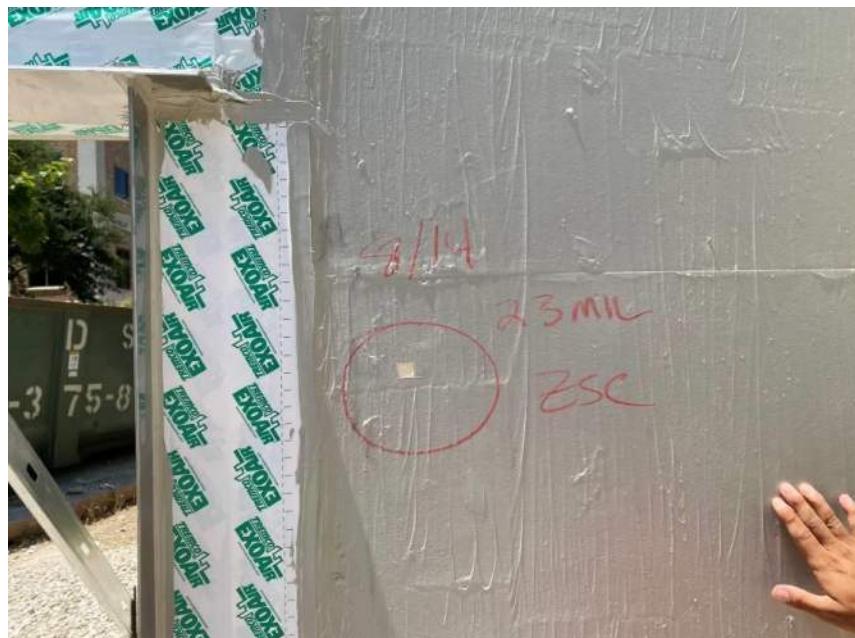
- At the mock-up, ZSC performed dry mil testing at 2 locations in order to verify air barrier (AB) complies with specifications. Per project specifications, a minimum of 35 dry mils are required. Sample specimens measured at 23 and 29 mils, and installation does not comply with specifications. ZSC recommends an additional coat of AB be applied to the substrate in order to meet project specifications. **See Photos 1-2**

**Photo 2**  
**Example of Measurement Performed at Mil Sample**

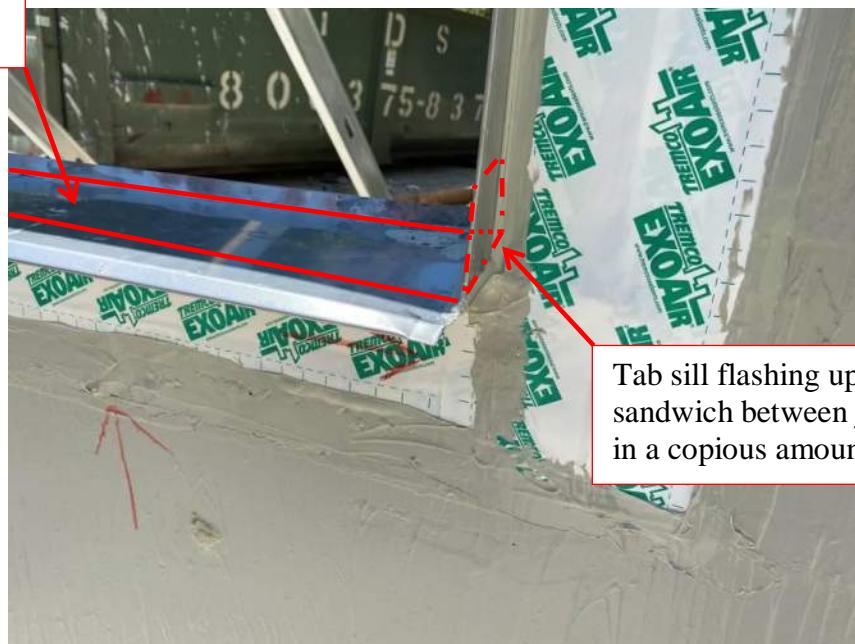
3. At the mock-up, ZSC observed installation of SAMF strip-in at window perimeter flashing. It was noted that the membrane transitions 3" onto flashing and substrate per manufacturer's specifications. However, upon observation, it was noted that multiple deficiencies exist in installation including fishmouthing and missed lap terminations. Please ensure that fishmouths are corrected per manufacturer's specifications, and membrane is properly terminated prior to installation of façade. ***See Photos 6-8***

**Photo 6**  
**Example of Fishmouthing at SAMF Strip-In at Window Flashing**

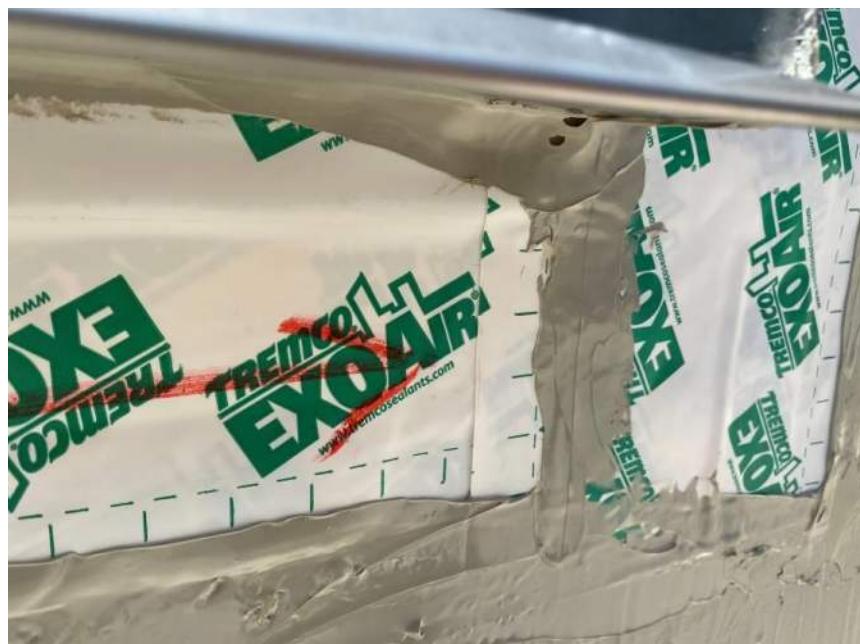
**Photo 7**  
**Example of Missing Termination Sealant**

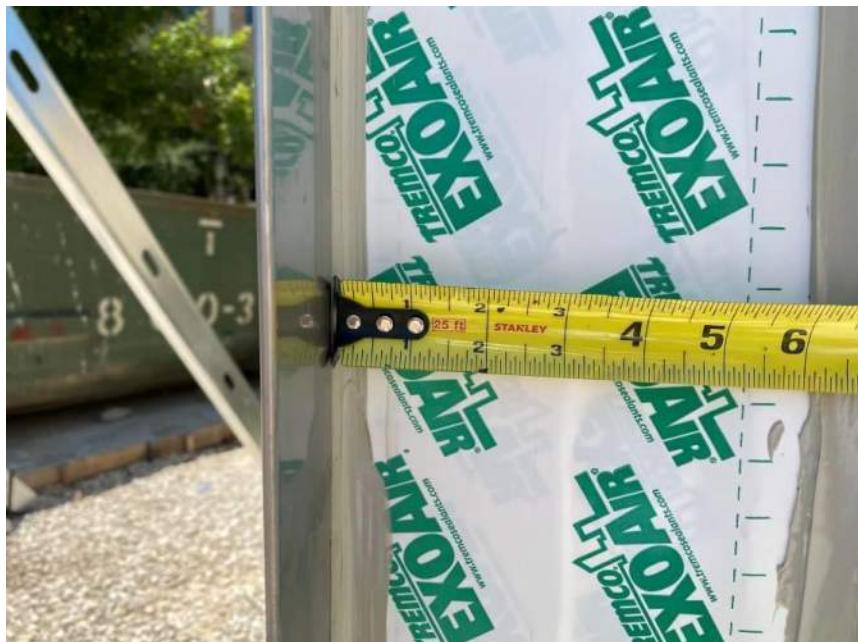
**Photo 8**

**Example of Sufficient SAMF Transition from substrate to Window Flashing**

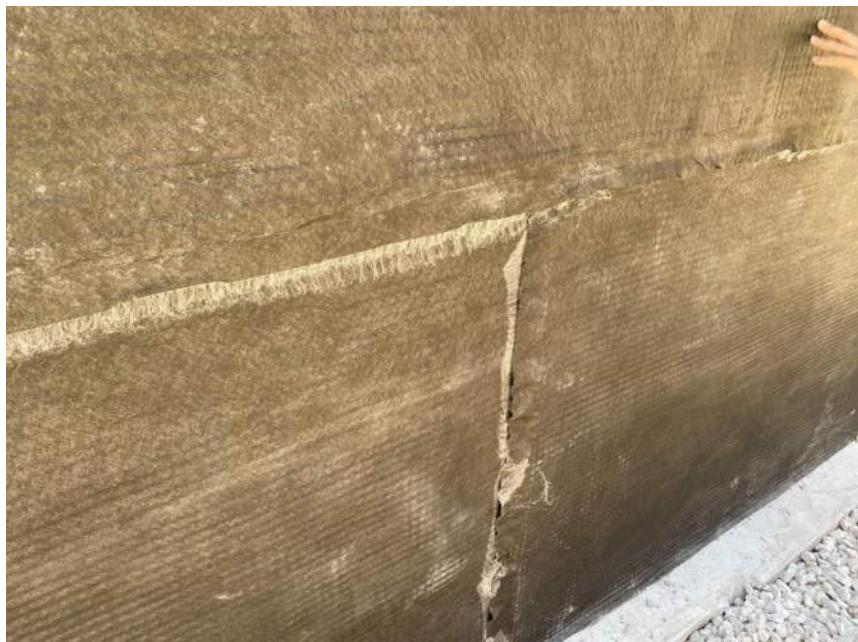
4. At the north and adjacent west elevations of the tunnel, ZSC observed installation of sheet waterproofing membrane. It was noted that drain board has been installed prior to observation, preventing access to sheet waterproofing throughout the field of installation. However, it was noted that membrane appears to be fully adhered to the substrate at termination points, and membrane has been sealed with the approved sealant. No deficiencies were noted at the time of observation, and installation appears to be sufficient.

**Photo 10**  
**Example of Membrane Terminations Sealed with Approved Sealant**

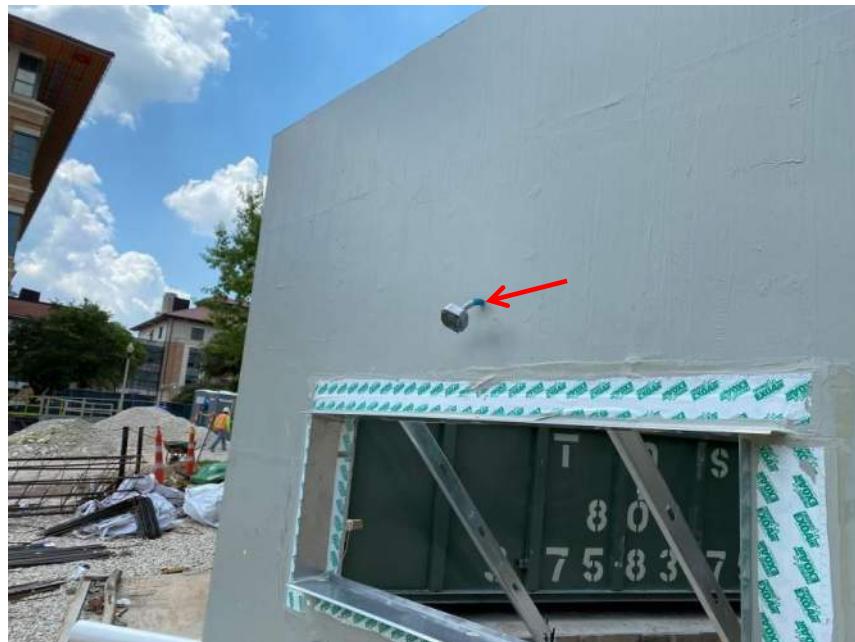
- At the mock-up, it was noted that flex conduit has been installed for an electrical box above the punched opening. Due to the movement of flexible conduit, a sufficient air/water tight seal cannot be achieved. ZSC recommends that flexible conduit be replaced with rigid conduit. SpawGlass was informed of these concerns, and directed electrical contractors to replace conduit. Please ensure conduit is detailed per weather resistant barrier (WRB) manufacturer, prior to installation of façade. **See Photos 1-2**

**Photo 2**  
**Overview of Flexible Conduit Replaced with Rigid**  
[www.z6consulting.com](http://www.z6consulting.com)

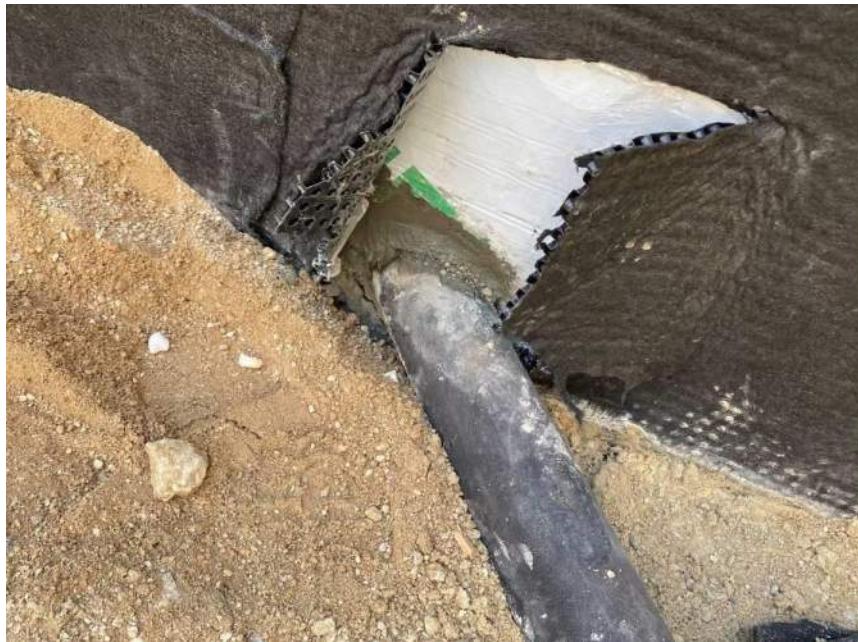
**Photo 3**  
**Overview of Incomplete Through Wall Penetration Detailing South of Pipe Chase**

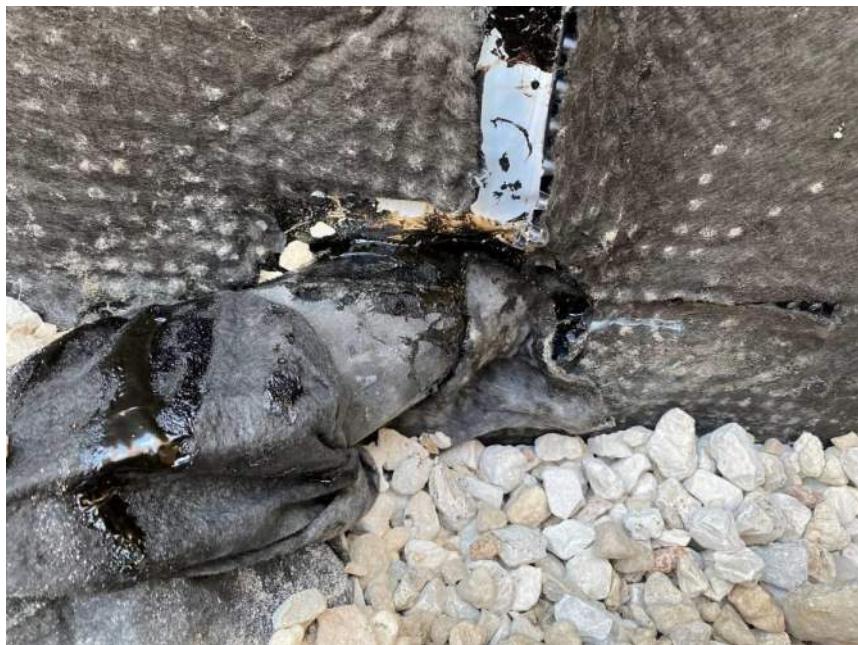
- At the west elevation of the tunnel, ZSC observed installation of penetration detailing at the French drain through wall condition north and south of the pipe chase. At the time of observation, it was noted that penetration detailing had not been completed per manufacturer's standard details. Photos were later forwarded by SpawGlass of completed detailing. Photos provided by SpawGlass

**Photo 5**  
**Example of Photo Verification Provided by SpawGlass**

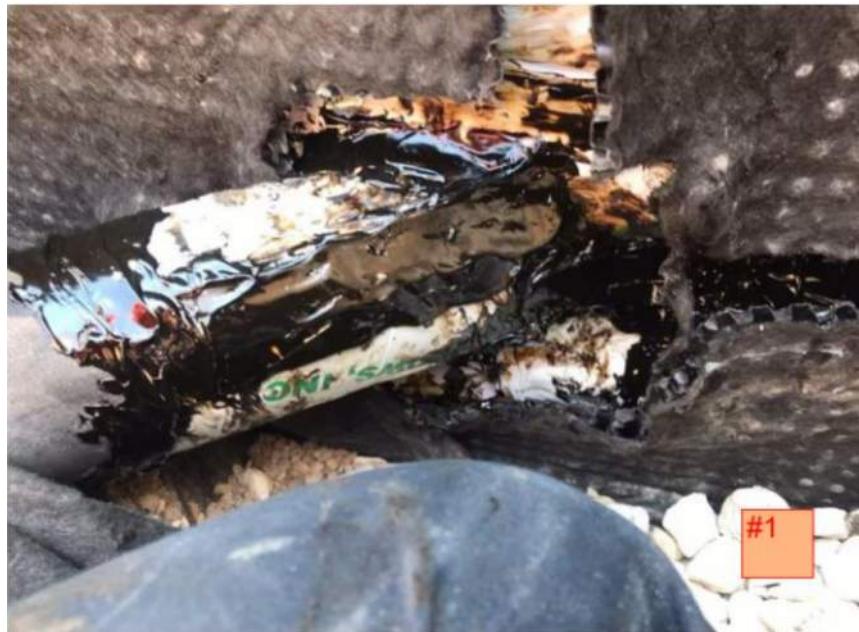
3. ZSC observed installation of blindside membrane at the tunnel slab on grade. It was noted that previously installed membrane has become discontinuous at northeast column. ZSC recommends that the manufacturer be contacted to determine a warrantable detail with current conditions. *See Photo 6*

**Photo 6**  
**Blind Side Membrane Discontinuous at Northeast Column**

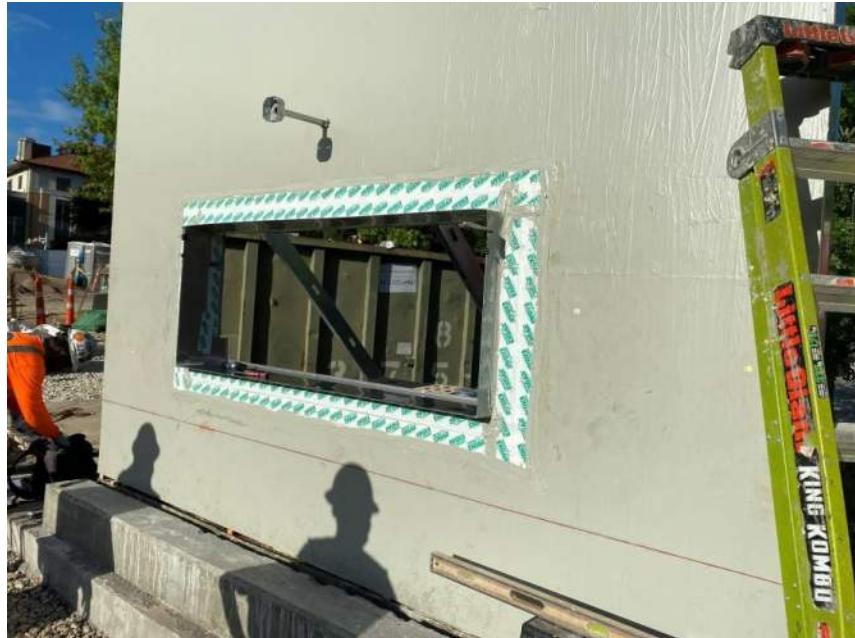
- At the mock-up, the T-flashing had been installed. It was noted that the head flashing had been turned down onto the jamb flashing, however the jamb flashing did not turn into the head flashing as recommended by ZSC. Sealant was added at this condition, but ZSC recommends turning the jamb flashing into the head flashing and embedding with sealant. *See Photos 1-3*
- At the mock-up, it was noted that concrete curb has been placed per 14/A311. However, upon observation, this does not provide a way to detail the cold joint between sheathing and finished interior slab. ZSC recommends that an RFI be issued to address detailing in this area, and recommends considering CMU in lieu of a concrete curb. *See Photos 4-5*
- At the mechanical room, ZSC observed installation of blindside waterproofing. Laps and penetrations appear to be detailed per manufacturer's specifications.

**Photo 2**  
**Example of Head to Jamb Transition**

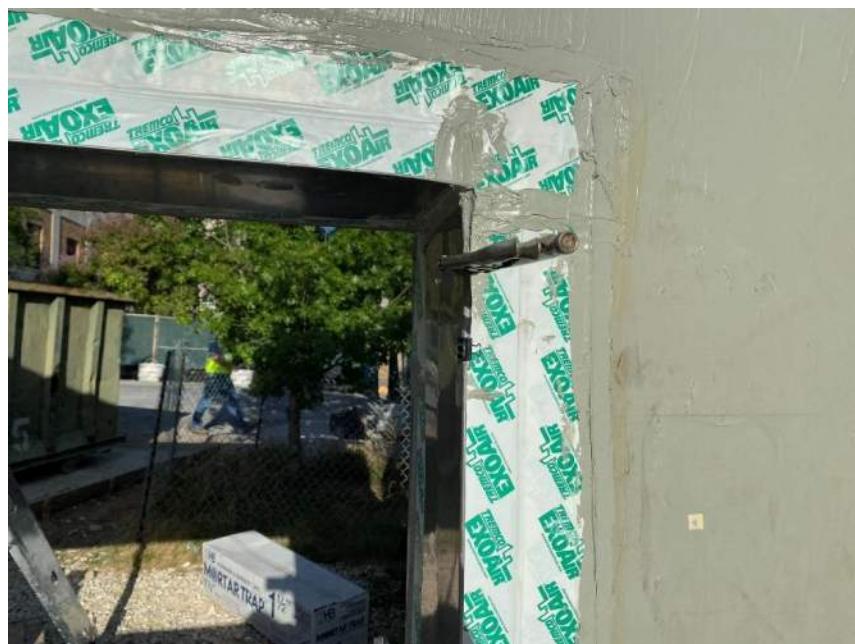
**Photo 3**  
**Overview of T-Flashing Installed at Sill Per Meeting on 8/18**

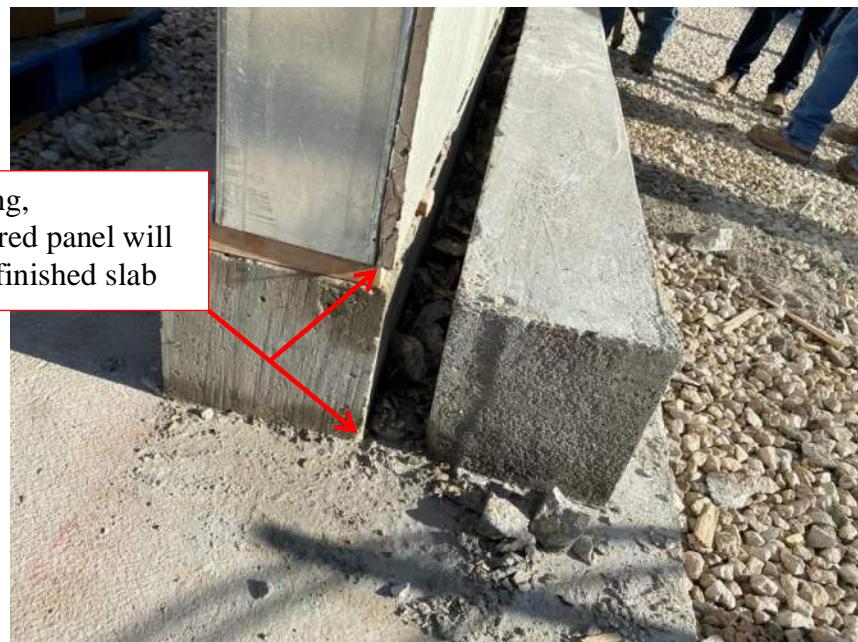
**Photo 4**  
**Overview of Concrete Curb**

ZSC recommends following solid grout filled CMU detail at scheduled curb.

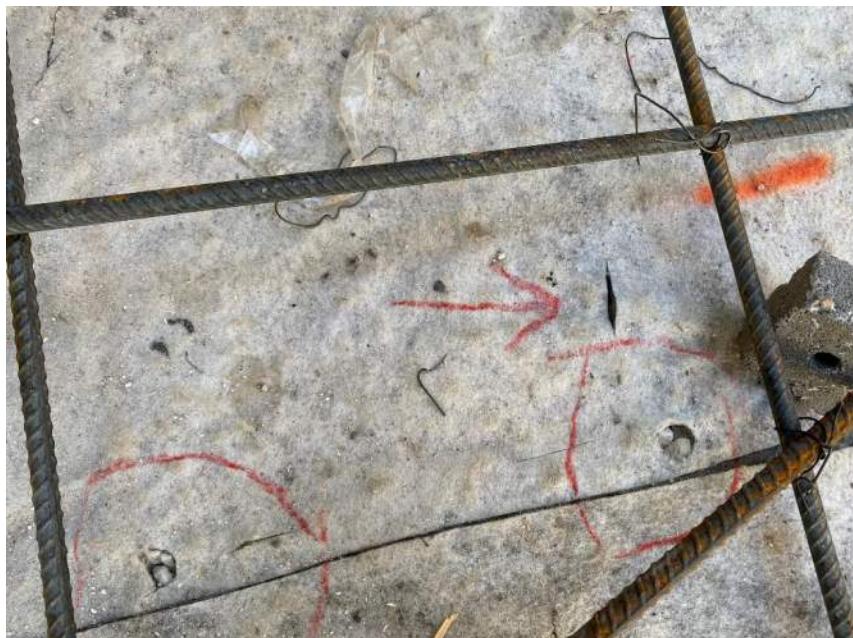
However, it was noted several areas were missing detail sealant along with punctures and cuts in the blindside waterproofing. Chamberlin personnel were on site and made repairs to these deficiencies at the time of observation. No further deficiencies were noted and installation appears to be sufficient. **See Photos 6-10**

**Photo 7**  
**Example of Cut in Blindside Waterproofing Membrane**

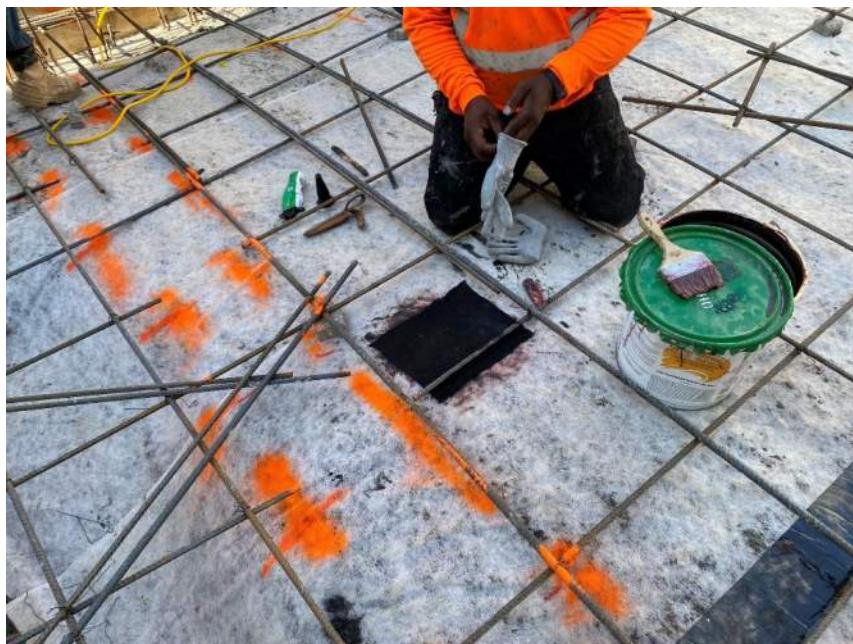
**Photo 8**  
**ZSC Observing Chamberlin Personnel Making Repairs to Damaged Membrane**

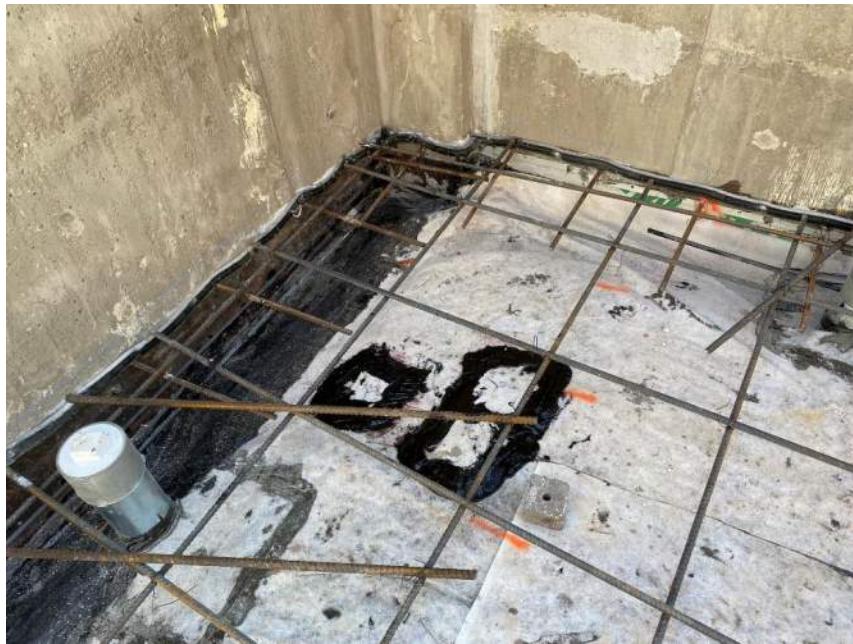
**Photo 9**  
**Repairs Made to Damaged Membrane Observed by ZSC**

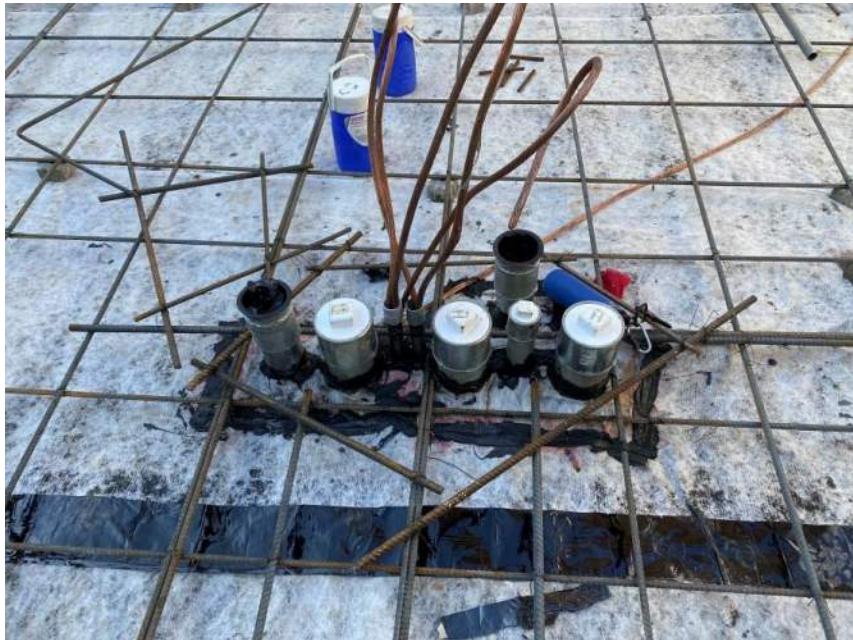
**Photo 10**  
**Example of Penetration Detailing**

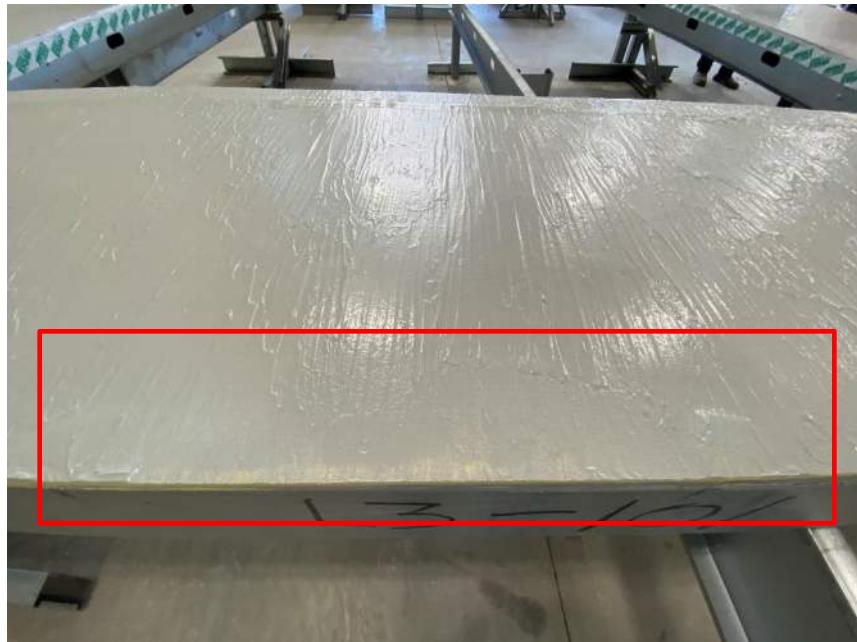
**Photo 1**  
**Example of Exposed DensGlass Exposed**

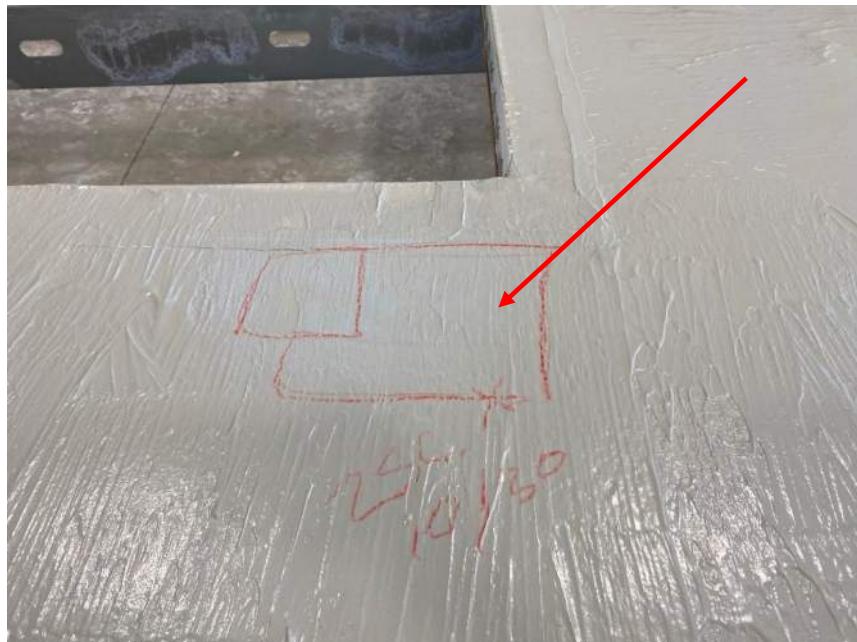
**Photo 3**  
**Example of Areas with Exposed Wall Fibers**

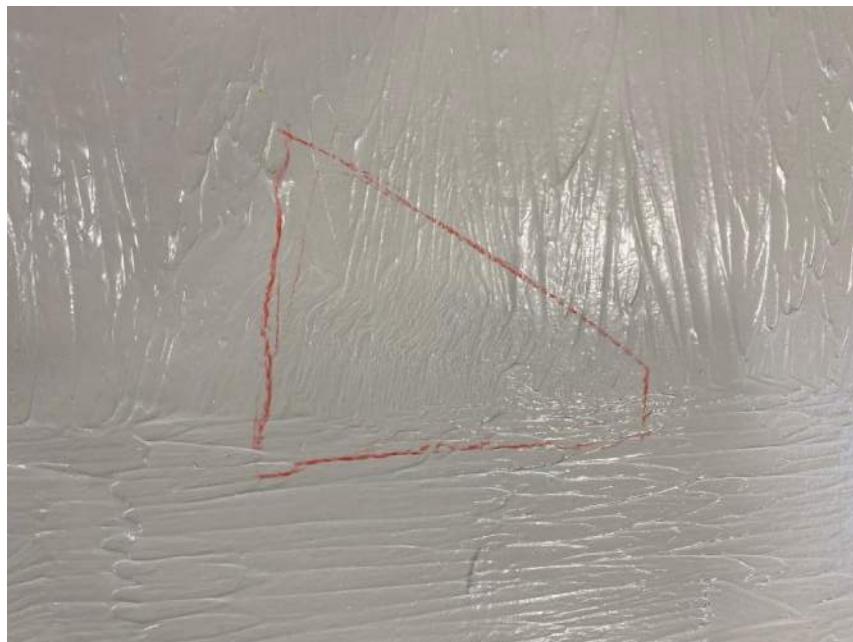
**Photo 4**  
**Example of Terminated SAMF**

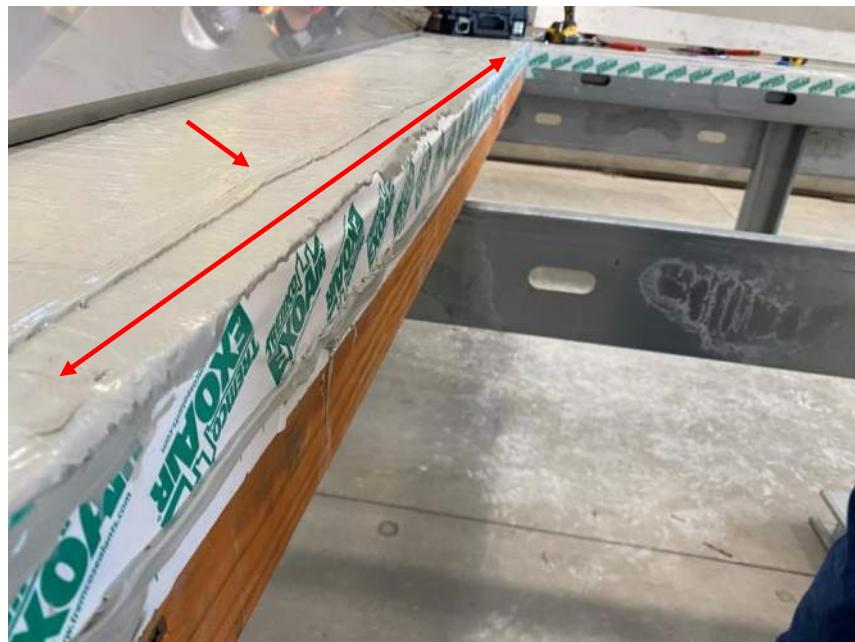
**Photo 2**  
**Example of Sealant at T-Flashing Joint**

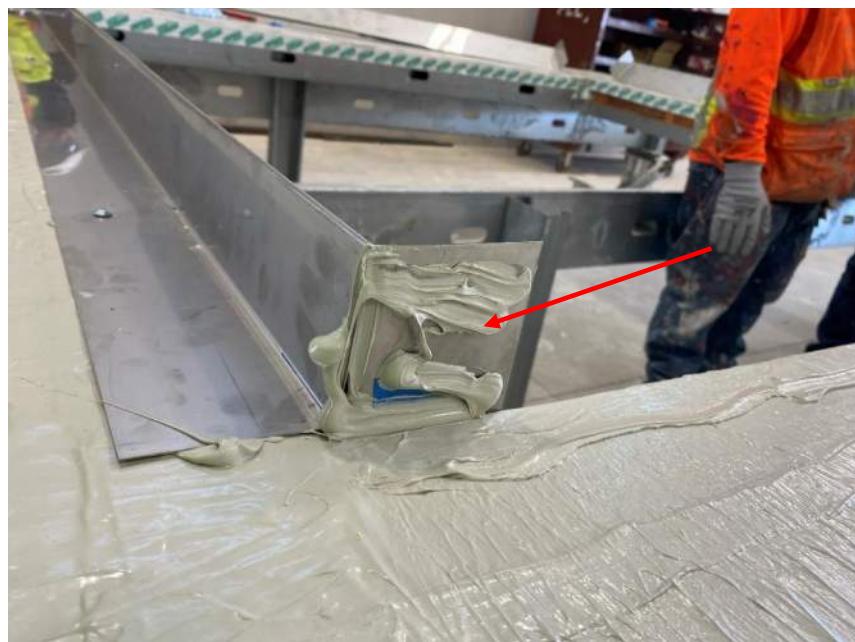
**Photo 3**  
**Example of Sealant at Fastener Penetration**

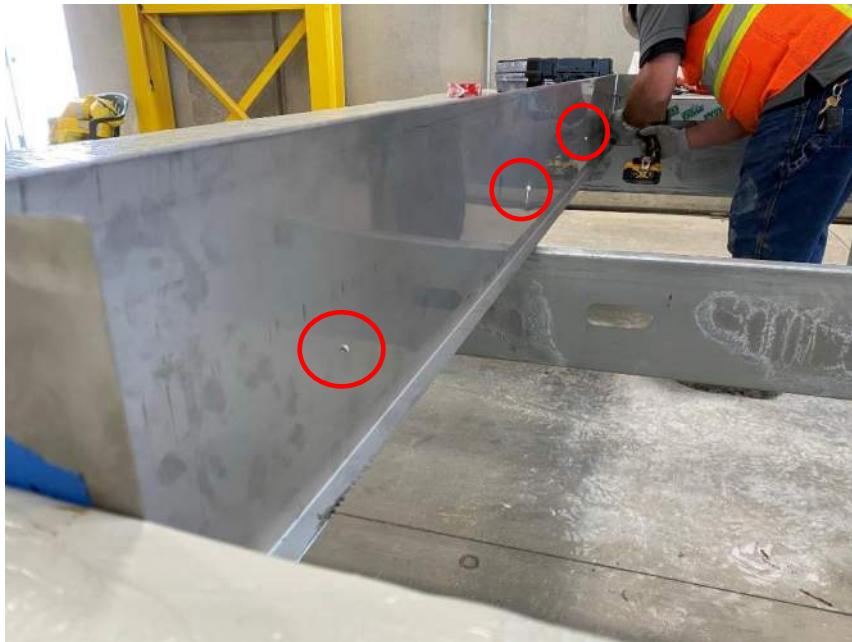
**Photo 4**  
**Example of Installed Flashing**

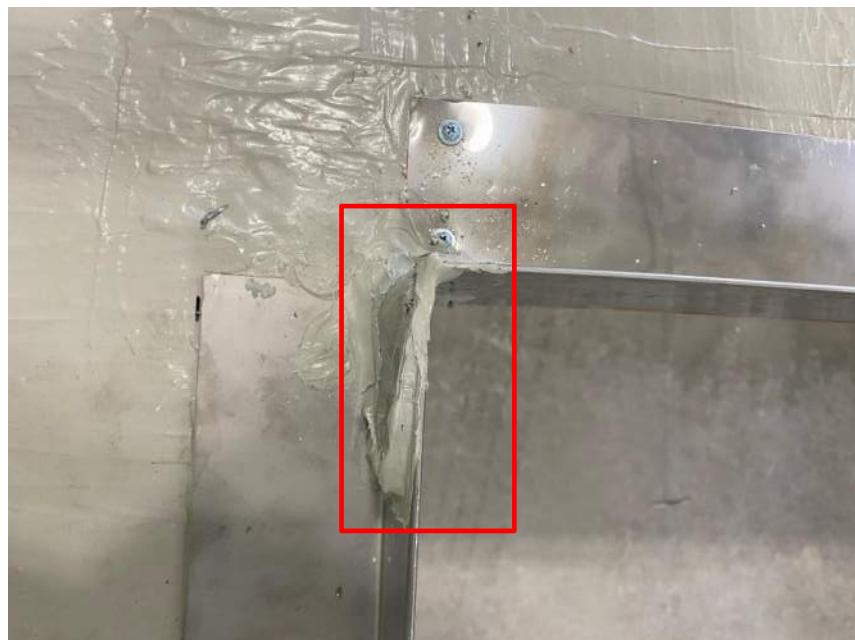
1. ZSC visited F&L Crane to observe the installation of "T-Flashing" and the opening of the pre-fab panels by Chamberlain. Prior to the installation, Chamberlain set the metal flashing in place to ensure the flashing was manufactured to the opening measurements and cut. Due to the header portion not being manufactured/cut as per T-flashing specifications. ZSC recommends for Chamberlain to manufacture a new header flashing to comply with flashing specification. A partial installation was observed, three sides of the flashing were installed while ZSC was on site. **See Photos 1-4**

**Photo 1**  
**Example of Insufficient Adhesion**

**Photo 2**  
**Example of Insufficient Adhesion**

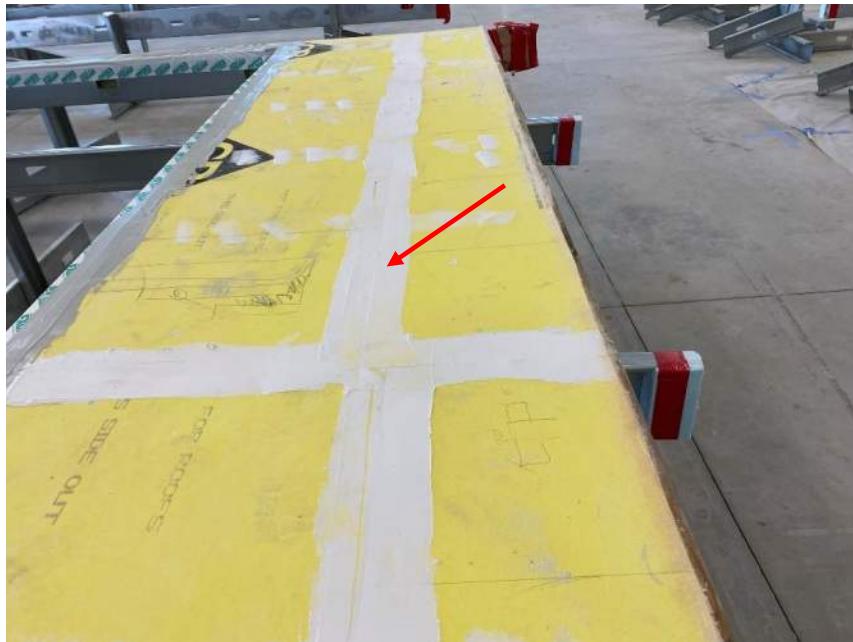
3. ZSC noted the DensGlass joint compound, application appeared to have been done in a workmanlike manner and in accordance to manufacture installation specifications. No deficiencies were noted at the time of observation and application appeared to be sufficient. ***See Photos 3-4***

**Photo 3**  
**Example of Joint Compound Application**

**Photo 4**  
**Example of Joint Compound Application**

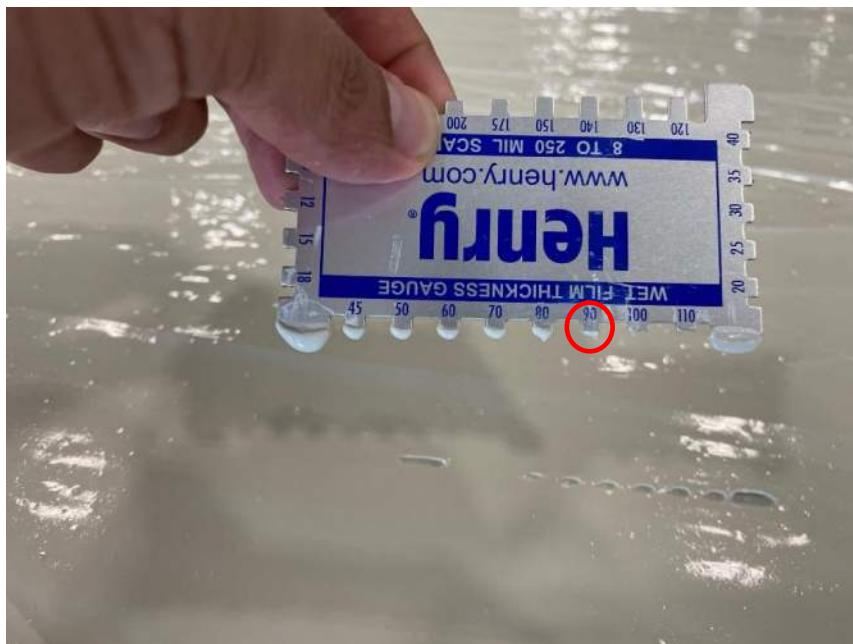
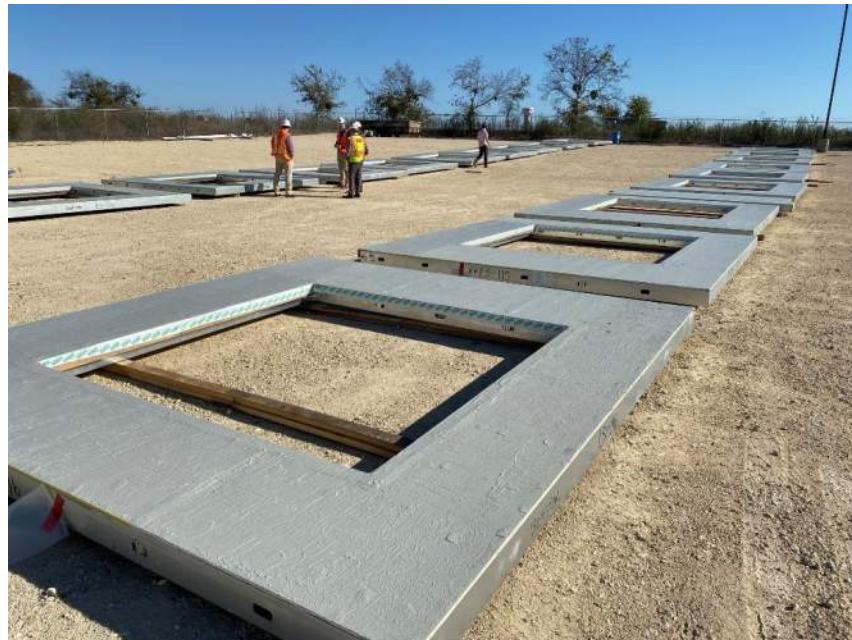
4. ZSC observed the application of the fluid applied AB by Chamberlain Roofing. Wet mil samples were randomly sampled ranging 90 mil. Chamberlain appeared to be working in a workmanlike manner and application appeared to be in accordance to manufacture installation specification. No deficiencies were noted at the time of observation and installation appeared to be sufficient. *See Photos 5-8*

**Photo 5**  
**Example of Ongoing AB Application**

**Photo 6**  
**Example of Wet Mil Reading**  
**90 mil**

**Photo 7**  
**Example of Wet Mil Reading 90 Mil**

**Photo 8**  
**Observation of Panels Awaiting QC by Chamberlain Roofing**
