## SUBMITTAL REVIEW

Description: Aluminum Framed Entrances and Storefronts -SD

Project Name: UT SEAY Building Addition

Project No.: 102-782

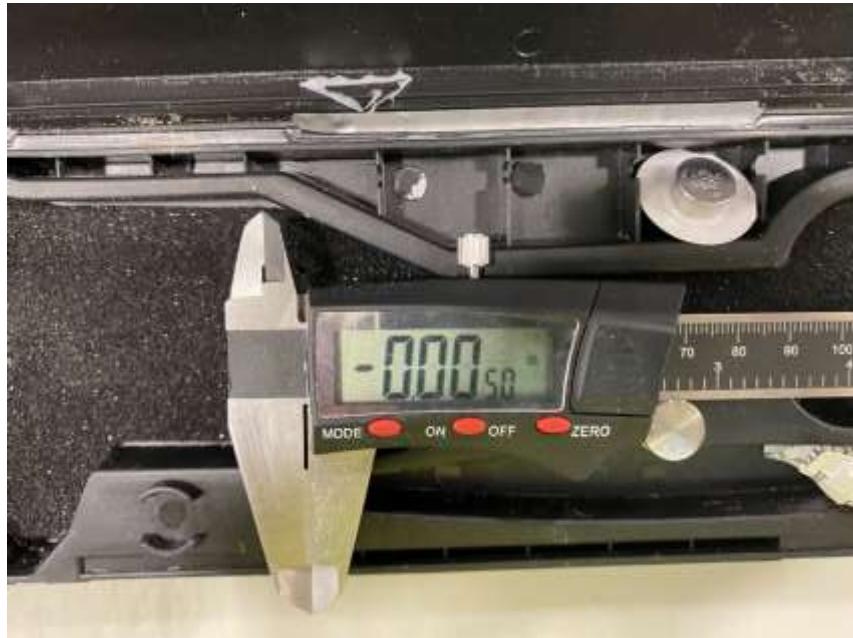
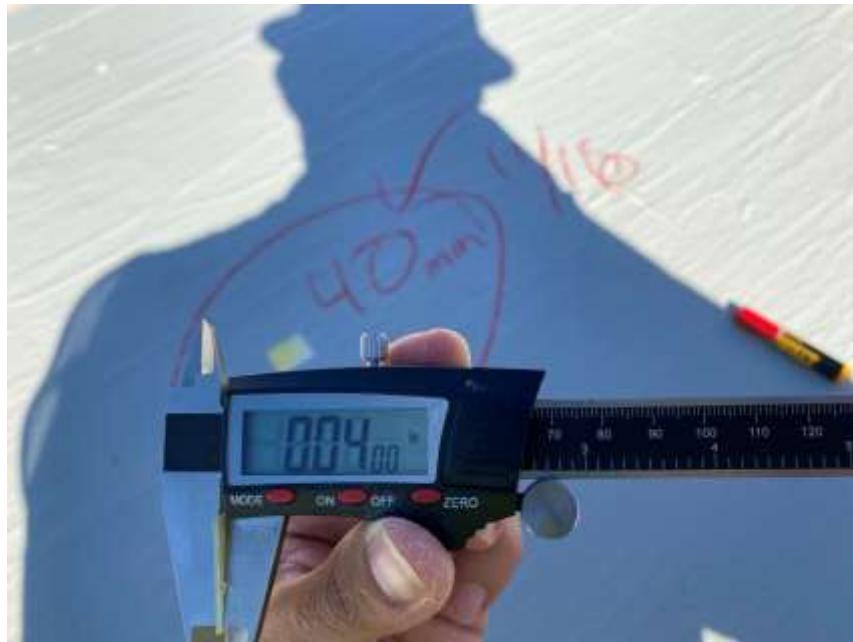
1. ZSC visited F&L Crane to observed the ongoing fluid applied Air Barrier by Chamberlain Roofing. Thirty-Six (36) panels appeared to be complete and ready for random AB specimen testing. One specimen was taken from each panel to measure the dry millage reading of AB, which by project specification is a reading of 40mil minimum. Five (5) out of thirty-six (36) panels AB coating ranged from 28 mil-35 mil and did not meet the project specification of mil requirement. ZSC recommended for additional coating to be applied on panels where mil readings were low. Chamberlain was present to apply additional coating in recommended areas and make corrections. The additional Thirty-one (31) panels mil reading ranged from 40 mil- 80 mil dry. Chamberlain appeared to have been working in a workman like manner and no additional deficiencies were noted at the time of

**Photo 1**  
**Example of Calibration**

**Photo 2**  
**Example of Mil Reading Met**

**Photo 3**  
**Example of Mil Reading Met**

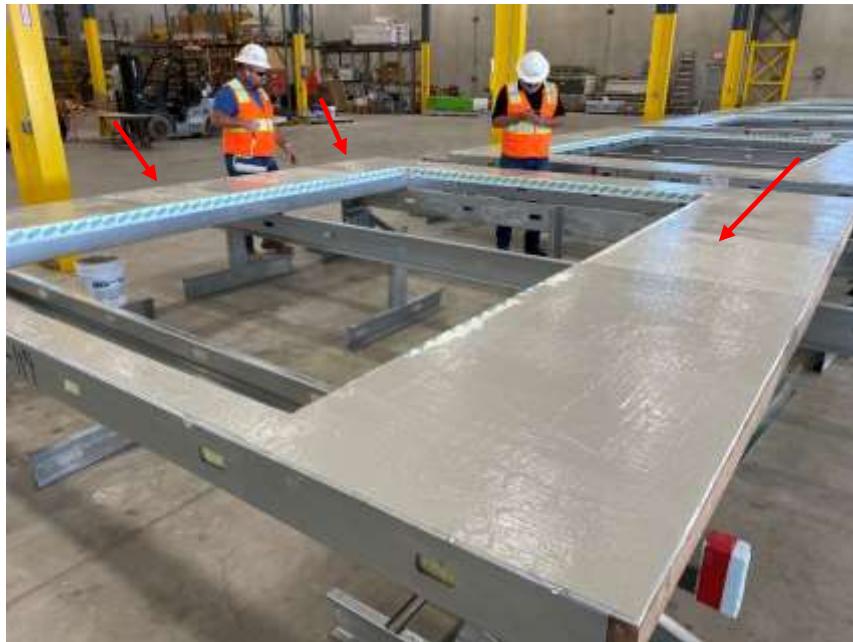
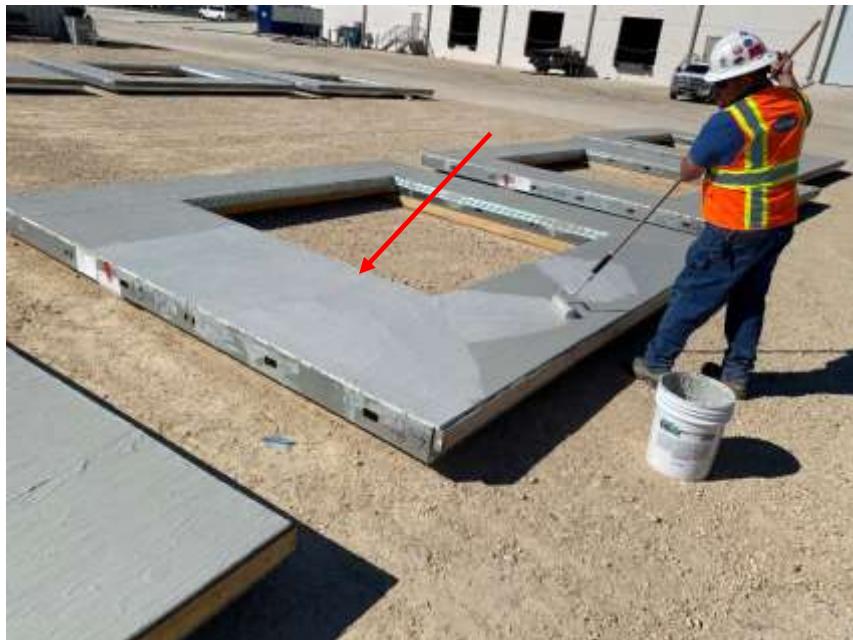
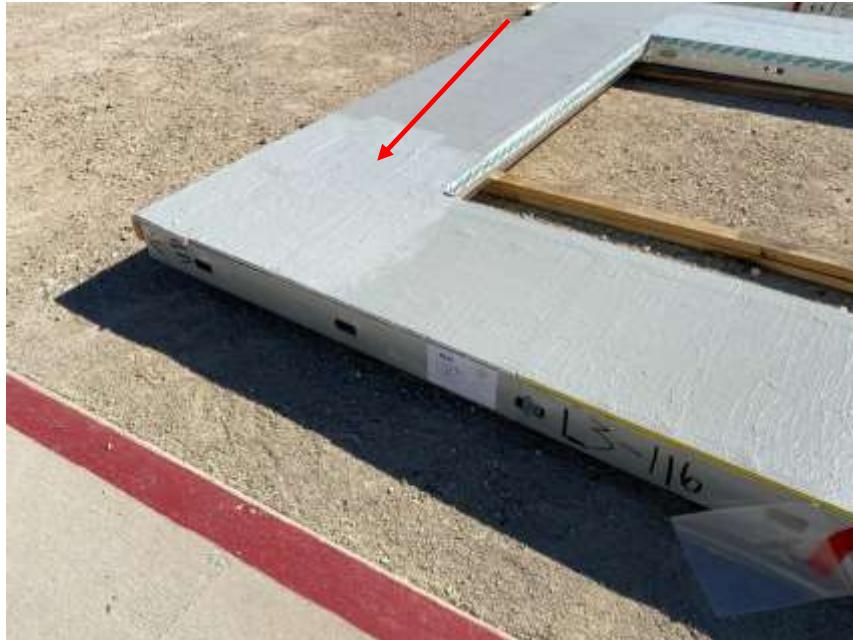
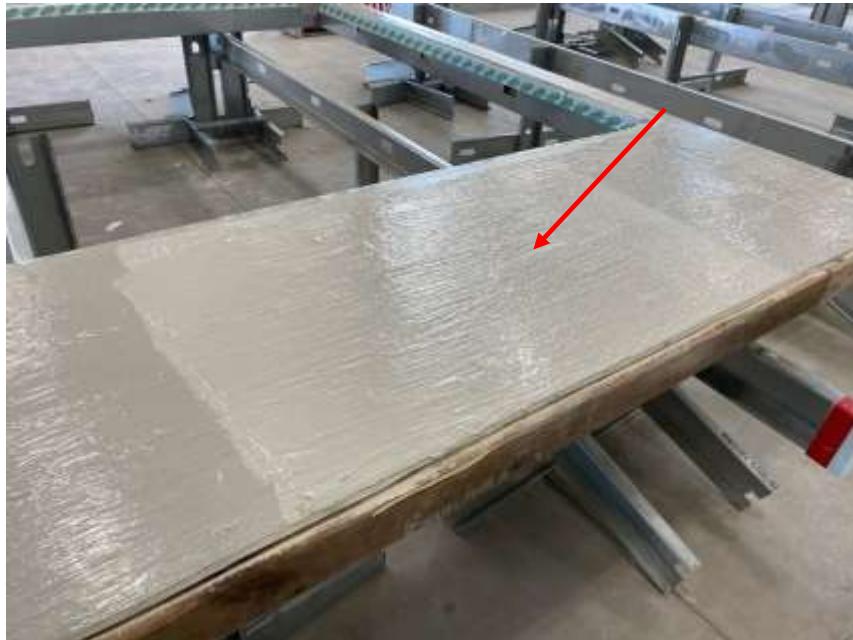
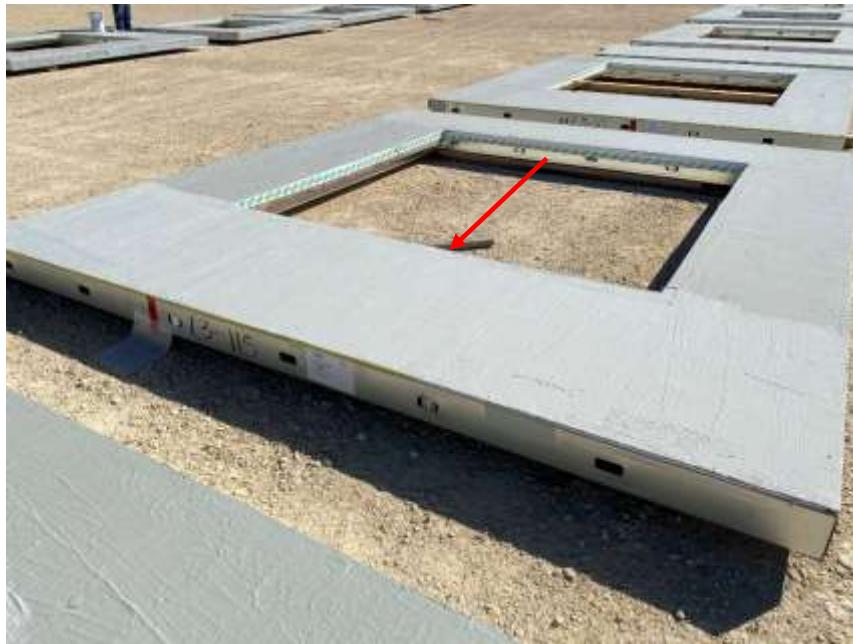
**Note:** Panels that needed additional coating are as follows:  
EX-L5-114, EX-L5-107, EX-L3-116, EX-L3-103 and EX-L3-115.

**Photo 4**  
**Example of Recoating of Panel EX-L5-114**

**Photo 5**  
**Example of Recoating of Panel EX-L3-103**

**Photo 6**  
**Example of Recoating of Panel EX-L3-116**

**Photo 7**  
**Example of Recoating of Panel EX-L5-107**

**Photo 8**  
**Example of Recoating of Panel EX-L3-115**

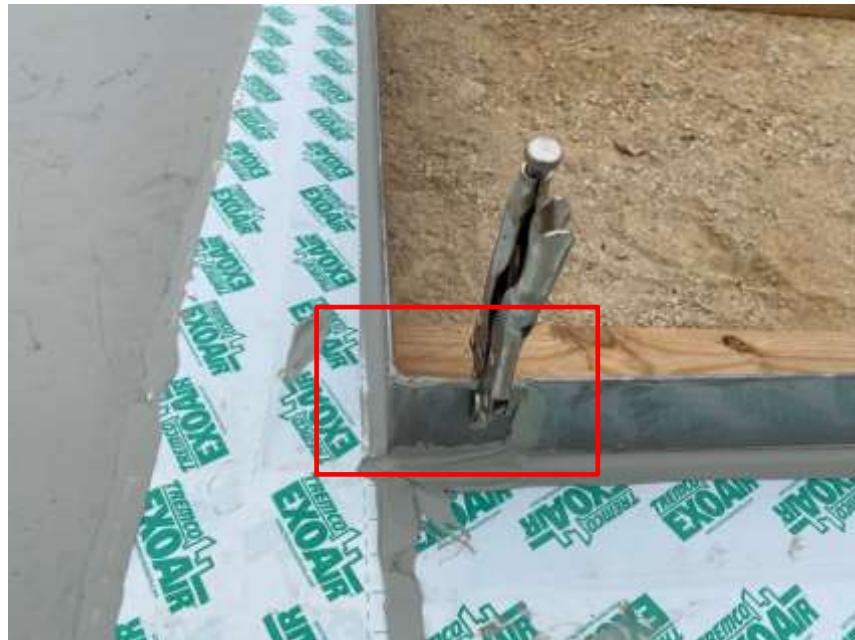
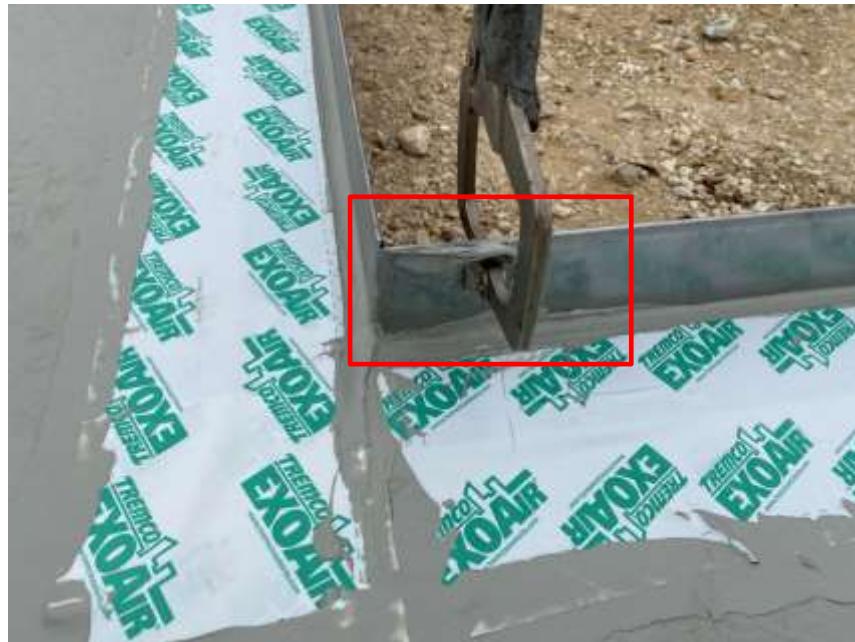
**Photo 1**  
**Example of Recommended Pressure Clamp**

**Photo 2**  
**Example of Recommended Pressure Clamp**

1. ZSC visited F&L Crane to observe the ongoing waterproofing of the prefabricated exterior panels. At the time of the observation ZSC noted the installation of the "T" flashing on panels that have been coated with AB. An observation of pressure clamps was made keep pressure at the corner tab to promote adhesion at SS flashing. Pressure clips were also utilized to promote adhesion but it appeared to not work as effective as the pressure clamps. ZSC recommends for the utilization of pressure clamps to be utilized vs pressure clips. In addition, any exposed seam to be sealed with additional sealant.

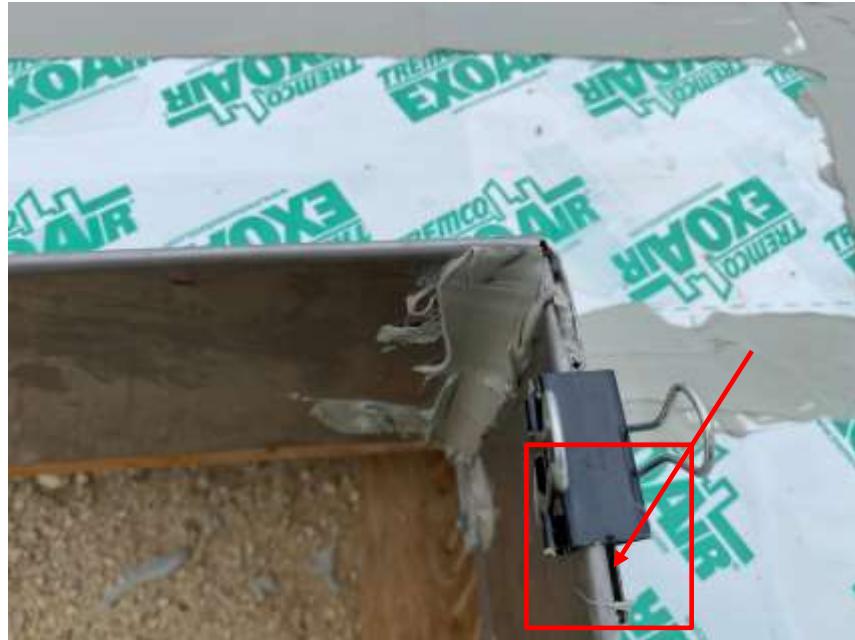
**Photo 3**  
**Example of Gaps at "T" Flashing Tab**

**Photo 4**  
**Example of Gaps at "T" Flashing Tab**

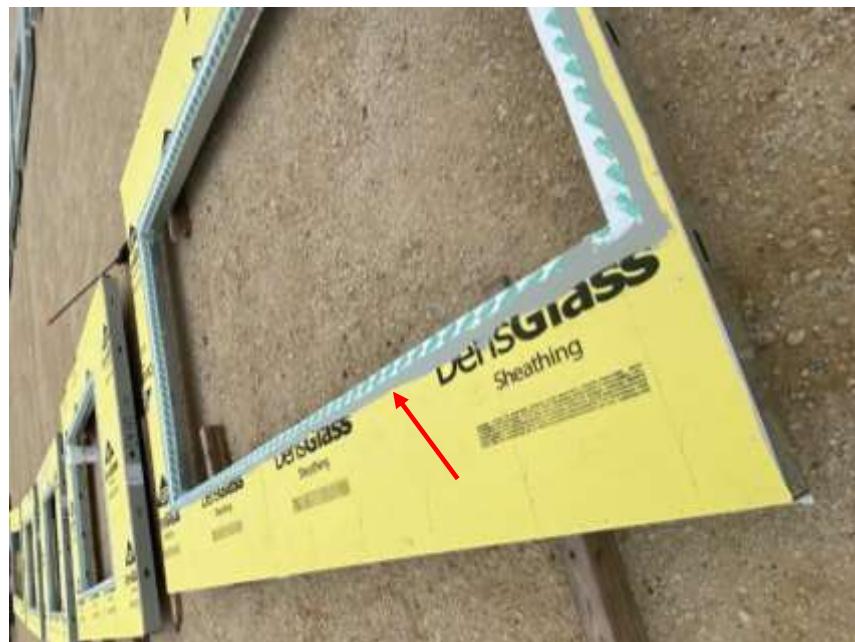
2. ZSC noted the installation of SAMF at the perimeter of the window opening, the seams of the SAMF appeared to have been sealed at the seem as premanufacture installation specification. Application by Chamberlain appeared to have been

done in a workmanlike manner, no deficiencies were noted at the time of observation and installation appeared to be sufficient. *See Photos 5-6*

**Photo 5**  
**Example of SAMF at Window Opening**

**Photo 6**  
**Example of SAMF at Window Opening**

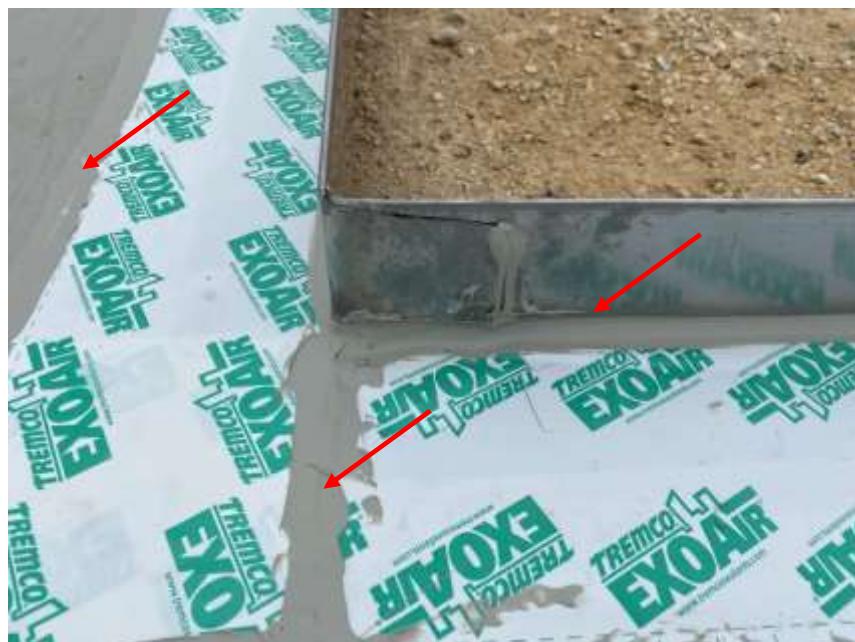
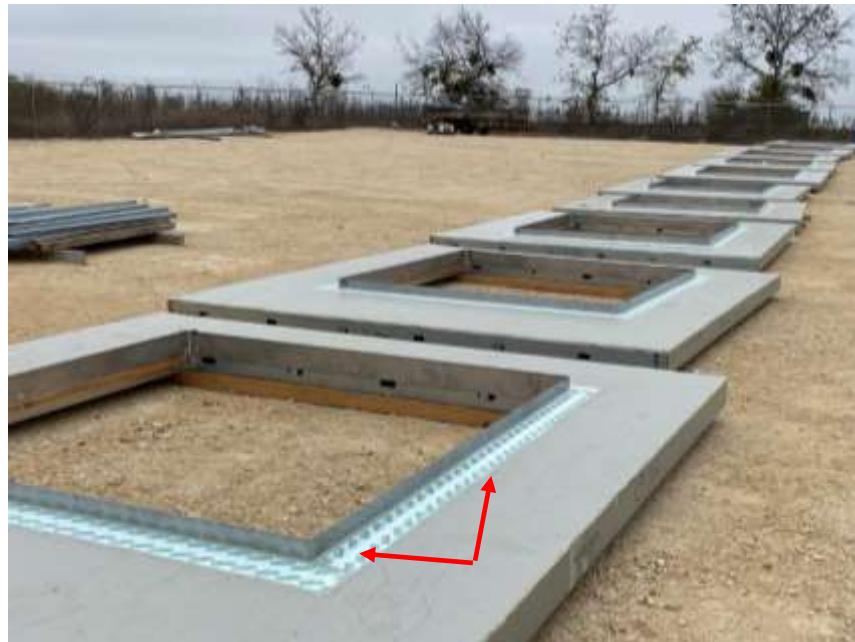
3. ZSC noted the installation of the SAMF at the exterior perimeter of the "T" flashing. Application of the SAMF appeared to have been sealed as per manufacture specifications at the seams. No deficiencies were noted at the time of observation and installation appeared to be sufficient. *See Photos 7-8*

**Photo 7**  
**Example of SAMF Sealed at Terminations**

**Photo 8**  
**Example of SAMF Sealed at Terminations**

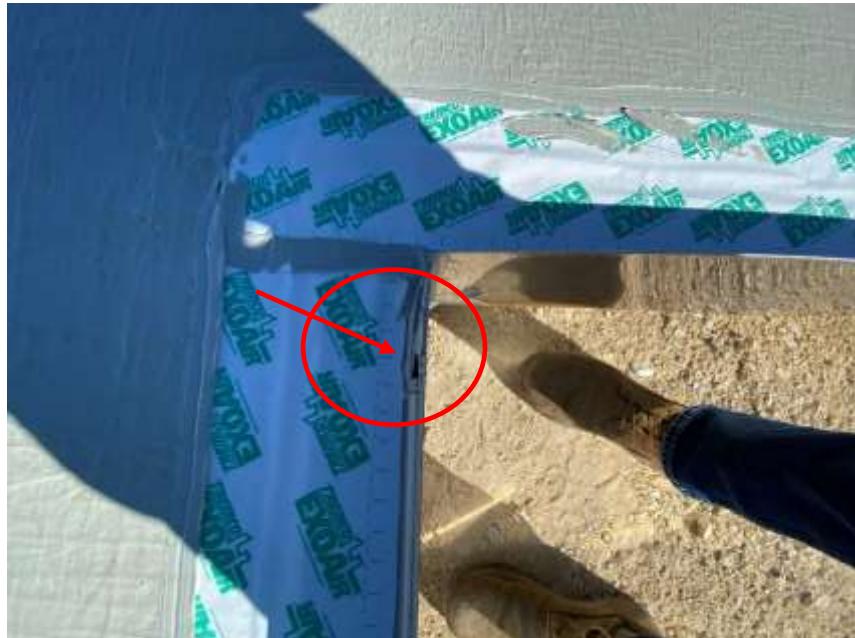
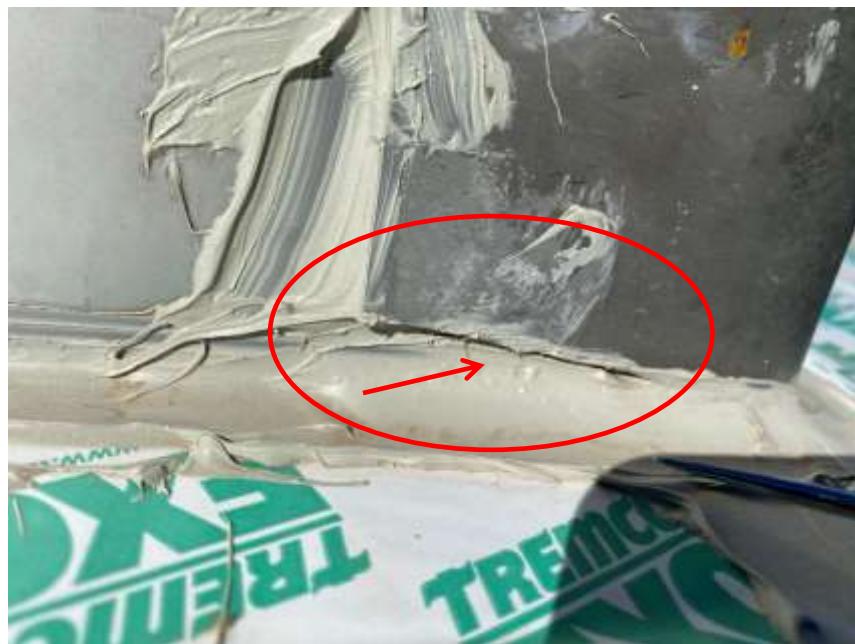
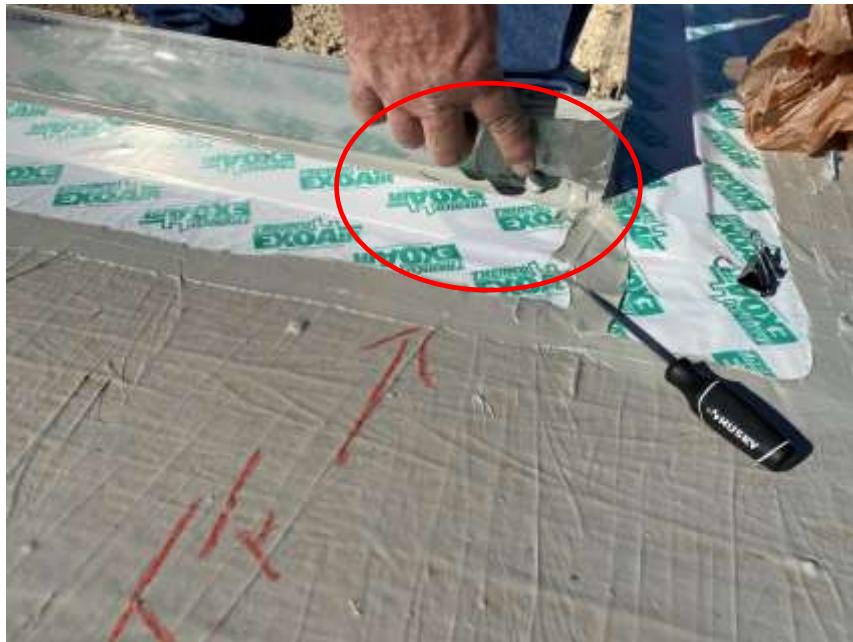
**Note:** ZSC noted the ongoing construction of exterior elevation panels at F&L Crane. The panels for the 3<sup>rd</sup> elevation appeared to be ready for site mobilization and onsite installation. Testing of the fluid applied AB has been measured and appeared to meet the manufacturer mil and project specifications for mil thickness. Additionally, the installation of the T-flashing was observed and appeared to have needed additional sealant at seams. Chamberlain roofing was on site to address areas that appeared to be suspect, ZSC recommended for additional sealant to be applied at specified locations. Contractor proceeded to address as recommended on site in a workmanlike manner. No deficiencies were noted at the time of observation and application appeared to be sufficient. ***See Photos 1-4***

**Photo 1**  
**Example of Missing Sealant**

**Photo 3**  
**Example of Sealant Needed**

**Photo 4**  
**Example of Sealant Addressed**

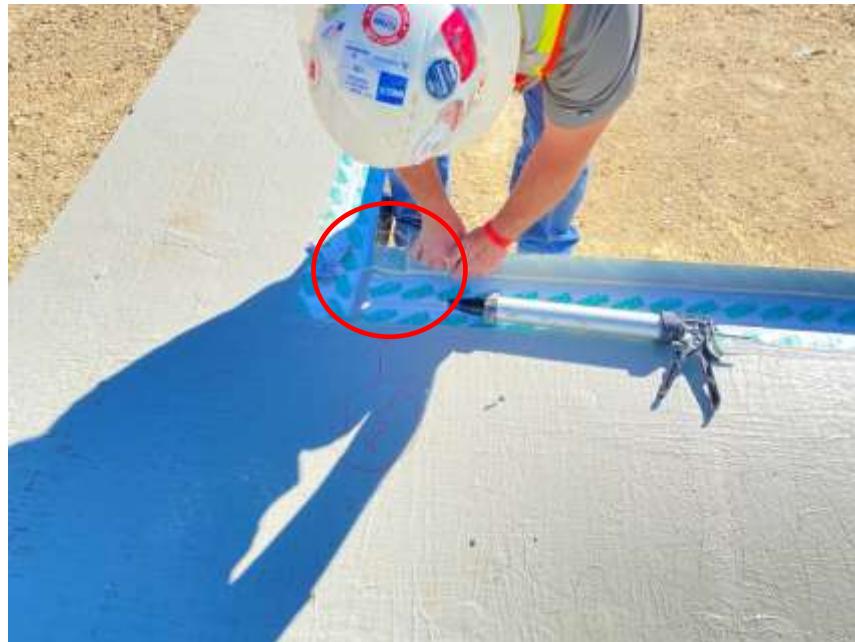
**Photo 2**  
**Example of Sealant Addressed**

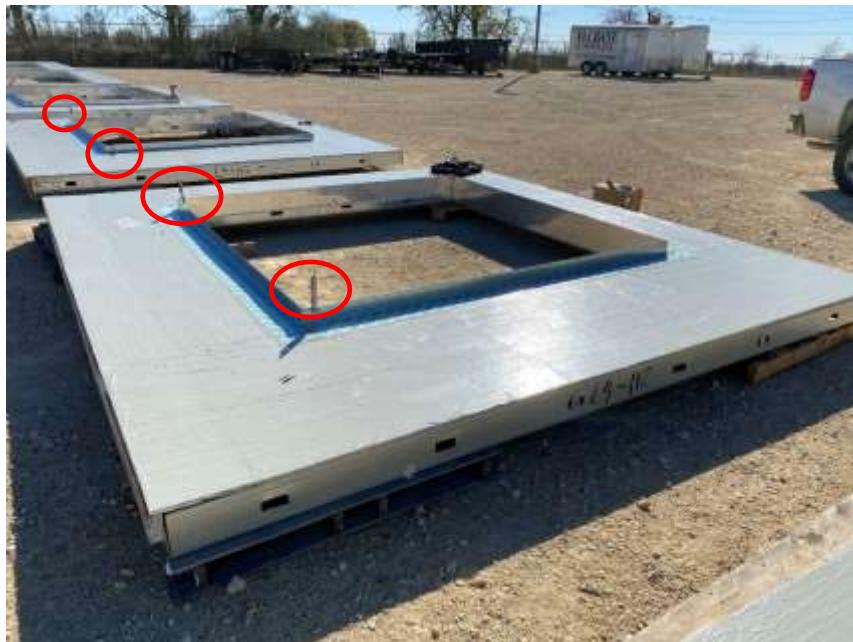
**Photo 5**  
**Example of Clamps Placed at Corners  
As Recommended**

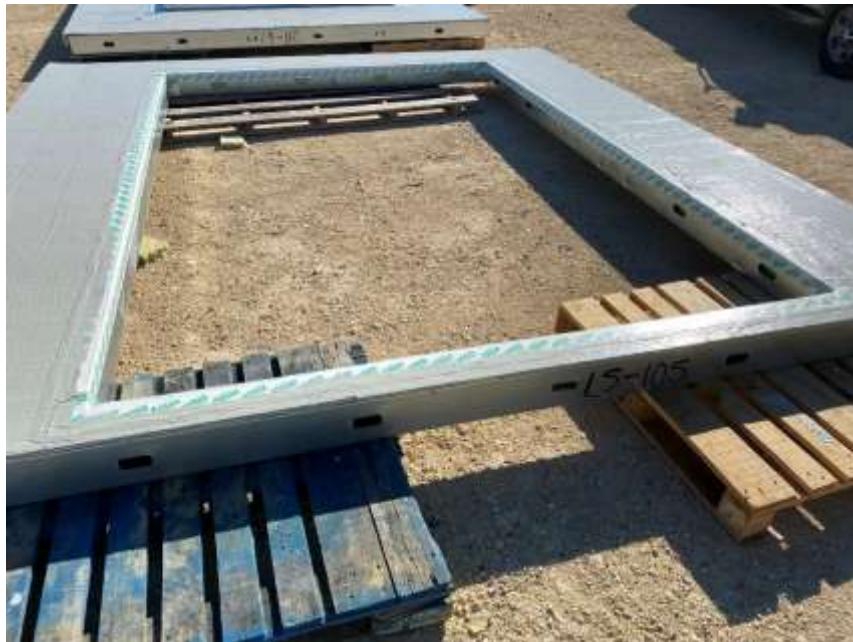
**Photo 6**  
**Example of SAMF Terminated**

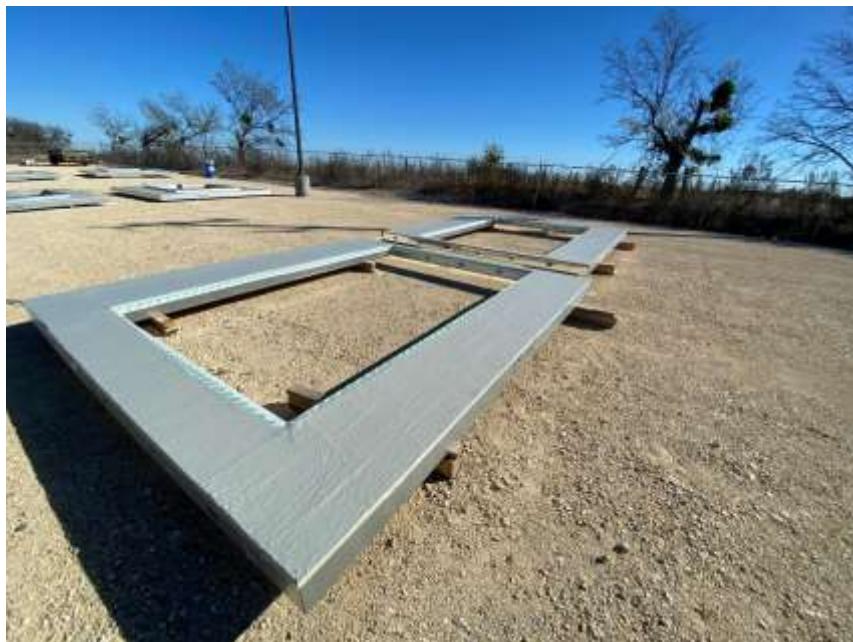
1. ZSC observed the ongoing construction of the exterior panels for the 4<sup>th</sup> elevation. The application of the T-flashing sealant was observed, Chamberlin appeared to be working in a workmanlike manner and application appeared to be in accordance to manufacture installation specifications. Additionally, the application of the SAMF at the T-flashing and wall transition appeared to have been installed as per manufacture installation specifications. No additional deficiencies were noted at the time of observation and installation appeared to be sufficient. ***See Photos 5-7***

**Photo 7**  
**Example of AB Application**

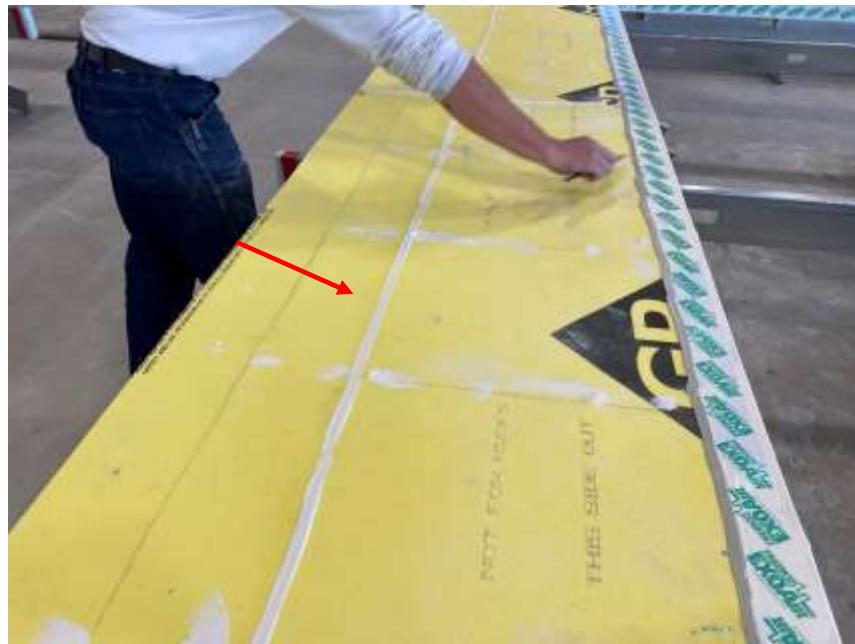
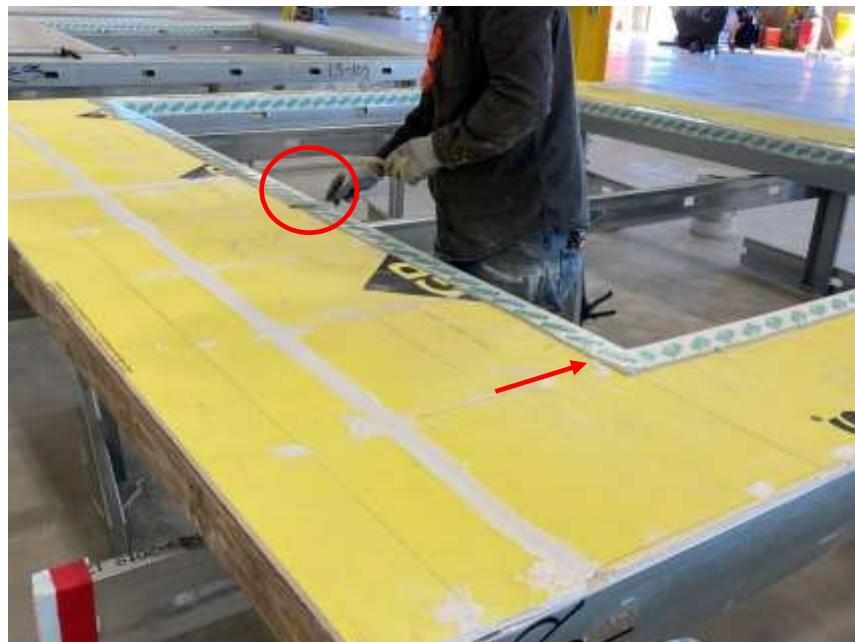
2. ZSC observed the application of bonding agent at the fastener penetrations and seams. Chamberlain appeared to be working in a workmanlike manner and application appeared to be in accordance to manufacture installation specifications. No deficiencies were noted at the time of observation and installation appeared to be sufficient. ***See Photos 8-10***

**Photo 8**  
**Example Seam/ Penetration Compound Application**

**Photo 9**  
**Example of SAMF Termination Application**

**Photo 10**  
**Example Seam/ Penetration Compound Application**

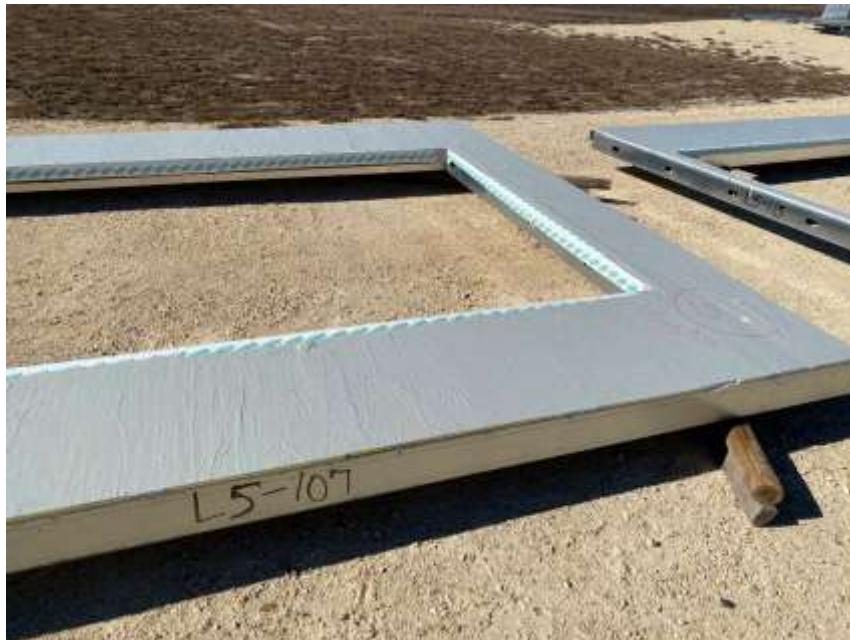
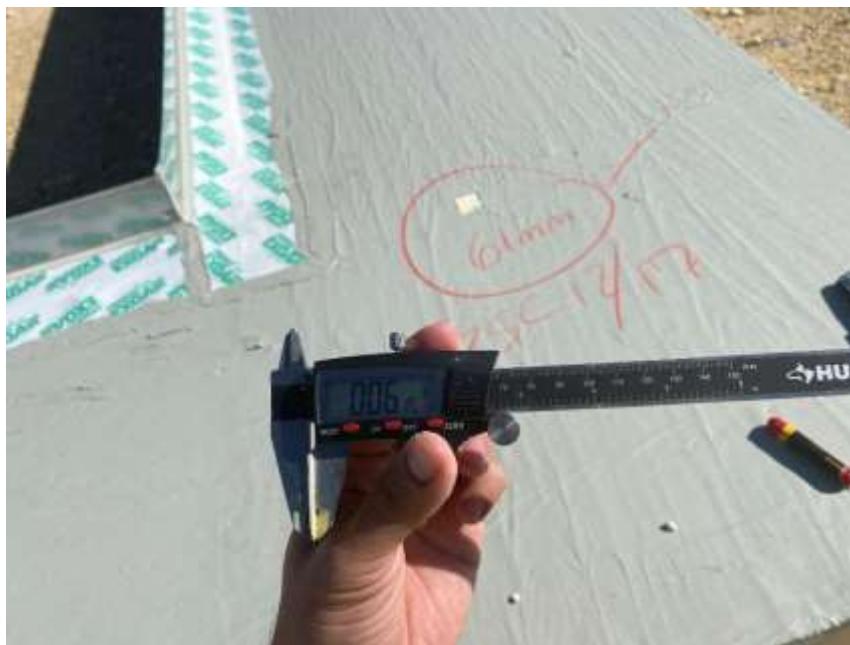
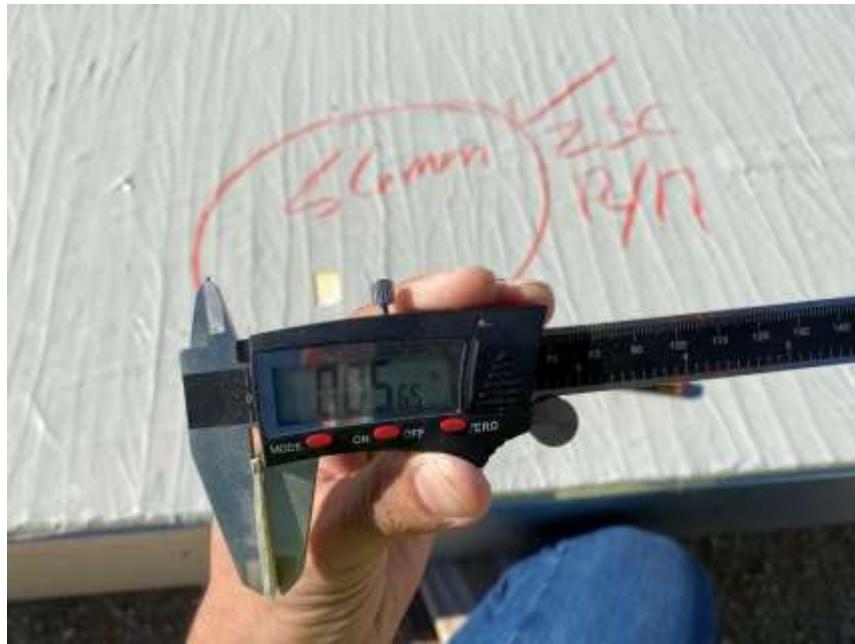
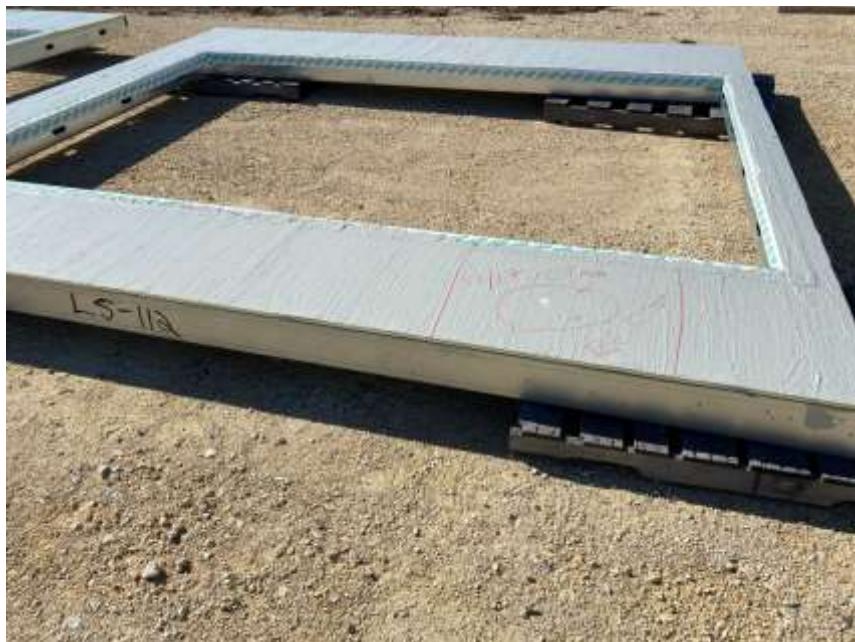
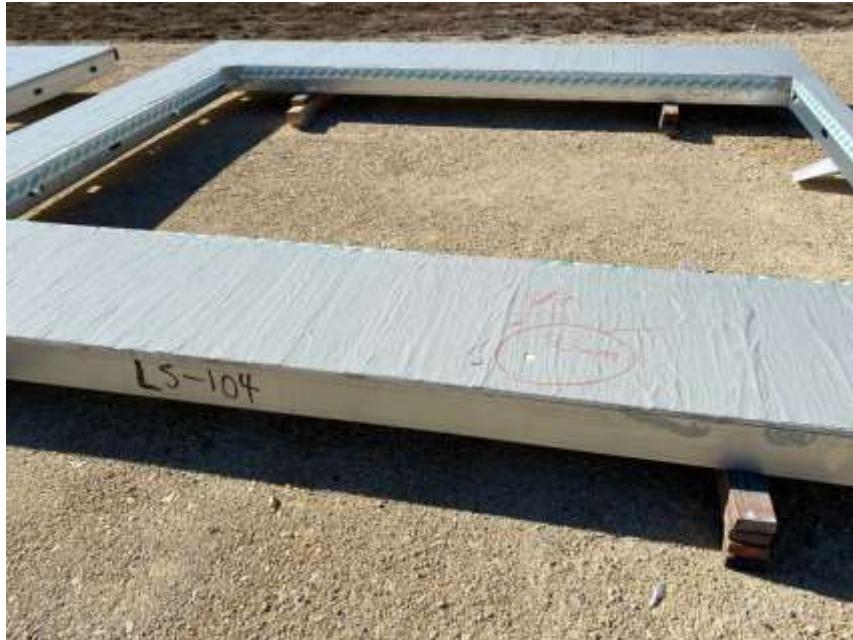
**Photo 1**  
**Example of AB Reading**

**Photo 2**  
**Example of AB Reading**

**Photo 3**  
**Example of AB Reading**

**Photo 4**  
**Example of AB Recoating**

**Photo 5**  
**Example of AB Recoating**

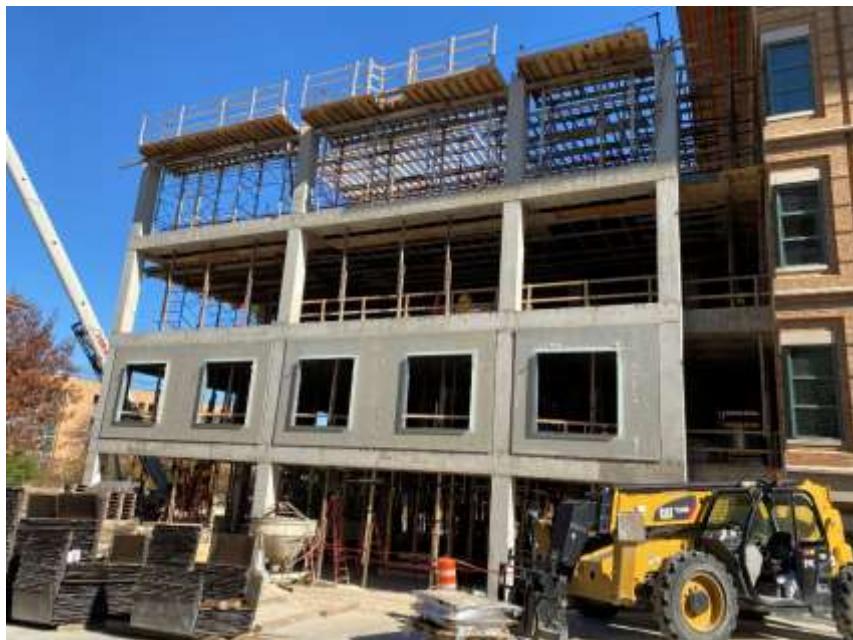
**Photo 6**  
**Example of West Elevation Panels**

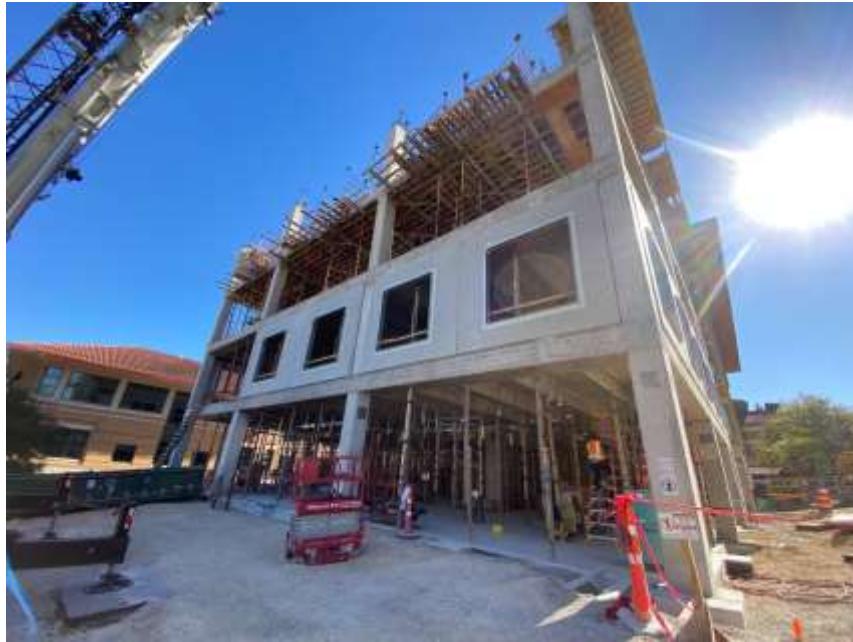
**Photo 7**  
**Example of North Elevation Panels**

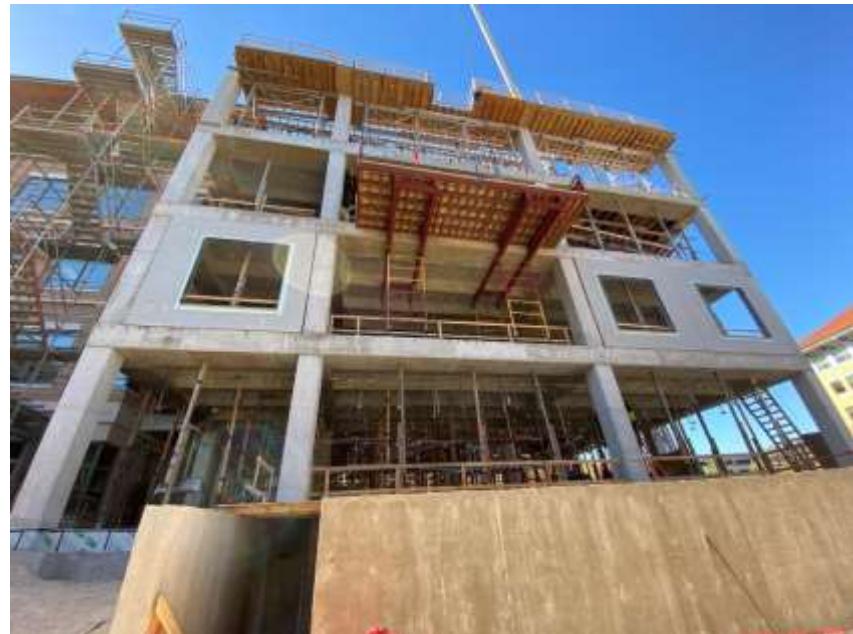
**Photo 8**  
**Example of East Elevation Panels**

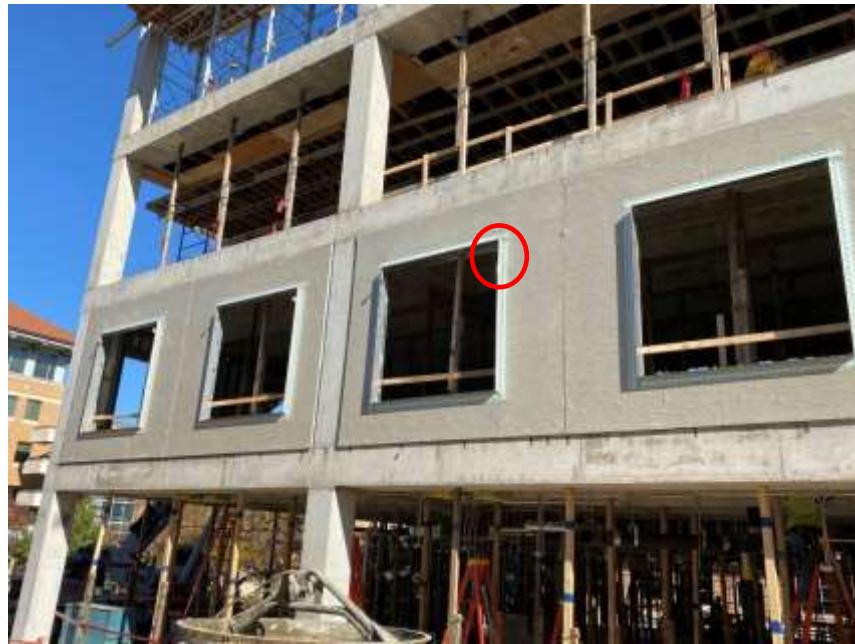
**Photo 9**  
**Example of SS Flashing Dent**

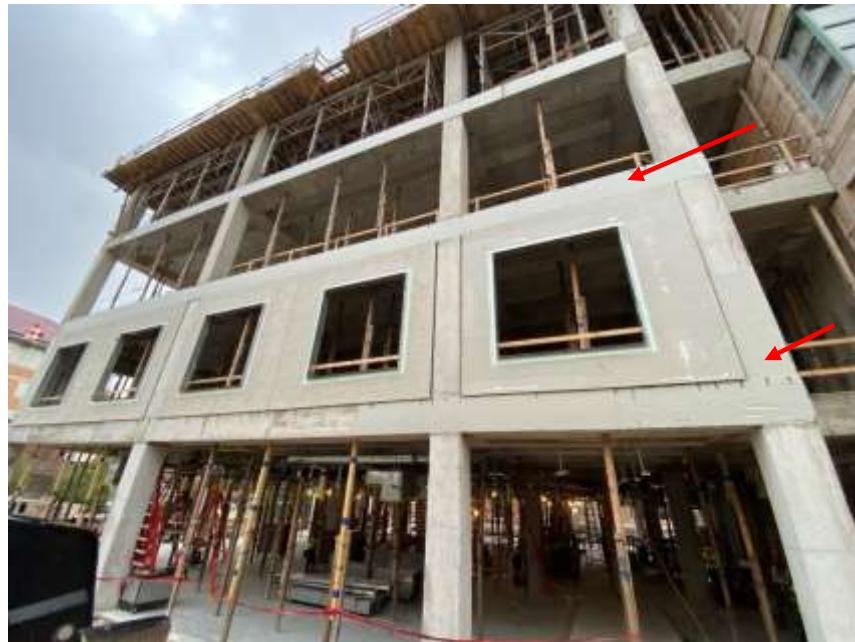
- ZSC visited the site to observe the ongoing construction related to the building envelope. Due to rain event, no exterior work was being performed at the time of observation. However, at the west elevation, level 3 between columns A-D, ZSC noted the commencement of the fluid applied AB onto the concrete. Application appeared to have been applied in a workman like manner and per application specifications. No deficiencies were noted at the time of observations and installation appeared to be sufficient. **See Photo 1**

**Photo 1**  
**Example of AB Application**

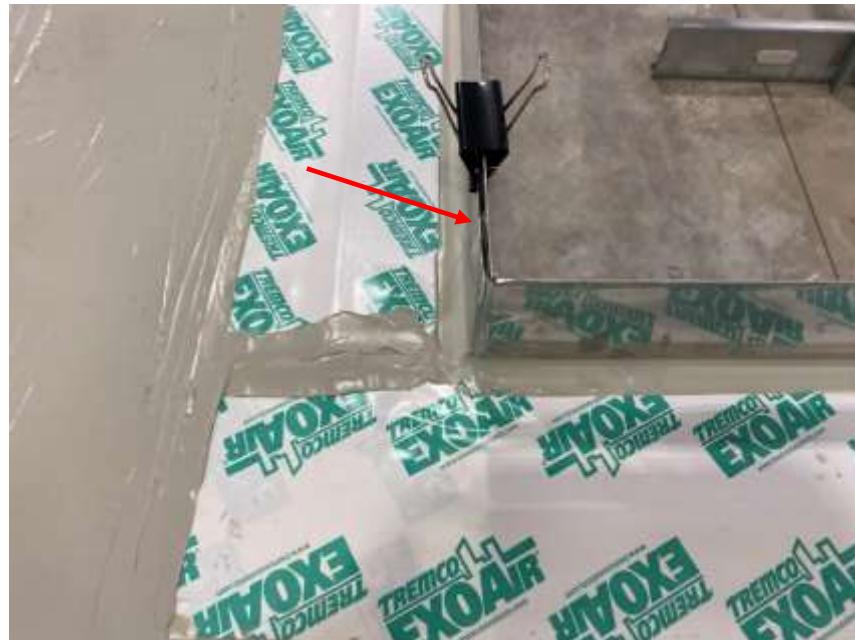
1. ZSC noted the level 4 panels SS T-flashing and SAMF at the perimeter of flashing. At the time of the observation ZSC noted the termination seams of the SAMF not installed as per manufacture installation specifications, leaving multiple fishmouths subject to moisture intrusion. It was also noted that SS flashing tabs have not been adequately bedded in sealant. ZSC recommends for SAMF to be removed and reapplied to promote adhesion and terminated per manufacture specifications. Additionally, it is recommended that SS tabs be bedded injected with sealant to prevent an avenue for moisture intrusion. **See Photos 1-6**

**Photo 1**  
**Example of Dry Lap at SS Tab**

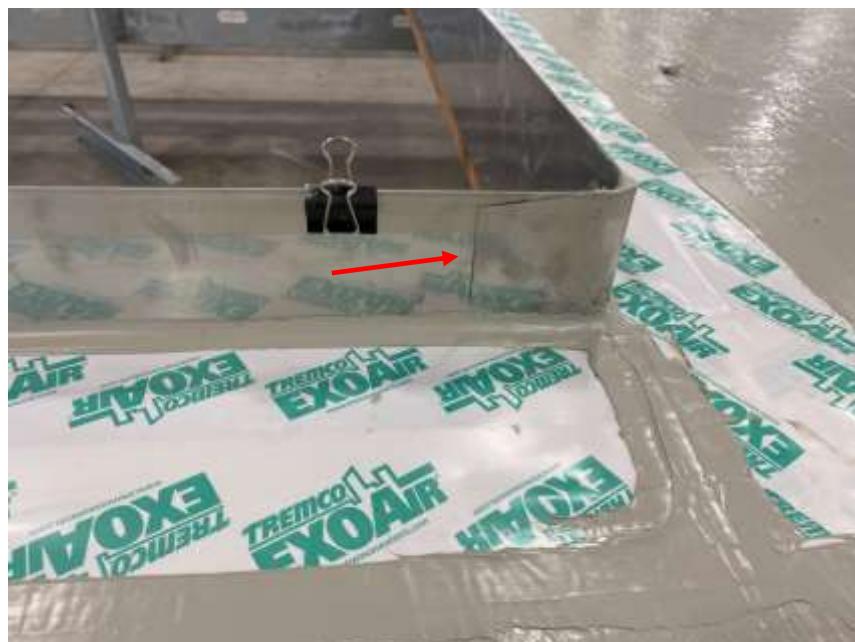
**Photo 2**  
**Example of No Sealant Bleed Out at Tabs**

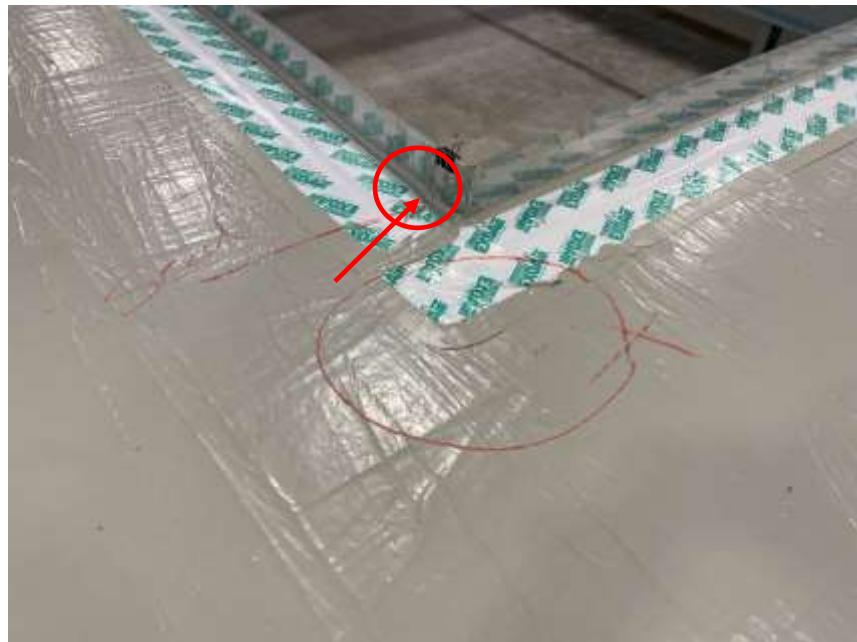
**Photo 4**  
**Example of Opening in Sealant at SS**

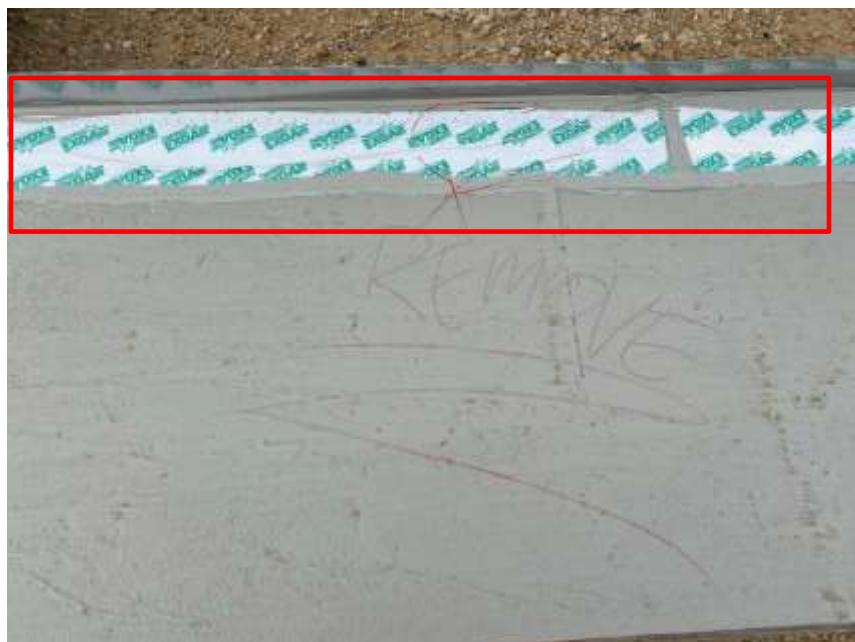
**Photo 6**  
**Example of “Fish Mouth” Opening in SAMF**

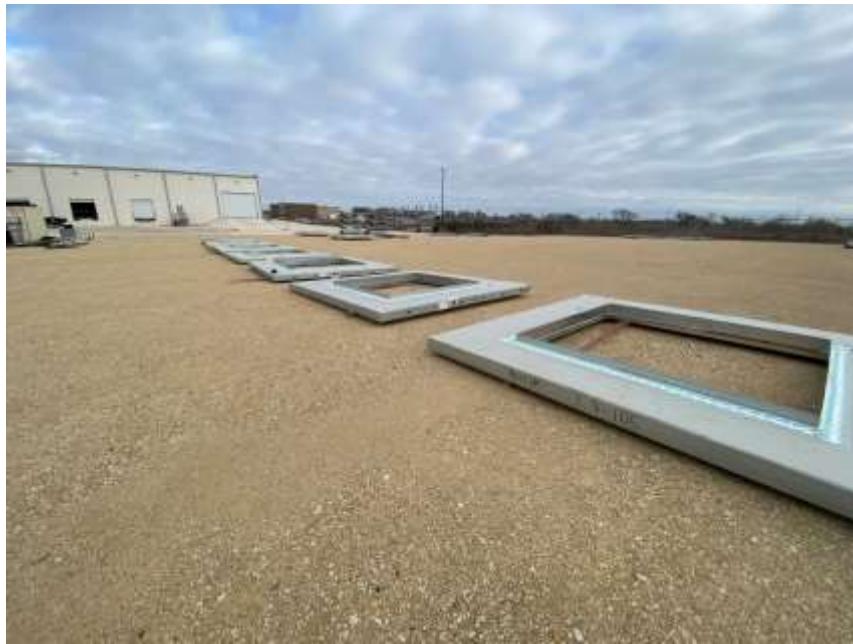
2. ZSC noted the level 4 panels SS T-flashing fasteners not sealed at the interior portion of the SS flashing, ZSC recommends for fasteners to be sealed to prevent moisture intrusion into the SS flashing and envelope. **See Photos 7-10**

**Photo 7**  
**Example of Panels at the Exterior**

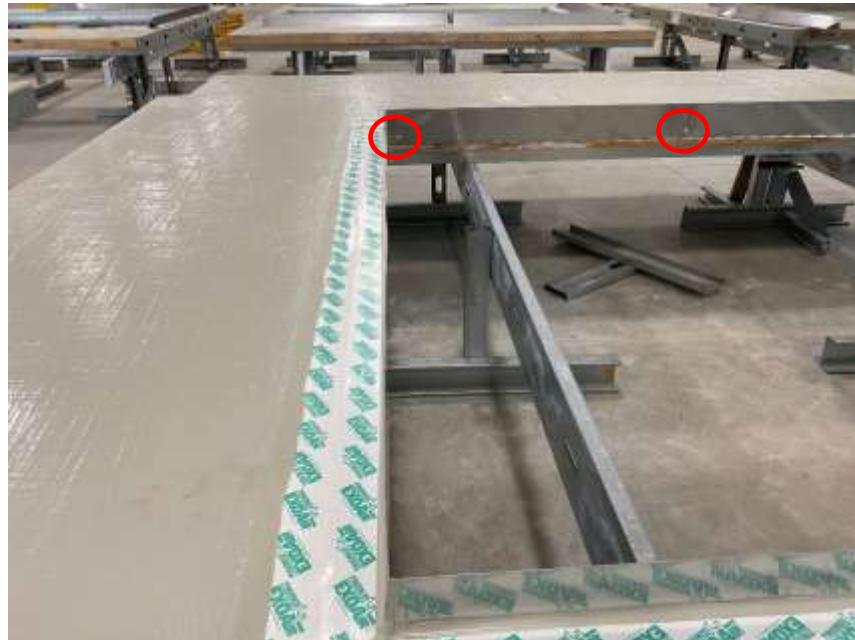
**Photo 10**  
**Example of Fasteners Missing Sealant**
