## SUBMITTAL REVIEW

Description: Aluminum Framed Entrances and Storefronts -SD

Project Name: UT SEAY Building Addition

Project No.: 102-782

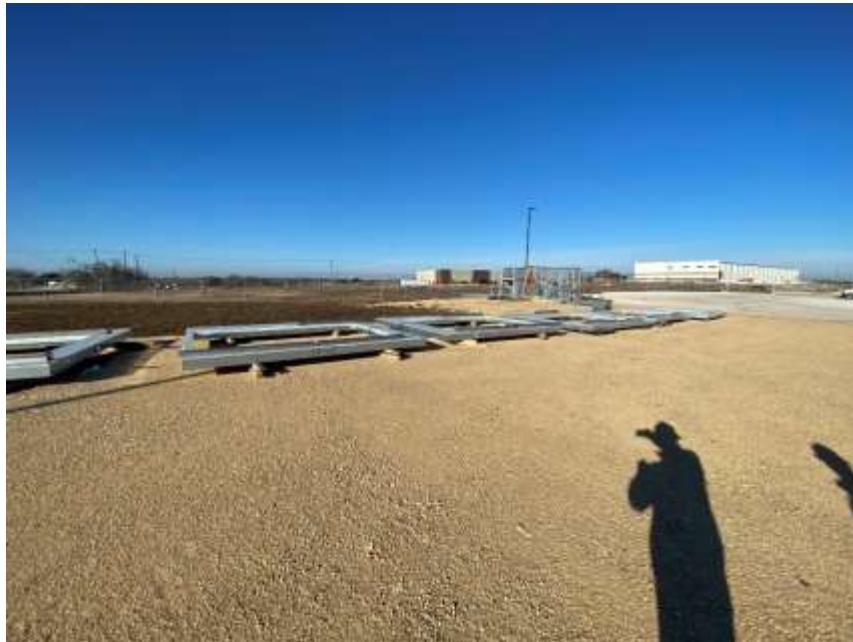
1. ZSC visited F&L Crane to observe the ongoing construction of exterior panels, ZSC observed the AB at the perimeter of the panel opening that are currently being stored at the yard location of F&L Crane. AB appears to be experiencing delamination due to recent snow fall and freezing weather conditions. ZSC recommended for delaminated AB be removed and terminated with sealant to promote adhesion at the seam. Chamberlain was onsite to perform repairs, contractor appeared to be working in a workmanlike manner. No further deficiencies were noted at the time of observation and installation appeared to be sufficient. **See Photos 1-8**
2. ZSC observed the ongoing installation of the SS T-flashing, Installation by Chamberlain, materials appeared to be installed in a workmanlike manner and in accordance to project specifications. A bead of sealant was applied between the

**Photo 1**  
**Example of that Experienced Delamination**

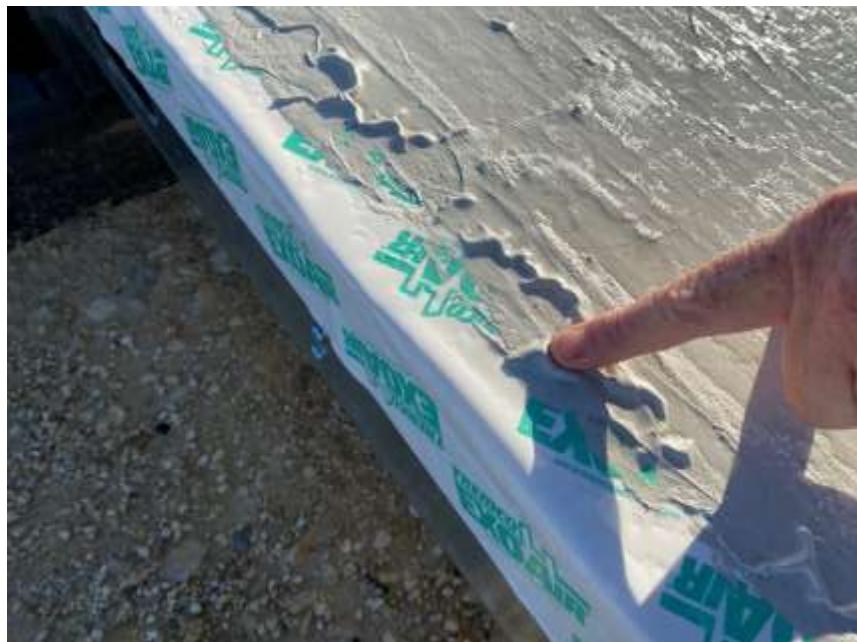
**Photo 2**  
**Example of Delamination**

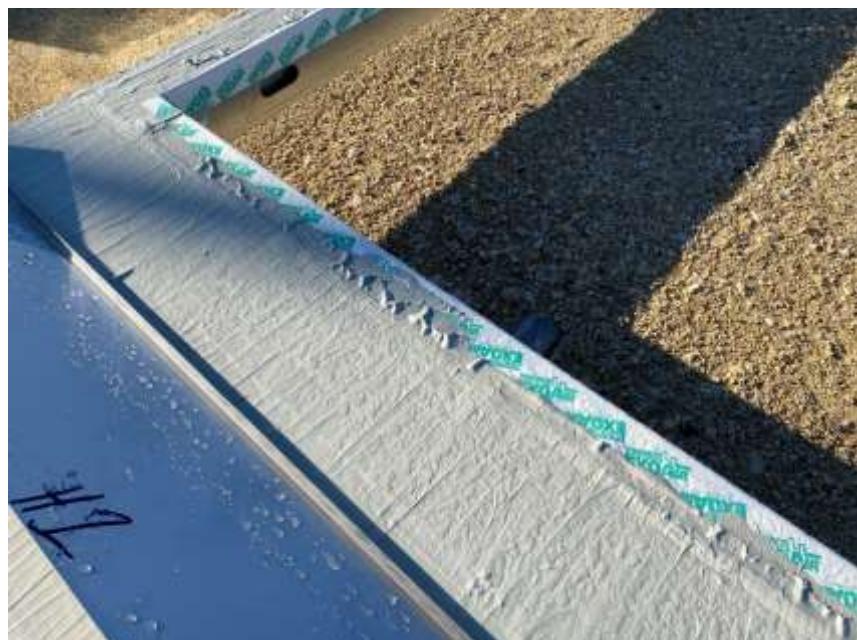
**Photo 3**  
**Example of Delamination**

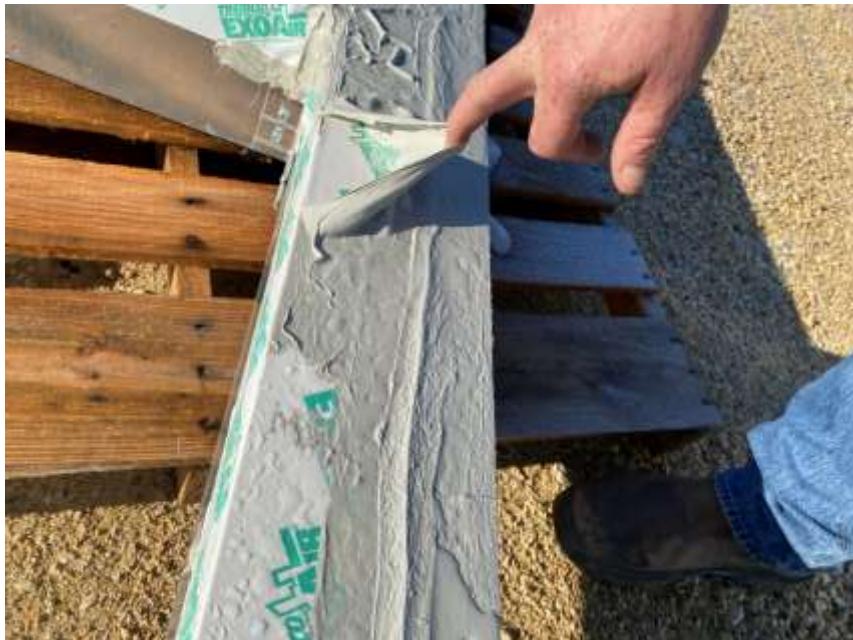
**Photo 4**  
**Example of Delamination**

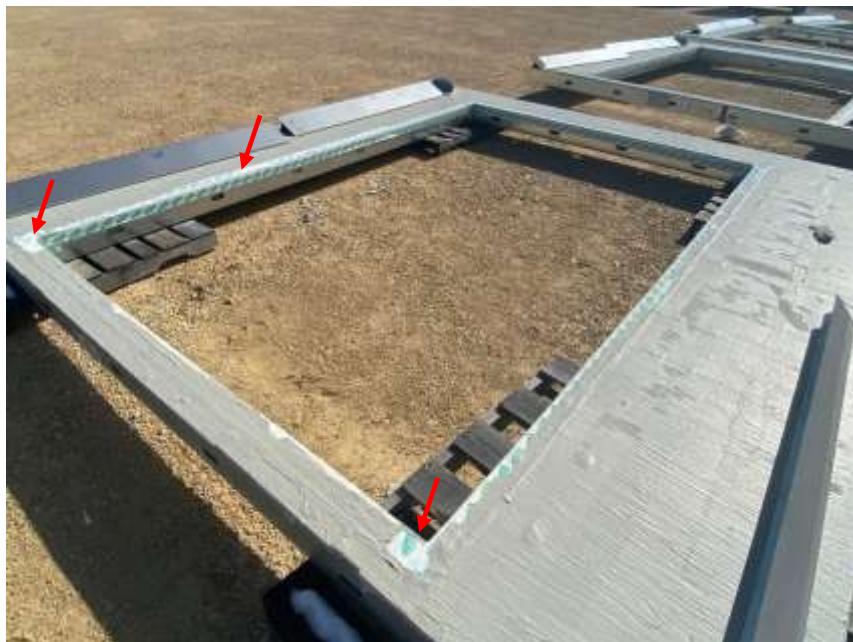
**Photo 5**  
**Example of Delamination Removed**

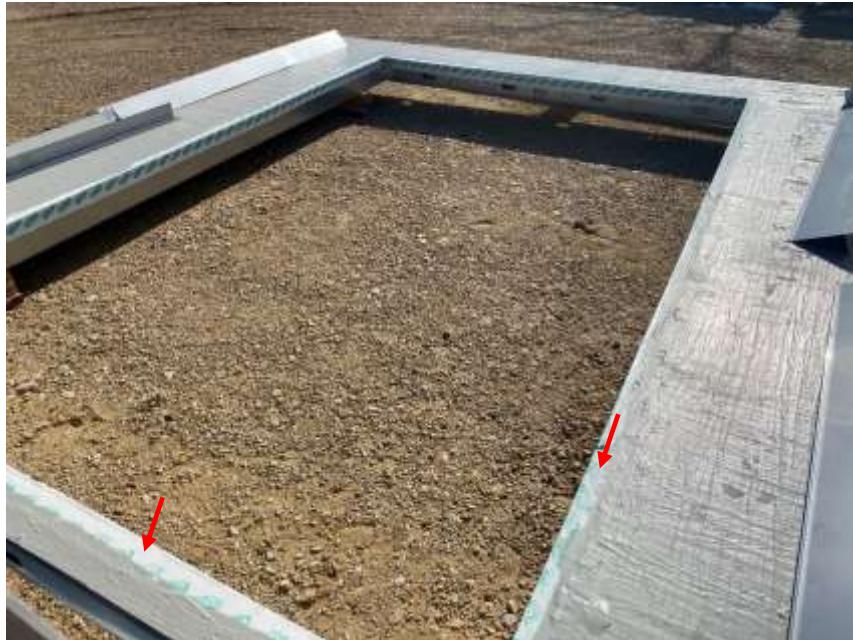
**Photo 6**  
**Example of Delamination Removed**

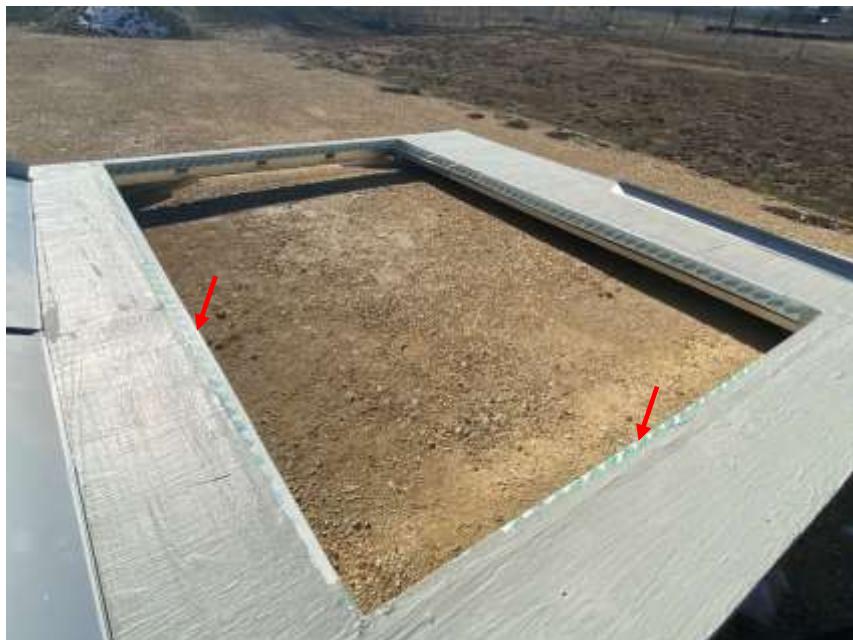
**Photo 7**  
**Example of Delamination Removed**

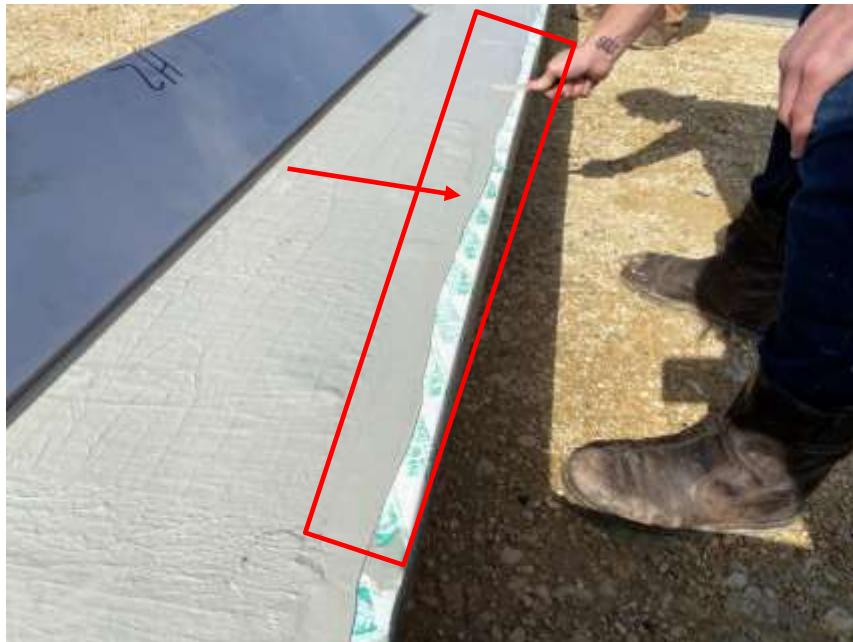
**Photo 8**  
**Example of Sealant Application**

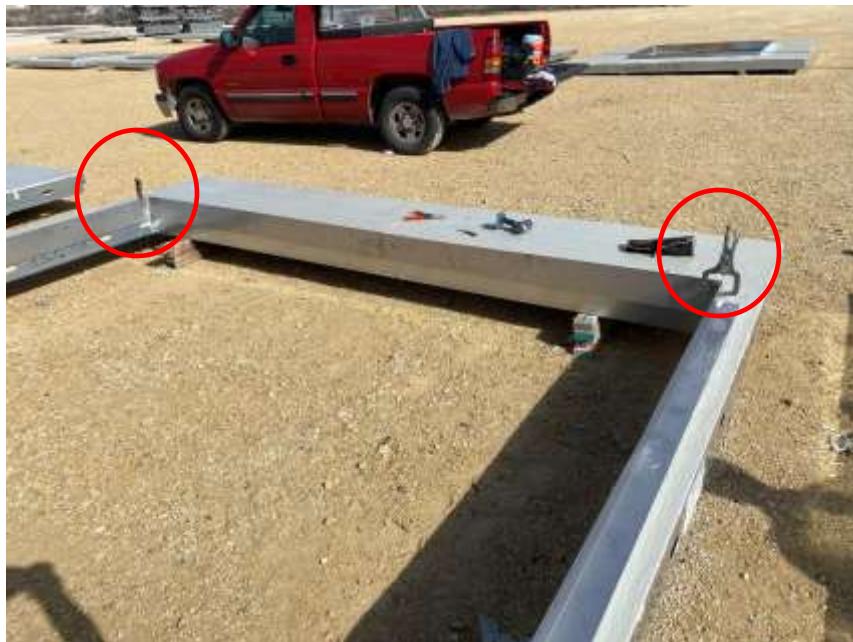
SS and panel surface to promote adhesion. No deficiencies were noted at the time of observation and installation appeared sufficient. *See Photos 9-12*

**Photo 9**  
**Example of Corners Compressed  
For Adhesion**

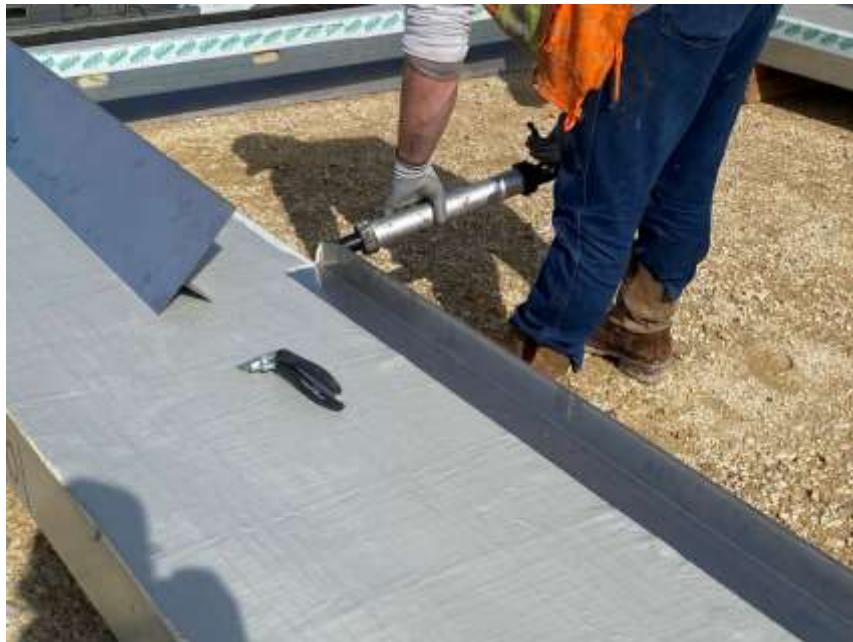
**Photo 10**  
**Example of Sealant Application**  
**At Seam**

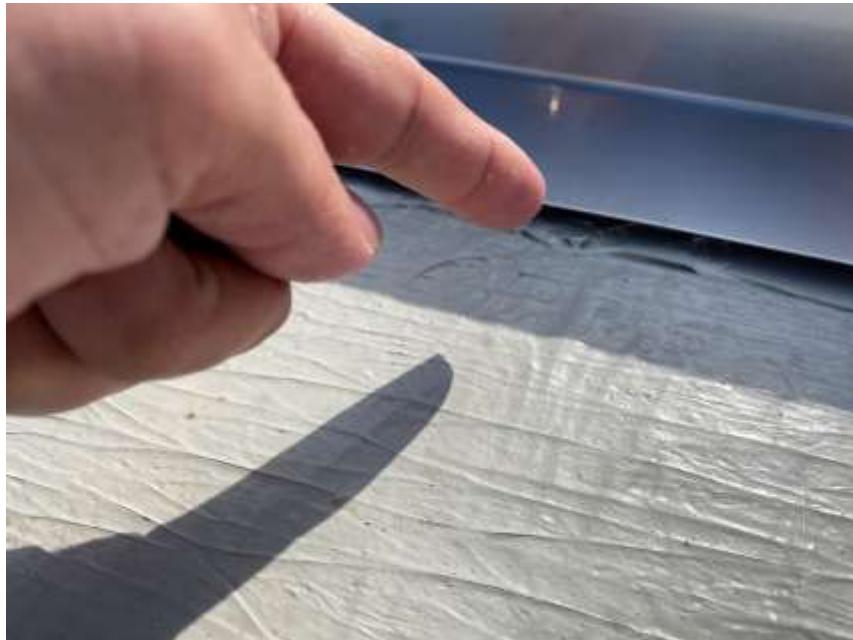
**Photo 11**  
**Example of Sealant Present**

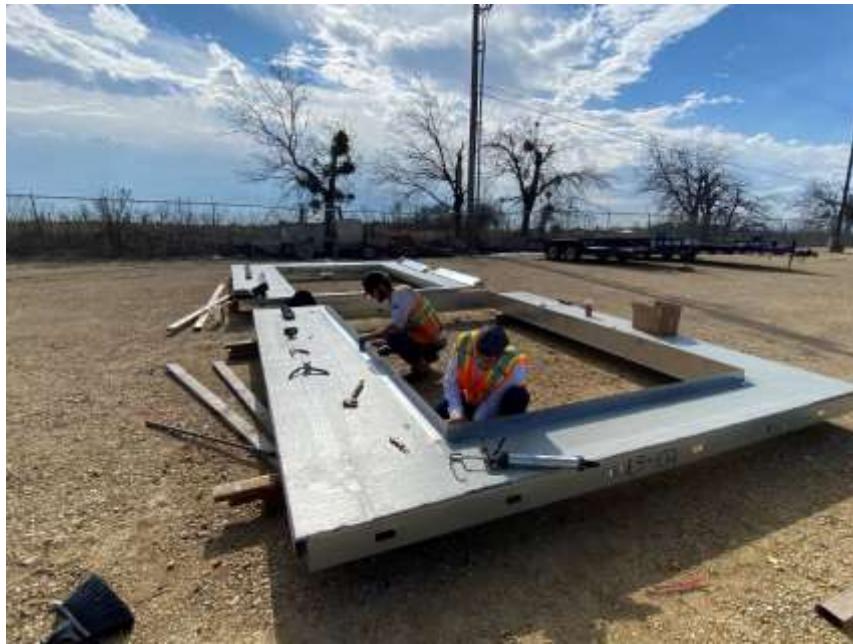
**Photo 12**  
**Example of Ongoing SS Application**

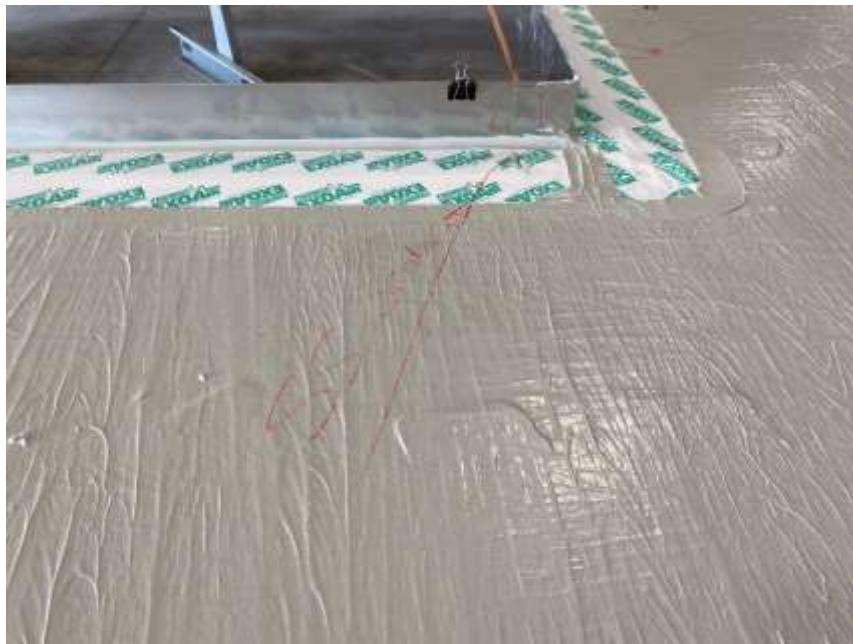
3. ZSC observed the installation of the SS flashing terminations and seams of the panels located at the F&L Crane warehouse. ZSC recommends for SS seams to be sealed to prevent moisture intrusion into the SS flashing. *See Photos 13-15*
4. ZSC observed the installation of the SAMF at the perimeter of SS flashing, ZSC recommends for additional sealant to be applied at the location of exposed seams. Additionally, any damaged SAMF should be detailed and corrected as per manufacture specifications. *See Photos 16-18*

**Photo 13**  
**Example of Additional Sealant at Seam**

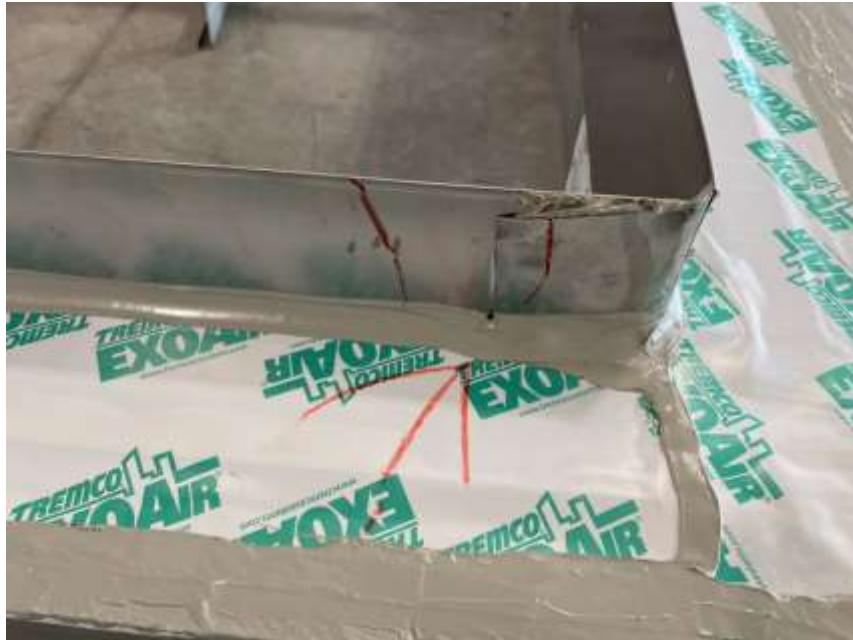
**Photo 14**  
**Example of Additional Sealant at Seam**

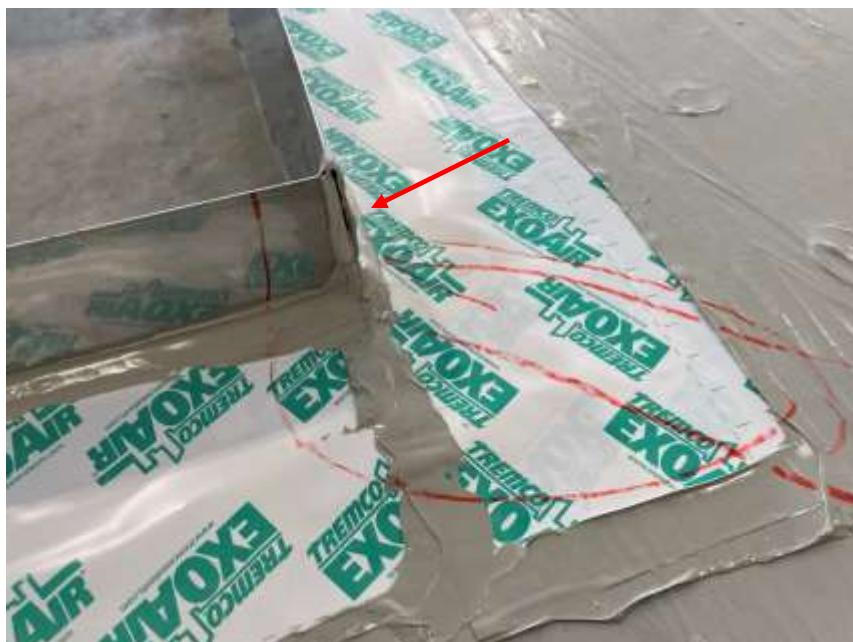
**Photo 15**  
**Example of Additional Sealant at Seam**

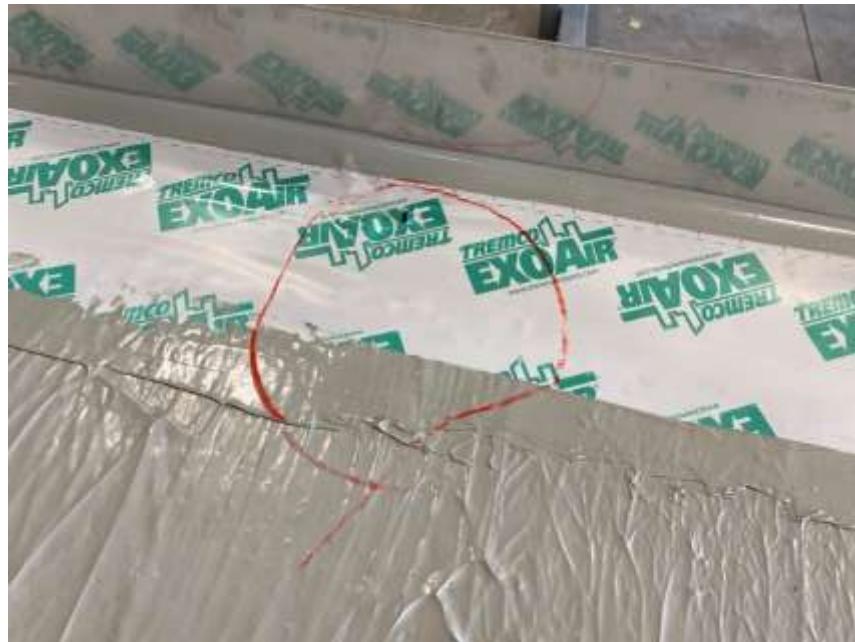
**Photo 16**  
**Example of Intrusion**  
**(Not supposed to be there)**

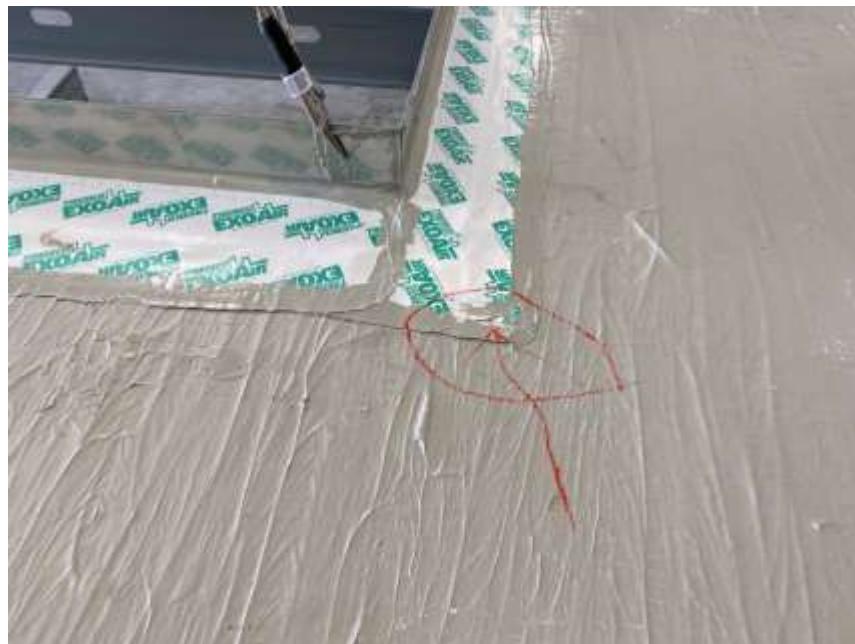
**Photo 17**  
**Example of exposed Seam**

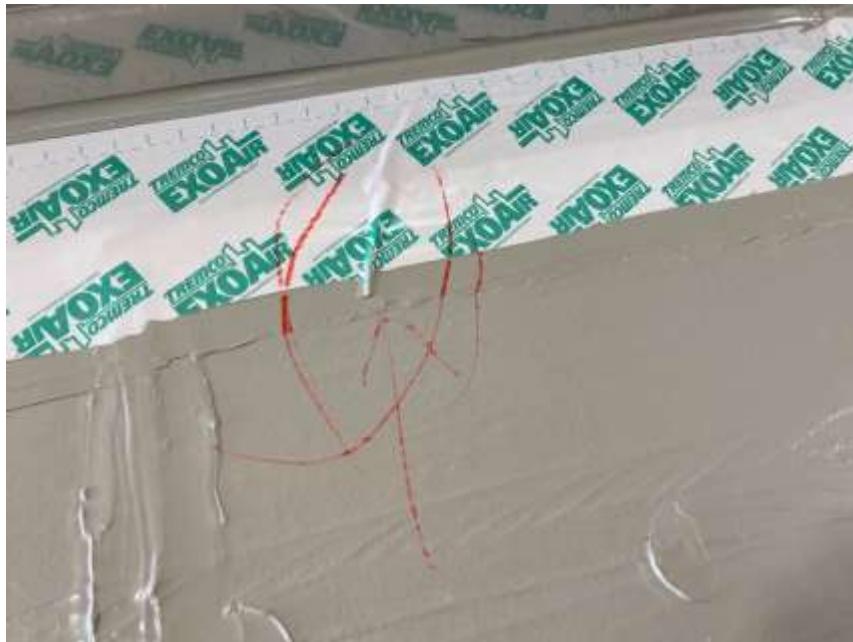
**Photo 18**  
**Example of exposed Seam**

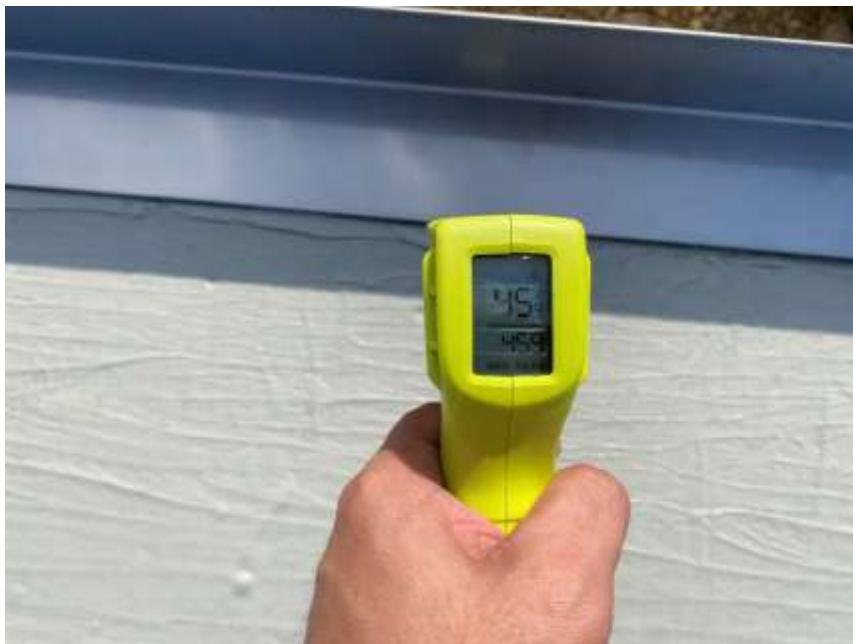
**Note:** Surface temperature of panels were checked prior to sealant application onto panel surface. *See Photo 19*

**Photo 19**  
**Example of Surface Temperature**

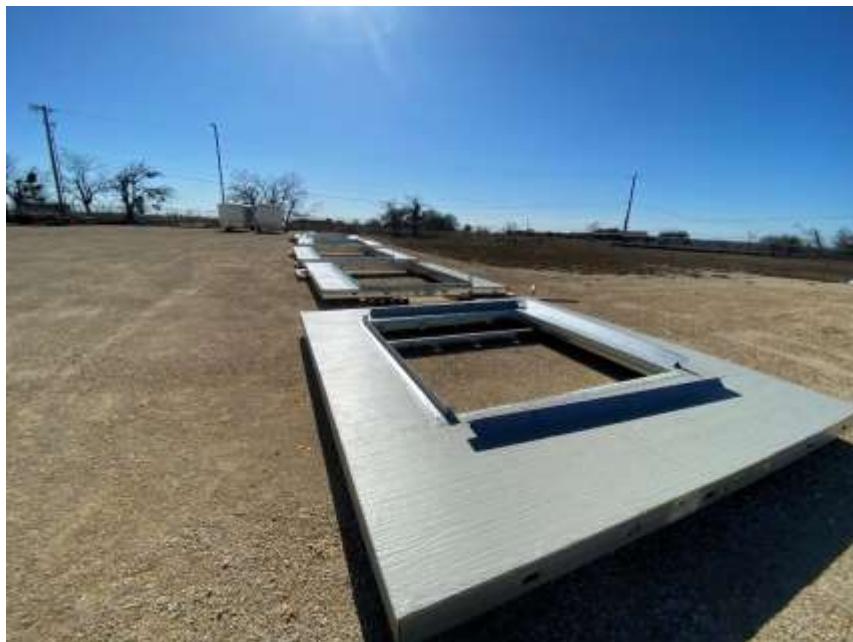
**Photo 1**  
**Example of Ongoing Flashing Installation**

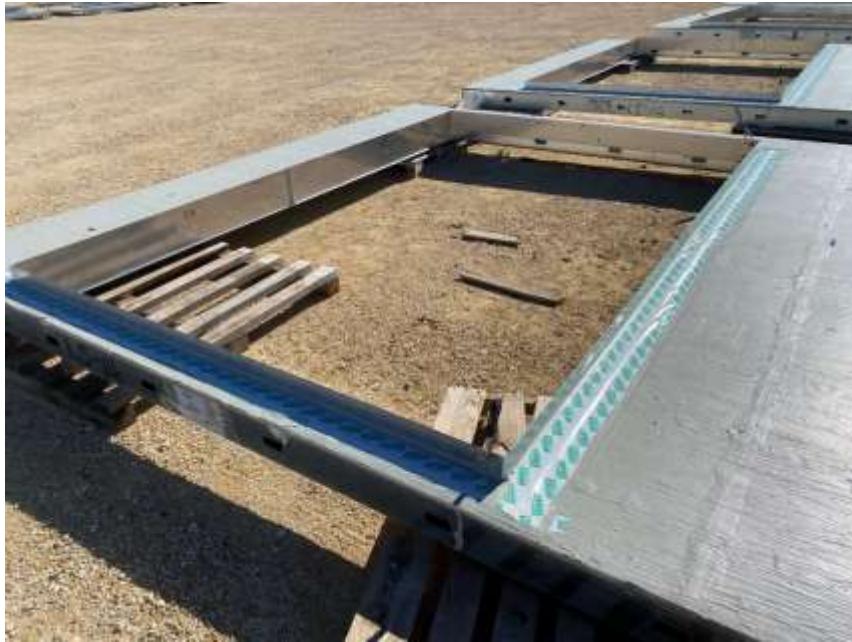
**Photo 2**  
**Example of SS Flashing Finalized**

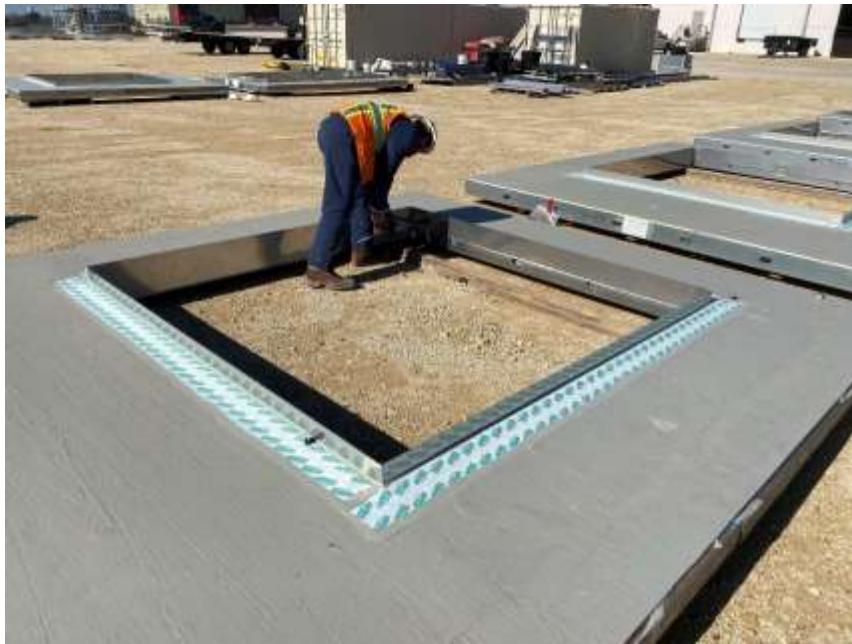
**Photo 3**  
**Example of SS Flashing Detailing**

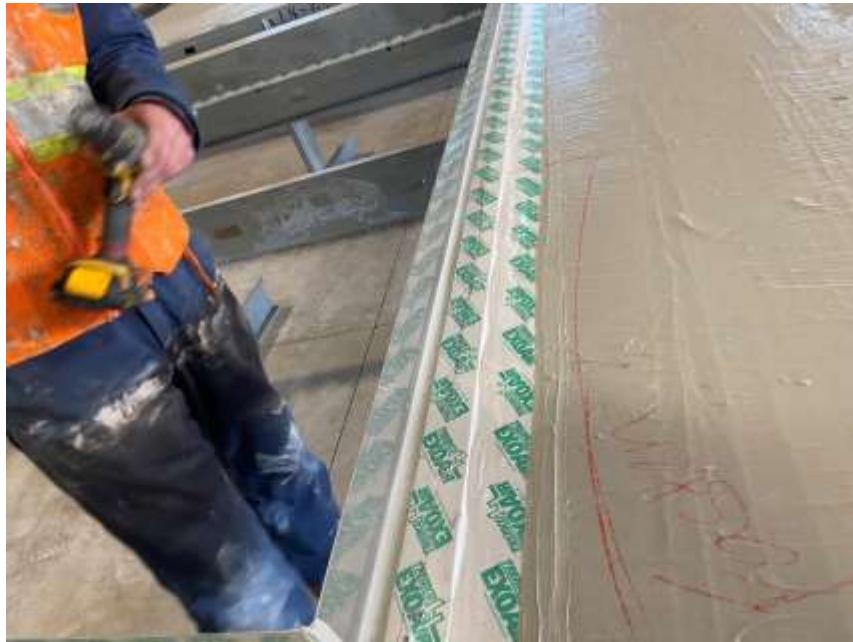
2. ZSC visited F&L Crane to observe the ongoing construction of exterior panels. At the time of observation ZSC noted the ongoing installation of SS flashing on the panels that are located within the warehouse by Chamberlin. It was noted that SS T flashing previously noted to be loose beneath SAMF has been secured; however, fasteners were installed through existing SAMF strip-in membrane. ZSC recommends that breaches in membrane at fasteners be patched per manufacturer's specifications. **See Photos 4-5**

**Photo 4**  
**Example of SS Flashing Needing Additional Fasteners**

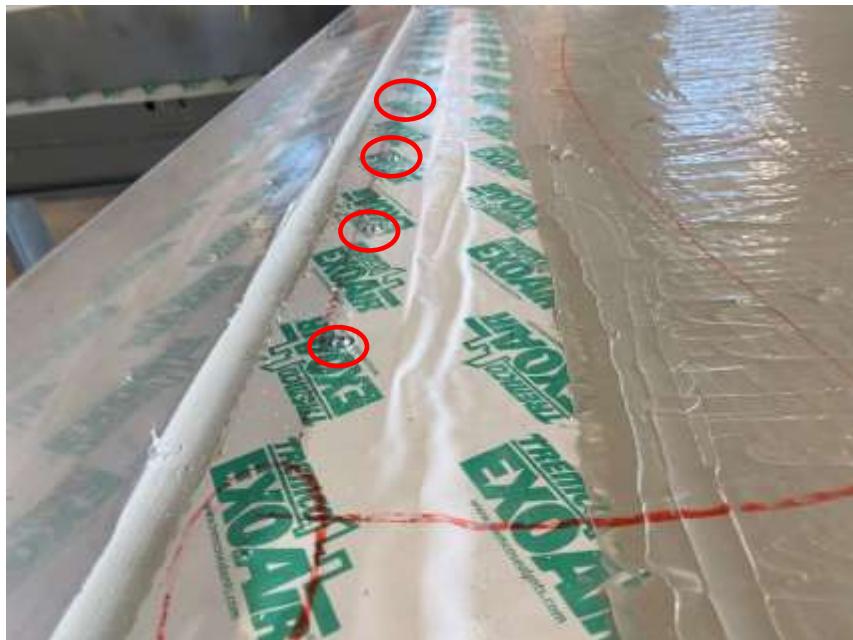
**Photo 5**  
**Application of Fasteners**

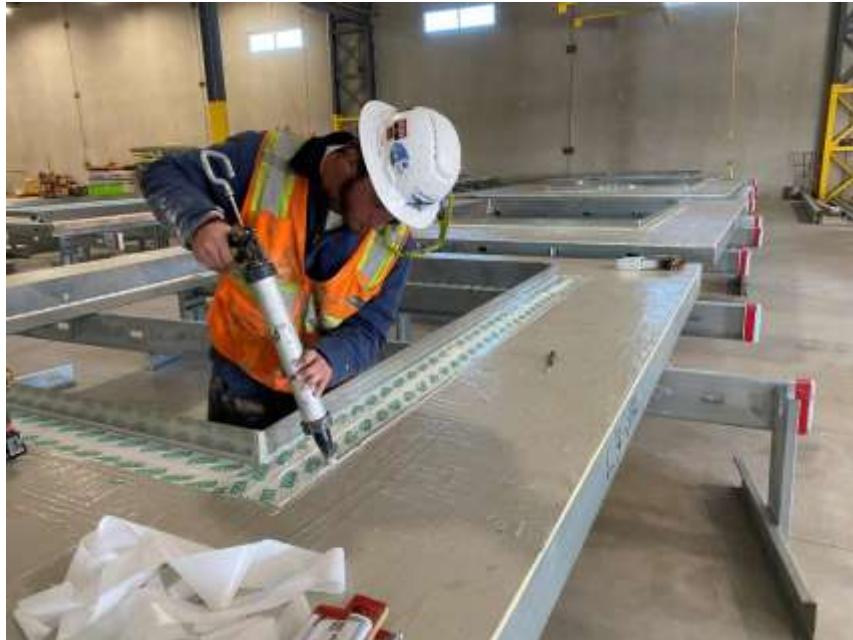
3. ZSC visited F&L Crane to observe the ongoing construction of exterior panels. At the time of observation ZSC noted the ongoing installation of SS flashing on the panels that are located within the warehouse by Chamberlin. ZSC observed the SAMF seams exposed at the perimeter of the SS flashing, ZSC recommends for seam to be detailed over with approved sealant. Chamberlin was onsite to perform recommendation, contractor appeared to be working in a workmanlike manner, no deficiencies were noted at the time of observation. **See Photo 6-10**

**Photo 6**  
**Example of SAMF Applied Over and Detailed**

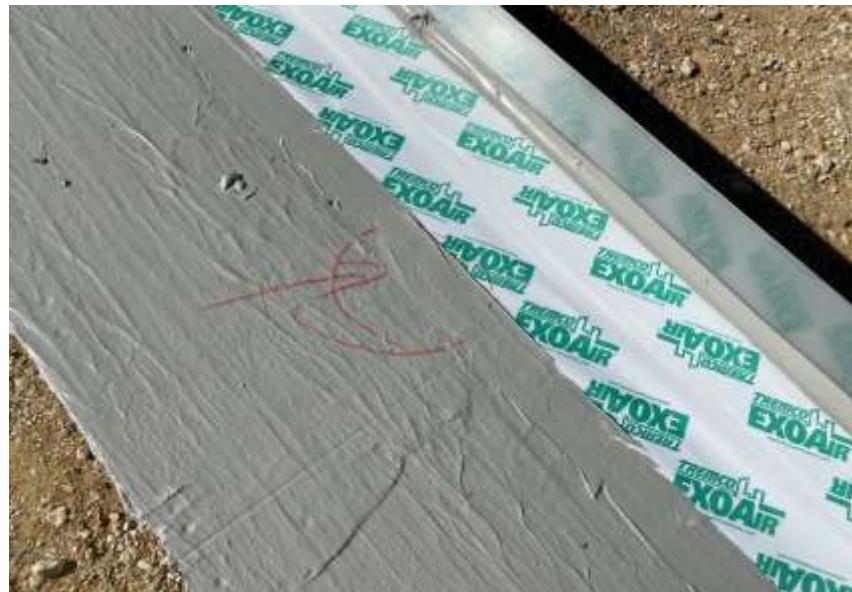
**Photo 7**  
**Example of Additional Sealant Applied at Seam**

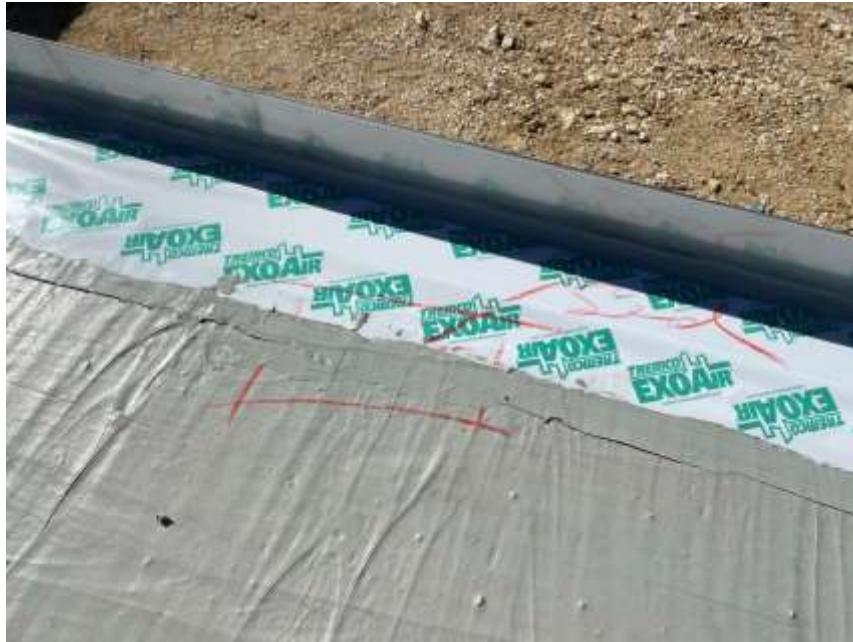
**Photo 8**  
**Example of Additional Sealant Applied at Seam**

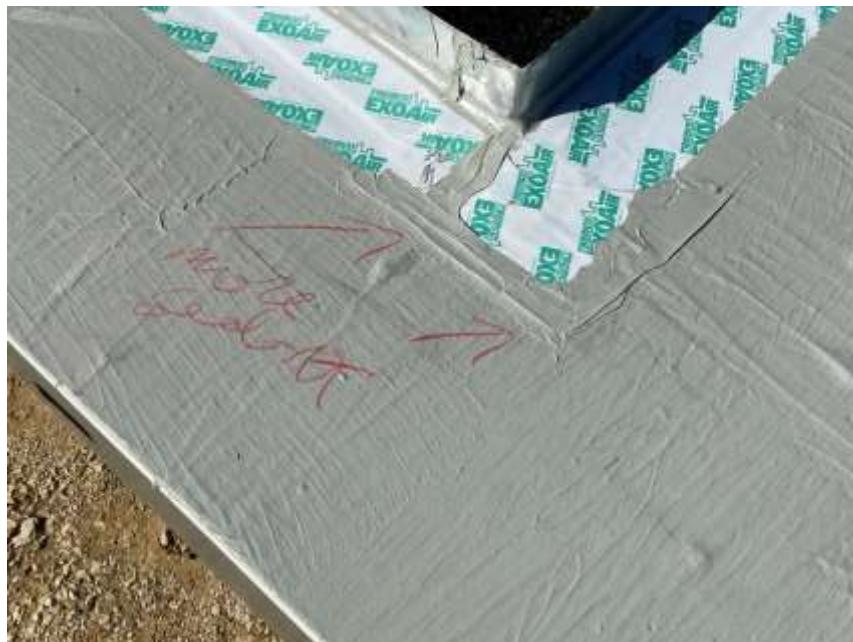
**Photo 9**  
**Example of Additional Sealant Applied at Seam**

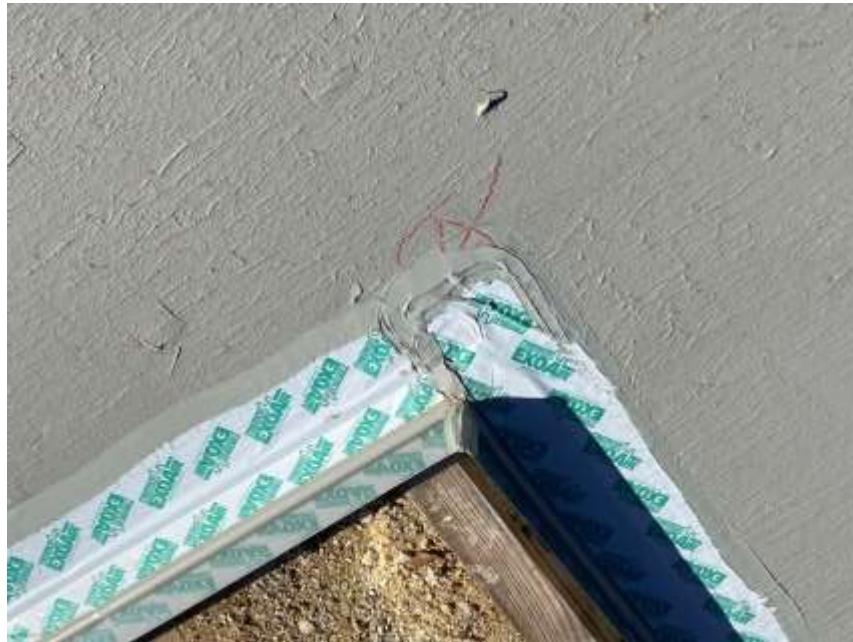
**Photo 10**  
**Example of Additional Sealant Applied at Seam**

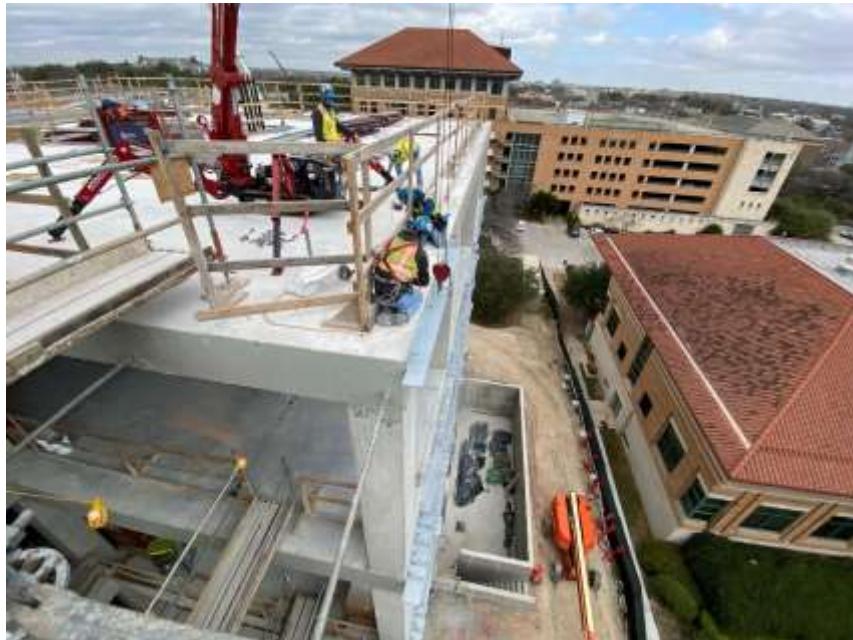
2. At the east elevation column D between level 5 and Roof parapet location, ZSC observed the installation of relief angle. Contractor appeared to be working in a workmanlike manner. Installation appeared to be as per construction documentation, no deficiencies were noted at the time of observation. **See Photos 2-3**

**Photo 2**  
**Example of Ongoing Relief Angle Install**

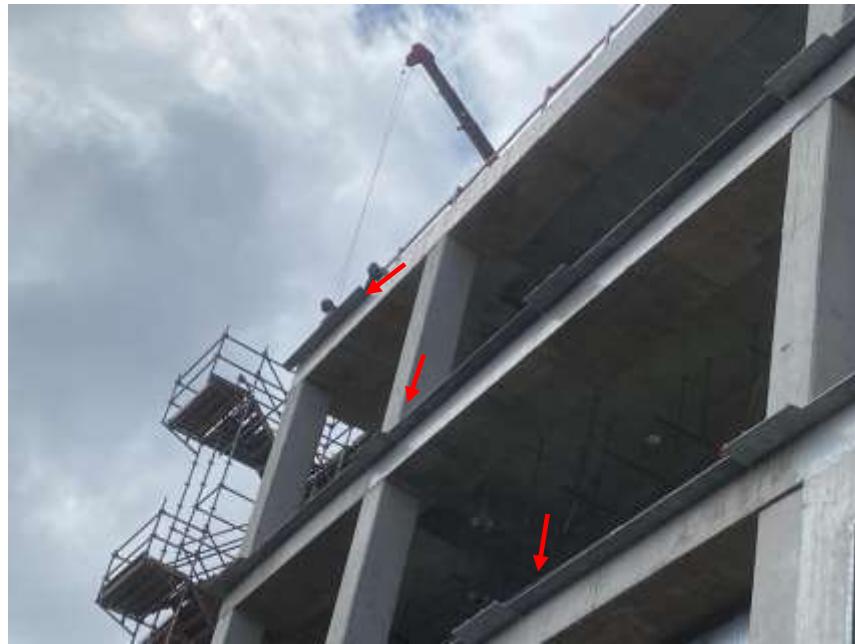
**Photo 3**  
**Example of Ongoing Relief Angle Install**

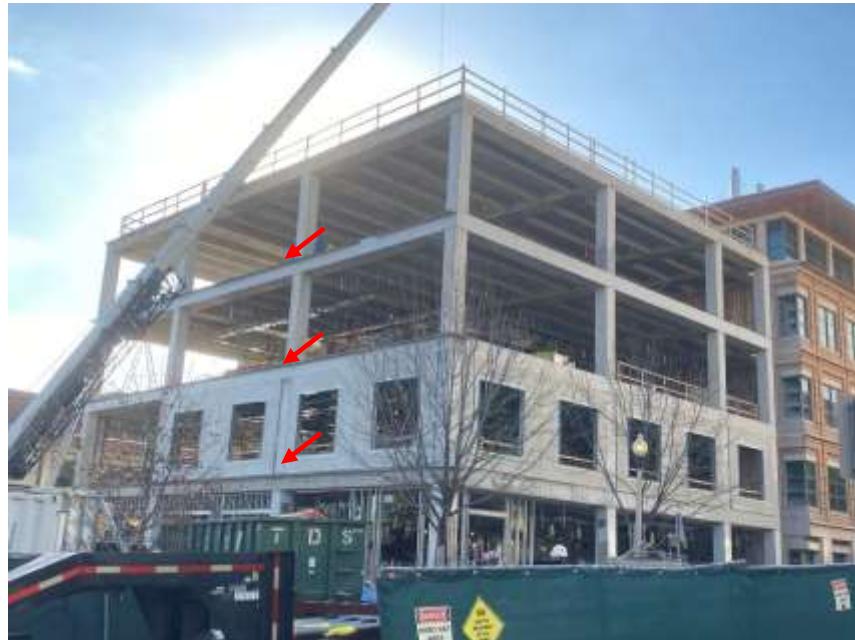
3. At the north elevation levels 3-5 column 1-4, ZSC noted the ongoing installation of the relief angles. Installation appeared to be as construction documentation, no deficiencies were noted at the time of observation and installation appeared to be sufficient. **See Photo 4**

**Photo 4**  
**Example of Ongoing Relief Angle Install**  
**North Elevation**

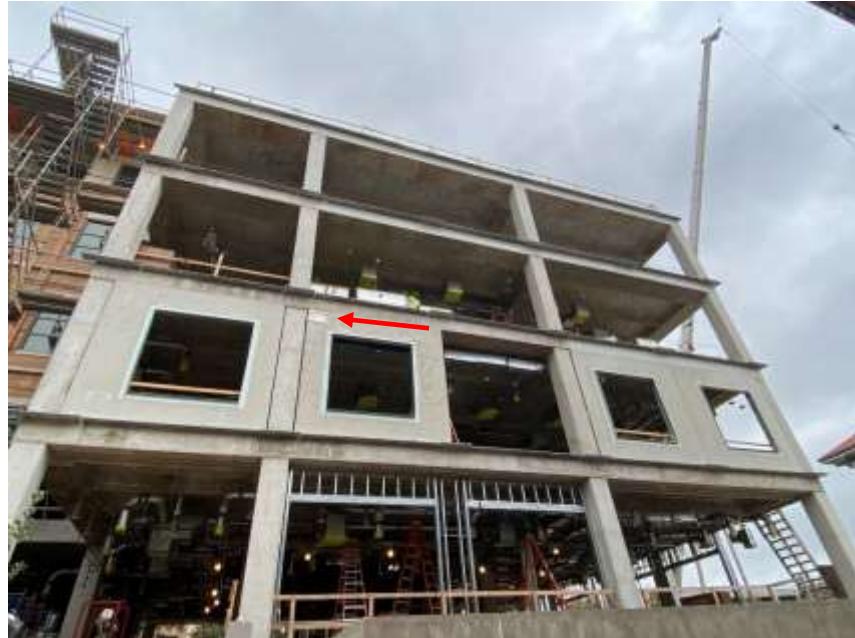
- At the east elevation level 3 between column B and C, ZSC observed the installation of panels. At the top left corner of the panel closest to column C, damages appear to have been during mobilization. ZSC recommends for panel sheeting to be repaired from stud to stud, and WRB be patched per manufacturer's specifications. **See Photos 1-5**
- At the west elevation level 4 between column A-C, ZSC observed the installation of prefabricated panels by F&L Crane. F&L Crane appeared to be working in a workmanlike manner, installation appeared to be as per construction documentation and specifications. No deficiencies were noted on panels at the

**Photo 2**  
**Example of Panel Damaged**

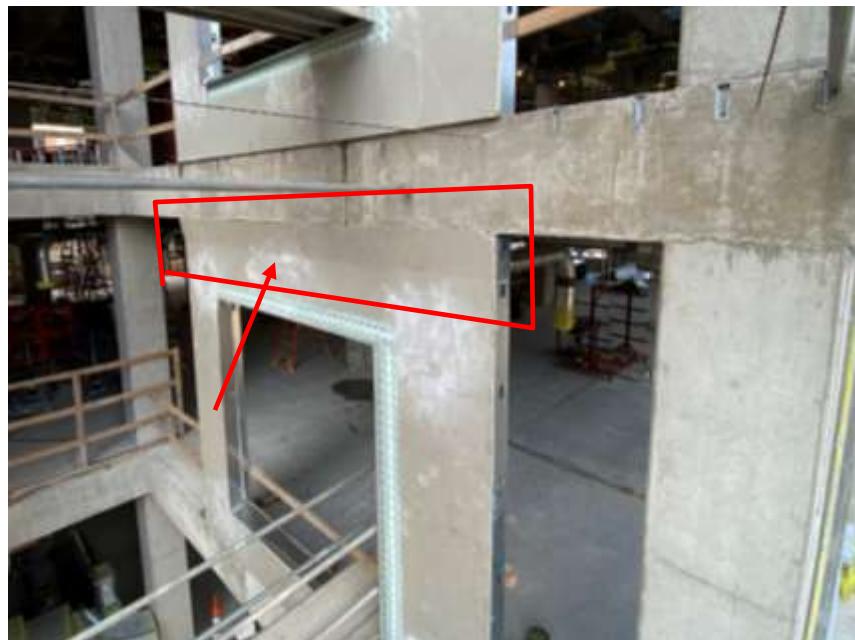
2. At the south east corner level 3 panel L3-119, ZSC observed the DensGalss damaged above the window header location. ZSC recommends for damaged DensGlass to be removed and replaced from stud-to-stud, and WRB be repaired per manufacturer's specifications.

**Photo 4**  
**Example of Damaged Panel**

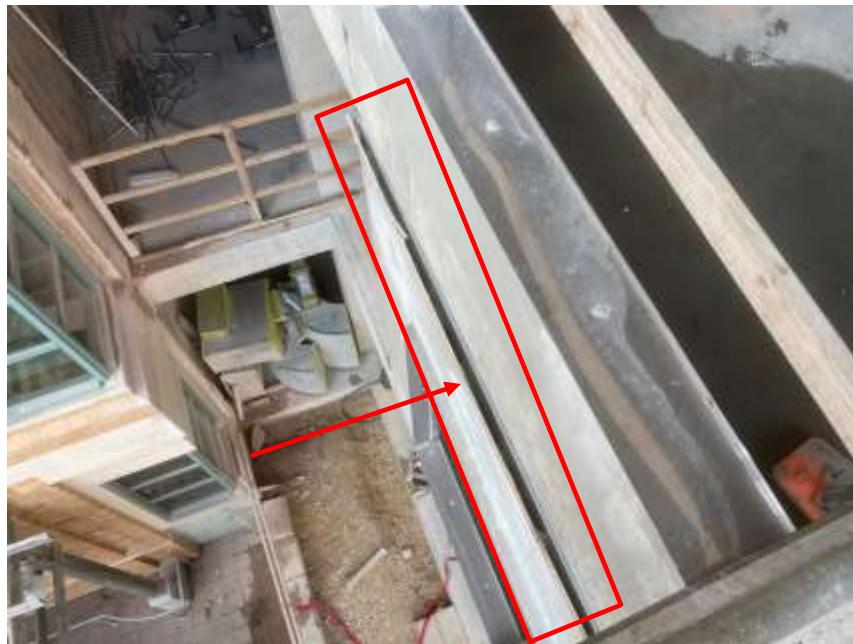
**Photo 5**  
**Example of Damage**

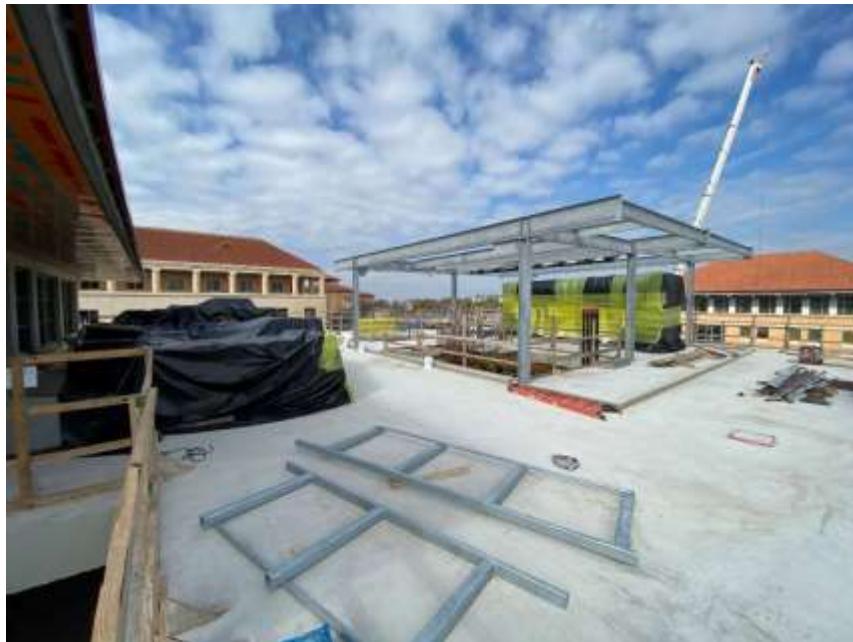
- At the roof deck, ZSC observed the ongoing installation of the penthouse framing. Installation appeared to have been done in a workmanlike manner and as per construction documentation. No deficiencies were noted at the time of observation. ***See Photo 3***

**Photo 3**  
**Example of Ongoing Penthouse Construction**

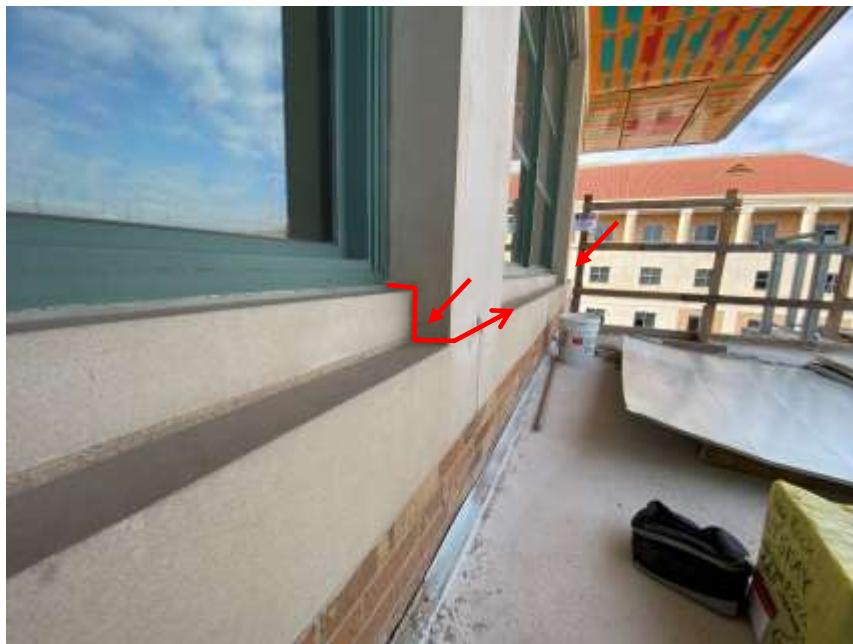
- Note:** ZSC noted the cast stone at the transitional wall of addition. ZSC to make recommendation after an onsite visit with project team on 02/03/2021. It is recommended for a RFI to be opened to address flashing concerns at vertical columns. ***See Photo 4***

**Photo 4**  
**Example of Flashing Detail Integration Concern**

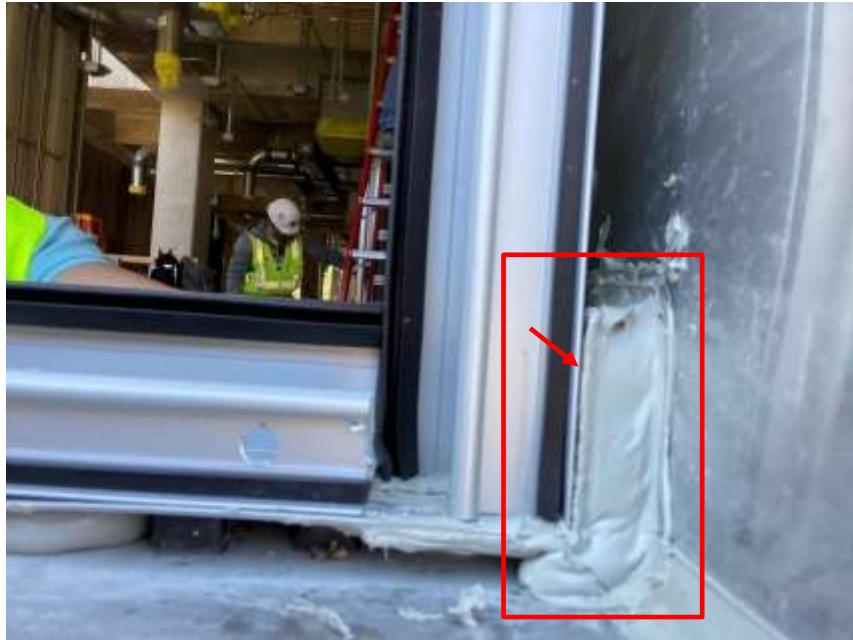
**Photo 3**  
**Example of Exposed Seam**
