## SUBMITTAL REVIEW

Description: Aluminum Framed Entrances and Storefronts -SD

Project Name: UT SEAY Building Addition

Project No.: 102-782

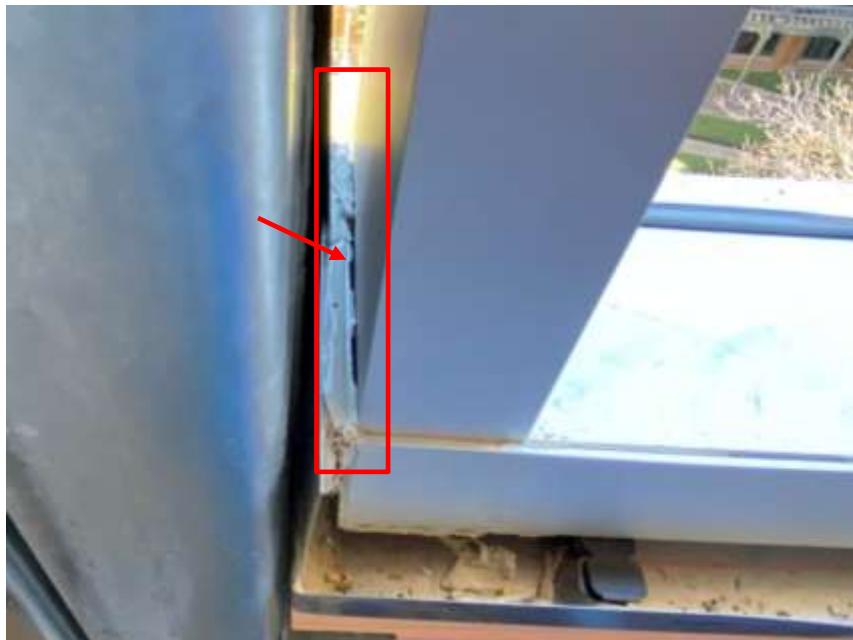
**Photo 4**  
**Example of Exposed Seam**

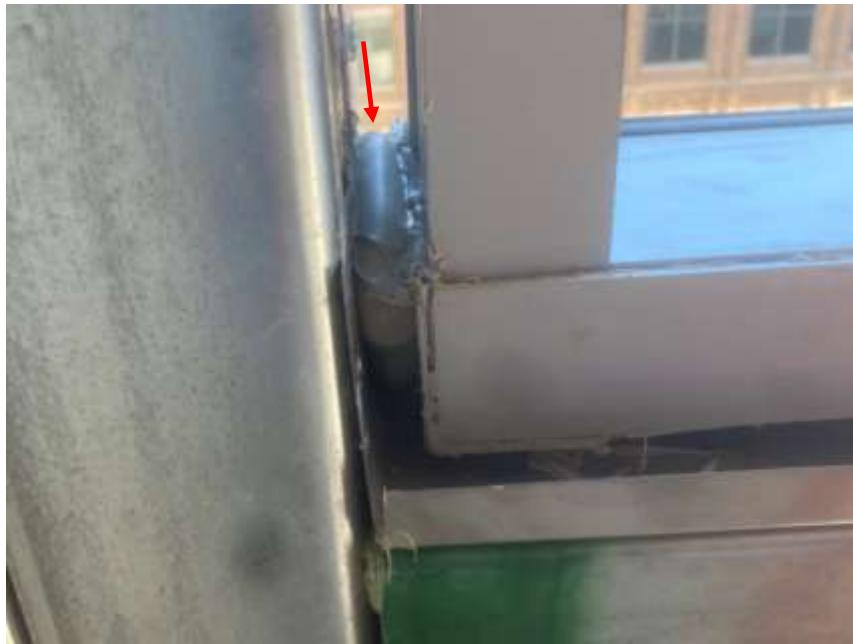
**Photo 5**  
**Example of Sealant to be Tooled**

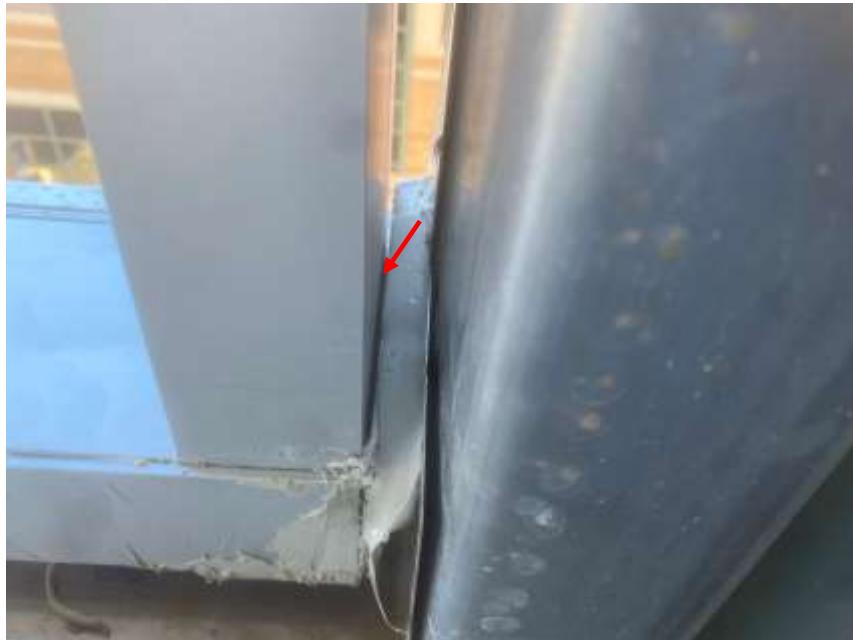
**Photo 6**  
**Example of Exposed Seam**

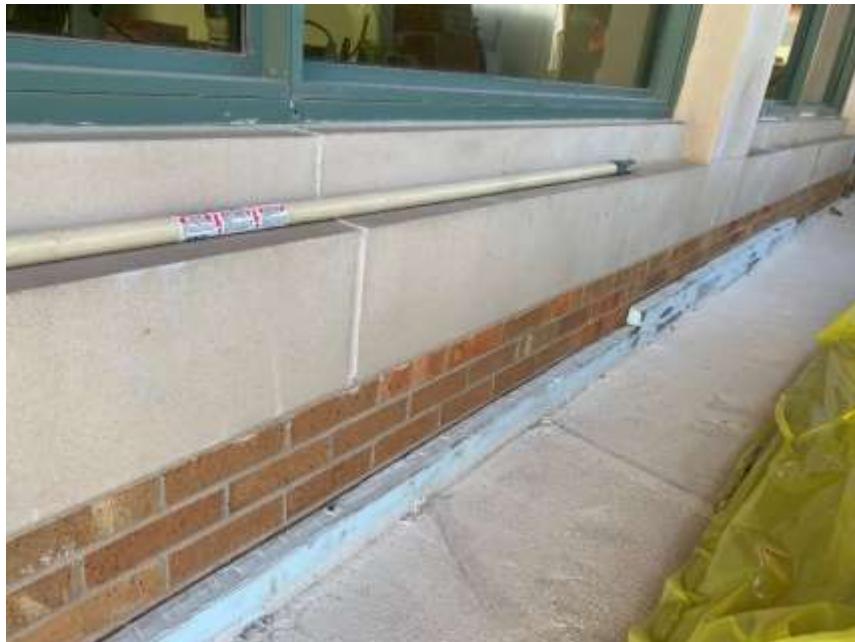
**Photo 1**  
**Overview of Current EJ Condition**

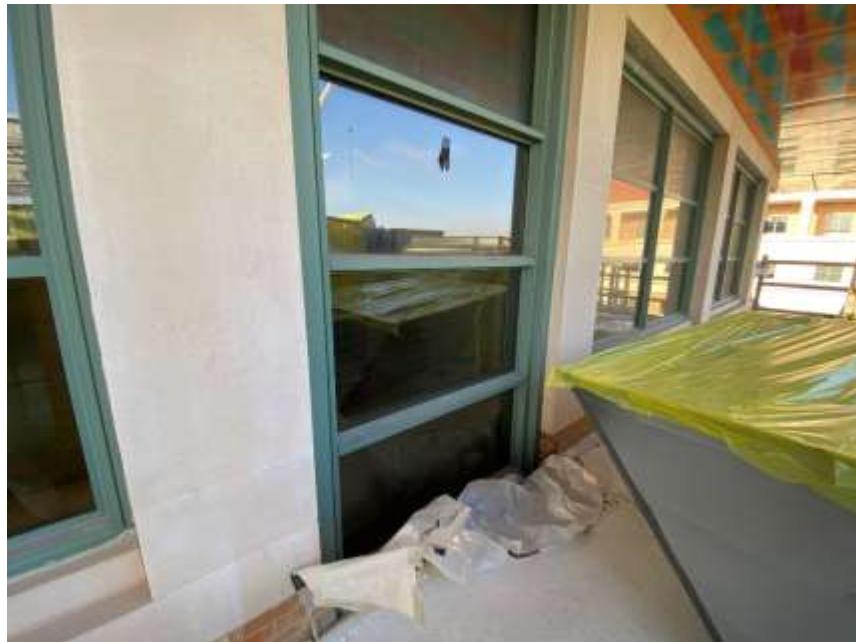
**Photo 2**  
**Overview of Current EJ Condition at CW**

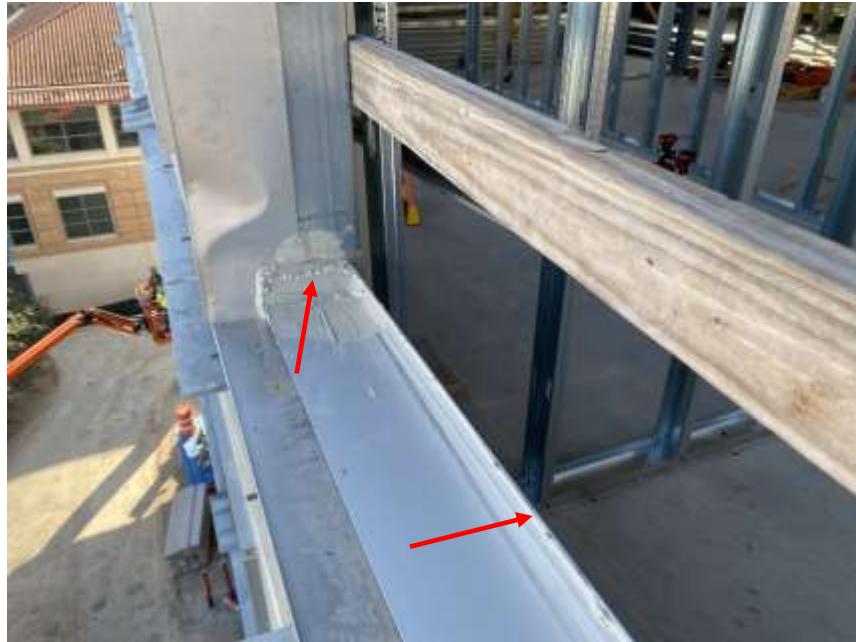
**Photo 6**  
**Example of Insufficient Sealant Bed at Sill Pan Prior to Framing Installation**

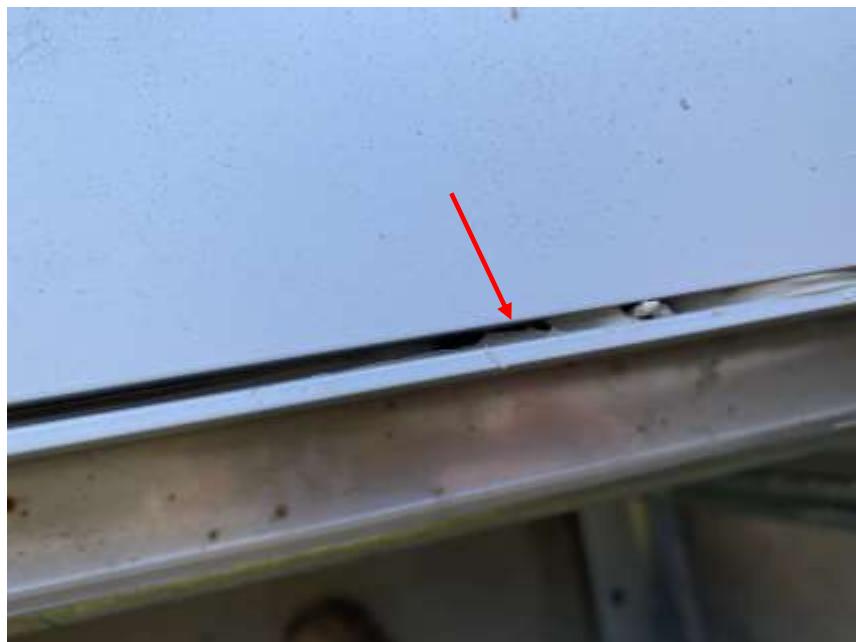
**Photo 7**  
**Example of Voids in Sealant Bed at Back of Sill Pan**

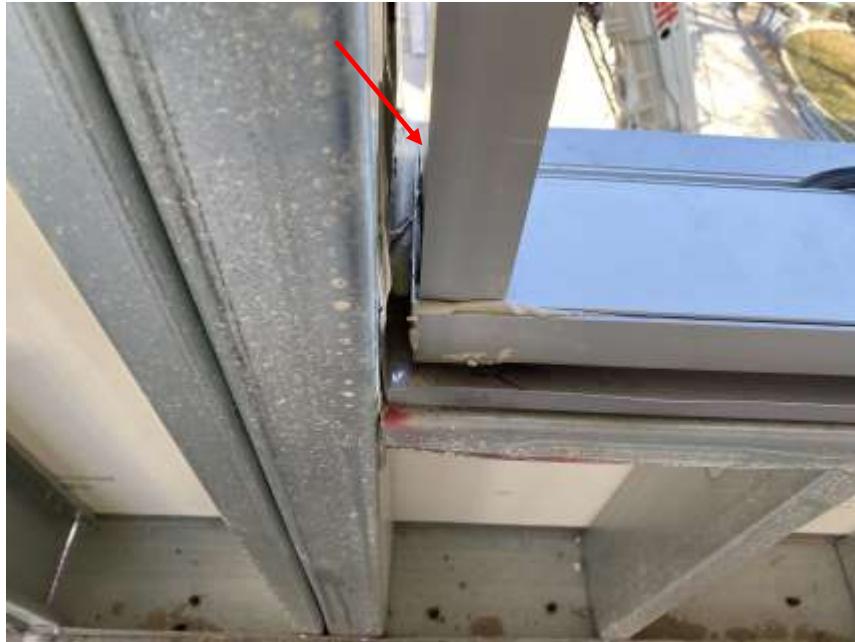
**Photo 8**  
**Example of Unsealed Gaps Between Sill Pan and Framing**

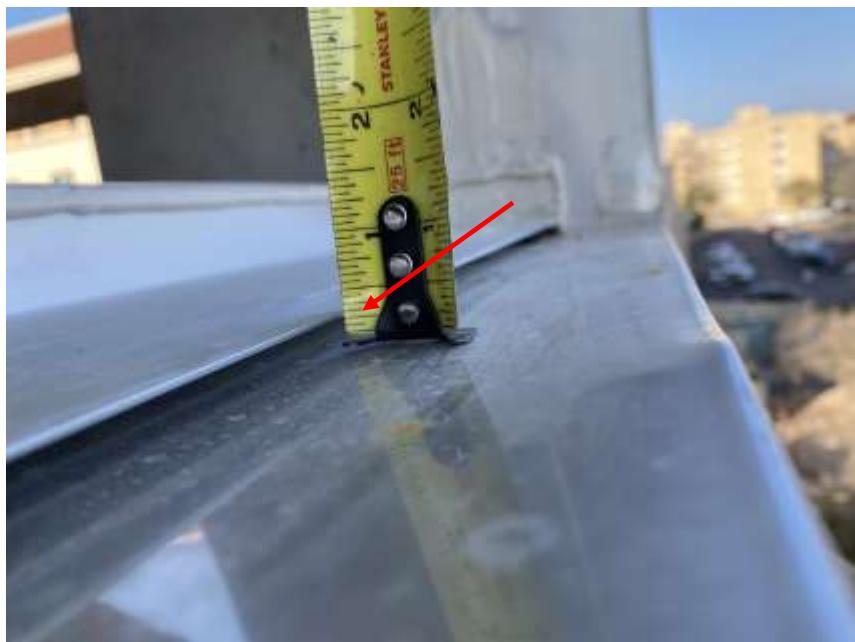
**Photo 9**  
**Example of Minimal Spacing for Sealant Joint**

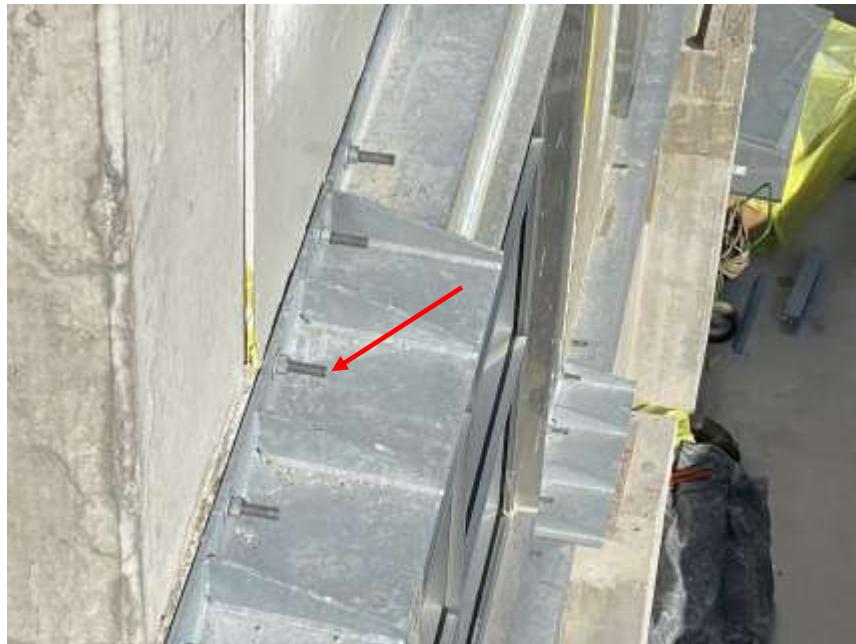
**Photo 10**  
**Example of Bolt Threads Protruding Past Nuts**

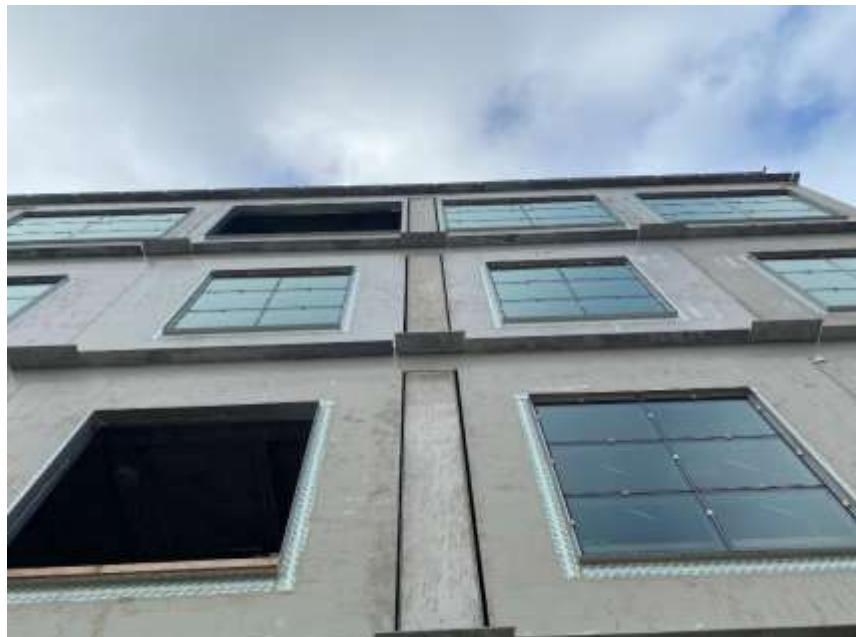
**Photo 1**

1. ZSC on site to review conditions regarding tie-ins between concrete columns and wall panels. Upon observation, it was noted that spacing between panels and columns range between 1 ¼"-1 ½" in most conditions; however, at the east elevation, level 5, it was noted that the wall panel immediately south of column line B has created a 4" gap that cannot be detailed with traditional methods. ZSC recommends that the panel south of column line B have additional CFMF and sheathing installed to provide a maximum gap of 1 ½" away from the column, in order to provide a transitional gap allowing for traditional waterproofing details. Following completion of added materials, ZSC recommends that gaps between all panels and columns be treated with backer rod and sealant, then stripped-strip in with the approved SAMF. **See Photos 1-6**

**Overview of Typical Gaps Observed at Panel to Column Transitions**

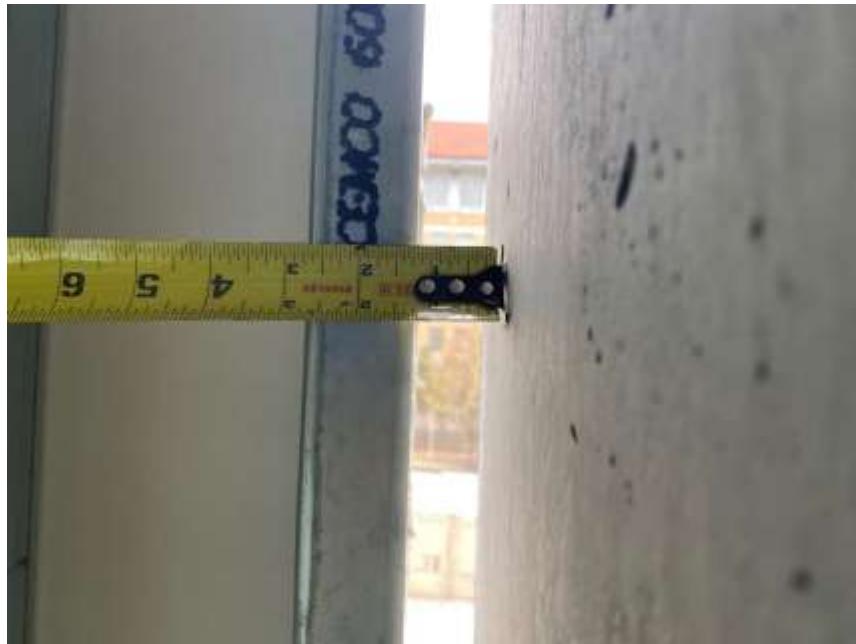
**Photo 2**  
**Example of 1 1/4" Gap at Panel to Column Transition**

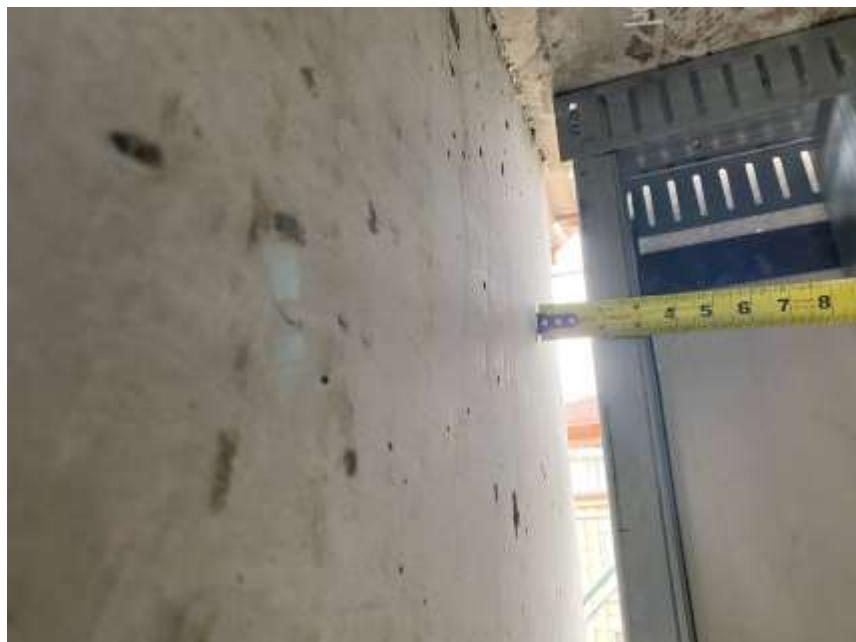
**Photo 3**  
**Example of 1 1/2" Gap at Panel to Column Transition**

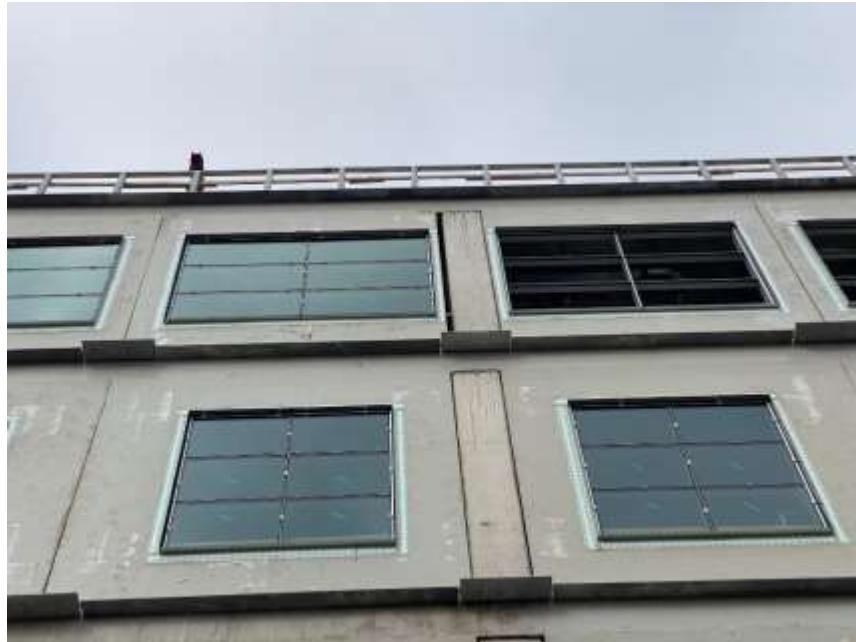
**Photo 4**

**Overview of Excess Gap at Panel to Column Transition at Column Line B L5**

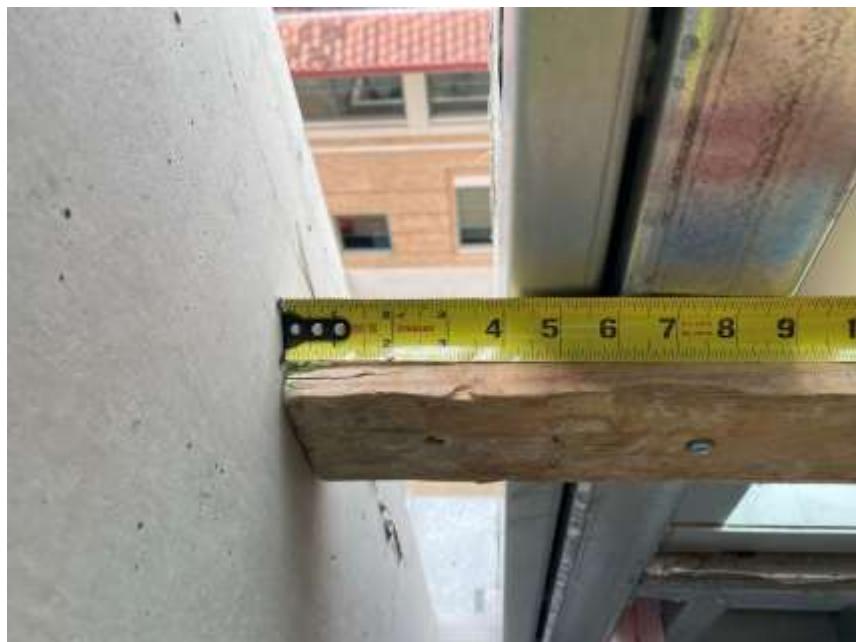
**Photo 5**

**Example of 4" Gap at Panel to Column Transition at Column B L5**

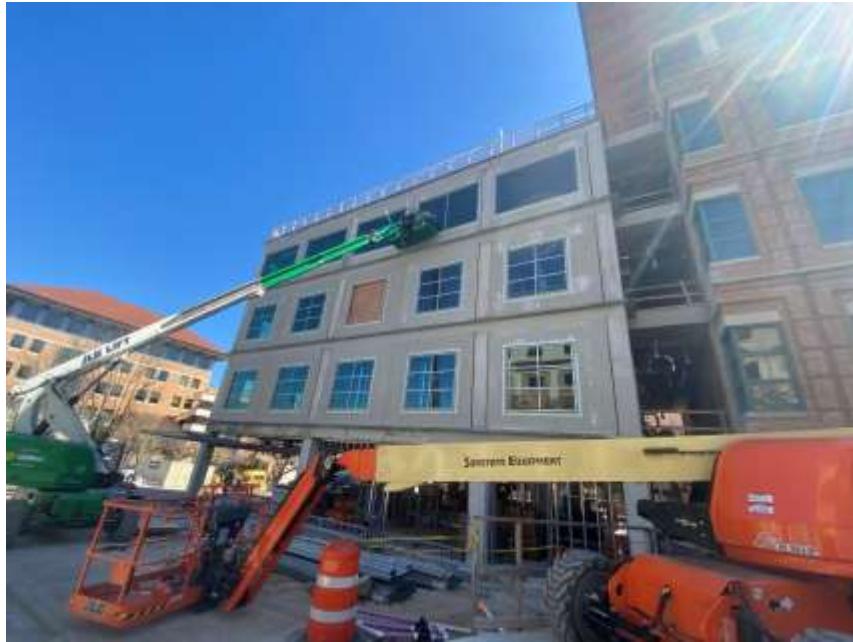
1. At the east elevation, ZSC observed the ongoing installation of the windows at prefabricated panel openings. Contractor appeared to be working in a workmanlike manner and ongoing installation appeared to be sufficient. No deficiencies were noted at the time of observation. **See Photos 1-2**

**Photo 1**  
**Example of Ongoing Window Installation**

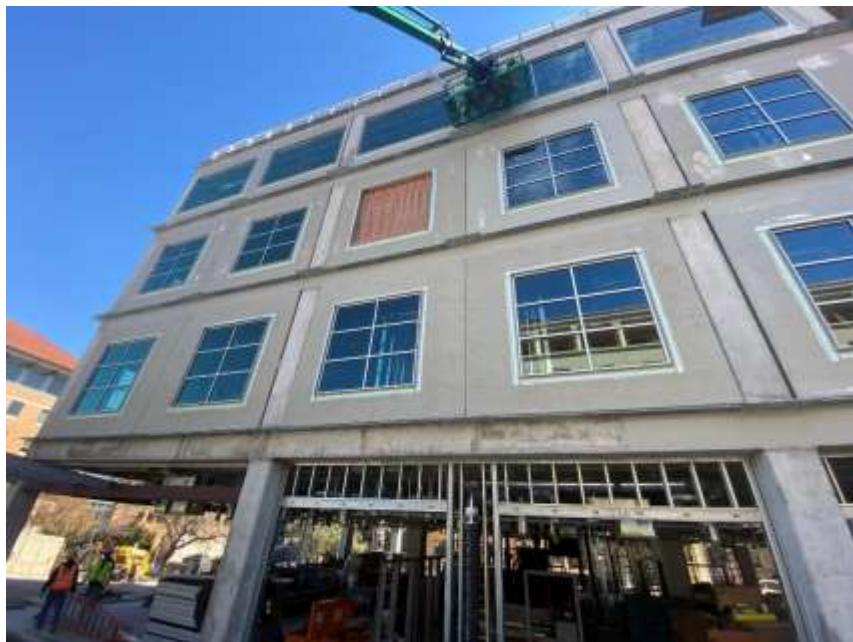
**Photo 2**  
**Example of Ongoing Window Installation**

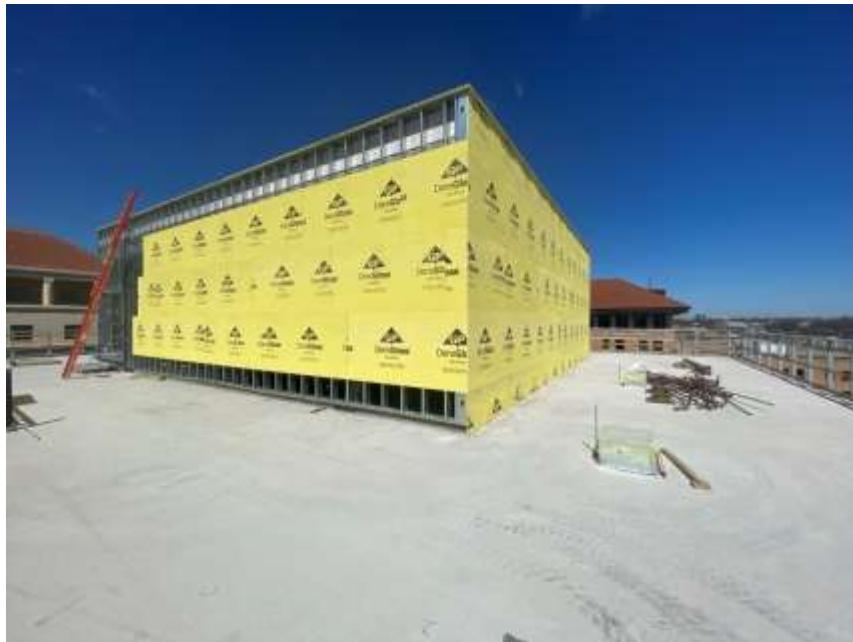
2. At the Penthouse location, ZSC observed the ongoing installation of the Densglass Sheathing. At the east wall of Penthouse, the Densglass appeared to be damaged at the seams. ZSC recommends for damaged Densglass be removed and replace according to manufacturer installation specifications. **See Photos 3-5**

**Photo 3**  
**Observation of Ongoing Sheathing Installation**

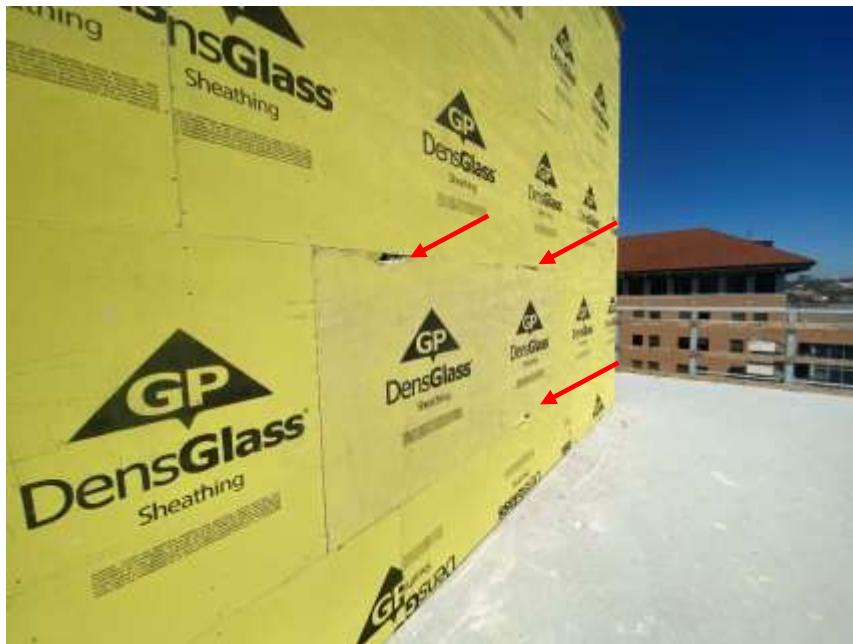
**Photo 4**  
**Example of Damaged Densglass**

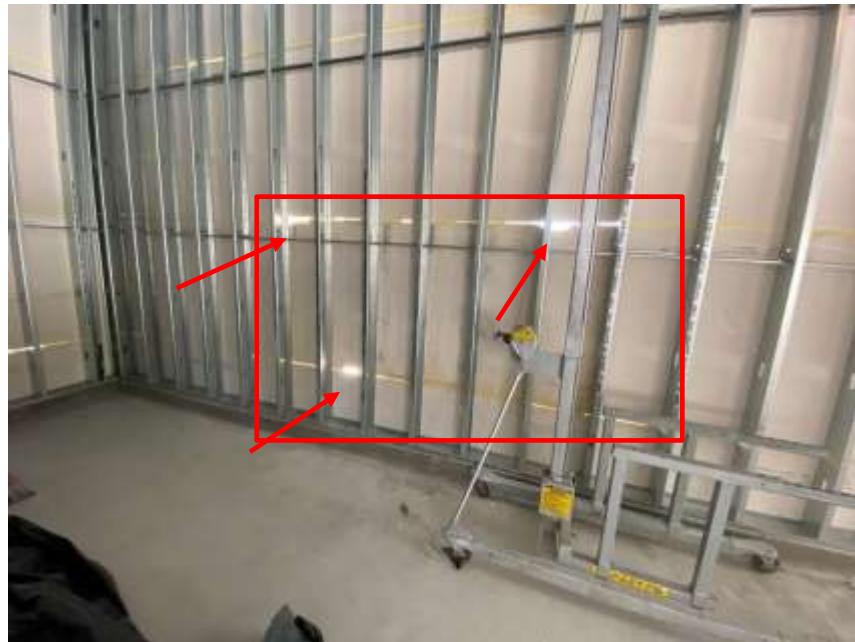
**Photo 5**  
**Example of Damaged Densglass**  
**(Interior View)**

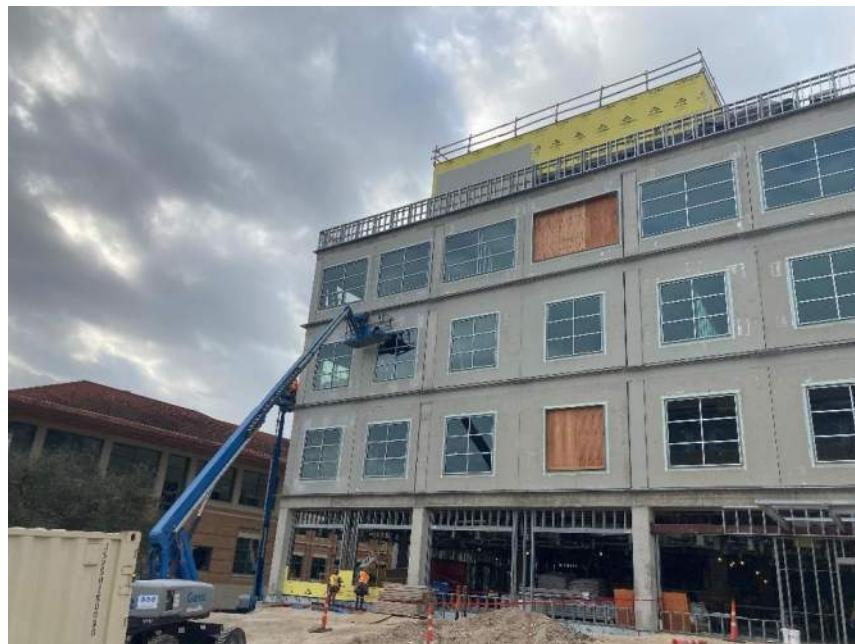
**Photo 1**  
Overview of Area of Installation

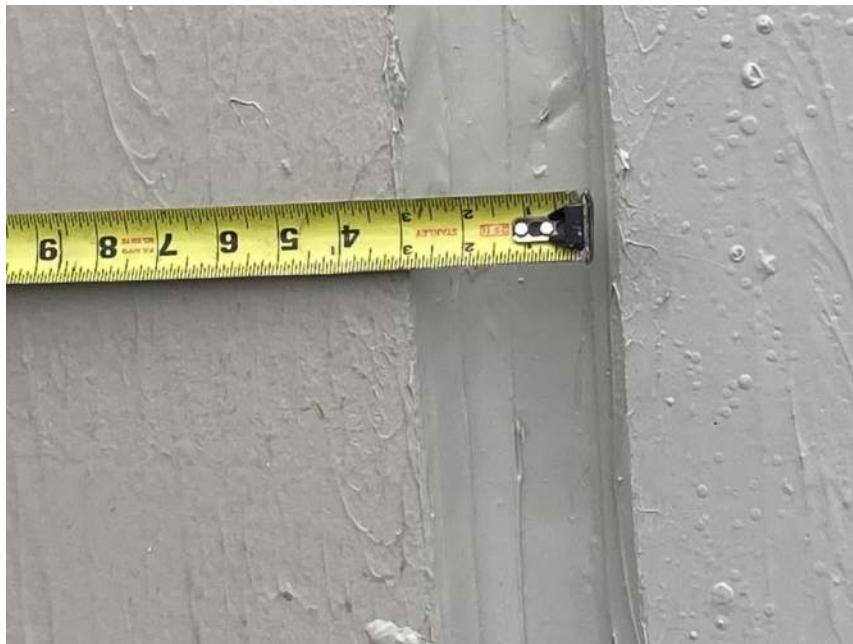
1. ZSC was on-site to observe the installation of the complete waterproofing system being installed by the Chamberlin team. **First** observation was, the span between the pre-fabricated panel and concrete column. The sealant joint measured a little over 3". ZSC recommends adding framing and sheathing, in order to close the gap to maintain a warrantable joint. **Second** observation was, the air barrier that has been installed is gassing, creating air bubbles in the air barrier. Upon further review, it was noticed that all bubbles are being caused by honeycombing in the substrate. Per manufacturer's specs, gaps larger than 1/16" need to be filled, prior to air barrier installation. **Third** observation was, some framing has been cut or adjusted, leaving or creating gaps that are greater than 2". Also, some of the framing is set too far out, causing the holes in the framing to line up with the sealant line creating a gap that is unwarrantable, per manufacturers specs. ZSC

**Photo 2**  
Panel to Column Control Joint at 3" Wide or More

recommends adding framing and sheathing to close said gap. In areas where the gap is okay, but the pre-fabricated panel sits out too far, ZSC recommends adding a piece of sheet metal flashing in order to cover the holes in the framing. Detailing the sheet metal flashing is also recommended, in order to maintain a warrantable condition. **Fourth** observation was, water behind the SAMF on the pre-fabricated panels. ZSC recommends removing the SAMF, letting everything dry out and reinstall the SAMF and detail with sealant. **Fifth** observation was, the substrate in which Chamberlin accepted, for installing air barrier. There are areas that should have been grinded down or patched with an approved material, in order to apply air barrier to a smooth clean substrate. *See Photos 01-14*

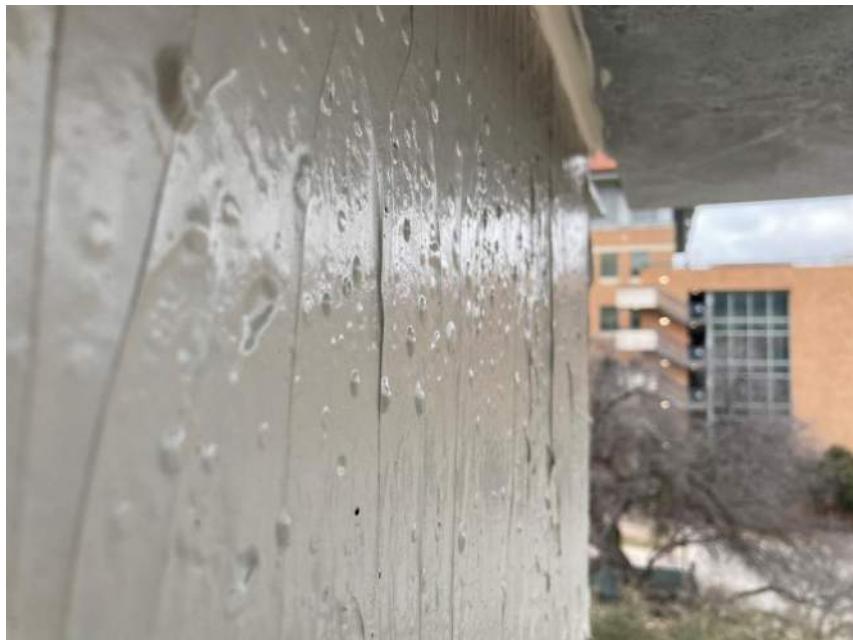
**Photo 3**  
Example of Air Barrier Blistering on Concrete Columns

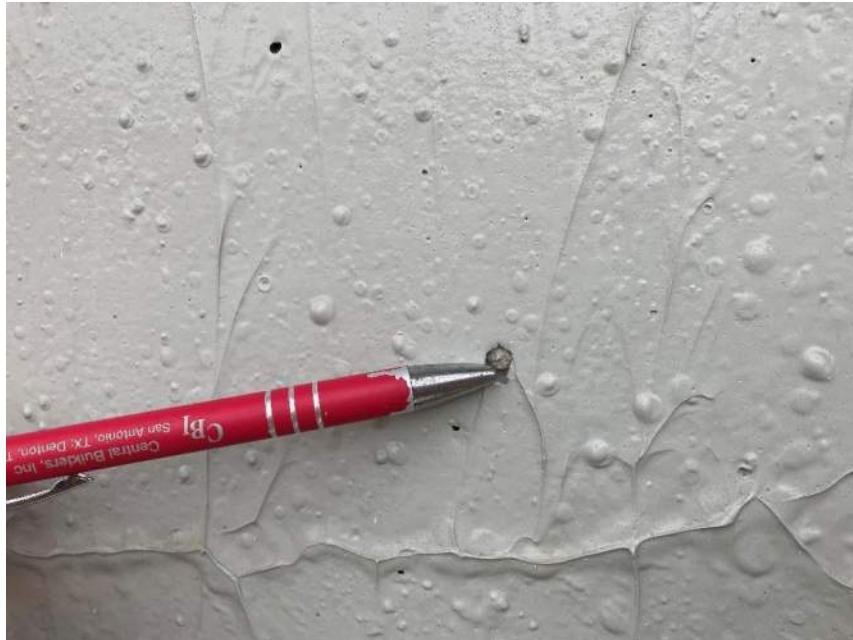
**Photo 4**

Close-up Example of Concrete Honeycombs Causing Air Pockets

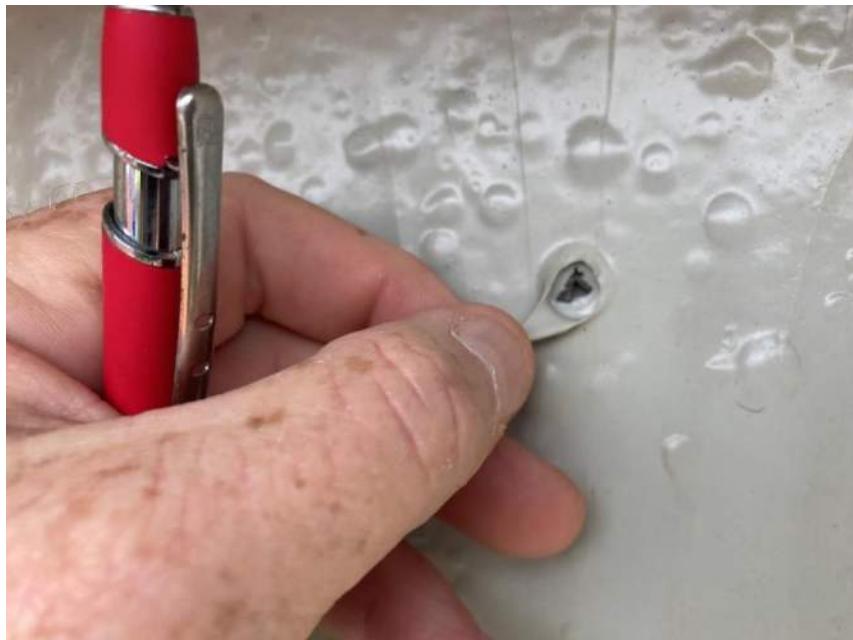
**Photo 5**

Example of Air Pocket Opened with Honeycomb Behind

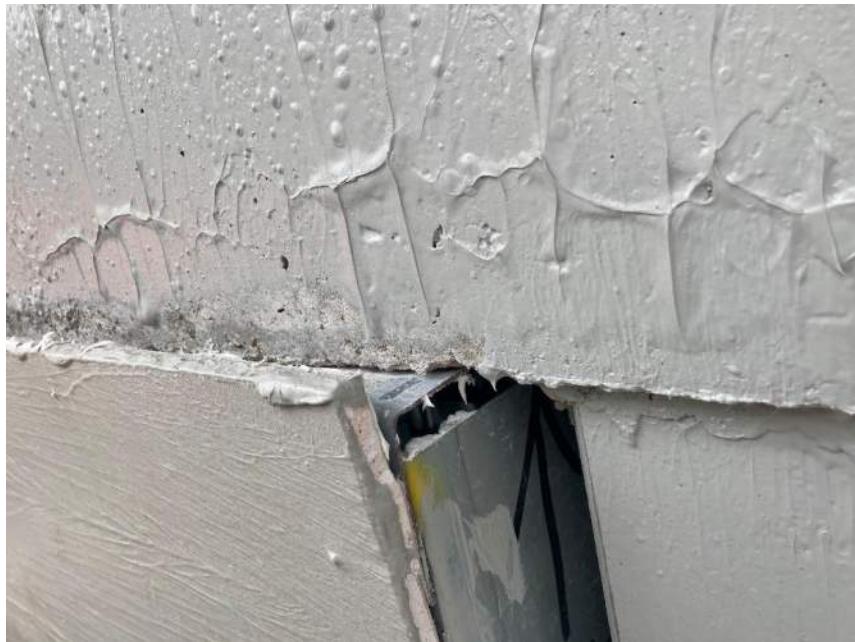
**Photo 6**  
Example of Framing with Gap at Head

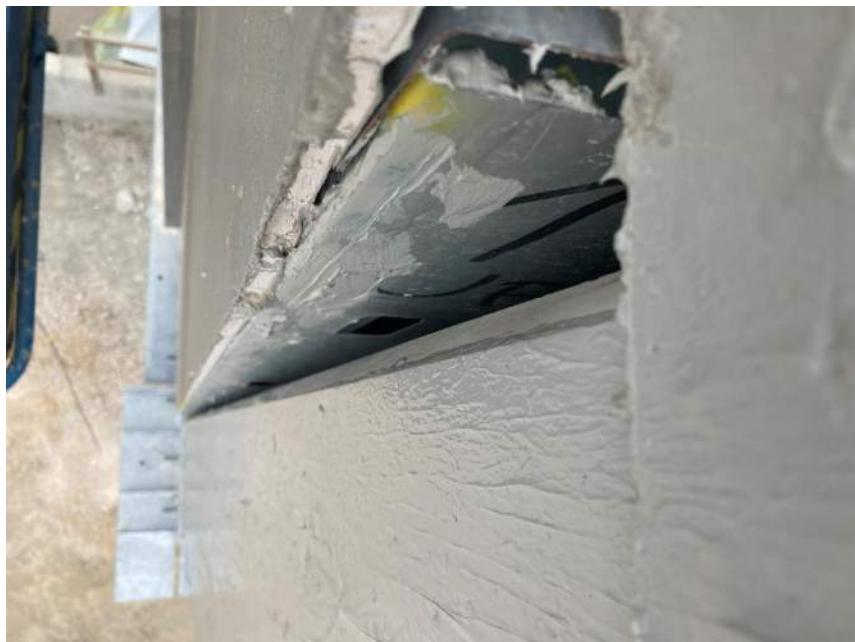
**Photo 7**  
Framing Placed Where Holes are in Line with Sealant Line

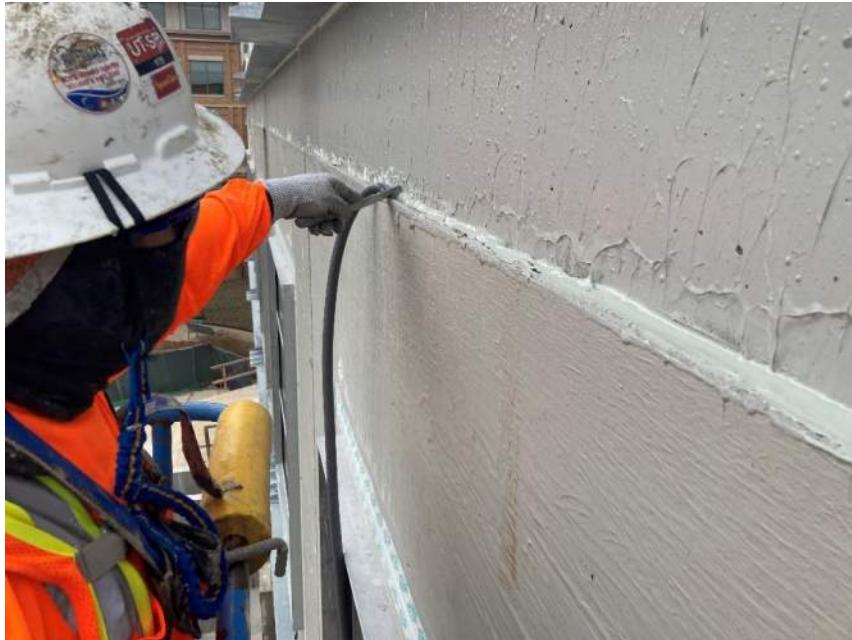
**Photo 8**

Example of Joint Sealant Tooled at Head of Pre-Fabricated Panel

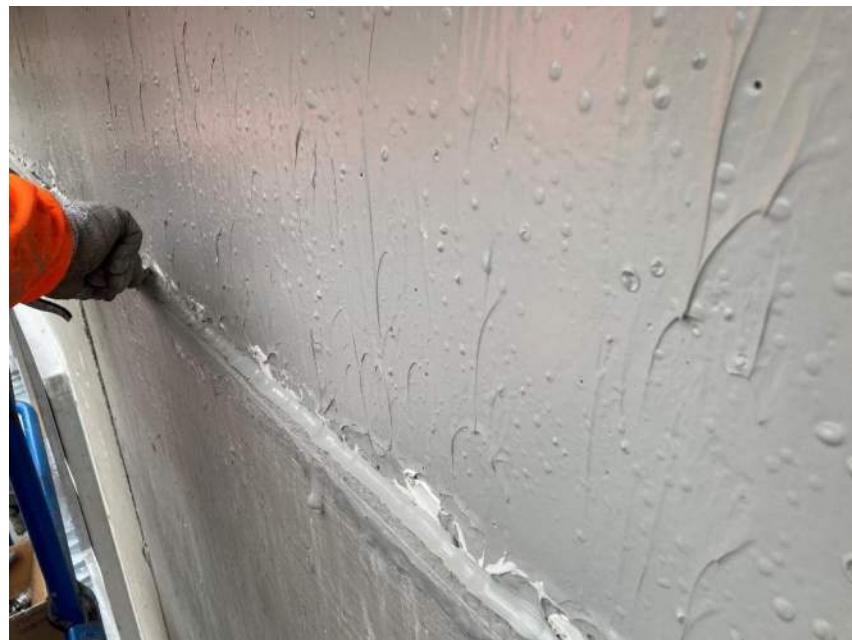
**Photo 9**

Sealant Tooled at Head of Panel

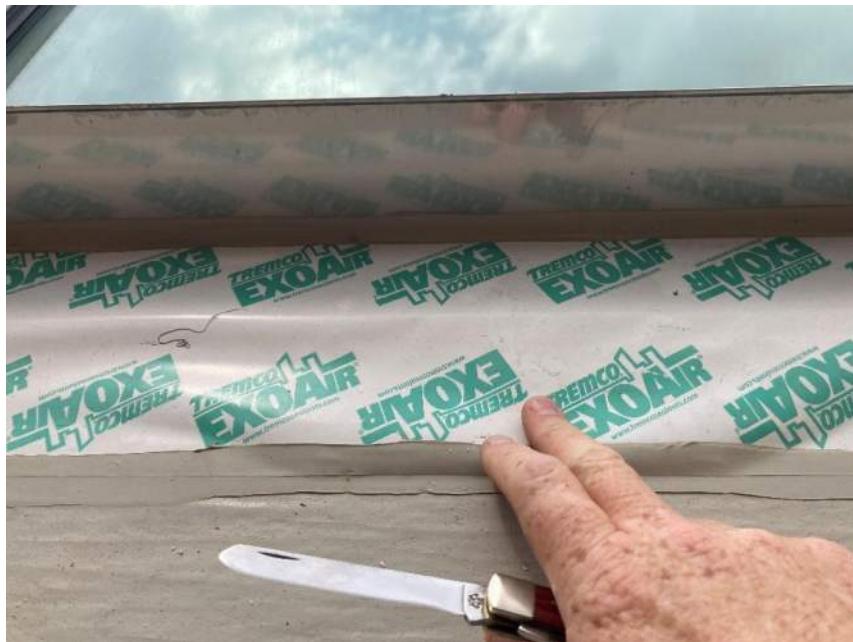
**Photo 10**  
Visible Water Behind SAMF

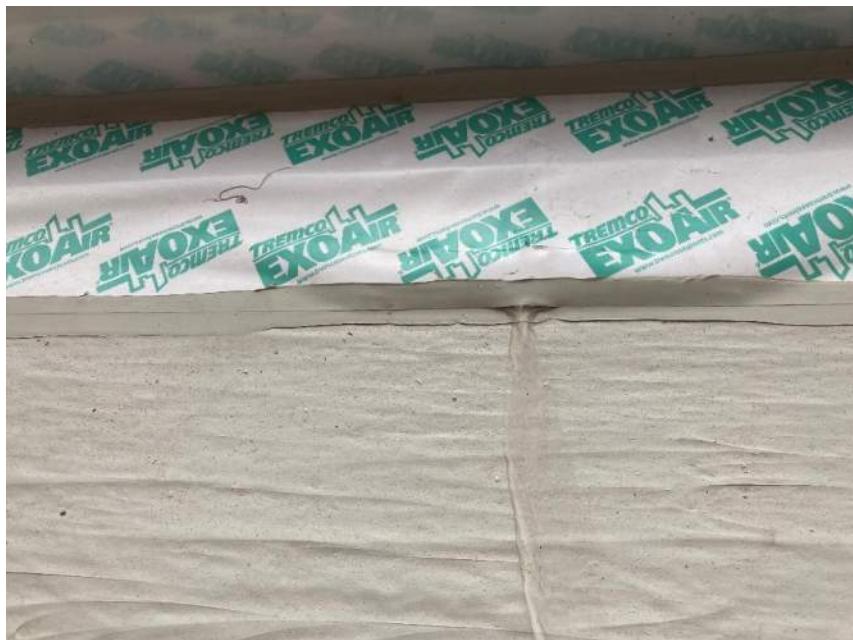
**Photo 11**  
Water Pouring out of SAMF After Cut

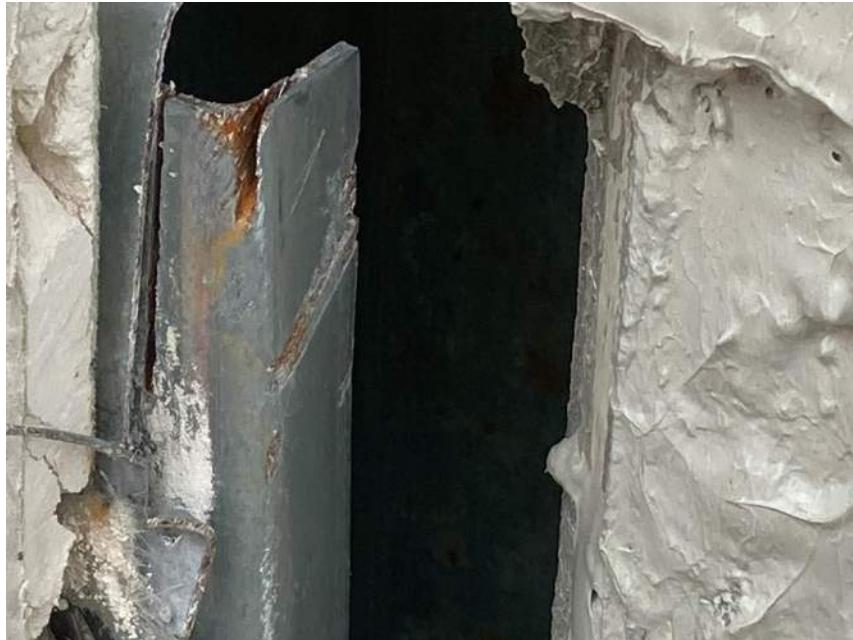
**Photo 12**  
Framing Cut to Fit Leaving Gap Un-sealable

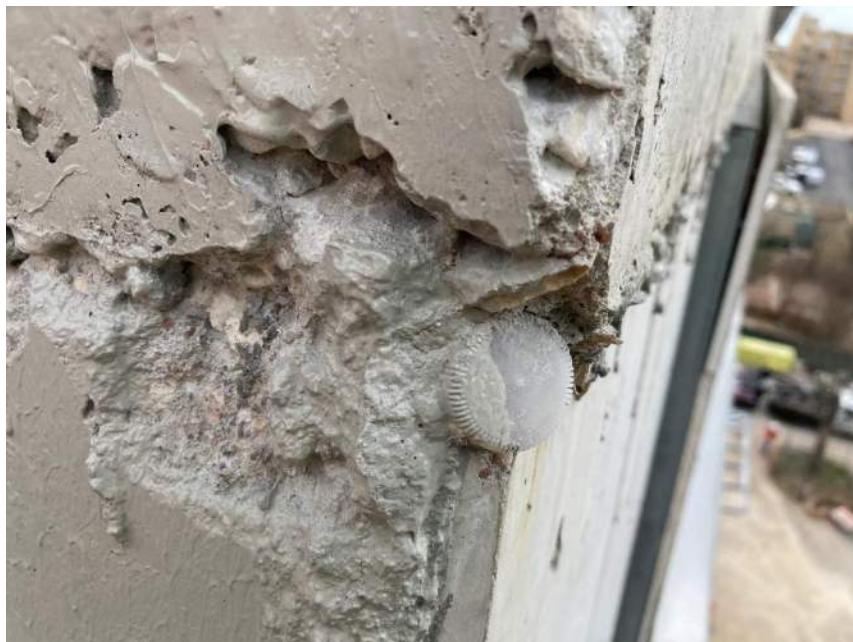
**Photo 13**  
Air Barrier Already Installed with These types of Substrates

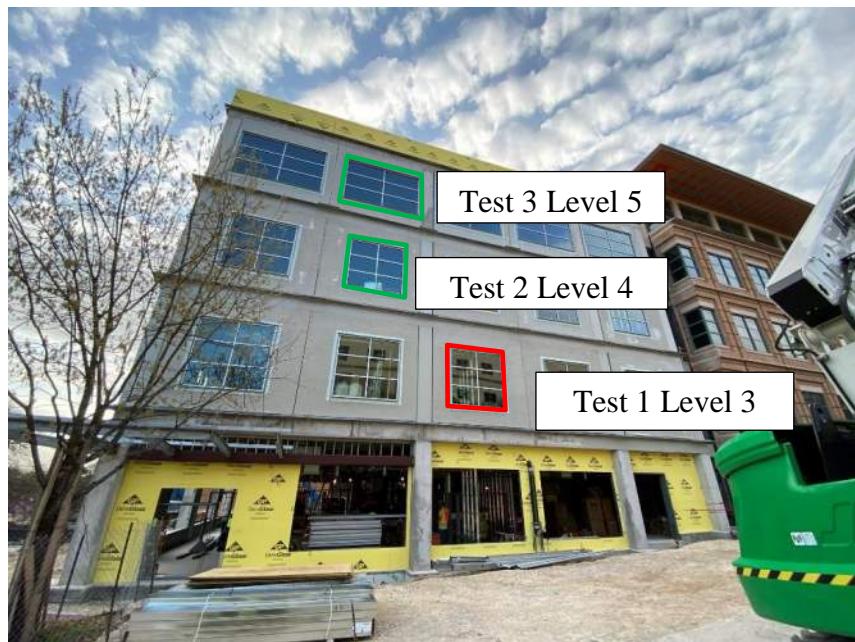
**Photo 1**  
**Windows Tested**

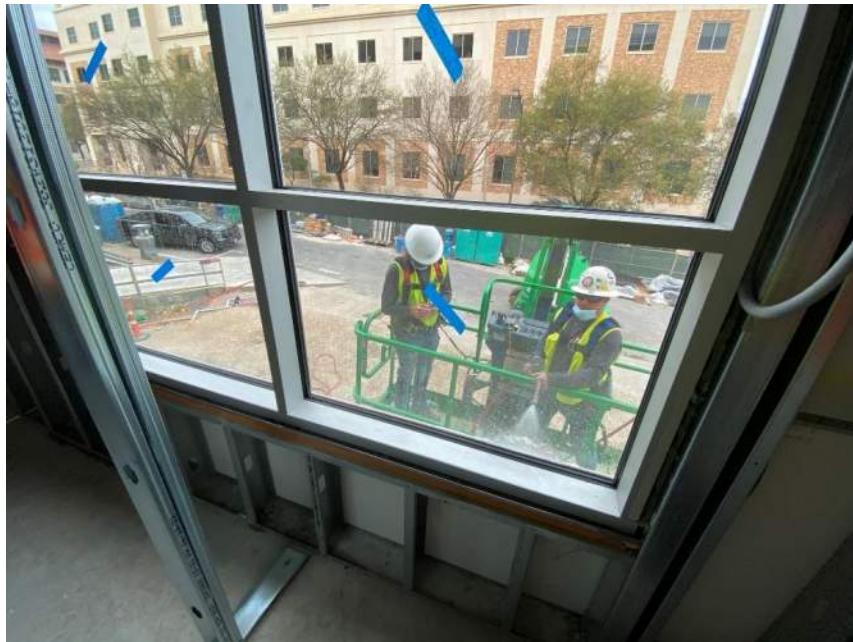
2. ZSC commenced testing of the west elevation 3<sup>rd</sup> window from column A on the 3<sup>rd</sup> floor, Test 1. Water intrusion was observed at the bottom left and right corners. At the right corner of the interior, water was observed at the perimeter sealant from 2 pinholes observed in the sealant along the jamb sill transitioning. At the left corner of the interior, water was observed at the SS T flashing corner joint seem. The deficient sealant along the T flashing should be removed and reapplied, as per manufacturer installation specification at the sealant failure location and tooled to create a proper end dam. **See Photos 2-8**

**Photo 2**  
**Observation of Testing**  
**Level 3, 3rd Window From Column A**

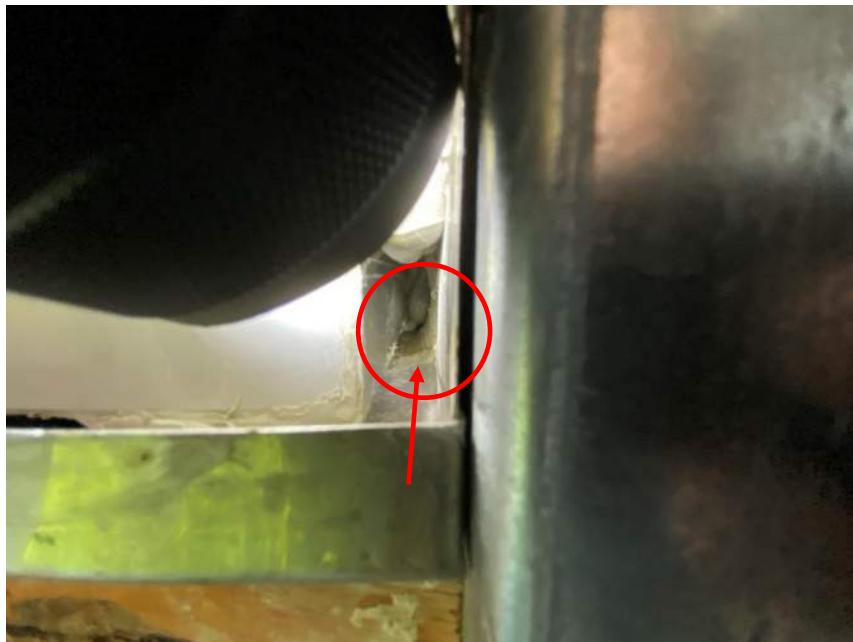
**Photo 3**  
**Example of Water Intrusion at Bottom Right Corner**

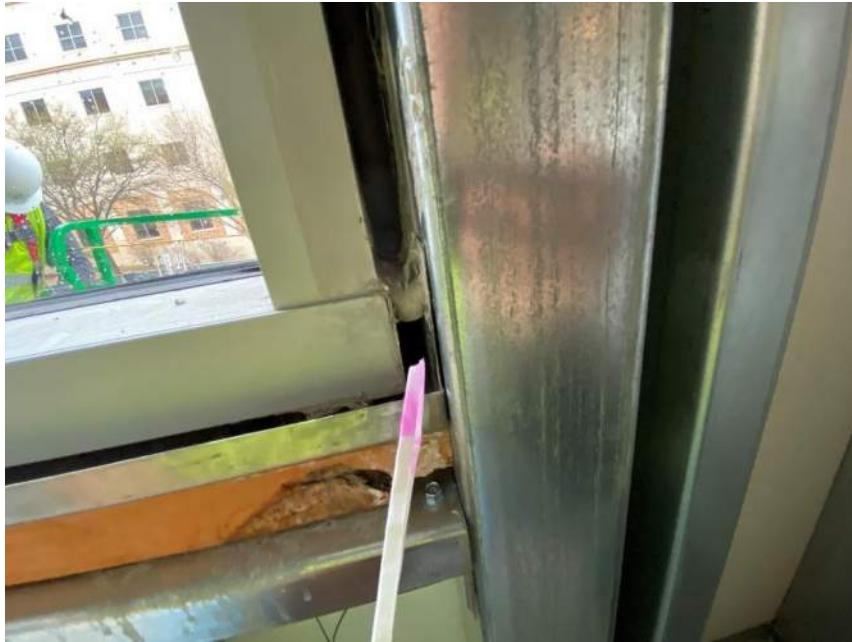
**Photo 4**  
**Water Intrusion at Bottom Right Corner**

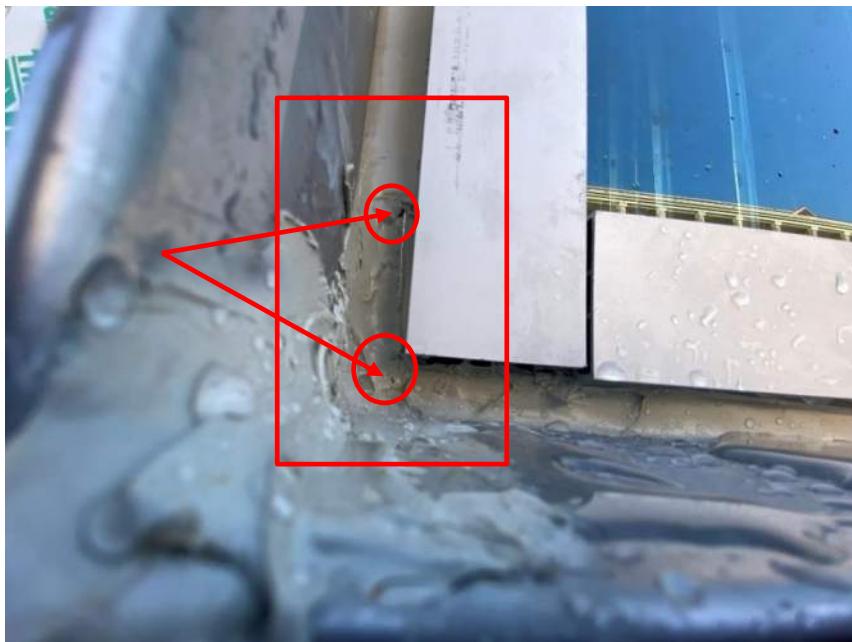
**Photo 5**  
**Exterior Observation of Point of Entry**
