## SUBMITTAL REVIEW

Description: Aluminum Framed Entrances and Storefronts -SD

Project Name: UT SEAY Building Addition

Project No.: 102-782

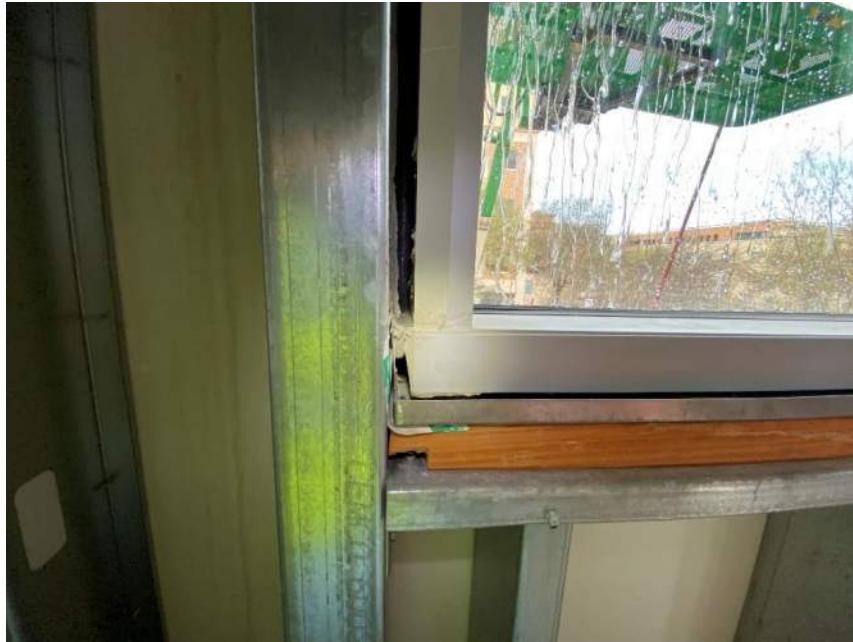
2. ZSC commenced testing of the west elevation 3<sup>rd</sup> window from column A on the 3<sup>rd</sup> floor, Test 1. Water intrusion was observed at the bottom left and right corners. At the right corner of the interior, water was observed at the perimeter sealant from 2 pinholes observed in the sealant along the jamb sill transitioning. At the left corner of the interior, water was observed at the SS T flashing corner joint seem. The deficient sealant along the T flashing should be removed and reapplied, as per manufacturer installation specification at the sealant failure location and tooled to create a proper end dam. **See Photos 2-8**

**Photo 6**  
**Observation of Left Corner**

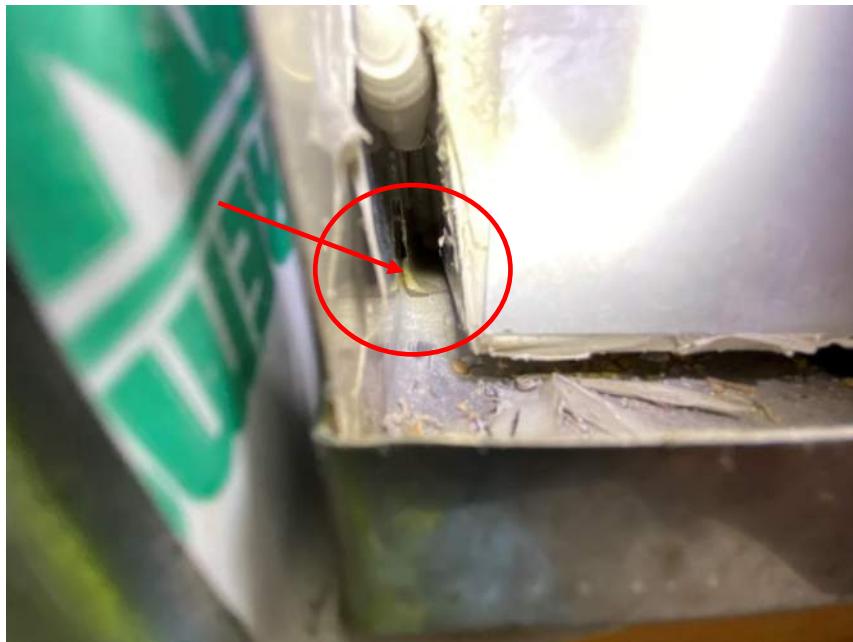
**Photo 7**  
**Example of Water Intrusion at Bottom Left Corner**

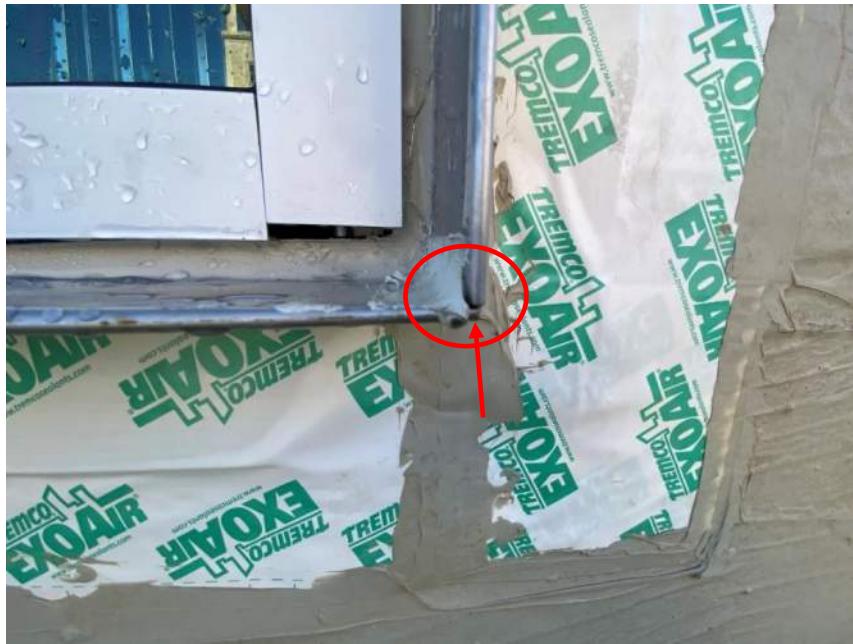
**Photo 8**  
**Exterior Observation of Point of Entry**

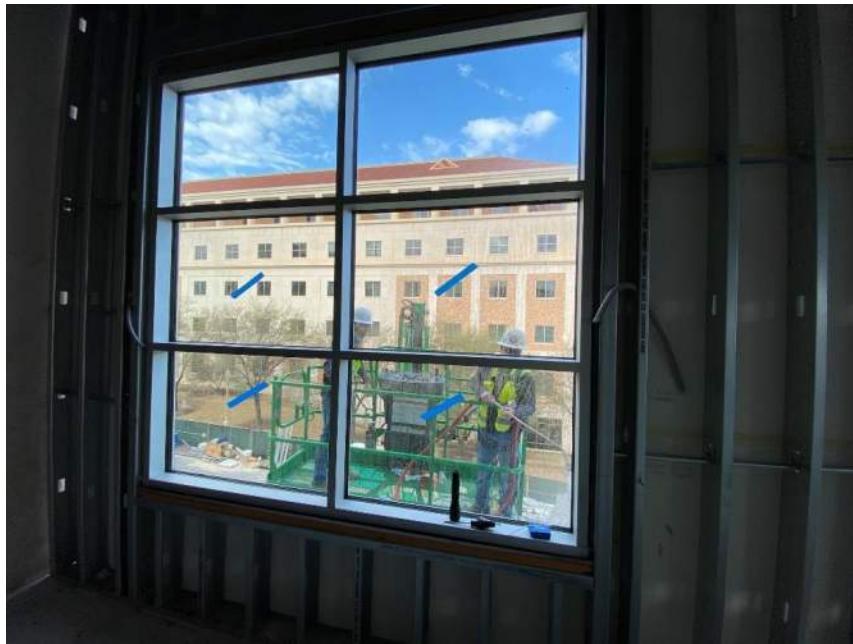
3. At the west elevation 2<sup>nd</sup> window from column A, level 4 and 5 were nozzle tested. ZSC continued nozzle testing, keeping the nozzle 1-foot away from glass and moving it back forth with a constant water pressure of 30 psi 1 min. per linear foot. At the time of observation, test 2 and 3 did not appear to show evidence of water intrusion or window system failure. ***See Photos 9-10***

**Photo 9**  
**Observation of Testing**  
**Level 4, 2<sup>nd</sup> Window From Column A**

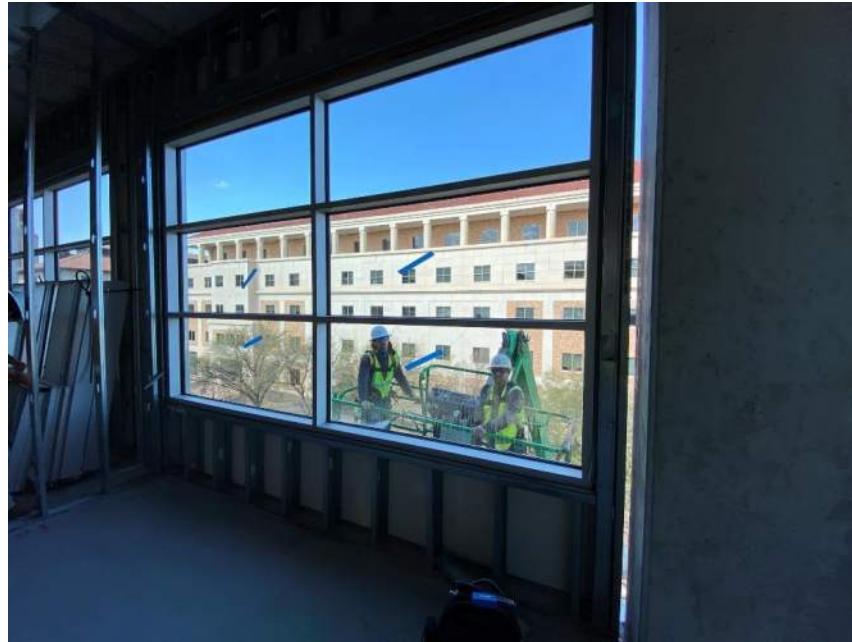
**Photo 10**  
**Observation of Testing**  
**Level 5, 2<sup>nd</sup> Window From Column A**

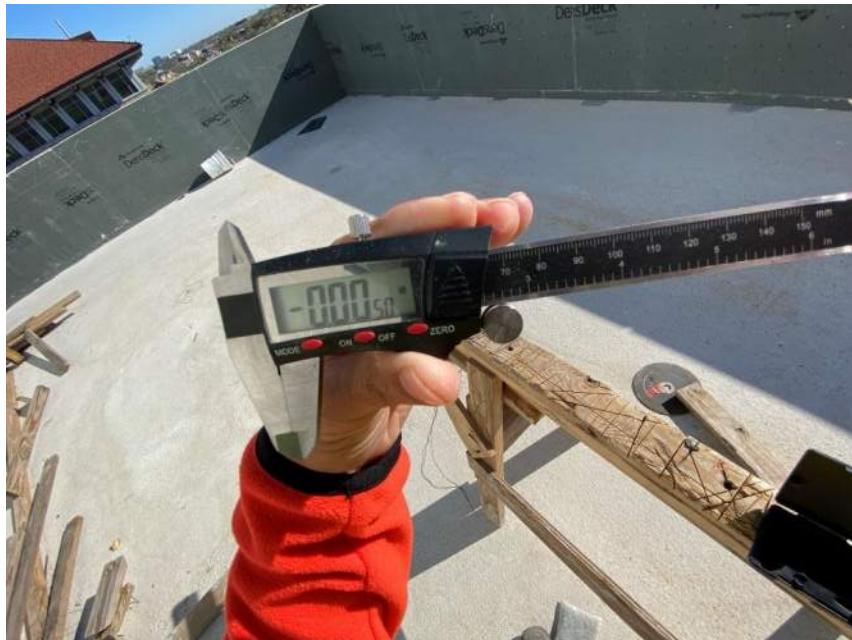
**Photo 1**  
**Example of Calibration**

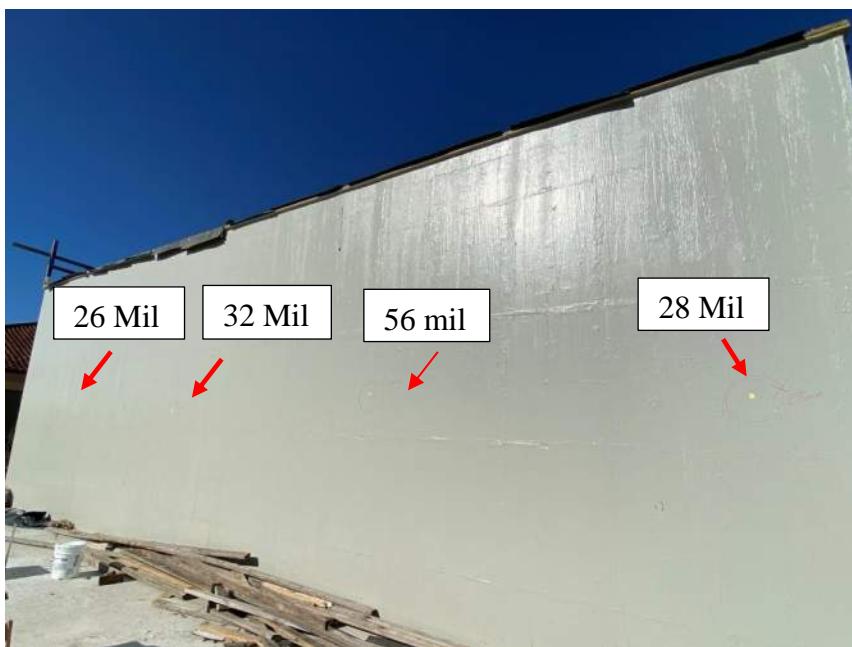
1. At the east elevations of the Penthouse, ZSC obtained specimen of the fluid applied air barrier. Four (4) samples of the east elevation were obtained, ranging from 26 mil-53 mil. ZSC recommends for east elevation to be recoated with fluid applied AB to keep a consistent mil thickness of a minimum of 40mil, as per project specification. **See Photos 1-5**

**Photo 2**  
**East Elevation Specimen Locations**

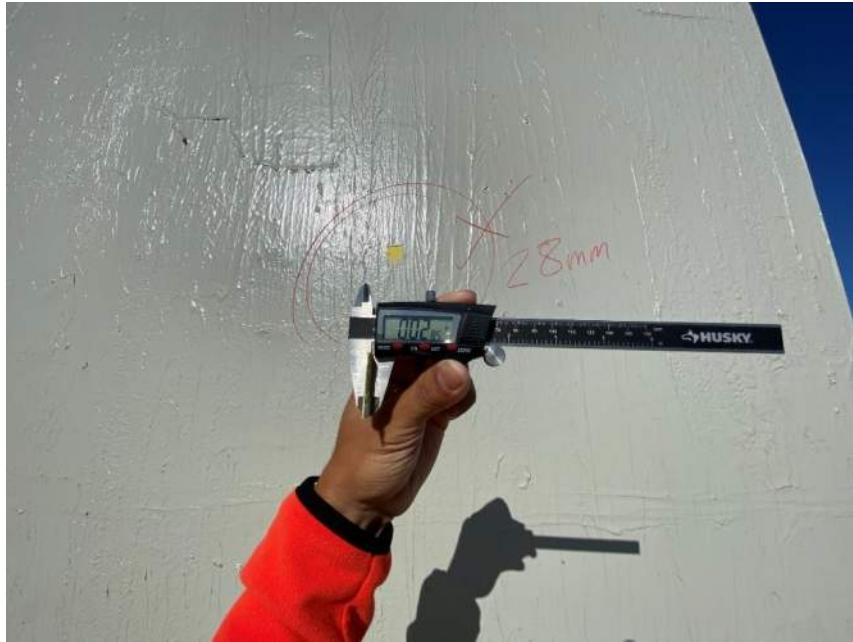
**Photo 3**  
**Example of Low Mil Reading**

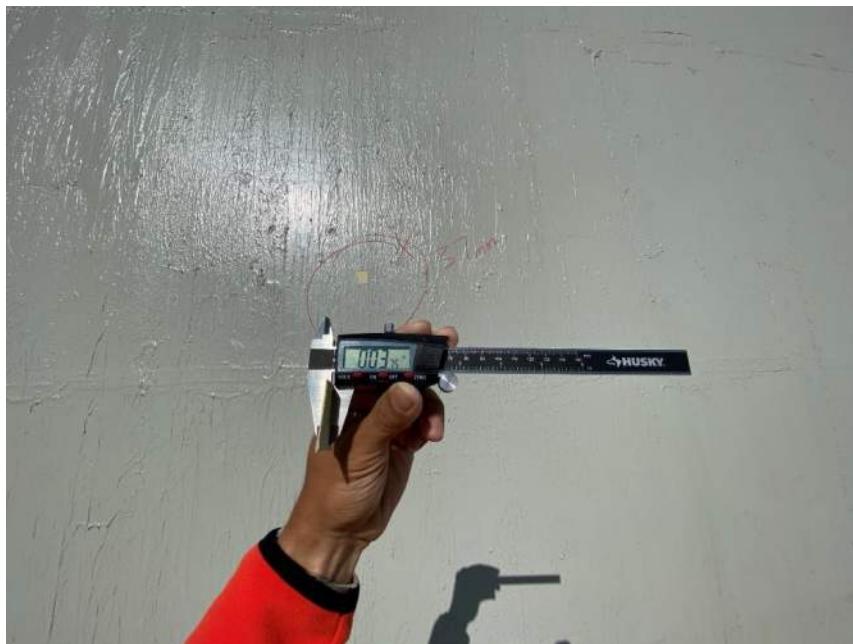
**Photo 4**  
**Example of Low Mil Reading**

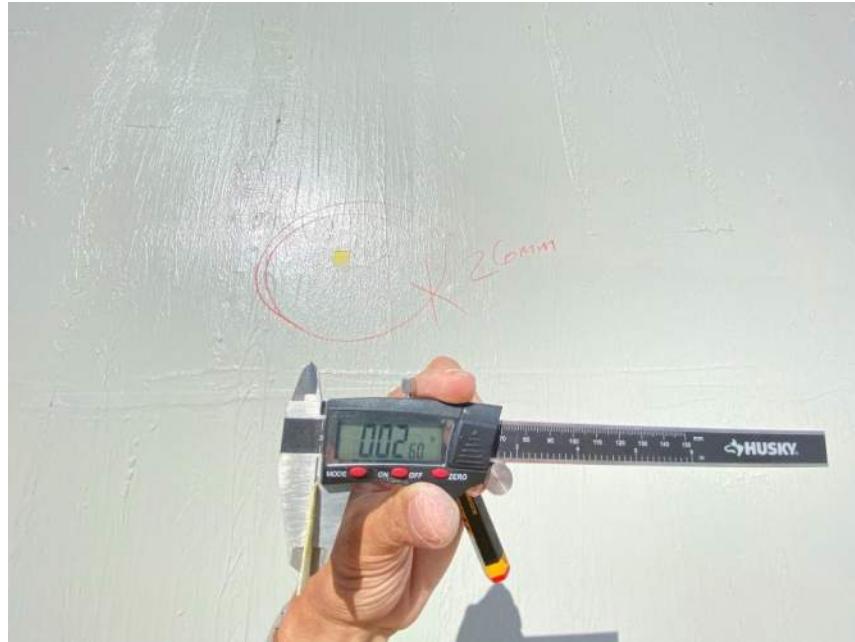
**Photo 5**  
**Example of Low Mil Reading**

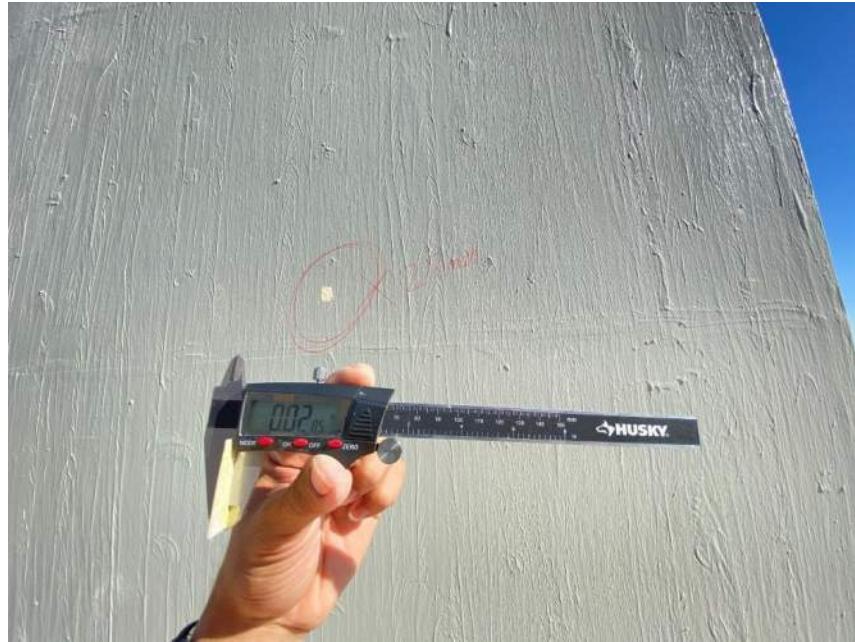
2. At the south elevation of the Penthouse, ZSC obtained specimen of the fluid applied air barrier. Due to ongoing application, only two (2) samples of the south elevation were obtained, ranging 28 mil and 60 mil. ZSC recommends for east elevation to be recoated with fluid applied AB to keep a consistent mil thickness of a minimum of 40mil, as per project specification. **See Photos 6-7**

**Photo 7**  
**Example of Low Mil Reading**

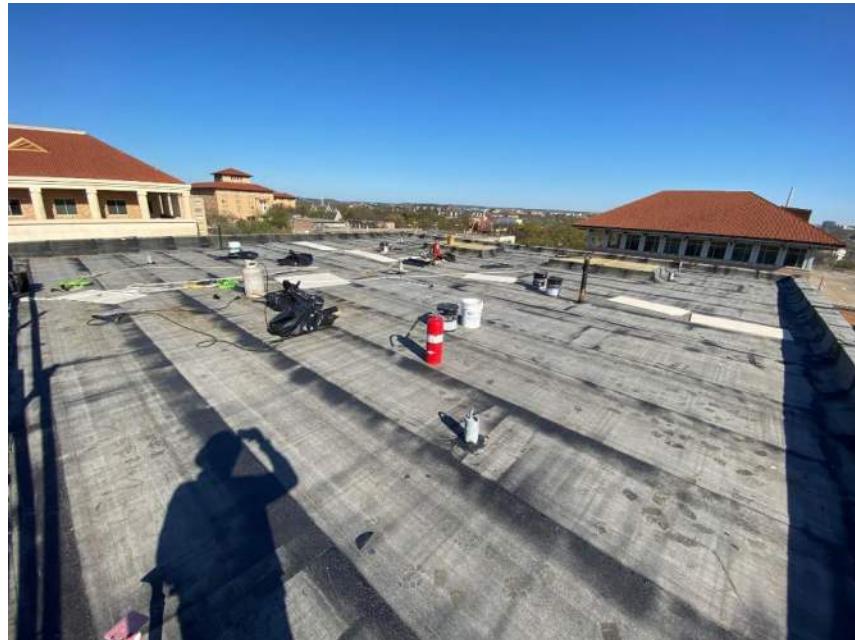
3. At the Penthouse roof deck, ZSC noted the ongoing installation of base sheet membrane. Base sheet appeared to be installed up the parapet wall and heat

welded over parapet. No deficiencies were noted at the time of observation and installation appeared sufficient. **See Photo 8**

**Photo 8**  
**Observation of Base Sheet Membrane Application**

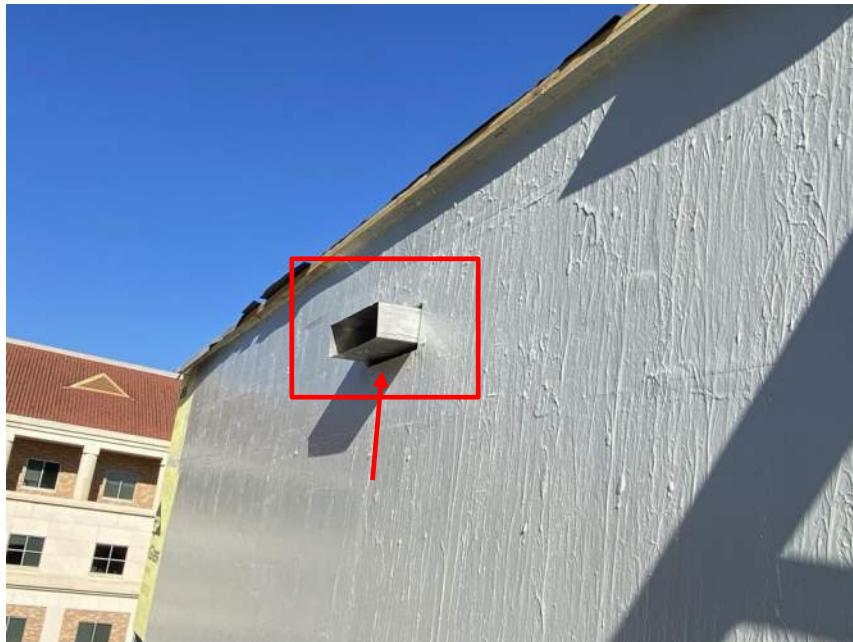
**Photo 9**  
**Example of supper to be Detailed With SAMF**

4. At the south elevation of scuppers of penthouse, ZSC recommends for SAMF to be installed at the perimeter, as per manufacture installation specifications to prevent moisture intrusion into envelope and roofing system. **See Photos 9-10**

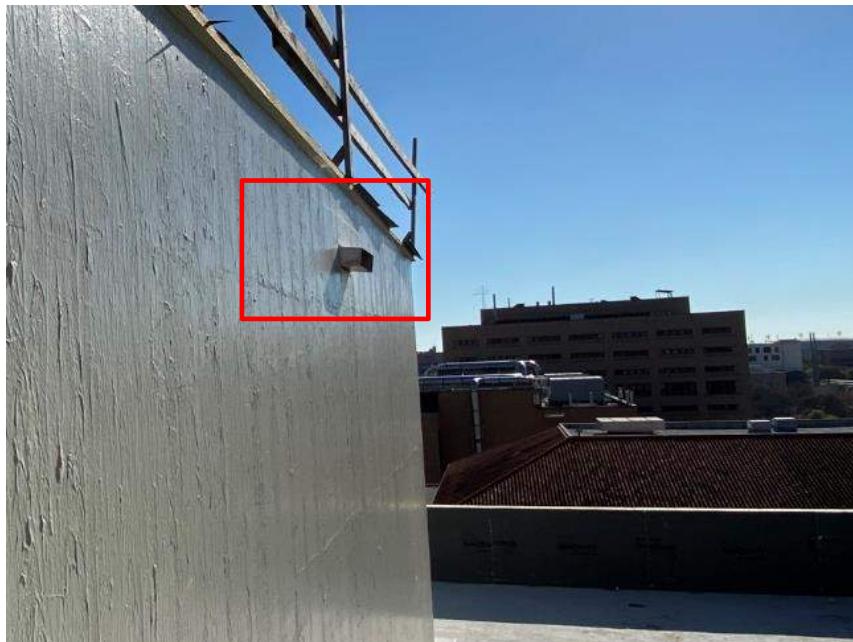
**Photo 10**  
**Example of supper to be Detailed With SAMF**

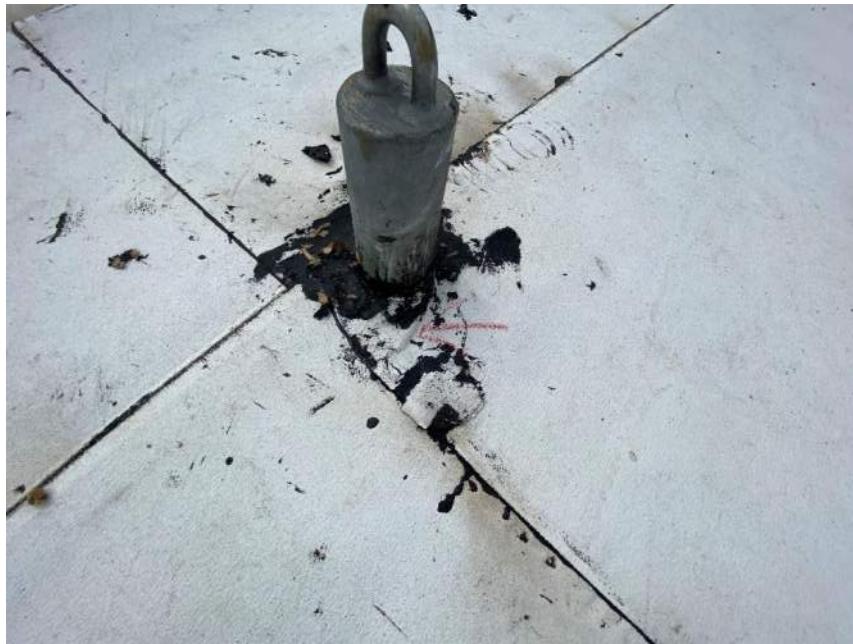
1. At the penthouse roof, ZSC noted the completion of the cap sheet and terminated up and over parapet walls. At the center anchor point, the cap sheet appeared to be wrinkled. ZSC recommended for defective cap sheet to be removed and replaced. Kidd roof was on-site to repair the cap sheet, as per ZSC recommendation, contractor appeared to be conducting work in a workmanlike manner. No additional deficiencies were noted at the time of observation and installation appeared to be sufficient. **See Photos 1-5**
2. At the east elevation level 2 between B-D, ZSC observed Chamberlain applying fluid applied vapor barrier onto DensGlass and applying sealant at the seems of SAMF at around window openings. Ongoing work appeared to performed in a workmanlike manner, no deficiencies were noted at the time of observation and installation appeared to be sufficient. **See Photos 6-9**

**Photo 1**  
**Wrinkled Cap Sheet Membrane**

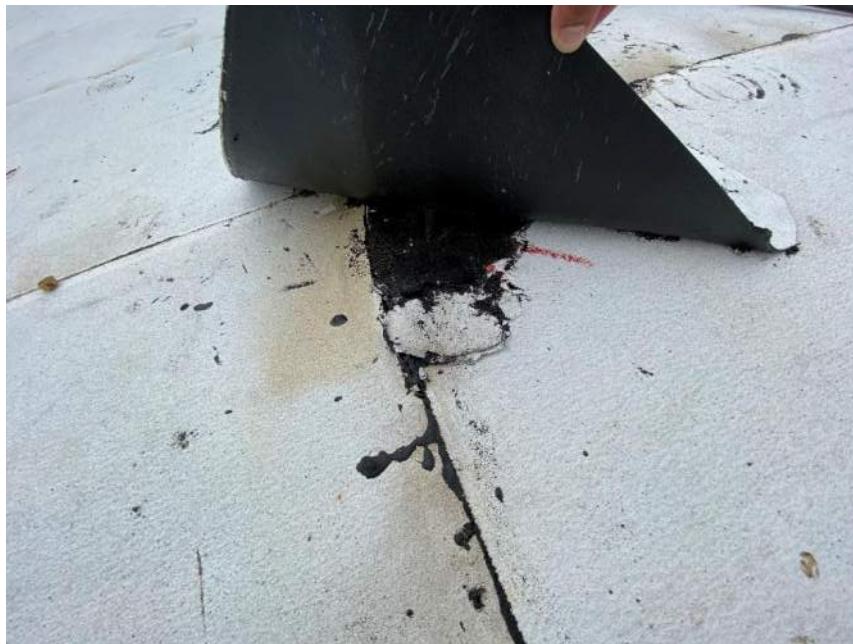
**Photo 2**  
**Example of Area Cut-Out**

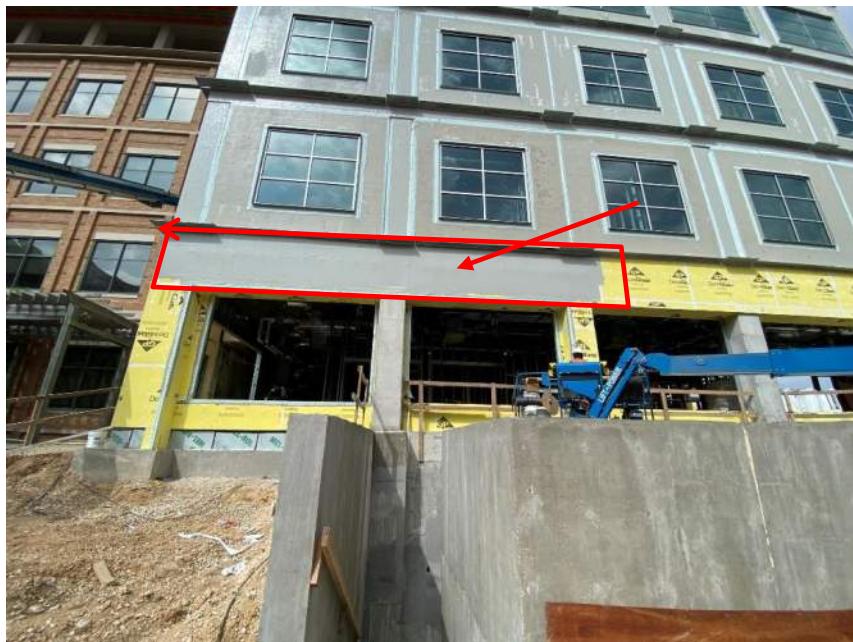
**Photo 6**  
**Observation of Fluid Vapor Barrier**

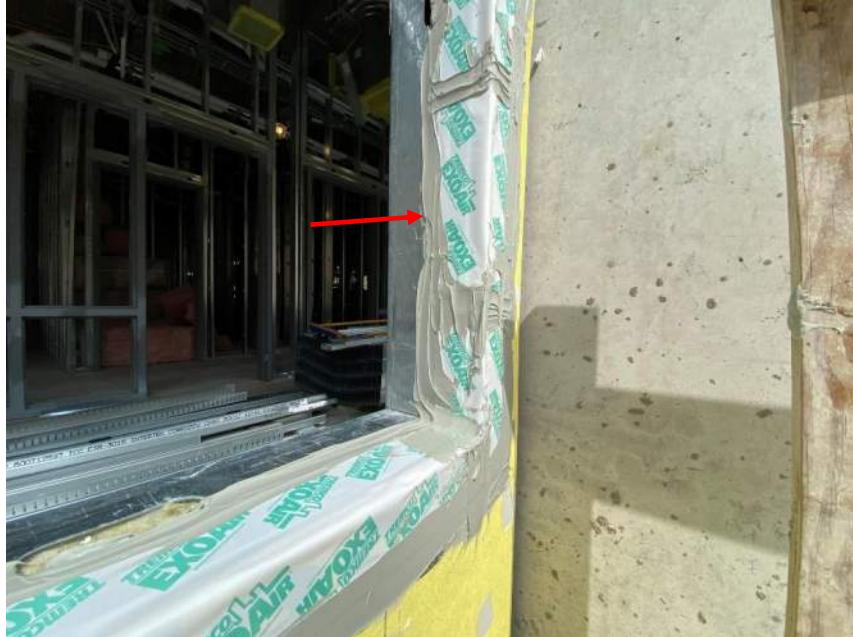
**Photo 8**  
**Observation of SAMF Seem Sealed with Dymonic 100**

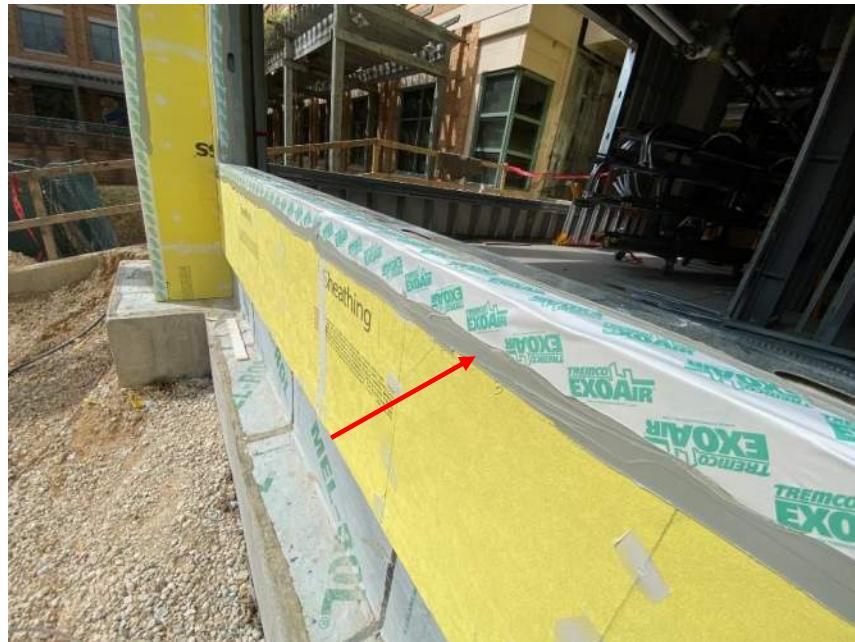
**Photo 9**  
**Observation of SAMF Seem Sealed with Dymonic 100**

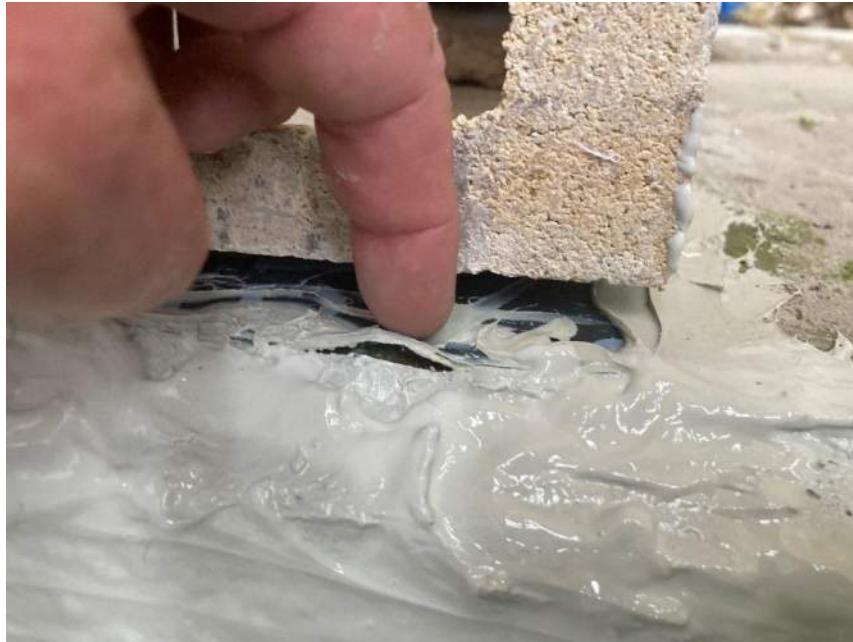
**Photo 5**  
Fish Mouth at Top of Vertical SAMF

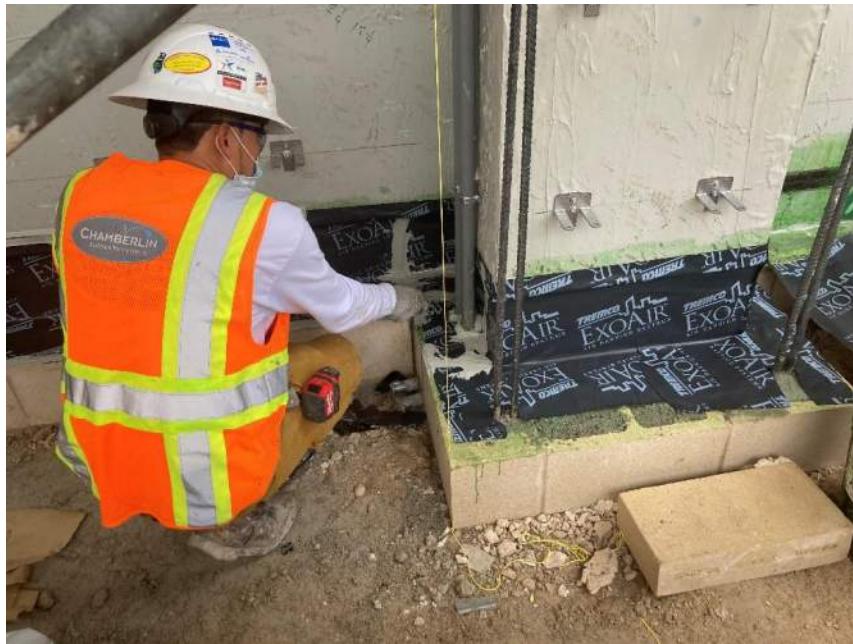
**Photo 7**  
SAMF Installed and Terminated with Sealant

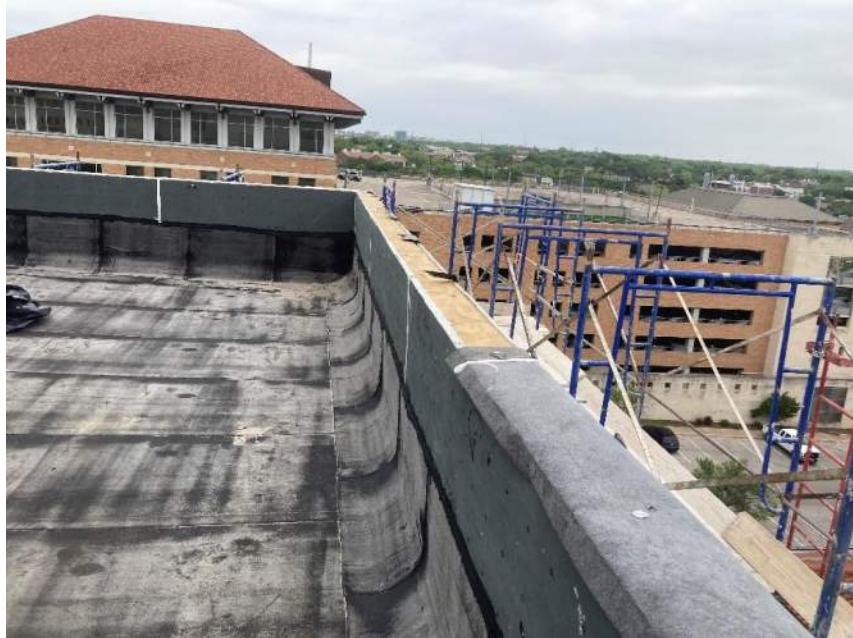
- At the roof, ZSC found the parapet and some of the edges of the roofing material were open and not prepared for inclement weather. Upon observation, there were areas of the parapet that had not been flashed or detailed with any materials and were wide open to the elements. It was also observed that some roofing materials were open at the edges and also open to rain in the forecast. It was brought to Kidd Roofing's attention and the edges of roofing materials were detailed with mastic. Chamberlin was not on site but the parapet issues were brought to SG's attention and said parapet was covered with SAMF, in order to prevent water infiltration into the roofing system. **See Photos 01-10**

**Photo 1**  
Parapet Open

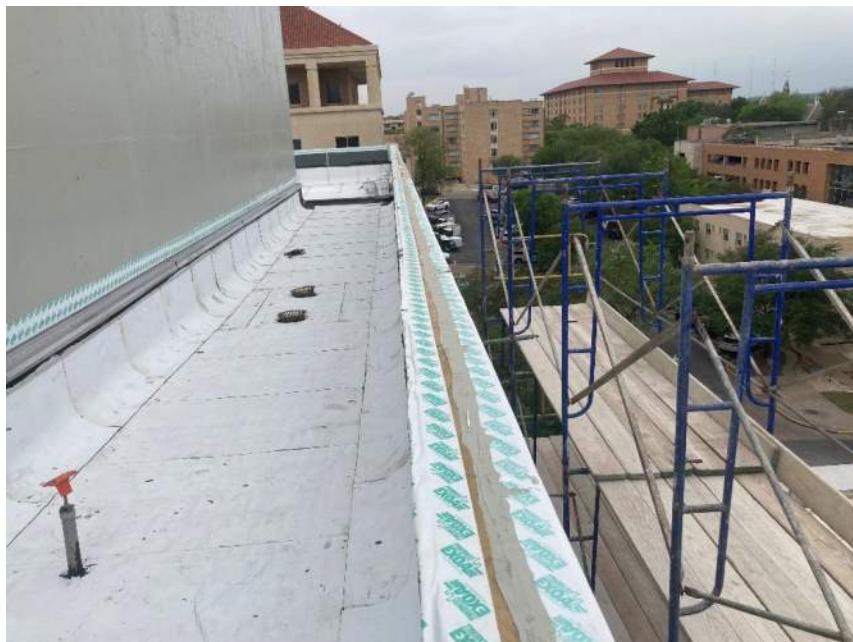
**Photo 2**  
Parapet Flashing Installed with no Termination Sealant

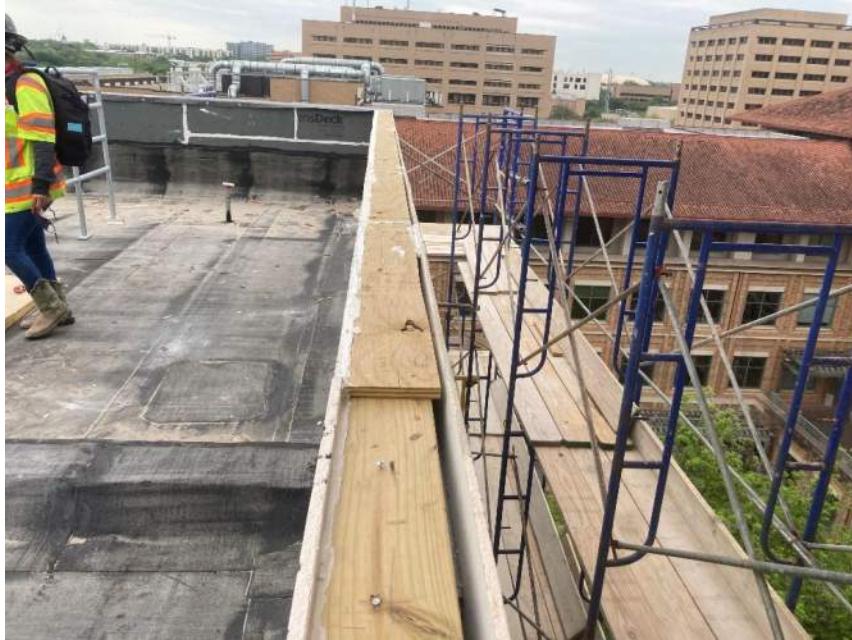
**Photo 3**  
Parapet Wide Open

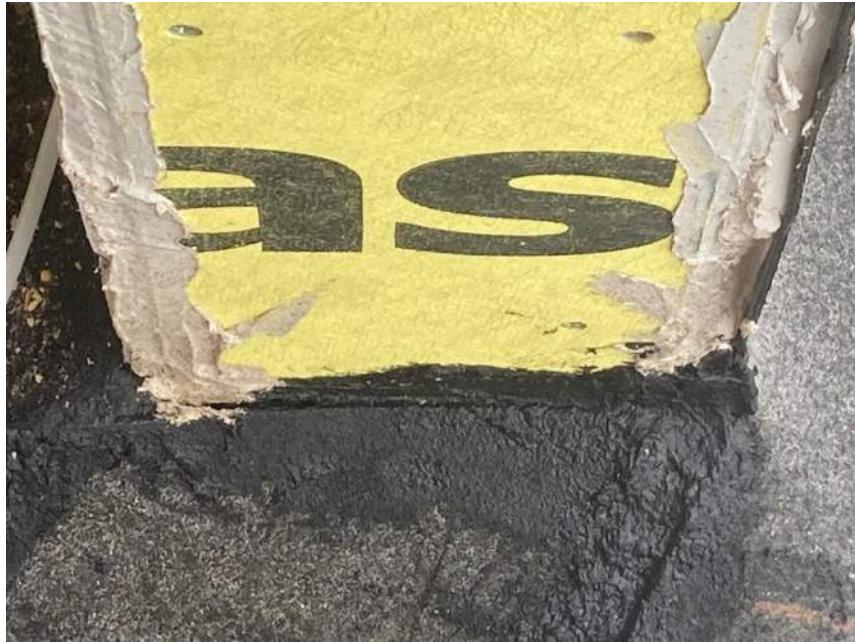
**Photo 5**  
Roofing Open at Parapet

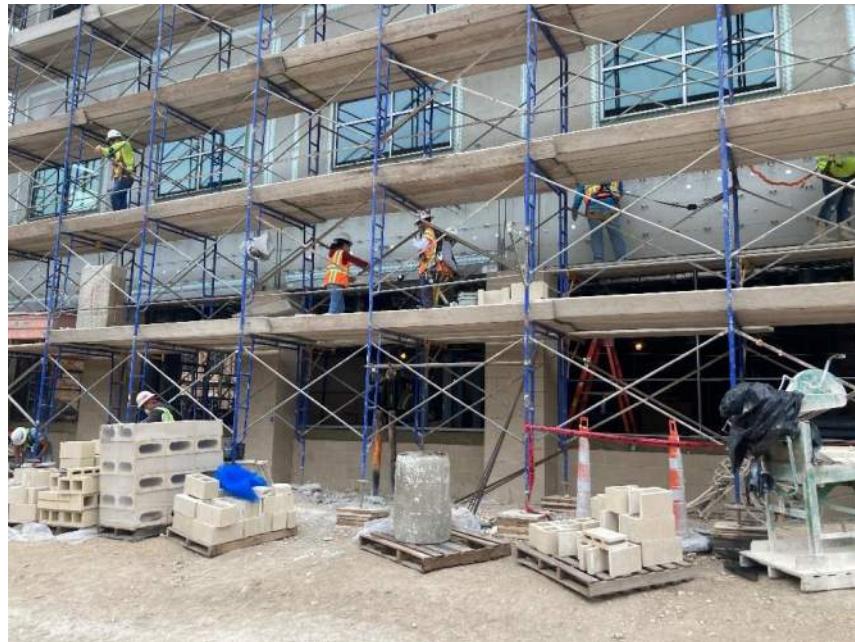
1. At the north face of the building, Chamberlin was installing metal flashing, flexible flashing, sealant and air barrier at the loose lintels ahead of the masons. The metal flashing was a 2 piece that was terminated with flexible flashing, term bar and sealant. Installation appeared to be a sufficient manner and ZSC had no issues. **See Photos 01-02**

**Photo 1**  
Overview of Work in Progress

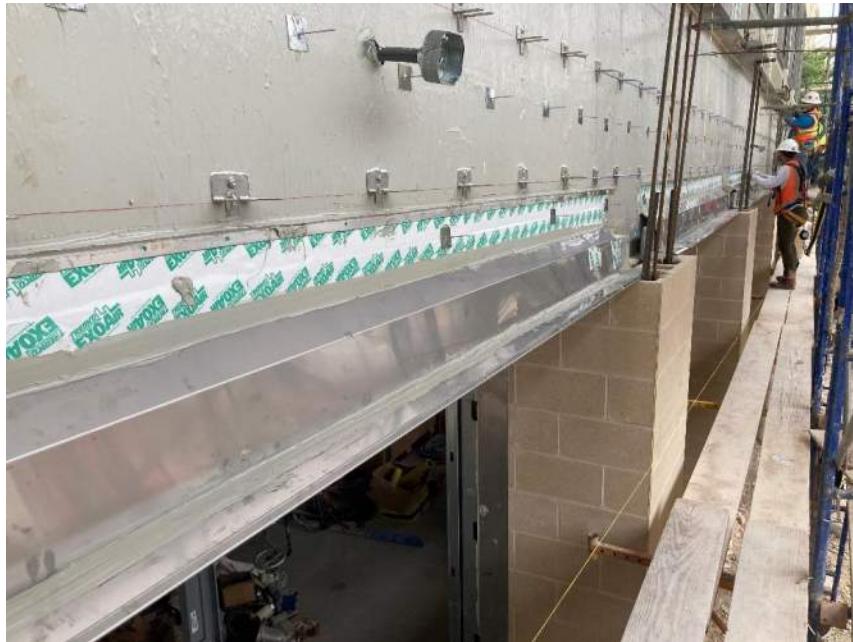
**Photo 2**  
Metal Flashing Installed at Loose Lintel

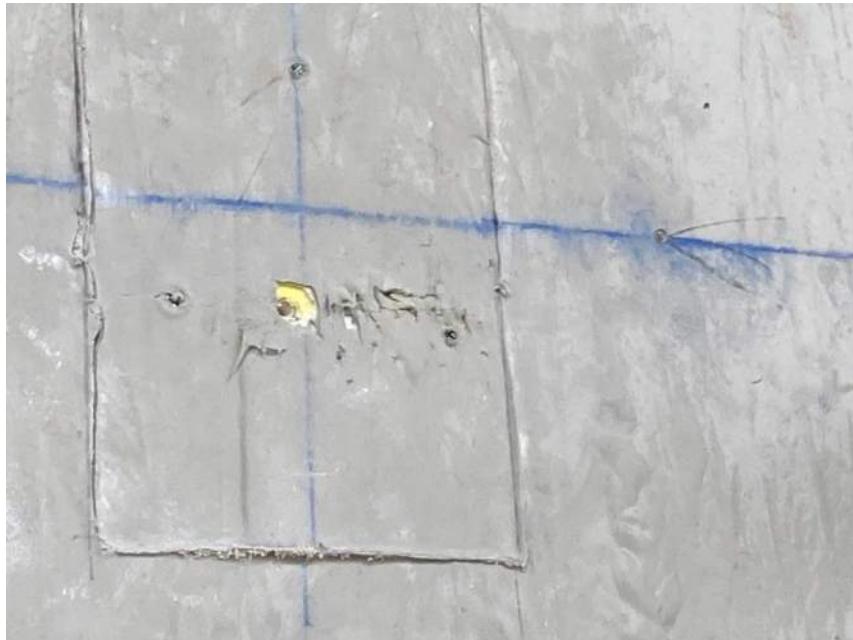
2. In the same area, there were squares of sheathing removed and replaced for framing reasons. The replaced pieces were detailed at the perimeters and air barrier was added to said patches. Repairs appeared to be in a sufficient manner. **See Photos 03-04**

**Photo 3**  
Sheetrock Removed and Replaced

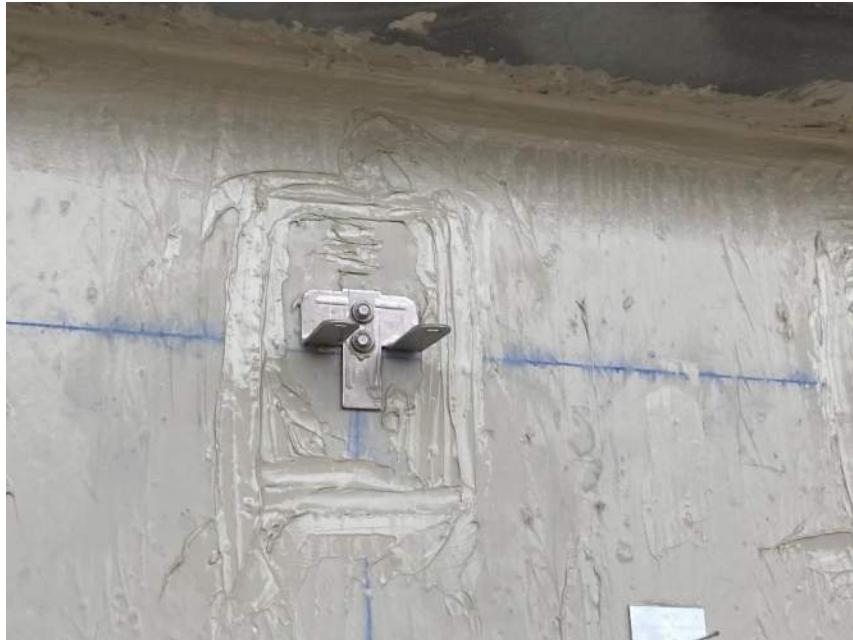
**Photo 4**  
Patches Sealed and Detailed after Replacement

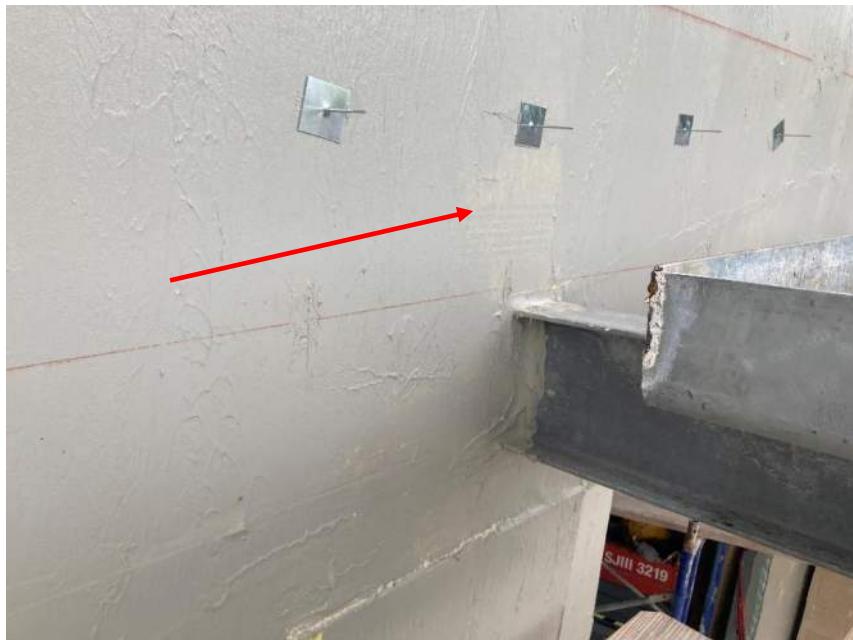
**Photo 5**  
Beam Detailed at Perimeter but Sheathing Lacking Air Barrier

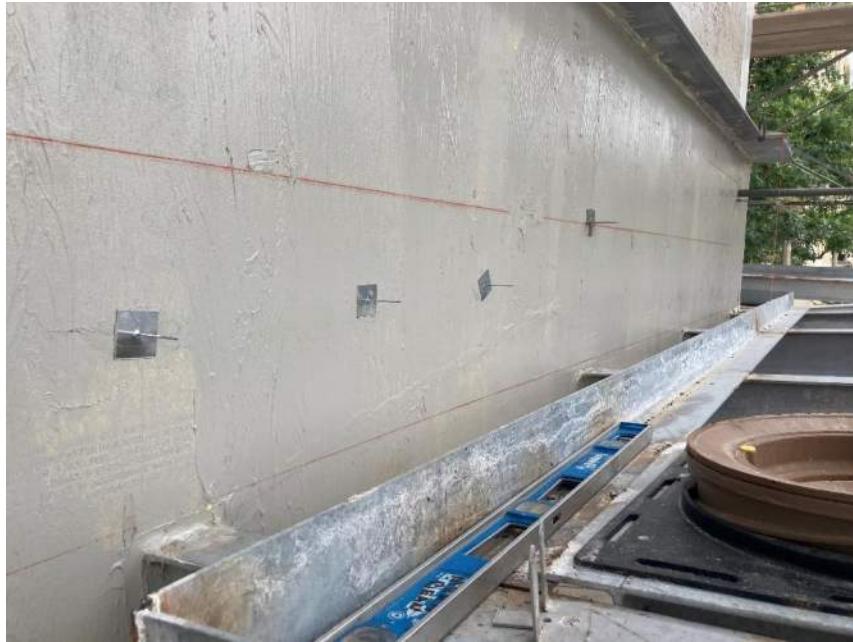
**Photo 6**  
Sheathing Needing Air Barrier

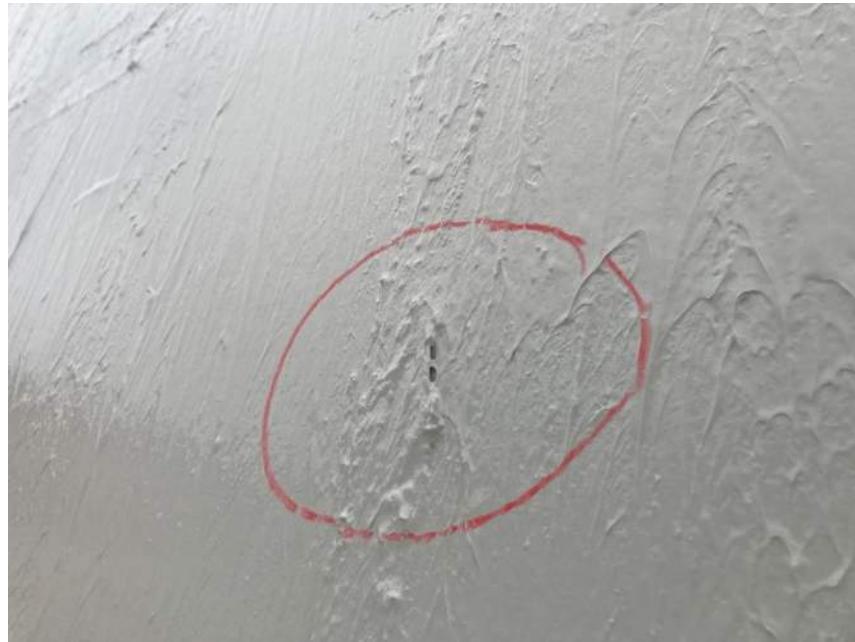
6. On the south face of the penthouse, it was observed that there was a hole in the sealant and air barrier. This was brought to Chamberlin personnel's attention and was repaired immediately. Said repair appeared to be in a sufficient manner. ***See Photos 10-11***

**Photo 10**  
Gap in Sealant

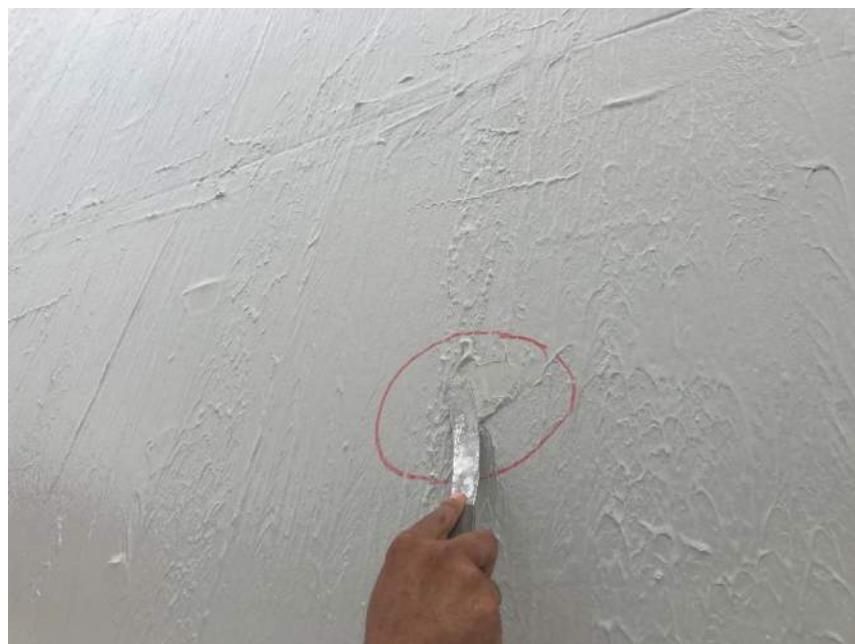
**Photo 11**  
Gap in Sealant Repaired

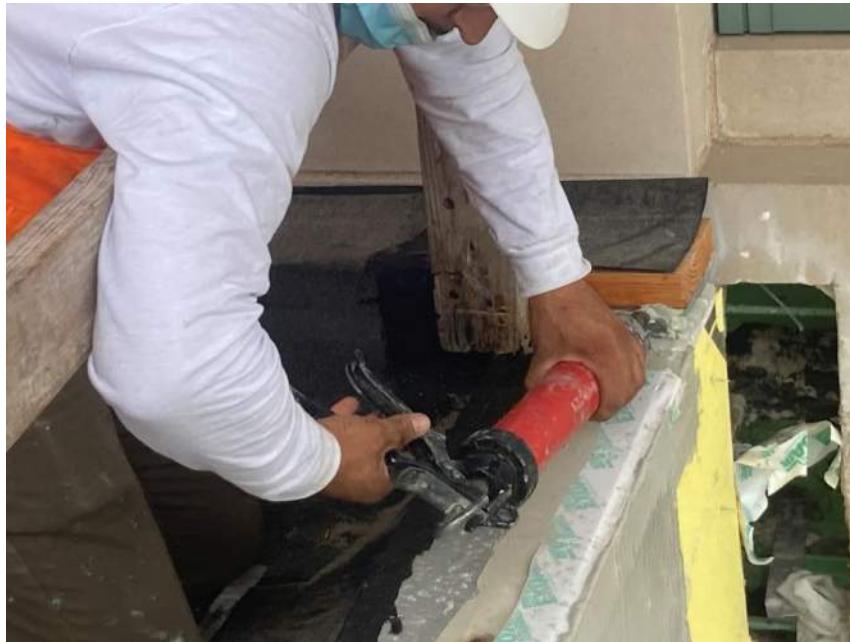
**Photo 12**  
Sealing Areas at Low Parapet to Prevent Water Infiltration

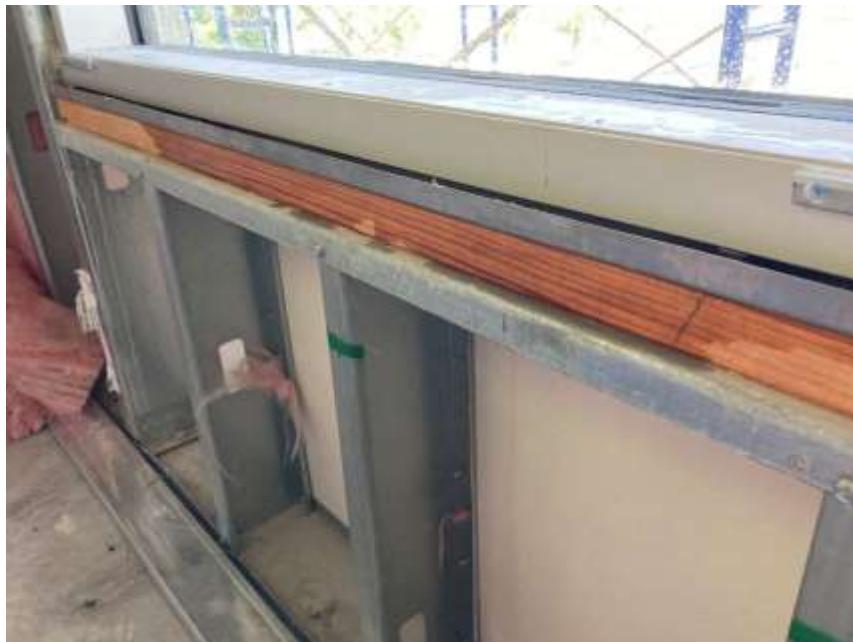
- At the north and west faces of the building, ZSC conducted nozzle testing on randomly picked windows when on-site. After spraying water at 1 minute per foot at 30 psi at the specimens, it was concluded that all but specimen #2 were passes. Once specimen #2 started having water applied to it, it took about a minute and a half for water intrusion to become visible. The moisture from this test was at the wood blocking below the sill of said specimen. Further investigation will be conducted from the exterior, in order to determine the root cause of this failure. **See Photos 01-06**

**Photo 6**  
Water Intrusion Below Window System (Specimen #2 Fail)

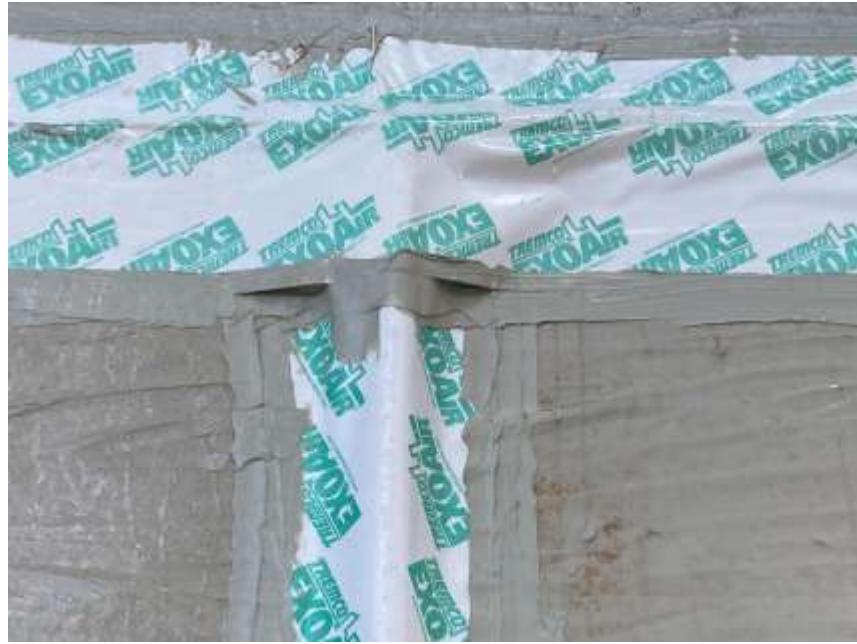
**Photo 7**  
Flexible Flashing Not Adhered

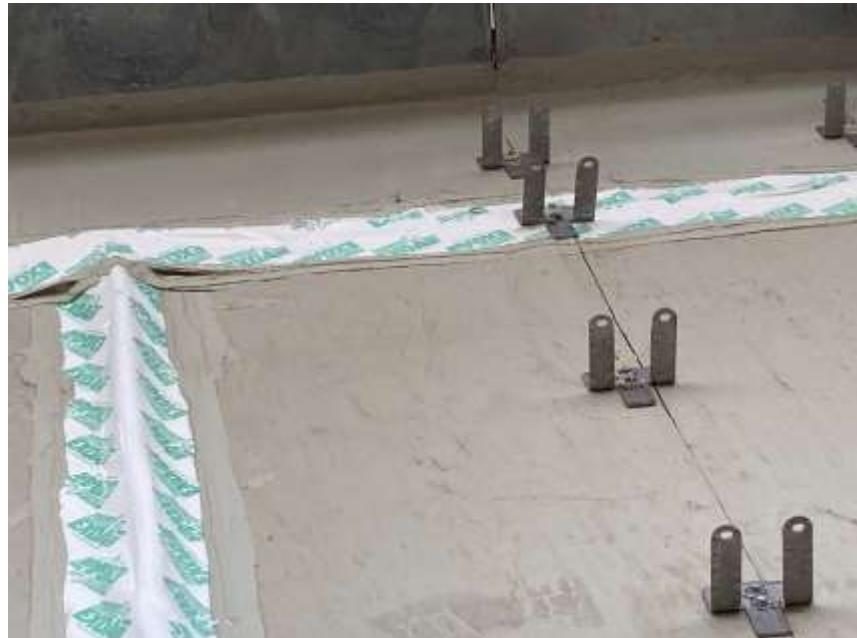
**Photo 8**  
Flexible Flashing Not Adhered
