## SUBMITTAL REVIEW

Description: Aluminum Framed Entrances and Storefronts -SD

Project Name: UT SEAY Building Addition

Project No.: 102-782

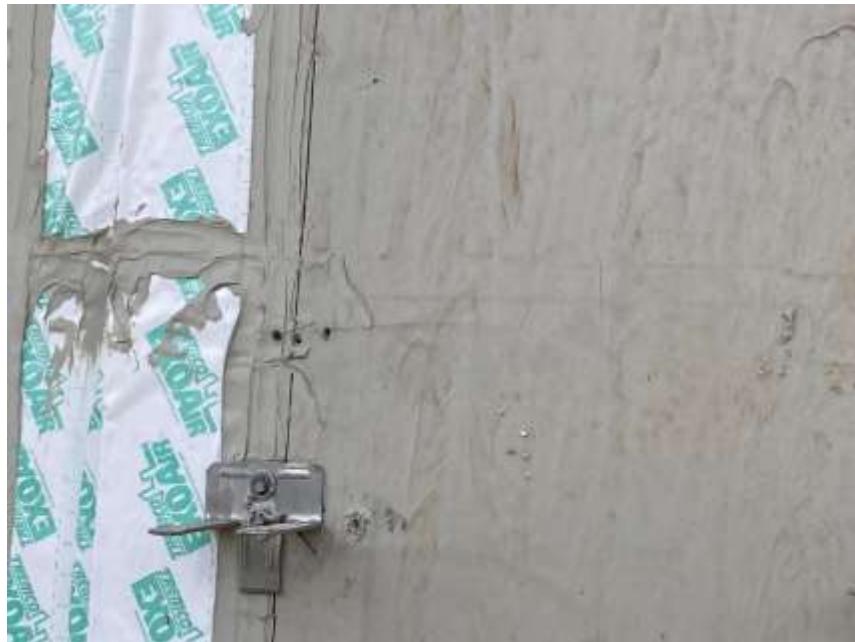
- At the north face, while ZSC was setting up for nozzle testing, it was noticed that in several areas there are screw holes in air barrier, flexible flashing with fish mouths, broken sheathing and areas of missing sealant. At several areas the masons are missing the studs and pulling the screws out, while leaving the

**Photo 9**  
Screw Holes in Air Barrier

penetrations open. ZSC recommends either giving the masons sealant for them to repair their mistakes or Chamberlin following the masons as they are installing brick ties. These mistakes appear to be happening far too often, only to be left open in a 20' section on the 3<sup>rd</sup> level of the scaffolding. ZSC also recommends stopping the masons and removing insulation, in order to insure all screw holes have been sealed. Chamberlin personnel need to inspect their flexible flashing, as there are fish mouths and unadhered areas that are areas of concern. There is missing sealant at transitions from sheathing to the lintel and one area was seen where the sheathing was broke and in need of repair. This sheathing repair needs to be repaired from stud to stud and re-waterproofed.

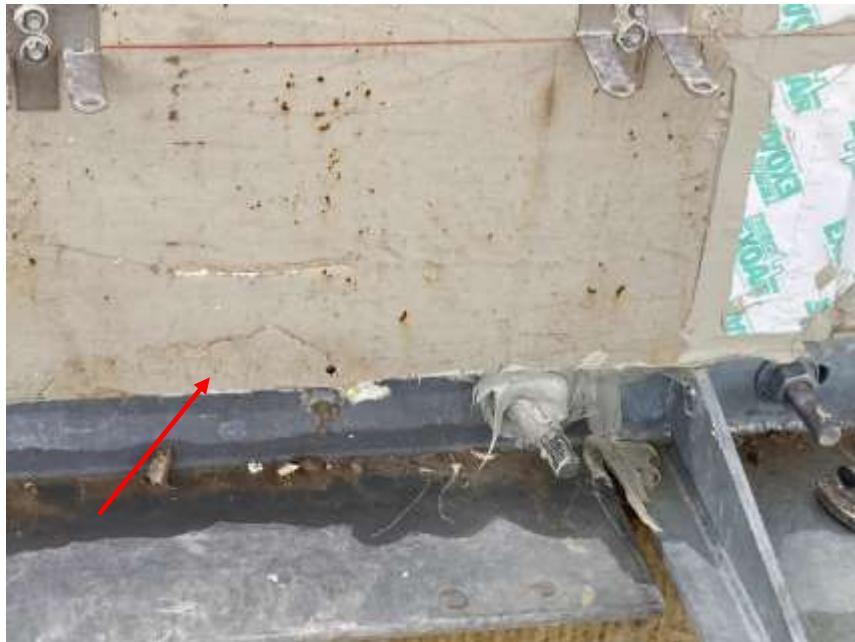
**Photo 11**  
Sheathing is Broke and in Need of Replacing

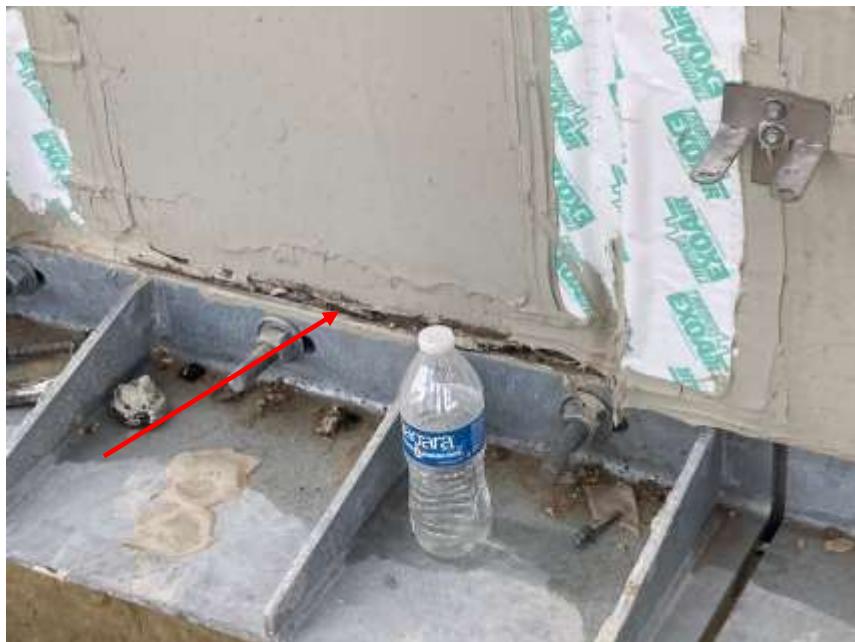
**Photo 12**  
Sealant Missing

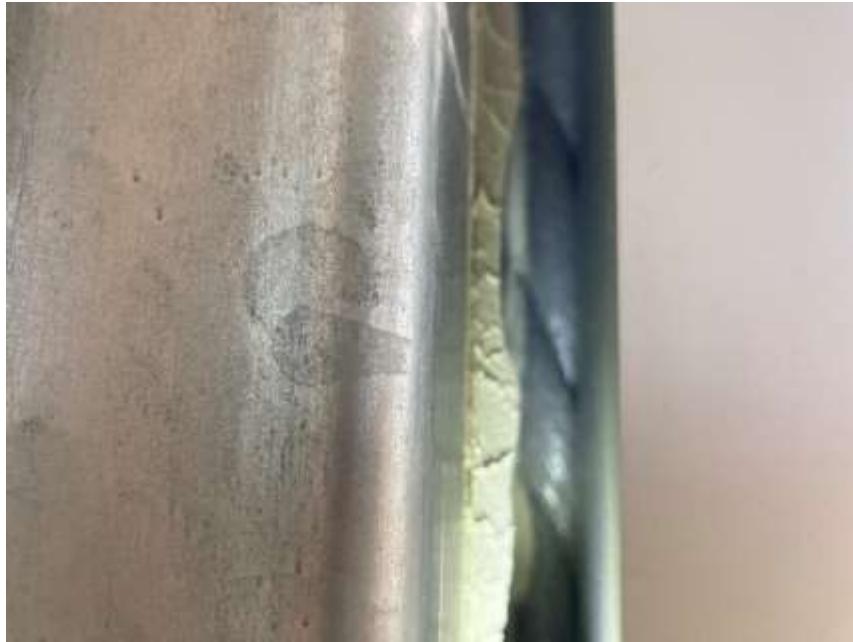
3. At the west face of the building, on specimen #5 from the interior, it was noticed that the joint was bigger than the backer rod on hand. Glass House took 2 pieces of backer rod and twisted it together. This is an unacceptable sealant joint profile and will NOT allow for proper expansion or flexibility. At the opposite side of the same window, it was noticed that the joint profile is too small and no backer rod was used at the top 2' of the joint. A cant profile was installed at the top of this joint and transitioned into the correct profile. It appears that this window was set at an angle or the opening is not square, which is causing these joint profiles to differ so substantially. ZSC recommends adjusting this window in order to be installed square, allowing for the correct joint profiles.

**Photo 15**  
Backer Rod Twisted on Exterior Sealant Joint

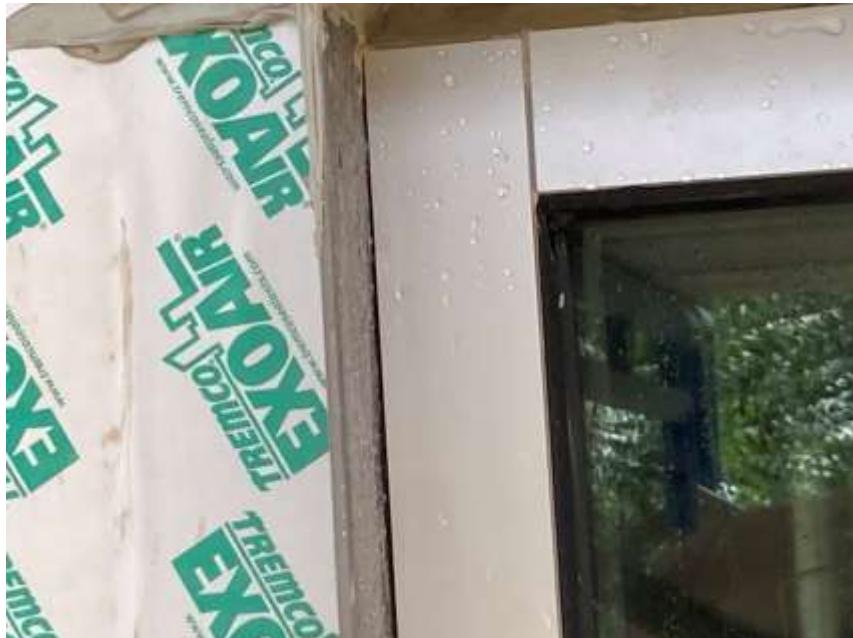
**Photo 16**  
Window is Set with a 1/16" Joint

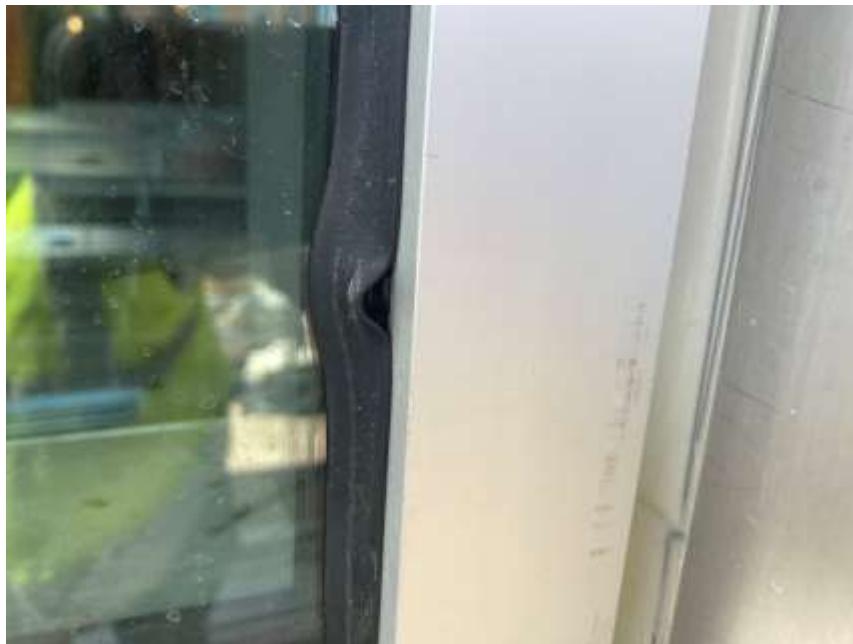
- At the north elevation window failure, it was observed from the exterior of the window, that the gaskets were not properly installed. These gaskets need to be reworked in order to ensure a proper seal. After further investigation of the water infiltration, it was noted that there was nothing visible to the naked eye that would lead ZSC to the exact cause of said water infiltration. **See Photos 01-02**

**Photo 1**  
Window Gasket not Properly Installed

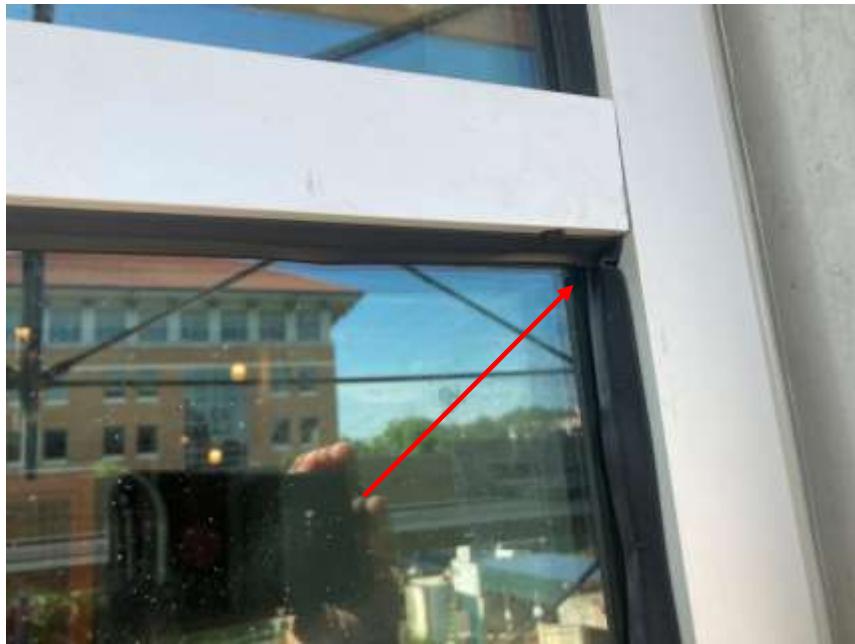
**Photo 2**  
Window Gasket not properly Installed

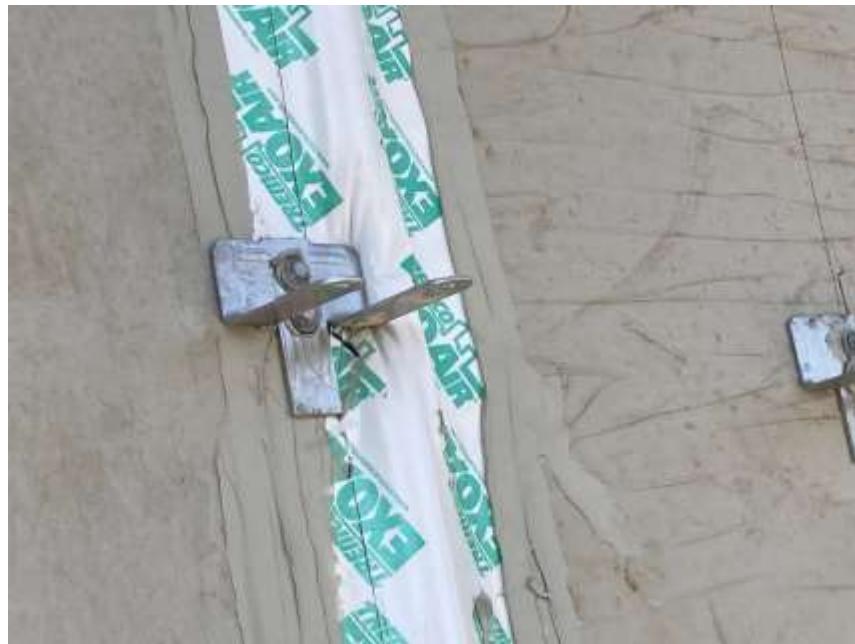
**Photo 4**  
Brick Tie Installed on Top of Expansion/Control Joint North

3. At the north and south elevations of the building, Rudd & Adams is installing their brick ties onto expansion/control joints. These brick ties will need to be removed and placed on either side of said joint or one on each side of the joint. The placement of these ties cannot be installed directly onto the joint, as movement will tear the flexible flashing allowing water intrusion. ***See Photos 03-09***
4. At the roof, TX Roofing continues installing the base sheet and detailing curbs to ensure a water tight system. Installation appears to be in a sufficient manner and ZSC had no issues at the time of visit. ***See Photos 10-12***

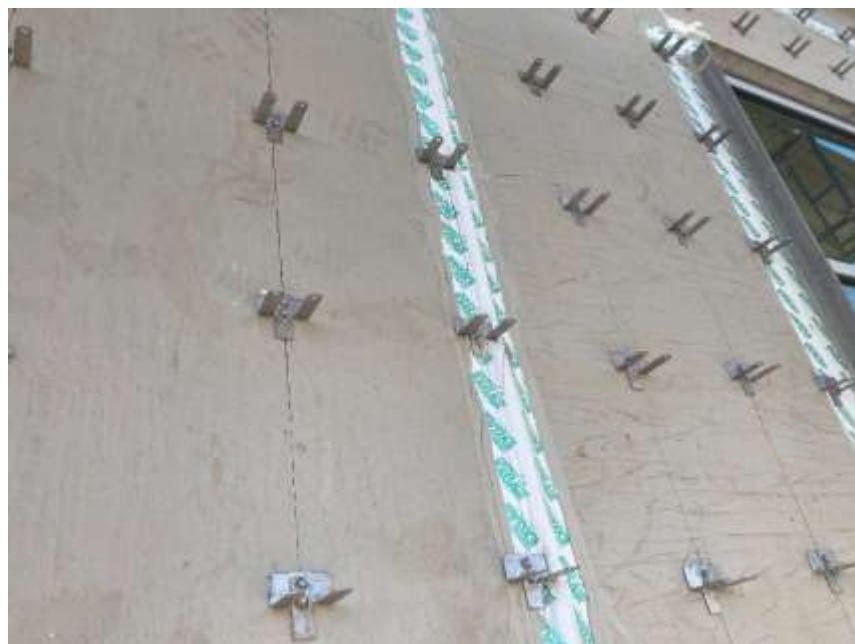
**Photo 5**  
Brick Ties Installed on Top of Expansion/Control Joints North

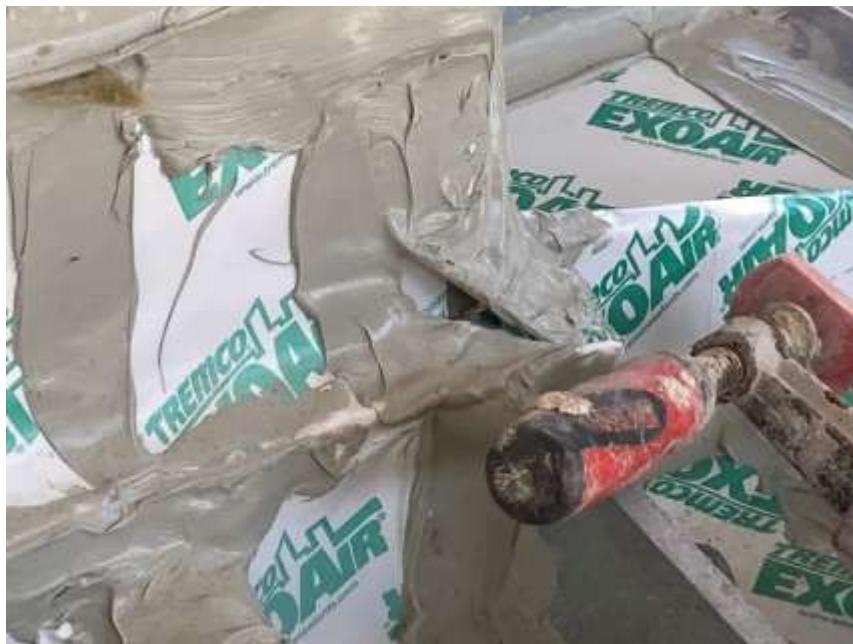
**Photo 7**

- At the north and east elevations, Chamberlin continues to install insulation, flexible flashing and metal flashing. It was noted that there was an area of concern that was brought to the attention of the Chamberlin team. The flexible flashing had a fish mouth at the northeast corner on the column, which was repaired immediately.

Flexible Flashing with Fish Mouth

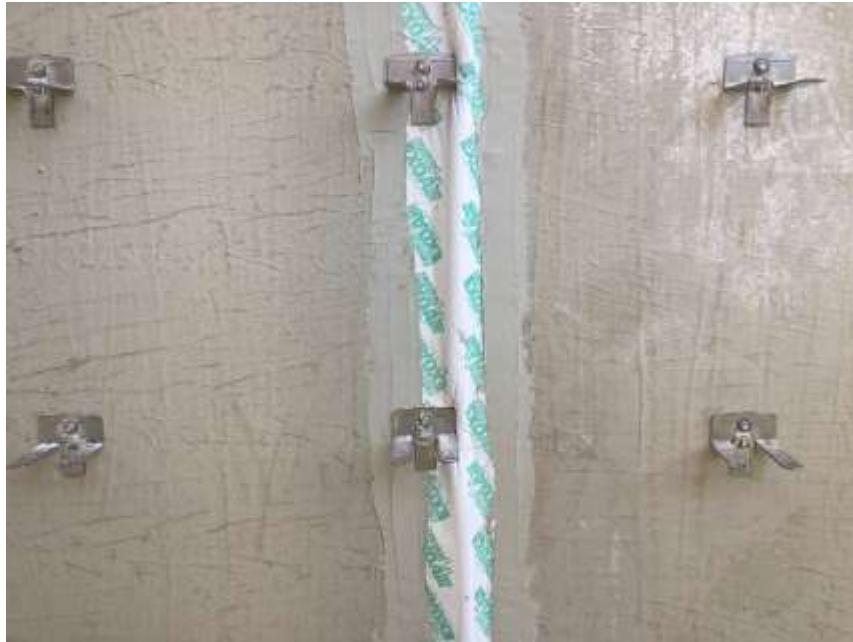
**Photo 8**  
Brick Tie Installed on Top of Expansion/Control Joint South

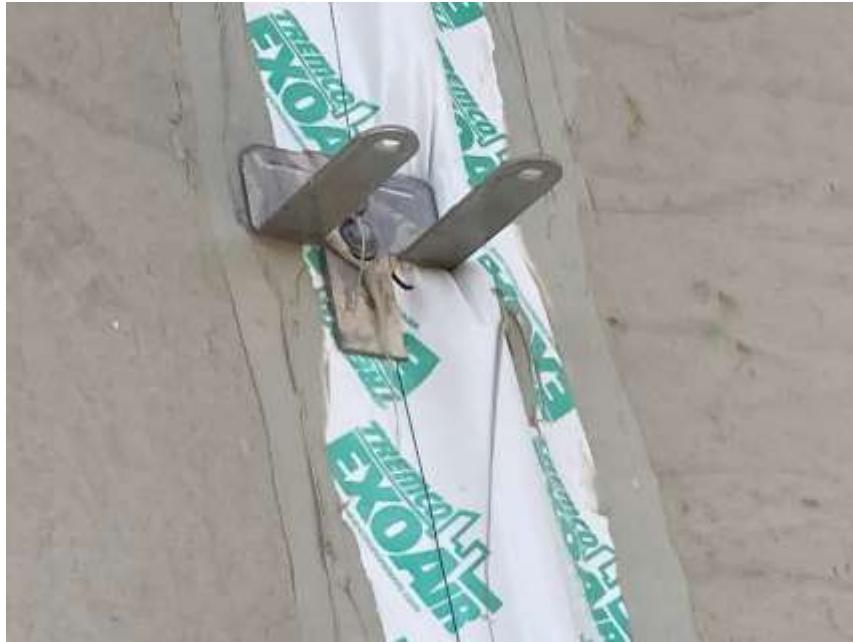
- At the north, south and west elevations, there are vertical control joints where two panels abut. Backer rod was placed on the exterior of the joint, then wrapped with flexible flashing, creating a bellow for movement. The masons followed installing their brick ties, which in turn, lap onto the protruded part of the joint. It is ZSC's recommendation to remove the brick ties, cut the backer rod out and install a control joint. Install backer rod into the joint, caulk the joint flush with the sheathing and install the flexible flashing over the joint.

**Photo 1**  
Brick Tie Placement on Control Joint

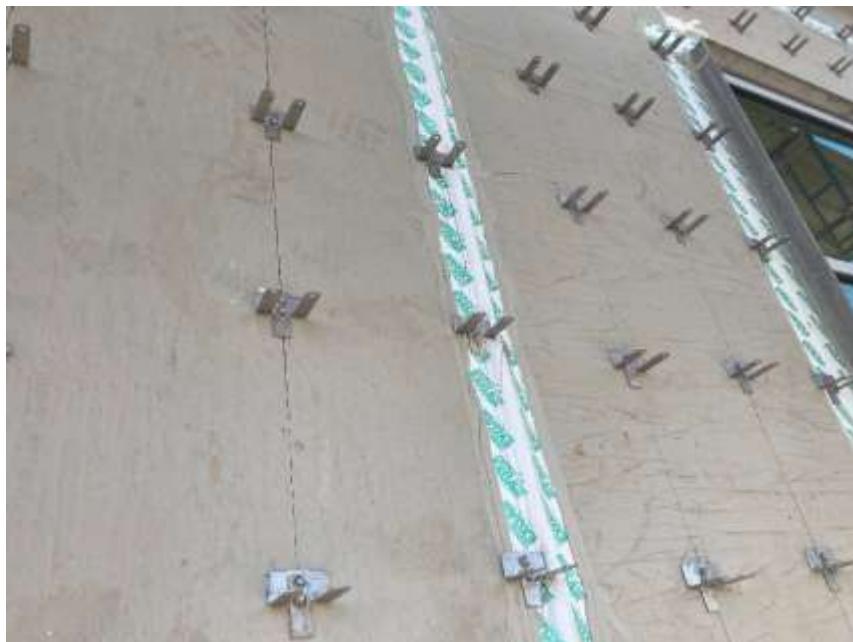
**Photo 2**  
Control Joint w/ Brick Ties Anchored Directly on Top

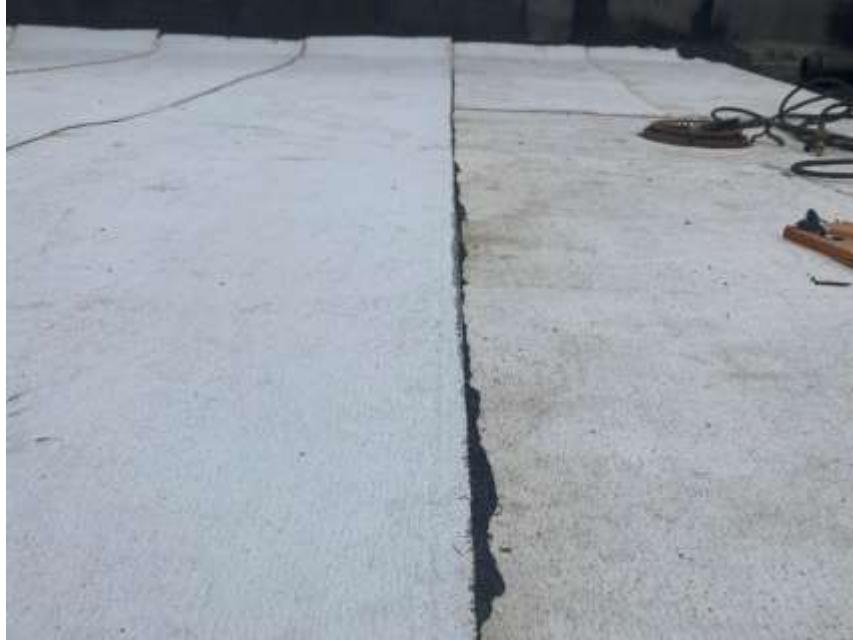
**Photo 5**  
Bleed Out on Cap Sheet

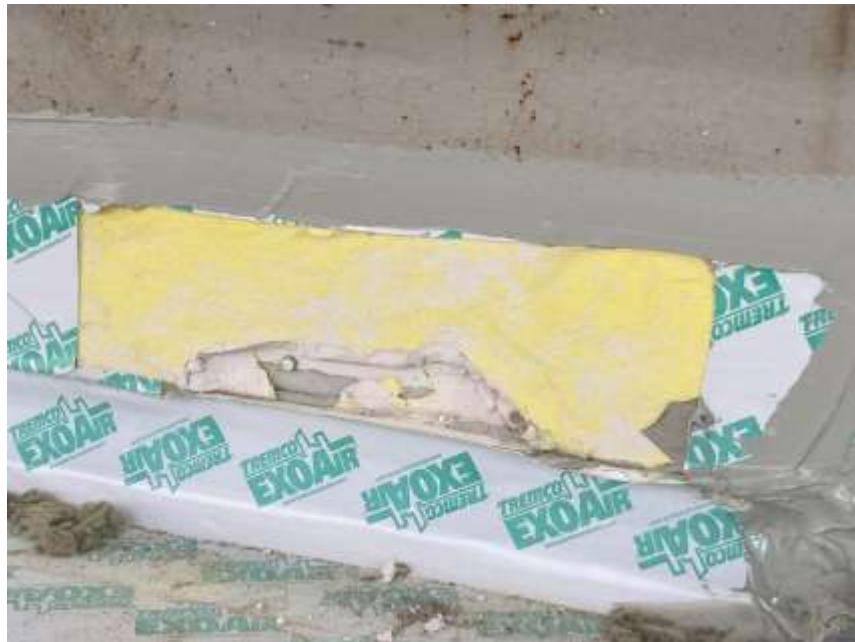
**Photo 9**  
Sheathing Needing Repair

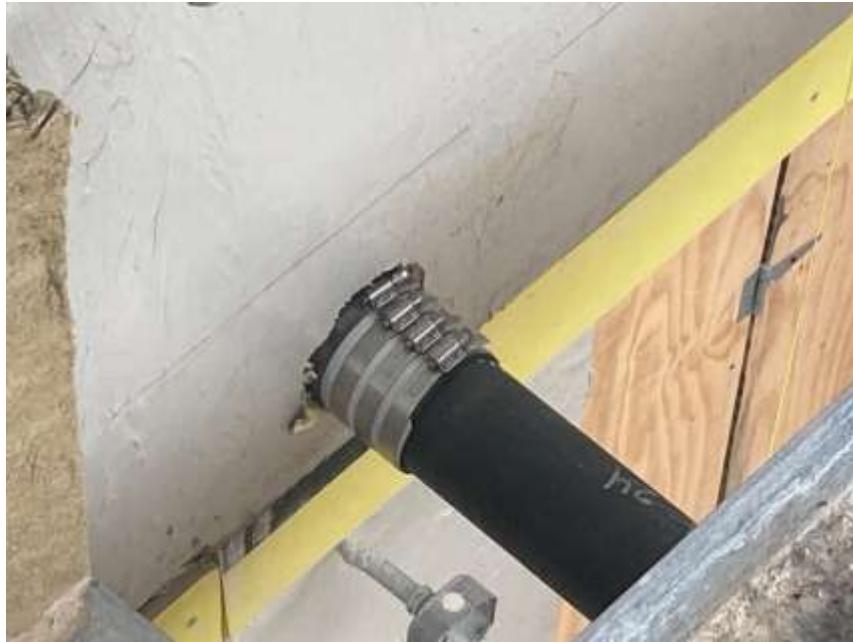
**Photo 11**  
Penetration Will NOT be Able to be Detailed Correctly

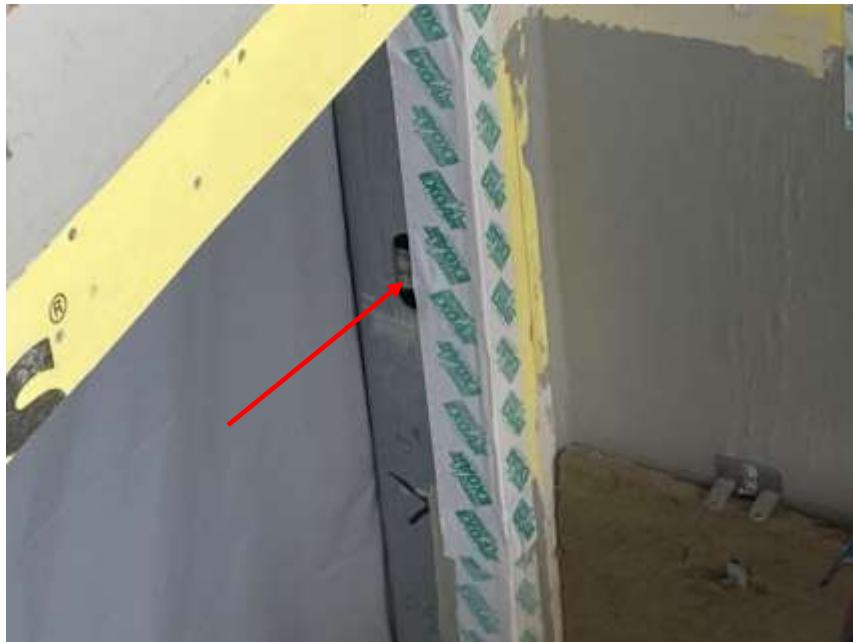
**Photo 12**  
Flexible Flashing Needs to be Cut at Knockouts

- d. At the window openings the flexible flashing will need to be cut around the knockouts where there is loose flashing. This will prevent the flashing from loosing adhesion in other areas. **Photo 12**

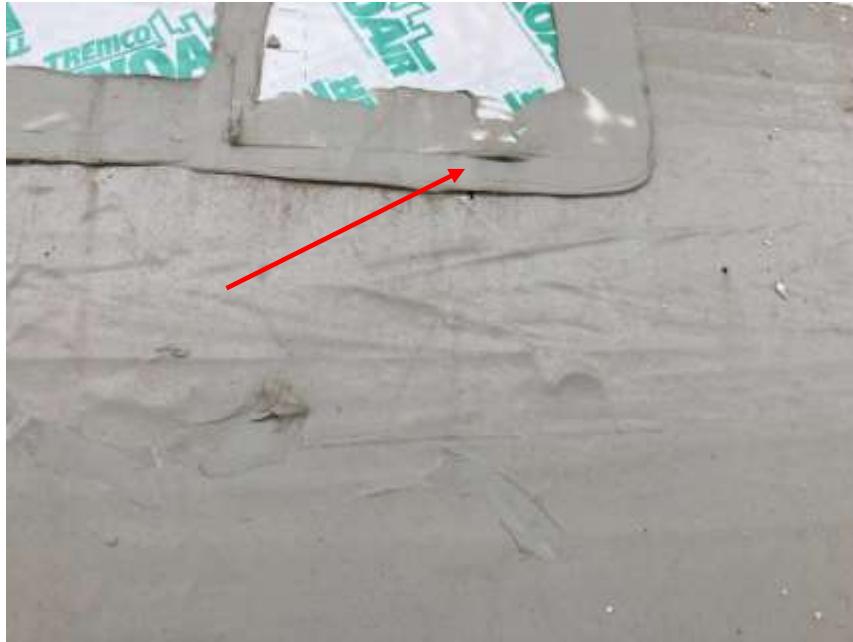
**Photo 13**  
Fish Mouth at Edge of Flexible Flashing

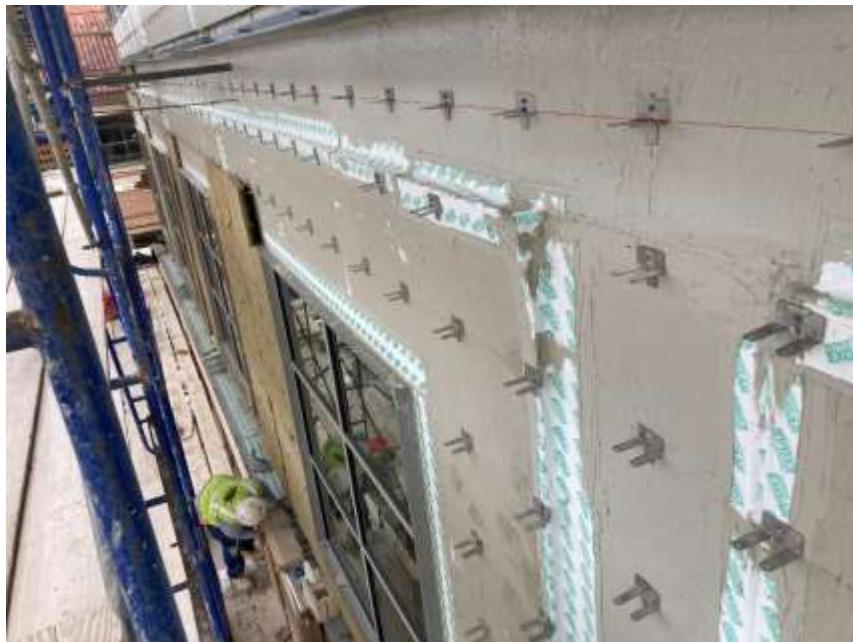
**Photo 14**  
Corner of Panel Protrudes out from the Building

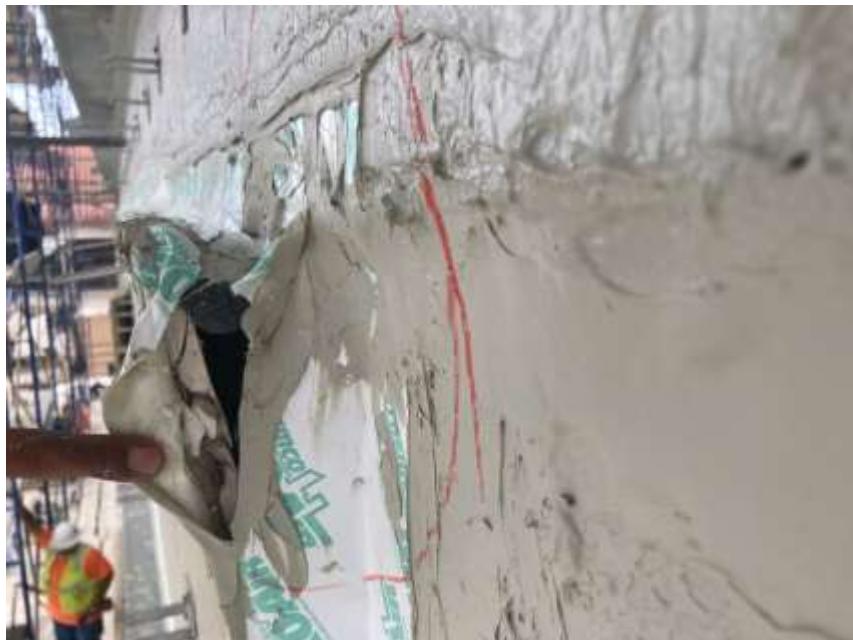
**Photo 16**  
Flexible Flashing Cut to Expose Missing Vertical Sealant

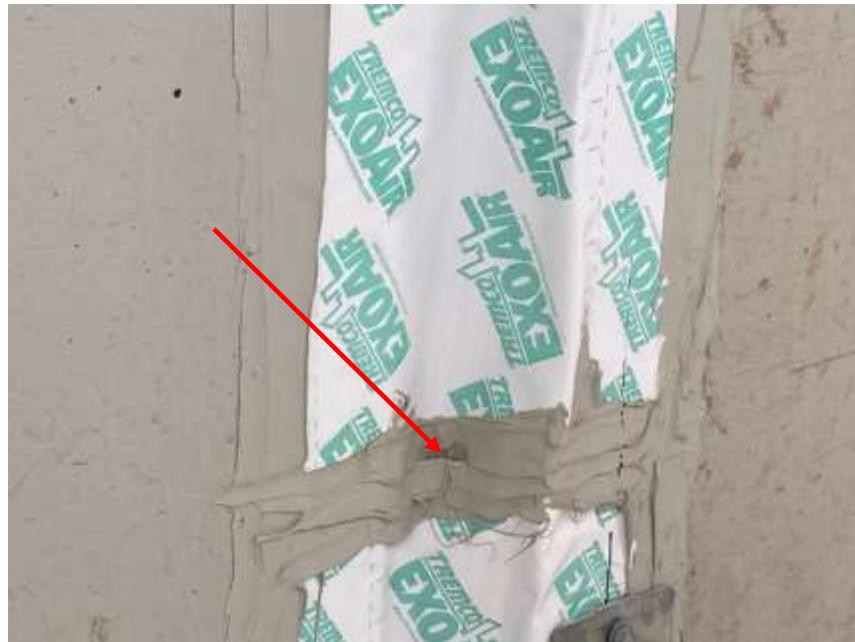
**Photo 17**  
Fish Mouth in Flex Flashing and Sealant

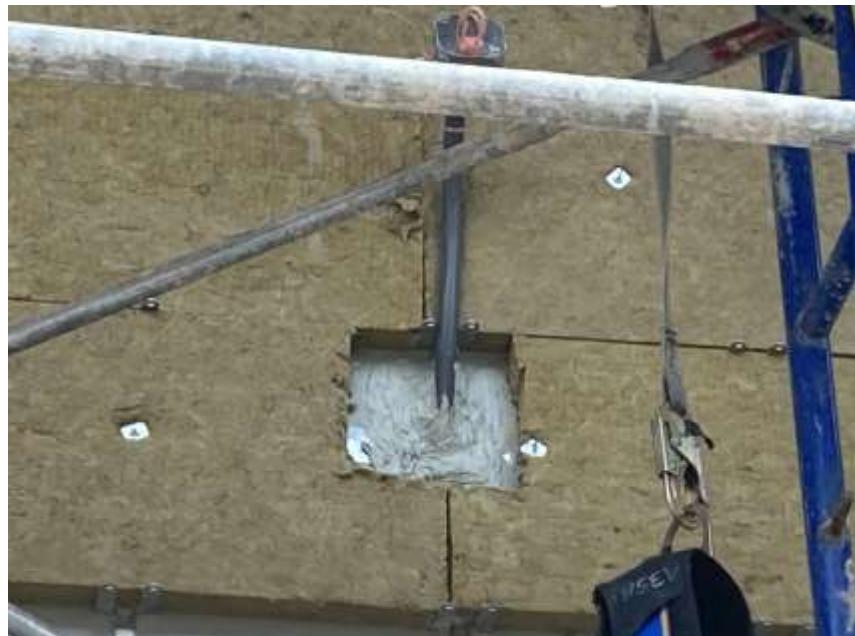
**Photo 18**  
Flexible Conduit Installed

- g. At the north face above the entry door, it was noticed that there is flexible conduit installed and detailed around. The flexible conduit will need to be removed and replaced with a solid conduit, in order to properly detail. **Photo 18**

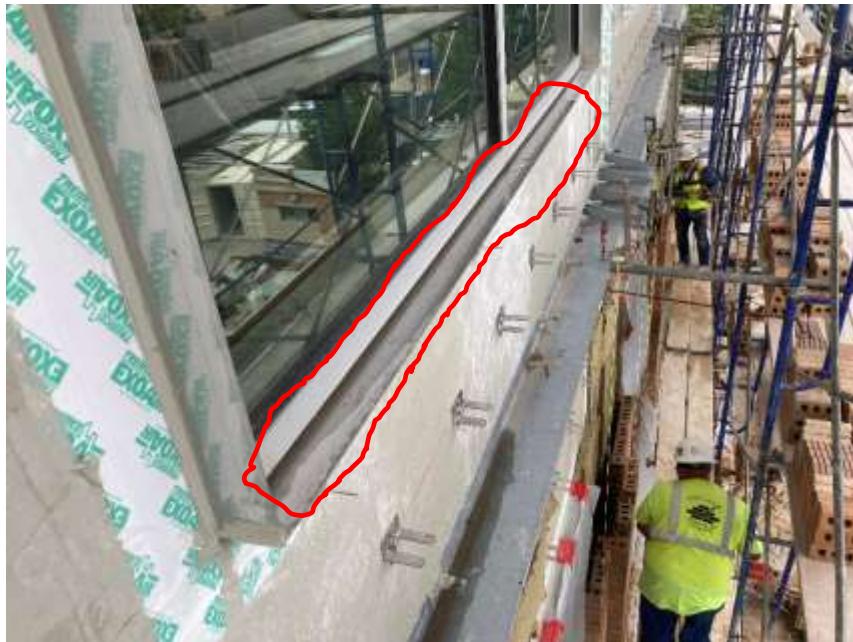
4. Upon inspection of window perimeter flashings, ZSC noticed in several locations, there is ponding water at the sills. ZSC recommends checking ALL sill flashing and take necessary steps to correct the metal flashing insuring there is slope at each sill for proper drainage. ***See Photos 12-13***

**Photo 12**  
Metal Sill Flashing Holding Water

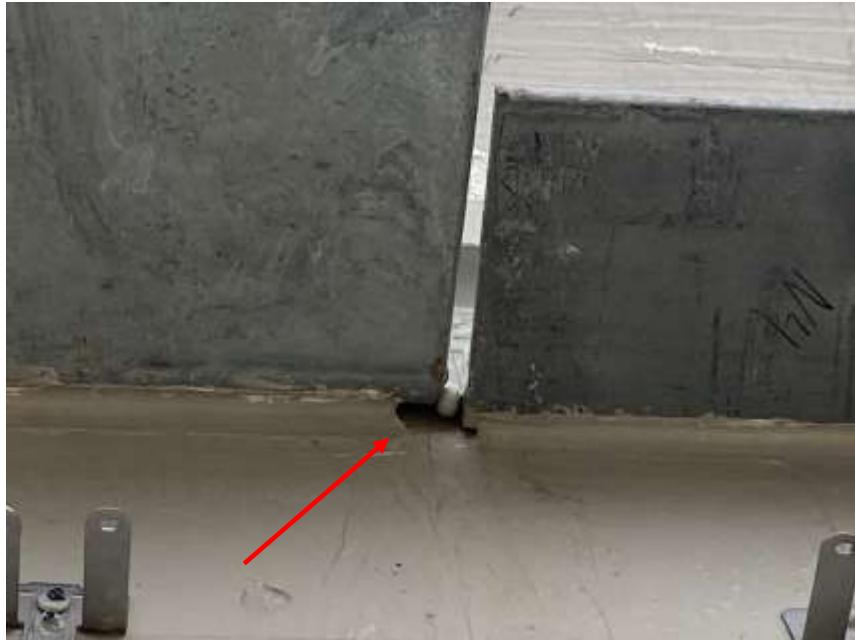
5. Upon inspection, it was noticed that under lintels at the columns, there is a gap in the sealant from wall to column. ZSC recommends checking All column lintels in order to insure there is a continuous bead of sealant throughout. This was brought to the attention of Chamberlin personnel, and ZSC will follow up. ***See Photos 14-15***

**Photo 14**  
Gap in Sealant Under Lintel

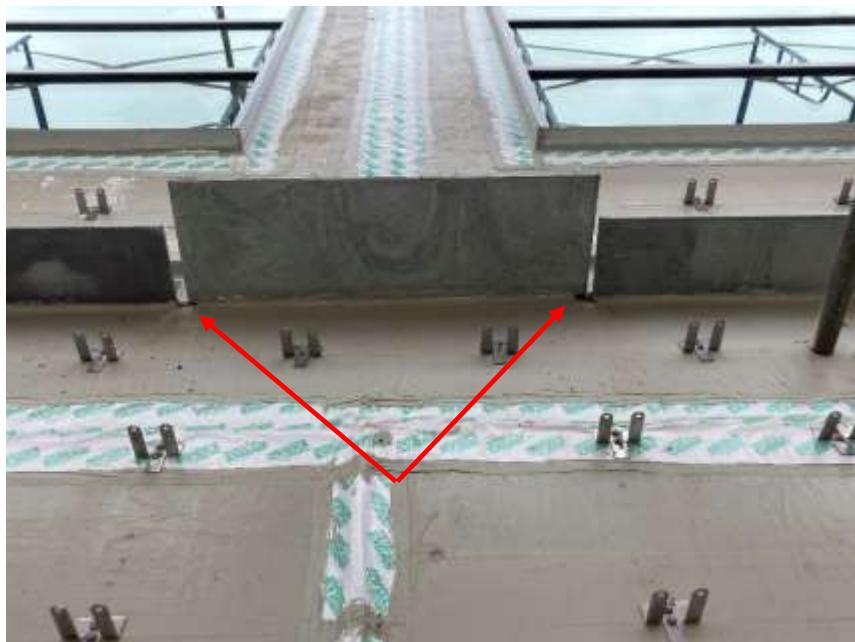
**Photo 15**  
Gaps in Sealant Under Lintels

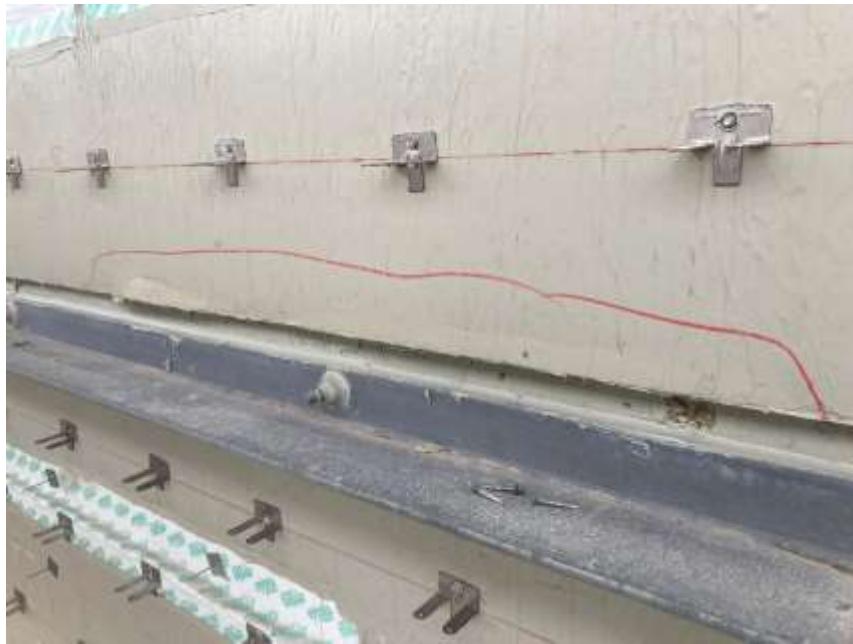
**Photo 16**  
Sheathing Broken Above Lintel

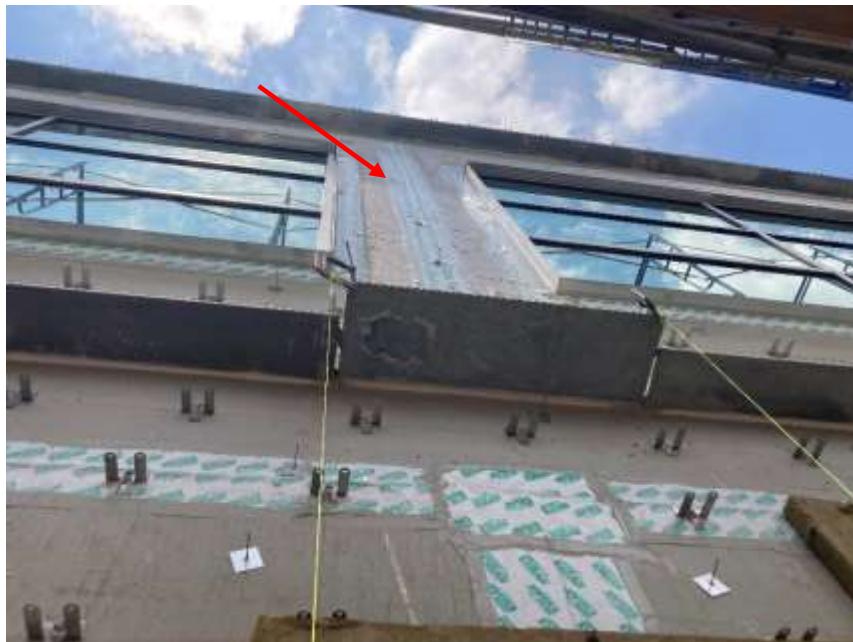
2. At the east face, insulation was being installed between the brick ties, in order to stay in front of the masons. From the previous report, Chamberlin installed sealant at the bottoms of lintels and repaired the control joints with sealant and flexible flashing. Installation and repairs appeared to be in a sufficient manner. **See Photos 04-06**

**Photo 06**  
Control Joint Repaired

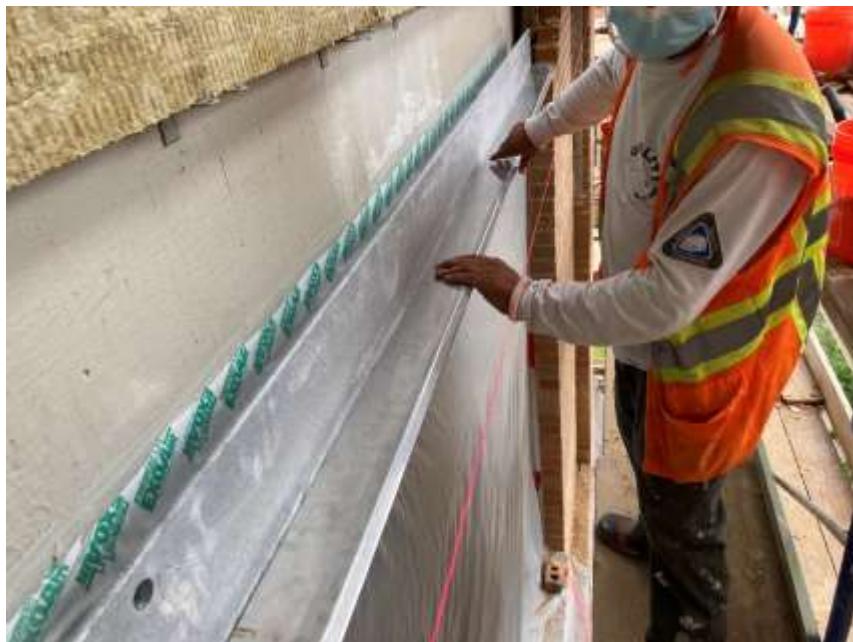
**Photo 10**

Example of Sealant Added to the Loose Lintel Prior to Metal Flashing

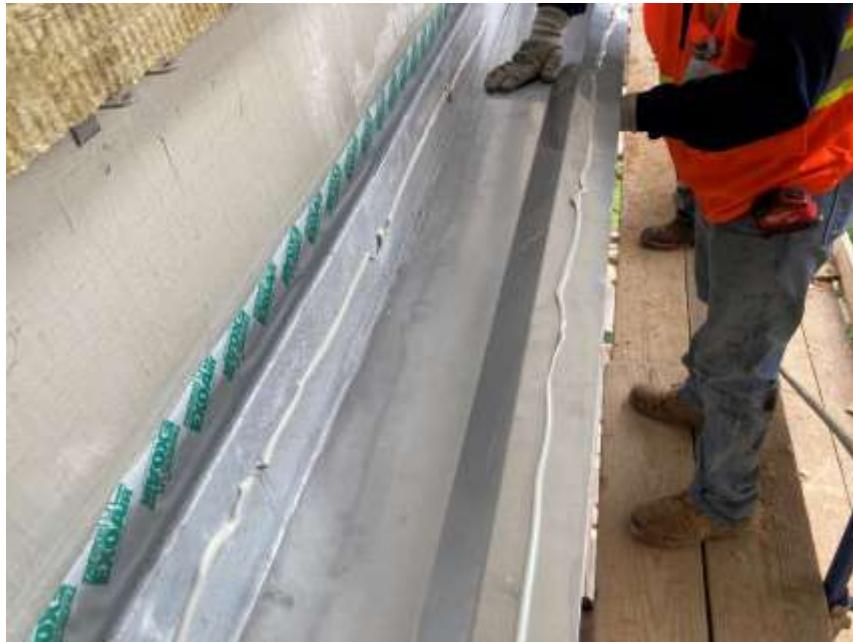
**Photo 11**

Metal Flashing Embedded in Sealant

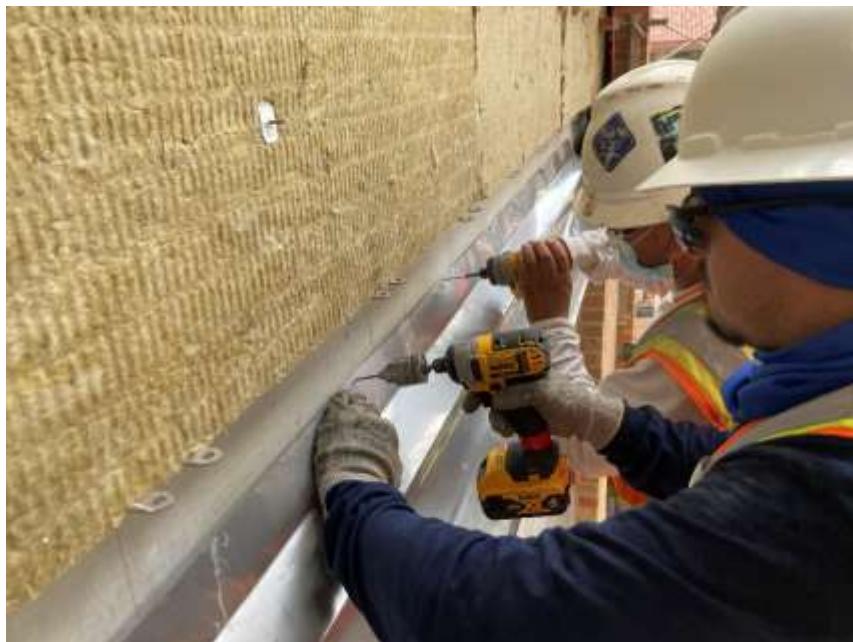
**Photo 12**  
Sealant added to Loose Lintel and Metal Flashing prior to Placement

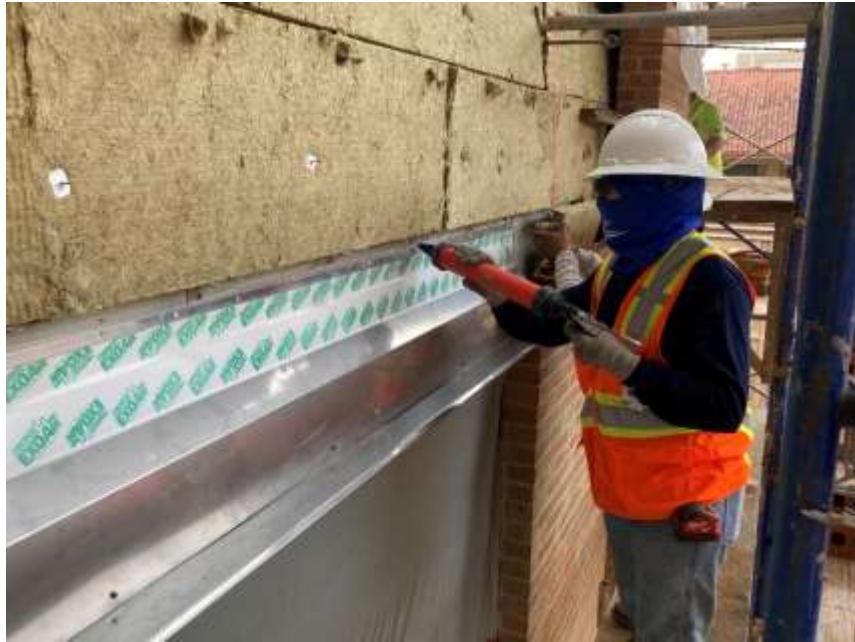
**Photo 13**  
Metal Flashing Anchored to Substrate

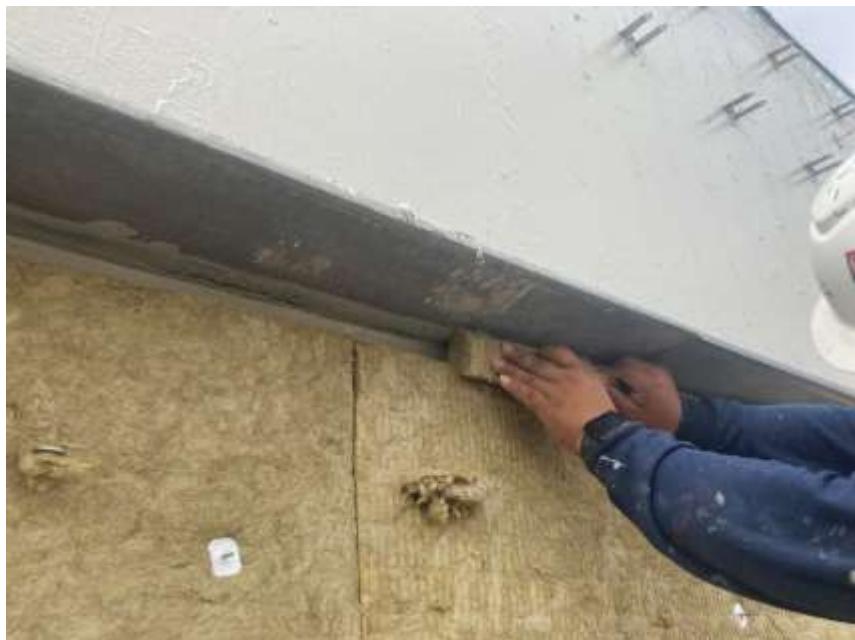
**Photo 14**

Flexible Flashing w/ Term. Bar Installed and Terminating w/ Sealant

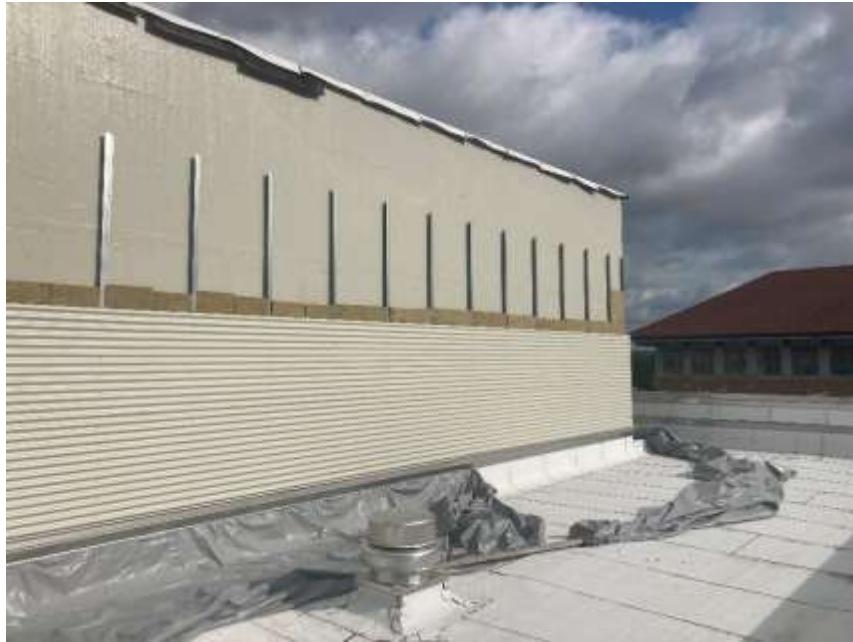
- At the penthouse on the roof, it was observed that installation of z-girts and metal panels appeared to be installed in a sufficient manner. **See Photos 05-06**

**Photo 05**  
Overview of Metal Panel Installation

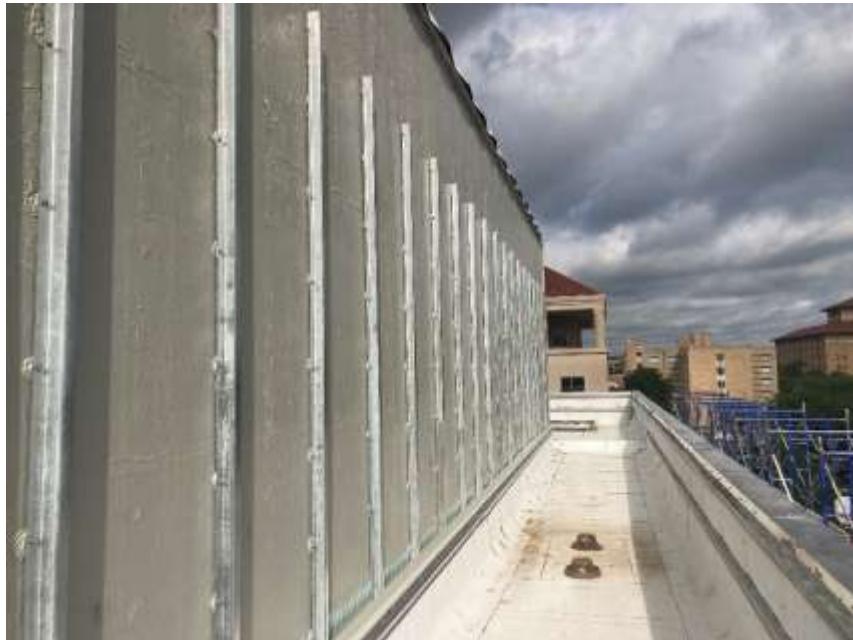
**Photo 06**  
Overview of Z-Girt Installation

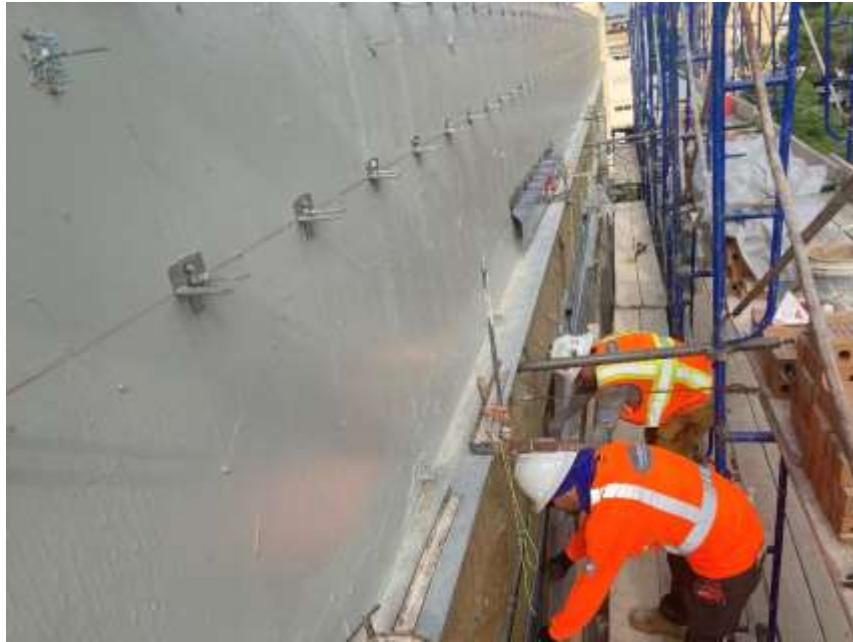
- At the north face of the building, Chamberlin continued installing metal flashing at the loose lintels. Sealant was added to the metal flashing prior to installation for bedding in sealant. Anchors were installed and also detailed with sealant. Flexible flashing was then installed over the metal flashing and terminated with a termination bar and sealant. Installation appeared to be in a sufficient manner.  
**See Photos 07-12**

**Photo 07**  
Overview of Metal Flashing Installation

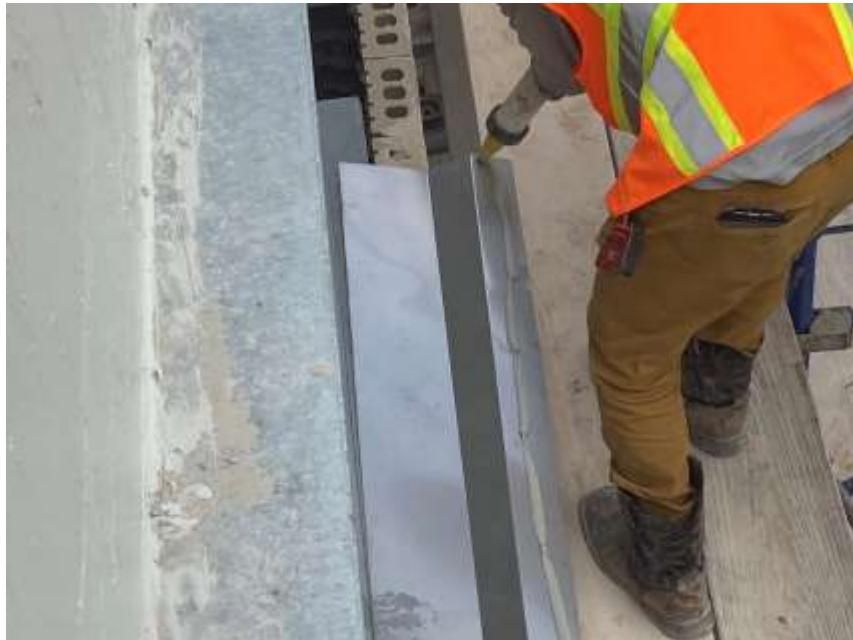
**Photo 08**  
Sealant Added to Metal Flashing Prior to Installation

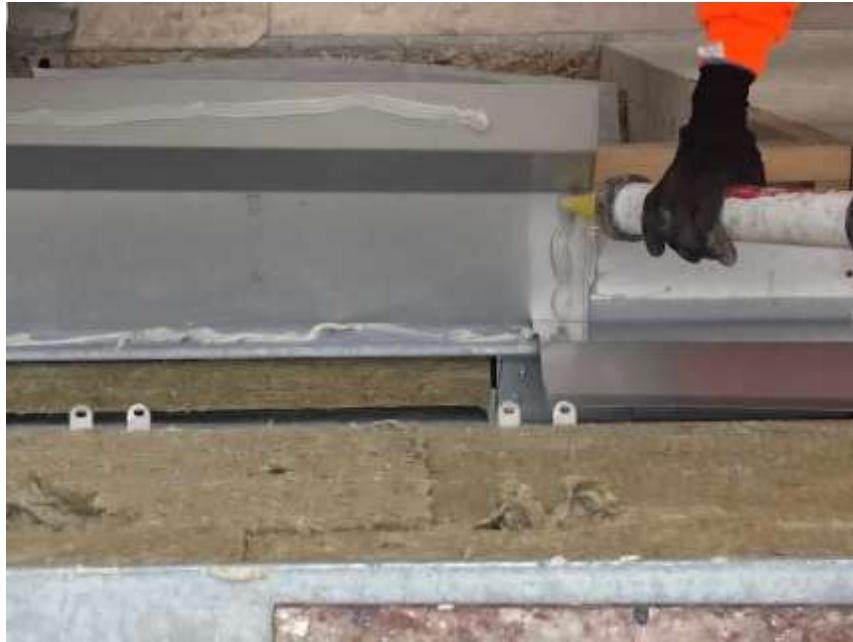
**Photo 09**  
Example of Sealant Added for Overlap
