## SUBMITTAL REVIEW

Description: Aluminum Framed Entrances and Storefronts -SD

Project Name: UT SEAY Building Addition

Project No.: 102-782

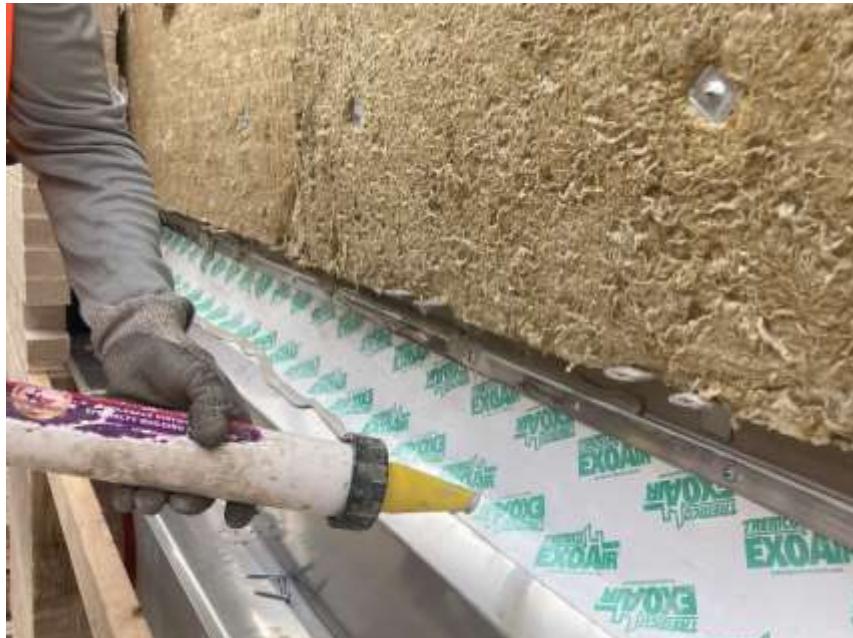
- At the north face of the building, Chamberlin continued installing metal flashing at the loose lintels. Sealant was added to the metal flashing prior to installation for bedding in sealant. Anchors were installed and also detailed with sealant. Flexible flashing was then installed over the metal flashing and terminated with a termination bar and sealant. Installation appeared to be in a sufficient manner.  
**See Photos 07-12**

**Photo 10**  
Flexible Flashing Detailed with Sealant

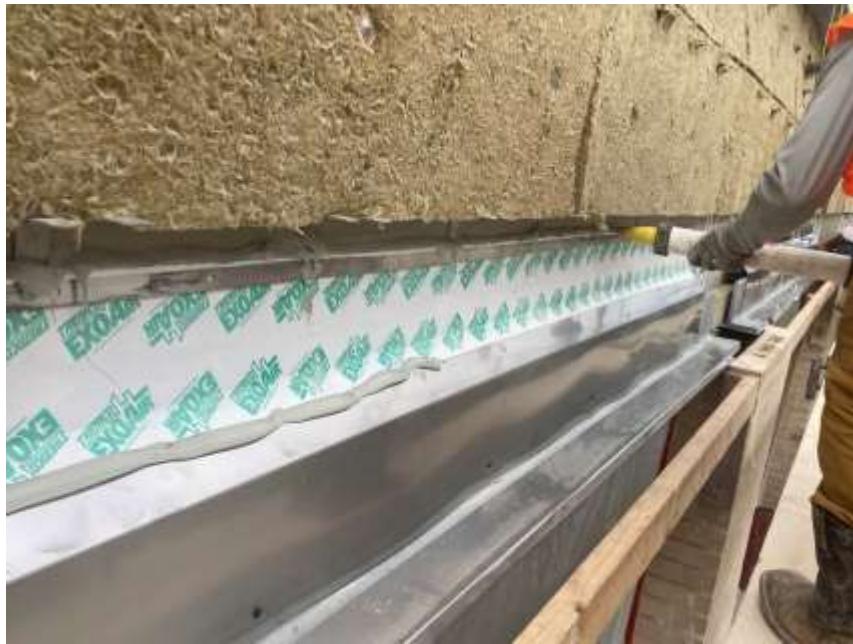
**Photo 11**  
Termination Bar and Anchors Terminated with Sealant

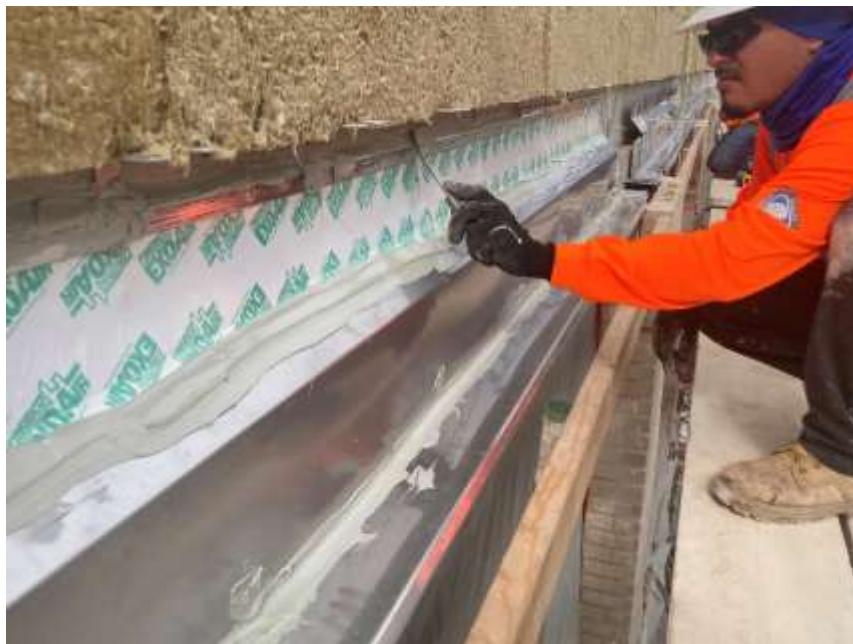
**Photo 12**  
Sealant Toolled into Place

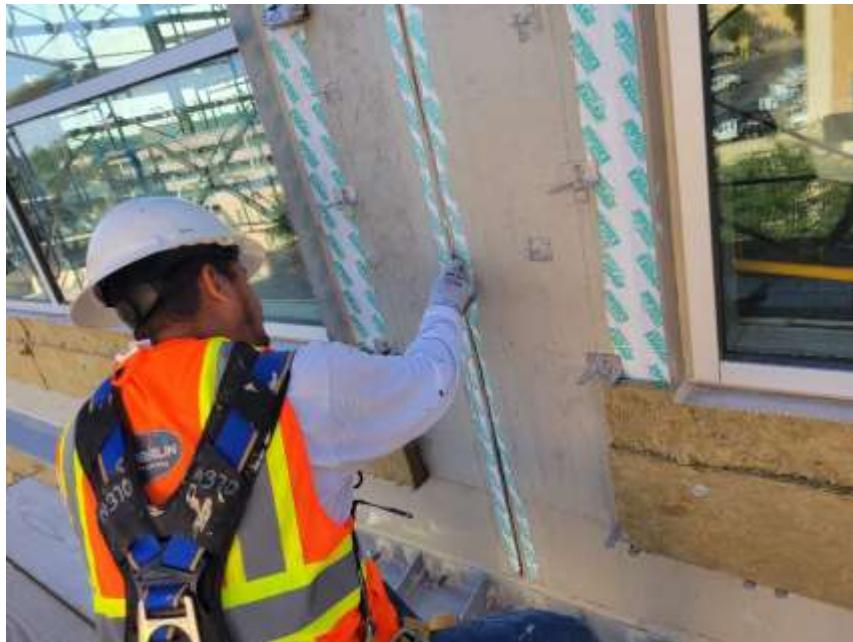
**Photo 1**

- At the west face of the building, Chamberlin was observed removing the bellows joint that had been installed. Once removed, titan foam was installed into the joint and was then sealed with Dymonic 100. Flexible flashing was then applied over said joint and detailed at the perimeters with sealant. Installation appeared to be in a sufficient manner. **See Photos 01-05**

Construction Personal Removing/Replacing Backer-Rod and Sealant at Control Joint

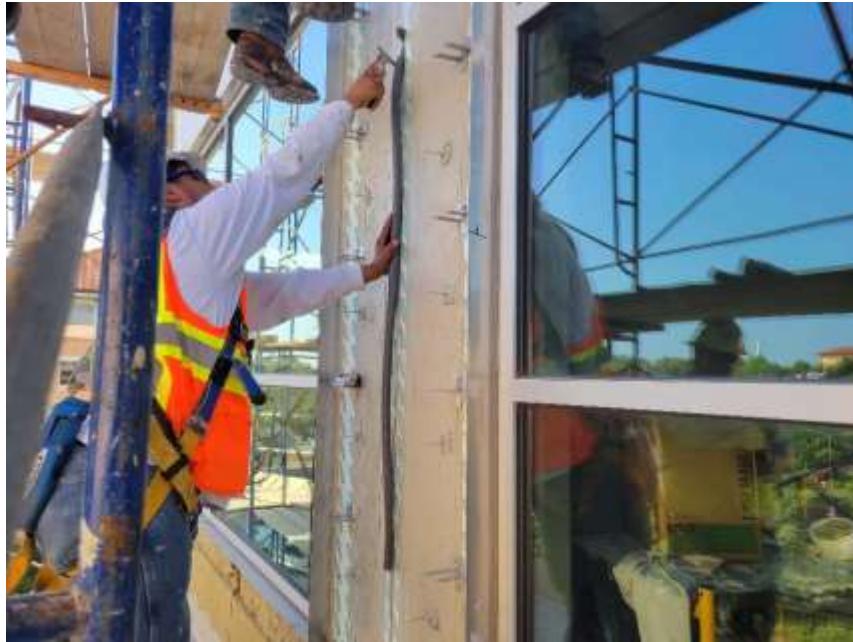
**Photo 2**  
Backer-Rod Installed at the Control Joint

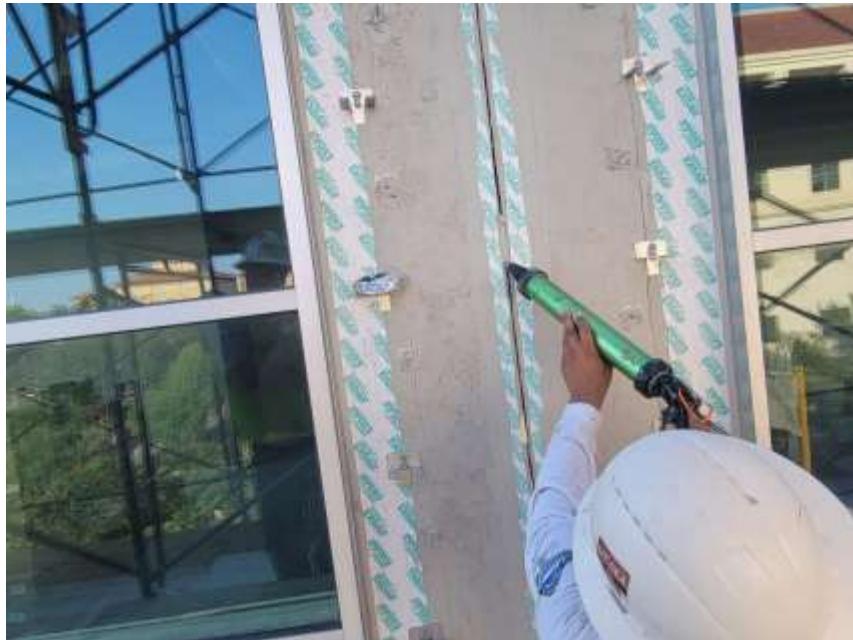
**Photo 3**  
Sealant Applied at Control Joint

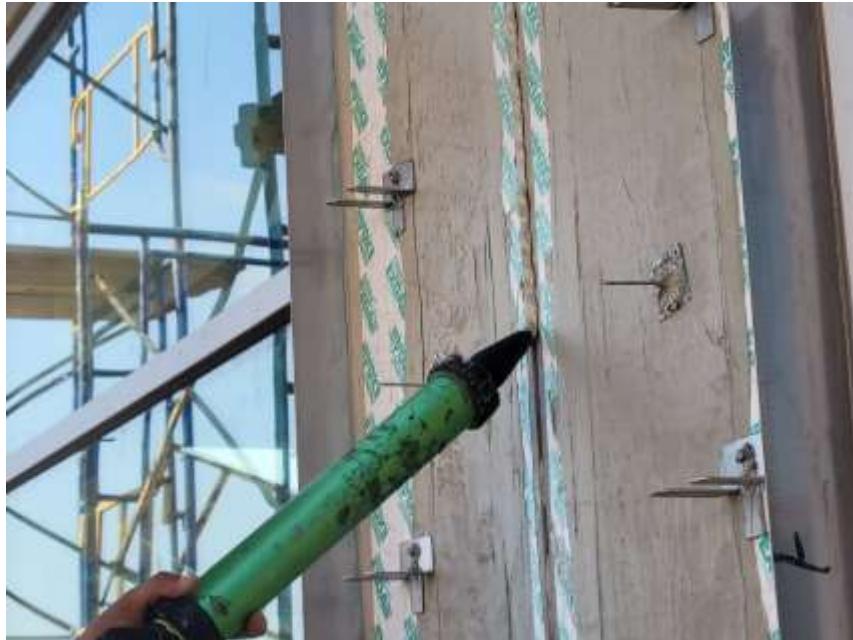
**Photo 4**  
Sealant Applied at Control Joint

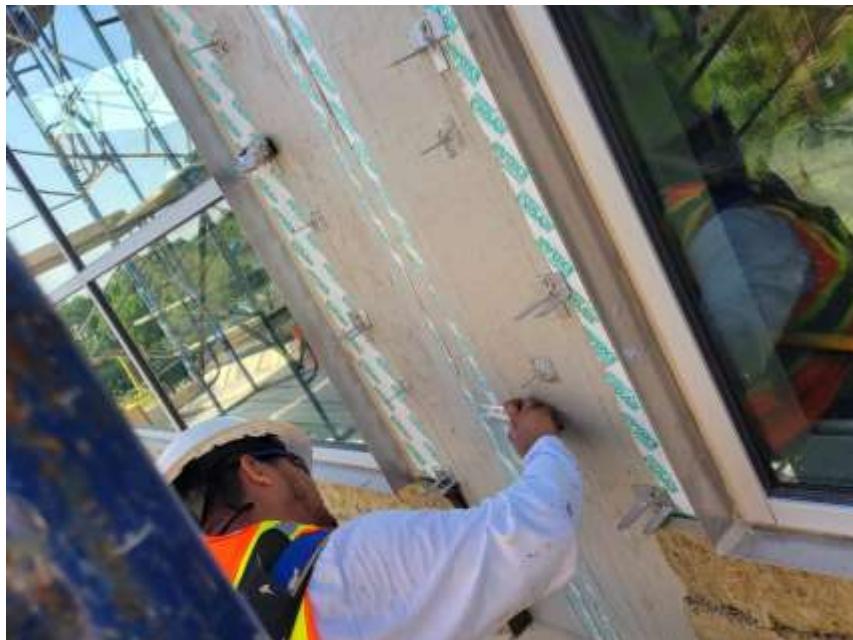
**Photo 05**  
Sealant Applied at Control Joint

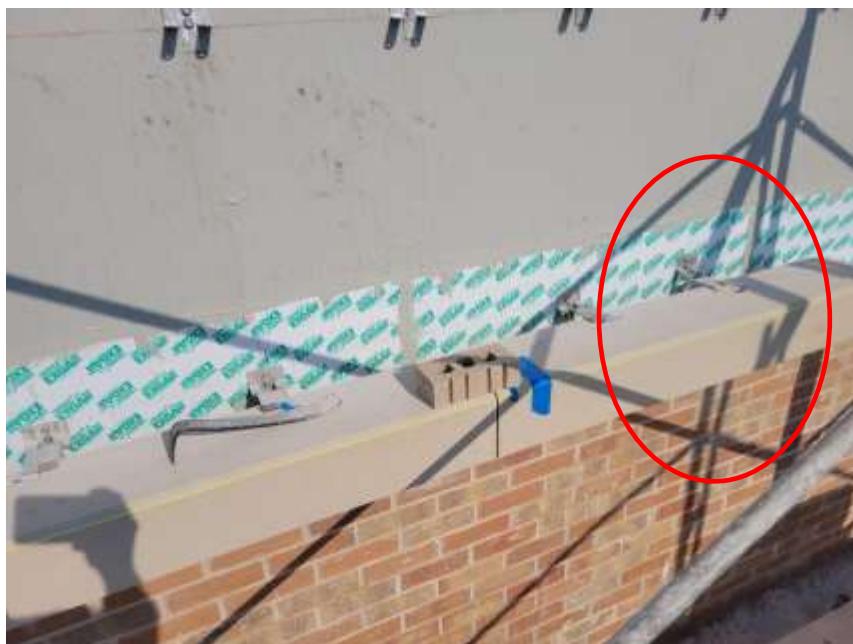
- At the east elevation on the 5<sup>th</sup> level, R&A was observed installing cast stone at the relief angle. In Addition, ZSC observed a brick pimple had been installed through the under side of the brick tie. As long as pintles are engaged half way, it doesn't affect the orientation. Installation appeared to be in a sufficient manner. **See Photos 06-11**
- At the southeast elevation on the 5<sup>th</sup> level, minor deficiencies were noted along the south wall. Observations made in this area were, in multiple areas the

**Photo 07**  
Brick Tie is Installed Up Side Down

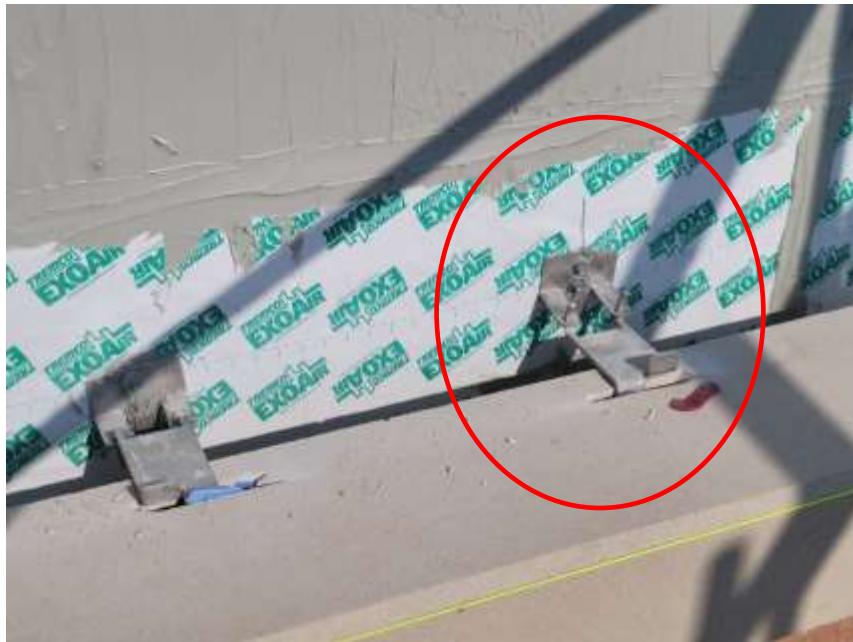
**Photo 08**  
Brick Tie is Installed Up Side Down

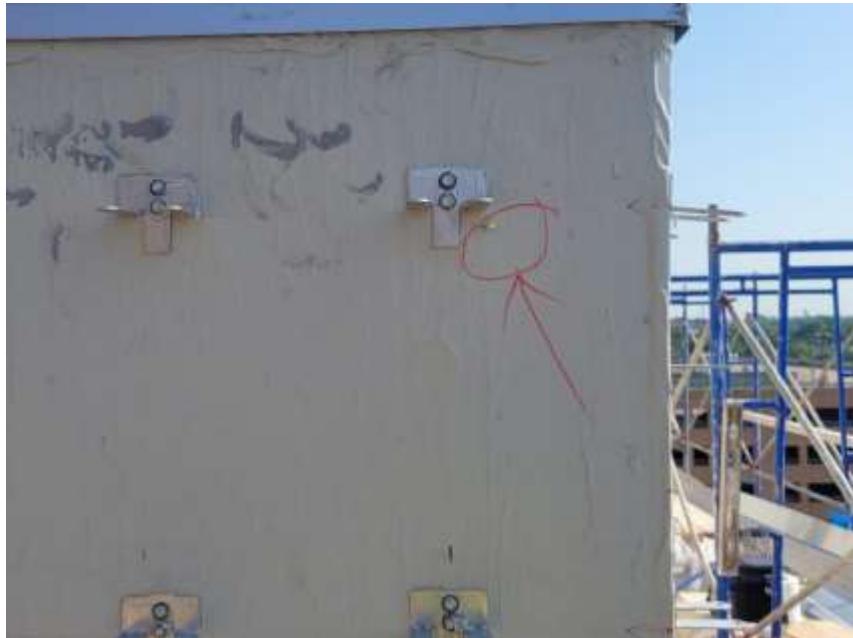
DensGlass was observed being exposed and will need sealant or air barrier applied. Also, at the top of the wall, brick ties were missing anchors. These items will need to be corrected, prior to masonry installation. **See Photos 13-16**

**Photo 13**  
Pin Hole Observed

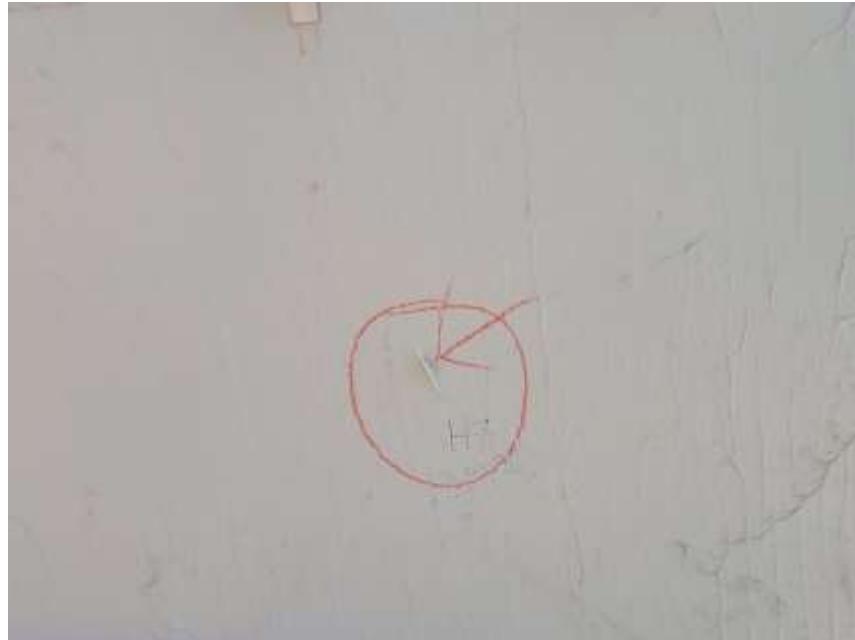
**Photo 14**  
DensGlass Exposed Due to the Shadowing of Air/Vapor Barrier

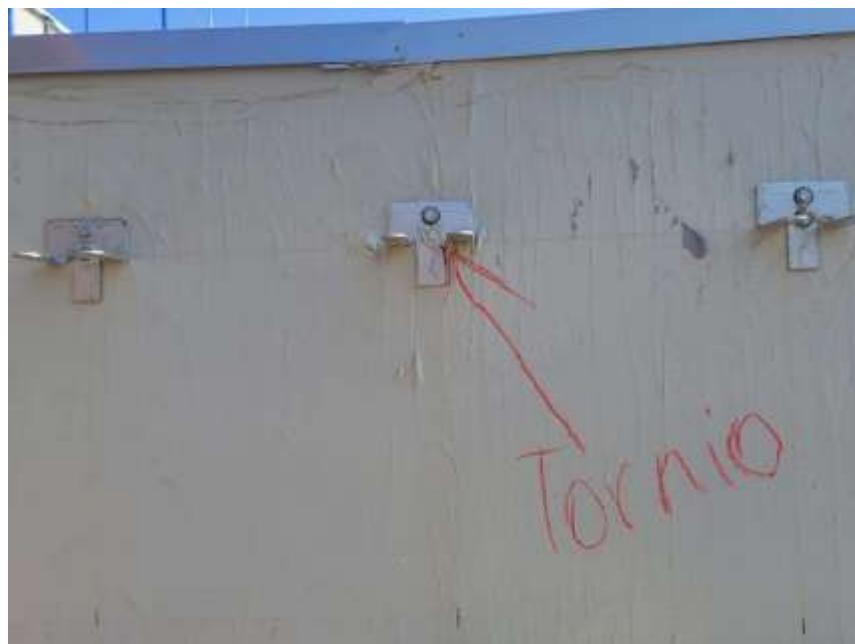
**Photo 15**  
Missing Fastener at the Brick Tie

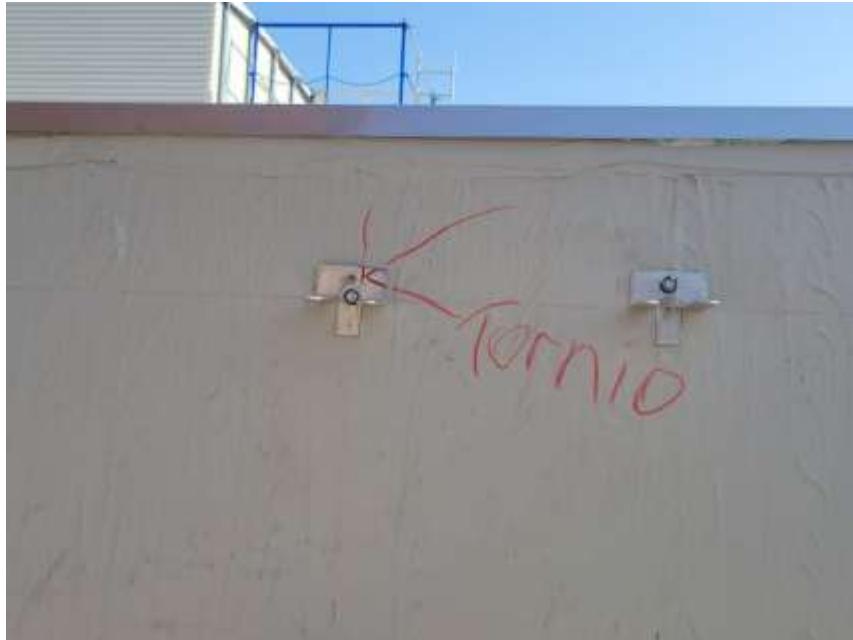
**Photo 16**  
Missing Fastener at the Brick Tie

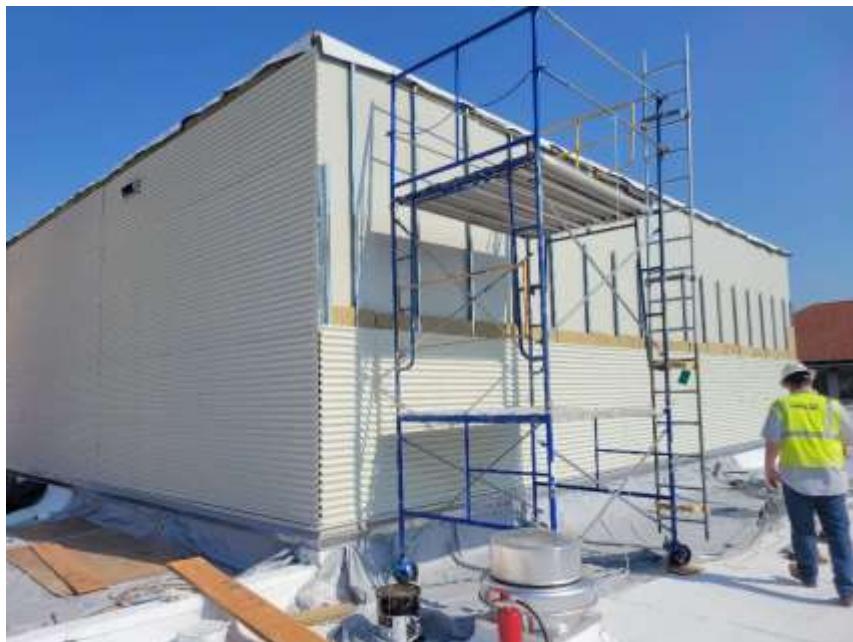
4. At the penthouse on the east elevation, Kidd Roofing personnel were observed installing z-girts. Shims had been preinstalled with sealant to the z-girt with sealant then added to said shims and all were embedded at time of installation. Upon further observation, ZSC noticed abandoned fastener holes with no sealant and informed SpawGlass of deficiencies. **See Photos 17-20**

**Photo 17**  
Overview of the East Elevation of the Penthouse

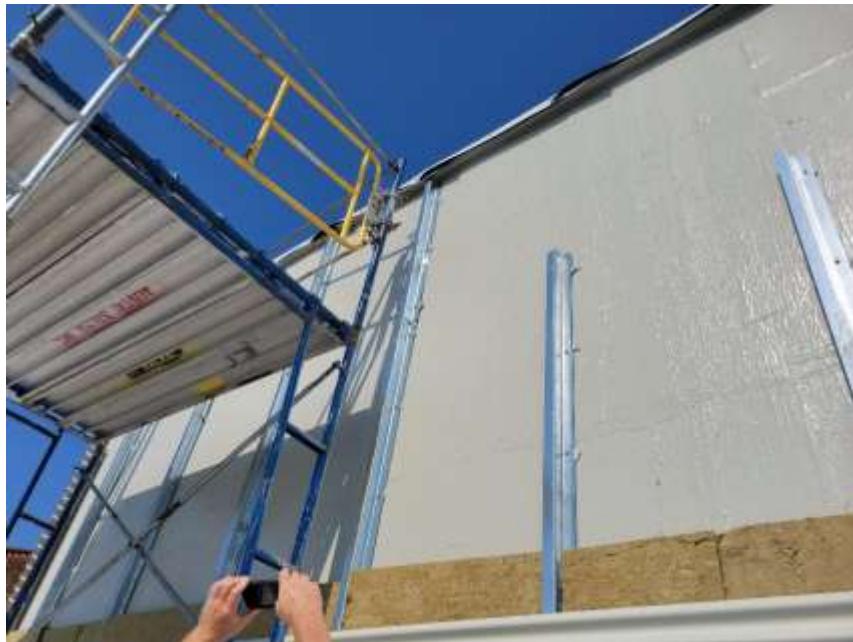
**Photo 18**  
Missing Sealant and Abandoned Fasteners Holes

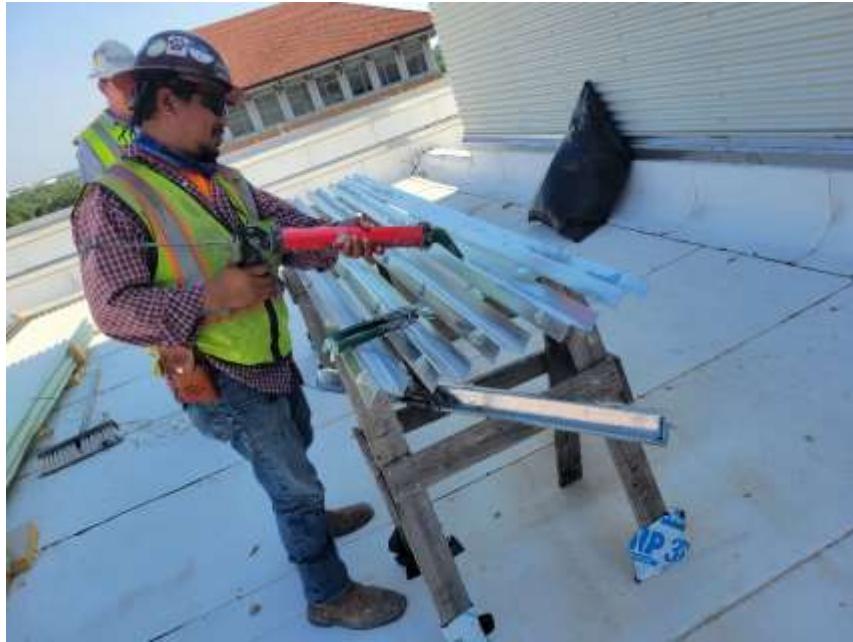
**Photo 20**

Construction Personal Pre-Installing Shims Embedded with Sealant

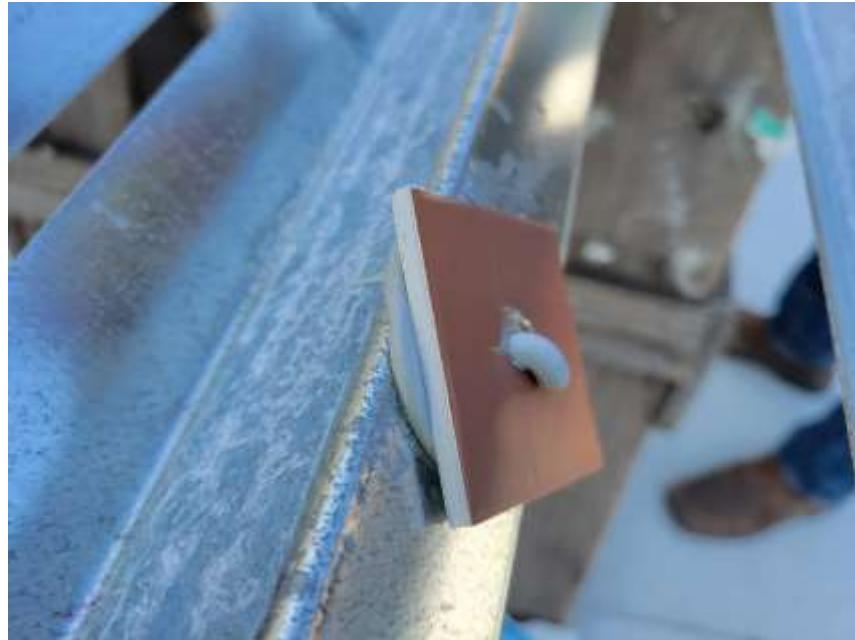
**Photo 20**

Construction Personal Pre-Installing Shims Embedded with Sealant

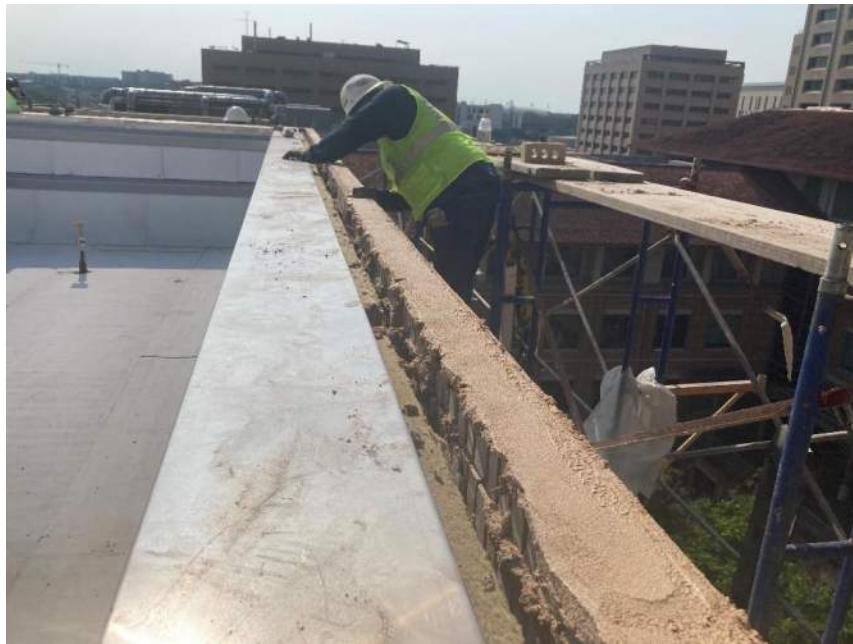
1. At the south face of the building, R&A completed the brick installation at the top of the wall. A bed of mortar was installed on top of the brick and allowed to cure. A metal flashing will be installed, prior to the cap stone and stripped in. All will have a positive slope to the roof. Installation taking place, appeared to be in a sufficient manner. **See Photo 01**
2. At the north face of the building, R&A continues to install brick at the top of wall. The wall cavity was free of excess debris and mortar, and insulation had been installed prior. Installation appeared to be in a sufficient manner. **See Photos 02-03**
3. At the Penthouse on the roof, metal panels had been installed. Installation appeared to be in a sufficient manner. **See Photos 04-05**

**Photo 01**  
Overview of Bed of Mortar Laid at Top of Brick

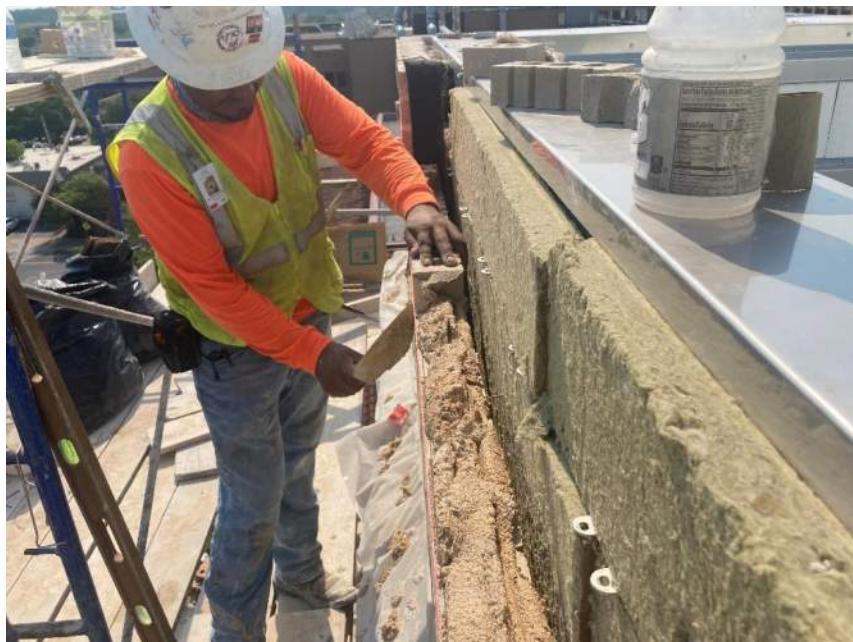
**Photo 02**  
Example of Brick Installation

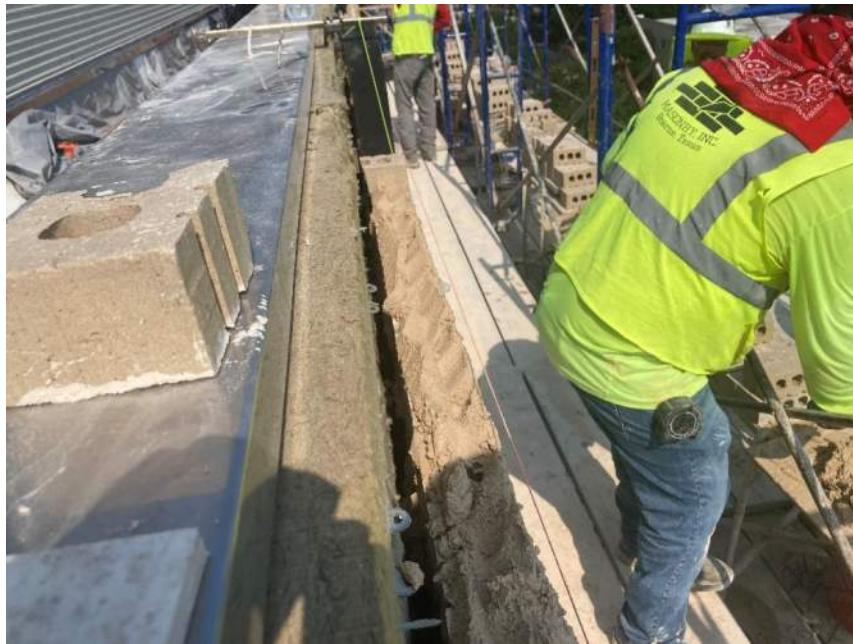
**Photo 03**  
Example of Mortar Bed Laid Prior to Brick Installation

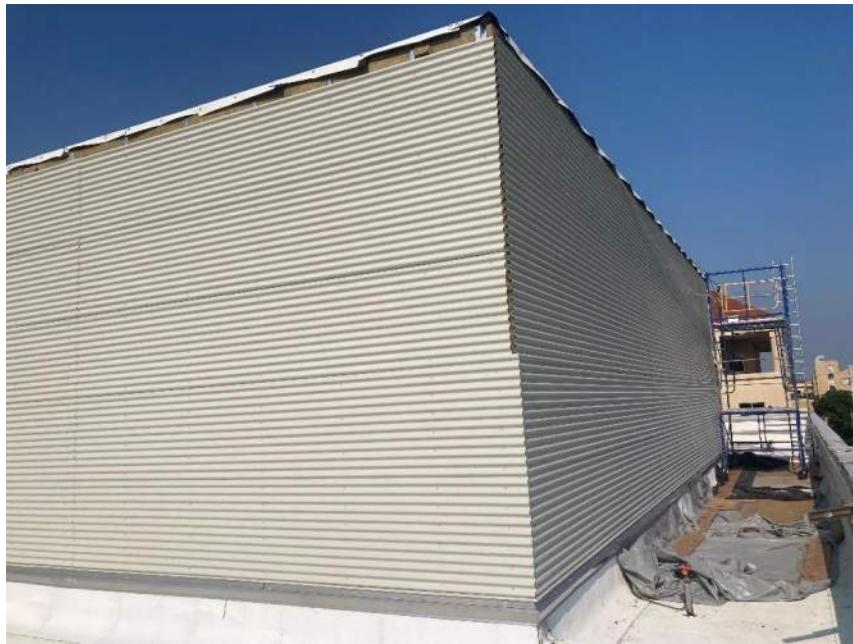
**Photo 04**  
Overview of Metal Panel Installation

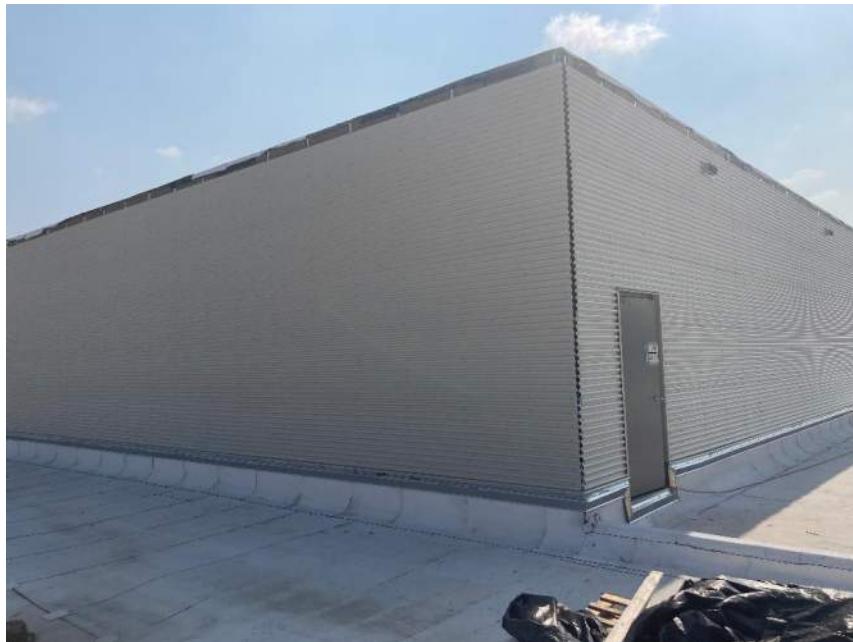
**Photo 05**  
View of Metal Panels Installed

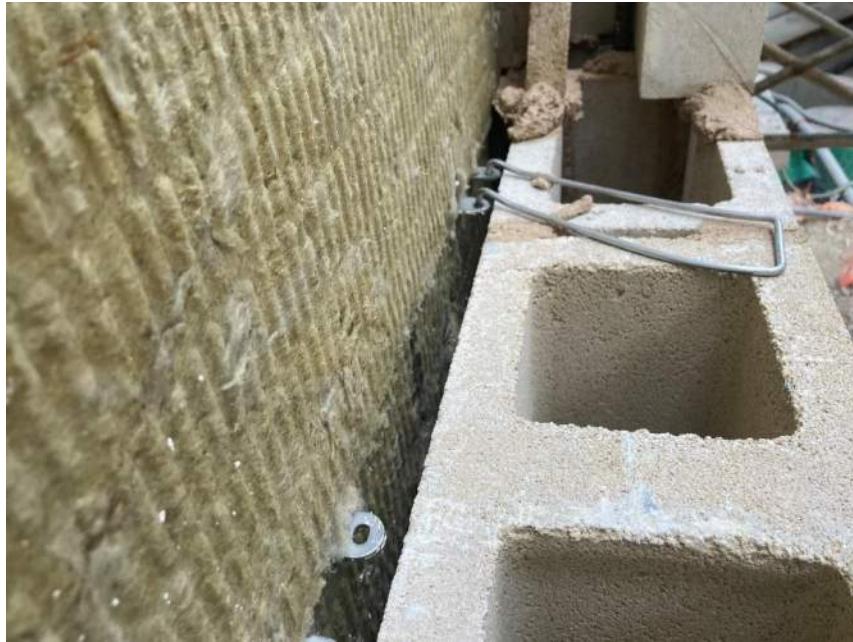
**Photo 01**  
View of Block Installation

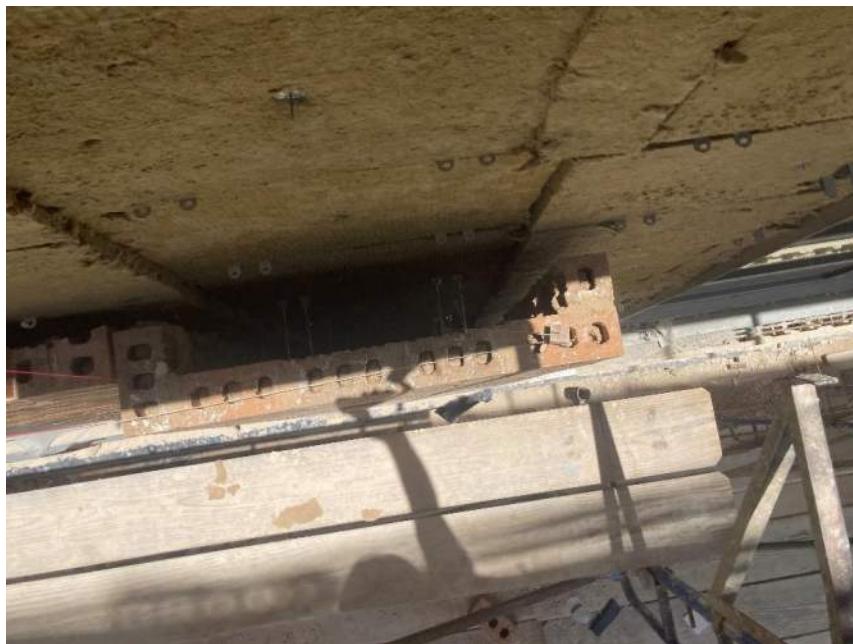
**Photo 02**  
Example of Brick Cavity Free of Excess Mortar

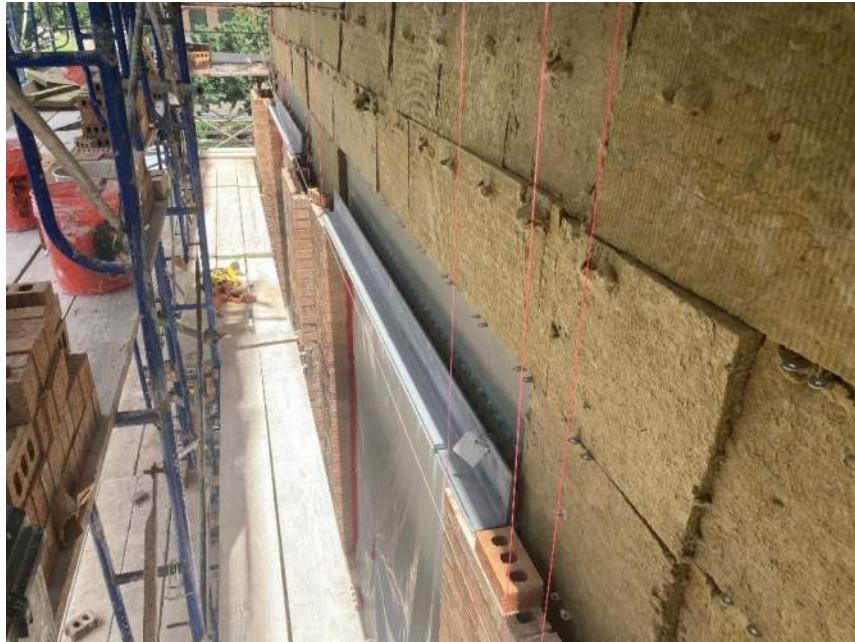
**Photo 03**  
Example of Loose Lintel Set in Place

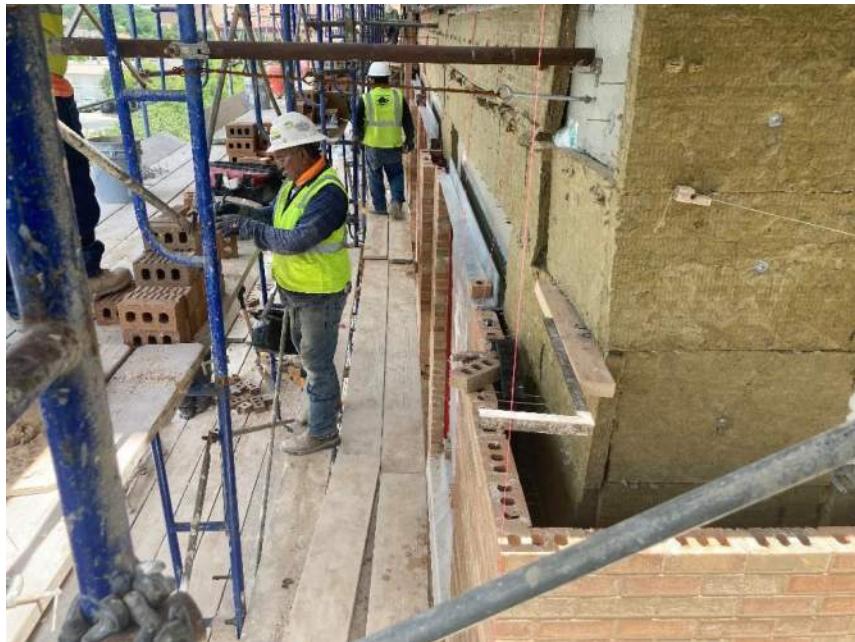
**Photo 04**  
Overview of Brick Installation in Progress

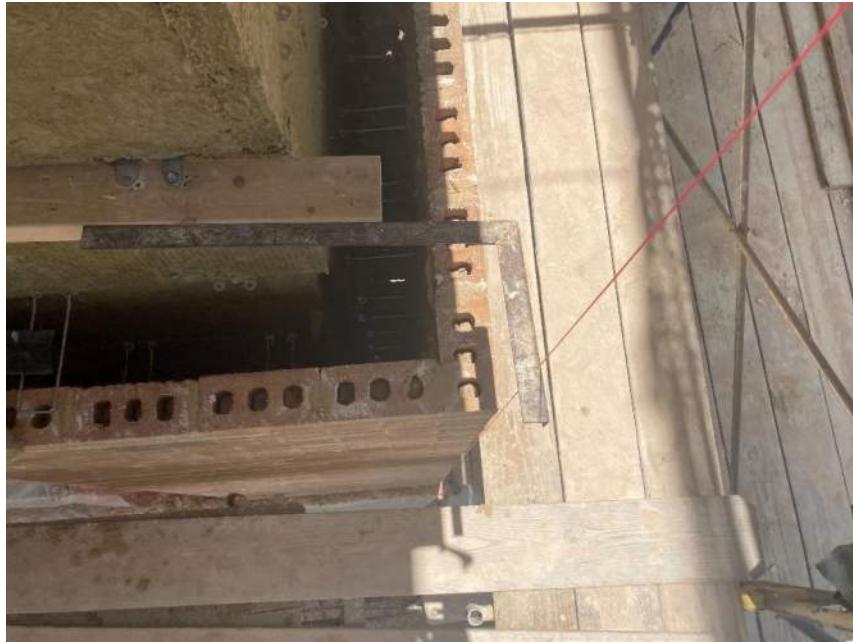
**Photo 05**  
Corner Column Brick Cavity Free of Excess Materials

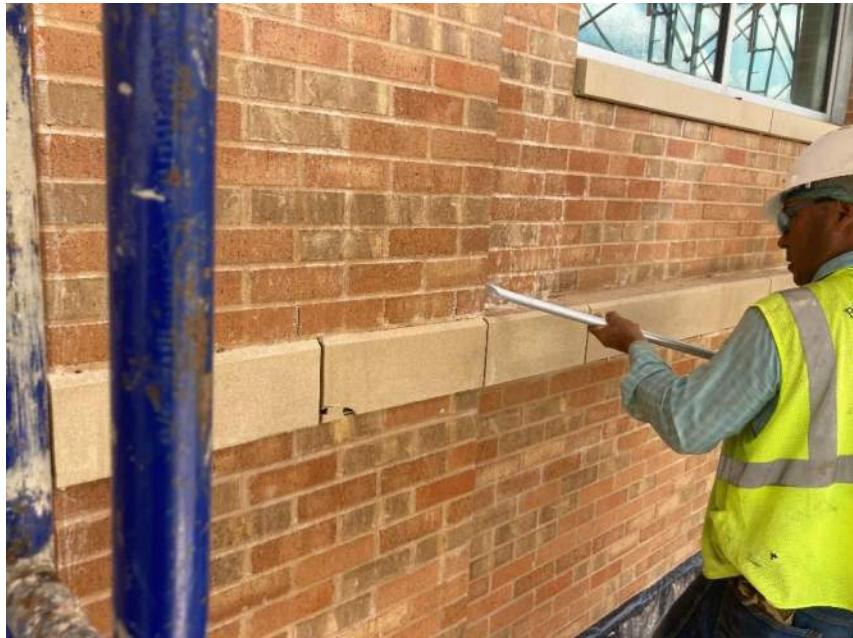
**Photo 06**  
Example of Masonry Cleaning

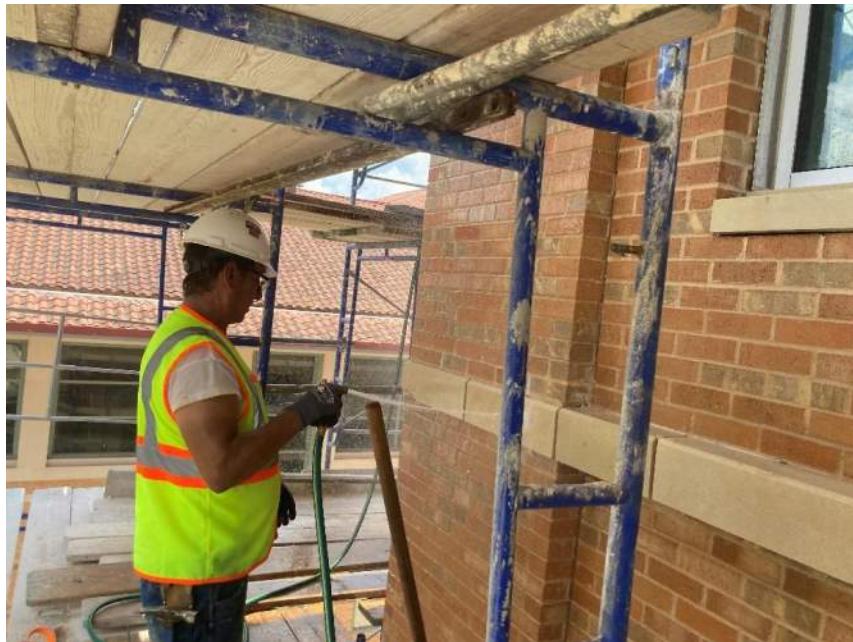
**Photo 07**  
Example of Masonry Cleaning

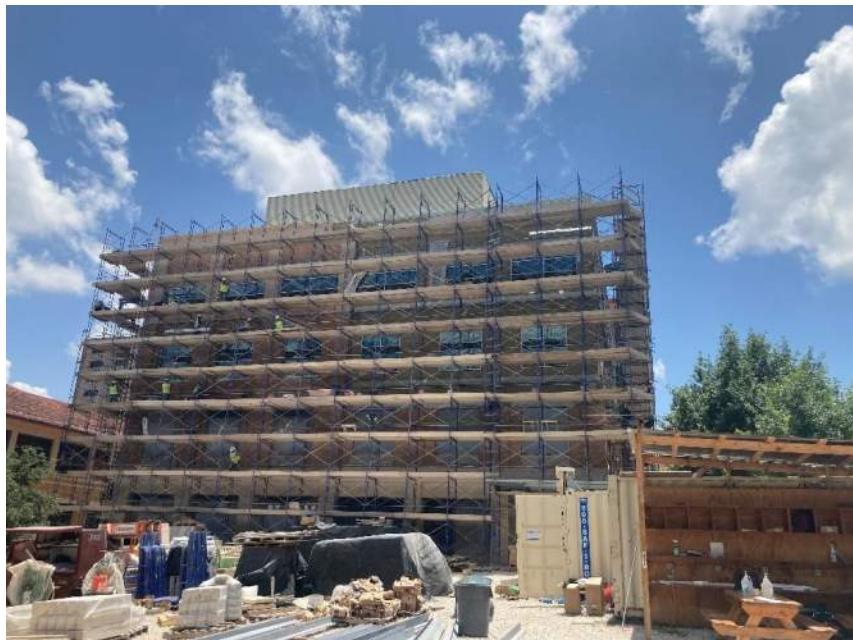
**Photo 08**  
Overview of Work in Progress

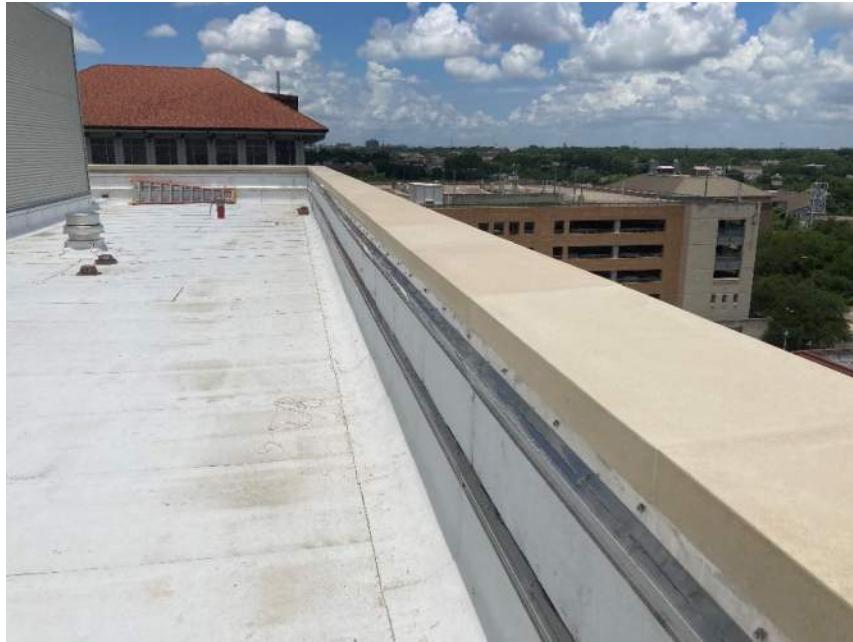
**Photo 01**  
Overview of Capstone in Place

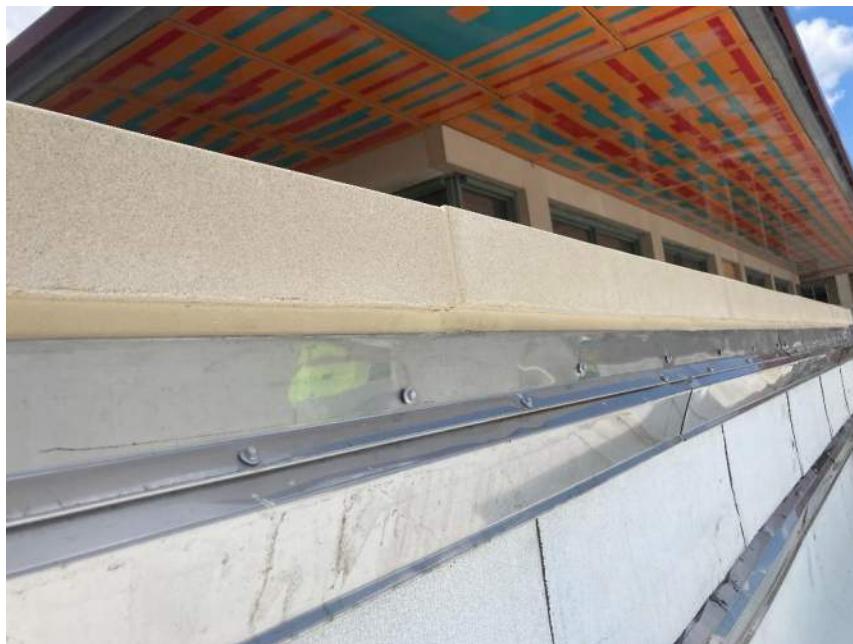
**Photo 02**  
Example of Sealant on Capstone

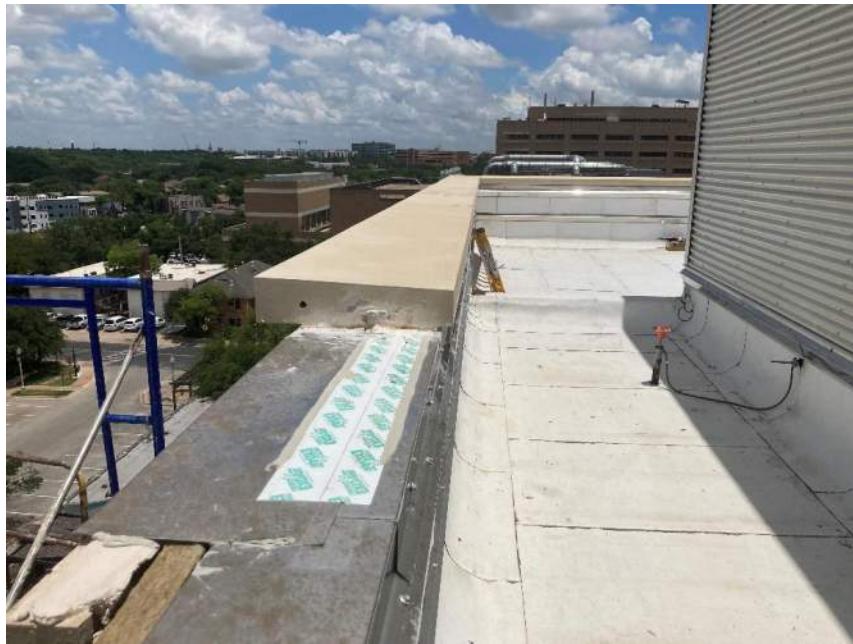
**Photo 03**  
Flashings Left Exposed for Tie-In

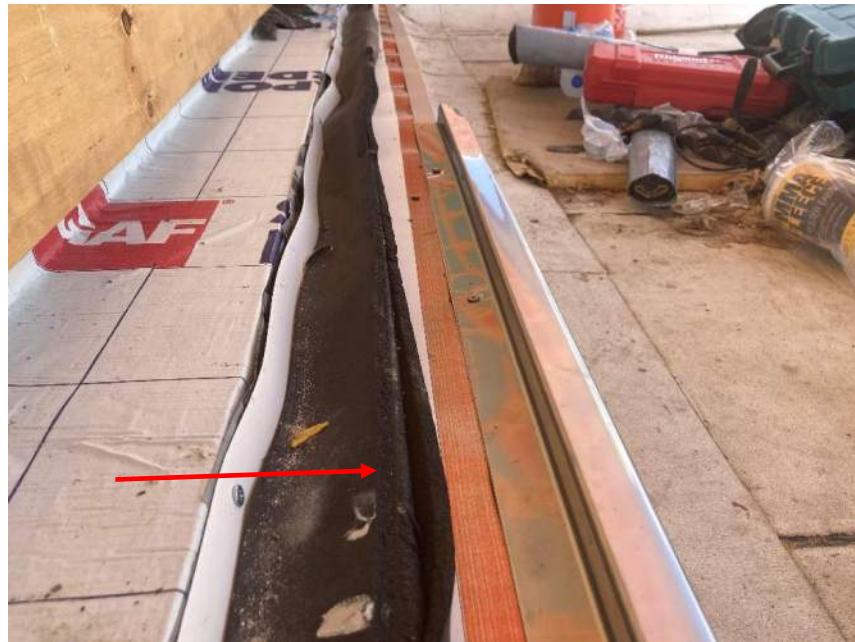
- At the roof expansion joint, from new to existing buildings, an expansion bellows joint has been installed. However, there is no approved submittal to be found for this material. The bellows joint that has been installed, appears to be over-compressed and the facer material is splitting where it has been folded. **See Photos 04-05**

**Photo 05**  
Expansion Joint Facer Material Splitting

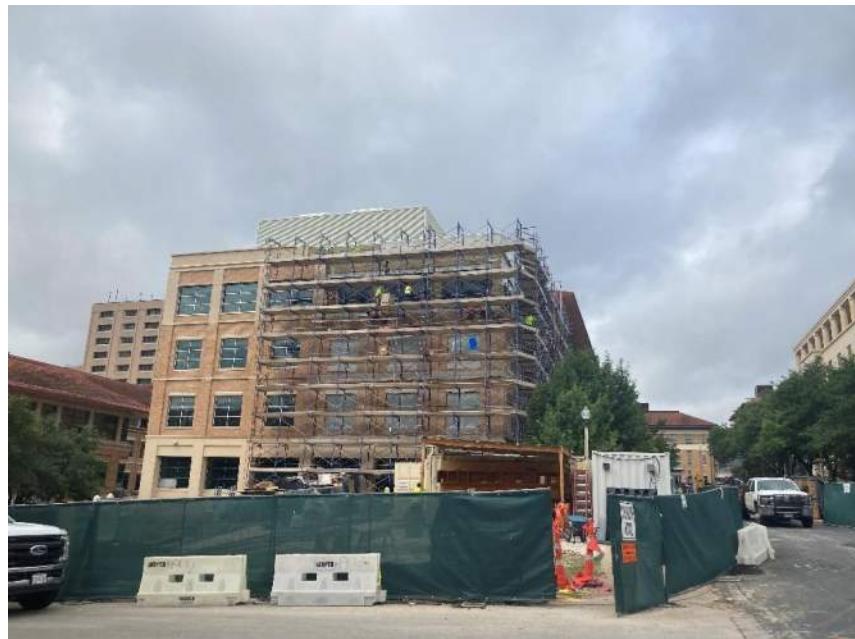
- At the west face, R&A was installing the stone band at the steel lintel. Wall ties were installed where needed at stone placement, and anchors had sealant, prior to installation. Above, also on the west side, wall ties were being pre-installed. At the time of installation, ZSC noticed missing anchors. This was brought to R&A personnel's attention and was immediately remedied. Installation appeared to be in a sufficient manner. **See Photos 01-06**

**Photo 01**  
Overview of Work in Progress

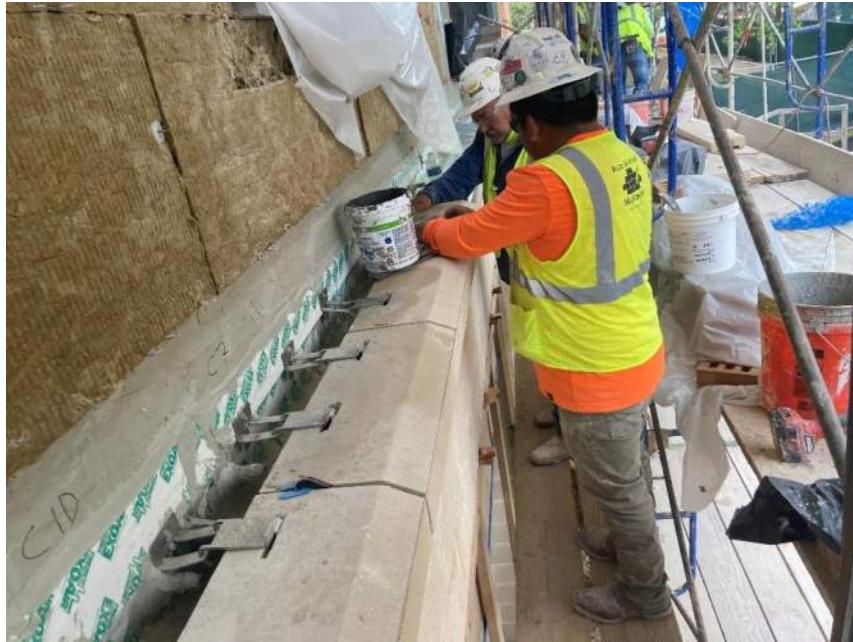
**Photo 02**  
Example of Stone Installation

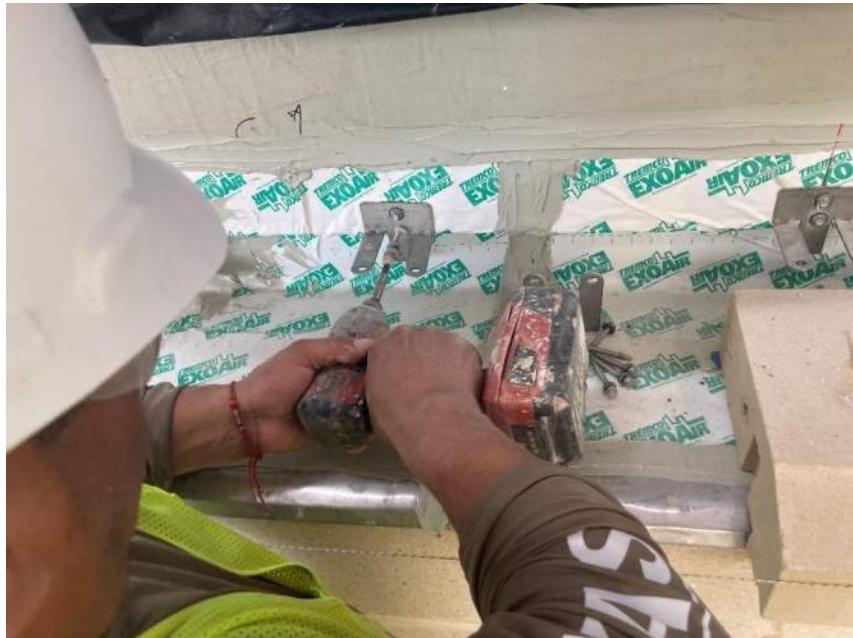
**Photo 03**  
Pintles Installed w/ Sealant on Anchors

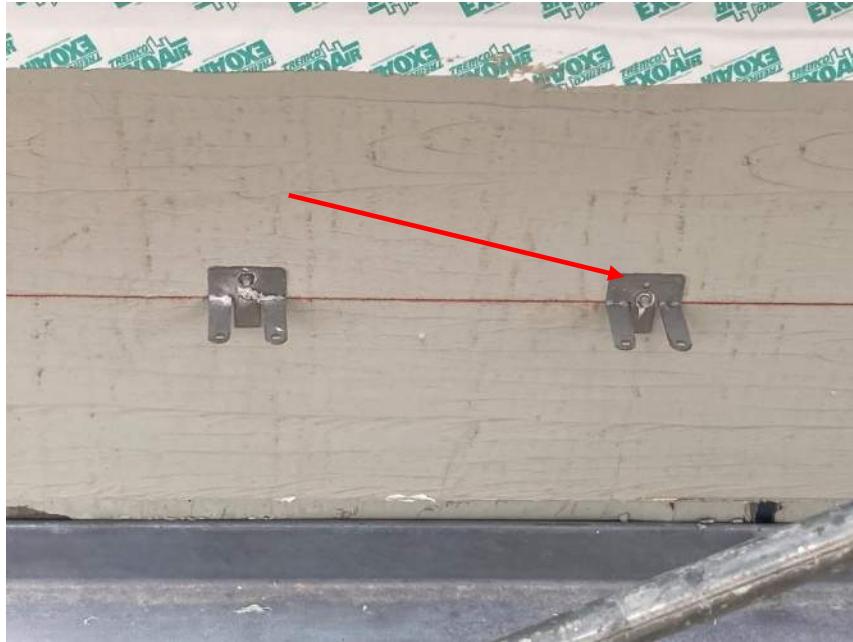
**Photo 04**  
Example of Missing Anchor
