## SUBMITTAL REVIEW

Description: Aluminum Framed Entrances and Storefronts -SD

Project Name: UT SEAY Building Addition

Project No.: 102-782

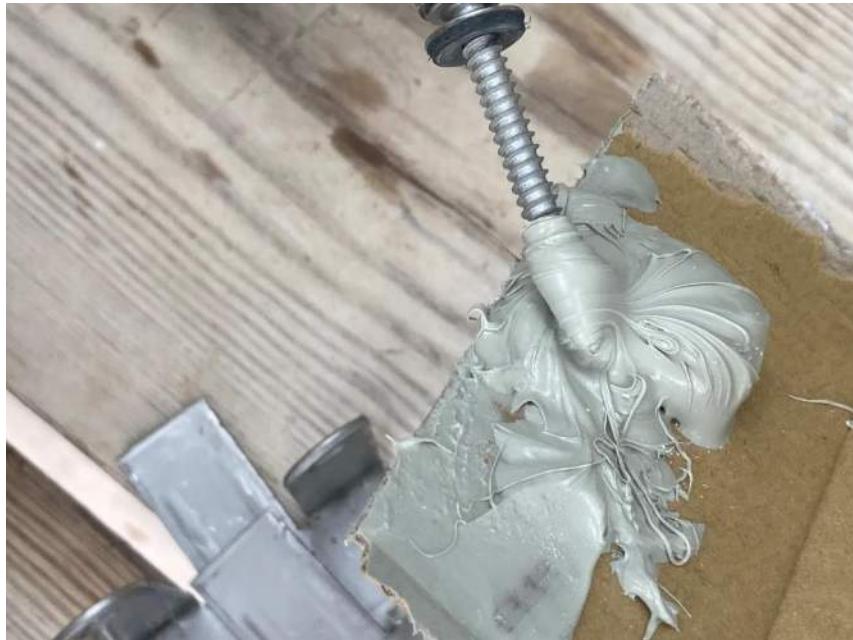
- At the west face, R&A was installing the stone band at the steel lintel. Wall ties were installed where needed at stone placement, and anchors had sealant, prior to installation. Above, also on the west side, wall ties were being pre-installed. At the time of installation, ZSC noticed missing anchors. This was brought to R&A personnel's attention and was immediately remedied. Installation appeared to be in a sufficient manner. **See Photos 01-06**

**Photo 05**  
Example of Sealant on Anchor

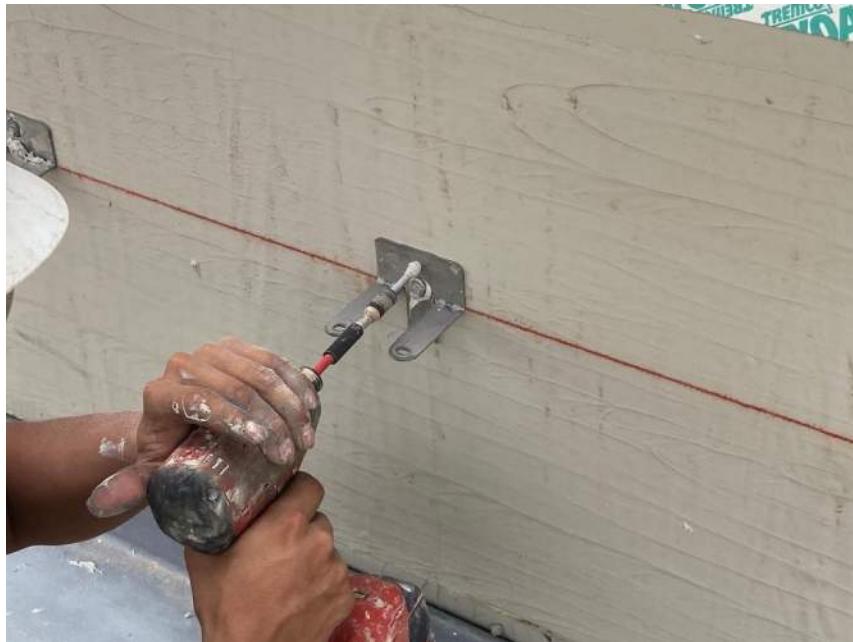
**Photo 06**  
Anchor Installed Where Missing

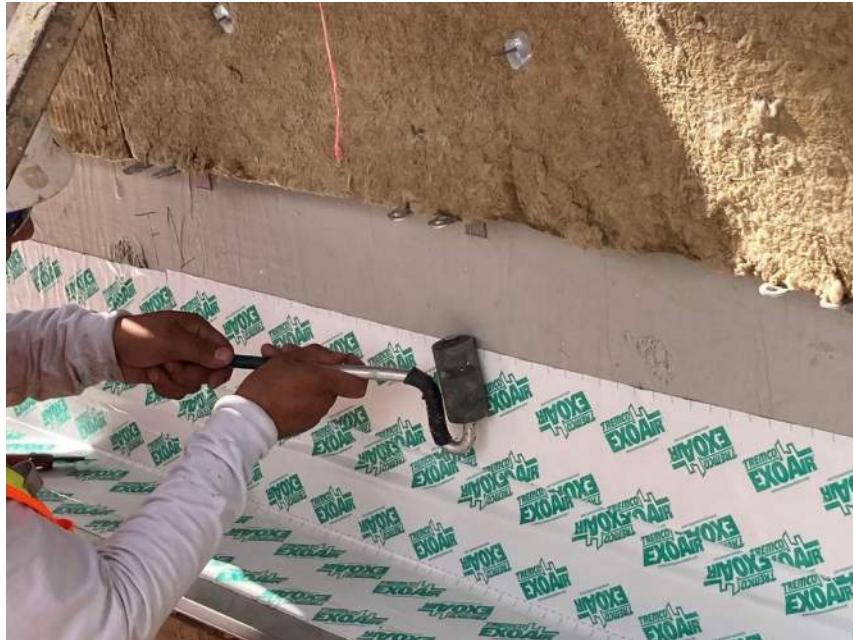
**Photo 08**  
Hand Roller Used for Flexible Flashing

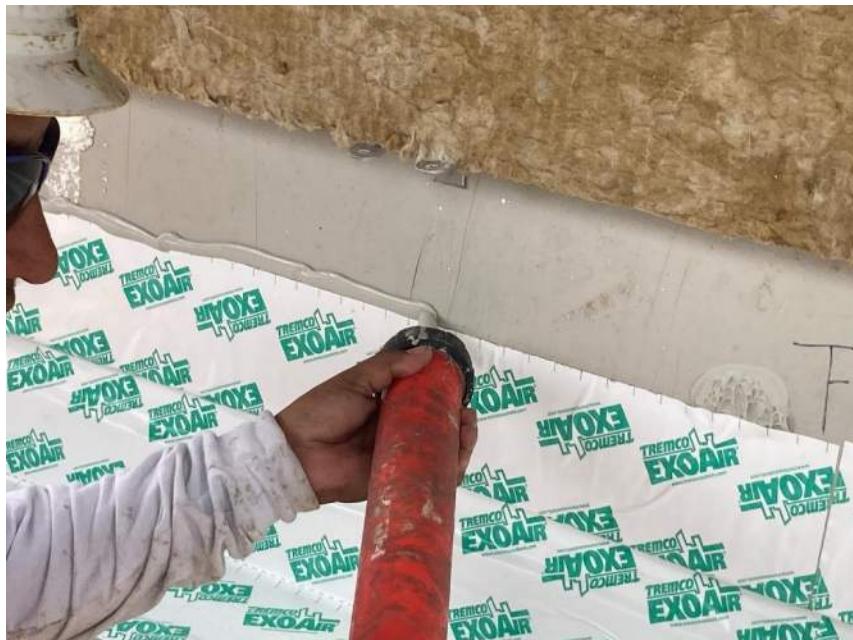
**Photo 09**  
Sealant Used for Terminating Flexible Flashing

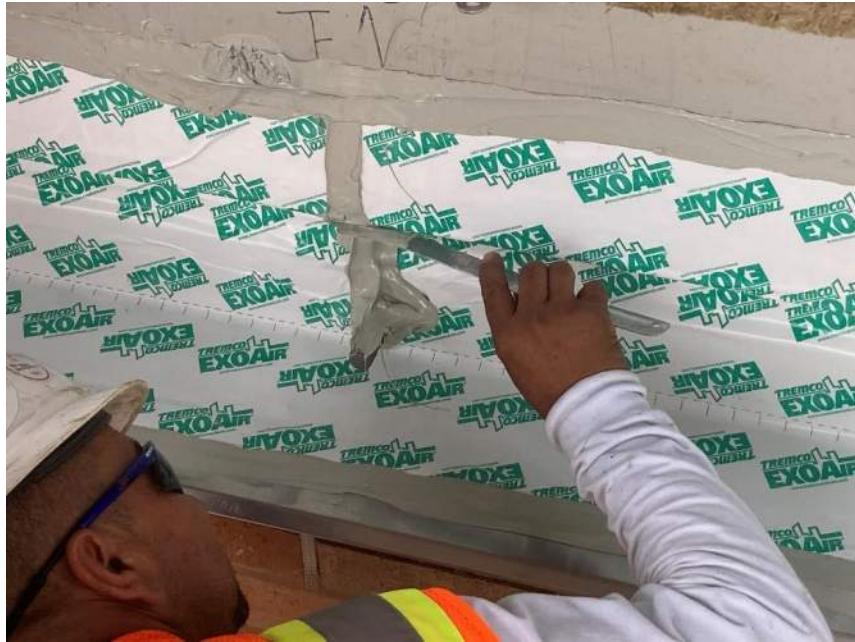
**Photo 10**  
Sealant Tooled into Place

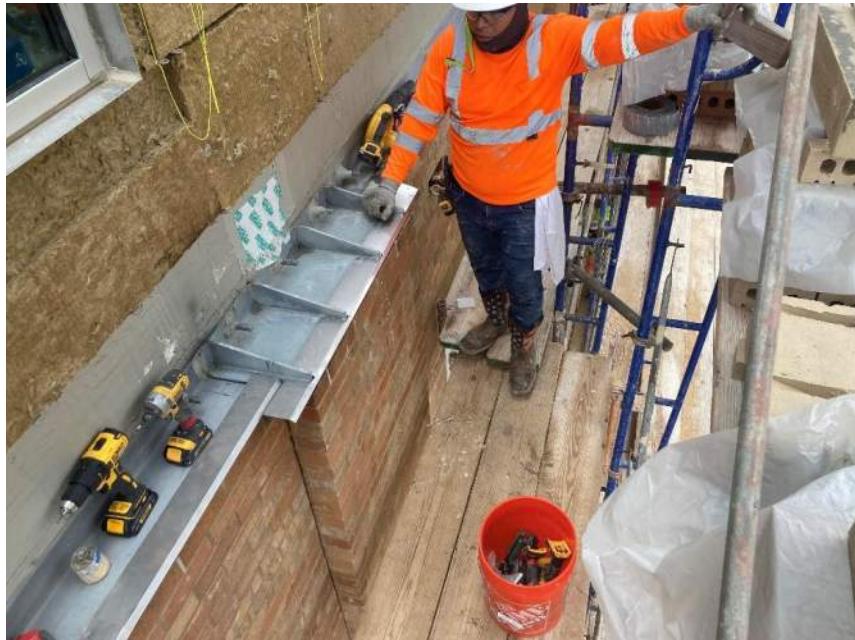
3. At the west face, Chamberlin was observed during the installation of metal flashing with a drip edge. Sealant was added to the backsides of the metal and embedded, in said sealant. The metal flashing was then anchored to the steel lintel. Overlaps were a minimum of 4" per SMACNA standards. Installation appeared to be in a sufficient manner. ***See Photos 11-14***

**Photo 11**  
Example of Metal Flashing Installation

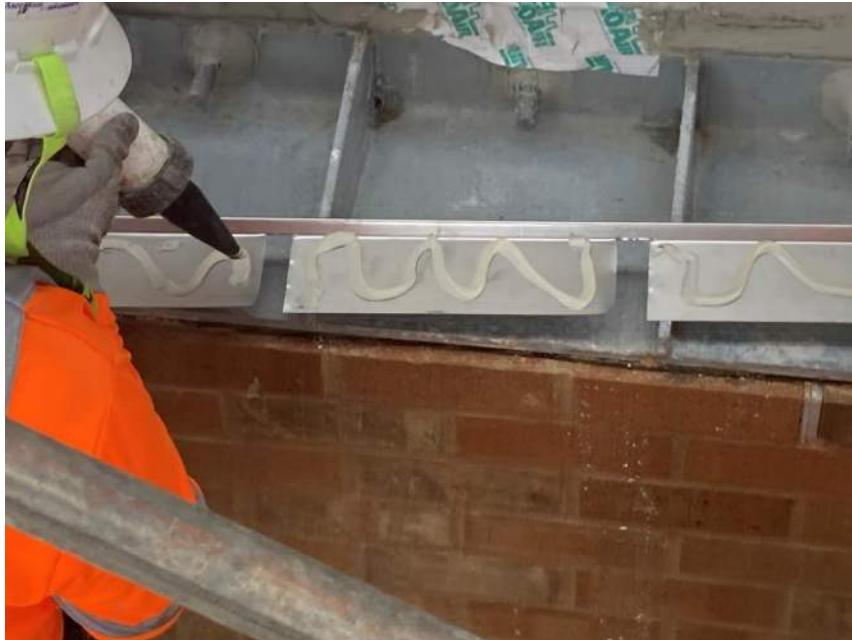
**Photo 12**  
Sealant Added to Metal Flashing Prior to Installation

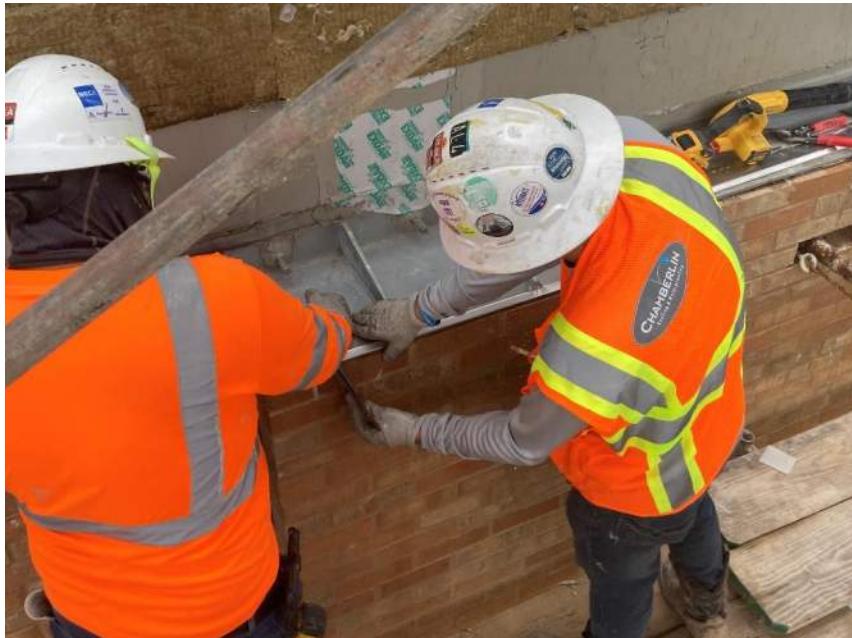
**Photo 13**  
Metal Flashing Installed

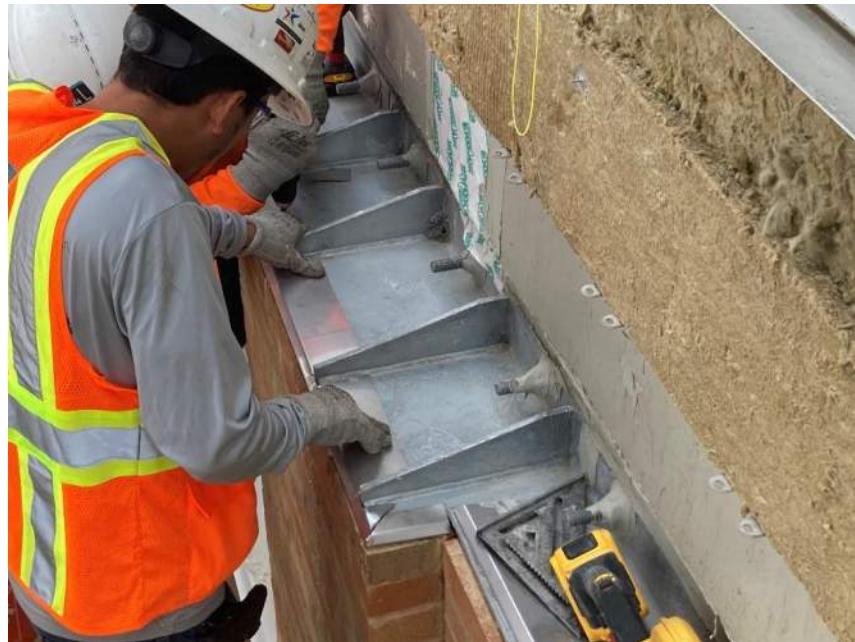
**Photo 14**  
Metal Flashing Anchored to Steel Lintel

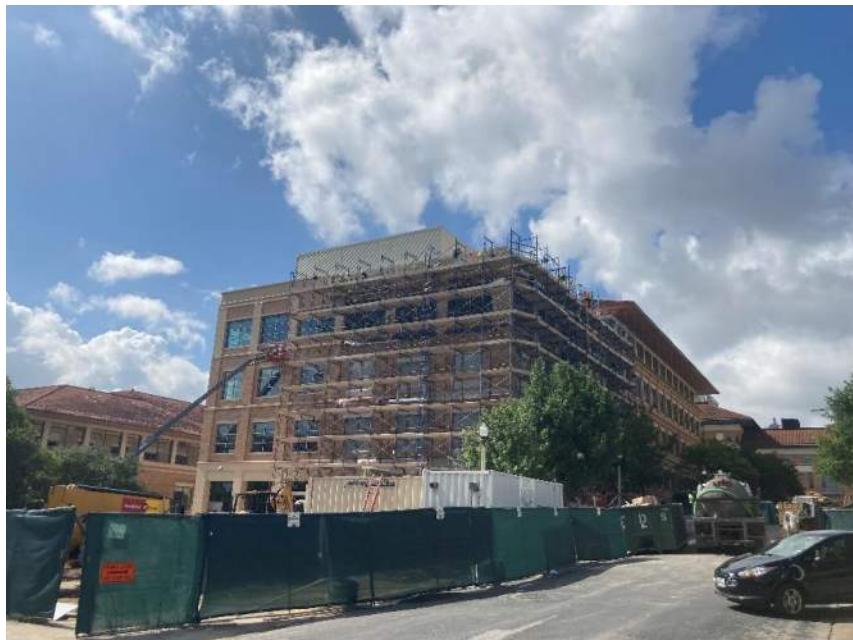
**Photo 01**  
Overview of Work in Progress

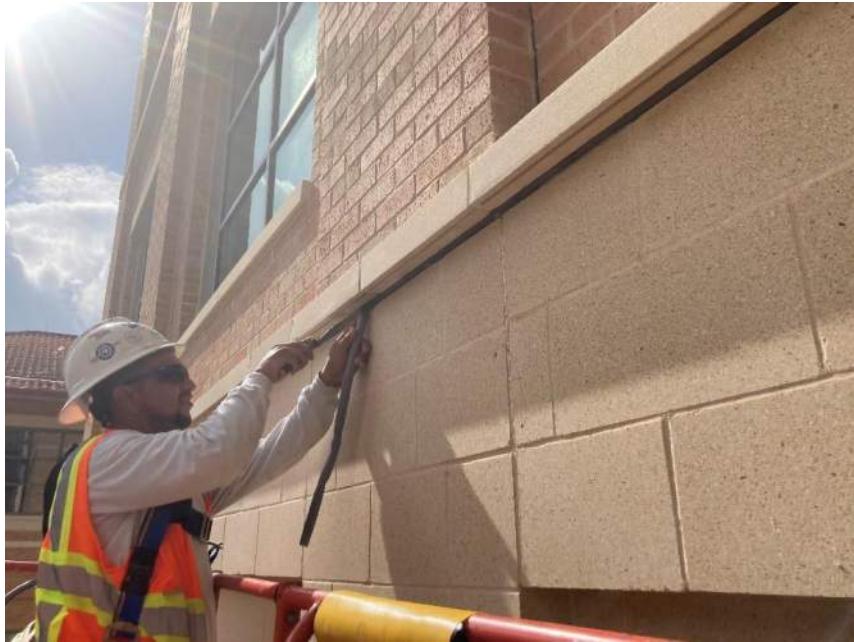
**Photo 02**  
Example of Backer Rod Installation

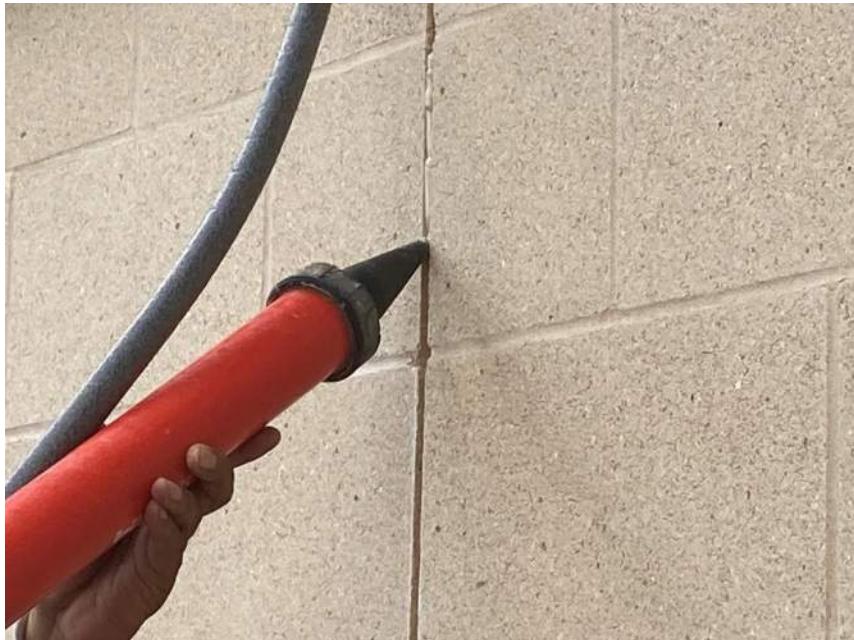
**Photo 03**  
Sealant Being Installed

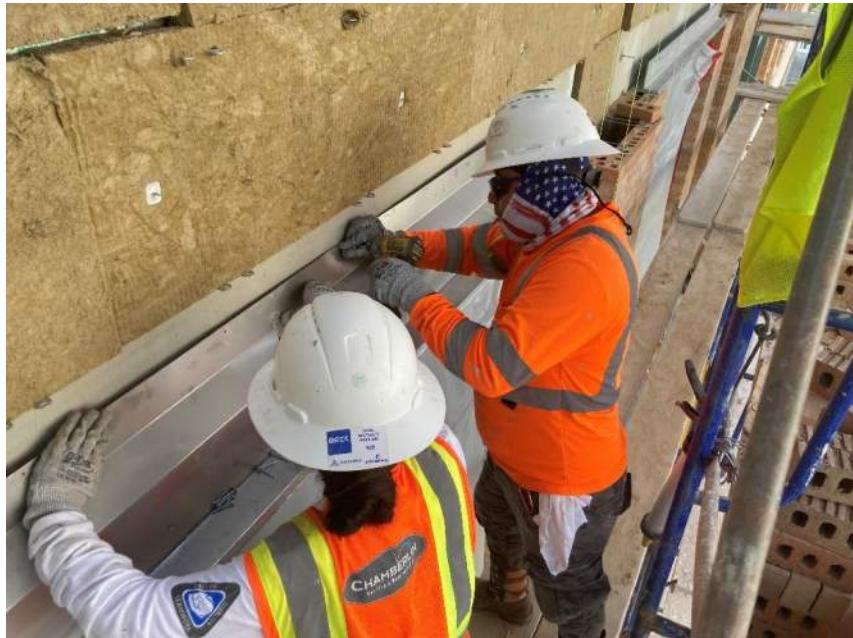
then added to the termination bar and the perimeter of the flexible flashing. Installation appeared to be in a sufficient manner. ***See Photos 05-11***

**Photo 05**  
Example of Metal Flashing Installation

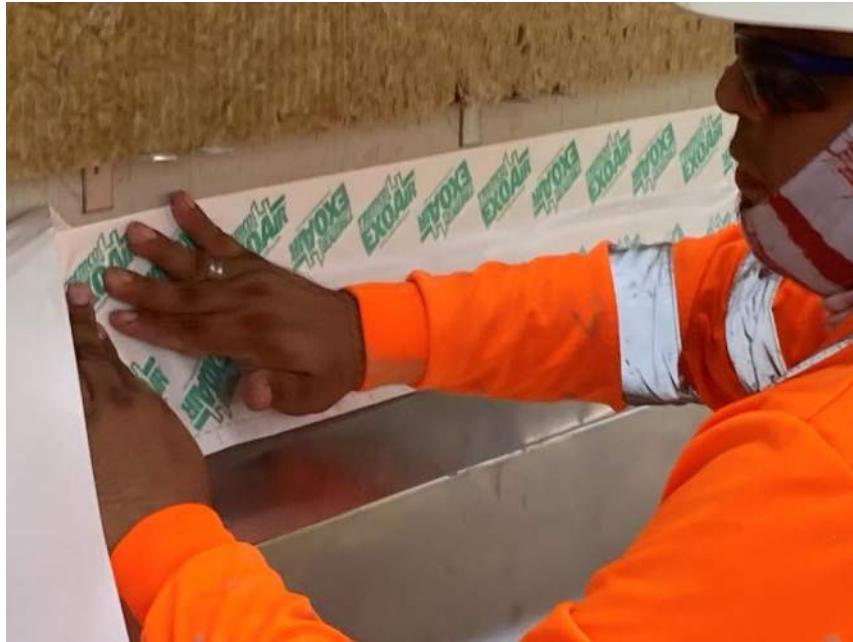
**Photo 06**  
Flexible Flashing Installed Over Metal Flashing

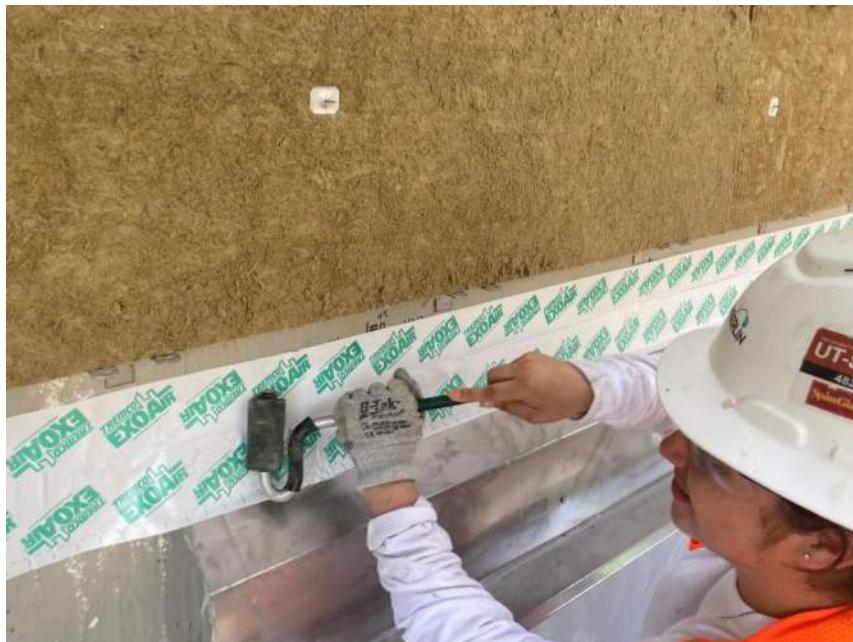
**Photo 07**  
Example of Flexible Flashing Rolled

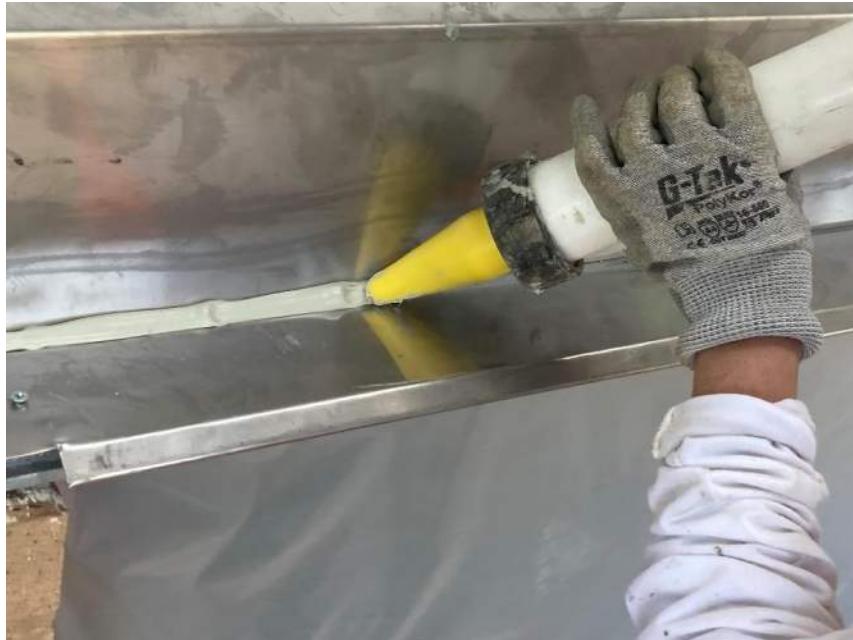
**Photo 08**  
Sealant Installed Between Metal Flashings

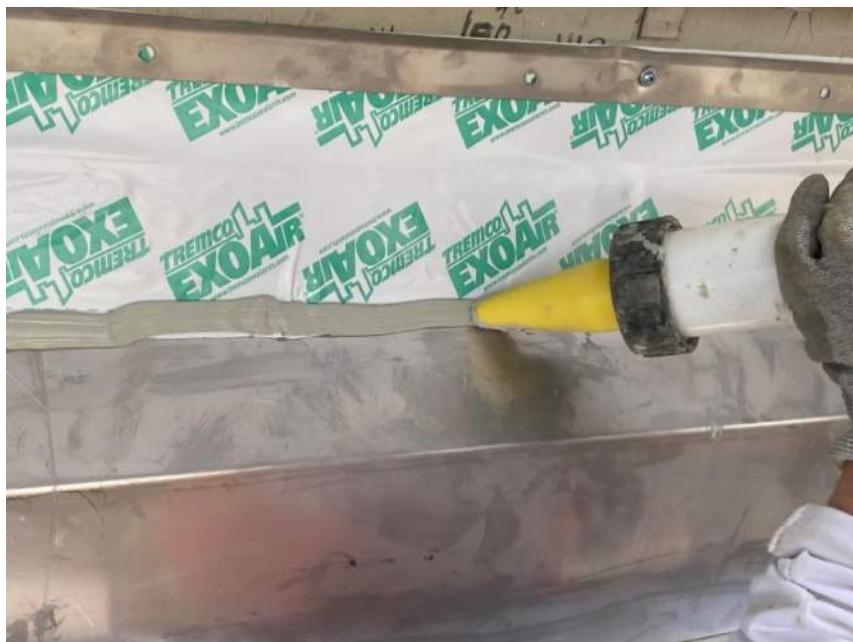
**Photo 09**  
Sealant Used for Terminating Flexible Flashing

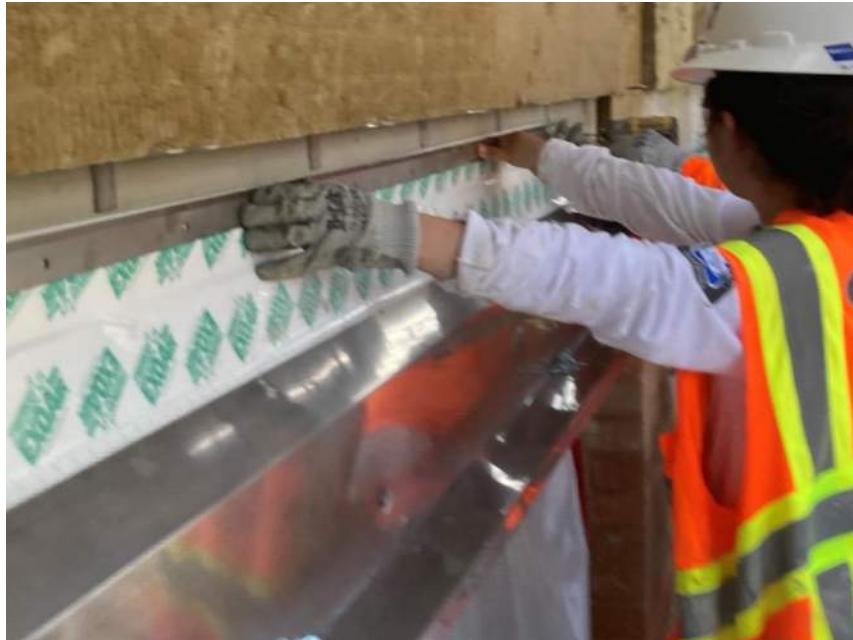
**Photo 10**  
Termination Bar Installed at Top of Flexible Flashing

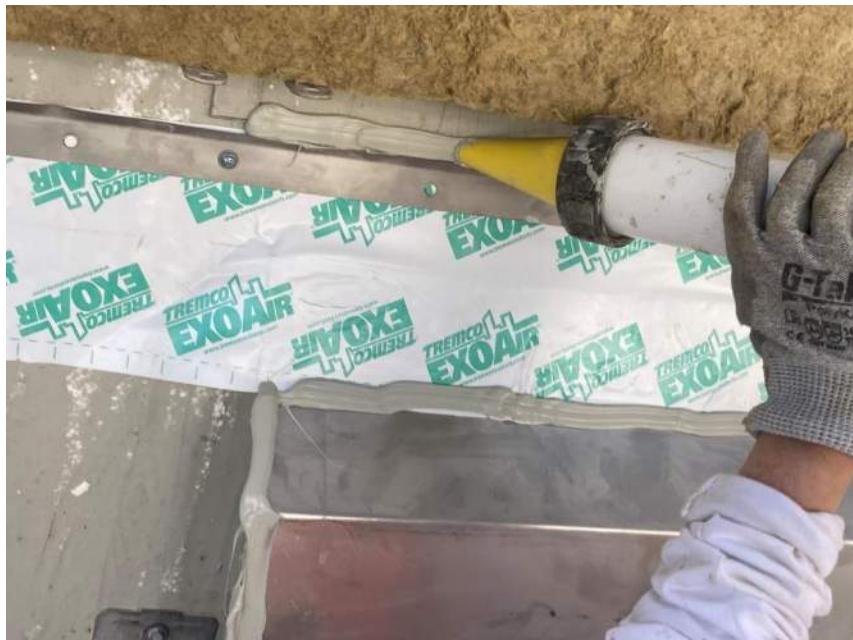
**Photo 11**  
Sealant Installed at Termination Bar

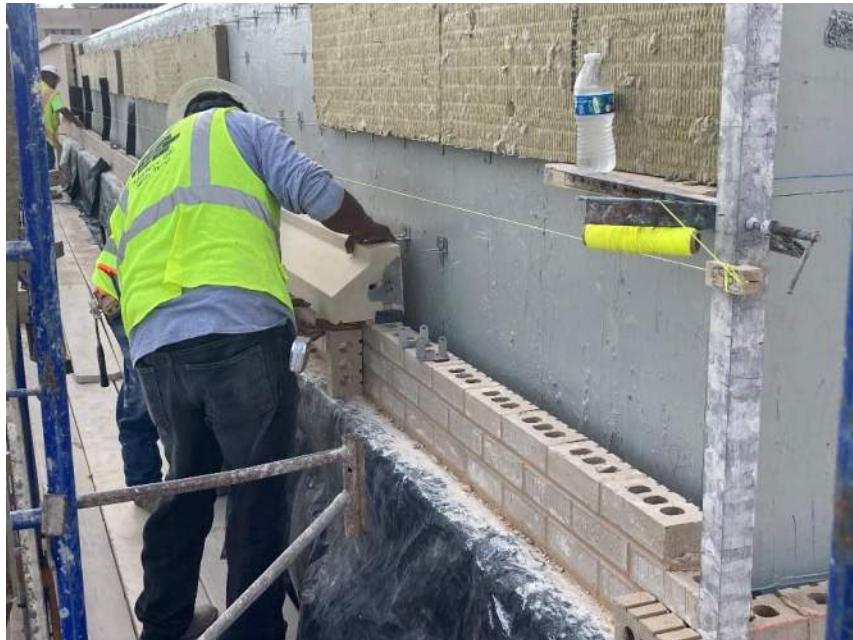
**Photo 13**  
Example of Stone Installation

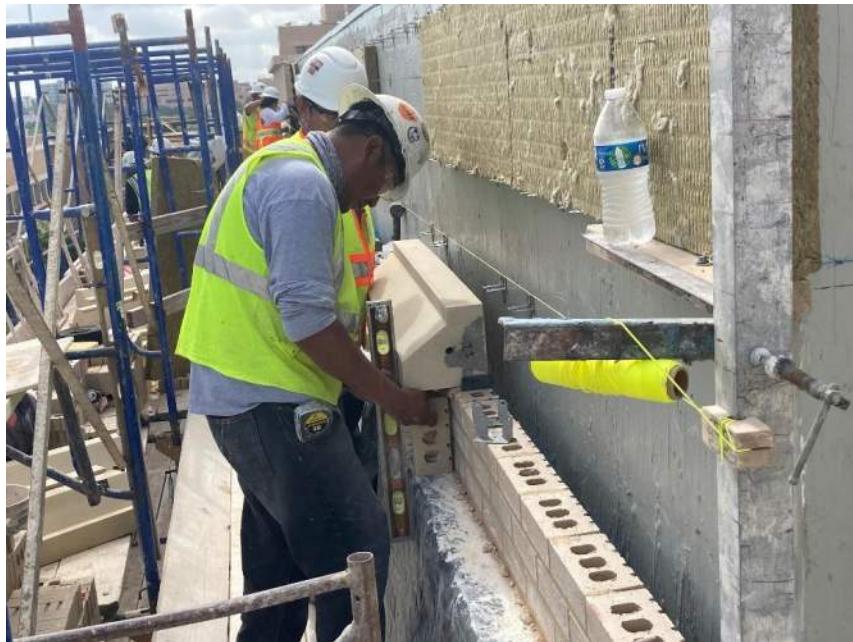
**Photo 14**  
Stone Placement Level and Plumb

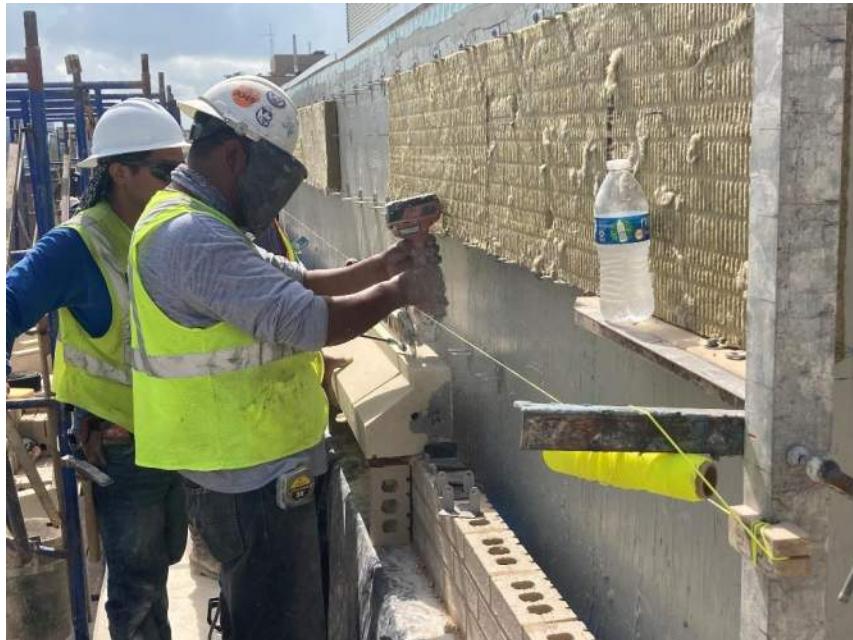
**Photo 15**  
Grinding Notch for Pintle Installation

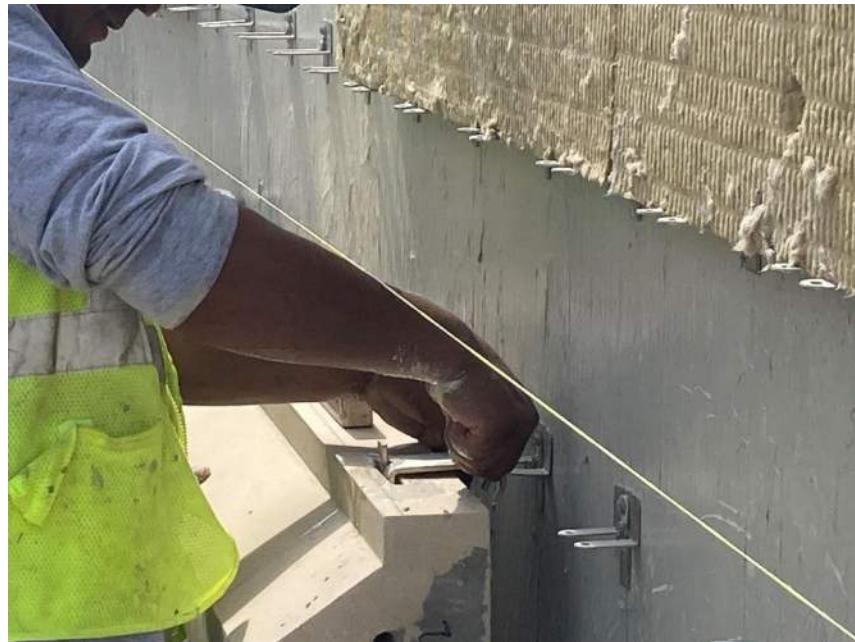
**Photo 16**  
Example of Pintle Installation

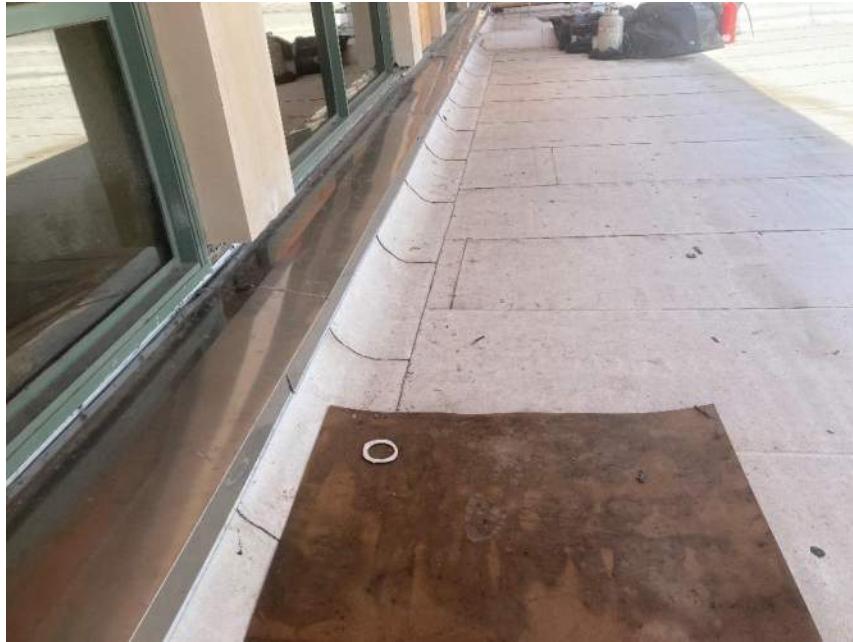
- At the roof, from existing to new buildings, ZSC observed the installed expansion joint, metal flashing, flexible flashing, termination bar and sealant. Upon observation, it was noticed that the flexible flashing (WIP 300), was not adhered properly and falling away from the substrate. It was also noticed that the termination bar installed, specifically below existing windows, was missing sealant for a proper termination. In the same location, there were areas noticed to have missing and gaps in sealant at the overlaps on the metal flashing.

**Photo 03**  
Flexible Flashing not Adhered and Falling

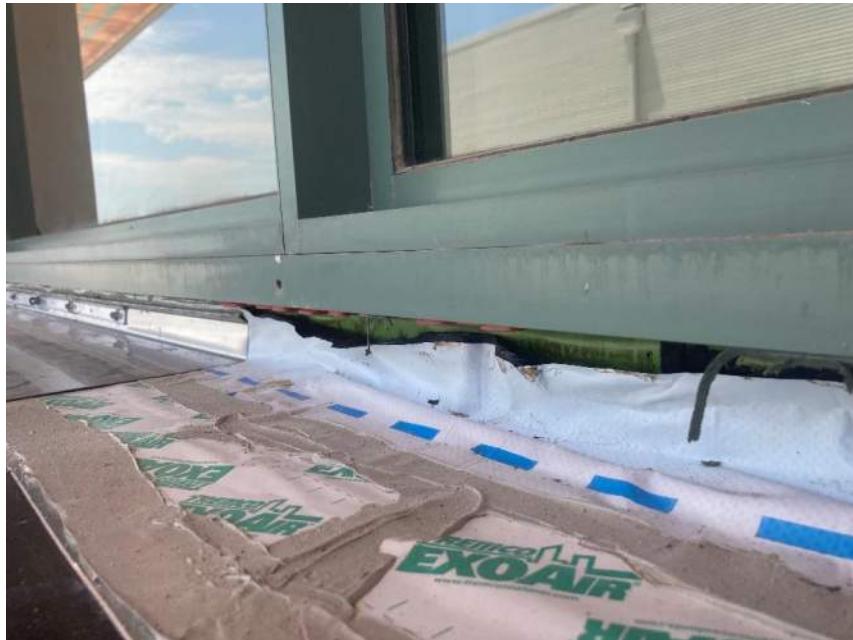
**Photo 04**  
Unadhered Flex Flashing w/ Fish Mouthing at Overlap

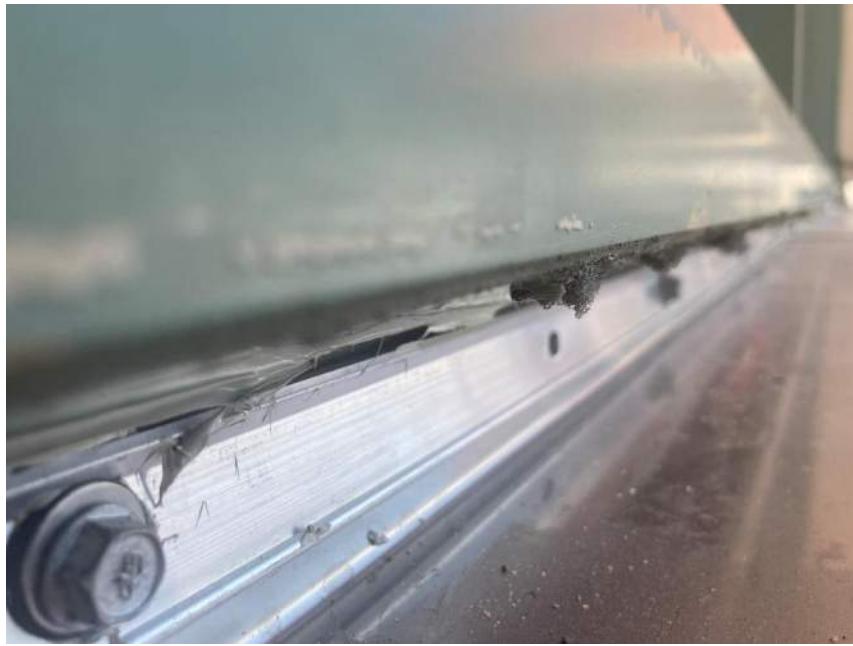
**Photo 05**  
Sealant Missing at Top of Term Bar

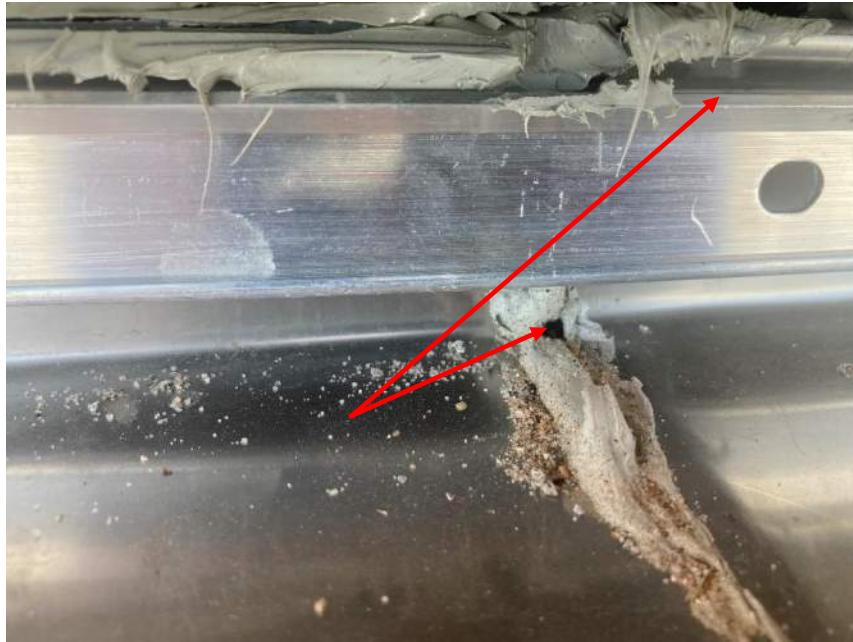
**Photo 07**  
Flexible Flashing not Adhered and Falling Away from Substrate

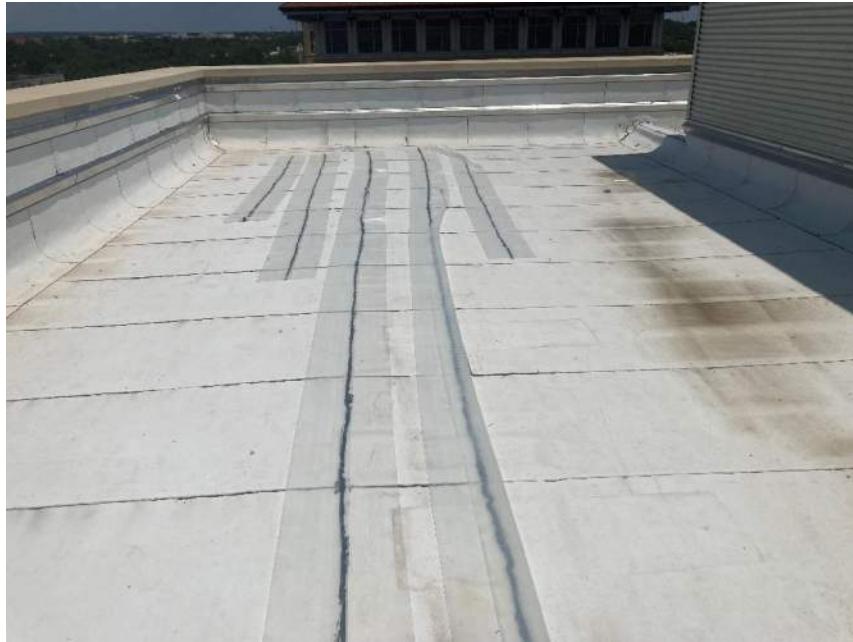
**Photo 09**  
Fish Mouths in Pro-Glaze

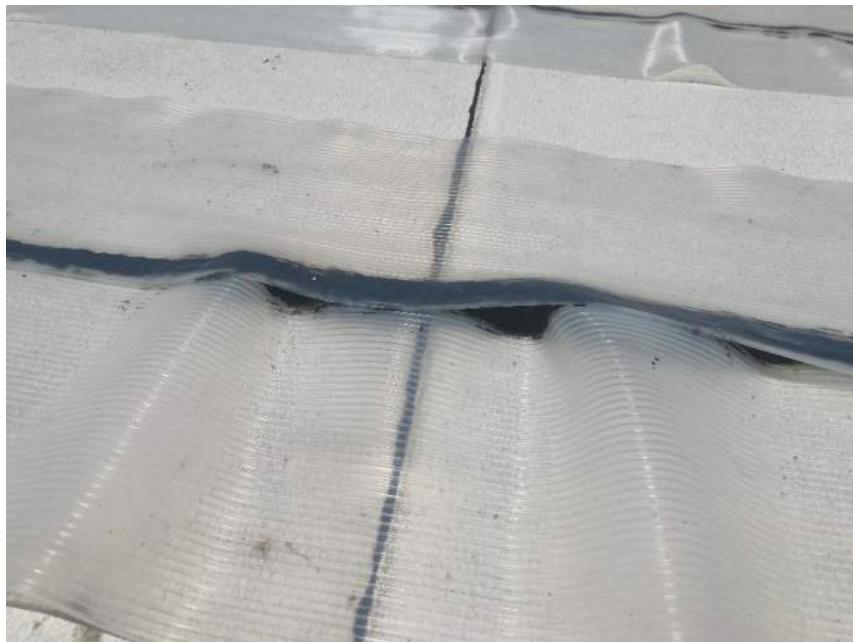
**Photo 10**  
Pro-Glaze Fish Mouthing

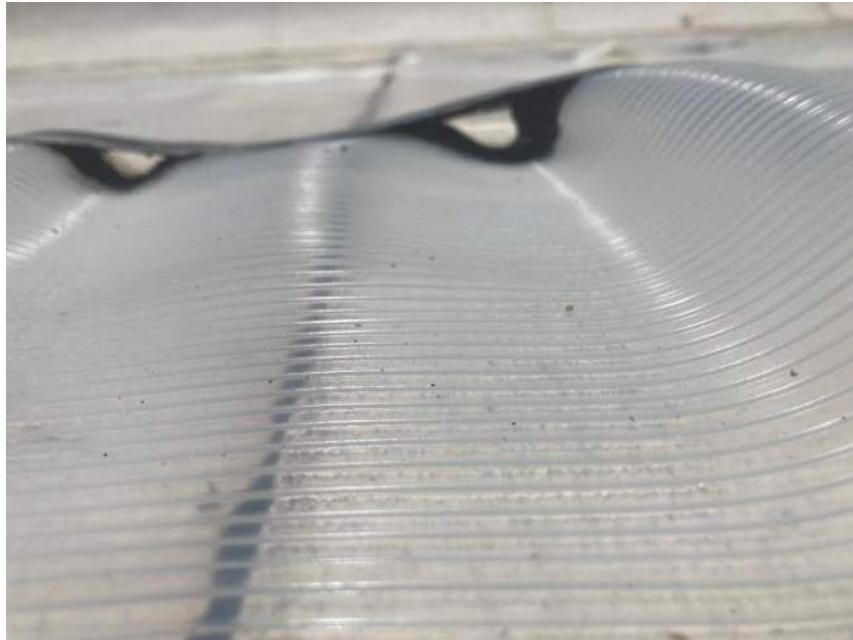
3. At Level 1 in the southwest corner, an example of the pro-glaze was installed on the existing substrate. Primer was rolled onto the wall and allowed to cure. Two (2) beads of sealant were then added with the pro-glaze embedded in said sealant. Tremco will be on-site to perform a pull test on 7/29/20.

**Photo 11**  
Example of Pro-Glaze Adhered to Existing Substrate

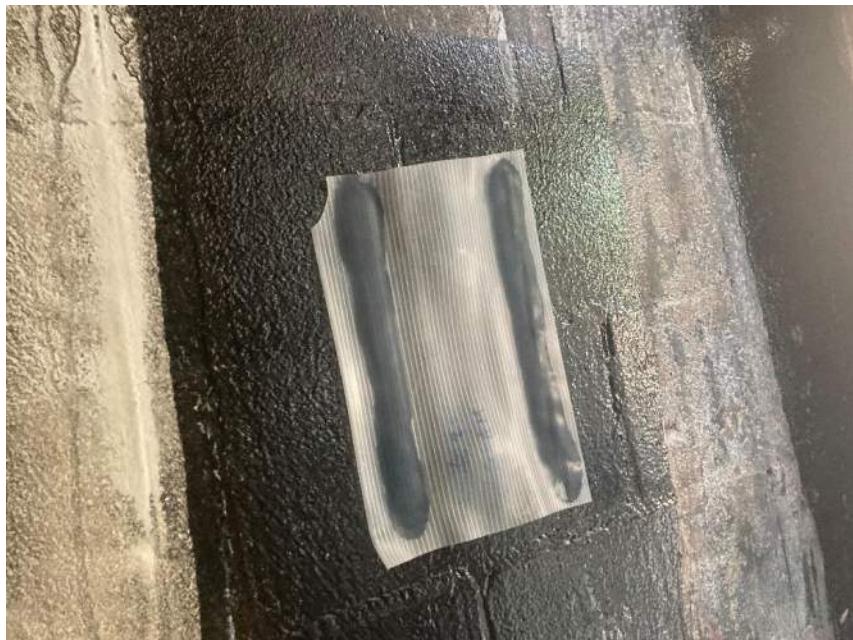
**Photo 12**  
Overview of Pro-Glaze Tested

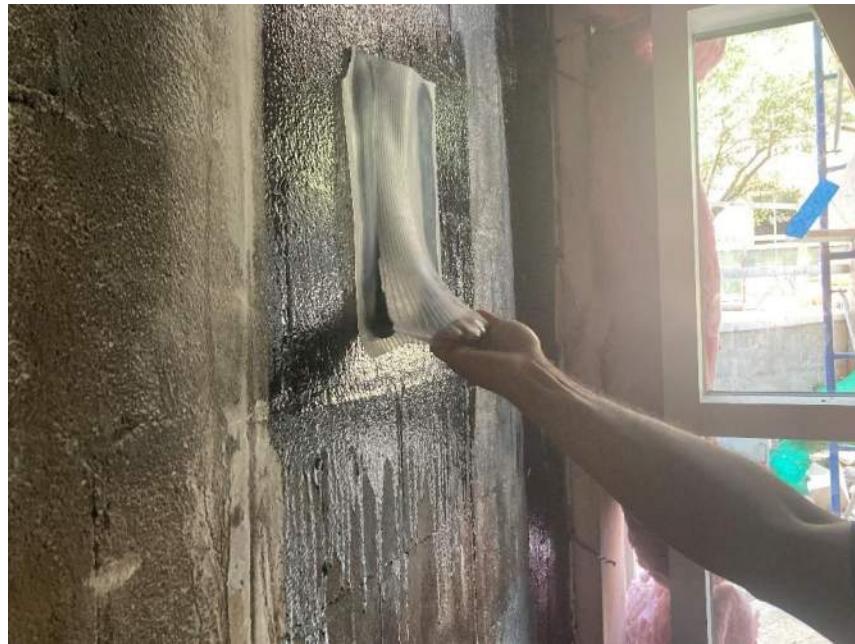
**Photo 13**  
Example of Pro-Glaze Tested

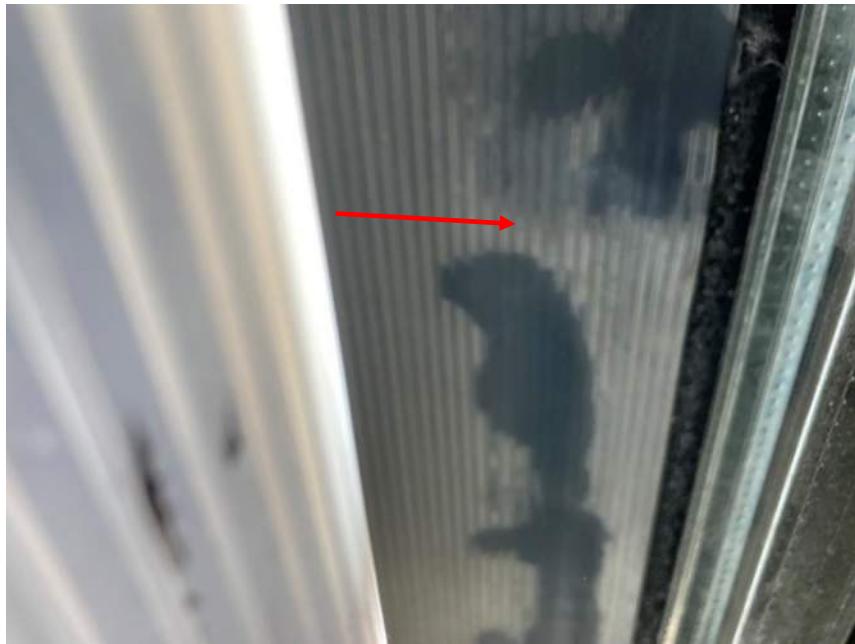
**Photo 10**  
Installed Pro-Glaze Missing Sealant

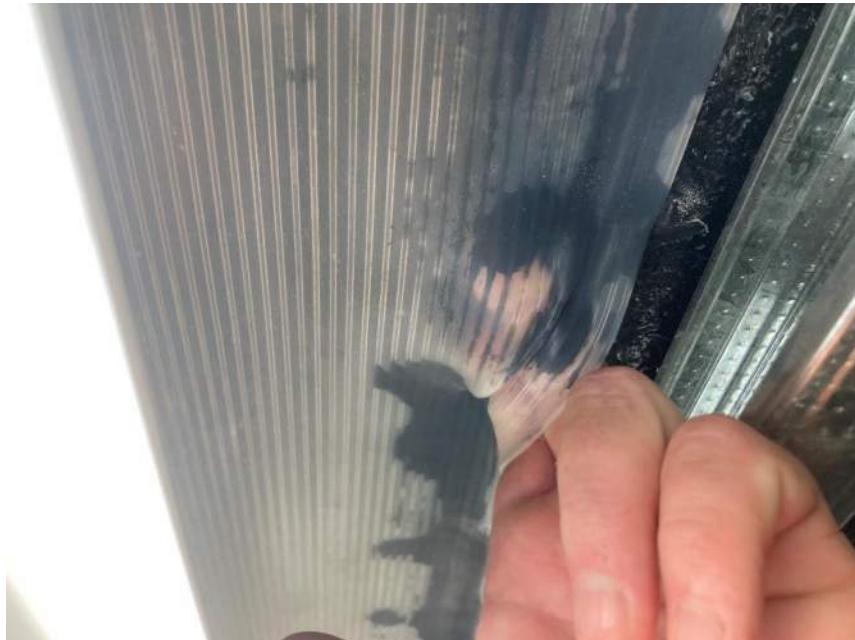
cure. Once cured, a bead of sealant was added to the epoxy primer and the pro-glaze was embedded into the sealant. At level one through four, areas were noticed to have insufficient adhesion. Sealant was not continuous in some areas and fish mouths were occurring. ZSC recommends removing the sealant from one side or the other of the fish mouths. This will allow the pro-glaze to lay flat and have continuous adhesion throughout the system. **See Photos 10-14**

**Photo 12**  
Example of Pro-Glaze not Adhered to Substrate

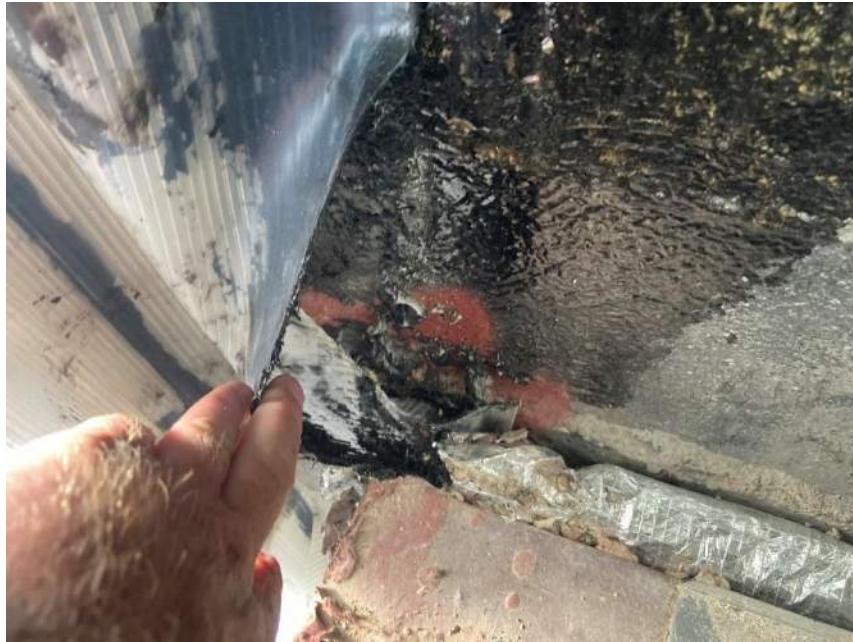
**Photo 13**  
Example of Pro-Glaze w/ Fish Mouth

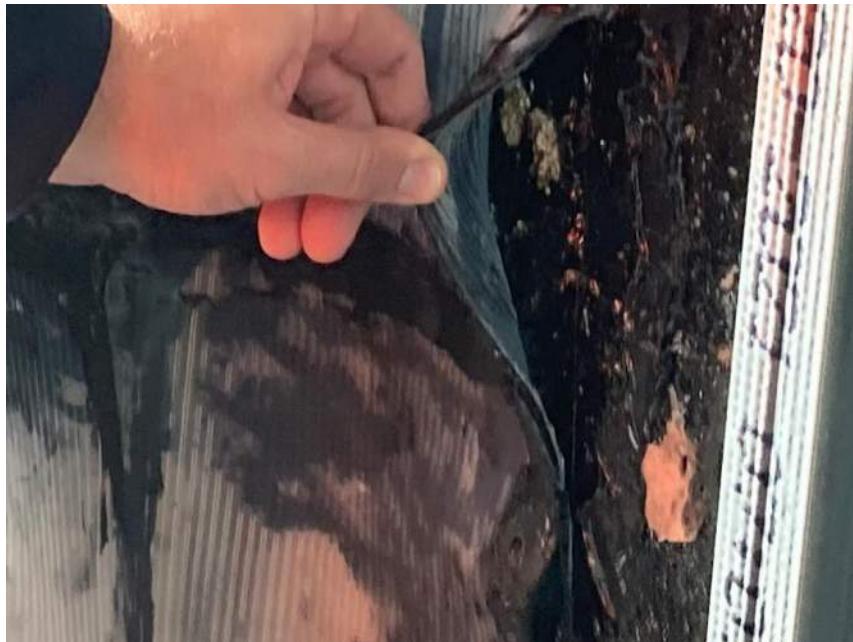
**Photo 14**  
Example of Pro-Glaze w/ Fish Mouth

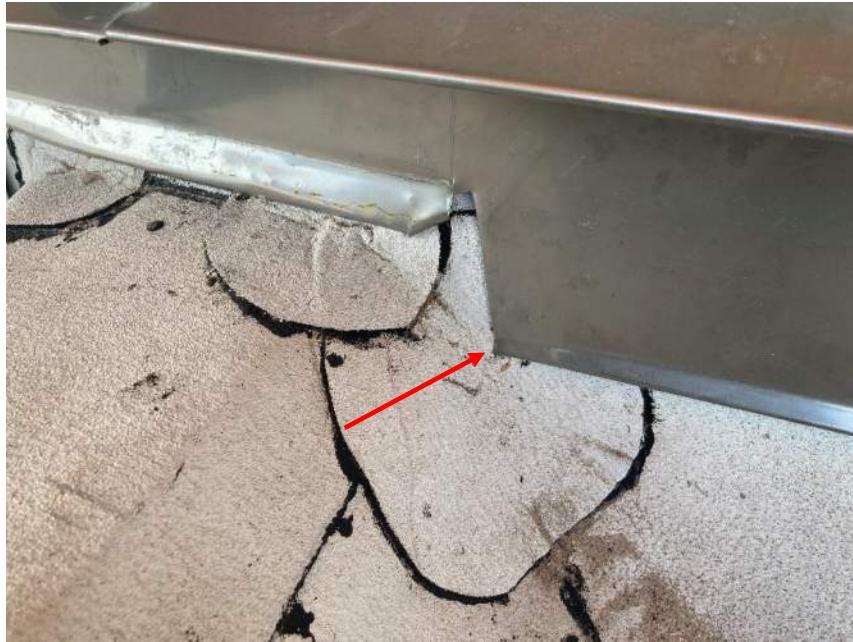
**Photo 05**  
Overview of Metal Flashing Resting on Roof Membrane

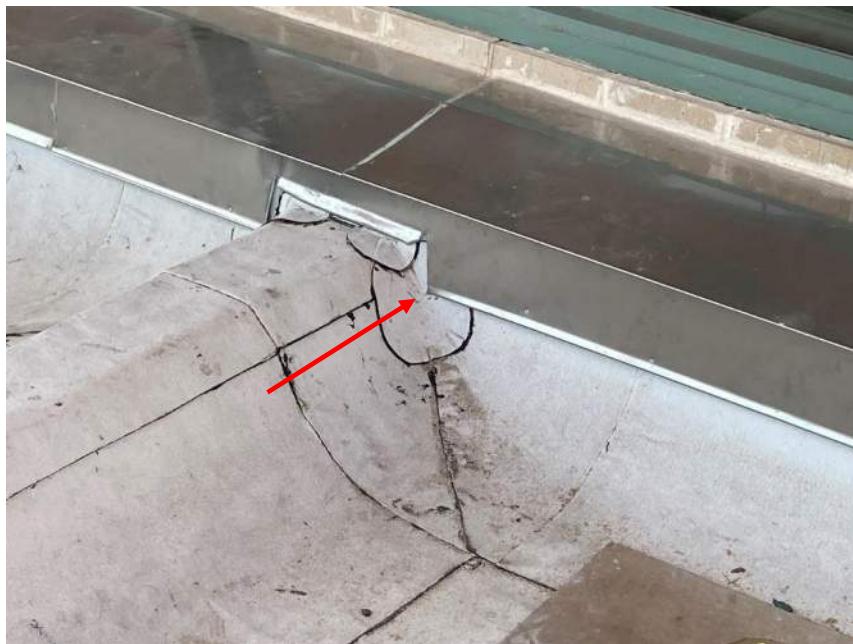
3. At the roof, metal flashing and term bar have been installed. However, under the existing window sills, there is missing sealant at the termination bar. This was brought up in Field Report #48, recommending the sealant be repaired. Upon this observation, brick has now been installed. This single layer of brick will need to be removed, sealant repaired and documented prior to covering again. **See Photos 06-08**

**Photo 06**  
Sealant w/ Gaps at Termination Bar

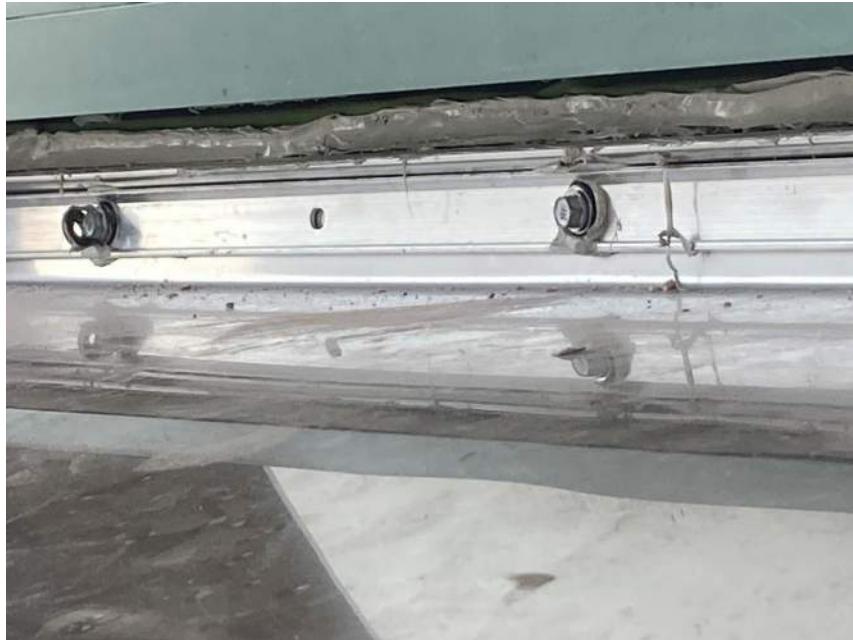
**Photo 07**  
Sealant Missing at Top of Term Bar

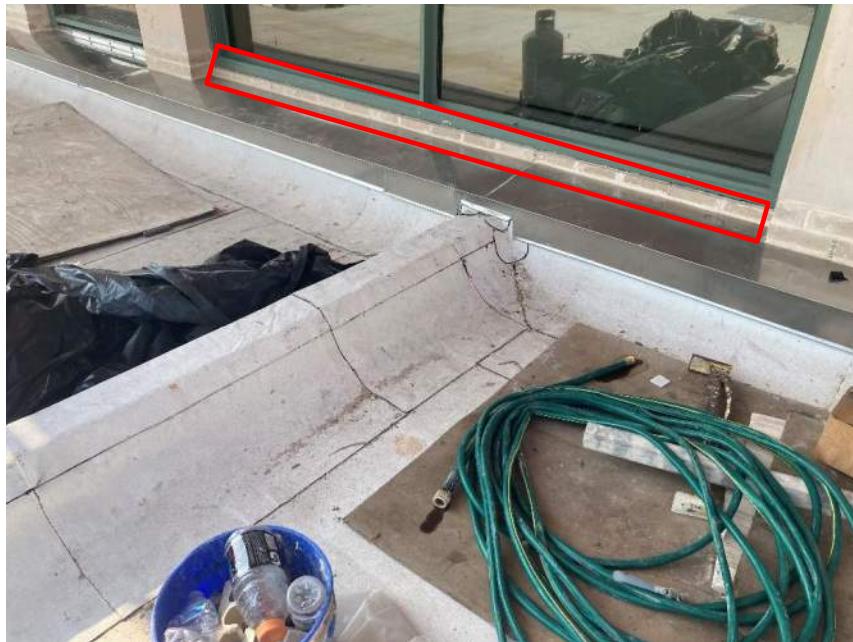
**Photo 08**  
Brick Installed Prior to Repairing Term Bar w/ Missing Sealant
