## SUBMITTAL REVIEW

Description: Aluminum Framed Entrances and Storefronts -SD

Project Name: UT SEAY Building Addition

Project No.: 102-782

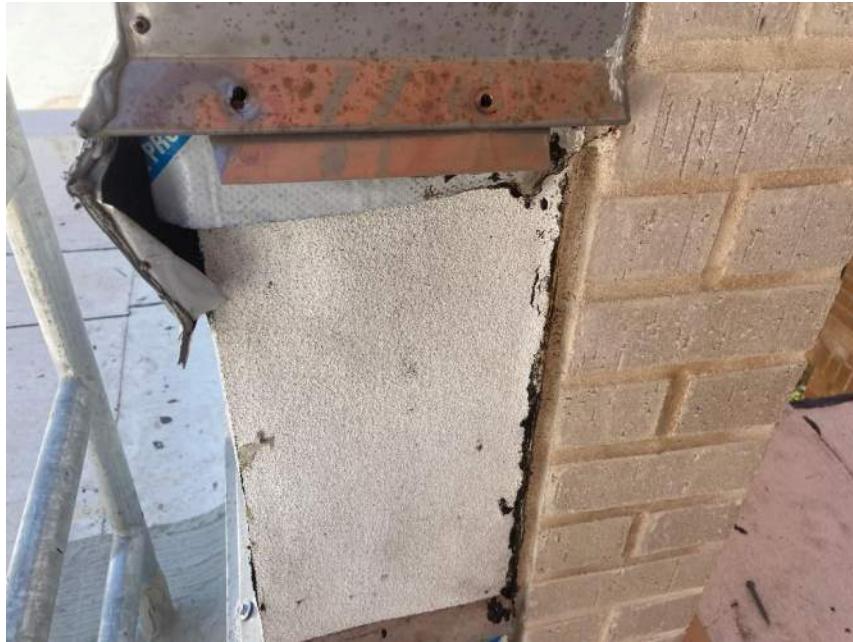
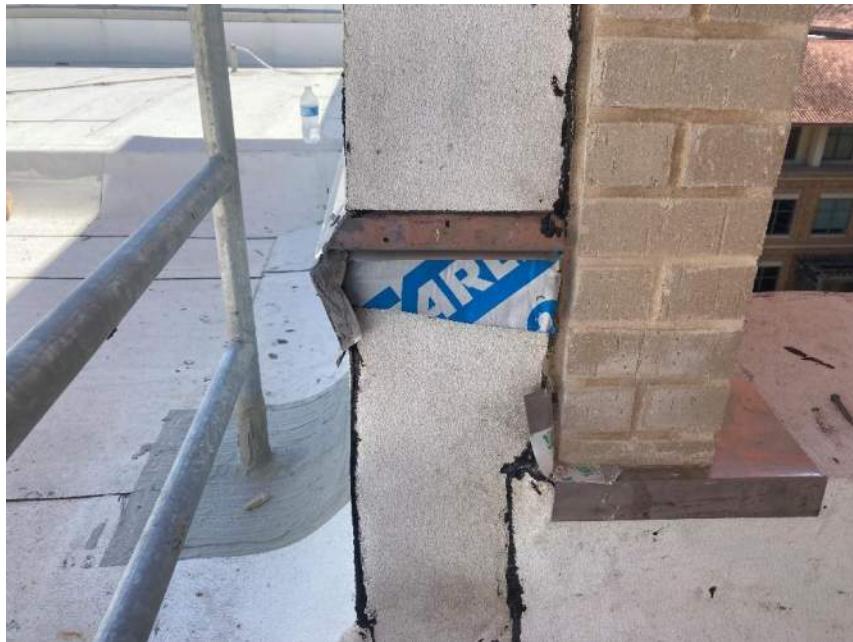
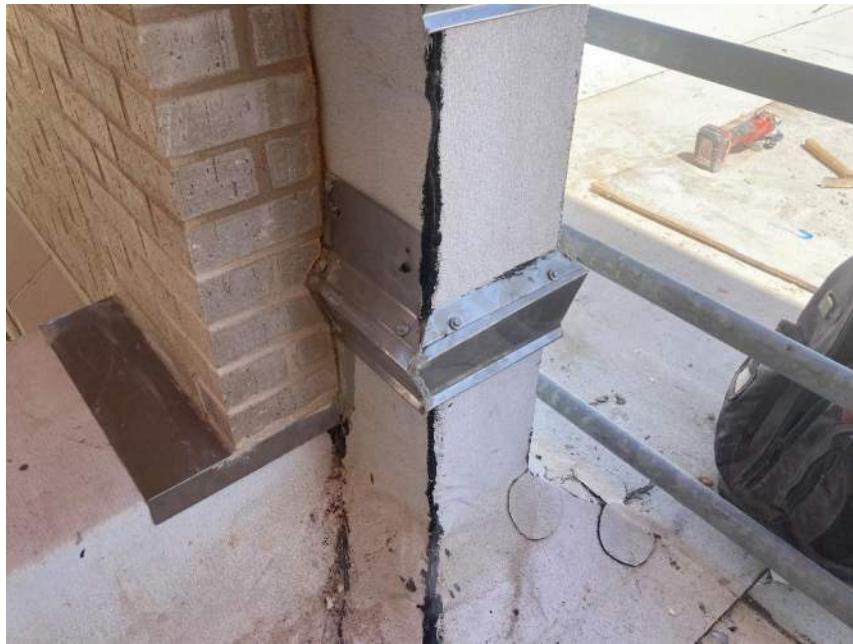
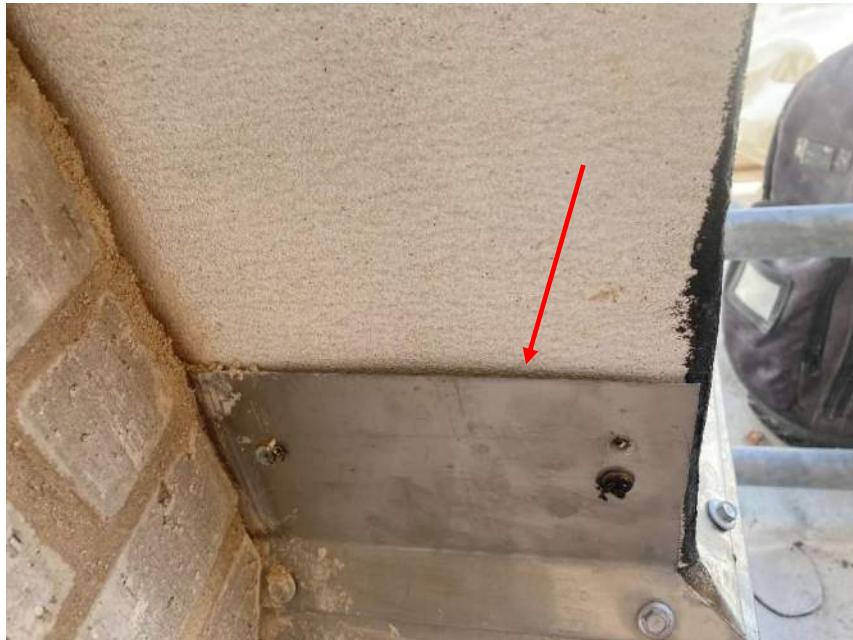
2. At the roof on both the east and west sides of the south parapet area, ZSC observed several areas where there is missing flashing and exposed flashings NOT terminated. At the end of the east parapet, it appears the receiver has been removed and the flexible flashing is exposed. This was brought the SG's attention and they were aware KR is in the process of making repairs. At the end of the parapet on the west side, metal flashing has been installed with no termination and on the outside of the cap sheet membrane. This will need to be repaired. **See Photos 04-07**

**Photo 04**  
Metal Flashing with Exposed Membrane

**Photo 05**  
Overview of Metal Flashing with Exposed Membrane

**Photo 06**  
Overview of Area Where Flashing NOT Terminated

**Photo 07**  
Metal Flashing Not Terminated

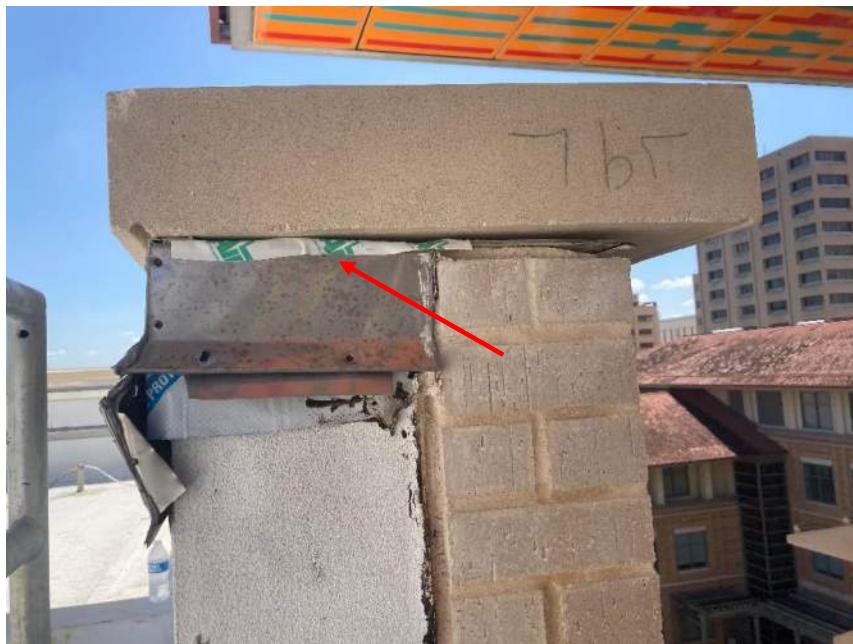
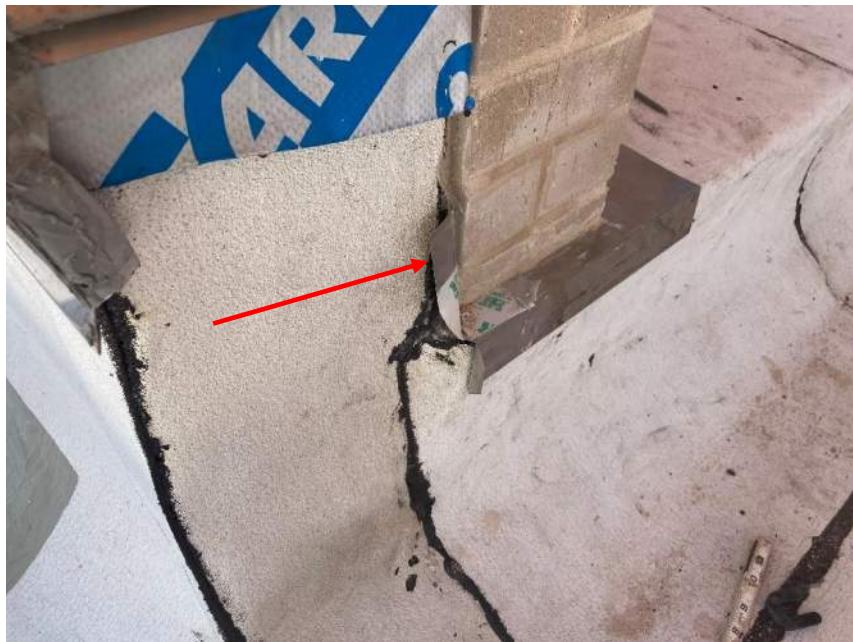
3. At the east end of the parapet, flexible and metal flashings have been installed, leaving exposed ends. The flexible flashing that is exposed under the cap stone, will need to be cut back and sealed. The metal flashing at the base of wall will need to be terminated. ***See Photos 08-09***

**Photo 08**  
Overview of the Area Where Flashing Not Terminated

**Photo 09**  
Flashing NOT Terminated

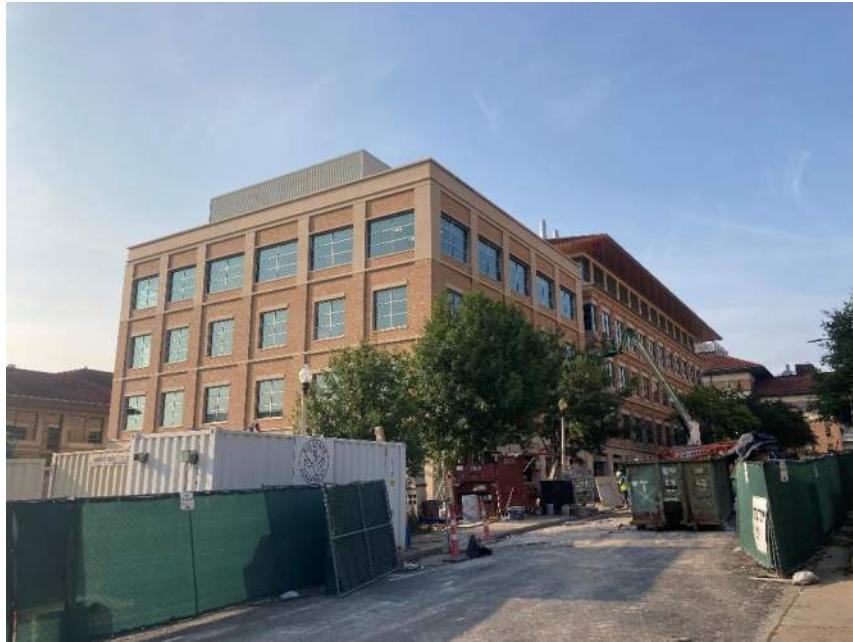
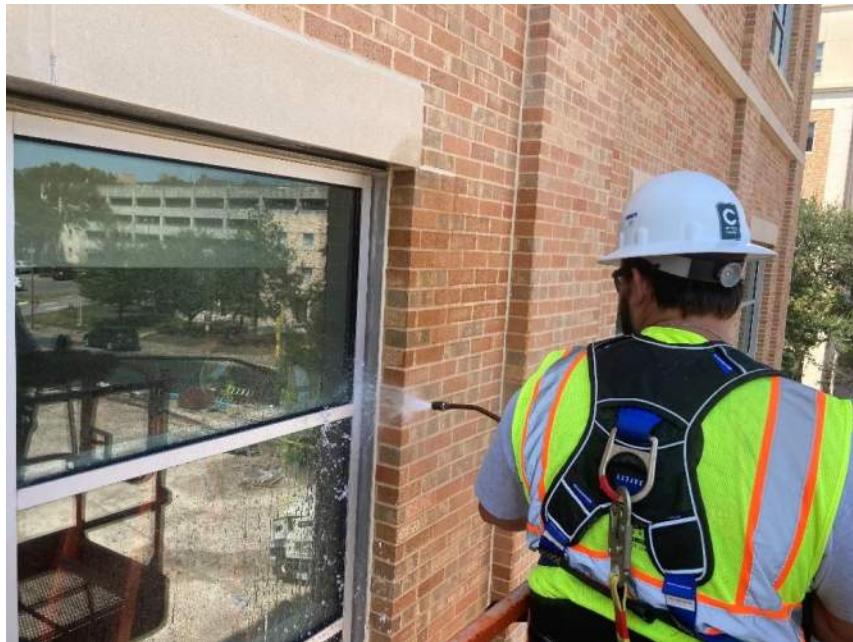
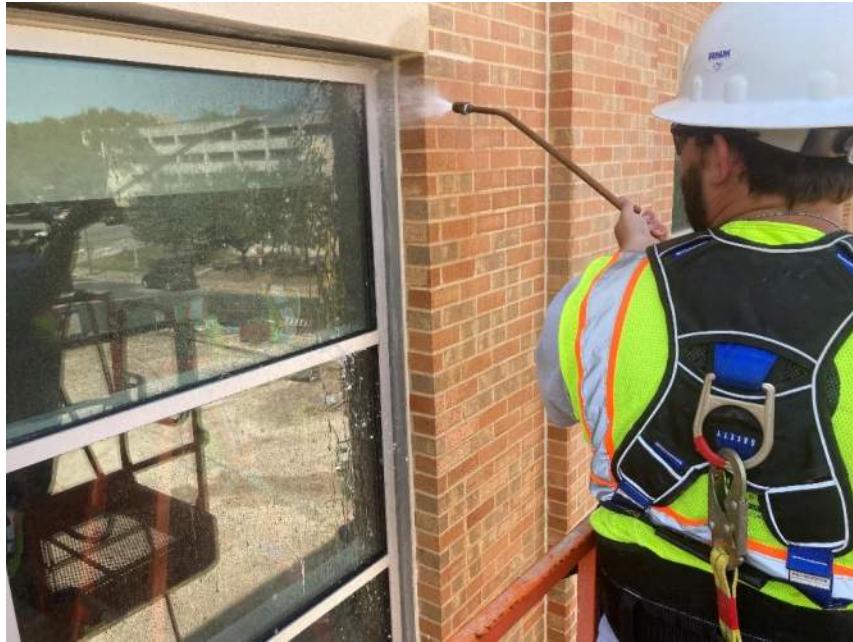
1. At the north and west face of the building, ZSC performed nozzle testing at two previously failed windows. Upon introducing water to the specimens at 30psi for one minute per linear foot, it was found that the repairs necessary were completed and both window retests passed. **See Photos 01-03**

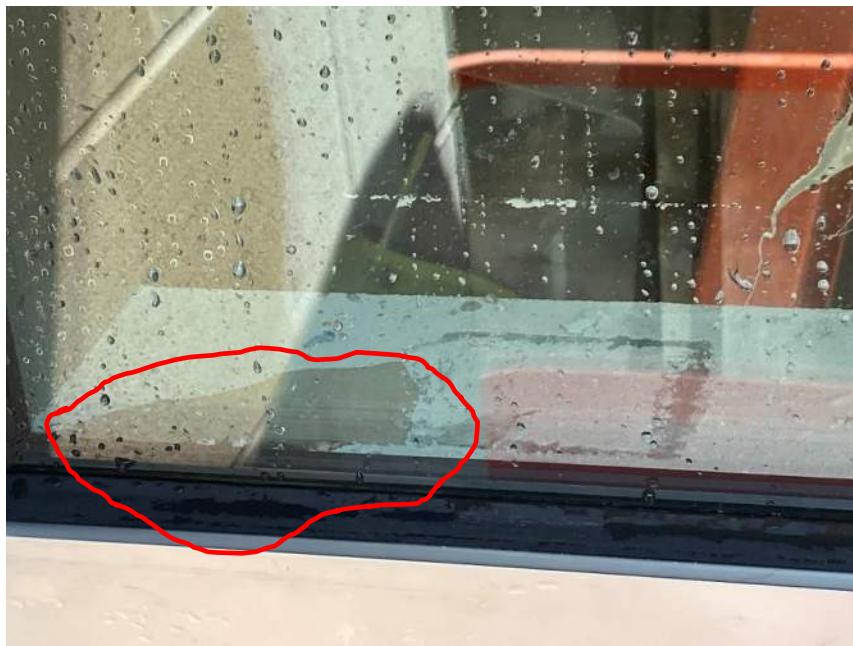
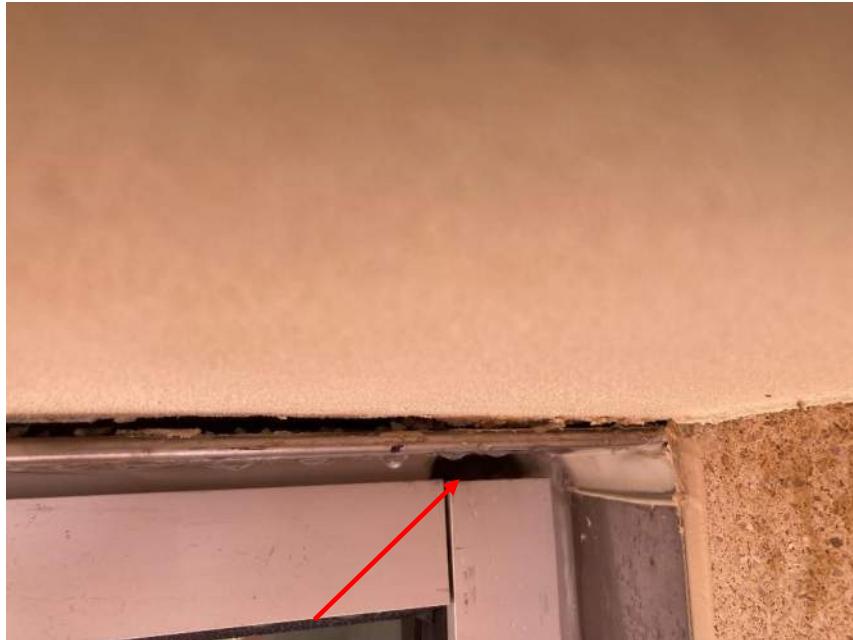
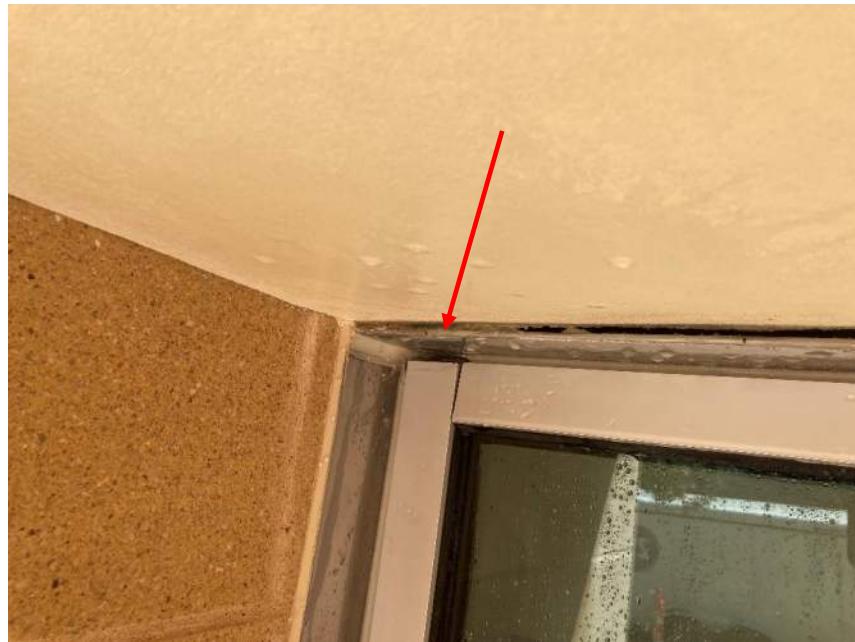
2. At the west face of the building on level 2, ZSC performed nozzle testing as an add-on for the previously failed windows. Upon introducing water, it was not until ZSC started the upper portion of the jamb to the head that water intrusion became visible. A visual inspection was conducted, and it was noticed that the heads of the window sealant was not properly installed. ZSC was scheduled to test a 2<sup>nd</sup> add-on, but upon a visual inspection of this window, it was noticed that it had been sealed in the same manner. **See Photos 04-07**

**Photo 04**  
Example of Water Intrusion at the Interior

**Photo 05**  
Window Head not Properly Sealed

**Photo 06**  
Window Head at Center Mullion not Properly Sealed

**Photo 07**  
Window Head not Properly Sealed

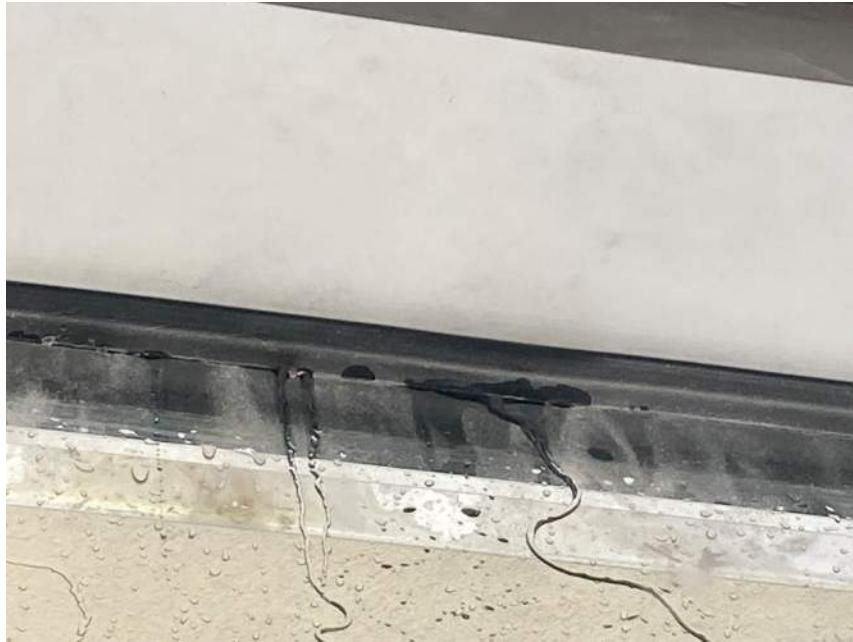
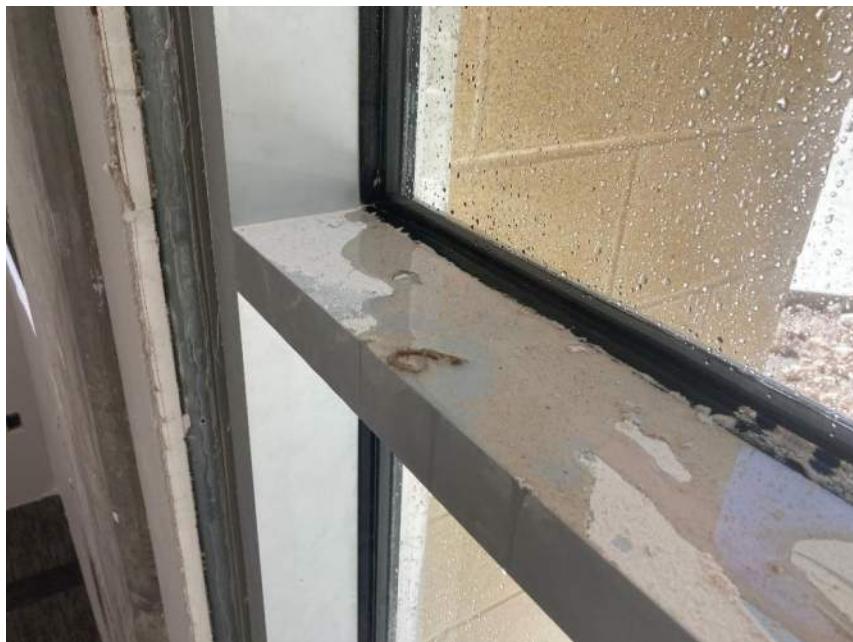
1. At the west face of the building on level 2, ZSC conducted nozzle testing on a previously failed window. Upon testing, at the head of the window system, water became visible at the gasket of the system on the interior at 4 minutes into the test. This specimen was considered a system failure. In the same area on the west, a specimen was picked next to the previous and was considered a pass. **See Photos 01-06**
2. At the north elevation on the 2<sup>nd</sup> level, ZSC conducted another nozzle test as a retest for a previously failed window. Upon introducing water to the specimen, water intrusion was detected in the stainless sill pan at 4 ½ minutes into the test. Water was detected in the sill pan once the jamb started to have water introduced. With water able to be visible in the stainless sill pan with no way to escape, this specimen was considered a fail. **See Photos 07-10**

**Photo 05**  
Water Intrusion at Gasket

**Photo 06**  
Example of Amount of Water from Intrusion

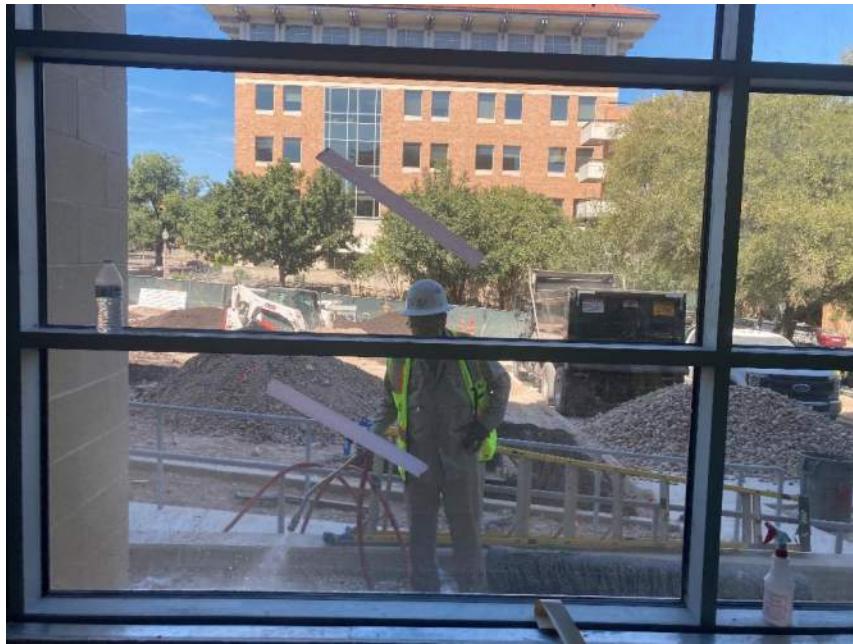
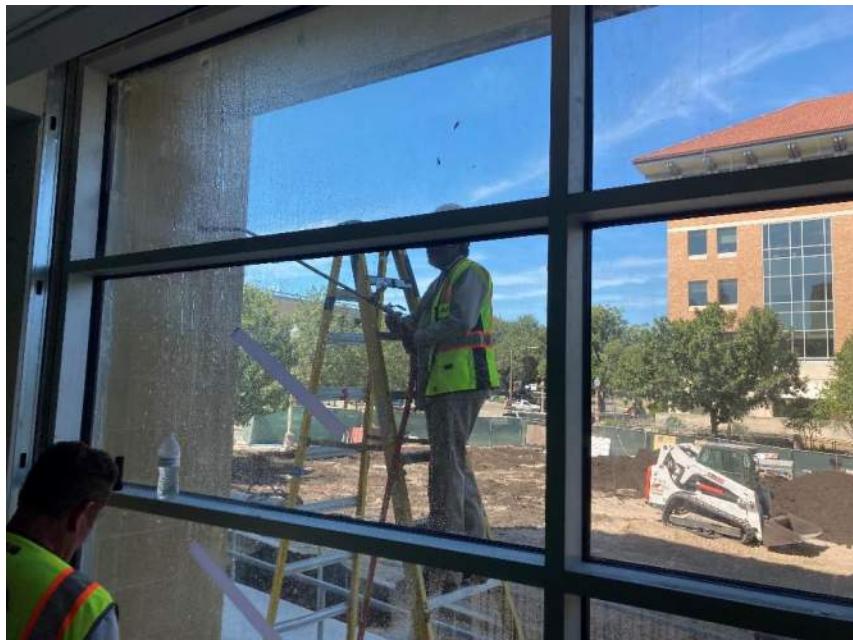
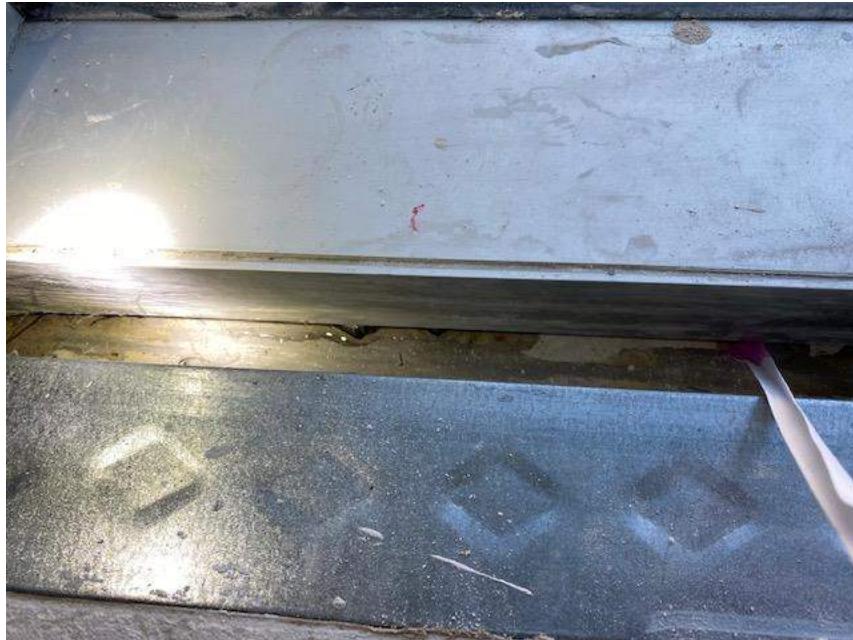
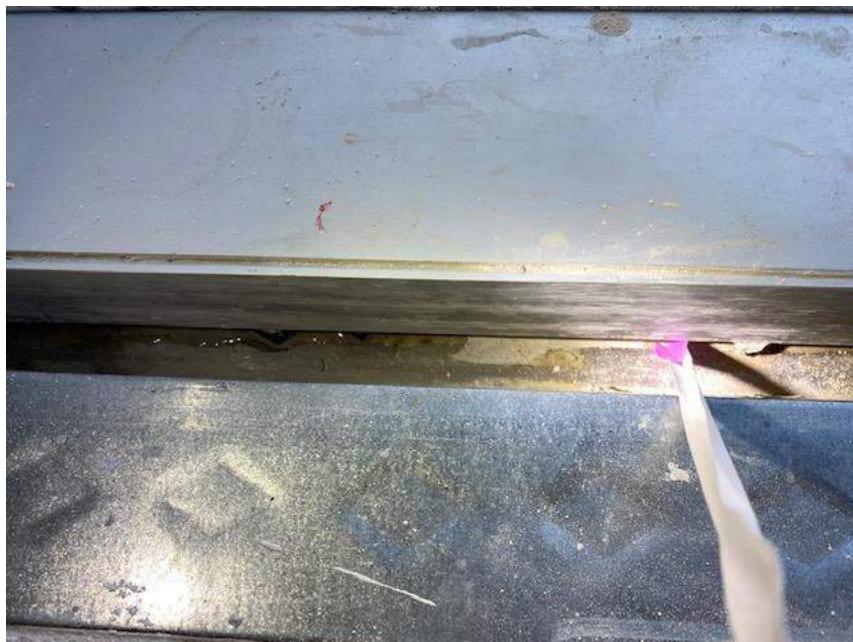
**Photo 07**  
View of Specimen Tested

**Photo 08**  
Example of Water Introduction at Specimen

**Photo 09**  
Water Infiltration Becomes Visible

**Photo 10**  
Example of Litmus Paper showing Moisture

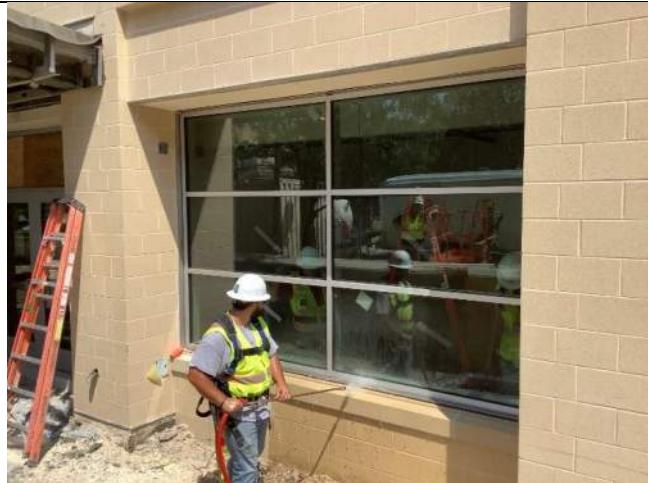
<b>5</b>	<b>Specimen 8</b> <b>5.4.2021</b>	
	Exterior view of AAMA 501.2 testing being performed at specimen 11.

<b>Specimen</b>	Specimen 11	<b>Date</b>	9.9.2021
<b>Test Standard</b>	AAMA 501.2	<b>Time</b>	2:50 PM
<b>Wand</b>	Wand 3	<b>Wind Speed</b>	7/16 NNE
<b>System Leak</b>	No Infiltration		
<b>Perimeter Leak</b>	L1 @ 2m0s 5 <sup>th</sup> Cycle		
<b>Test Result</b>	<b>FAILURE</b>		
<b>Description:</b>	<p>A visual examination was performed and no modifications or pertinent observations were observed with the exterior, cladding, or interior.</p> <p>Testing was performed in 5 ft or less sections, passing the wand across the intersection as prescribed in AAMA 501.2 at 1 min/ft. Testing commenced from bottom to top. During testing of specimen 11, failure occurred when water infiltration was observed within the system at the head.</p>		
	<p>Passed Testing      <span style="color: green;">— — — —</span></p> <p>Failed Testing      <span style="color: red;">— — — —</span></p> <p><b>Elevation as viewed from interior</b></p>

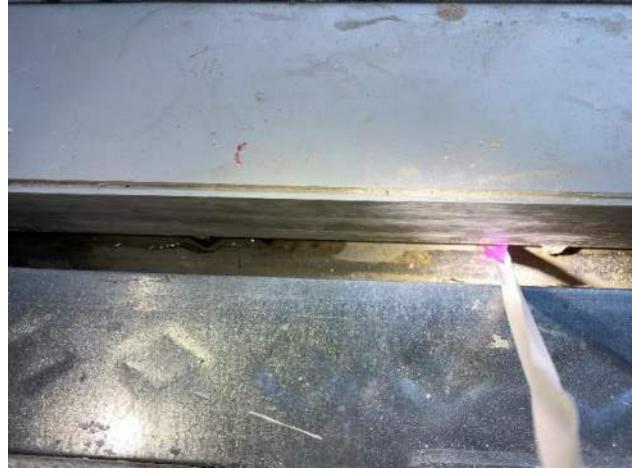
<b>Specimen</b>	Specimen 12	<b>Date</b>	9.23.2021
<b>Test Standard</b>	AAMA 501.2	<b>Time</b>	2:20 PM
<b>Wand</b>	Wand 3	<b>Wind Speed</b>	CALM
<b>System Leak</b>	No Infiltration		
<b>Perimeter Leak</b>	L1 5 <sup>th</sup> Cycle		
<b>Test Result</b>	<b>FAILURE</b>		
<b>Description:</b>	<p>A visual examination was performed and no modifications or pertinent observations were observed with the exterior, cladding, or interior.</p> <p>Testing was performed in 5 ft or less sections, passing the wand across the intersection as prescribed in AAMA 501.2 at 1 min/ft. Testing commenced from bottom to top. During testing of specimen 12, water infiltration was observed within the sill pan which was not being managed out through the weeps.</p>

<b>10</b>	<b>General Photo</b> <b>9.23.2021</b>	
	Water infiltration observed at specimen 12.
