# Stream Habitat Fragmentation Caused by Road Networks in Spanish Low-order Forest Catchments

**Jorge García Molinos**

School of Natural Sciences, Department of Zoology  
Trinity College, Dublin 2, Ireland

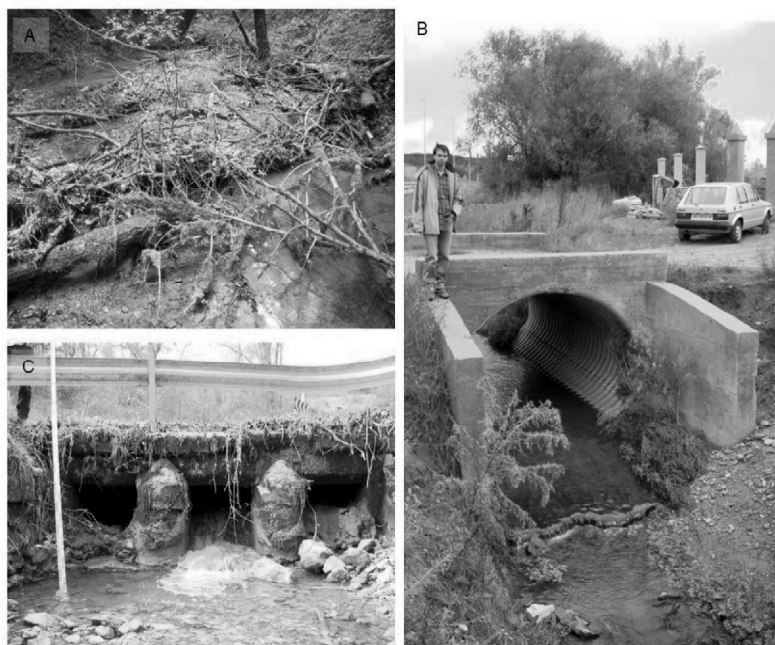
Stream barriers commonly occur when culverts are used instead of bridges (Warren and Pardew, 1998; Benton et al., 2008). This is common in forest roads because culverts are more cost-effective (Gibson et al., 2005). Hydraulic efficiency and road protection guide normal culvert design criteria (Norman et al., 2001). However, culverts based purely on engineering criteria can severely impair stream ecosystems by blocking the passage of aquatic organisms and altering or limiting important stream processes such as the movement of sediment, woody debris, organic carbon and nutrients (Bates et al., 2003; Bates et al., 2008). Poorly designed culverts are typically narrower than the width of the natural channel, have a skewed alignment with the stream, are improperly graded or present steep slopes and smooth interior surfaces to increase drainage capacity (Fig. 1). Undersized and poorly aligned

**Fig. 1.** Examples of common culvert barriers (photos J. García Molinos): (A) large volumes of sediment and debris accumulated upstream of an undersized culvert, (B) poorly graded corrugated pipe culvert creating a depth barrier, and (C) multi-box culvert with perched outlet.

culverts are often responsible for abrupt stream-to-culvert transitions. Depending on flow conditions, this can create excessive flow velocities and turbulence at the culvert entrance or obstruct the flow producing a backwater effect that favours the deposition of sediment and woody debris. Poorly graded culverts, steep slopes and smooth surfaces create problems related to the hydraulic conditions (velocity and depth) inside the culvert barrel. A very common related issue is downstream streambed scouring resulting in culverts with perched outlets.
