केस स्टडी / CASE STUDY

OISD/CS/2024-25/MOLPG/10

Title: Major accident during activity of putting soap solution to the chain conveyer soap tray.

Location: LPG Bottling Plant

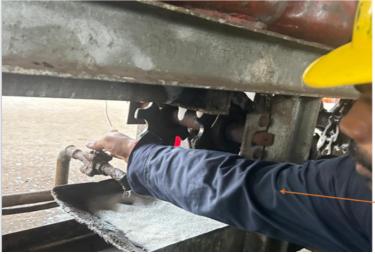
Hand Gloves Used

This hand gloves used

- 4 Behaviour based safety culture to be implemented.
- 7. Suitable hand gloves should be used so that loose open ends can be avoided.
- 8. Normalization of deviation if any to be noticed and reported as unsafe act and unsafe condition.
