# Remedial Engineering Report

**Remedial Engineering Report #1 at  
17a Fort Street, Petersham NSW 2049  
Strata Plan Number 17078**

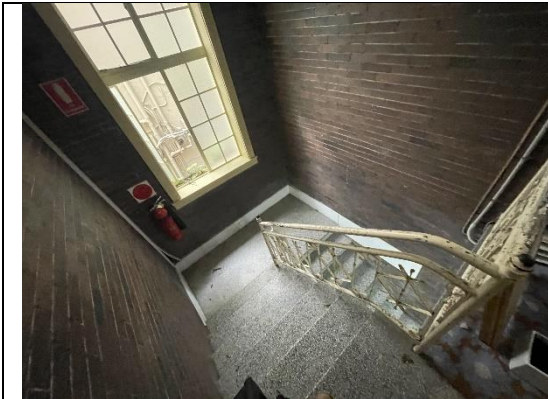
- The entry to the units is via a common entry staircase with terrazzo treads and steel balustrade (refer to photo 1).
- Evidence of internal water penetration in the form of localised water staining and flaked paint to the ceiling, walls and cornice of the common staircase area (refer to photos 2, 3 and 4).

Photo 1 General view of common entry stairs

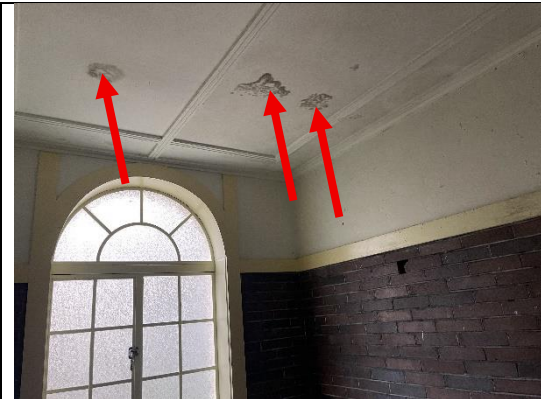
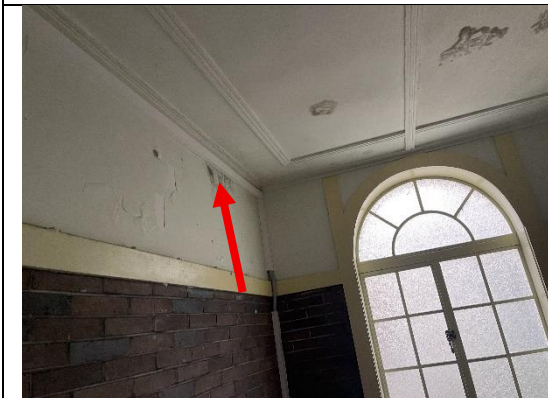
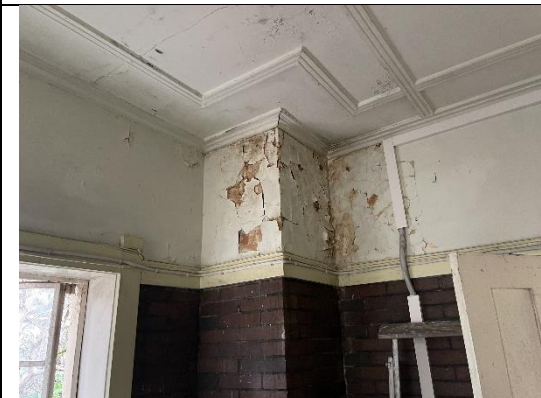
Photo 2 Water staining to the ceiling

Photo 3 Water staining to the cornice

Photo 4 Flaking paint and water staining to upper common stair walls

We note that evidence of water ingress was observed into the common staircase in the form of water staining and flaking paint. This may be the result of water pathing through corroded fixings or cracks to the façade. Given the location, this may be from either the façade or the roof above. We provide further comment in Section 4.2 above.

Additionally, we recommend conducting water testing of the roof and the façade to confirm the source of water ingress to the common internal stairwell.

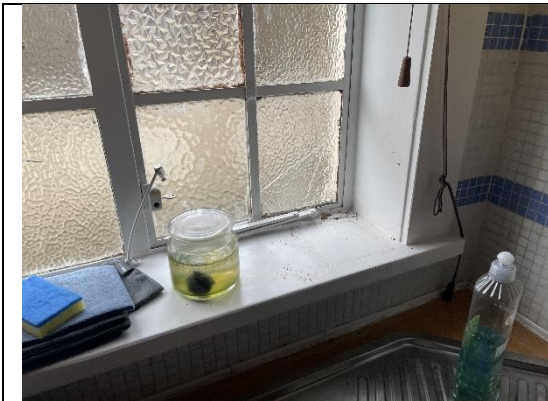
- Unit 3 appeared to be in largely good condition with the internal finishes being recently painted.
- Cracking was observed to the kitchen window glazing (refer to photo 5)
- Deterioration of the windows was observed externally with flaking/missing paint, corroded fixings and separation of timber frame elements (refer to photos 6, 7 and 8).

Photo 5 Crack to kitchen window glazing

Additionally, given the observed cracking to the Unit 3 kitchen window and the windows age, the windows are likely not tempered and therefore not up to modern safety requirements. Whilst retrospective replacement is not required, where the glazing has cracked the owners should consider replacement with a modern system including modern safety glass.

Accordingly, we recommend replacement of any existing timber framed windows which have cracked glazing or rotted timber elements. We would recommend they be replaced with modern powder-coated aluminium windows which meet the current NCC and Australian Standards. We recommend these windows be installed with glazing compliant with modern standards which will provide superior safety, thermal and acoustic properties.

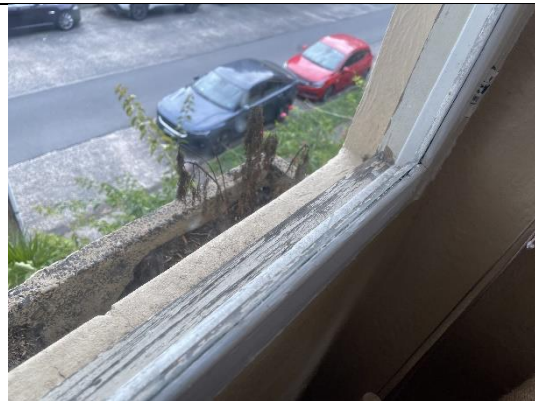
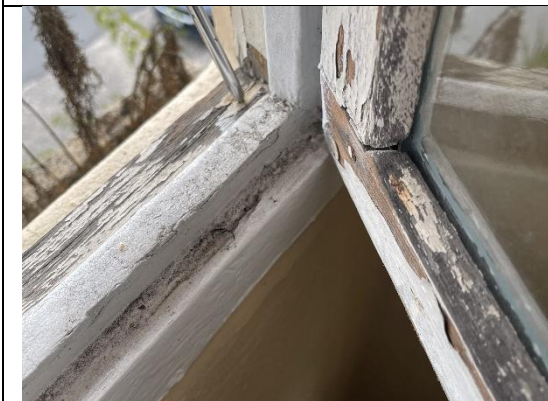
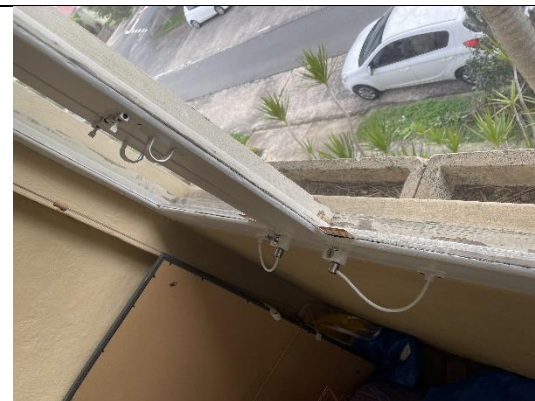
Photo 6 Deteriorated to sunroom windows

Photo 7 Deteriorated to sunroom windows

Photo 8 Deteriorated to sunroom windows

Further, timber windows rely on paint coatings to prevent degradation. Where the paint coating has not been maintained, dilapidation such as the observed flaking paint, rot and fixing corrosion is accelerated. Regular maintenance of windows should be included within the buildings' Capital Works Plan as maintenance of the windows prevents costly replacement.

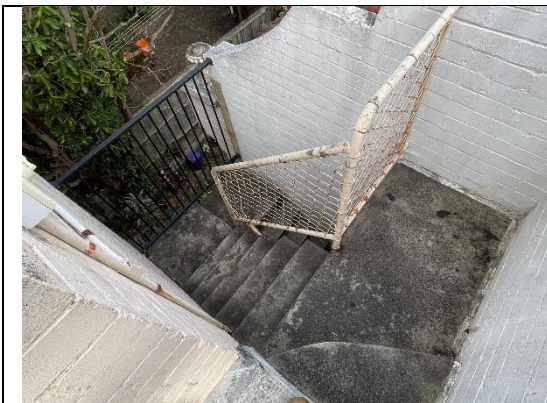
- The fire stairs to the rear of the property are of concrete construction and feature two balustrades being what appears to be original steel balustrading constructed of steel pipe infilled with steel wire weave and newer powder-coated balustrades.
- Multiple instances of concrete spalling were observed to the soffit of the staircase.
- Evidence of further concrete spalling to the level 1 common door in the form of cracking to concrete lintel.
- The steel pipe balustrading features heavily corroding to all elements including the steel wire, steel piping and the fixings.
- There are multiple instances of the steel pipe adjacent the façade with corrosion pitting. This is likely the result of non-compatible original fixings accelerating corrosion as the pitting is adjacent what appears to be newer fixings.

Photo 9 General view of the fire stair

Photo 10 General view of the fire stair

Typically, we would recommend concrete spalling repairs and the replacement of the balustrade. Further, the concrete should be protected with a suitable waterproof membrane.

We understand that the owners have considered replacement of the staircase with a new concrete or a prefabricated steel staircase. We expect that the construction of a new staircase would present more value for money in the long term.

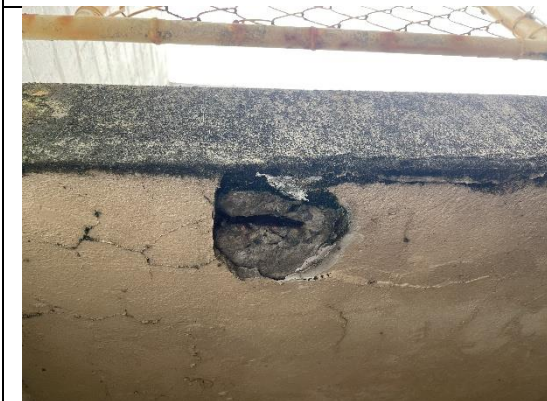
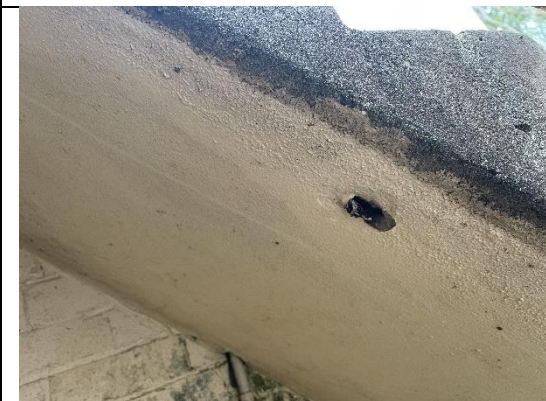
Photo 11 Concrete spalling to staircase soffit

Photo 12 Concrete spalling to staircase soffit

Concrete spalling was observed to the soffit of the staircase and evidence of concrete spalling was observed to the concrete door lintel in the form of cracking.

Concrete spalling is the deterioration of reinforced concrete elements, where sections of the concrete surface crack, delaminate, and ultimately detach from the structure. This process typically occurs as a result of corrosion of the embedded steel reinforcement, which is most commonly caused by prolonged exposure to moisture and oxygen penetrating through the concrete cover. As steel reinforcement corrodes, it expands in volume. This expansion leads to cracking, delamination and spalling of the concrete. Please see below diagram from HB84:2018 Guide to Concrete Repair and Protection (HB84) for a diagram of this occurrence.

With continuous exposure to moisture and the environment, the steel balustrade, fixings, steel reinforcement and concrete will continue to deteriorate, reducing the structural integrity of these elements. This poses a significant risk to the building's stability and safety of its occupants in the long term if not addressed promptly. Further, remediation costs will increase over time.

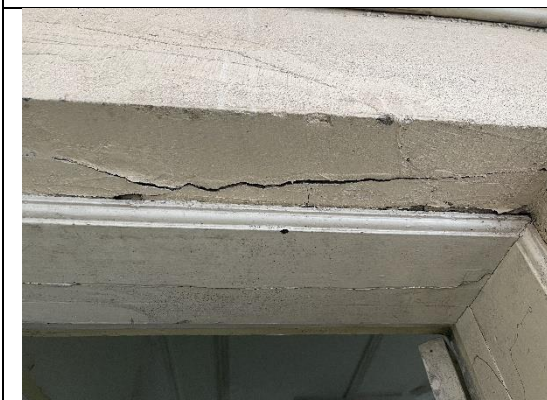
Photo 13 Cracking to level 1 concrete lintel

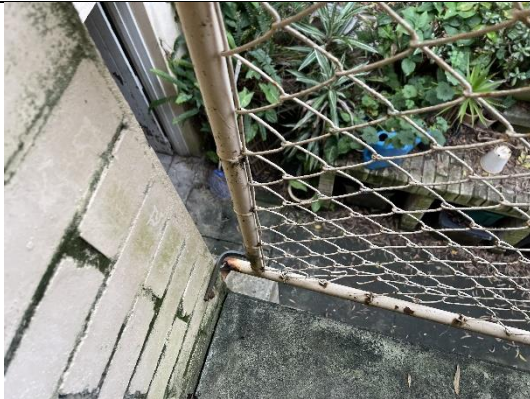
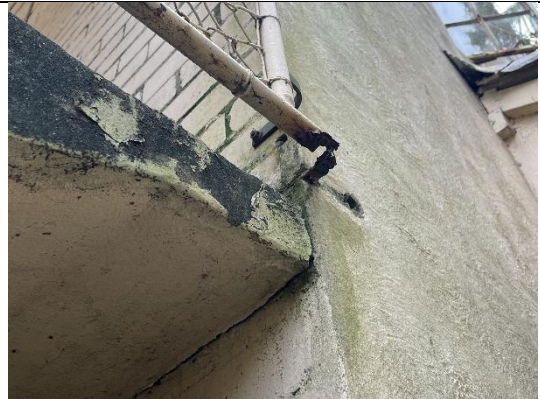
Photo 14 Corrosion to steel pipe balustrade toprail

Photo 15 Corrosion to multiple steel balustrade elements

Photo 16 Corrosion pitting to the end of the steel balustrade bottom rail

Additionally, corrosion was observed to the steel pipe balustrade which has pitted the steel pipe completely through. It appears that attempted repairs have been undertaken in the form of additional fixings to attempt to maintain the balustrade integrity.

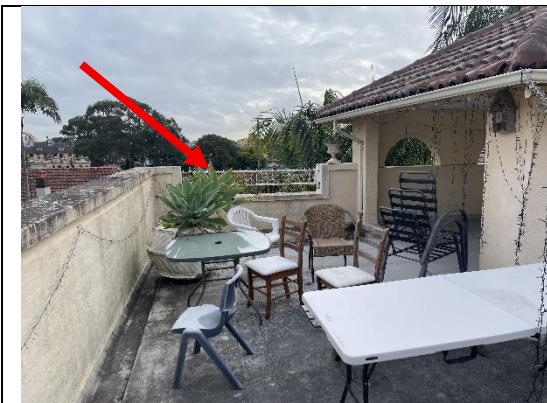
- The roof features brick masonry balustrades a twisted steel spindle segment (refer to photo 17).
- The existing drainage is not acting in service with ponding to multiple locations and evidence of ponding to various other locations (refer to photos 18, 19 and 20).

Photo 17 General view of roof with twisted steel spindle section.

We also note that unreinforced masonry balustrades do not meet the current lateral loading requirements as per *AS1170.1:2002 'Structural Design Actions Part 1: Permanent, imposed and other actions'*. Further, the observed northern parapet balustrades twisted steel spindles do not meet the minimum requirements of the *NCC*, which stipulates that any horizontal element within the barrier between 150 mm and 760 mm above the finished floor level must not facilitate climbing, for a floor more than 4000mm above the surface beneath.

Additionally, whilst retrospective replacement of the balustrade is not necessary, if any remedial works affect the integrity of the masonry balustrade, provision will need to be made to ensure that the balustrades are compliant with *AS1170.1* and the *NCC*.

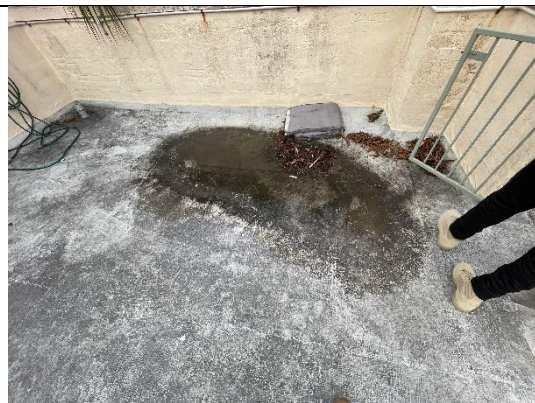
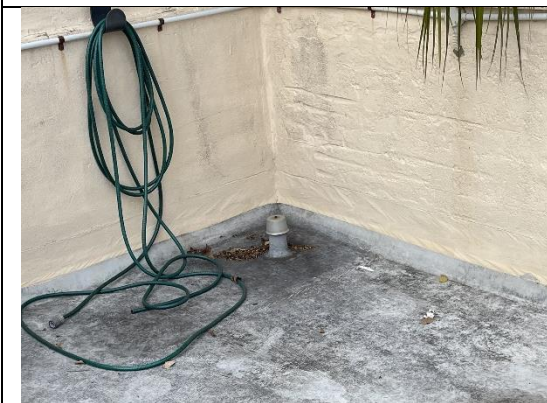
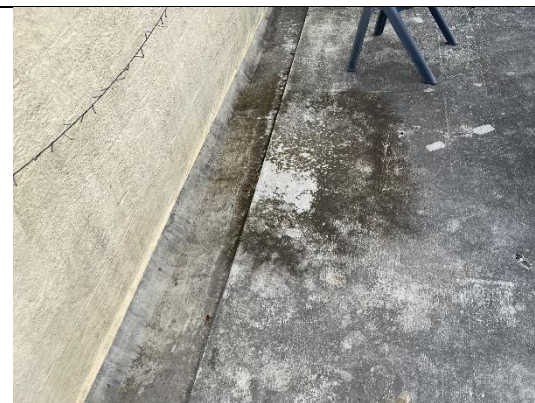
Photo 18 Ponding water above common staircase

Photo 19 Ponding water above common staircase

Photo 20 Evidence of water ponding

All roofs are required to feature falls that adequately drain water. There are multiple instances of ponding water and therefore the existing drainage to the flat roof area is not acting in service. This ponding presents a slip hazard to the common roof area. Further, waterproof membranes are not typically designed to remain submerged. The observed evidence of water ingress to the common stairwell is likely the result of ponding water pathing through a failure in the rooftop membrane or façade coating.

We recommend the owners consider replacement of the roof waterproof membrane. Whilst no water ingress was observed to habitable areas, it is clear that the membrane is nearing the service life with failing details and a lack of falls. As part of these works, we recommend removal of redundant services, replacement of corroded fixings and correction of falls.

We note that the changes to building legislation from the Design and Building Practitioners Act prevent localisation repairs being a consideration. Accordingly, where rectification of falls and waterproof membrane repair is required, the full system is required to be remediated. Further, the new waterproofing system will need to be designed by a registered design engineer with a comprehensive scope of works and DBPA designs to ensure compliance with current codes and standards.

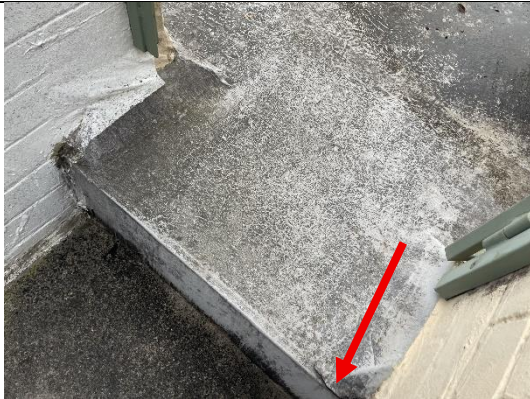
- An instance of cracking to the edge of the membrane (refer to photo 21).
- Corroded fixings were observed to the brick parapet (refer to photo 22).
- Leaf litter collected within the drainage outlet (refer to photo 23).

Photo 21 Deteriorated waterproof membrane with cracking

During our inspection, we observed cracking to the nosing of the rooftop membrane at the entrance of the rooftop. This would result in water pathing through the substrate and into the building.

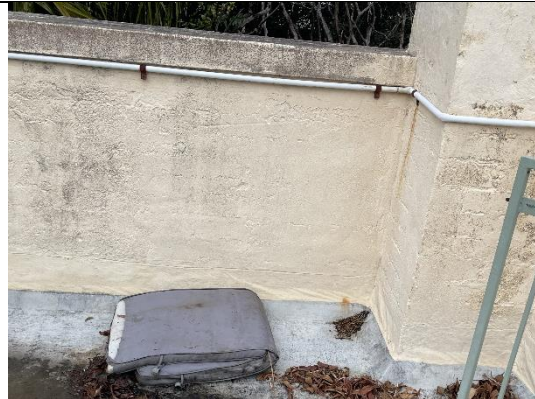
Photo 22 Brick parapet with corroded fixings

- Miscellaneous render repairs including to the western façade and to where fixings have deteriorated.
- Replacement of all corroded fixings (noting some may be fixed to redundant services)

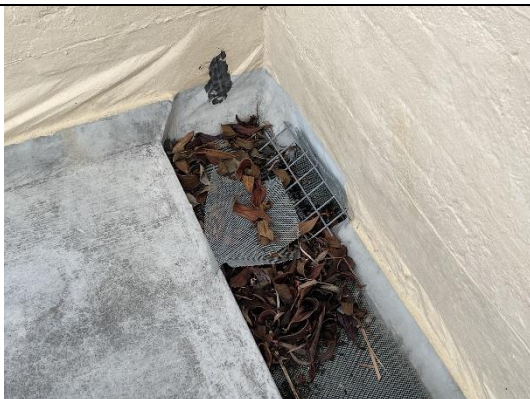
Photo 23 Leaf litter filling outlet

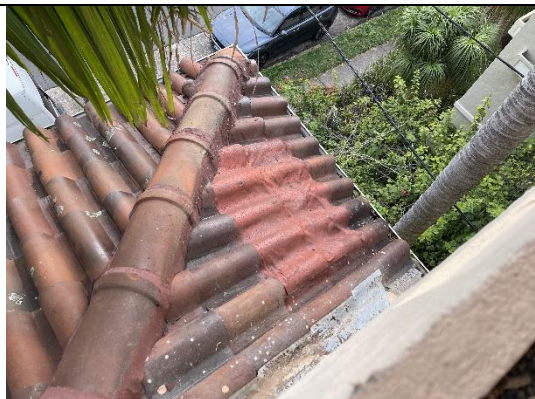
- Patch repair to the pent roof above Unit 3 sunroom (refer to photo 24).

Photo 24 Patch repairs to the pent roof above Unit 3 sunroom

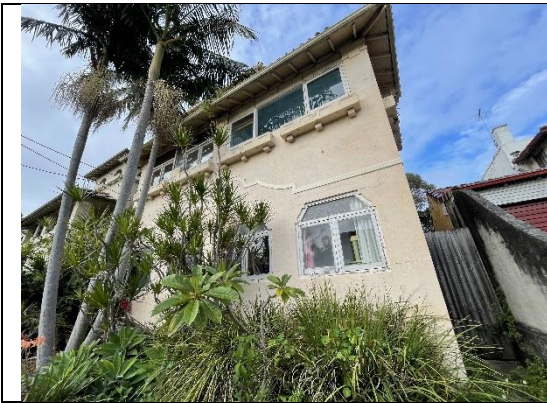
- The building façade is largely rendered and painted and features timber windows and multiple small ledges and planterboxes.
- There is an instance of missing render behind the northern-most downpipe of the western façade (refer to photo 26).
- The façade features what appears to be several redundant services (particularly to the eastern façade) which are pitted and not visibly routed to any location (refer to photo 27).
- The windows to the façade are largely in a deteriorated condition with various instances of flaking paint, rot and corrosion (refer to photos 28, 29, 30 and 31).
- There is step cracking to the head of the door to the common laundry (refer to photo 32).

Photo 25 General view of render and painted façade

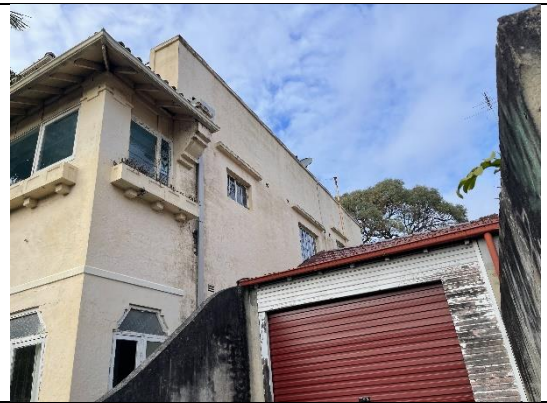
Photo 26 Missing render to western façade

Further, given the location of the missing render observed to the western façade, it is likely contributing to water ingress into Unit 4. We note that access was not granted to Unit 4 at the time of the inspection.

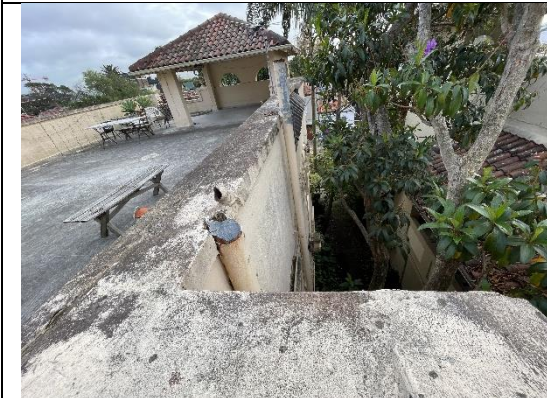
Photo 27 Redundant services to the eastern façade

We note that whilst onsite we observed multiple services to the façade appear redundant. Various pipes were rusted through or were not routed into the building. Should the owners wish to remove any redundant pipework, a plumber will be able to test and confirm serviceability of all plumbing and remove redundant pipework.

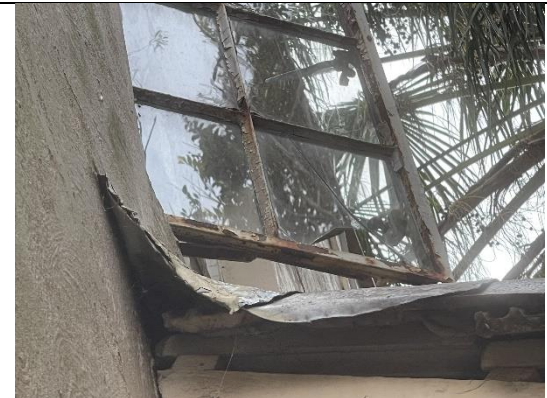
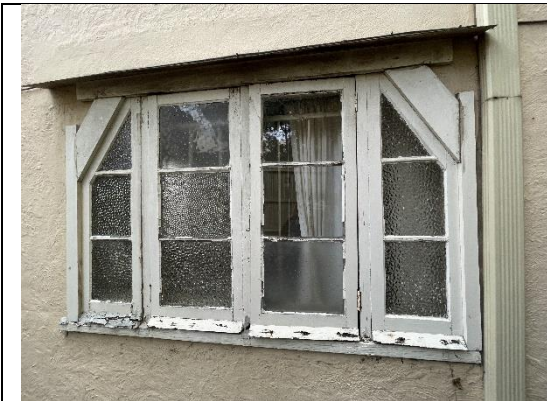
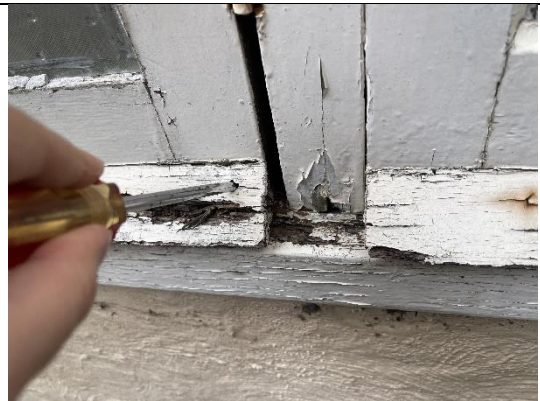
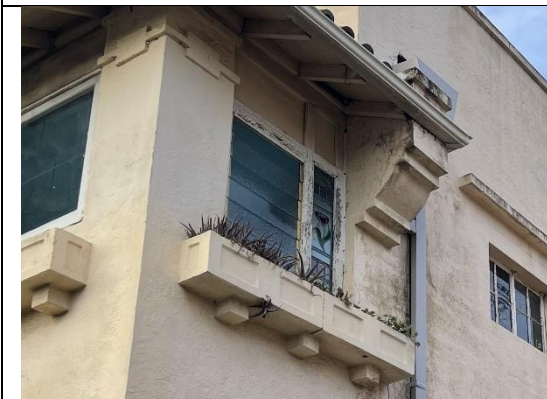
Photo 28 Flaking paint and corrosion staining to southern window

Photo 29 Rot and flaking paint to southern window

Photo 30 Rot to southern window

Photo 31 Flaking paint to Unit 4 sunroom window

The owners may also consider replacement of all windows with modern powder-coated aluminium. Given the condition of the paint coating, the timber construction and the glazing, this would upgrade the building to be safer, easier to maintain, and superior thermally and acoustically.

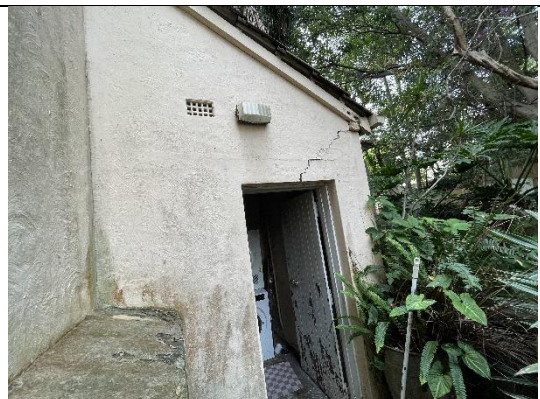
Photo 32 Step cracking to common laundry lintel

- Missing render to western façade (refer to photo 26)
- Step-cracking to the head of the common laundry door. Given the location of the step-cracking we expect this is the result of subsidence. We recommend further monitoring for progression of cracking (refer to photo 32)
- Rusted fixings to services (refer to photo 22)
- Hole in southern façade (refer to photo 16)

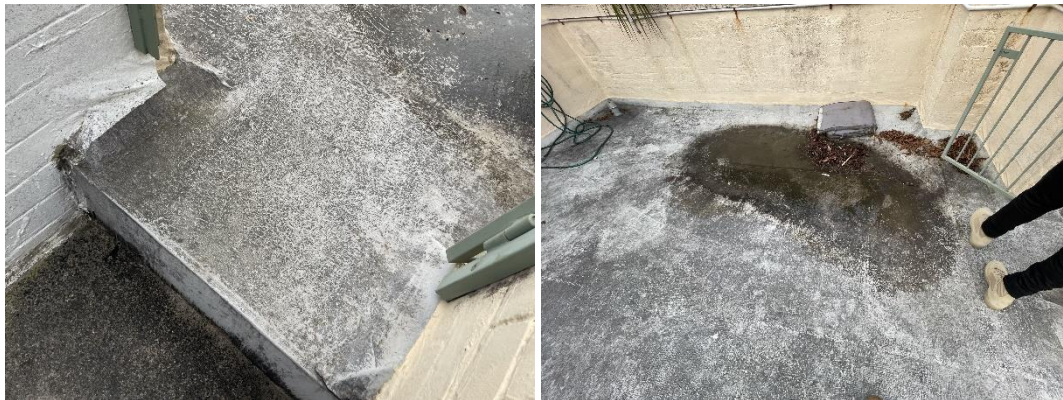
*Left: Cracking to the roof waterproof membrane.  
Right: Water ponding to the roof.*
