# Umalwad Rural Water Supply Scheme Village: Umalwad, Taluka: Shirol,

**District: Kolhapur**

# **Third Party Assessment Report**

March 2023

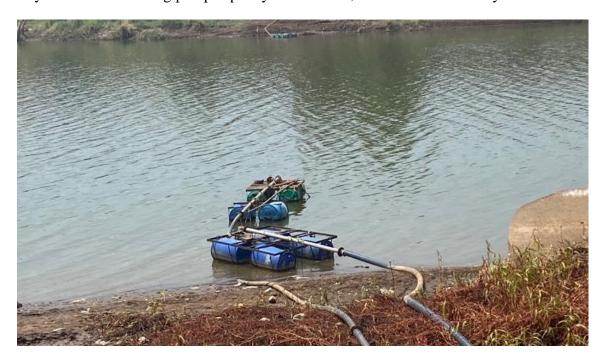
As per DPR, the provision of pumping machinery was made on the field. The 2 Pumping machinery are installed having pump capacity is of 15 HP, hence it is satisfactory.

Figure 3: Float and Pumping machinery

As per DPR, the provision of float and pumping machinery was made on the bank of Warana river. The 2 Pumping machinery are installed having pump capacity is of 15 HP, hence it is satisfactory.

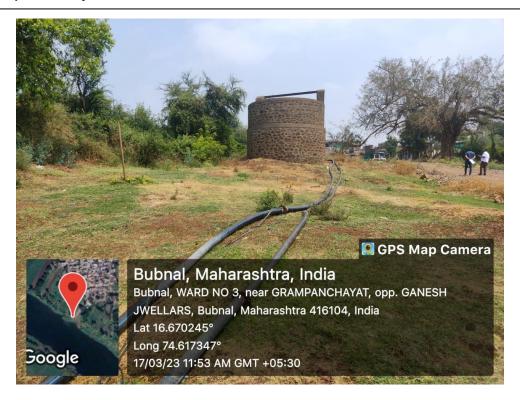
The laying of rising main is completed. The implemented raw water rising main is 140mm @  $(6 \text{ kg/cm}^2)$  of length 7250m & pure water rising main @  $(6 \text{ kg/cm}^2)$  of length 850m . Also there are 02, 32mm dia Air Valve and 01 Non-Return Valve was verified during field visit.

Figure 5: Rising Main

The continuous maintenance problem of rising main is resolved in the new scheme by replacing GI material with HDPE material of pipes. The same is verified and found satisfactory in the village.
