# Agricultural Innovation Submission 89

## Re: ASI submission to Building Ministers Forum (BMF) Committee

## **Australian Steel Institute submission**

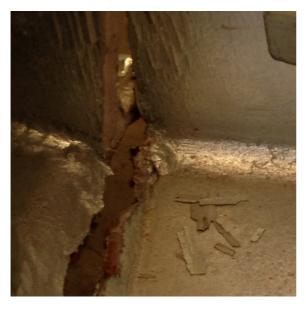
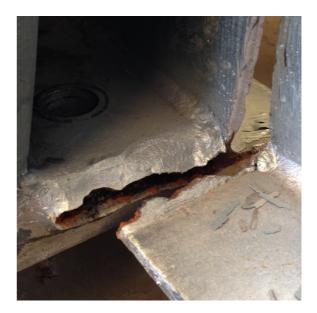
# **Quality problems with imported steel fabrication for the Brisbane City Council (BCC) Ferry Terminals**

- Poor workmanship on the steelwork fabrication
- · Failures on the steelwork in particular welding
