## Analysis Report

| Plant Name | Essens Renewable Pvt Ltd | | |
| Inverter SN | I23B1700303 | | |

The inverter model SG3125HV-32 was tripping due to AC overvoltage.

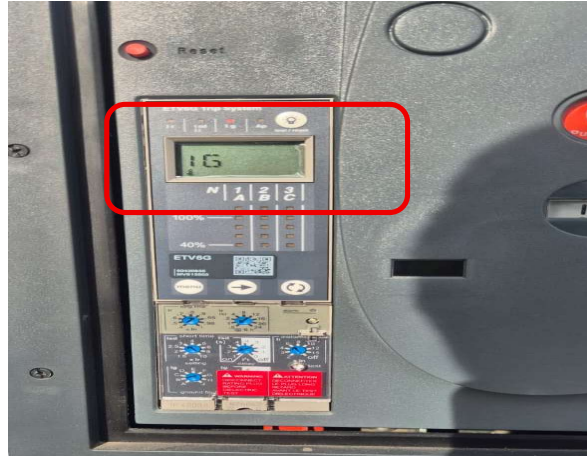
Fig: ACB tripped image

7. Based on the analysis of the ACB and inverter event records, the ACB was observed to trip initially on Ig (ground-fault) protection, indicating the detection of abnormal residual/ground-fault current in the AC circuit. Subsequently, the inverter recorded abnormal grid conditions, including a frequency drop to approximately 46.1 Hz and a transient AC overvoltage, with the maximum line-to-line voltage reaching approximately 978.5 V. The inverter then tripped on abnormal-frequency and AC-overvoltage protection.

8. The event sequence indicates that the ground-fault condition and subsequent ACB Ig operation preceded the inverter protection trips. Therefore, the inverter abnormal-frequency and AC-overvoltage faults are considered consequential responses to the AC-side disturbance following the ACB operation, rather than the initiating cause of the event.

9. Accordingly, the primary cause of the incident is considered to be an abnormal AC-side ground-fault condition that resulted in ACB Ig protection operation and subsequent disturbance of the inverter AC supply. Further investigation of the AC cables, cable terminations, transformers, switchgear and grounding system is recommended to identify the exact source of the ground fault.

Further verification of the AC cables, terminations, transformers, grounding system, ACB operation and upstream grid/measurement records is recommended to identify the exact source of the initial ground-fault condition and associated voltage disturbance.
