# 64 Carbon - Technical Monitoring Report

29 May 2025

10 Una place  
Huddersfield  
HD2 2BQ

B1 - Cavity Wall Insulation

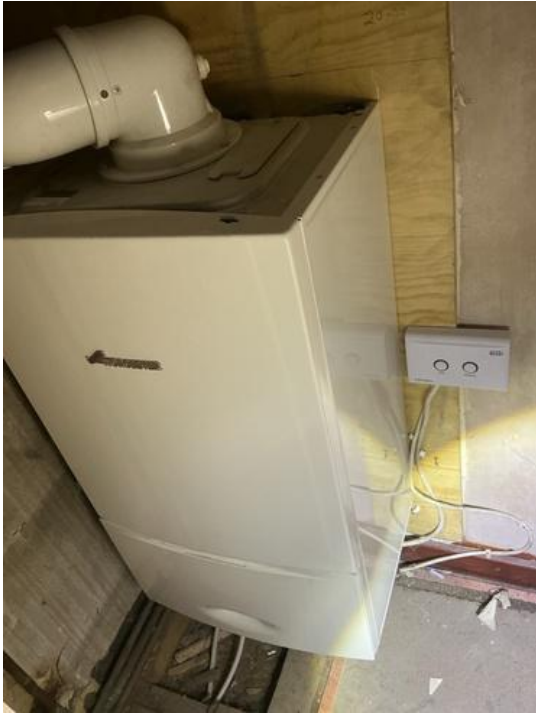
Photo 1

Combi boiler

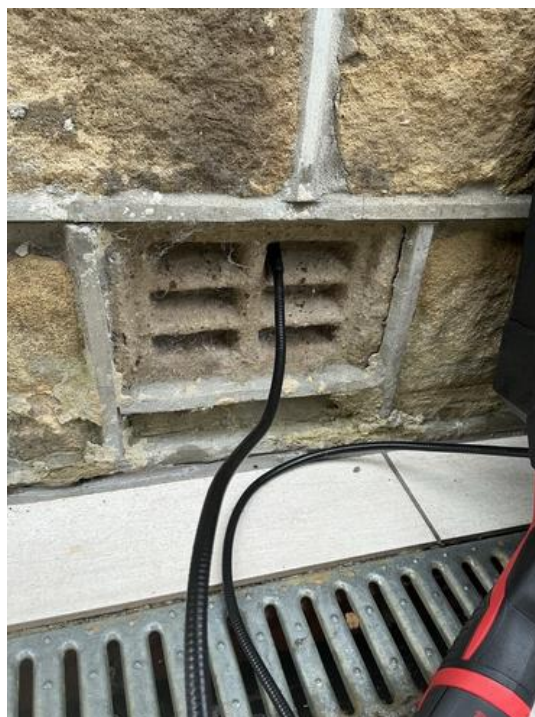
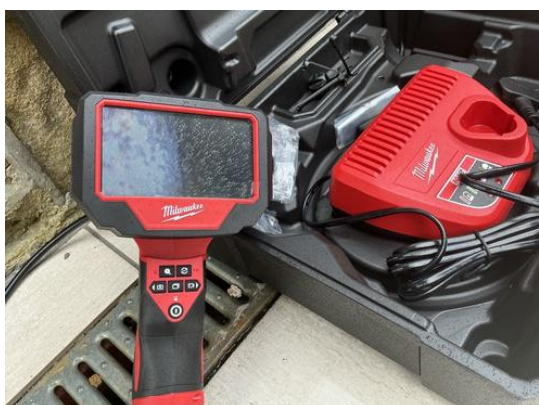
**CWI 6 - Have all vents been safeguarded and have redundant vents been sealed?**

Fail

Floors not sleeved and showin insulation

Floors not sleeved and full of insulation

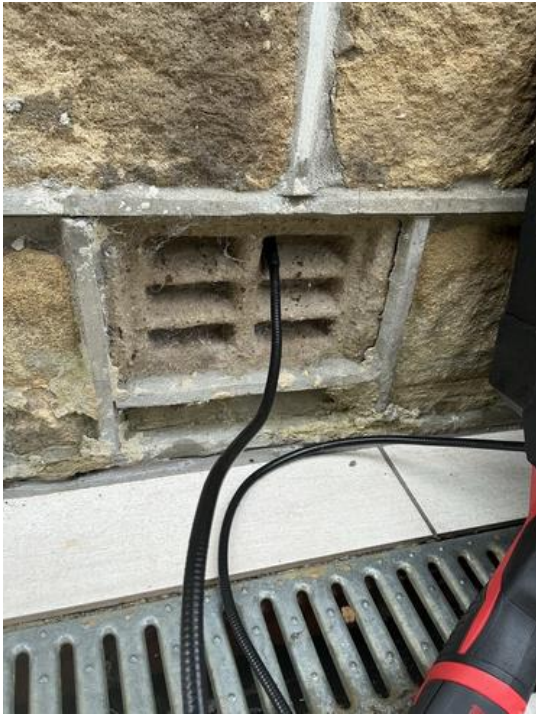
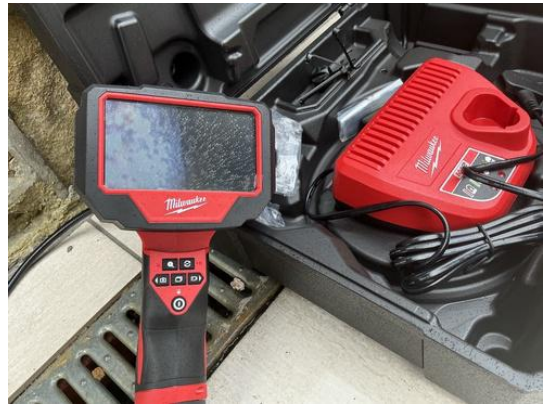
**HSCWI 3 - Are all the air bricks and eaves vents clear of insulation material and sleeves installed where appropriate?V**

No

Air bricks not sleeved

Vents not sleeved
