System safety in rail: The ATSB investigation into the 2018 Devonport cement train

runaway and derailment

Australian System Safety Conference (ASSC) 2024 Brisbane, Queensland

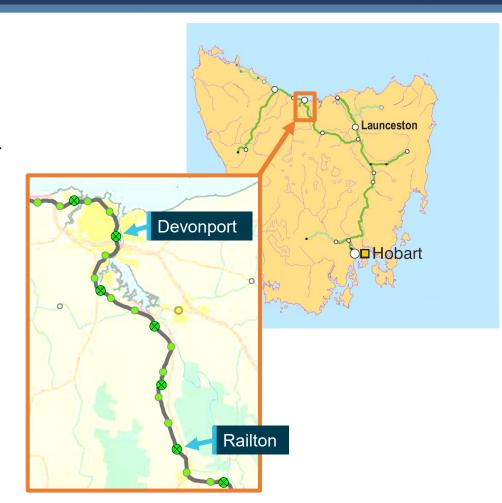
- Train ran onto the main line and gathered speed
- Speeds mostly higher than the maximum track speed at each point – up to 87.5 km/h
- Continued for about 20 km
 - through several populated areas
 - through 13 public level crossings (10 active and 3 passive)
 - beneath a highway overpass
- Operator alerted police, who blocked major level crossings from public access
- No collisions

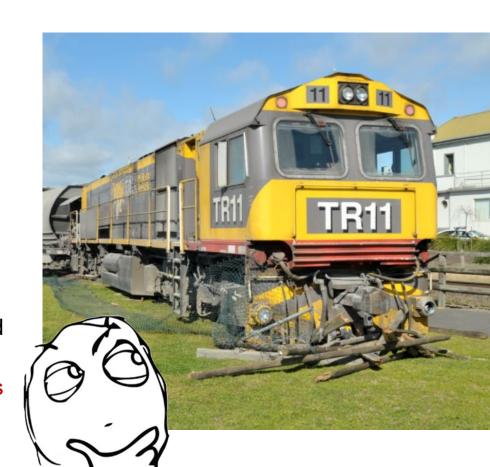
- Remote control equipment was designed with multiple safety features
- Had been used for 19 years with no accidents attributable to the equipment
- Remote control equipment had recently undergone a near-total redesign using new hardware and software
- Design team of two people (one did the hardware design, manufacture, and customer liaison work, the other designed the software)
- Large number of "minor" in-service issues after the latest version was introduced
