## Investigation Report

Published: February 2026

The October 10, 2024, fatal hydrogen sulfide release at the  
PEMEX Deer Park Refinery fatally injured two people:

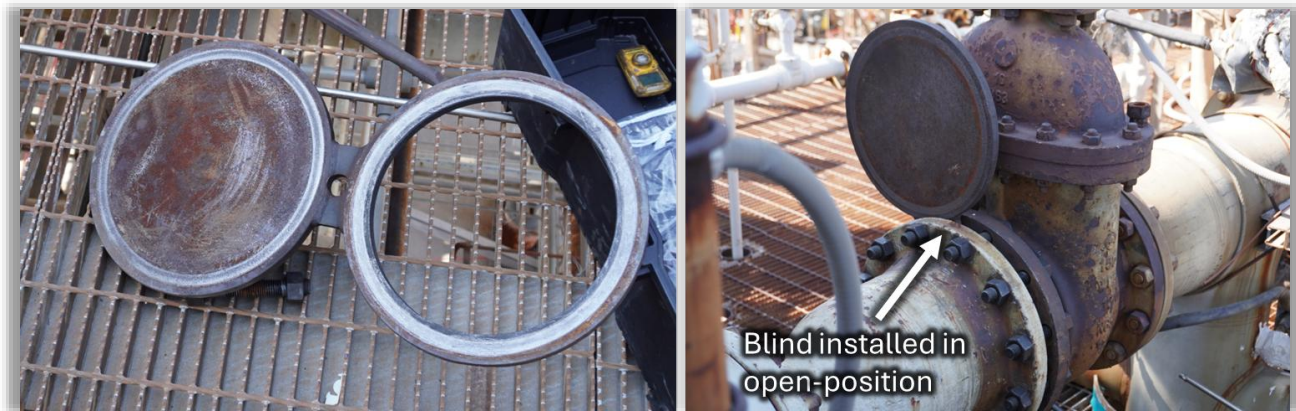
**Figure 4.** A “figure-eight” or “spectacle” blind used to isolate piping in the Amine Unit.<sup>a</sup> (Credit: CSB)

<sup>a</sup> “Figure-eight” or “spectacle” blinds (**Figure 4**) can be rotated, or “rolled,” from the isolated (closed) position to an open position, which does not require removal of the blind from the piping. **Figure 4** (right) shows an example of a spectacle blind installed in the open position.

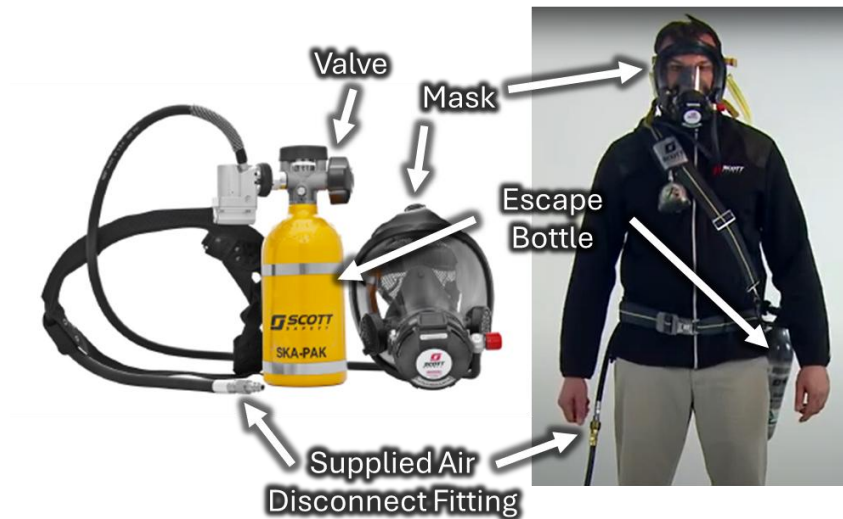
**Figure 5.** Supplied air respirator system. The Repcon boilermakers had the escape bottle shown on the left of the figure. (Credit: 3M [13, 14])

Before beginning work to remove the final two blinds, the Repcon boilermakers obtained supplied-air respirators and escape bottles from Code Red (**Figure 5**). Two of the boilermakers went to a blind location elsewhere in the unit. The remaining two boilermakers climbed to a fixed, elevated platform to begin work at the Blind 407 location. The Repcon foreman accompanied the boilermakers to the Blind 407 location to provide instructions. The foreman then left to locate a contractor from another company to serve as the “bottle watch,” the person responsible for monitoring the supplied air tanks connected to the boilermakers’ respirators, among other responsibilities. Once the foreman returned with the bottle watch, the boilermakers connected their respirators to the supplied-air hoses. The boilermakers then removed their personal hydrogen sulfide gas detectors and placed them on the platform nearby because PEMEX Deer Park’s policy did not require personal gas detectors to be worn while using supplied-air respirators. Despite the permit requiring the PEMEX Deer Park operator to be present for the final line breaks, no operator was present for the Repcon removal of Blind 407.

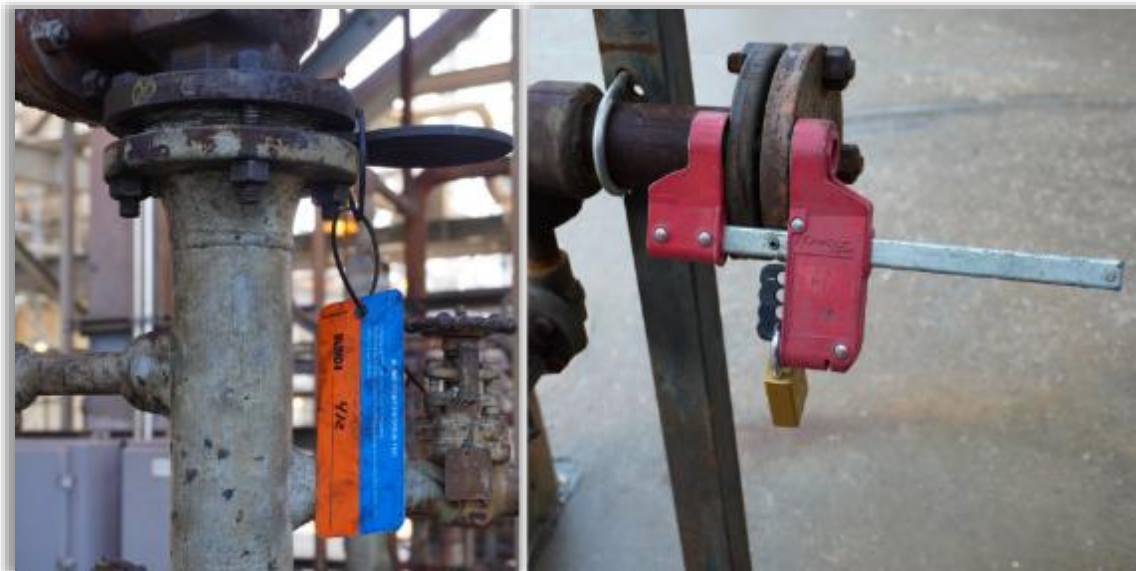
**Figure 7.** Blind tag (left) and flange-locking device (right). (Credit: CSB)

After the boilermakers finished installing a blind, they typically placed an unlocked flange-locking device (Figure 7) on each flange, which was the required practice in the Sulfur Unit turnaround, where they had been working in the days prior. The boilermakers consequently placed unlocked flange-locking devices on the ARU6 equipment. PEMEX Deer Park's procedures did not require the use of flange-locking devices for the ARU6 blind installation activities, however. The Repcon night shift foreman stated to the U.S. Chemical Safety and Hazard Investigation Board (CSB) that they did not witness PEMEX Deer Park operators lock the flange-locking devices after they were placed on ARU6 equipment. The PEMEX Deer Park operator also stated to the CSB that he was not aware that the flange-locking devices had been placed on ARU6 equipment because they were not normally used outside of turnaround activities.

Over the next several hours, the four Repcon boilermakers worked in two pairs, opening flanges and removing blinds from the ARU6 piping. The boilermakers told the CSB that they looked for either the orange-and-blue blind tags or unlocked red flange-locking devices to locate the 15 blinds (**Figure 7**), rather than referencing the blind list or drawing. As will be described in Section 3.1.1, the blind list and drawing did not clearly indicate where each flange to be opened was located.

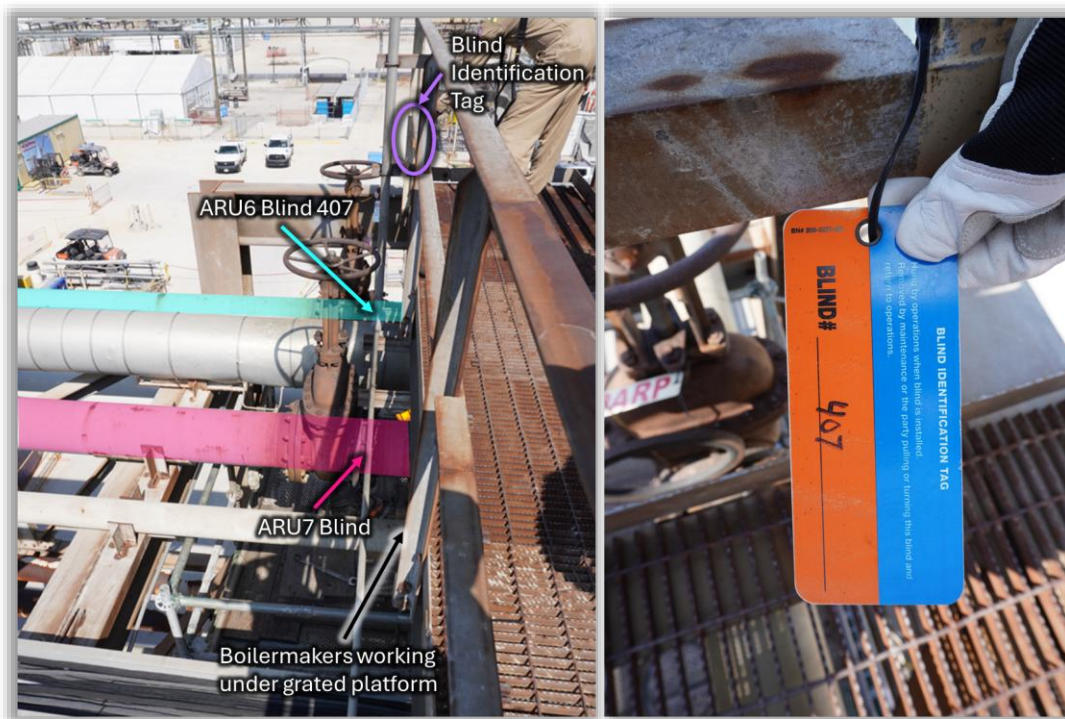
**Figure 8.** ARU6 Blind 407 could not be easily accessed, so operators hung the blind tag on the railing on the platform above the piping. (Credit: CSB)

The two Repcon boilermakers stated to the CSB that they did not see the orange-and-blue Blind 407 tag that had been fastened to the railing above the blind (**Figure 8**). Instead, the boilermakers observed a flange-locking

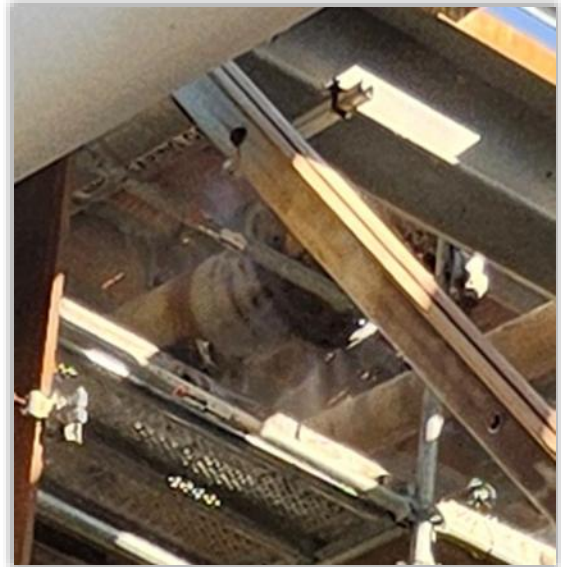
Believing that they were working on Blind 407, the Repcon boilermakers began removing bolts from the ARU7 flange, which was not covered by the work permit. Moments later, hydrogen sulfide began leaking from the flange. Because they were wearing supplied-air respirators and did not have personal hydrogen sulfide gas detectors, the two Repcon boilermakers did not detect the hydrogen sulfide leak by either air monitoring or odor detection. As a result, they continued to loosen and remove bolts from the ARU7 flange.

**Figure 10.** Hydrogen sulfide release from the ARU7 flange. (Credit: PEMEX Deer Park)

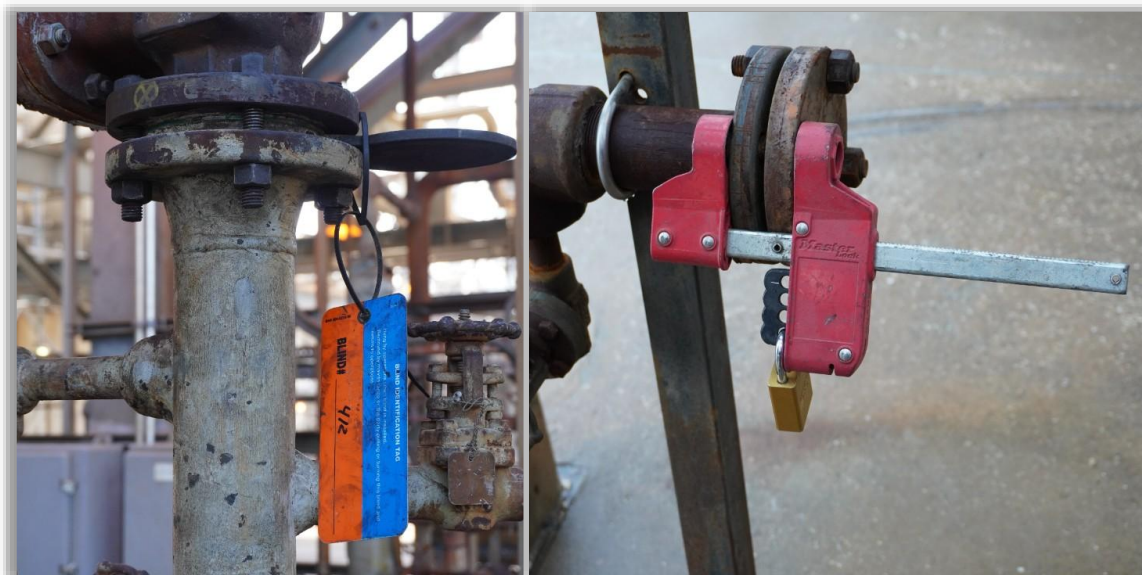
Flange-locking devices (**Figure 14**) were commonly placed on flanges during the Sulfur Unit turnaround to secure a blind installation. PEMEX Deer Park did not instruct Repcon to install these flange-locking devices for the Amine Unit maintenance task, however. Nevertheless, the surviving Repcon boilermakers told the CSB they located the isolation blinds in the Amine Unit primarily by looking for unlocked flange-locking devices because the flange-locking devices were used in the Sulfur Unit. As the Repcon boilermakers removed the blinds, they collected the flange-locking devices, as shown in **Figure 15**. As detailed in Section 2.2, when the boilermakers attempted to locate Blind 407, they found an unlocked flange-locking device on the ARU7 piping, which informed their decision to open the piping, believing it was the location of Blind 407. After the incident, the CSB found the flange-locking device under the ARU7 piping, as shown in **Figure 16**.

**Figure 14.** Blind tag (left) and flange-locking device (right).<sup>a</sup> (Credit: CSB)

<sup>a</sup> The photo of the red flange-locking device was taken in another part of the facility and is displayed here as an example of an installed lock.

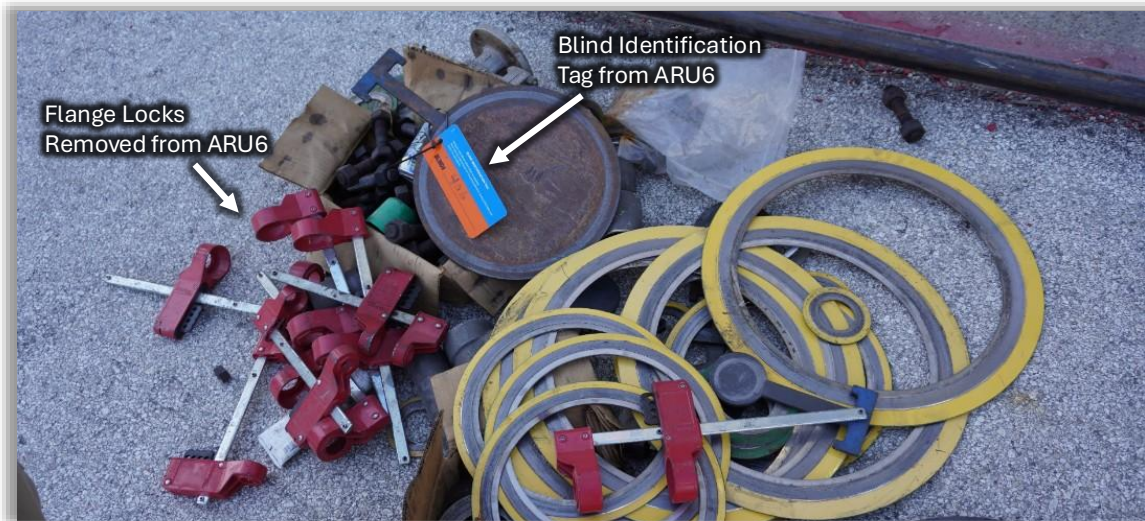
**Figure 15.** Flange-locking devices and blind tag from the ARU6 maintenance activity. (Credit CSB)
