# Detailed Diagnostic Report (DDR)

## 1. PROPERTY ISSUE SUMMARY

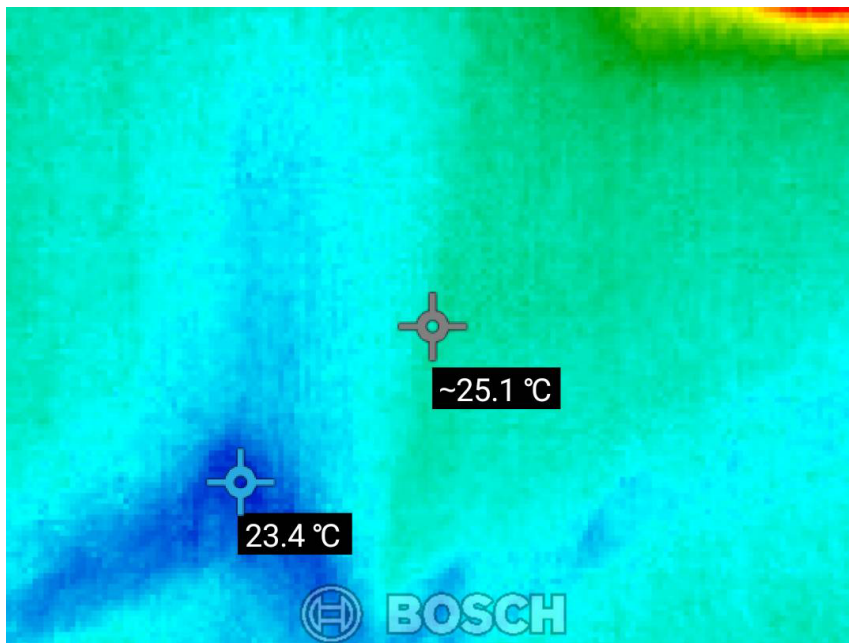
## Parking Area

The Parking area below Flat No. 103 has leakage at the ceiling. The thermal camera readings for this area are not specified, but the presence of leakage suggests a potential water ingress issue.

4. Address the leakage at the Parking ceiling below Flat No. 103.
5. Check and repair any other potential sources of water ingress.
