# Detailed Diagnostic Report (DDR)

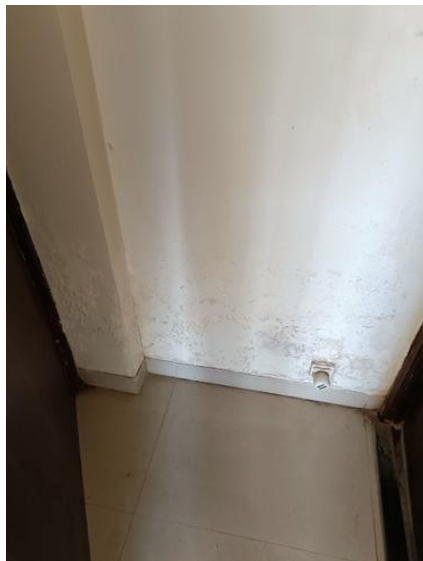
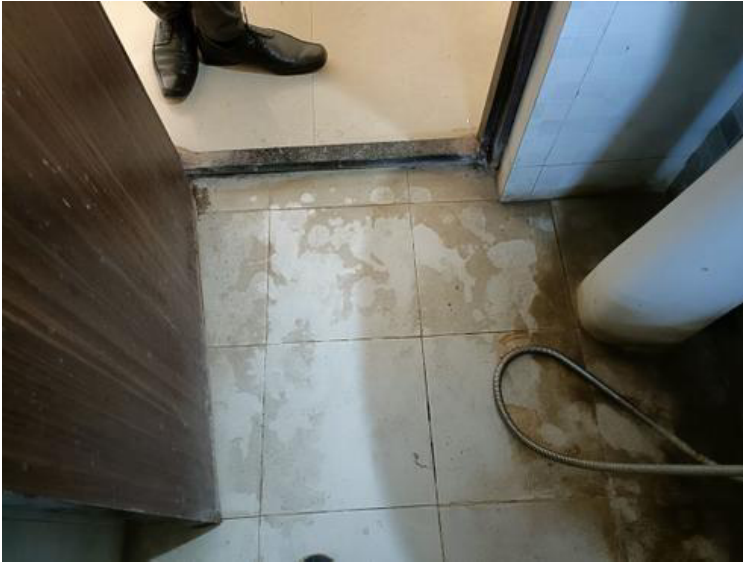
### Hall

The Hall area shows visible symptoms of dampness at the skirting level, indicating moisture accumulation. The thermal camera readings reveal a cold spot with a temperature of 18°C, which suggests localized water cooling. This temperature drop correlates with the moisture trapped inside the wall, causing the dampness. The exact cause of this moisture accumulation is Not Available, but it is likely related to the gaps between tile joints in the adjacent Common Bathroom.

1. Seal the gaps between tile joints in the Common Bathroom and Master Bedroom Bathroom.
2. Repair the cracks on the External wall near the Master Bedroom.
3. Address the plumbing issues and gaps between tile joints in the Common Bathroom.
4. Dry out the affected areas and apply a waterproofing coating.
5. Monitor the property for any further signs of moisture accumulation or damage.
