# Detailed Diagnostic Report (DDR)

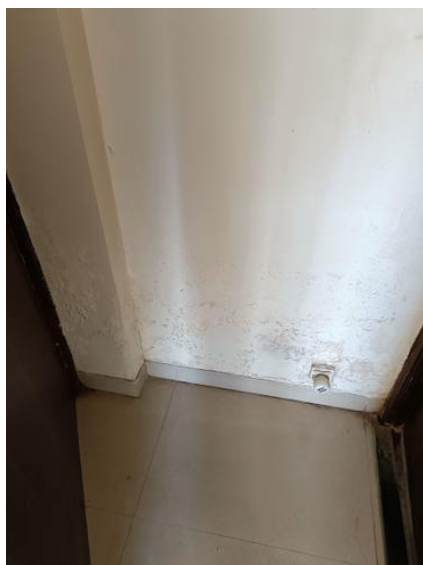
### Hall

The Hall area showed visible symptoms of dampness at the skirting level. The thermal camera readings for this area indicated a hotspot temperature of 27.4°C and a coldspot temperature of 22.4°C. This temperature drop suggests that there is moisture trapped inside the wall, causing the dampness. The moisture is likely entering the wall through gaps or cracks in the exterior of the building.

1. Seal all gaps and cracks in the exterior walls and ceiling to prevent moisture from entering the building.
2. Repair or replace any damaged or deteriorated building components, such as skirting boards and ceiling tiles.
3. Install a waterproofing system to protect the building from external moisture.
4. Improve ventilation in the building to reduce the risk of condensation and moisture buildup.

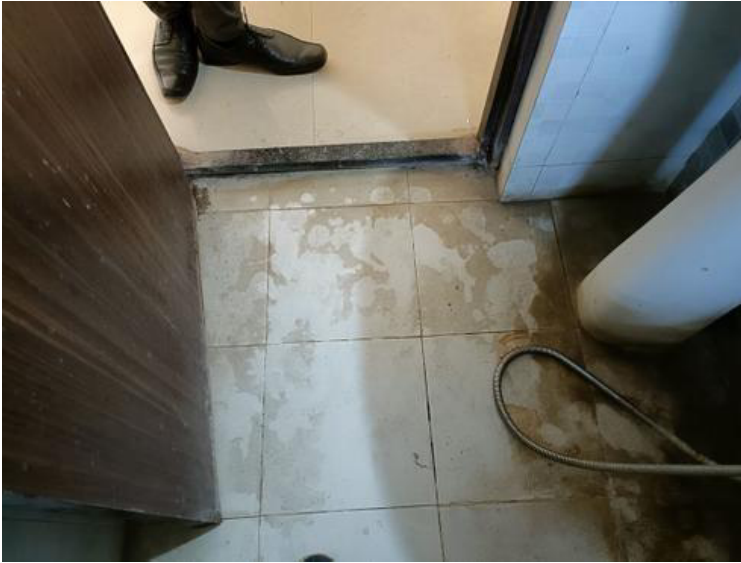
## Bedroom

The Bedroom area also showed signs of dampness at the skirting level. The thermal camera readings for this area indicated a hotspot temperature of 26.5°C and a coldspot temperature of 21.5°C. This temperature difference suggests that there is moisture present in the wall, which is causing the dampness. The source of the moisture is likely a leak or crack in the exterior of the building.

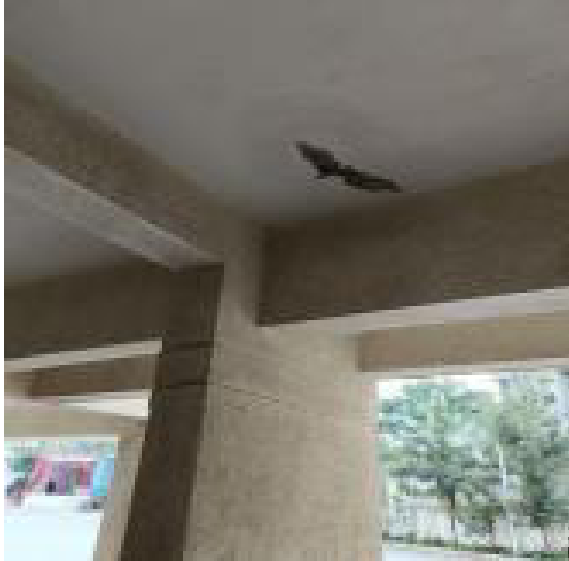
## Master Bedroom

The Master Bedroom area showed dampness at the skirting level, as well as efflorescence on the wall surface. The thermal camera readings for this area indicated a hotspot temperature of 27.3°C and a coldspot temperature of 22.3°C. This temperature difference suggests that there is significant moisture present in the wall, which is causing the dampness and efflorescence. The source of the moisture is likely a leak or crack in the exterior of the building.

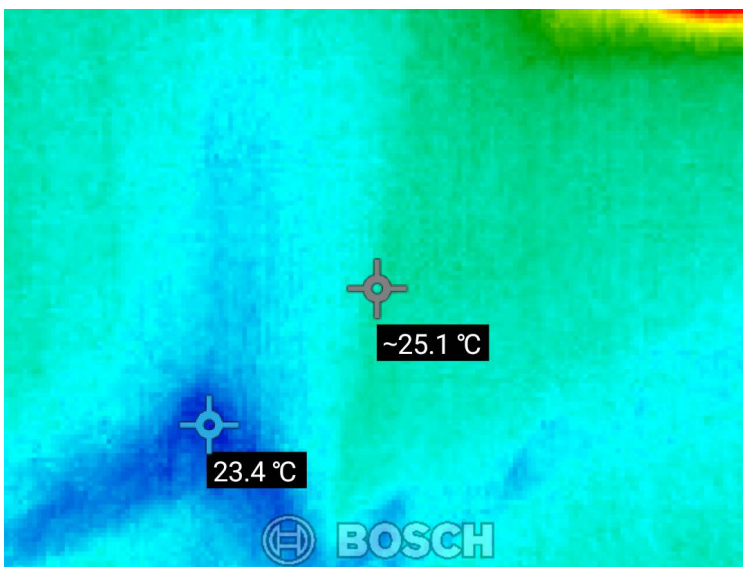
## Common Bathroom

The Common Bathroom area showed ceiling dampness, with thermal camera readings indicating a hotspot temperature of 26.9°C and a coldspot temperature of 21.9°C. This temperature drop suggests that there is moisture trapped inside the ceiling, likely entering through gaps or cracks in the exterior of the building.

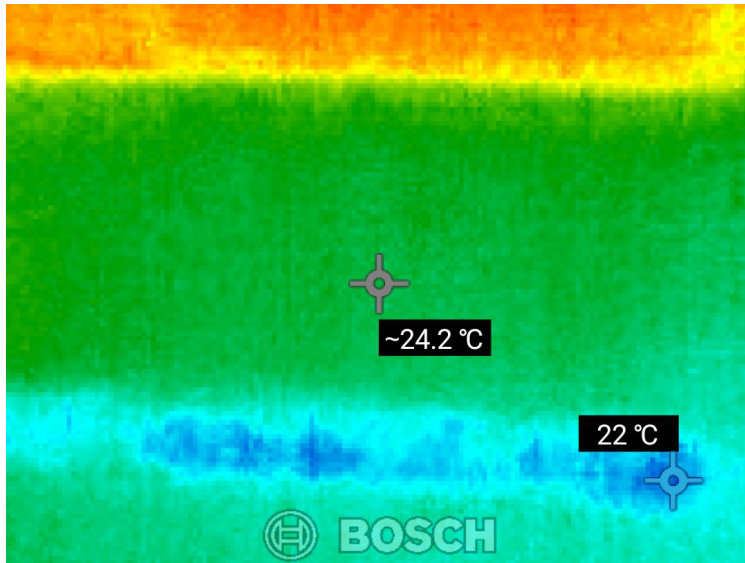
## Parking Area

The Parking Area showed leakage at the ceiling, with thermal camera readings indicating a hotspot temperature of 25.2°C and a coldspot temperature of 20.2°C. This temperature difference suggests that there is moisture present in the ceiling, which is causing the leakage. The source of the moisture is likely a leak or crack in the exterior of the building.
