# Detailed Diagnostic Report (DDR)

## 1. PROPERTY ISSUE SUMMARY

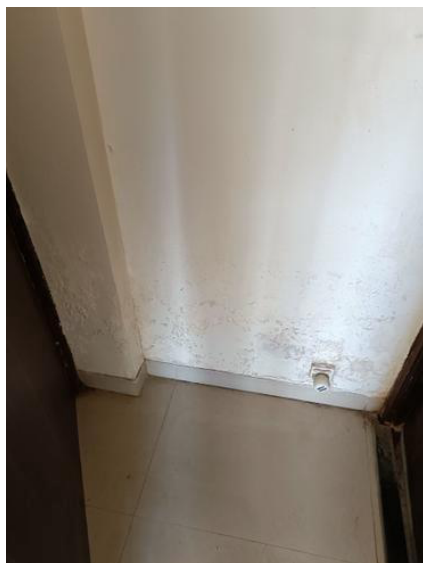
### Hall

The Hall area shows signs of dampness at the skirting level, with visible water stains and peeling paint. The thermal camera readings for this area show a hotspot of 27.4°C and a coldspot of 22.4°C, indicating a significant temperature drop, which correlates with the moisture trapped inside the wall. This suggests that the dampness is likely due to water seeping into the wall from an unknown source.

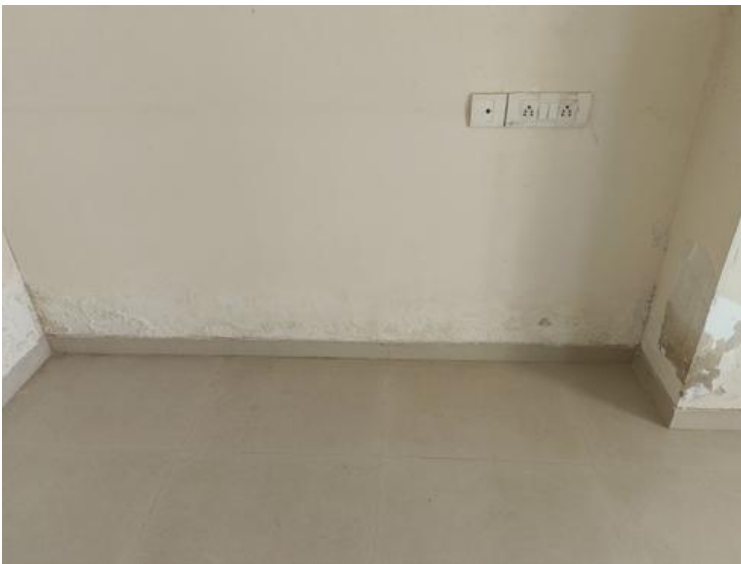
## Kitchen

The Kitchen area shows signs of dampness at the skirting level, with visible water stains and peeling paint. The thermal camera readings for this area show a hotspot of 26.2°C and a coldspot of 21.2°C, indicating a temperature drop that correlates with the moisture trapped inside the wall.

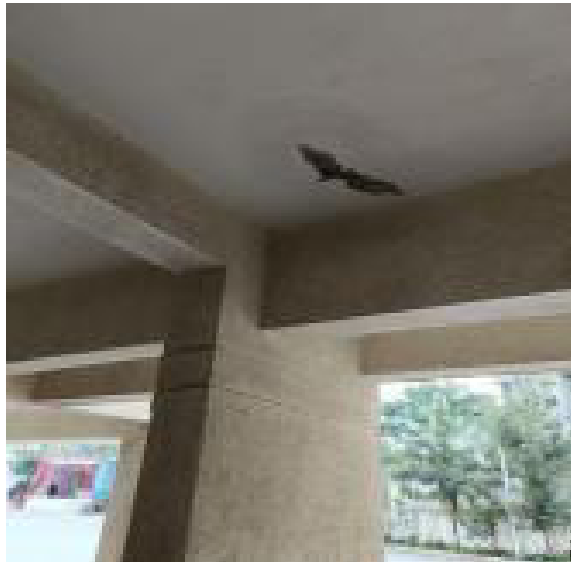
## Parking Area

The Parking Area shows signs of leakage at the ceiling, with visible water stains and peeling paint. The thermal camera readings for this area show a hotspot of 26.5°C and a coldspot of 21.5°C, indicating a temperature drop that correlates with the moisture trapped inside the ceiling.
