# Detailed Diagnostic Report (DDR)

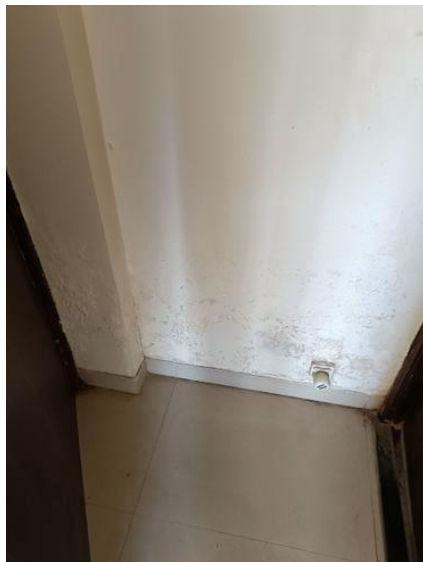
### Hall

The Hall area shows visible symptoms of dampness at the skirting level. The thermal camera readings for this area show a hotspot temperature of 27.4°C and a coldspot temperature of 22.4°C. The temperature drop correlates with the moisture trapped inside the wall, indicating a potential water seepage issue. The dampness could be due to water entering through the external wall or from the ceiling.

1. Check the external wall for any cracks or gaps and seal them to prevent water seepage.
2. Inspect the ceiling for any water leakage and repair it.
3. Check the tile joints in the bathrooms for any gaps and re-grout them.
4. Check the plumbing system for any leaks and repair them.
5. Use a dehumidifier to reduce the moisture level in the building.

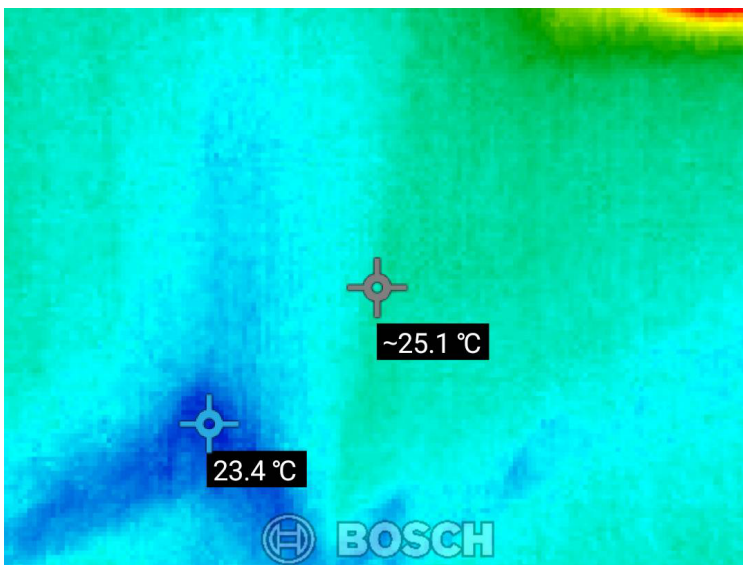
### Common Bathroom

The Common Bathroom area shows gaps between tile joints and mild dampness at the ceiling. The thermal camera readings for this area show a hotspot temperature of 26.9°C and a coldspot temperature of 21.9°C. The temperature drop indicates moisture trapped inside the wall, which could be due to water seepage or condensation.
