# Detailed Diagnostic Report (DDR)

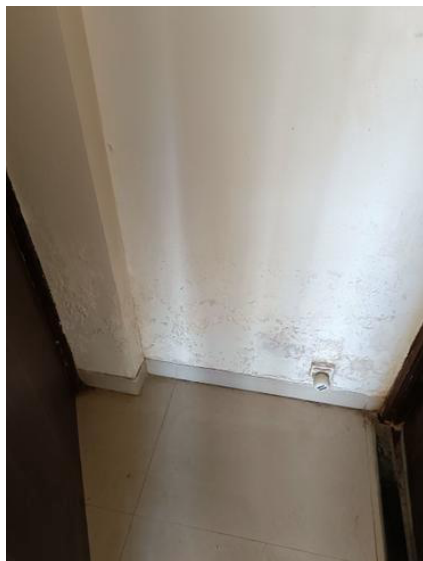
### Hall

The Hall area shows signs of dampness at the skirting level, with a visible water stain. The thermal camera readings for this area show a hotspot of 26.5°C and a coldspot of 21.5°C. This temperature drop indicates that there is moisture trapped inside the wall, causing the dampness. The moisture is likely entering the wall through a gap or crack, and then becoming trapped, leading to the dampness.

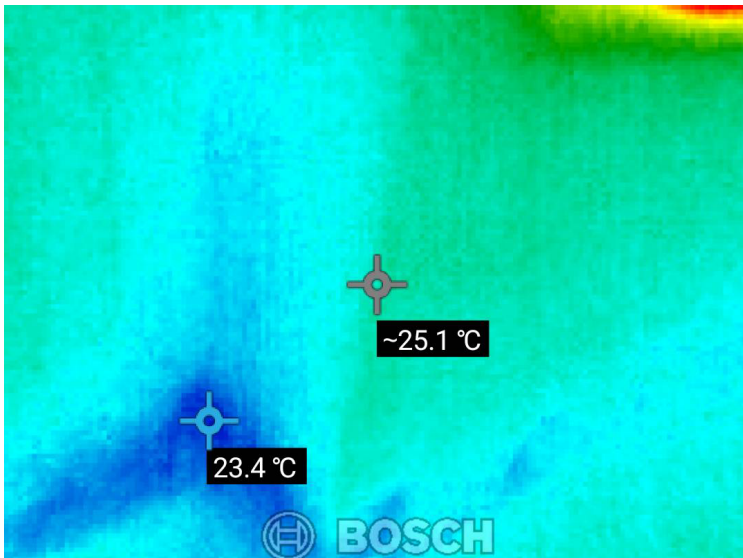
## Common Bathroom

The Common Bathroom area shows signs of gaps between tile joints, as well as a plumbing issue. The thermal camera readings for this area show a hotspot of 26.9°C and a coldspot of 21.9°C. This temperature drop indicates that there is moisture trapped inside the wall, causing the gaps between tile joints and plumbing issue. The moisture is likely entering the wall through a gap or crack, and then becoming trapped, leading to the gaps and plumbing issue.

1. Identify and seal all gaps and cracks in the walls and ceiling.
2. Repair or replace any damaged or rotten wood or other materials.
3. Improve ventilation in the affected areas to reduce moisture buildup.
4. Fix any plumbing issues, including leaks and gaps between tile joints.

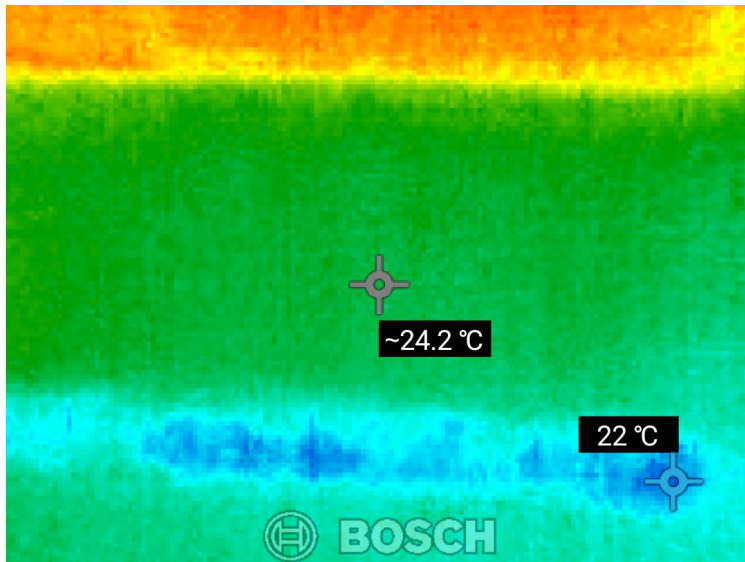
## Parking Area

The Parking Area shows signs of leakage at the ceiling below Flat No. 103. The thermal camera readings for this area show a hotspot of 25.2°C and a coldspot of 20.2°C. This temperature drop indicates that there is moisture trapped inside the ceiling, causing the leakage. The moisture is likely entering the ceiling through a gap or crack, and then becoming trapped, leading to the leakage.
