# 13th National Conference on EARTHQUAKE ENGINEERING

## Seismic Assessment of Buried Prestressed Concrete Reservoir using Nonlinear Soil-Structure Interaction Analysis

A. Nisar<sup>1</sup>, N. Doumbalski<sup>2</sup>, E. Mantchev<sup>3</sup> and W. Yen<sup>4</sup>

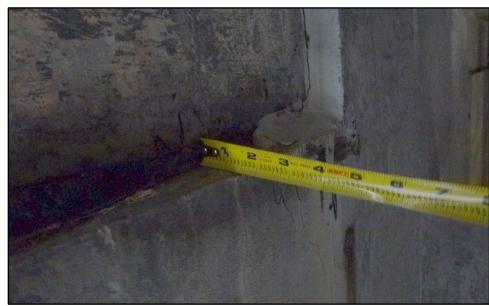
The Eastside reservoir, constructed in 1986, is a fully buried cast-in-place prestressed circular concrete tank with an outside diameter of 352 feet (Figure 2a). It was designed for Seismic Zone 3 provisions of the 1982 Uniform Building Code [1]. The reservoir has a 10-inch thick roof slab supported by the exterior reservoir wall and interior concrete columns (Figure 2b). The tapered exterior wall is prestressed in the hoop direction by cables and in the vertical direction by prestressing rods. Seismic cables (Figure 3) are the only positive connection between the wall and its foundation, allowing movement in the radial direction but restraint in the tangential direction. The reservoir floor slab is cone-shaped and provides an additional 20 feet of water depth near the center of the structure. The maximum fill-height of the reservoir along the perimeter wall is 33.5 feet. The roof-to-wall connection is through shear keys (Figure 4). Neoprene pads between the roof slab and the wall allow movement in the radial direction. A shift of as much as 1.5 inches in the shear keys between the wall and the roof was observed at multiple locations. This movement could have been a result of the 2001 Nisqually earthquake but it cannot be confirmed.

(b) Movement at Shear Keys
