# Seismic Assessment of Buried Prestressed Concrete Reservoir using Nonlinear Soil-Structure Interaction Analysis

Figure 2. 30 MG Buried Prestressed Concrete Reservoir.

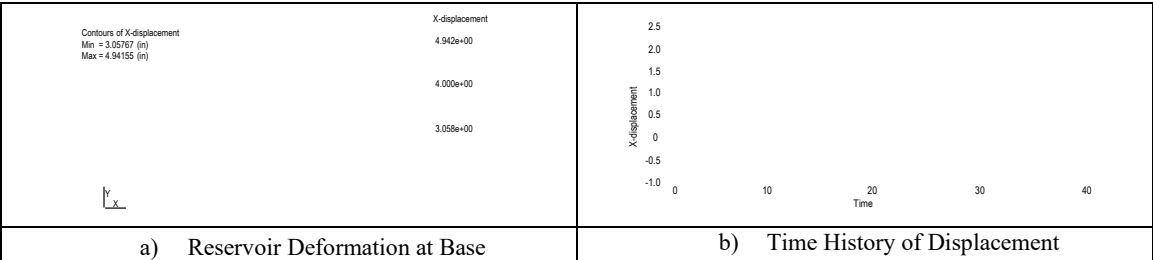
Figure 6. Relative Displacement between Foundation and Floor Slab.

The results of the analysis showed a generally good performance of the reservoirs with three significant vulnerabilities. For 975-year return period and higher ground motions hoop stress in the upper 3 to 4 feet of the reservoir wall exceed capacity and there is a potential for several inches of sliding at the wall base (Figure 6). The assessment also showed potential risk of cracking the shear key corners due to brittle reinforcing detail. Although costly to repair, the risk of major damage and loss of water for this vulnerability is low.
