SP2 Report on

Reactions of CAC in the Field Hydration, Conversion, Carbonation and Corrosion

Part 1: Thermal Analysis

SWSOOS 2 North Cell, Hayden Place, Banksmeadow (6 years)

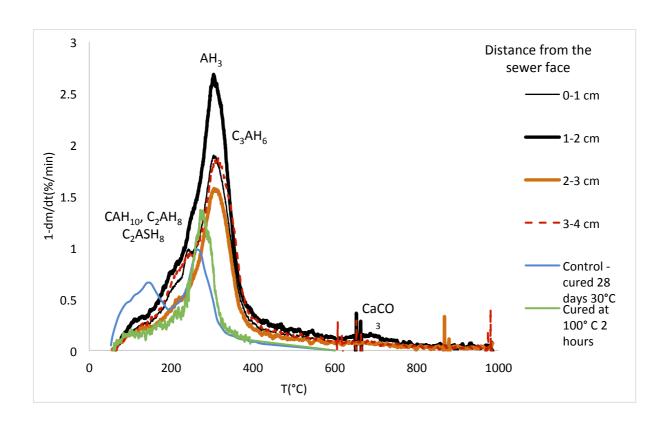
Figure 1. DTG profile of CAC taken from 1000 mm above the sewage floor (tidal zone)

The CAC hydrates were identified according to Table 1. The differential thermal gravimetric analysis (DTG) of CAC obtained from the tidal, wall and roof are shown in Figures 1-3 respectively.

The DTGs of the 6 year CAC specimen are compared with the DTG of a control sample cured for 28 days at 30°C and CAC cured for 2 hours at 100°C. It is apparent that compared to the control CAC, the progression of conversion in CAC after 6 years appear substantial. When compared with CAC cured at 100°C, the extent of conversion after 6 years is also substantial. These are evident from the reduction in the metastable peaks between 100-200°C and both the rise in C₃AH₆ at 310-350°C and AH₃ at 270-290°C. The quantities of the CAC hydrates varied across the coating and these variation is attributed to the effects of hydration, conversion and corrosion. In the tidal zone sample, it appears there is very little of the C₃AH₆ phase that is loss. However in the wall sample (Figure 2) and roof sample (Figure 3), the greater loss of C₃AH₆ closest to the sewer front demonstrate the greater corrosivity of this phase.

As shown in Figure 1-3, there is a definite loss of C_3AH_6 from the various DTG peaks closest to the sewer front. A plot of C_3AH_6 profile in Figure 8 shows the corrosion effect more clearly. As shown greater loss of C_3AH_6 was observed at the sewer front, progressively decreasing with CAC samples close to the concrete. The loss is more extensive in the roof and wall, and is significantly less in the tidal zone. This could be attributed to the biogenic acid formation promoted on the walls, whereas the corrosion effect may be neutralised by the alkaline nature of the sewage near the tidal zone.

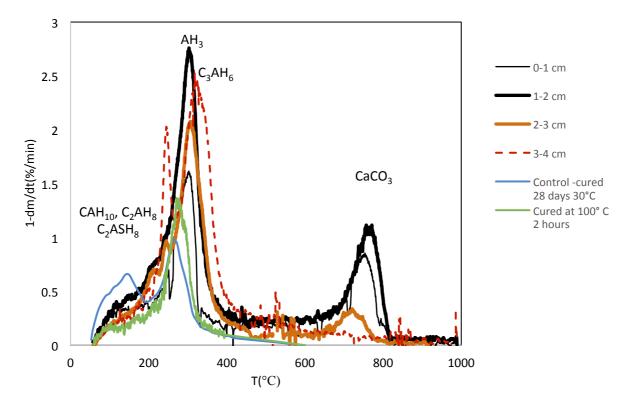
Figure 3. DTG profile of CAC taken from the roof.

CAC was also subjected to the carbonation reaction and this is apparent from the formation of CaCO₃ around 600-800°C. Carbonation affected all the samples principally on the top layers closest to the sewer face. Its effect on the tidal zone and wall samples were not significant, whilst its effect on the roof sample was noticeable and appear only the remaining 1 cm layer closest to the concrete substrate was unaffected by carbonation.

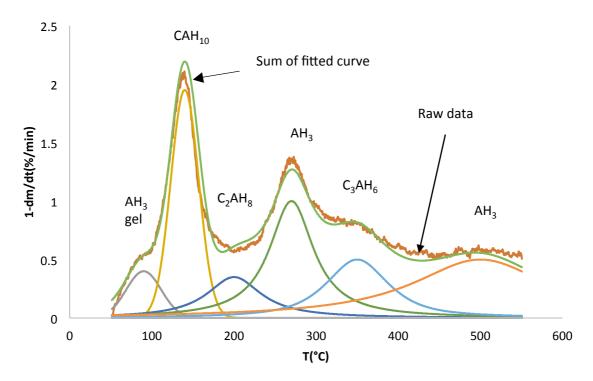
Figure 4. Curve fitting analysis of CAC coupon installed in Sydney North Barrel for 24 months.

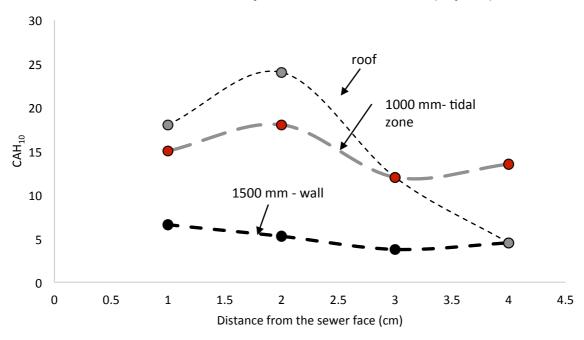
Figure 5. Distribution profile of CAH₁₀ across CAC.

The quantities of the metastable phases (CAH_{10} and C_2AH_8) are likely to be subjected by the their formation by the hydration of calcium aluminate (CA) and removal by their conversion to the stable phase. The net effect of these reactions are show in Figures 5 and 6 respectively. The amount of CAH_{10} progressively decreased from the sewer front towards the concrete substrate. This was balanced by counter increase in C_2AH_8 .

This suggests that the low CAH_{10} closest to the substrate means most of this phase has been converted to C_2AH_8 according to equation (9). However because C_2AH_8 closest to the concrete substrate remained high its subsequent conversion to C_3AH_6 must have been slower. Whilst CAC closer to the sewer front showed slower CAH_{10} conversion but faster conversion of C_2AH_8 . This is evident in the lower areas of C_2AH_8 and higher AH_3 in Figure 7. The amount of AH_3 generated reflects the extent of conversion. In general it appear the rate determining step in overall rate of conversion of CAC appear to depend on the conversion of C_2AH_8 and this is faster closer to the sewer front progressively decreasing close to the substrate.

The relative difference in the metastable phases based on the various location of CAC is also noticeable. It is apparent that the wall has the least amount of CAH_{10} and C_2AH_8 . Figure 7 shows the amount of CAH_{10} generated is also lower relative to the roof and tidal zone. This suggests these lower metastable phases are attributed to the lower hydration reaction in the

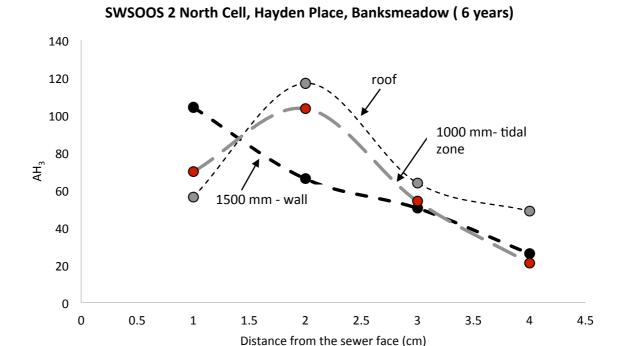
Figure 7. Distribution profile of AH₃ across CAC.

Figure 7 shows also the loss of AH₃ at the sewer front of the roof and tidal samples. Greater amounts of this gibbsite phase are removed in the roof and tidal zone in comparison to the wall.

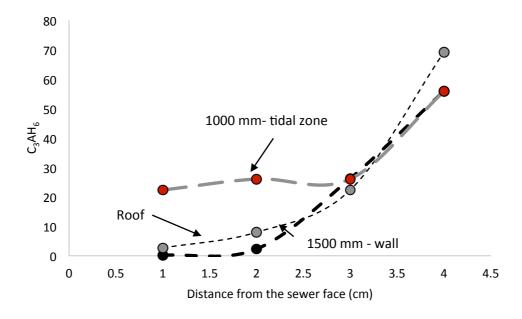
Figure 8. Distribution profile of C₃AH₆ across CAC.

least. However as shown in Figure 8, the C_3AH_6 are all significantly lower above this position, demonstrating the extent of C_3AH_6 corrosion. It should be noted that part of the roof C_3AH_6 have also been converted to $CaCO_3$.

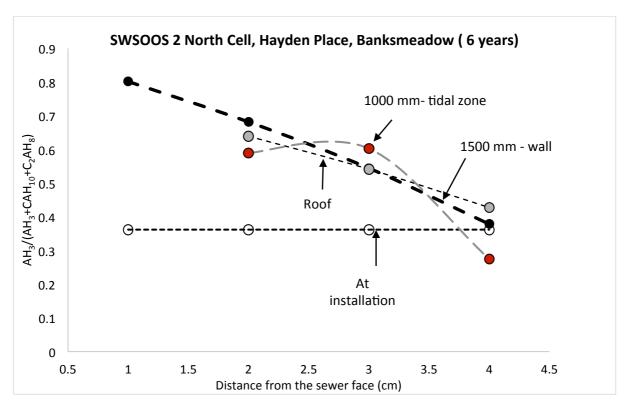
Figure 9. Distribution profile of conversion across CAC.

Because the sewer front of the CAC specimens are subjected to corrosion, which includes the removal of AH₃, the conversion estimated at this region may be less than what is experienced by the sample. In the roof and tidal samples, where there is significant removal of AH₃, the conversion were excluded. The estimated conversion profiles are shown in Figure 9. As shown the conversion at the sewer front is greater than close to the substrate. The conversion close to the substrate is very similar to the conversion at the beginning of the installation, which suggest very little progression in conversion has occurred here. The conversion at the beginning of the installation was estimated from a control sample that was cured for 48 hours at 21°C. This observed conversion profile is consistent with the observed trends in the metastable profiles observed in Figure 5 and 6. The extent of conversion in first half of the CAC sample is between 70-80% and the remaining half is from 35-70%. This suggests these first half would be subjected to greater rate of corrosion. The greater loss of C₃AH₆ and AH₃ in this first half (see Figure 7 and 8) confirms this. The location does not appear to affect the conversion.
