# Home Survey

Address: 482 Willow Creek Lane, Green Valley, AZ 85614

Survey Date: September 23, 2022

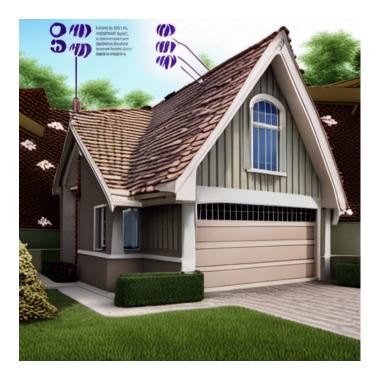
#### Roof

Type: Tile

Estimated Age: 3 years Condition: Excellent

Notes: Newer roof in great condition.
