# Radiation Tests: SIHFS9N60A MOSFET

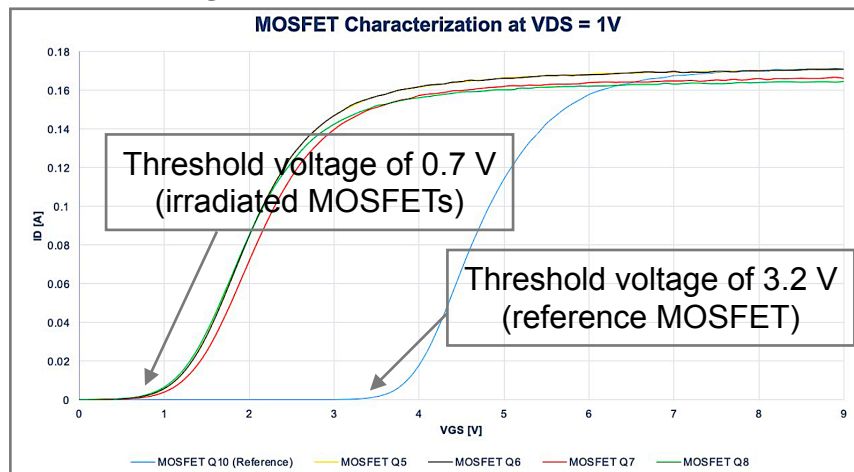
- SEE tests performed at a flux of  $3.5 \times 10^8$  p/cm<sup>2</sup>/s
  - The chips were biased and monitored for SEEs, and no events observed up to  $3.4 \times 10^{11}$  p/cm<sup>2</sup>), **passing the SEE tests**
  - The chips were characterized at CERN after irradiation and a shift of 2.5 V were observed in gate-source threshold voltage after 200 Gy (a very small effect in brick's performance)
- Performed at 3 Gy/h followed by annealing, **TID tests showed a smaller shift in gate-source threshold voltage, and were passed**
- **NIEL tests showed very small deviation in characterization** (due to gamma radiation in reactor)

MOSFET characterization after TID of 200 Gy

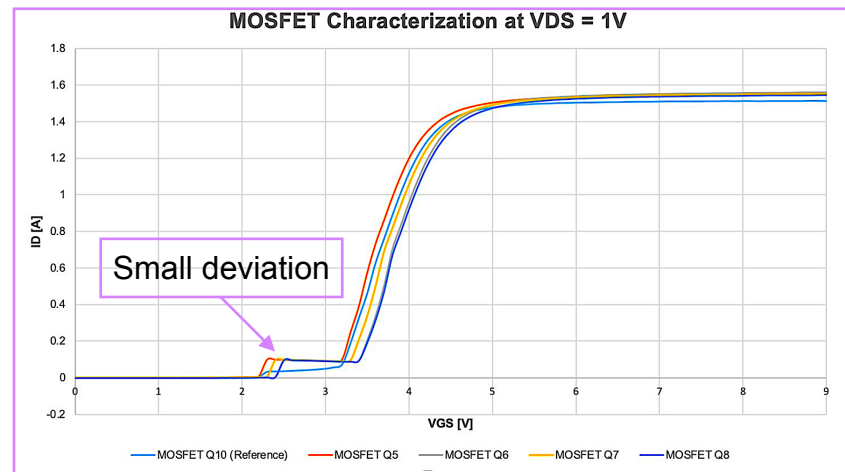
MOSFET characterization after NIEL tests
