### Kobo Sage

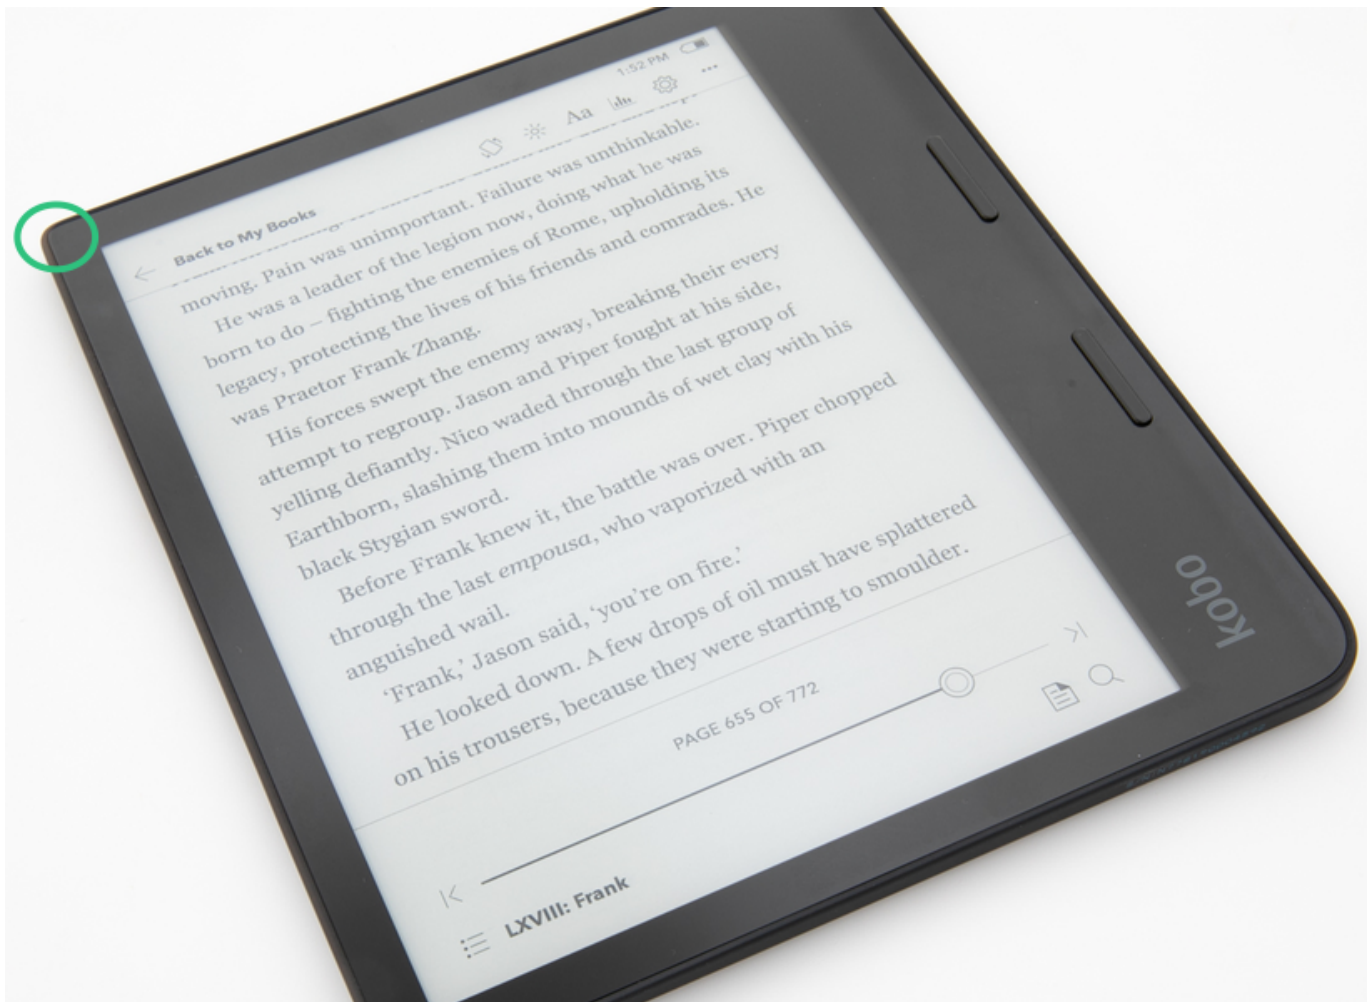
I found that the top left corner (marked below) was the easiest to open when I applied a little force with my fingers (not nails—do not stick your nails between the screen and the cover). If you use a tight case with your e-reader, there is always one corner that takes more pressure than the others when you remove it. Without exaggerating, apply a bit of force to the thin corners and see if they yield a little space.

I do not recommend starting from the more rounded corners on the button side. Specifically, on the top-right, there is a screen connector and even more sticky adhesive above it. Also, **please do not take the chance of sticking anything sharp into the top-right corner; do not risk tearing that screen connector.** (Fixing and soldering a torn ribbon cable is extremely difficult and requires too much attention, patience, time, and specialized equipment).

After getting a small opening in one corner, you will need a prying tool that is **flexible**, **blunt**, and **thin**. I used a couple of plastic picks. The adhesive goo is not on the vertical sides; it is attached where the back cover meets the internal chassis, parallel to the surface.

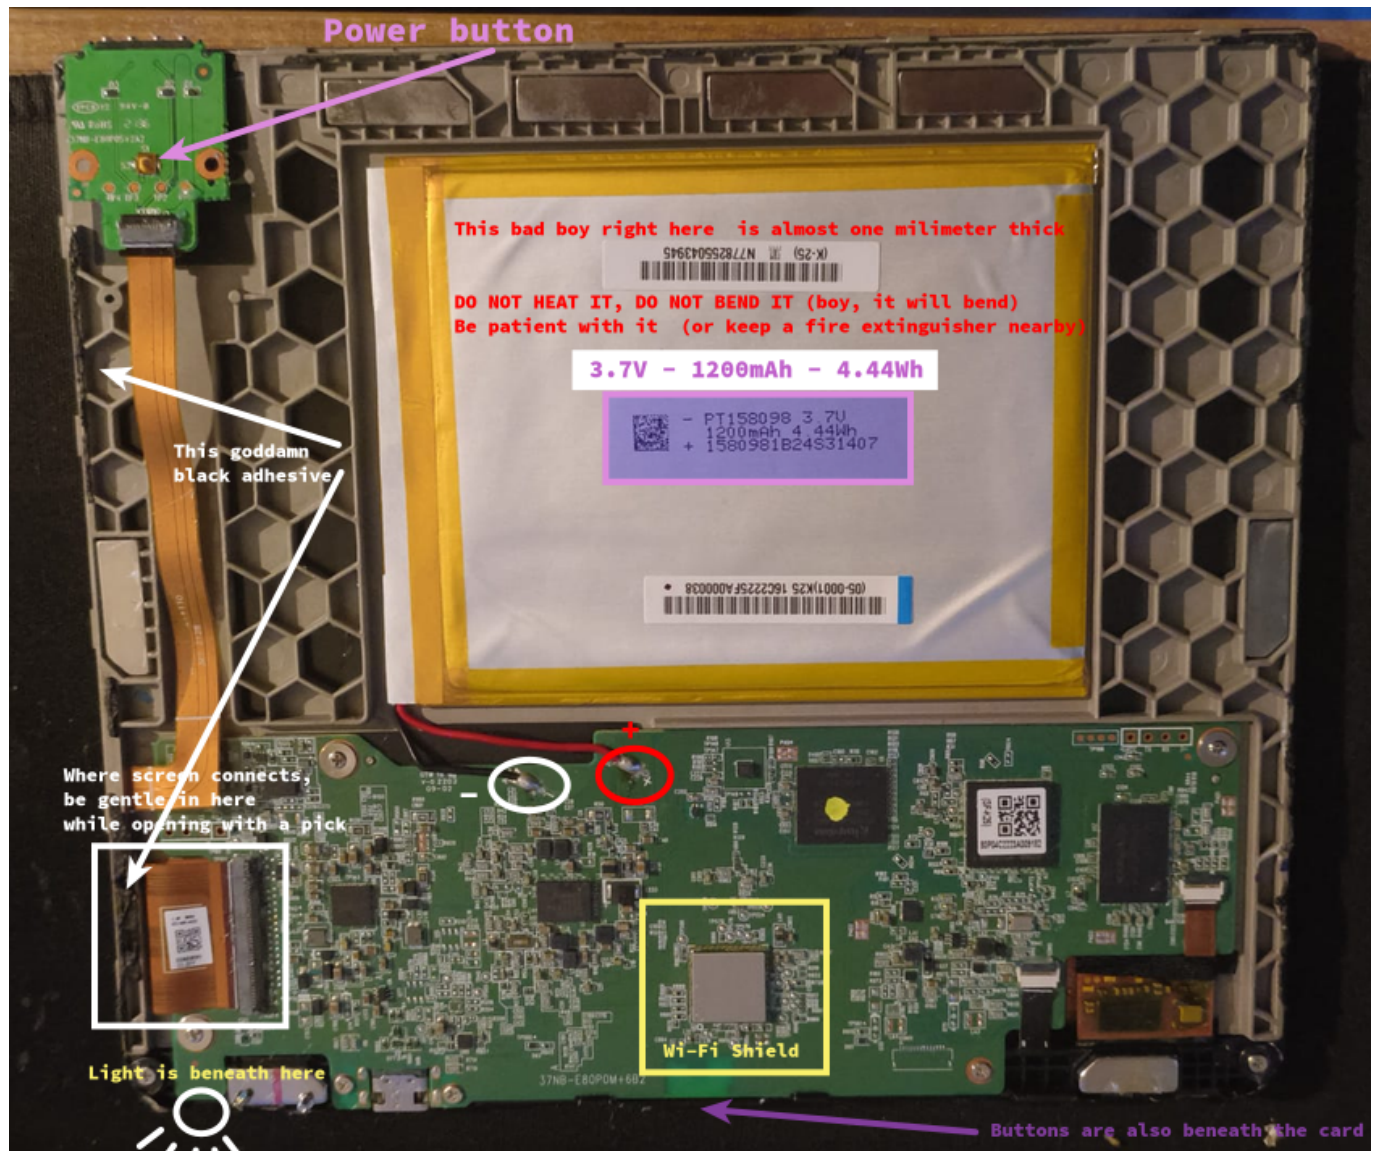
- The battery cables are directly soldered to the motherboard, and the solder points have a small transparent protector over them.
- It's no wonder the power button felt weird before; it looks even more ridiculous when you see the actual switch mechanism they opted for.
- The battery takes up a lot of space, but don't be fooled by its footprint; it is EXTREMELY THIN. If you want a perfect OEM-style solution, you can try to buy a battery with the exact dimensions (which will be very hard to find, mind you). But if you are just repairing it for functionality, there are other batteries that, while not a perfect fit size-wise, won't prevent the back cover from closing properly.

Here is a sneak peek of the internals. Take a look at the image below.

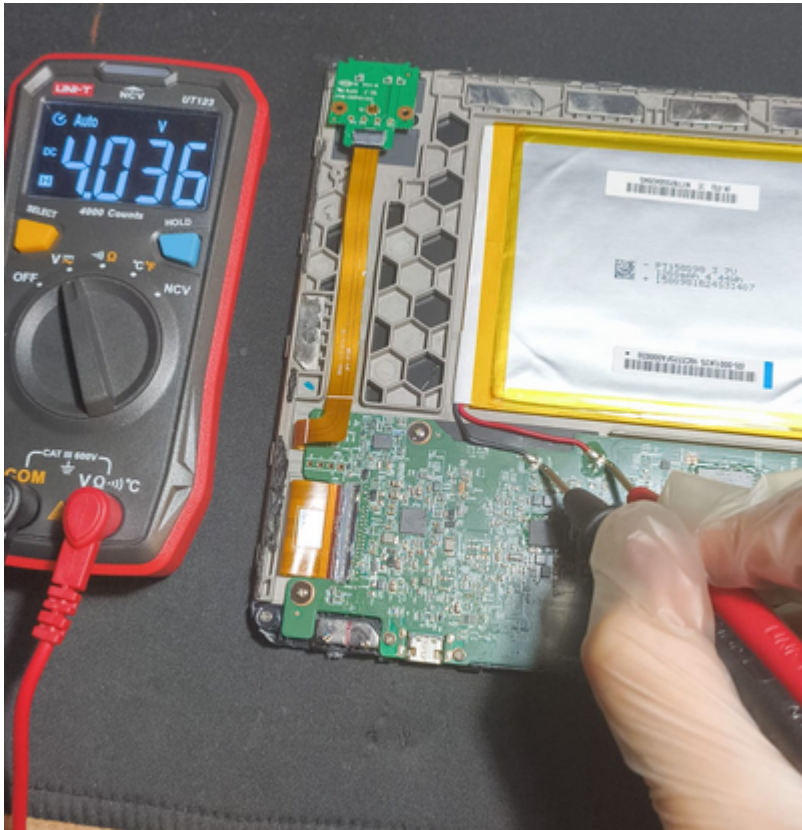
I scraped off a little of the protective glue on the battery solder points to get a decent reading and placed my multimeter probes. While the device was frozen or just sitting idle, I measured 4V. However, when I pressed the power button while monitoring the values, the voltage suddenly dropped to 3.4-3.5V. This voltage sag was the reason the PMIC kept locking out my device; it was registering values below the expected operating voltage under load.
