16/655/0276

Tensile and bending test on sheet pilling clutch bars

SteelWall ISH GmbH

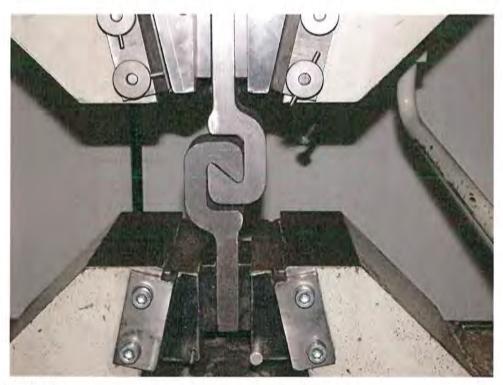
Figure 1: Overview photo, sample no. 1 (LBP300-20), Test setup

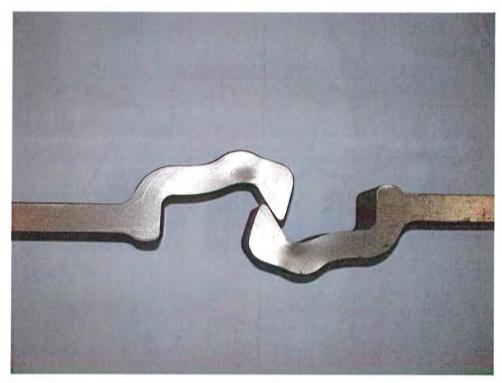
Figure 2:
Overview photo, sample no. 1 (LBP300-20), after test, failure by deformation

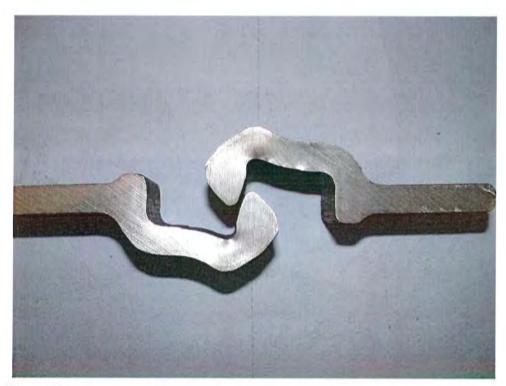
Figure 6:
Overview photo, sample no. 7 (LBP180-12), after test, failure by deformation

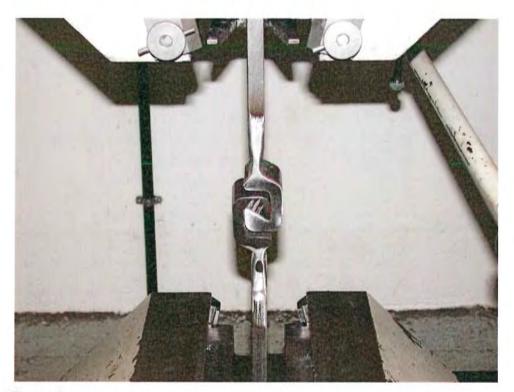
Figure 9: Overview photo, sample no. 14 (LBP100-10), Test setup

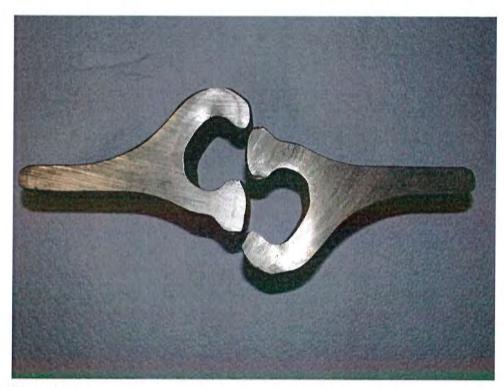
Figure 12:
Overview photo, sample no. 17 (FD180-12), after test, failure by deformation

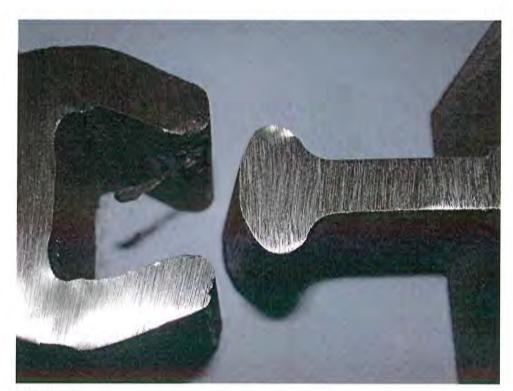
Figure 16:
Overview photo, sample no. 21 (PZM/PZF), after test, failure by deformation

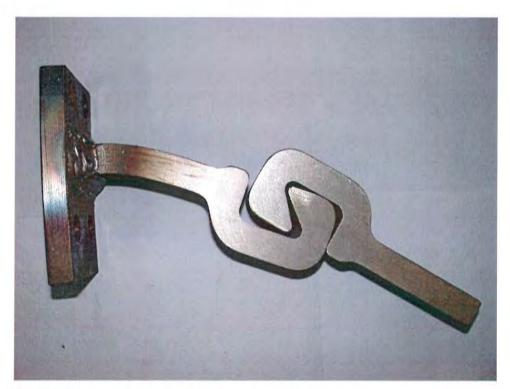
Figure 18:
Overview photo, sample no. 2 (LBP300-20),
Deformation after test

Figure 19: Overview photo, sample no. 2 (LBP300-20), Deformation after test

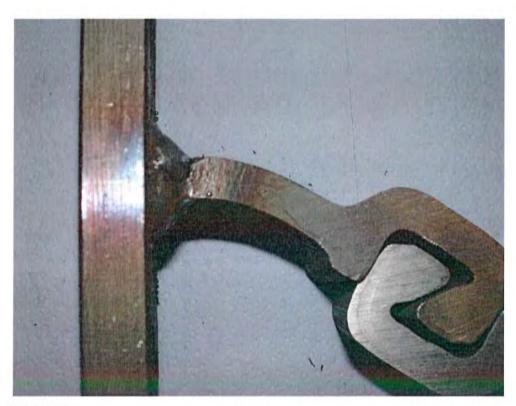
Figure 27:
Overview photo, sample no. 9 (LBP180-12),
Deformation after test

Figure 28:
Overview photo, sample no. 9 (LBP180-12),
Deformation after test

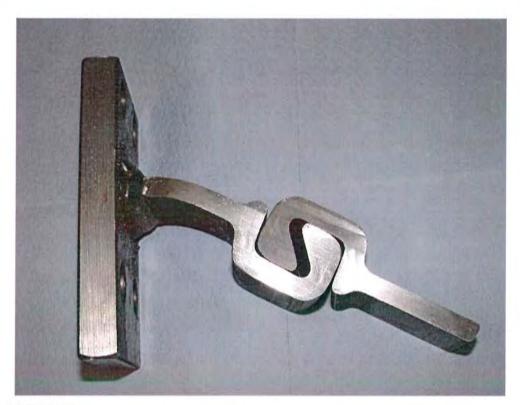
Figure 30:
Overview photo, sample no. 12 (LBP180-10),
Deformation after test

Figure 31:
Overview photo, sample no. 12 (LBP180-10),
Deformation after test

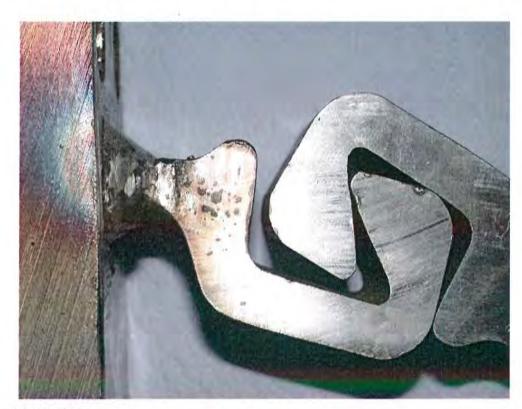
Figure 33:
Overview photo, sample no. 15 (LBP100-10),
Deformation after test

Figure 34:
Overview photo, sample no. 15 (LBP100-10),
Deformation after test

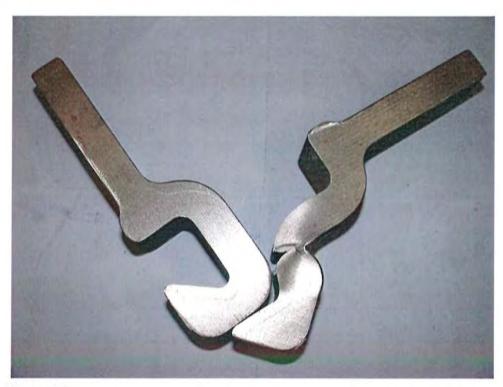
Figure 36:
Overview photo, sample no. 3 (LBP300-20),
Deformation with break after test

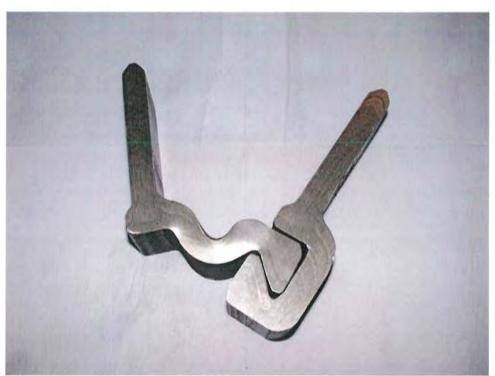
Figure 37:
Overview photo, sample no. 6 (LBP300-16),
Deformation after test

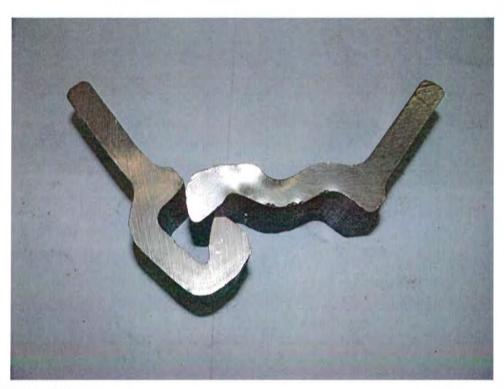
Figure 38:
Overview photo, sample no. 10 (LBP180-12),
Deformation after test

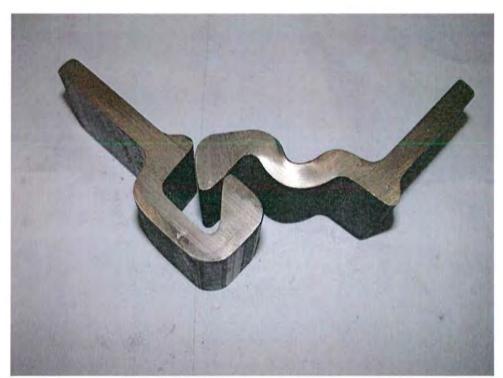
Figure 39:
Overview photo, sample no. 13 (LBP180-10),
Deformation after test

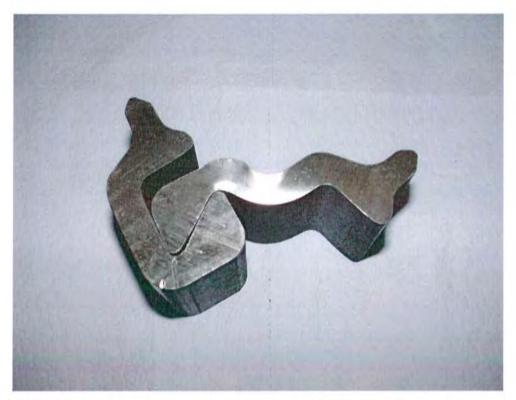
Figure 40:
Overview photo, sample no. 16 (LBP100-10),
Deformation after test

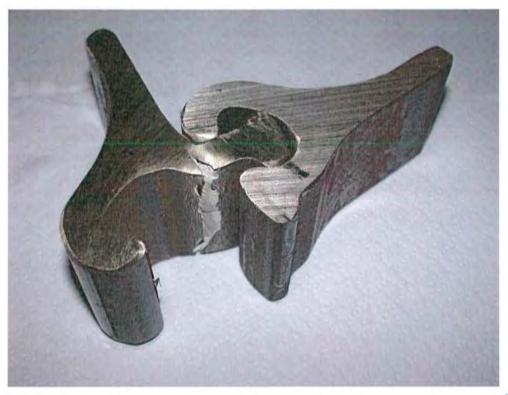
Figure 41:
Overview photo, sample no. 18 (FD180-12),
Deformation with break after test

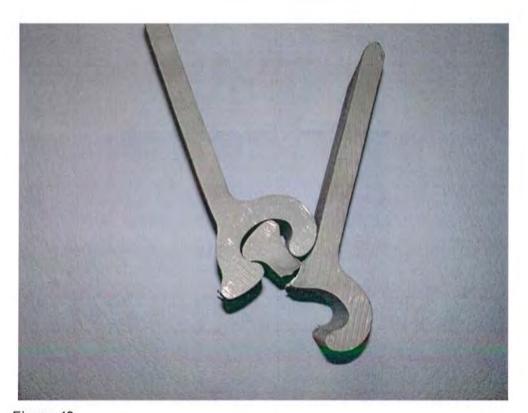
Figure 42:
Overview photo, sample no. 20 (FD300-12),
Deformation after test

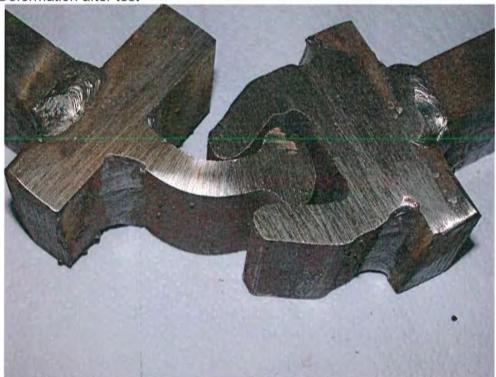
Figure 43:
Overview photo, sample no. 22 (PZM/PZF),
Deformation after test
