Test Report 19/657/0135-2

Tensile test on sheet piling clutch bar LPB100-9A

SteelWall ISH GmbH Tassilostr. 21 82166 Gräfelfing

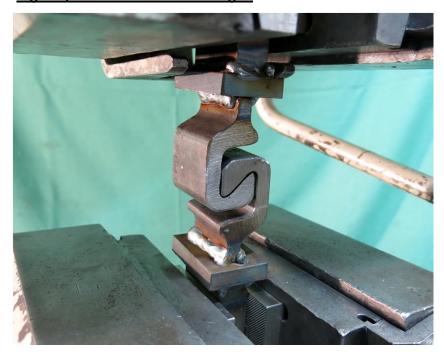
Figure 1.1:
P4Z1 (LPB100-9A)
test setup

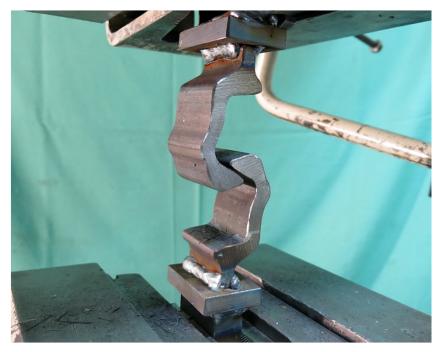
Figure 1.2:

P4Z1 (LPB100-9A) after testing, failure through deformation

Sample no.	Maximum force F _m		Length of the clutch bar		Length-related maximum resilence		
Sample no.	[kN]	[lb]	[mm]	[in]	[kN/m]	[t/m]	[kip/in]
P4Z1 (LPB100-9A)	44,52	10.008,48	48,80	1,92	912,30	93,03	5,21
