# Open-FDD AI Agent Report

AHU · ACME Office · Detroit, MI

• June 2026, 72 samples,  $\Delta t \approx 60$  min, span 72.0 h

## AHU\_1

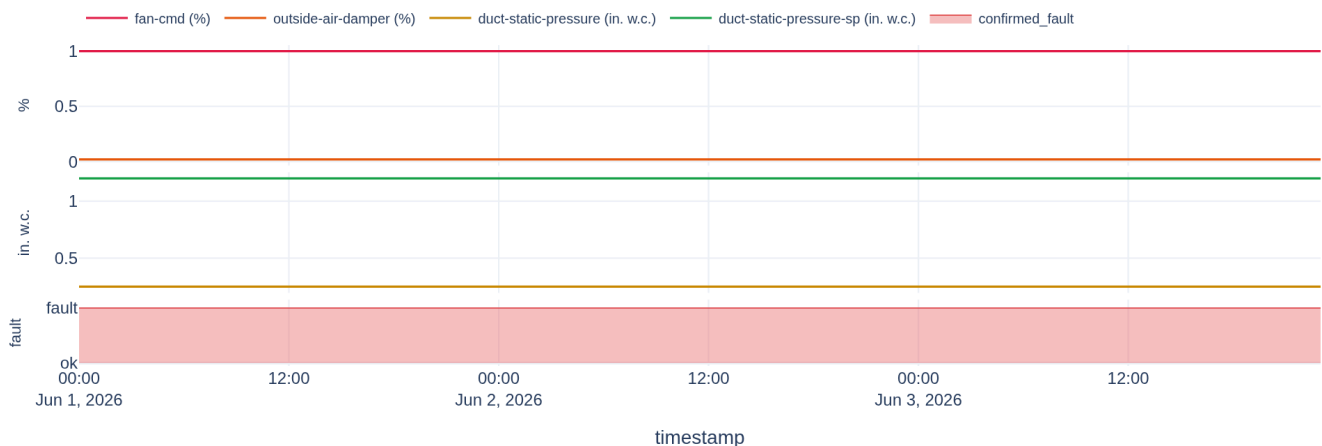
#### FC1 – Duct static below SP at full fan (GL36 A)

Troubleshoot: Flags duct static too low while the supply fan is near full speed. Check:  $DSP < DSPSP - \epsilon DSP$  AND  $VFDSPD \geq 100\% - \epsilon VFDSPD$ .

In the data: In June 2026 this holds for 72.0 hours, 2026-06-01 00:00 UTC through 2026-06-03 23:00 UTC. duct static pressure was on for 0.0 percent of those samples; duct static setpoint was on for 100.0 percent of those samples; fan speed command was on for 100.0 percent of those samples.
