# Open-FDD AI Agent Report

AHU · ACME Office · Detroit, MI

• June 2026, 72 samples,  $\Delta t \approx 60$  min, span 72.0 h

## AHU\_1

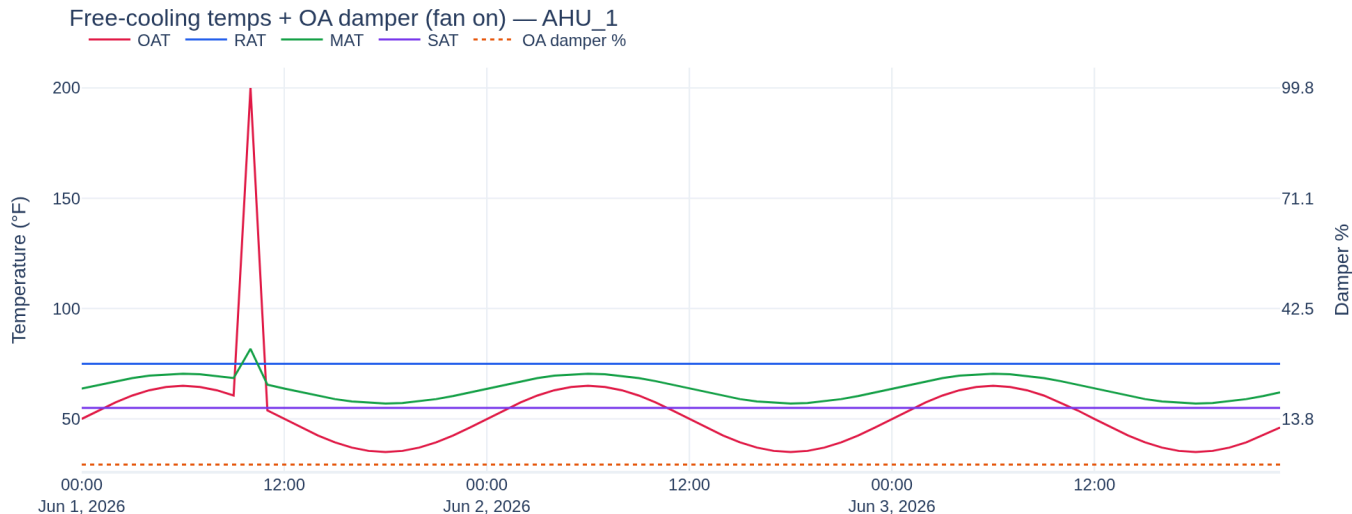
Free-cooling temperatures and outdoor-air damper

Outdoor air temperature read outside its physical range (low 35.0, high 200.0). Return air temperature and supply air temperature stayed stuck flat. Outdoor air temperature jumped suddenly and changed faster than expected.

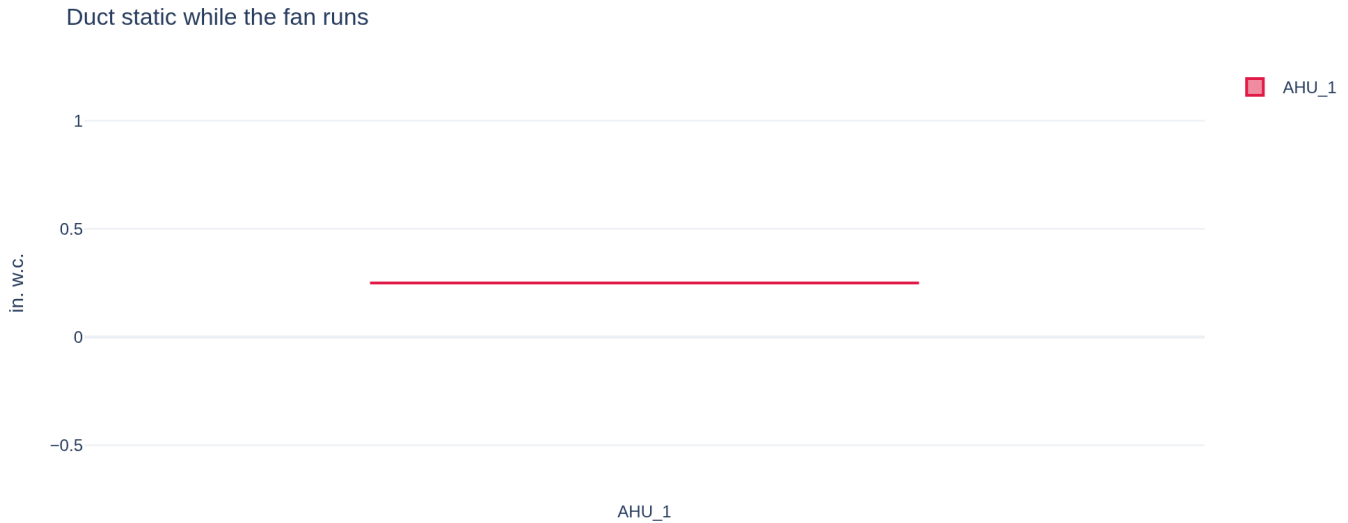
Duct static while the fan runs

Duct static pressure with the fan running.

#### FC1 – Duct static below SP at full fan (GL36 A)

Troubleshoot: Flags duct static too low while the supply fan is near full speed. Check:  $DSP < DSPSP - \epsilon DSP$  AND  $VFDSPD \geq 100\% - \epsilon VFDSPD$ .

In the data: In June 2026 this holds for 72.0 hours, 2026-06-01 00:00 UTC through 2026-06-03 23:00 UTC. duct static pressure was on for 0.0 percent of those samples; duct static setpoint was on for 100.0 percent of those samples; fan speed command was on for 100.0 percent of those samples.

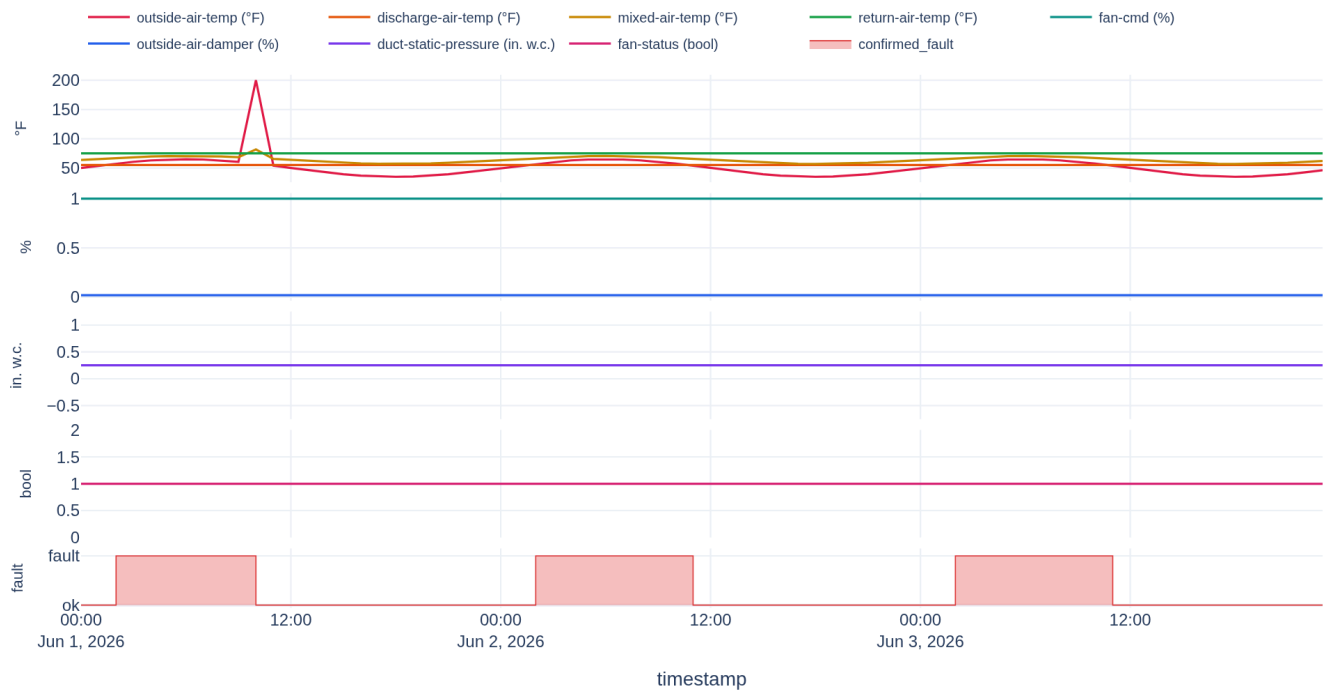
#### ECON-1 – Economizer stuck closed

Troubleshoot: Fan on, OA damper < 5%, OAT > 55°F (should be economizing). Check: Fan on, OA damper < 5%, OAT > 55°F (should be economizing).

In the data: In June 2026 this holds for 26.0 hours, 2026-06-01 02:00 UTC through 2026-06-03 10:00 UTC. fan speed command was on for 100.0 percent of those samples; outdoor air damper was on for 0.0 percent of those samples; outdoor air temperature was about 63.0.

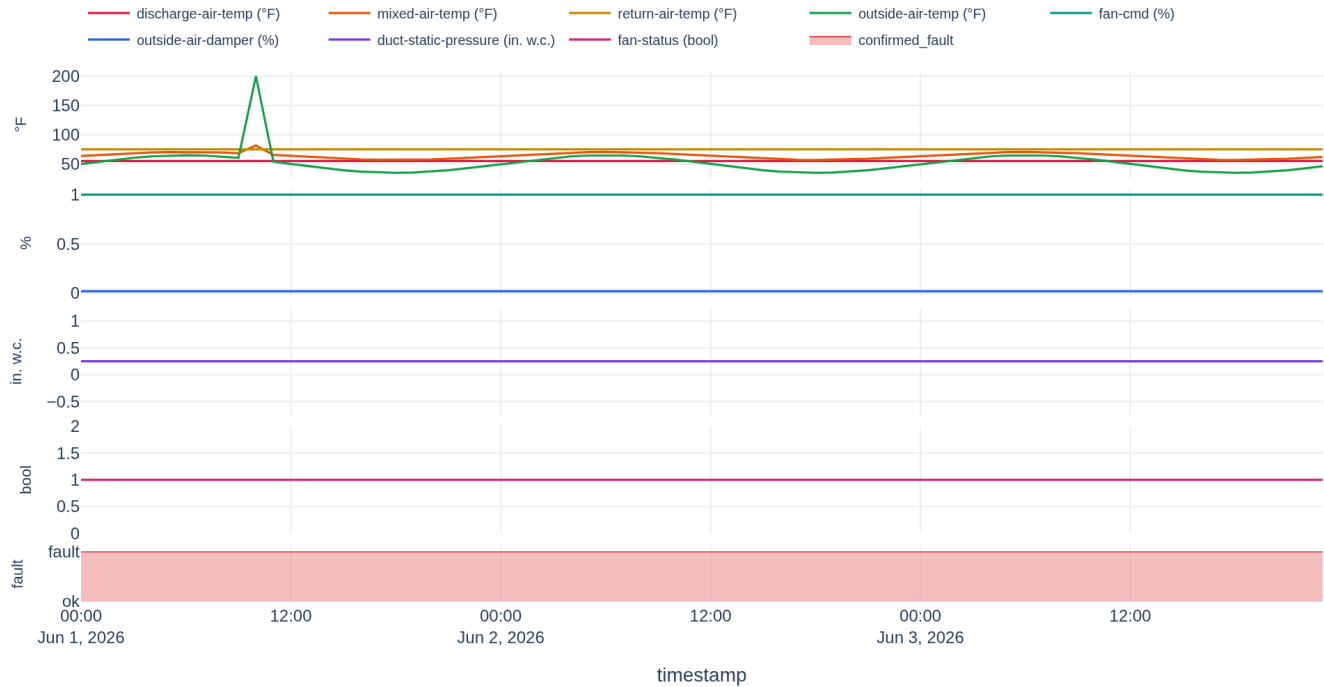
#### SCHED-247 – Always-on fan or pump runtime

Troubleshoot: Flags fans or pumps that stay on for nearly the entire analysis window (24/7 runtime). Check: Ranked proof (status/current > command) is on for  $\geq$  always\_on\_pct of the window. Pressure is inferred runtime only and does not trip this rule ID.

In the data: In June 2026 this holds for 72.0 hours, 2026-06-01 00:00 UTC through 2026-06-03 23:00 UTC. fan status was on for 100.0 percent of those samples; fan speed command was on for 100.0 percent of those samples; duct static pressure was on for 0.0 percent of those samples.

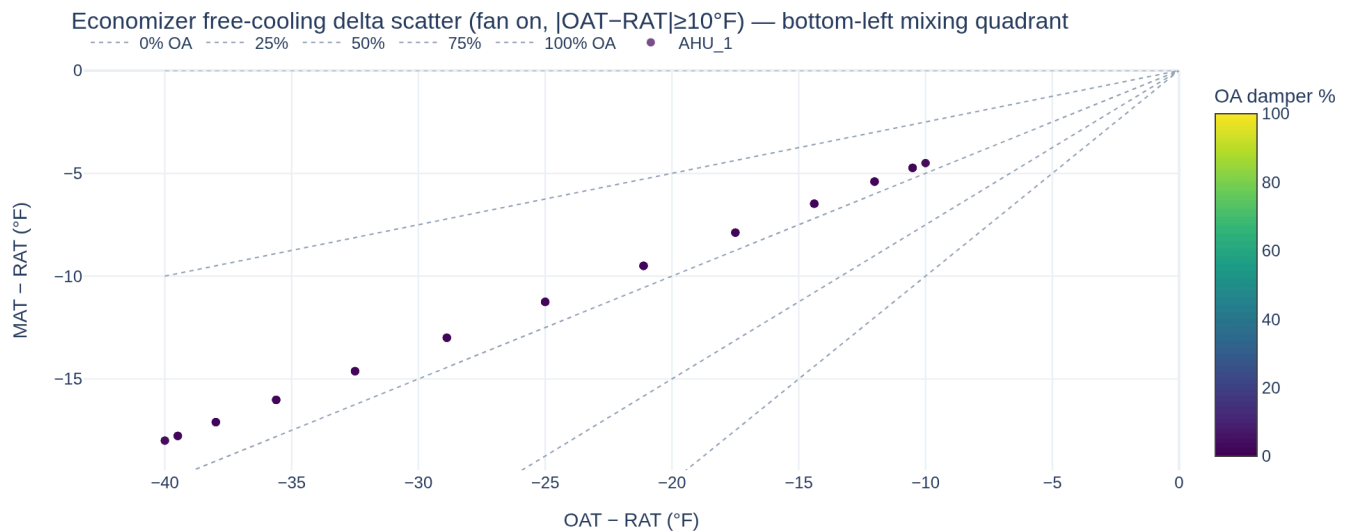
## Economizer delta scatter

Outdoor-air mixing with the supply fan on. The horizontal axis is outdoor-air temperature minus return-air temperature ( $OAT - RAT$ ). The vertical axis is mixed-air temperature minus return-air temperature ( $MAT - RAT$ ). The view is the bottom-left diagnostic quadrant only, where outdoor air is at or below return air and mixed air is at or below return air. A sample is plotted only when the fan is on and the absolute difference between outdoor air and return air is at least  $10^\circ F$ , so the outdoor-air fraction is identifiable.
